Effects of Degradation in Textolite Elements of Damaged Surge Arresters

Keywords: surge arrester; TSE glass textolite; discharge (short circuit) current; EDS method

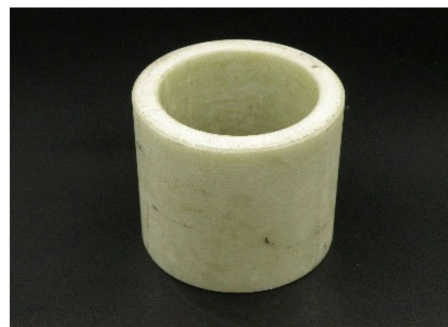
Typical textolite bushing support without degradation effects obtained from a 110 kV surge arrester that was removed from operation is shown in Figure 1. It had a height of 72 mm, an outer diameter of 80 mm and a hole diameter of 60 mm. It served as a reference sample and material for the remaining samples with very different degrees of degradation.

Figure 1. Textolite bushing support that came from an operated 110 kV surge arrester. Due to the lack of any degradation effects, the element was taken as a reference sample.

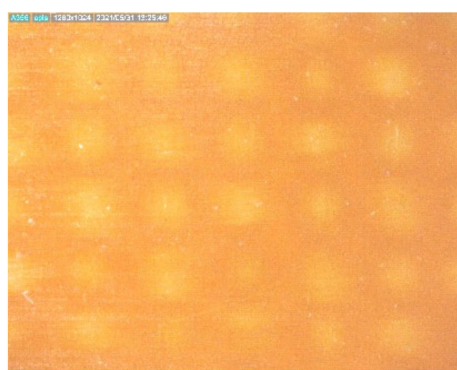
The textolite support had a bright colour and was carefully examined. Figure 2 presents the microscopic image (MO) of the material. The photo shows the fibre bundles of the textile support (roving), but they were covered with a layer of transparent epoxy resin and were located under the surface of the textolite material. The surface of the laminate was quite smooth and free of cracks, which was confirmed using an SEM investigation.

Figure 2. MO image of the surface of the reference sample textolite material (40 times magnification). The lighter weave of the support fabric is visible as fibreglass under a transparent resin layer.

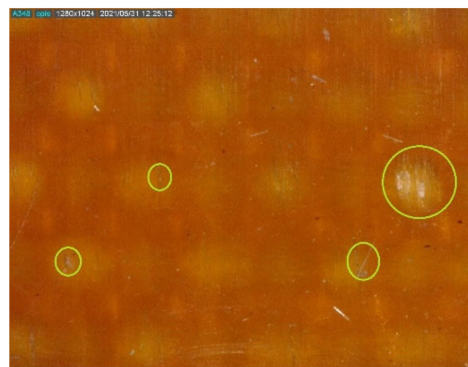
Figure 4 shows the textolite material of the element from the operated HV surge arrester, in which there were weak degradation effects, mainly slight carbonisation of the epoxy resin. The device was removed from service in a 110 kV system after almost 10 years of operation due to increased leakage currents. Some depressurisation of the surge arrester structure and the presence of moisture were found inside. However, there were no strong discharges inside the device. The MO photo demonstrated a change in the colour of the textolite material of the element, which had clearly darkened. Moreover, small fragments of the textile support appeared on the surface, which resulted from the local melting of the

Figure 4. MO image of the textolite material's surface with initial degradation effects (40 times magnification). There was a visible change in the colour of the material, indicating the process of carbonisation of the organic resin. Small fragments of the fibreglass textile support began to appear on the surface (marked in circles).

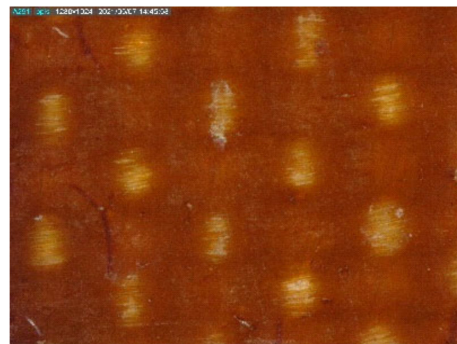
Figure 6 shows the MO image of the material structure of a textolite support from a decommissioned surge arrester with clear degradation effects. Due to the high increase in the value of leakage currents, the three surge arresters, which were operating in various phases of a 110 kV system at the transformer substation, were dismantled after about 10 years of operation. The cause of the malfunction was a loss of tightness of the devices. All three elements were disassembled to obtain test samples. As a result of the flow of discharge currents inside the surge arresters, the local temperature increased significantly. Consequently, in some areas of the tested elements, the organic epoxy resin was significantly carbonised. This was evidenced by the change in the colour of the material to an intense brown. There were several bundles of fibres from the textile support, which appeared on the surface of the material as a result of melting the top layer of the epoxy resin. Moreover, on the surface of the material, there was a network of small cracks in the epoxy resin, which are clearly visible in Figure 7.

Figure 6. MO image of the surface of the textolite material with clearly marked degradation effects (40 times magnification). Shiny bundles of fibres of the textile support are visible. They appeared on the surface of the material after the top layer of the resin had melted.

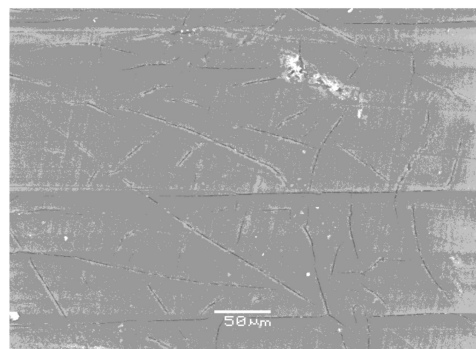
Figure 7. SEM image of the textolite material surface with clearly marked degradation effects at a high magnification of 300 times. A network of small cracks in the resin surface is visible.

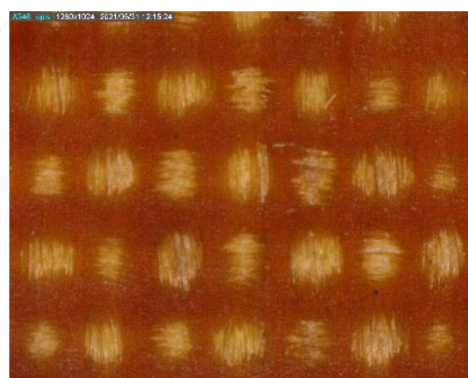
Figures 9 and 10 show the material of the textolite support from an HV surge arrester, which was removed from service as a result of damage. The failure of the device, which was operating at a 220 kV transformer substation, was a consequence of the device un-sealing at the bottom fixing device and the penetration of moisture after over a dozen years of operation. The discharge current flows caused a significant increase in the local temperature inside the device. Taking into account the thermal resistance of the material, it can be estimated that it exceeded 200 °C locally. As a consequence, this led some areas of the textolite element to show degradation effects that could be described as advanced. Nevertheless, depending on the intensity and duration of the discharge currents, and thus the temperature generated, there were significant differences in the images of microstructures and the degree of degradation of the sample material. There were areas where the carbonisation process of the epoxy resin reached a high level. This was evidenced by the change in the laminate colour to intense brown. The top layer was melted to such an extent that the characteristic bright bundles of fibres from the textile support were quite numerous on the surface of the material. They were clearly visible in both the MO images (Figure 9) and the SEM pictures (Figure 10). The surface of the strongly melted and significantly charred resin in the top layer of the tested sample was cracked.

Figure 9. MO image of the surface of the textolite material with advanced degradation effects (40 times magnification). Significant carbonisation of the organic binder of the sample material occurred. Numerous bright fibre bundles of the textile support are visible. After the top layer of the resin had melted, the fibre bundles were found on the laminate surface.

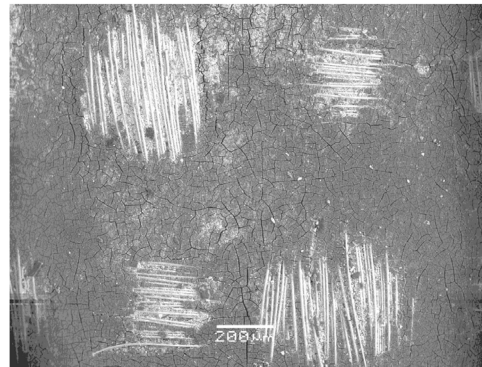
Figure 10. SEM image of the textolite material surface with visible degradation effects (75 times magnification). In addition to the light bundles of fibres of the textile support, there was clear cracking of the top layer of resin.

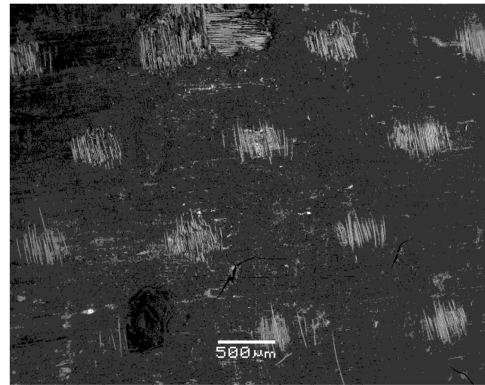
High carbonisation and significant melting of the epoxy resin occurred on the laminate surface, the colour of which changed to dark brown and, in places, black. At the same time, it was significantly cracked. Bundles of fibres from the textile support were clearly visible on the surface of the material (Figure 12). In particular, intense degradation was observed in the edge part of the textolite sample, next to the edge. There, the heavily charred resin was locally burned out almost completely and the textile support was exposed (Figure 13).

Figure 12. SEM image of the surface of the textolite material with strong degradation effects (30 times magnification). There is a large amount of charring and melting of the resin visible in the top layer of the material and numerous bundles of bright fibres of the textile support on the surface. There were also single large cracks in the resin.

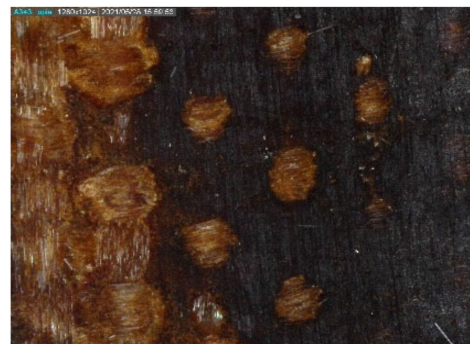
Figure 13. MO image of the surface of the textolite material with intensified degradation effects (40 times magnification). The edge part of the textolite element is visible, in which a strong charring and burning out of a fragment of the top layer of the resin took place. On the left side, at the edge, the exposed textile support is visible.

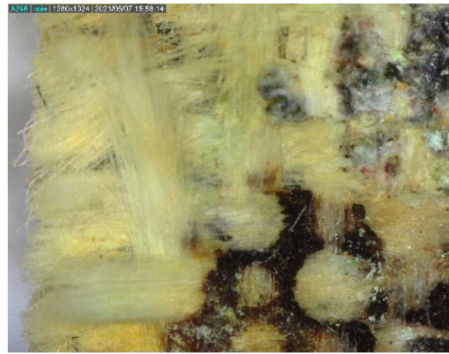
Flows of high discharge currents cause a large local temperature increase. Repeated flows of such currents in surge arresters lead to very strong degradation effects inside them. This applies in particular to elements made of laminate. During the examination of the damaged HV surge arresters that had been taken out of service, textolite elements were found, the degradation of which was very strong in some areas. A device operating at a 110 kV electrical substation suffered a serious failure after about 15 years of operation. The cause was most likely a loss of tightness and moisture ingress. Depending on the intensity and duration of the discharge currents, large differences were observed in the microstructure images and the degree of degradation of the textolite. The high temperature rise occurred only in certain, usually small, areas of the textolite elements inside the surge arresters. In these places, the epoxy resin, in particular, its top layer, had been strongly melted, charred and even burned out or chipped off (Figures 15–17). The strongest degradation effects were found in the edge part of one of the textolite supports in the vicinity of the edge (Figure 15). Only the remnants of the strongly charred resin remained there. The textile support was unveiled and disturbances in the arrangement of the fibreglass bundles were created.

Figure 15. MO image of the marginal part surface of the textolite support, which was heavily degraded (40 times magnification). In the immediate vicinity of the edge, the resin had been almost completely burned out; the exposed textile support is visible.

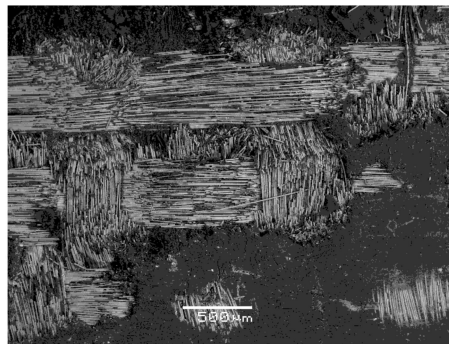
Figure 16. SEM image of the surface of the textolite material with very strong degradation effects (40 times magnification). The resin on the top layer of the material had been largely melted, charred and burned out. In the visible textile support, the fibre bundles were damaged and moved.

Figure 16 shows the burning and chipping off of large pieces of the epoxy resin from the sample surface and the exposure of the textile support. Some of the glass fibres were damaged as well. The fragments of resin remaining on the surface, apart from strong charring, showed characteristic cracking (Figure 17). More detailed observations with the use of various magnifications revealed the cracking and displacement of several glass fibres, and even damage and dislocation of their entire bundles in the textile support.

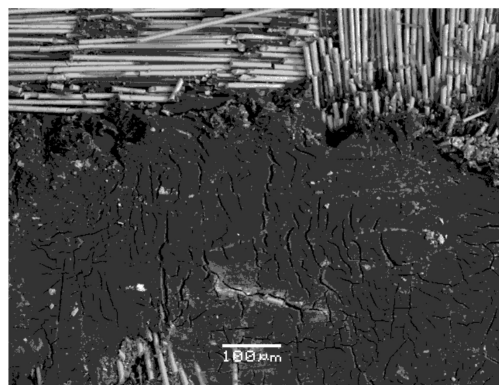
Figure 17. SEM image of the textolite surface with very strong degradation effects (150 times magnification). Strong cracking of the carbonised resin and damage to the glass fibres in the textile support is visible.

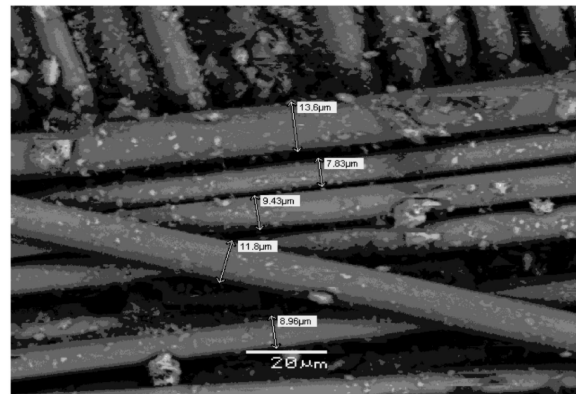
visualisation of the support allowed for a more detailed inspection of the glass fibres and the assessment of their diameters (Figure 18). The measurements performed showed that the fibres had a diameter ranging from less than 8 μm to approximately 14 μm . The authors' experience and literature data [31] show that in similar materials, the most common fibres are of a very similar diameter, i.e., a dozen or so micrometres (usually approx. $11 \div 17 \mu\text{m}$).

Figure 18. SEM image of the surface of very badly damaged textolite material (magnified 900 times). Exposed textile support glass fibres are visible, and on their surfaces are the remains after the destruction of the organic phase.

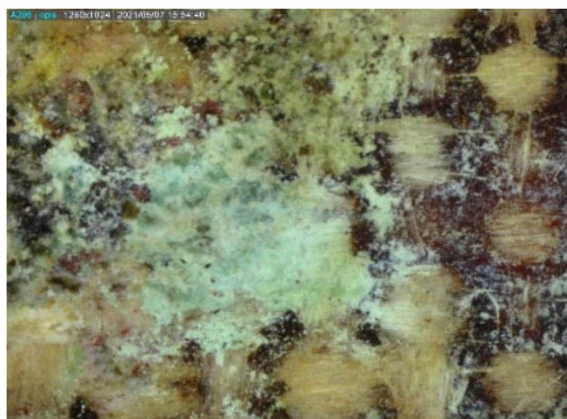
Regardless of the copper compounds, the surface of the textolite element showed traces of high-temperature exposure and very severe degradation effects. Most of the epoxy resin melted and burned out, and the rest of it was completely charred. The microscopic images of places with greenish sediment were dominated by areas with exposed textile support. The deposition of copper compounds was not a thicker layer and was present both on the exposed bundles of the support fabric and on the carbonised resin. The fields of the greenish sediment were heterogeneous and had a small surface area, of the order of individual square millimetres at most (Figure 20).

Figure 20. MO image of the surface of a textolite material with a greenish deposit of copper compounds and very strong degradation effects (magnified 40 times). Strong charring of resin residues on the surface of the sample material is visible.

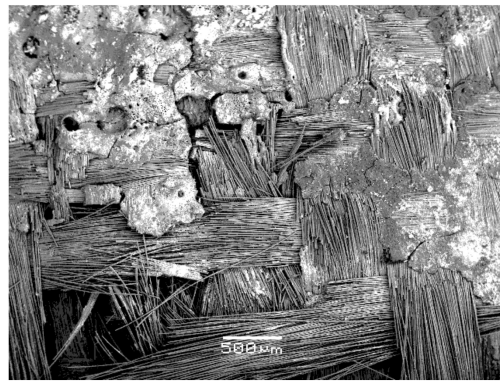
Observations made with the SEM technique revealed cracks and characteristic cavities on the surface of the corrugated sediment layer. The thickness of the deposited layer was distinctly differentiated. Textile support was damaged in many places. Some of the fibres were cracked and moved. Even damage to the entire fibre bundles in the fabric was visible (Figure 21).

Figure 21. SEM image of the surface of the textolite material with a copper compounds sediment and very strong degradation effects (magnified 35 times). The resin on the top layer of the material was almost completely charred and burned out. Damage to the textile support is visible. There were cracks and characteristic cavities in the sediment layer.
