# Integrated Application of GPR and Ultrasonic Testing in the Diagnostics of a Historical Floor

**Abstract:** The paper presents the results of integrated ground penetrating radar (GPR) and ultrasonic testing (UT) measurements conducted on a historical floor in St. Nicholas' Church, Gdańsk, Poland. The described inspection was the first stage of the technical state assessment of the building. The aim of the study was the detection of underfloor air gaps, which were observed in a few trial pits. The condition of the ground under the floor was determined by localizing other inclusions such as rubble, human remains, brick walls and pipes. To identify the phenomenon of electromagnetic and ultrasonic wave propagation within the air gap, laboratory tests were conducted on physical models consisting of two concrete slabs stacked on top of each other and gradually moved apart to simulate a slot of varying thickness. The conducted research was supported by the numerical models of electromagnetic wave propagation. The obtained results showed that the integration of the GPR and UT methods provided an effective imaging of the floor and the area under it. Ultrasonic testing was proved to be a

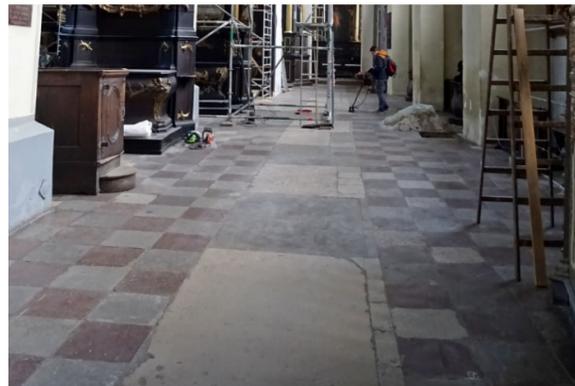
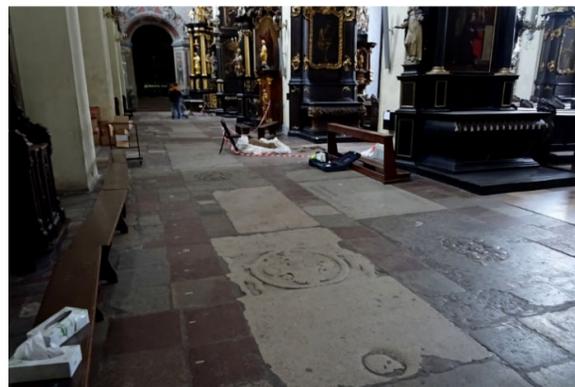
The conducted floor inspection reported in this paper was the first stage of investigations directed to assess the technical state of the church. NDT tests were performed on the floor of two aisles, south and north, as shown in Figure 1. In both aisles, the top floor layer was made of stone tiles measuring approximately 43 cm × 43 cm. In the central part of each aisle, tombstones were laid. The cross-section layers of the floor were identified in a few trial pits. One of the pits located in the north aisle is shown in Figure 2. Based on a visual inspection of the cross-section visible in the trial pit, particular layers in the floor were identified (Figure 3). It was found that the stone tiles laid on the cement mortar layer had a thickness of approximately 2–6 cm. Below was a layer of sand and ground backfill. It was also identified that at some edges, an air gap with a thickness of approximately 1–2 cm was visible below the cement mortar.

**Figure 1.** Photograph of the floor in St. Nicholas' Church in Gdańsk, Poland (Google Maps coordinates in a WGS84 system: 54.352206 N, 18.651510 E): (a) south aisle; (b) north aisle.

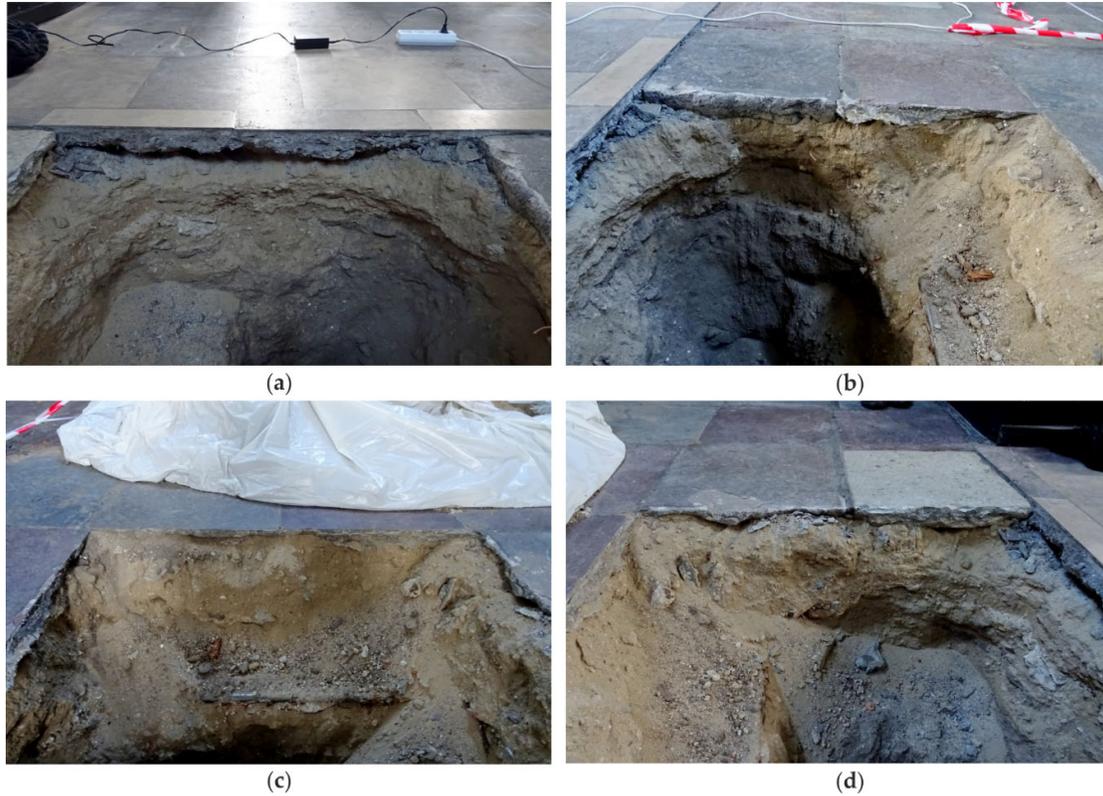
**Figure 2.** Photographs of the trial pit in the floor: (a) edge 1; (b) edge 2; (c) edge 3; (d) edge 4.

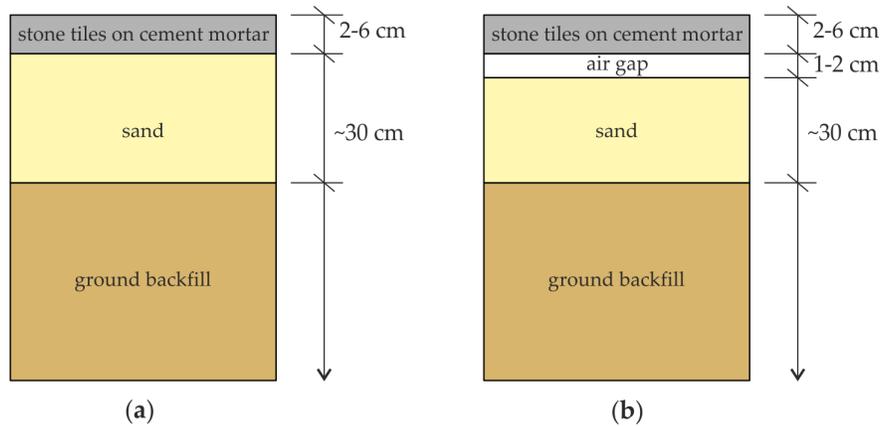
**Figure 3.** Schematic sketch of floor layers in the trial pit: (a) appropriate cross-section (without air gap); (b) cross-section with damage (air gap).

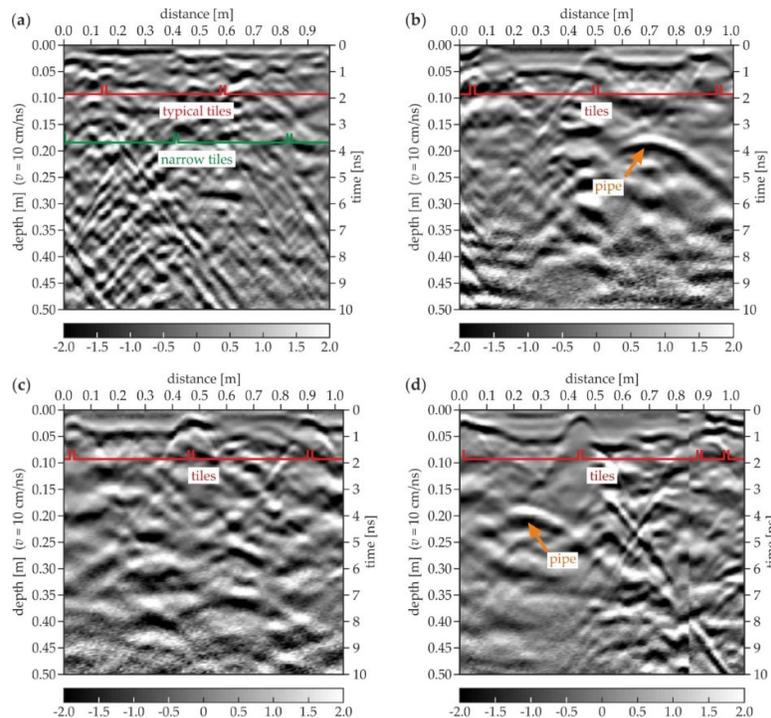
Figure 15 presents the GPR B-scans collected around the trial pit. As can be seen in Figure 7a, several rectangular tiles formed a joint at one of the pit's sides. Therefore, during the acquisition of the C-1 scan (Figure 15a), the GPR antenna was moved along the joint, thus the bottom faces of the tiles were not clearly imaged. However, the analysis of the upper part of the scan allowed identifying two different rows of tiles; the typical tile (43 cm × 43 cm) row was replaced at the edge of the trial pit with a narrower one (43 cm × 10 cm) laid with the overlap (cf. Figure 2a). The overlap length was about 0.16 m and it could be seen the clearest at the distance of 0.42–0.58 m. The ground under the C-1 scan had many inclusions, resulting in numerous irregularly distributed reflections (cf. the concentrated inclusions in Figure 14c,d). The C-2 scan (Figure 15b) clearly presents the line patterns being the reflections from the joints. The bottom faces of the tiles were identified at dissimilar levels, therefore the tiles (or the mortar layers below them) had different thicknesses. The hyperbola located at the distance of 0.7 m and the depth of 0.18 m denoted the presence of a metallic (steel or aluminum) pipe (cf. Figure 2). The ground on the right side of the scan (around the pipe, at the distance of 0.5–1.0 m) seemed less heterogeneous than the remaining part. This might be caused by the fact that the original ground was removed and replaced with another, more homogeneous one during placing the pipe under the floor. The C-3 scan (Figure 15c) shows the clear image of two tiles, one with the regular bottom face and the second with an unbalanced shape. The ground seemed to be original because it is highly heterogeneous, such as in the C-1 scan. The C-4 scan (Figure 15d) also clearly shows two typical tiles together with the narrow one (located at the distance of 0.88–0.98 m). The shape of the bottom face of all tiles was irregular. The shift was observed in the scan (at the distance of 0.85 m), caused by the slip of the antenna at the joint between the standard and the narrow tile (cf. Figure 2d). The reflection from the pipe was visible at the distance of 0.25 m and the depth of 0.18 m (the same as observed in the C-2 scan). The ground around the pipe was less inhomogeneous (the distance of 0.0–0.5 m) compared with the remaining part. Generally speaking, it was difficult to say whether there were any air gaps under the floor. The subtle difference between the image of the tiles with and without the air gap (observed in the numerical results) was here blurred by the ground inhomogeneities and a signal noise.

**Figure 15.** GPR B-scans for the trial pit: (a) edge 1 (trace C-1); (b) edge 2 (trace C-2); (c) edge 3 (trace C-3); (d) edge 4 (trace C-4).

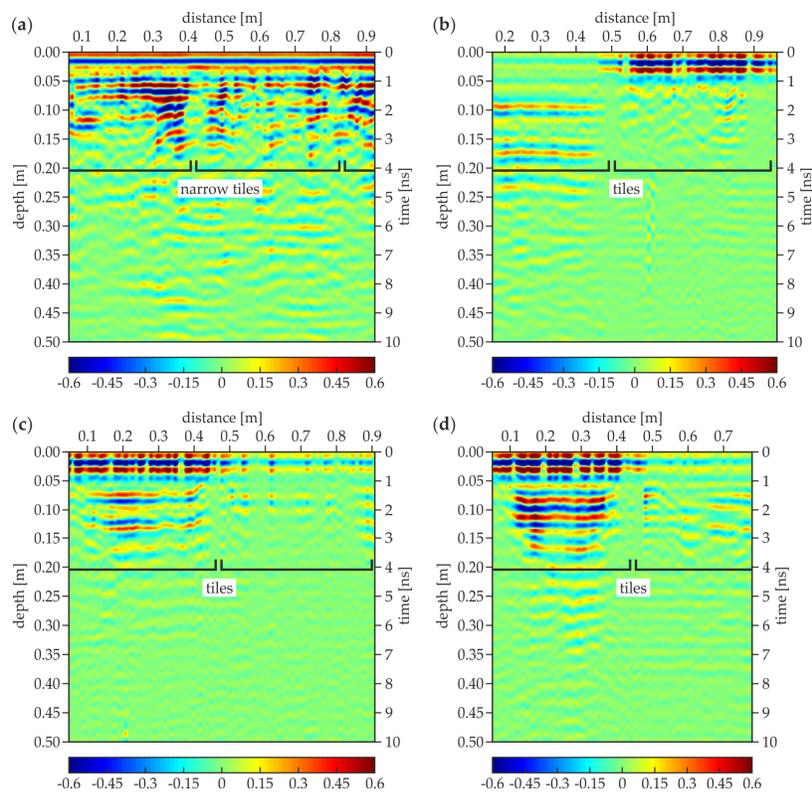
Figure 16 contains the UT B-scans corresponding to the above-discussed GPR B-scans. The C-1 scan (Figure 16a) was performed through the narrow tiles, as can be seen in Figure 7a, thus the joints of the standard tiles were not observed. In the top part of the scan (at the depth of about 0.03 m), there was a straight line denoting the regular bottom face of the narrow tiles. However, there was no regularity in the lower part of the scan, where many multiple reflections occurred. Compared with the results for the concrete slabs, it might be stated that the air gap with an irregular shape was present in this area. The non-uniform settlement of the original ground probably led to the appearance of the air gap. The C-2 scan (Figure 16b) shows the image of two different tiles. The right tile, unlike the left one, was clearly visible at the top of the scan; it was possibly removed and then placed again with the use of a different (stronger) mortar. The multiple reflections appeared under the left tile, indicating the presence of the air gap (this tile laid on the original ground). On the contrary, there were no reflections under the right tile. The pipe detected in the GPR scans was not visible, which stays in agreement with the results for the concrete slabs where the UT scans did not reveal the table tennis ball. This observation allowed concluding that concentrated inclusions could not be detected by the UT scanning. It also should be mentioned that, according to the UT antenna instruction, the diameter of the pipe did not exceed 30 mm. In the C-3 scan (Figure 16c), two tiles were also visible. The left one was much more pronounced: it could have been replaced during some renovation works. Additionally, there were multiple reflections under both tiles, indicating the presence of the air gaps (resulting from the ground settlement). However, it needs to be noted that the reflections were less intensive under the right tile because it was weakly identified itself. The possibility of detecting the tiles in the C-4 scan (Figure 16d) was also distinguished: the left one was much better imaged. Although the ground below the left tile was replaced, the multiple reflections indicating the presence of an air gap were visible under both tiles. Like in the C-3 scan, the reflections under the right tile were weaker because it was weakly imaged itself. It also needs to be added that the pipe was not observed like in the C-2 scan.

**Figure 16.** Ultrasonic B-scans for the trial pit: (a) edge 1 (trace C-1); (b) edge 2 (trace C-2); (c) edge 3 (trace C-3); (d) edge 4 (trace C-4).

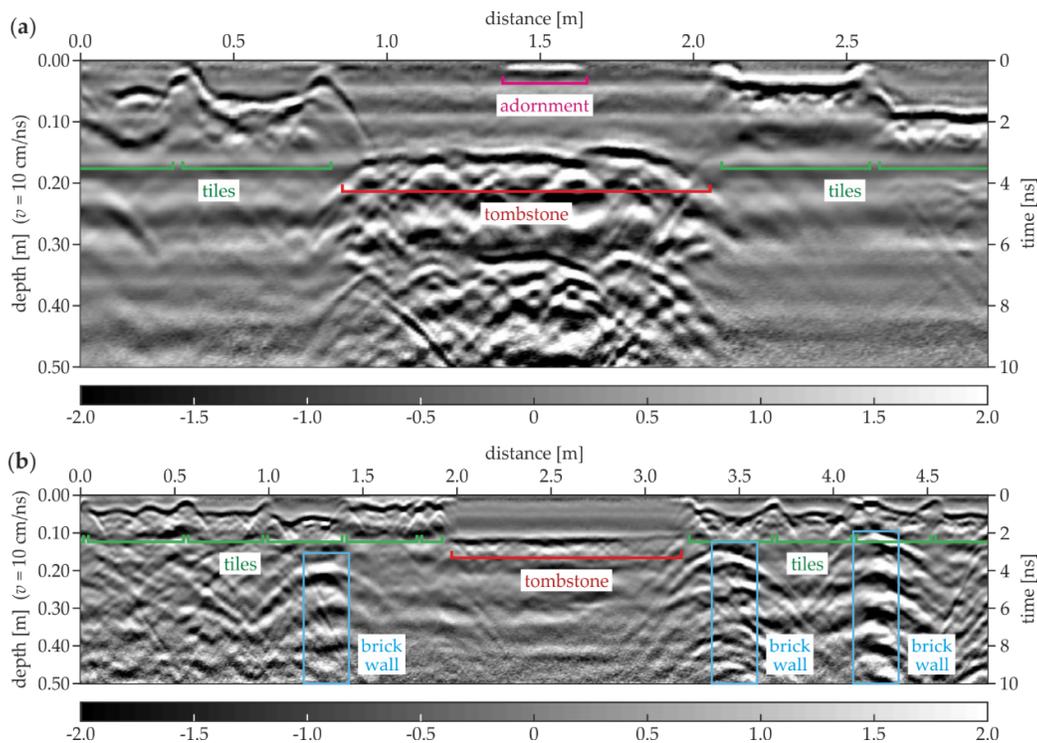
Figure 17 presents two examples of the GPR B-scans acquired in the area of the south aisle. The A-19 scan (Figure 17a) clearly reveals the location of the tiles based on the reflections from the tile grouts. The bottom faces of the tiles were identified at different depths, thus they had different thicknesses, varying between 0.04 and 0.09 m. The tombstone with a thickness of approximately 0.16 m could be observed in the center of the scan. An additional reflection denoting the tombstone adornment was also visible at the top of the scan. The ground under the tombstone had many concentrated inclusions, probably being the rubble or the human remains from the original crypts (cf. Figure 14c,d). Aside from this area, inhomogeneities were not observed. It was difficult to state whether there were any brick walls under the edges of the tombstone because the hyperbolas denoting the concentrated inclusions blurred the image. The A-117 scan (Figure 17b) shows the tiles with different thicknesses between 0.03 and 0.08 m. The tombstone was also visible; however, its shape was far more regular compared with the one from the A-19 scan. The ground below the tombstone had no strong inhomogeneities, thus it could be stated that not all the tombstones were laid in the area of the original crypts. Other interesting reflections were the hyperbolas located vertically one above another at the distances of 1.3, 3.4 and 4.2 m. They indicated the presence of three brick walls (cf. Figure 14b,d), that might be the remainders of the original supporting structures of the crypts.

**Figure 17.** GPR B-scans for the south aisle (survey A): (a) A-19; (b) A-117.

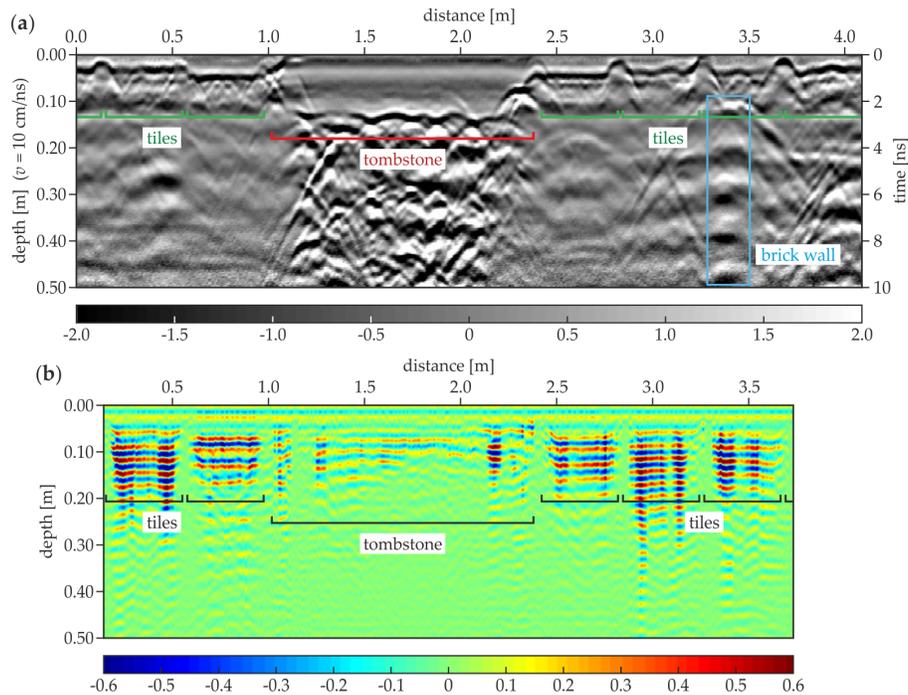
The next two GPR B-scans from the south aisle are presented together with the corresponding results of the UT scanning. In the A-121 GPR B-scan (Figure 18a), the tiles with different thicknesses (in the range of 0.02–0.04 m) were visible, and also a tombstone with the thickness of about 0.12 m was identified. The ground below the tombstone contained some concentrated inclusions (probably rubble or human remains). The brick wall was present at a distance of about 3.4 m. The UT scan (Figure 18b) clearly revealed the tile pattern, and also the tombstone was observed. The presence of the multiple reflections under each tile allowed stating that there were many air gaps below them, which agreed with the fact that the floor of the south aisle experienced significant settlement. The reflections denoting the air gaps generally did not appear below the tombstone, probably because of

its weight. What is also worth noting is that no additional reflections from the ground heterogeneities could be identified. The UT scanning did not detect concentrated inclusions, which were already observed for the pipe in the area of the trial pit and the table tennis ball in the concrete slab. The GPR B-scan for the trace A-129 is presented in Figure 19a. The tiles with different thicknesses (varying between 0.02 and 0.06 m) are clearly detectable. Two tombstones with a thickness of approximately 0.12 m and irregular shape of the bottom face were also present. The ground under both tombstones had many concentrated inclusions unlike aside from this area. The brick wall could be visible at the distance of about 4.3 m; however, the intensity of the reflections from the bricks was not as strong as in the A-121 scan. In the UT scan (Figure 19b), the tiles and the tombstones could be localized. There were no significant reflections under the tombstones, thus the air gaps were not likely to be there, unlike under the most of the tiles, where multiple reflections appeared. This observation corresponded with the settlement of the floor in the area of the south aisle.

Figure 18. GPR and UT B-scans for trace A-121 (south aisle): (a) GPR scan; (b) UT scan.

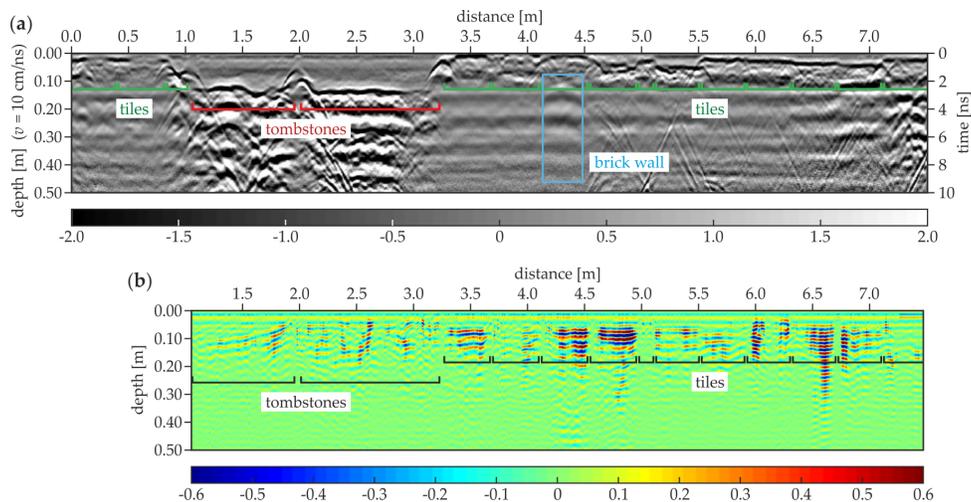
Figure 19. GPR and UT B-scans for trace A-129 (south aisle): (a) GPR scan; (b) UT scan.

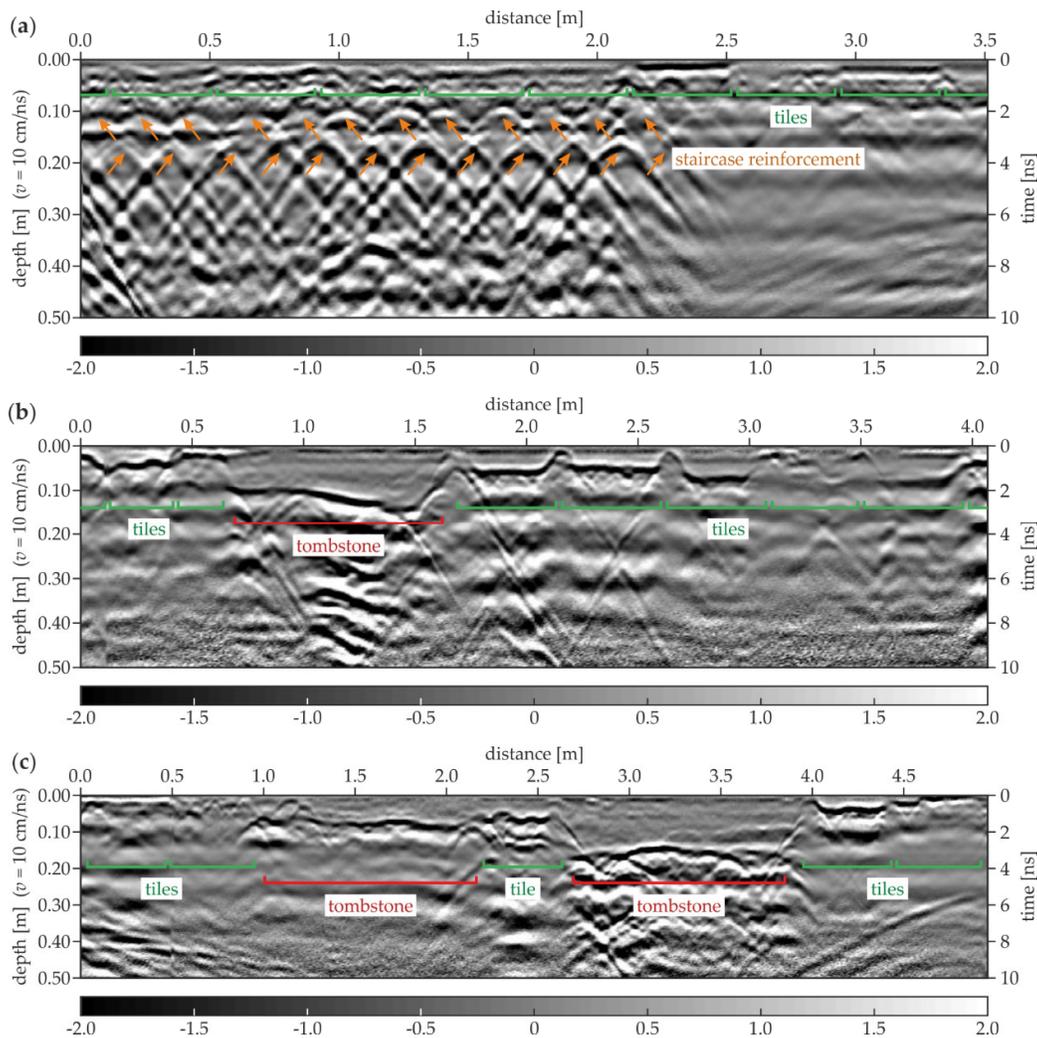
Figure 20 shows the examples of the GPR B-scans for the north aisle. The B-5 scan (Figure 20a) shows the regular pattern of tiles with a constant thickness of 0.03 m. Several evenly spaced hyperbolas were visible at two levels (the depth of 0.11 and 0.18 m) and the distance of 0.0–2.1 m. These reflections represented the reinforcement of the staircase located under the floor. The ground below the tiles aside of the staircase seemed to be devoid of significant heterogeneity. In the B-35 scan (Figure 20b), the tiles had different thicknesses in the range of 0.02–0.06 m. The tombstone had a thickness varying between 0.10 and 0.15 m and the skew shape of the bottom face. The ground below the tombstone had some concentrated inclusions. The B-143 scan (Figure 20c) presents the tiles with the thicknesses between 0.02 and 0.05 m. Two tombstones were also visible, the left one with the thickness of about 0.09 m and the right with the thickness of approximately 0.16 m. The ground under the thinner tombstone did not have inhomogeneities, unlike the ground under the second one, where multiple reflections from the concentrated inclusions occurred. This observation confirms the fact that some of the tombstones were placed aside from the area of the original crypts.

Figure 20. GPR B-scans for the north aisle (survey B): (a) B-5; (b) B-35; (c) B-143.

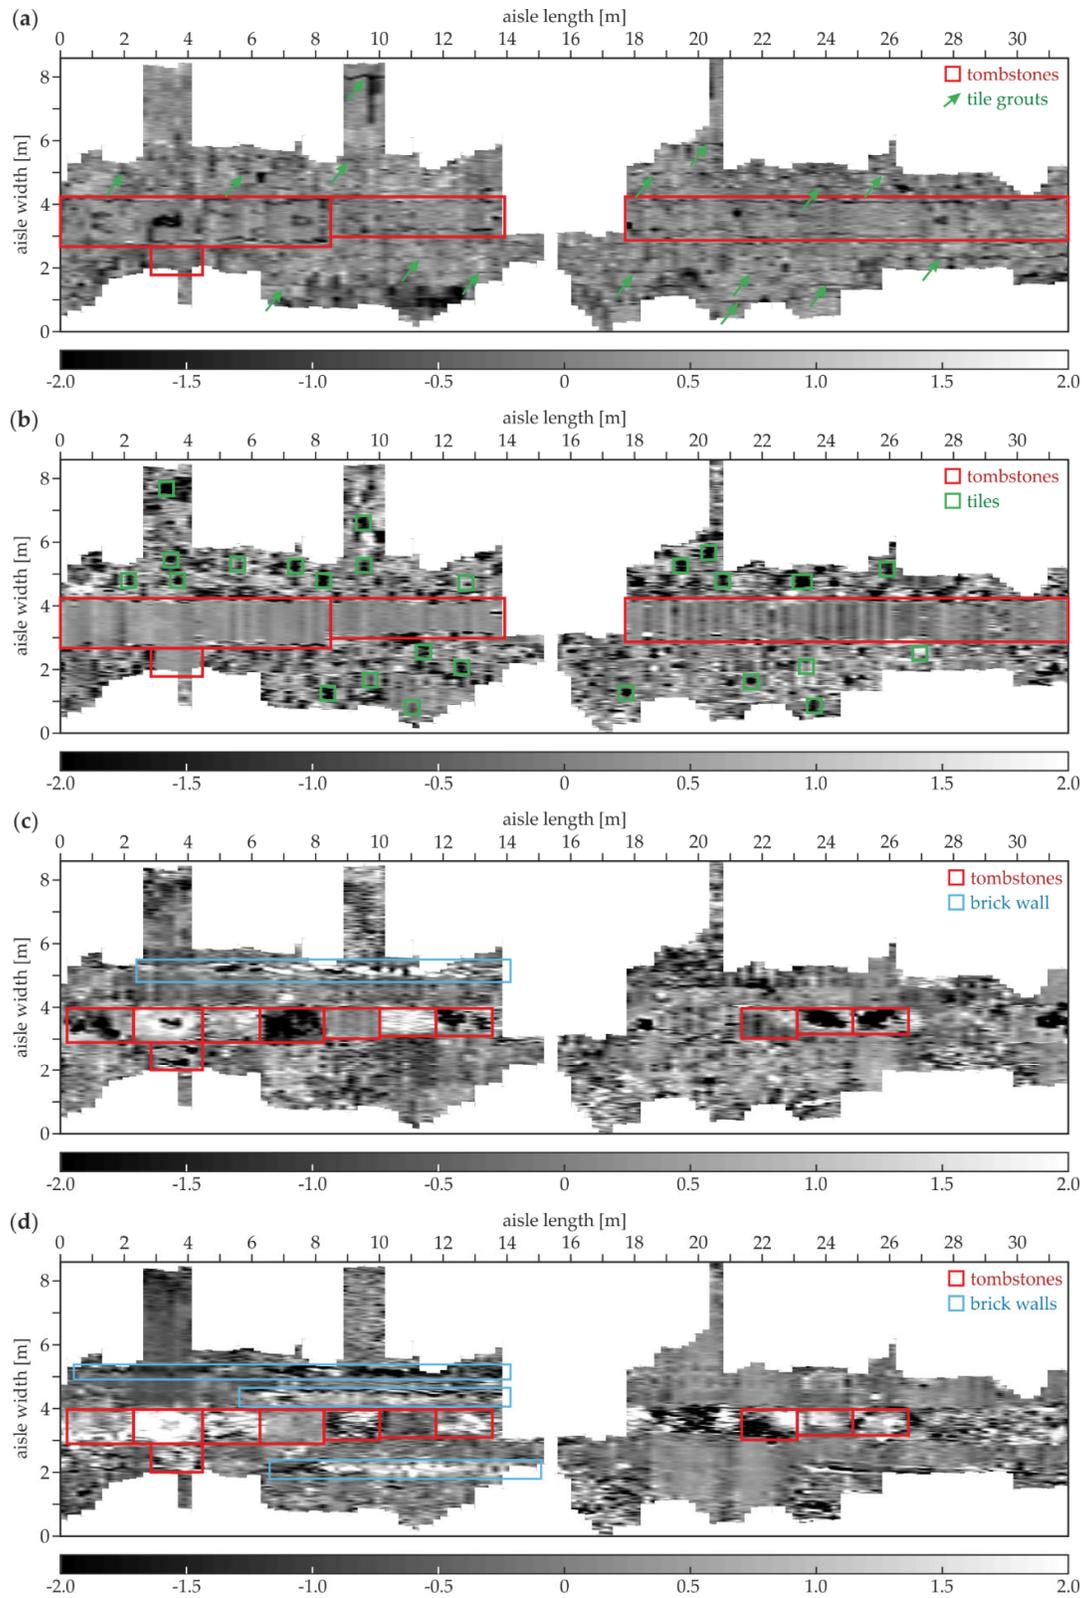
Figure 21 presents the tomographic images of the south aisle. At the depth of 0.16 m (Figure 21a), the tombstones identified in the above-discussed B-scans of the south aisle were detected. The elements were laid in a straight line along the whole aisle at the width between about 2.75 and 4.25 m. Additionally, the single tombstone was located aside from the main row at the length between 2.5

and 4.5 m (it was seen in the A-129 scan, Figure 19). The distinction of singular tombstones from the main row was not possible; the scanning was performed along the tombstone grouts, thus they could not be imaged. The singular tiles were not detected due to a single direction profiling. The tile grouts in the lengthwise direction (perpendicular to the measurement traces) were identified, unlike the crosswise grouts (oriented in the same direction as the scan traces). At the depth of 4.06 cm (Figure 21b), the imaging of the tombstones was far clearer; however, there was still no possibility to distinguish the singular elements. On the contrary, the individual tiles could be detected; the chosen tomography depth was between the minimum and the maximum thickness of the tiles, thus some of them were visible, whereas other ones could not be observed. At the depth of 12.19 cm (Figure 21c), most of the tombstones were clearly visible. The lower faces of some thicker tombstones were below the tomography depth, unlike the thinner ones, which were not detected at this level. The adornment was detected on the second tombstone from the left. The tiles could not be identified because their bottom faces were located certainly above the actual tomography level. What is more, the brick wall was moderately imaged at the width of about 5.2 m and the length between 2.2 and 13.8 m. The tombstones were still distinguishable at the depth of 23.75 cm (Figure 21d). The inhomogeneities in the ground under certain tombstones were visible, especially on the right side of the tomography. The brick wall discovered at the depth of 12.19 cm was still detectable and seemed to be longer. What is more, another two brick walls were identified: the first one at the width of 4.5 m and the length between 5.5 and 14.0 m, the second at the width of 2.2 m and the length between 6.5 and 15.0 m. All of the three walls were clearly imaged in the A-117 B-scan (see Figure 17b).

**Figure 21.** GPR tomographic images of the south aisle (survey A) at different depths: (a) 0.16 cm; (b) 4.06 cm; (c) 12.19 cm; (d) 23.75 cm.

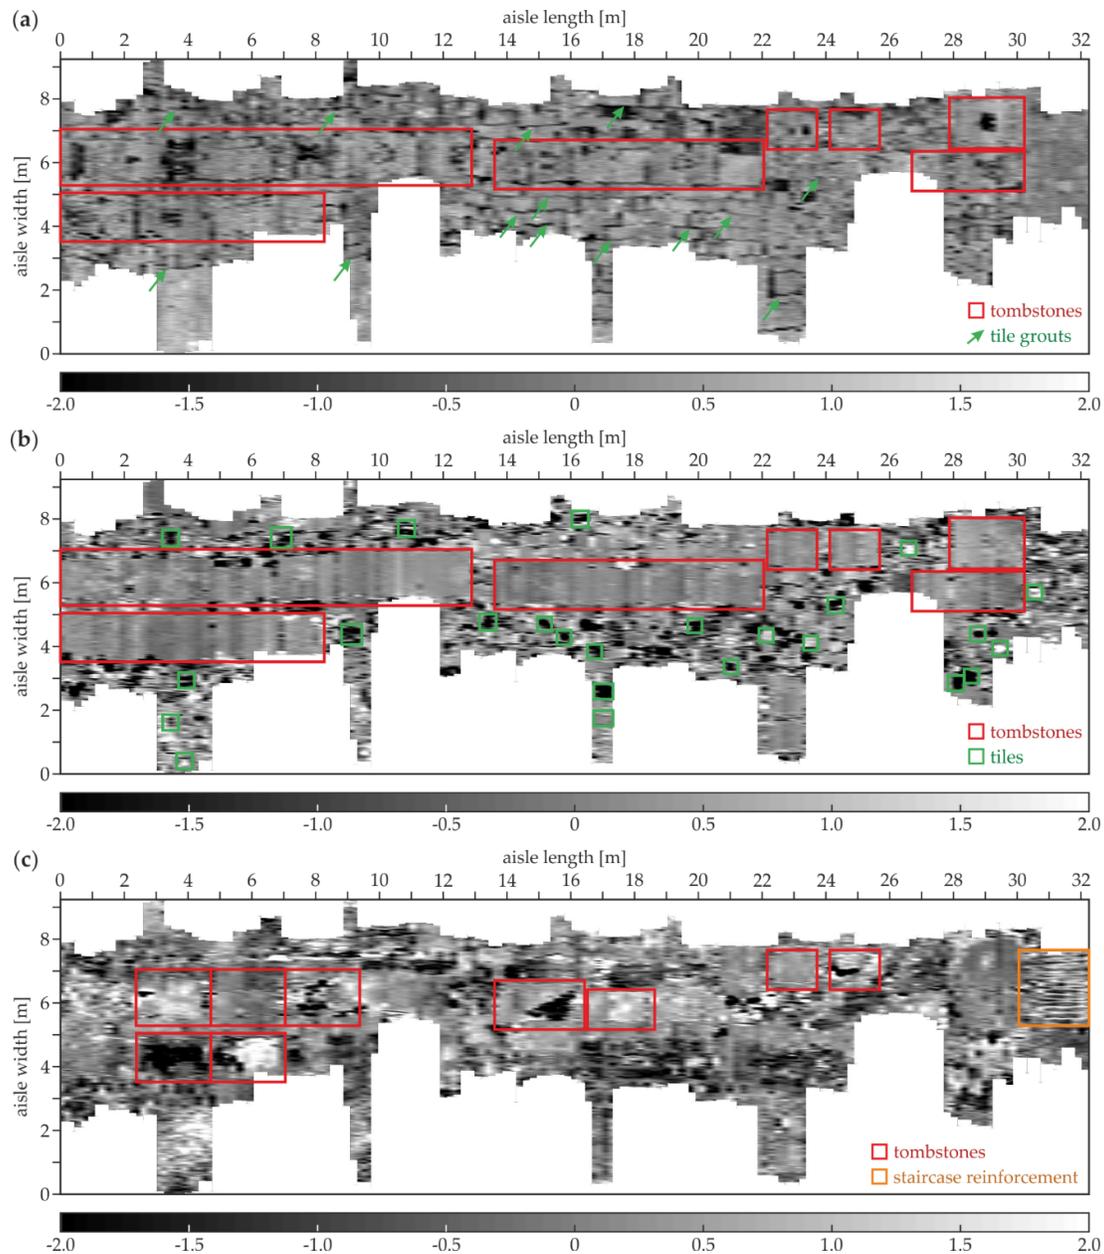
Figure 22 shows the tomographic images of the north aisle. Similarly to the results for the south aisle, the tombstones were detected at the depth of 0.16 cm (Figure 22a); however, their configuration was not so regular. The lengthwise tile grouts were also imaged, unlike the crosswise grouts. The adornments were visible on some of the tombstones. At the depth of 4.06 cm, the tombstones were shown far more clearly. Some individual tiles were also observed. At the depth of 12.19 cm, the singular tombstones could be distinguished. Some of them did not seem to be rectangular because of the irregular shape of their bottom faces. It is also worth noting that the staircase reinforcement was visible at the length of 30.0–32.0 m and the width of 5.2–7.8 m. Only the lengthwise bars were noticeable, and the crosswise reinforcement could not be imaged because of the single direction of the GPR scanning.

**Figure 22.** GPR tomographic images of the north aisle (survey B) at different depths: (a) 0.16 cm; (b) 4.06 cm; (c) 12.19 cm.
