Risk Analysis for Earthquake-Damaged Buildings Using Point Cloud and BIM Data: A Case Study of the Daeseong Apartment Complex in Pohang, South Korea

Citation: Park, E.S.; Seo, H.C. Risk Analysis for Earthquake-Damaged Buildings Using Point Cloud and BIM Data: A Case Study of the Daeseong Apartment Complex in Pohang, South Korea. *Sustainability* **2021**, *13*, 456. <https://doi.org/10.3390/su13020456>

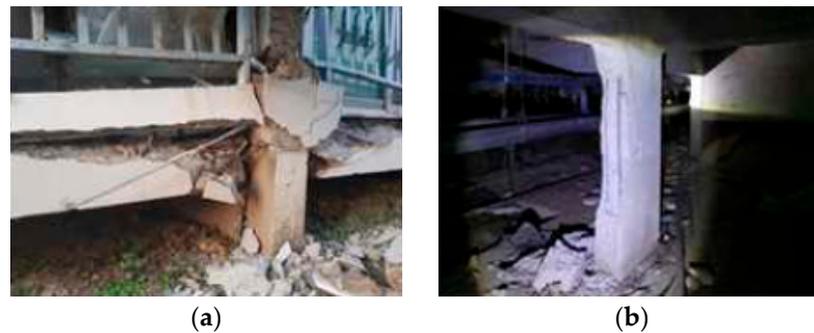
Among the six buildings of the Daeseong Apartment Complex, the use of Buildings D, E, and F was restricted after the occurrence of the Pohang earthquake, and they were demolished in March 2020. In the case of Building E, which sustained the most damage, precision inspection results showed that more than half of the building ground was inclined due to damage to the walls that were in contact with the ground as shown in Table 2 and Figure 1 [10].

Figure 1. Separated joint, impact fracture, joint fracture, and short column fracture in the Dae-seong apartment complex. (a) Separated joint, impact fracture; (b) Short column fracture on the basement floor.

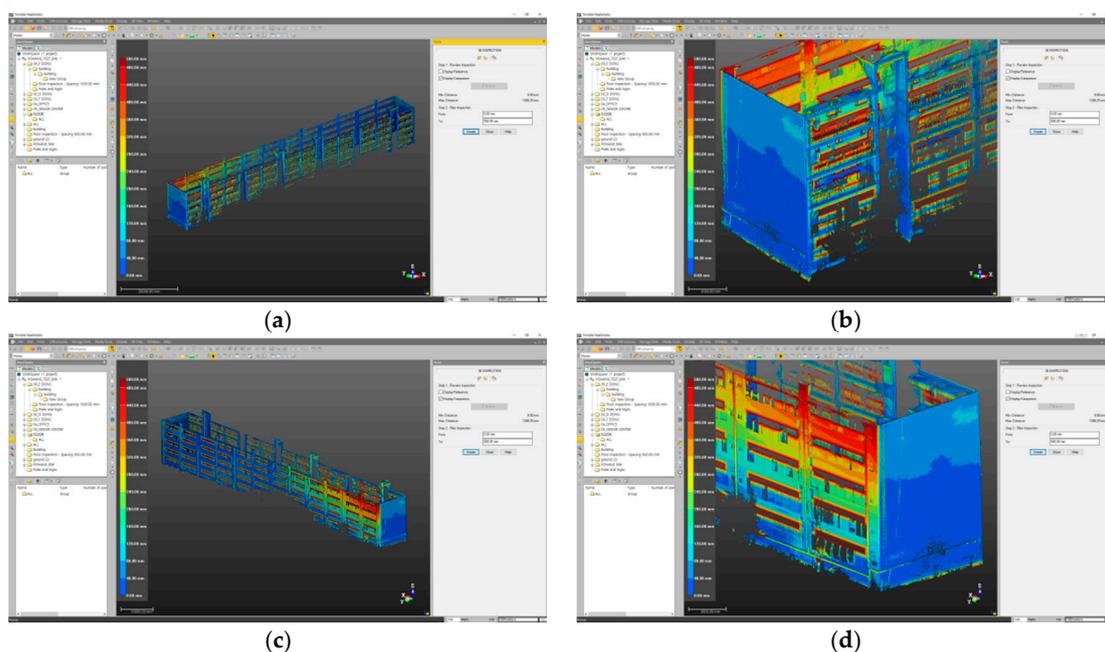
Figure 7 shows the numerical results of inspection through scanning data and BIM data. The analysis results set the legend from blue to red. To explain the meaning of the colors, the blue series means that the two data differ by 0 to 80 mm, the green and orange series by 150 to 360 mm, and the red series by 360 to 500 mm. This analysis effectively provides a quantitative value for the degree of earthquake damage in building E.

Figure 7. 3D inspection using the point cloud and BIM data. (a) Entire 3D inspection; (b) Front 3D inspection; (c) Rear 3D inspection; (d) Rear 3D inspection in detail.

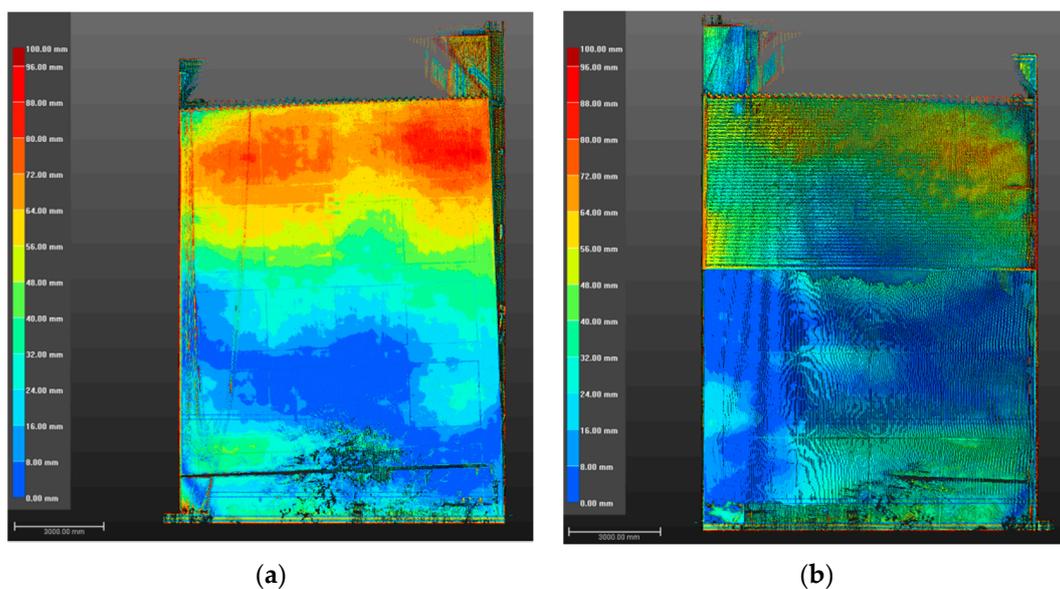
Figure 9 shows the smoothness analysis results for Building E's east and west sides. Significant differences in displacement between the upper and lower parts of the building E's west side were observed. The difference was found to be a maximum of 35 mm (from 0

to 35 mm) in the lower part and 84 mm (from 40 to 84 mm) in the upper part, indicating that the deformation of the building occurred as a result of the lateral force exerted by the earthquake on the vulnerable side.

Figure 9. Smoothness analysis results for Building E's east and west walls. (a) Analysis of Building E's west wall; (b) Analysis of Building E's east wall.

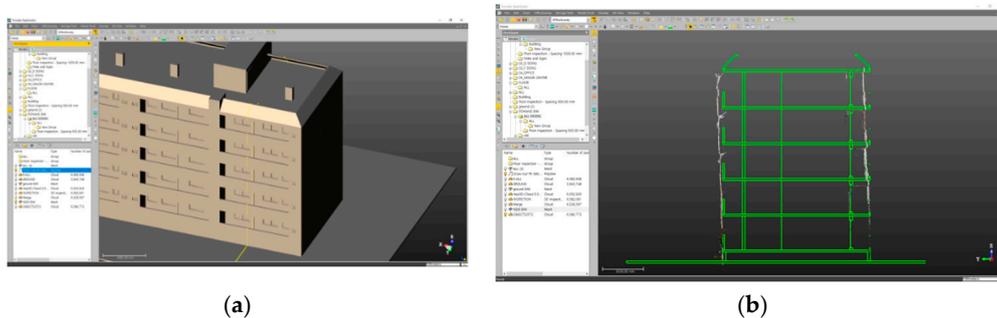
The lines of the desired cross-sectional areas were extracted from the BIM data, and the overall slope of the building was measured by comparing them with the point cloud data. The above wall smoothness analysis results revealed a significant change in the displacement of the west wall, which shows that the building was inclined backward. Therefore, the side slope of the building was analyzed in detail as shown in Figure 10.

Figure 10. Analysis of Building E's slope. (a) Extraction of cross-sectional information from BIM data; (b) Results of examining Building E's overall slope.

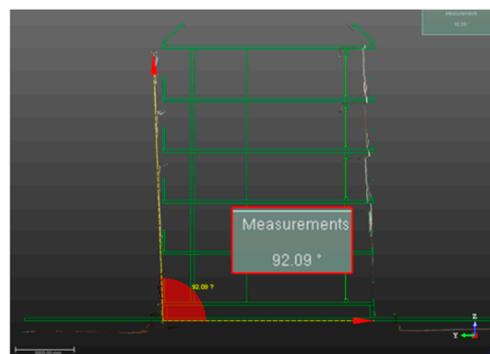
As follows Figure 11, the overall analysis of the east and west walls showed that the building was inclined by 2.09° and that the upper part of the wall was inclined forward by 88 mm compared to the lower part. This is because there was no internal column and only the walls were designed to bear the load of the Daeseong Apartment Complex ground floor.

Thus, the walls, which were constructed by stacking bricks, were vulnerable to seismic loads due to insufficient wall volume caused by the weak Rahmen structure.

Figure 11. Slope analysis results for Building E.

This phenomenon resulted from the apartments' unique structure; that is, the Dae-seong Apartment Complex was constructed without the application of seismic design, and it appears to have been affected by the pilotis structure, in which the ground floor's load-bearing walls are supported by the short lower columns. The ground floor structure was supported only by pilotis, because it was not connected to the underground outer walls, and the pilotis were classified as short columns due to the underground pit level's low floor height. The slope appears to have been caused by the short column phenomenon of the pilotis, which completely collapsed under the force of the earthquake due to structural vulnerability. These results were analyzed in the same way as the nonlinear dynamic analysis according to the Committee of Site Inspection and Damage Investigation's "Site inspection and damage investigation of buildings by earthquakes in Gyeongju and Pohang" report [10].

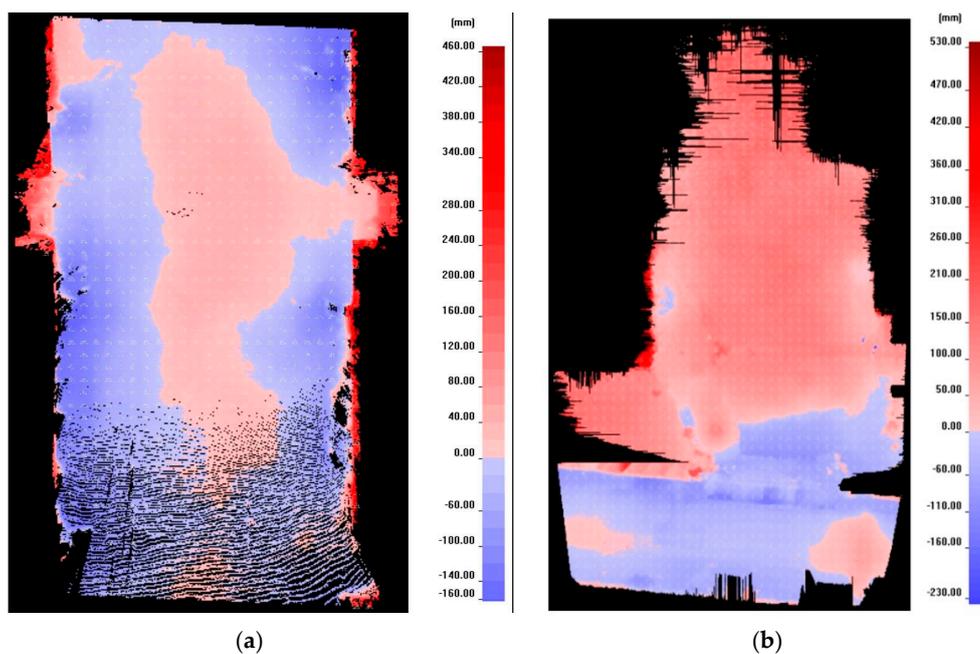
The ground smoothness analysis results for Building E showed that there was a difference in displacement between the terrains around the building as shown in Figure 13. There was a 620.00 mm difference between Buildings E and D (from 460.00 to -160.00 mm) and a 760.00 mm difference in front of Building E (from 530.00 to -230.00 mm), indicating that changes in terrain displacement occurred due to ground subsidence caused by the earthquake.

Figure 13. Smoothness analysis results for Building E's surrounding area. (a) Smoothness analysis result between Buildings E and D; (b) Smoothness analysis result in front of Building E.

It appears that a number of structures in the surrounding area were overturned, and the topographic change around the building was intensified by the 44 aftershocks that followed the first major earthquake. The Korea Institute of Geoscience and Mineral Resources analyzed the Heunghae-eup area in 2017 and found that it sustained the most damage due to the severe impact of ground subsidence, which corresponded to the active fault in the marine sediment created in the tertiary period.
