Acoustic Tomography as a Supporting Tool in the Sustainable Management of Historic Greenery: Example of the Church Garden in Horostyta (Poland)

Abstract: Senile trees in historic church gardens have natural, aesthetic, historical, and cultural value. Cutting them down too hastily annihilates the achievements of entire generations. We should try to preserve the greenery surrounding historic churches and integrate it into a clear compositional arrangement with the sacral architecture. The primary purpose of the paper was to describe the process of inventorying 200-year-old trees and to present the revalorization project for the garden around the historic Orthodox church in Horostyta, located in the Lublin Voivodeship, in southeastern Poland. The church complex consists of a wooden 18th-century building, bell tower, garden, and cemetery. Within the church garden's boundaries, there are 15 trees, with two predominant species: *Acer pseudoplatanus* L. and *Tilia cordata* Mill. These trees are of varying ages and health conditions. We used acoustic tomography to perform tree health diagnostics. Three trees, for which the initial visual assessment was disturbing, were examined thanks to

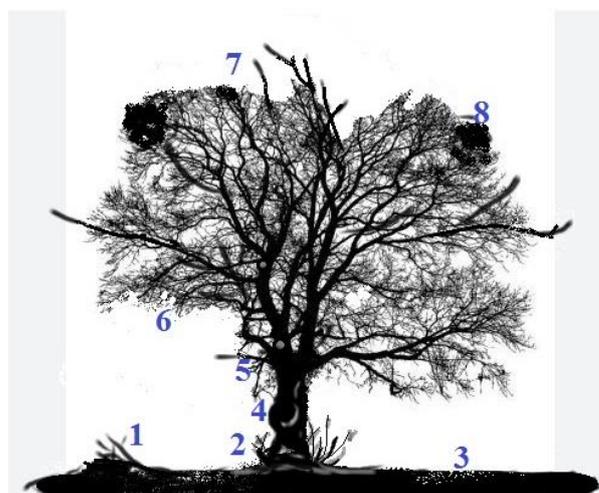
Figure 10. Senile tree. Designations: 1. dry branches under the tree; 2. suckers around the tree's crown; 3. early leaf fall; 4. bumps and mushrooms on the trunk; 5. hollow; 6. asymmetric crown; 7. broken top; 8. mistletoe.

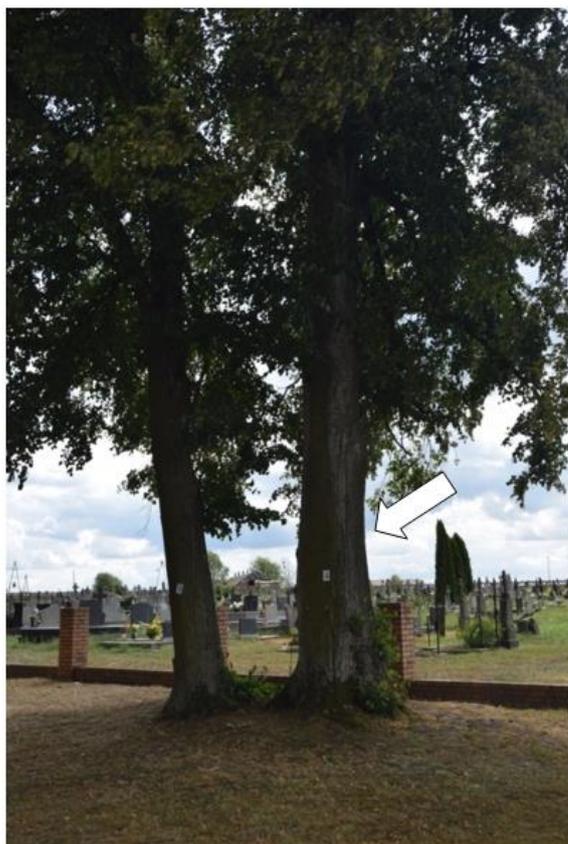
Figure 11. General view of small-leaved linden (by M. Dudkiewicz, 2020).

The red line illustrated the minimum wall thickness of 12.8 to 13.6 cm (average 13.2 cm), depending on the site, which indicated that the safety limit against trunk fracture was preserved on most of the cross-section. Destructive processes only went beyond this limit on the north side of the trunk.

Calculated for different directions, the trunk section's geometric moment of inertia, measured at the weakest point at the measurement height, ranged from 3.2% to 7.8% of the maximum strength relative to a trunk without defects or damage. The calculations themselves only took into account the trunk's geometry at the measurement level, while the properties of the wood itself may affect the final result of the measurement. Based on the results obtained, one could assume that the tree's mechanical strength and resistance to trunk bending were safe for the environment (Figure 12).

The minimum thickness of a healthy wall relevant to the preservation of tree statics, calculated by the Tree SA method, should be 6.6 cm on average (green line on the attached tomogram). Based on the measurement carried out at the height of 120 cm above ground level, we found that significant weakening of the wood structure occurred only at the height of the 1st and 2nd measurement points in the northern part of the trunk section, and the safety limit was still preserved.

allowed the penetration of fungi that weakened the tree. The wilting leaves were also evidence of a slight weakening of the plant's vitality.

Straight trunk with outgrowths at the base of the trunk. The crown is symmetrical, dense, and well-developed, sitting at 4.5 m. and slightly leaning toward the west. Dry hanging branches and wilting leaves are visible in the crown.

The project suggested leaving the tree and its surroundings unchanged, i.e., as lawn turf. Planting a floor of shrubs around the trunk or locating small architectural objects under the tree canopy were not planned. The project recommended removing dead branches, and that all work and care procedures should be performed following the rules of arboriculture by a team qualified to care for veteran trees. The condition of the tree should be monitored every 2 years.

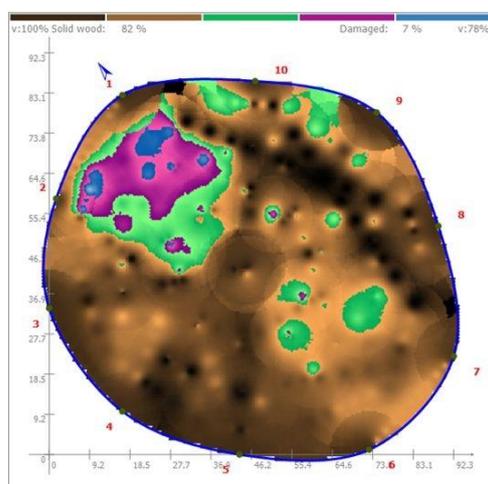
Trunk circumference at the height of 1.3 m: 293cm
 Height: 17 m
 Crown range: 11.5 m
 Approximate age: 121years, 121years, 202years, 97years

Damaged wood on the cross-section of the trunk occupied 30% of the area, and healthy wood occupied 62%. The remaining area was transitional wood (Figure 14). It was most likely that the destructive processes that had begun would worsen in the future. Therefore, monitoring the tree was recommended for the time being in order to prevent possible felling.

The minimum wall thickness indicated by the red line on the tomogram, considered the safety limit before stem fracture, was between 9 and 12.1 cm (average 10.6 cm), depending on the site. It was preserved in most of the cross-section. Destructive processes only went beyond this limit on the northeast side of the trunk (Figure 14).

Calculated for different directions, the geometric moment of inertia for this section of the trunk, measured at the weakest points at the height of the measurement, ranged from 51.3% to 56.7% of the maximum strength compared to a trunk without defects or damage. Based on the results, one could assume that the tree's mechanical strength and resistance to trunk bending were safe for the environment.

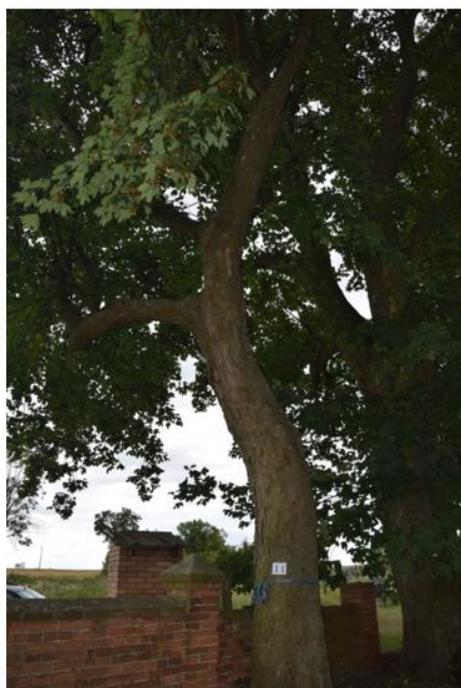
Figure 13. General view of sycamore maple (by M. Dudkiewicz, 2020).

The tree grew 0.3 m from the fence wall in the eastern part of the property (Figure 13). The trunk had several cavities, mainly hollows of various sizes. The initially straight trunk from a height of 2.5 m sloped northward at an angle of 30° and revealed several breakages in the crown, resulting in hollows and branch ashes at a level of 15–20%. The topographic examination showed progressive destruction of the trunk's interior in the core, moving to the outer layers on the northeast side at the height of measuring points 7–8. At this point, the minimum wall thickness required to maintain the proper mechanical strength of the trunk, which should have an average thickness of 10.6 cm, was also not maintained. The recorded speed of sound traveling in the wood of the tested maple ranged from 818 m s⁻¹ between measurement points 7 and 2 to 1616 m s⁻¹ between sensors 4 and 3. Referring to the average speed of sound waves propagating in healthy maple wood, which is on average from 1006 to 1426 m s⁻¹ [58], one could conclude that the lower recorded value was slightly lower than the norm while the other was well above the accepted level.

The tree grew close to another tree and right next to a brick fence, which may have resulted in insufficient sunlight. There were hollows in the trunk, broken branches, and deadwood in the crown. The tree's strength was probably weakened by the low amount of light and humid conditions in which the tree grew (by the old brick fence), which resulted in the decay of the trunk.

From the south, a hollow at the height of 0.8 m reaching deep inside the trunk \varnothing 0.1 m. The second hollow - smaller, at a height of 1.5 m from the south, measuring 0.1×0.02 m. From the west, at the height of 2.8 m, a hollow, probably from a broken branch measuring 0.3×0.15 m. Trunk initially straight up to 2.5 m and then sloping toward the north at an angle of 30°.

The project suggested planting low turf vegetation around the tree. Locating small architectural objects under the tree crown was not planned. The project suggested removing the dead branches, and that all work and care procedures should be performed following the rules of arboriculture by a team qualified to care for veteran trees. The condition of the tree should be monitored every 2 years.

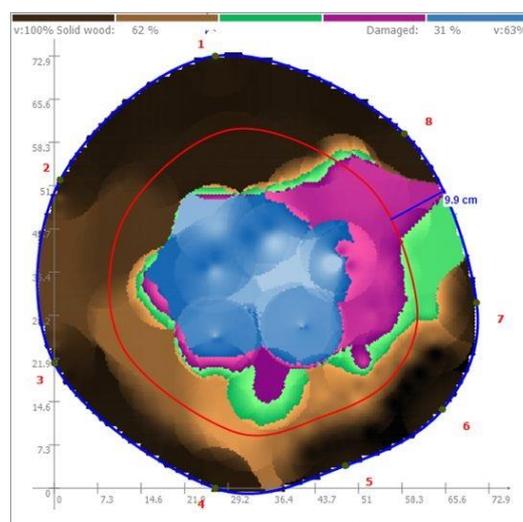
Trunk circumference at the height of 1.3 m: 232 cm
 Height: 17 m
 Crown range: 18 m
 Approximate age: 132years, 132years, 133years, 62 years

The recorded speed of the sound wave in the wood of the evaluated linden ranged from 320 m s^{-1} between measurement points 8 and 2 to 1245 m s^{-1} between sensors 4 and 12. The recorded value was much lower than the average, influenced by the movement of sound through the damaged areas slowing down its speed. The upper value, on the other hand, was within the norm and even slightly exceeded it.

Damaged wood occupied an area equal to 26% of the cross-sectional area of the trunk, while healthy wood occupied 56%. The remaining 18% was transitional wood (Figure 16). Most likely, the destructive processes that had begun would worsen in the future, but it was unknown at what rate. Therefore, it was worth monitoring the tree and holding off on possible felling.

The minimum wall thickness marked on the tomogram with a red line, considered the safety limit against trunk fracture, was 16 to 17.8 cm (average 16.9 cm), depending on the location. This limit was preserved practically throughout the cross-section, indicating that the trunk's mechanical strength was still good.

The attached tomogram also shows two yellow lines indicating the possibility of internal cracks, the most likely one oriented to the northeast between measurement points 11 and 12.

Calculated for different directions, the geometric moment of inertia for this section of the trunk, measured at the weakest points at the height of the measurement, was 10.8% to 48.9% of the maximum strength compared to a trunk without defects or damage. Based on the results obtained, one could assume that the tree's mechanical strength and resistance to trunk bending were safe for the environment.

The minimum thickness of a healthy wall relevant to the preservation of tree statics, calculated by the Tree SA method, should average 5.8 cm (green line on the attached tomogram). Based on the measurement carried out at 130 cm above ground level, there was no significant weakening of the wood structure at this trunk section. The required safety limit was maintained in excess.

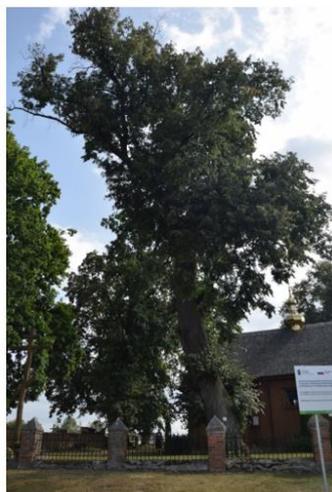
Figure 15. General view of small-leaved linden growing at the entrance of the property (by M. Dudkiewicz, 2020).

A small-leaved linden grew near the main gate on the northern side of the church (Figure 15). It was characterized by its considerable size and quite downy solid growth in the upper parts of the crown. The crown showed traces of broken branches, and the surgical cuts were partially healed. Numerous heavily leafy outgrowths appeared on the trunk. The crown was asymmetrical, facing north. At the base of the trunk, large root intakes had developed. Traces of insect activity were also visible. The upper part of the tree trunk had numerous hollows. The root system was strongly developed, pushing slightly against the fence's foundation. The CT scan made it possible to determine the health of the trunk's interior (Figure 16). Linden trees are characterized by wood susceptible to biocorrosion; hence, the destruction visible on the tomogram in the core part of the trunk was a common phenomenon. We calculated the limiting wall thickness considered safe for this trunk's mechanical strength to be 16.9 cm on average.

Numerous broken branches. Large stature in the crown. Crown facing north. Large rooting and regrowth on the trunk. Thick branch cut from the south, as well as from the north and east sides. Roots are pushing the fence foundation outward. Visible hollows in the upper part of the trunk on the north side. Falling bark. Traces of insect feeding in the trunk (exit holes). Nodular growths - remnants of branches - at different heights on each trunk side.

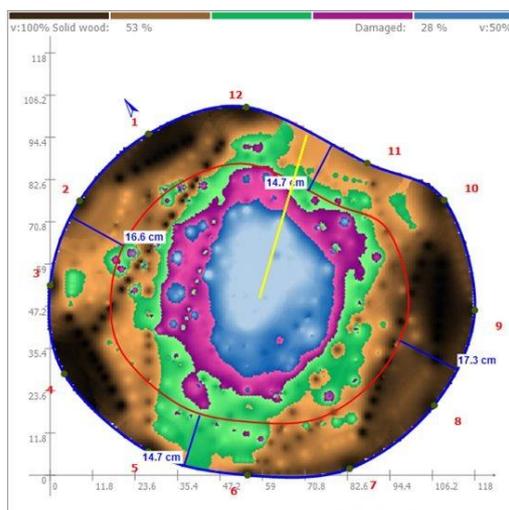
Trunk circumference at the height of 1.3 m: 367 cm

Height: 17.8 m

1. Tree to keep.
2. Dead branches to be removed. All work and care procedures should follow the rules of arboriculture by a team qualified to care for veteran trees.
3. Modifying the foundation of the fence to allow root growth.
4. Health monitoring every year.

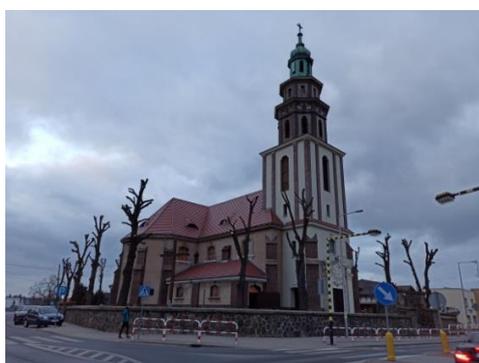
Figure 17. Destruction of trees around the Church of St. Marcin Wincenty in Skórzewo near Poznań (Greater Poland Voivodeship) (photo M. Dudkiewicz, 2022).

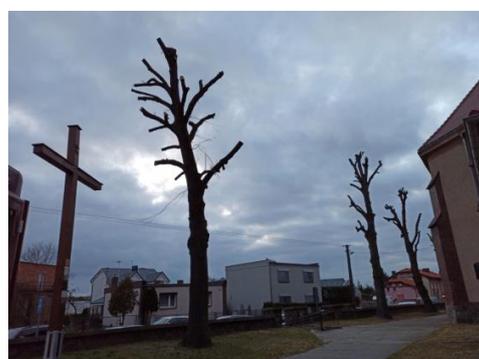
Figure 18. Destruction of trees around the Church of St. Marcin Wincenty in Skórzewo near Poznań (Greater Poland Voivodeship) (photo M. Dudkiewicz, 2022).

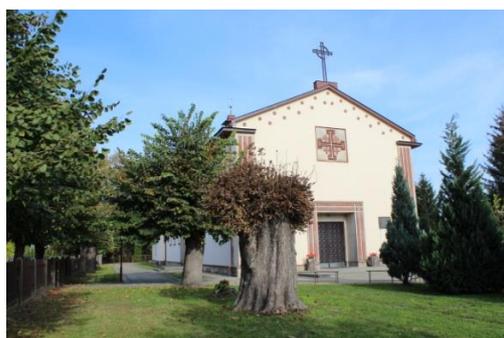
Figure 19. Destruction of trees around the church in Zajezerze near Dęblin (Lubelskie Voivodeship) (photo M. Dudkiewicz, 2022).

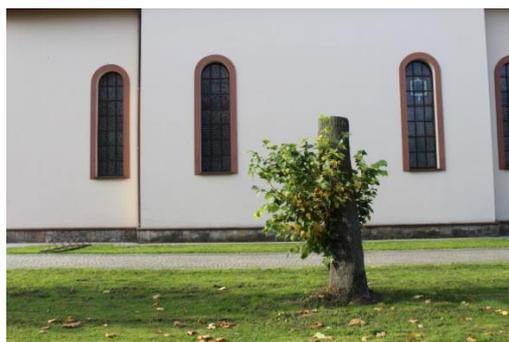
Figure 20. Destruction of trees around the church in Zajezerze near Dęblin (Lubelskie Voivodeship) (photo M. Dudkiewicz, 2022).
