# Failure Analysis of PHILOS Plate Construct Used for Pantalar Arthrodesis Paper I—Analysis of the Plate

**Abstract:** The failure of a proximal humerus internal locking system (PHILOS) used in a pantalar arthrodesis was investigated in this paper. PHILOS constructs are hybrids using locking and non-locking screws. Both the plate and the screws used in the fusion were obtained for analysis. However, only the plate failure analysis is reported in this paper. The implant had failed in several pieces. Optical and scanning electron microscopic analyses were performed to characterize the failure mode(s) and fracture surface. The chemical composition and mechanical properties of the plate were determined and compared to controlling specifications to manufacture the devices. We found that equivalent tensile strength exceeded at the locations of high stress, axial, and angular displacement and matched the specification at the regions of lower stress/displacement. Such a region-wise change in mechanical properties with in vivo utilization has not been reported in the literature. Evidence of inclusions was qualitatively determined for the stainless steel 316L plate failing the specification

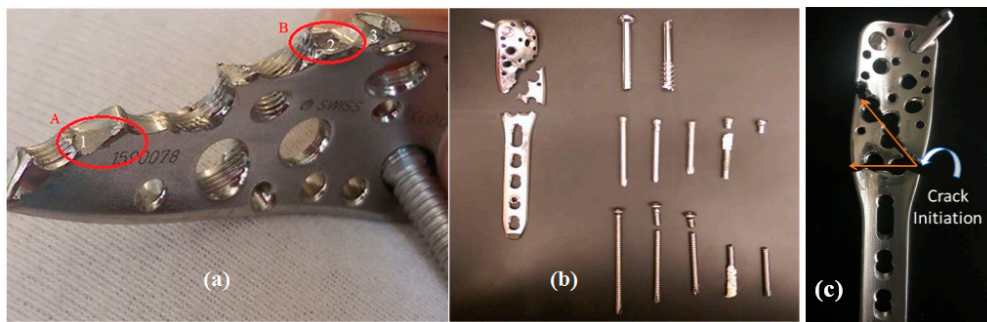
**Figure 1.** Submitted proximal humerus internal locking system (PHILOS) device for analysis; (a) plate through the thickness shows regions of interests marked by A and B and 1–3 investigated in this paper (b) the failed samples and (c) crack initiation and propagation of the plate.

was not removed from the distal end. Figure 1 shows that the crack initiated from under one of the locking screw holes near the middle of the plate. This fracture initiation has progressed in two different directions, one diagonally  $45^\circ$  in the directions of maximum shear and one perpendicularly (Figure 1), which caused the plate to fail into three pieces. The observed features are summarized in Table 3. Since the plate and screw construct was removed after it had failed, we do not know whether the material dissolution or contact between two mating surfaces during removal removed the pitting and or other localized damage sites prior to crack formation.

Location	Damage Feature(s)
Distal area (Figure 1B)	Scratches and pits
Close to fracture plane (Figure 1A)	Scratches, pits, corrosion, cracking
Area (A), (Figure 1)	Debris, discoloration

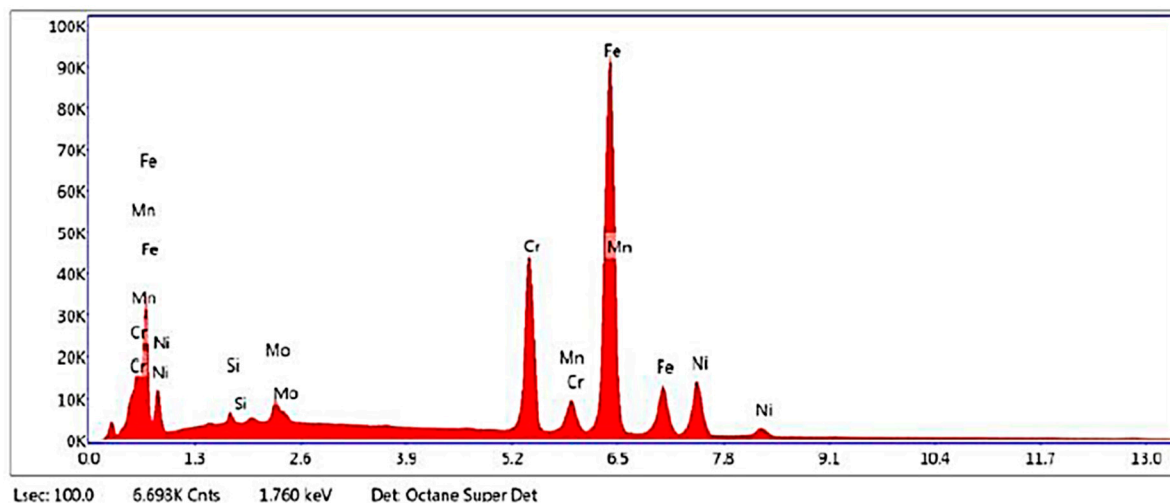
**Figure 2.** Energy dispersive X-ray analysis shows qualitatively the peaks of different element weight percent present in the PHILOS plate.

The plate conformed to ASTM standards according to the tolerated ranges of element composition but failed equation 1 in this instance shown in Table 1. However, in another instance, the results of the composition analysis gave a result of 28.7 for Equation (1), thus passing the requirements.

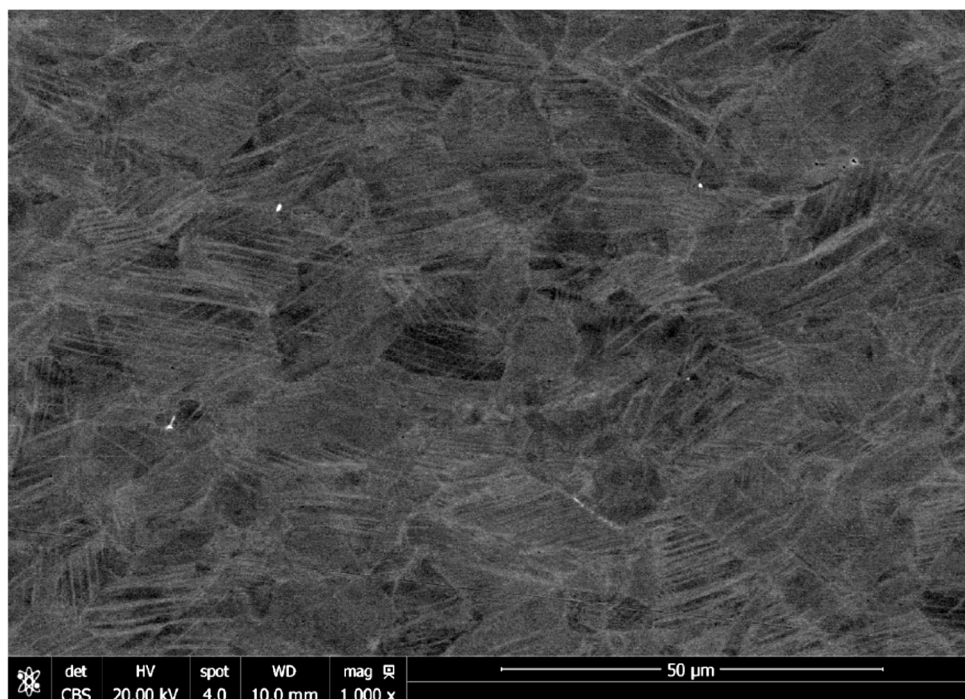
EBSID and backscatter imaging methods were used to characterize the structure of the material. The microstructure is shown in Figure 3. The range in the average grain size of the plate was four to six micrometers shown in Figure 4.

**Figure 3.** Microstructure of PHILOS plate at 1000 $\times$ .

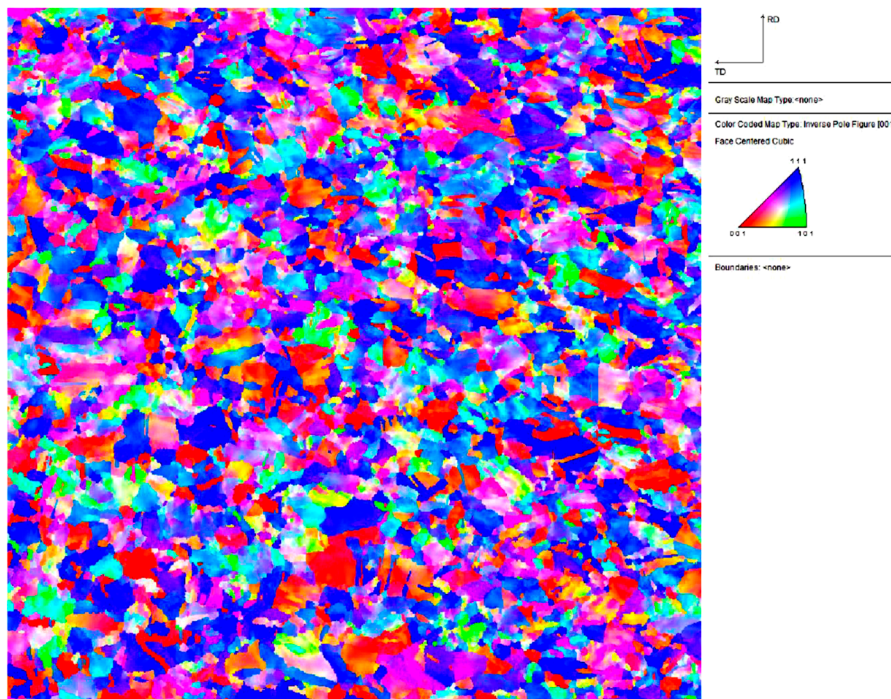
**Figure 4.** Electron backscatter diffraction (EBSD) grain map of the PHILOS plate.

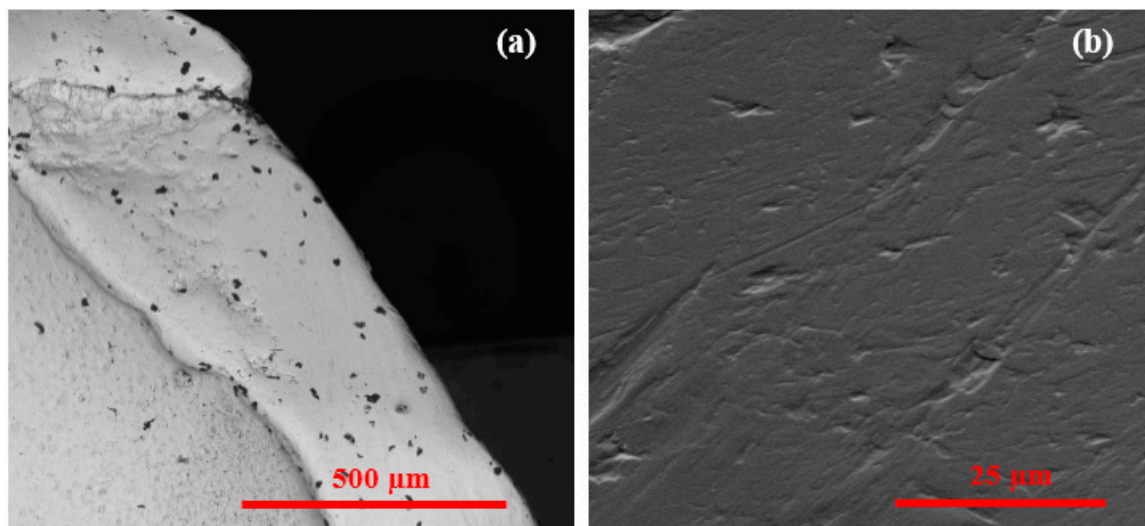
An attempt was made to identify and characterize the inclusions. Two regions of interest identified in Figure 1 as area 2 and 3, were investigated for inclusions and presented in Figure 5a,b. The composition of one inclusion was mapped in Figure 6 using EDS. The maps in Figure 6 show that inclusions are likely Mo rich (though this could be S), these inclusions may be fine, localized chi and sigma intermetallic phases which may have started the crack. There is a need to characterize inclusions in surgical grade SS 316L as a dedicated basic research focus since this paper deals with failure analysis and the importance that the inclusions have on failure initiation.

**Figure 5.** Backscattered electron images of likely inclusions (a) SEM EBSD image of area 2 (b) Topographical SEM image of area 3.

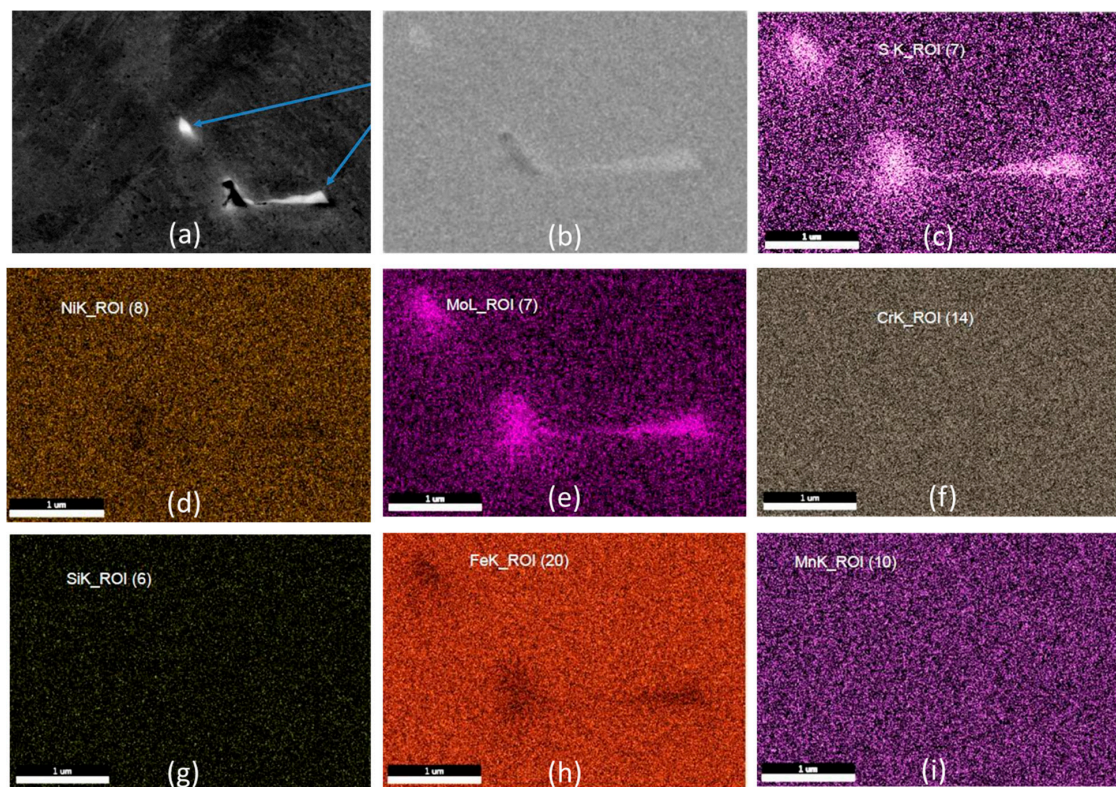
**Figure 6.** Characterization of inclusions using EDS. (a) The inclusions, (b) Gray scale of inclusions. Overlapping spectra of S and Mo visible in (c) Sulfur and/or (d) Nickel, (e) Molybdenum in the microstructure of the PHILOS plate. While the rest (f) Chromium, (g) Silicon, (h) Iron and (i) Manganese are not visible.

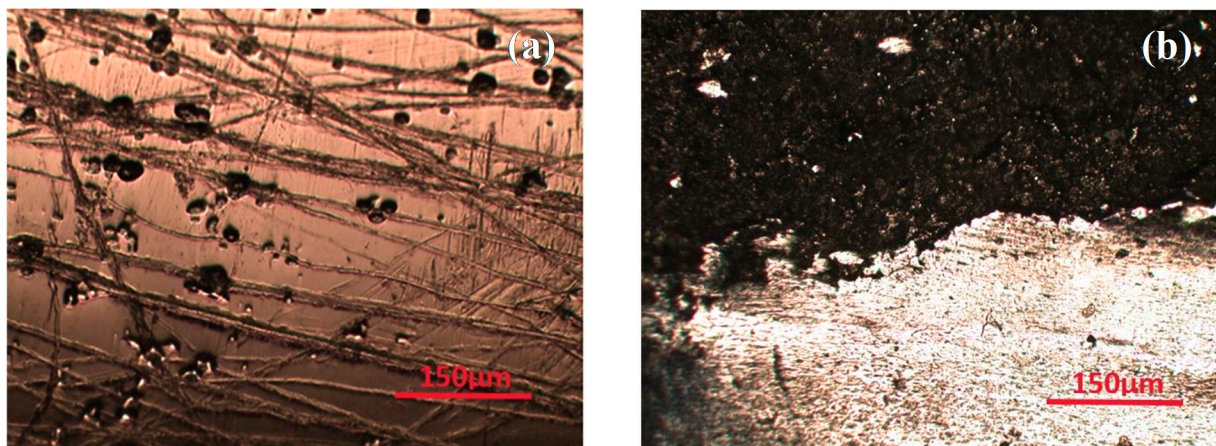
The markings shown in Figure 7a are changes in surface elevation eluding to pitting in area of interest 3. Figure 5 shows EBSD image and distribution of different phases present in the material that may be described as non-metallic/inclusions. Non-metallic inclusions are known to be areas of stress concentration and increase the likelihood of pitting corrosion and secondary crack initiation. Sudhakar et al. and Kanchanomi et al. found that non-metallic inclusions initiated the eventual failure of devices in their studies [13,18]. This evidence of pitting and foreign body inclusions, seen in Figures 5 and 6, respectively, supports secondary crack initiation due to corrosion-fatigue at these sites. Figure 8a–c show fatigue striations in the areas of interest 1, 2, and 3, respectively. Striations are evident within all three images. Figure 8a also shows some evidence of cleavage and facets. The striation spacing in each image was measured and displayed in Table 4. The arrows indicate the direction of crack propagation based on increase in striation spacing.

**Figure 7.** Light microscopy images showing (a) scratches and uniform pitting, and (b) debris and discoloration.

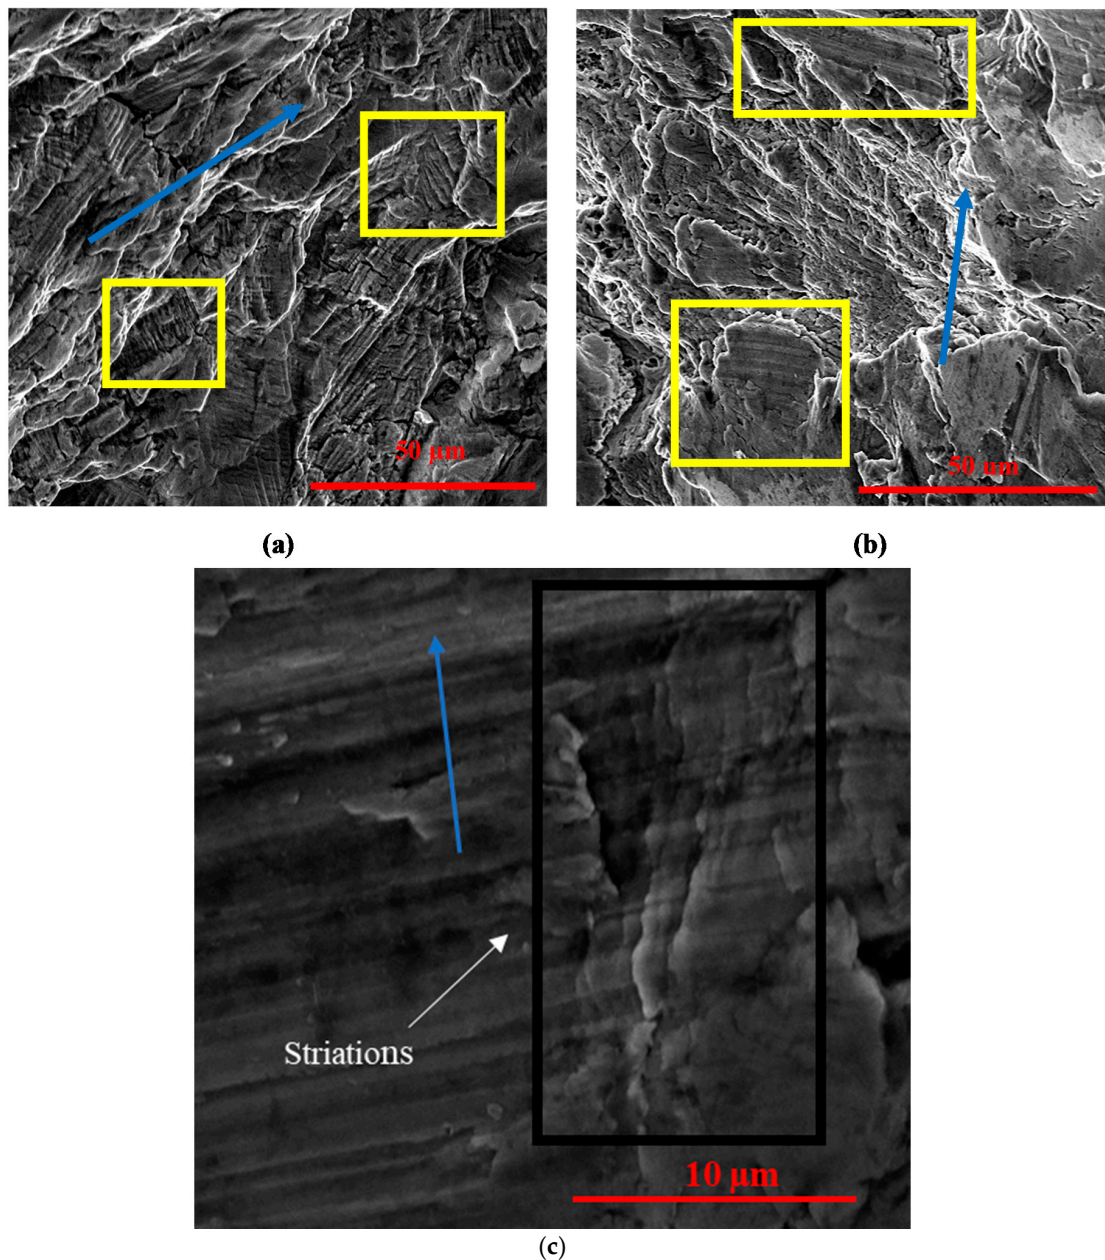
**Figure 8.** SEM images of (a) area 1, (b) area 2, and (c) area 3 showing striations perpendicular to crack propagation. The yellow boxes show striations and blue arrows denote the direction of crack propagation.

From these methods it is quite clear that striation spacing increased as the crack advanced through the three regions, 3 to 1, respectively. The origin for crack appears to be from area 3 (distal end of plate, latterly); however, as it advanced, the linking occurred through the screw holes in a  $45^\circ$  angle which may have coincided with dorsiflexion angle or slight movement by gait. Upon failure, the plate

was not able to load bear along this angle, the load transferred perpendicularly causing cracking and linking through the screw holes in that direction as well.

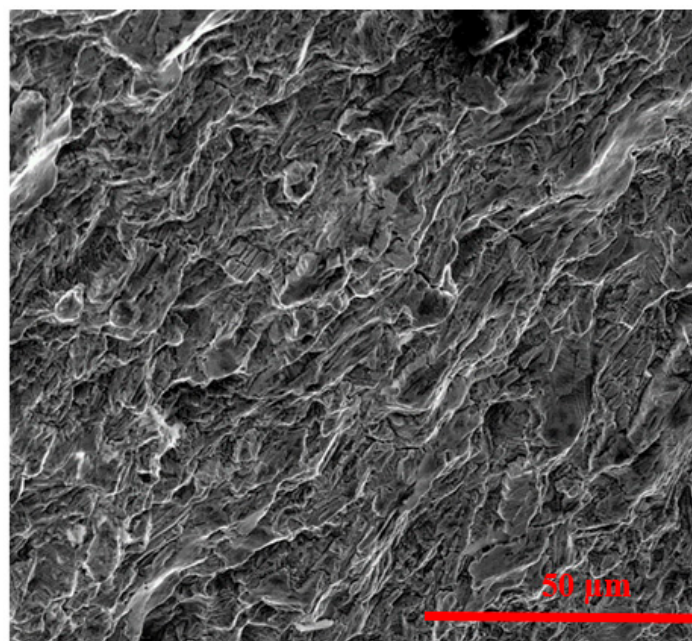
**Figure 9.** SEM image taken at area of interest 1. This image contains examples of quasi-cleavages and facets.

The quasi-cleavage and facets seen in Figure 9 are highly characteristic of brittle fracture—an end consequence of corrosion-fatigue crack propagation. Imaging of the distal end of the failed piece on the optical microscope (Figure 7b) showed evidence of progressive fatigue fracture that eventually led to brittle fracture, depicted by the abrupt change in surface pattern. It is this brittle fracture that ultimately led to the failure of the PHILOS.

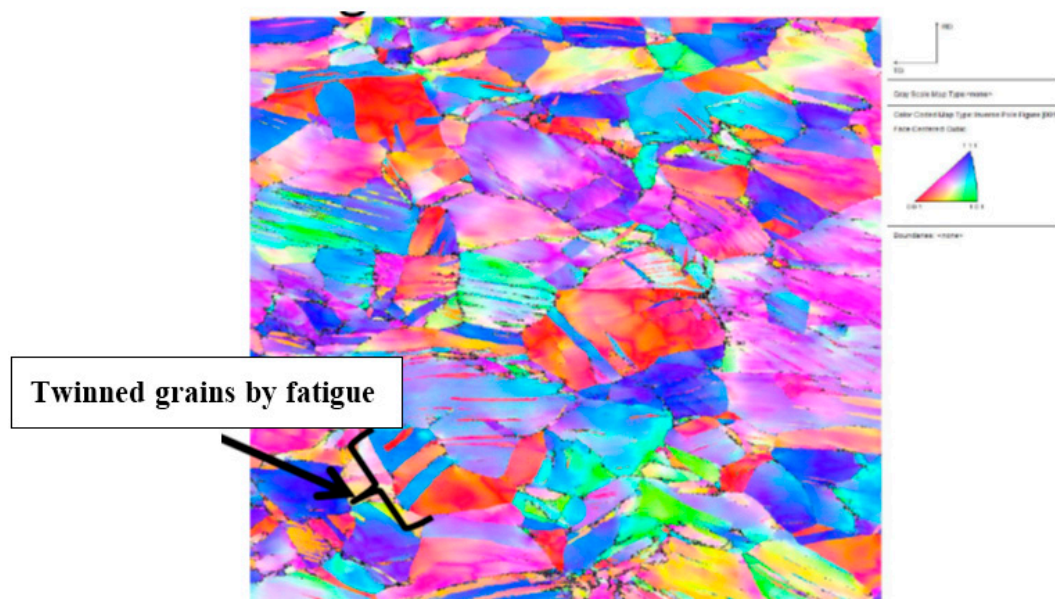
**Figure 10.** Inverse pole figure showing crystallographic characterization of the plate microstructure showing twinning that may have occurred due to in vivo use by fatigue or a material feature.

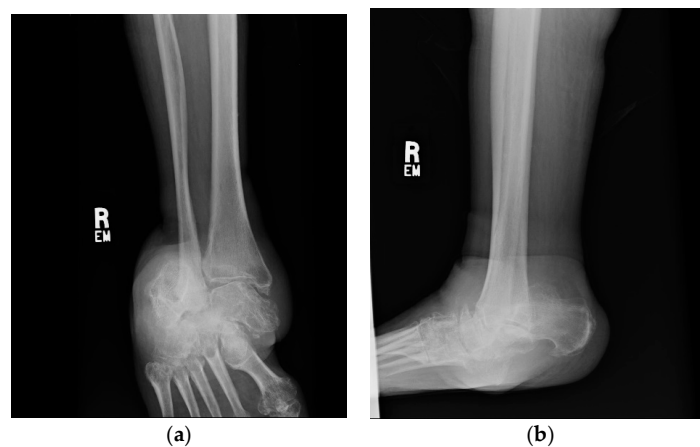
**Figure A1.** Initial X-Ray images showing lateral subtalar dislocation with varus tibiotalar joint alignment.

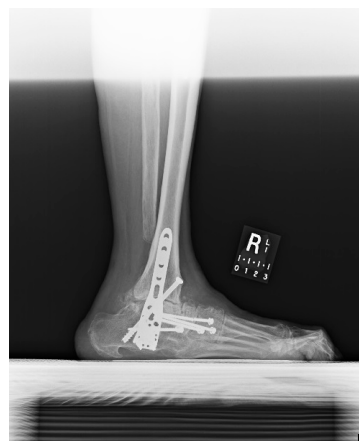
X-rays from the 18-month post-op visit showed evidence of breakage of a distal 3.5 mm talonavicular screw (Figure A2). The fracture line was located in the thread near the screw head. At two years post-op, the screw breakage was more displaced and there was an additional fracture in the most proximal 3.5 mm cortical screw in the tibia (Figure A3). The fracture line of this screw was again in the thread near the screw head. At three years post-op, a new fracture of the most proximal 3.5 mm locking screw in the talus was present (Figure A4). There was also evidence of a newly forming valgus deformity. At five years post-op, an additional 3.5 mm cortical screw in the tibia, a second 3.5 mm talonavicular screw, the 6.5 mm cannulated screw, and the 3.5 mm LCP plate all exhibited fracture on imaging (Figure A5). At six years post-op, an additional 3.5 mm cortical screw in the tibia broke and the fractured plate became more widely displaced (Figure A6). The valgus deformity seen earlier had now progressed to nearly 30 degrees.

**Figure A2.** 18 months post-op imaging with evidence of breakage of a distal 3.5 mm talonavicular screw.

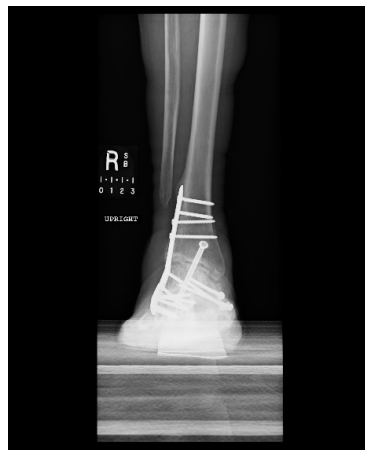
**Figure A3.** 2 years post-op imaging with screw fracture more displaced and an additional fracture in the proximal 3.5 mm cortical screw in the tibia.

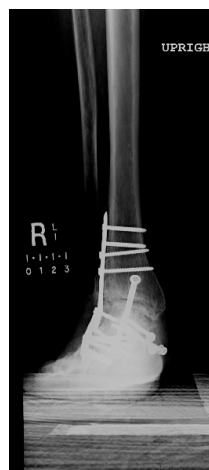
**Figure A4.** 3 years post-op showing new fracture of the most proximal 3.5 mm locking screw in the talus.

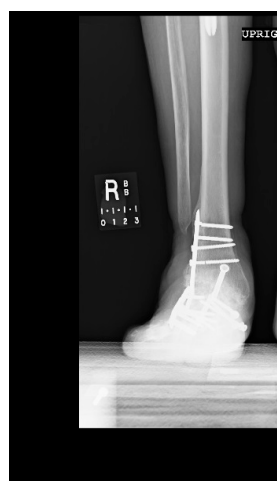
**Figure A5.** 5 years post-op with additional fractures in a 3.5 mm cortical screw in the tibia, a second 3.5 mm talonavicular screw, the 6.5 mm cannulated screw, and the 3.5 mm LCP plate.

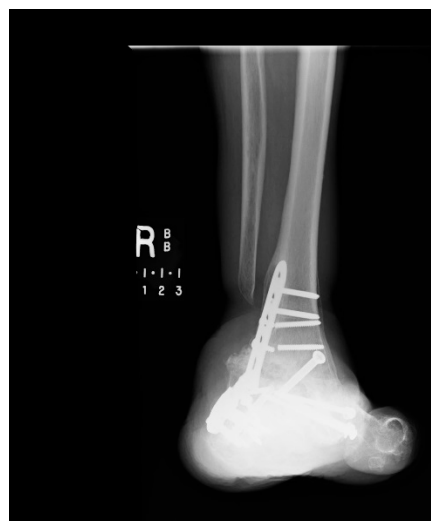
**Figure A6.** 6 years post-op with an additional fracture in a 3.5 cortical screw in the tibia and the fractured plate became more widely displaced. The valgus deformity seen earlier had now progressed to nearly 30 degrees.
