Monitoring of the Technical Condition and Optimisation of the Functioning of Small Hydraulic Structures in Poland: The Case Study of the Oświecim Weir

Citation: Nowak, B.; Ptak, M.; Sojka, M. Monitoring of the Technical Condition and Optimisation of the Functioning of Small Hydraulic Structures in Poland: The Case Study of the Oświecim Weir. *Buildings* **2022**, *12*, 1527. <https://doi.org/10.3390/buildings12101527>

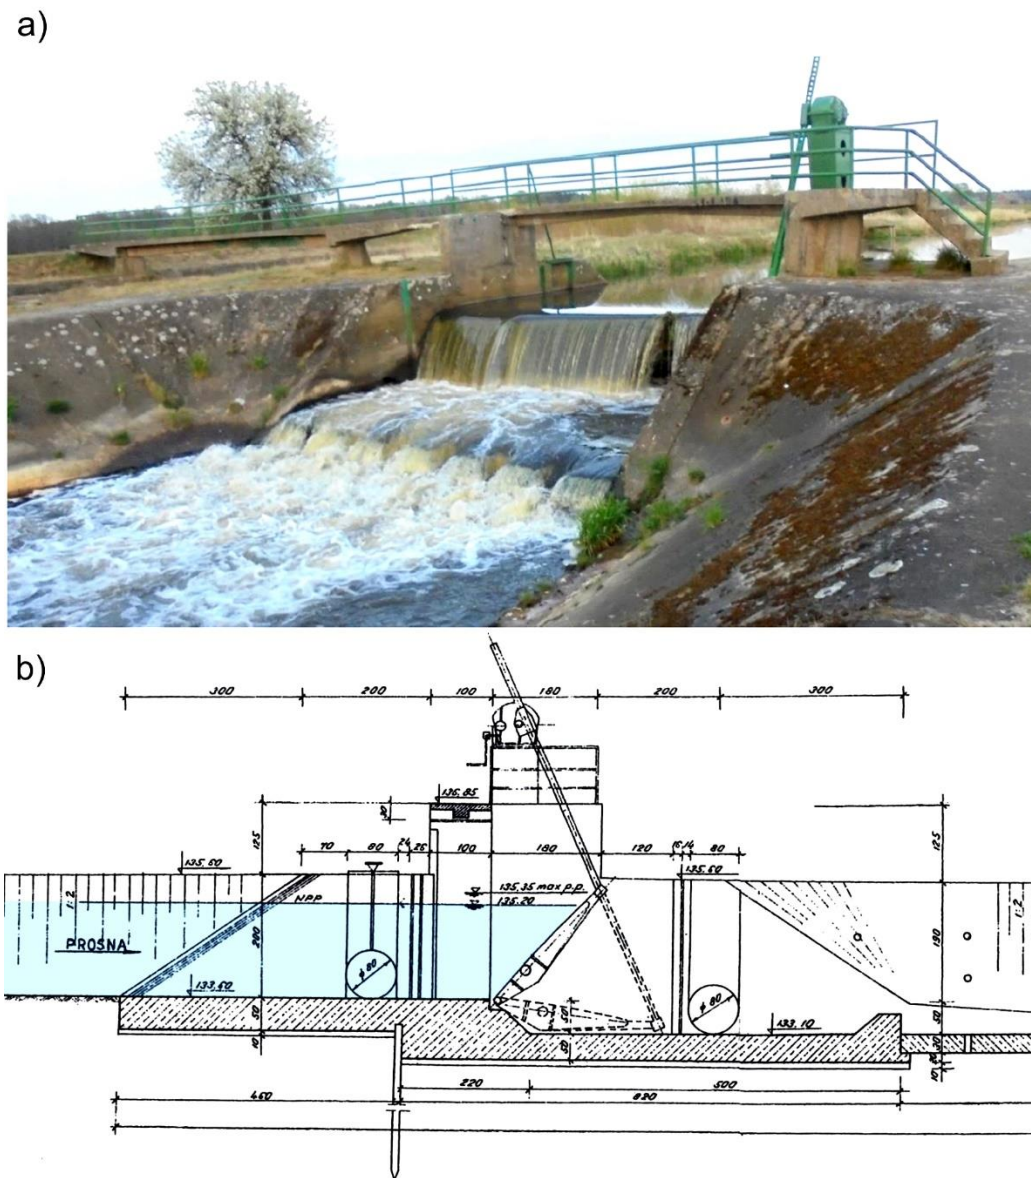
Figure 2. Oświęcim Weir: (a) view of the structure subject to the assessment of the technical condition (before renovation); (b) longitudinal section of the weir (source: State Water Holding Polish Waters).

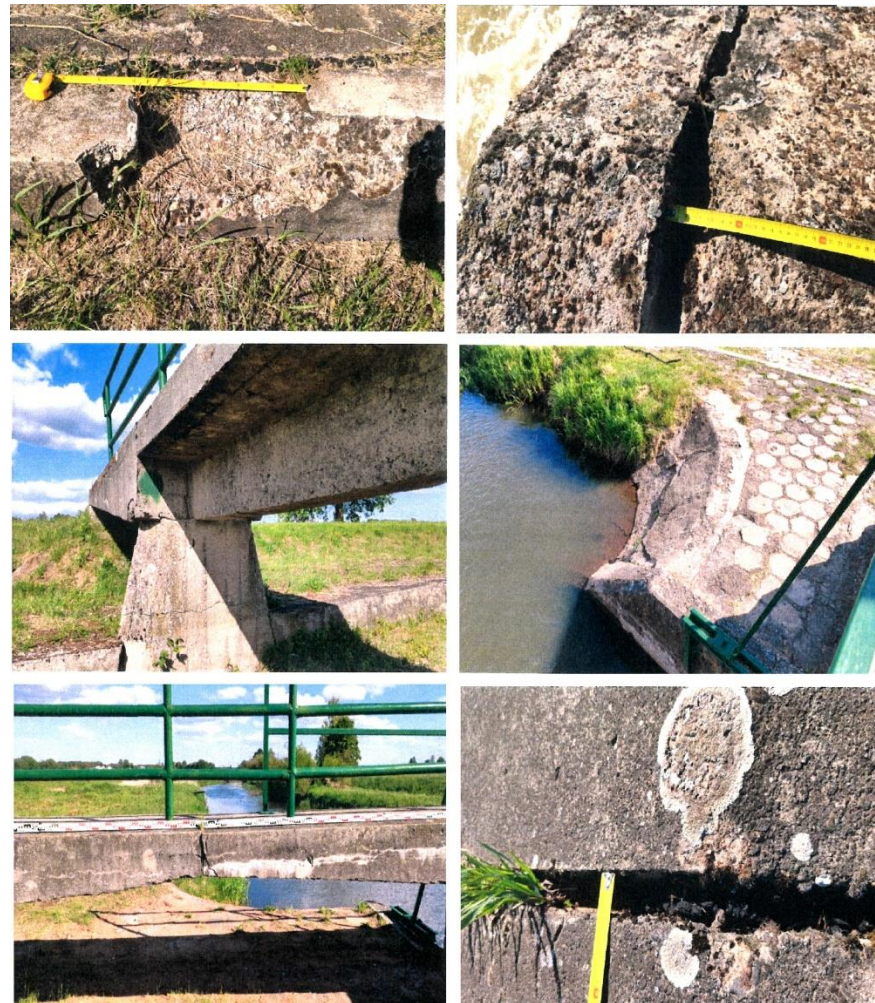
- (a) Walls of the weir:
 - Local cavities in concrete with a depth of up to 15 cm over the entire surface of the walls;
 - Numerous shallow cracks in the concrete structure, visible evident frost corrosion of the wall surface (Figure 4);

- (b) Bottom slab:
 - Cavities in concrete with a depth of up to 20 cm over the entire surface;
- (c) Service footbridge:
 - Numerous damages, cavities, and cracks in the concrete structure;

- Exposed reinforcement of the footbridge pillar;
 - (Frost) surface corrosion of the concrete elements of the footbridge;
- (d) Strength of the concrete in the weir structure:

- Our evaluation by means of a non-invasive method with a type N Schmidt sclerometer revealed the compressive strength of the concrete in the left wall of the weir to be at an average level of $f_{cm} = 27.02$ MPa (with the consideration of the age of the concrete, 18.16 MPa), and in the right one at a level of $f_{cm} = 26.72$ MPa (with the consideration of the age of the concrete, 17.95 MPa);

- (e) The steel elements of the weir:
 - Gates and maintenance gate guides at the level of water level fluctuations, showing visible signs of corrosion;

- The exhaust system; difficulties with its efficient operation potentially resulting from flap deformation;
- (f) The reinforcements of the bottom and the scarps of the river at the upper site:

- Numerous damages and cracks in concrete slabs;
- (g) The reinforcements of the bottom and the scarps of the river on the lower site:
 - Numerous cavities and cracks in concrete surfaces, the lack of filling in concrete slabs, the faulty surface of reinforcements in concrete slabs, the degradation of the bottom reinforcements from fascine mattress, and the degradation of a palisade and wooden tight walls;

- (h) The reinforcements of the lateral outflow:
 - The outflow surface on the right bank—partially covered with soil;
 - The reinforced concrete elements forming an outflow channel showed numerous cracks and small cavities;

- The surface of the outflow on the left bank—numerous deformations with cavities, the surface partially covered with soil, obstructed drainage outflow, and

numerous cracks and cavities in the reinforced concrete elements forming the outflow channel;

- (i) Flap gates:
 - A trial run of the gate revealed considerable difficulties in raising the flap, with the time of raising of 1 h;
 - Bent gate flap;
- (j) Embankment crowns at the object:
 - No signs of considerable subsidence.

Figure 4. Technical condition of the Oświęcim Weir before renovation [30].

The detailed expert opinion on the technical condition of the Oświęcim Weir revealed evident frost corrosion of the wall surface, a problem common in cold regions. The degradation of concrete caused by frost is important in reference to the lifespan of concrete structures [51]. The damage caused by freezing and defrosting affects the parameters of cracking in concrete structures [52]. Importantly, repairs to damaged concrete structures are usually complicated and costly [53]. In the analysed case, an optimal solution was the demolition of the existing (degraded) weir and the construction of a new object in its place.

The above expert opinion provided the basis for formulating the guidelines and instructions concerning the necessary renovation work on the Oświęcim Weir. Based on the applications derived from the aforementioned expert opinion, the Voivodeship Inspector of the Building Supervision Authority issued a mandated decision on the elimination of the reported irregularities in the technical condition of the object, termed the Decision of the Wielkopolska Voivodeship Building Supervision Inspector [29]. Considering that the term of the implementation of the repairs was specified for 31 December 2023, the thorough modernisation of the weir commenced in the second half of 2021 (Figure 1). The final acceptance of the construction work was performed on 15 December 2021. On 24 February 2022, after inspection, the Voivodeship Building Supervision Inspectorate determined that the owner of the weir had performed the necessary repair, thus meeting the requirements for further operation of the object (Figure 5).

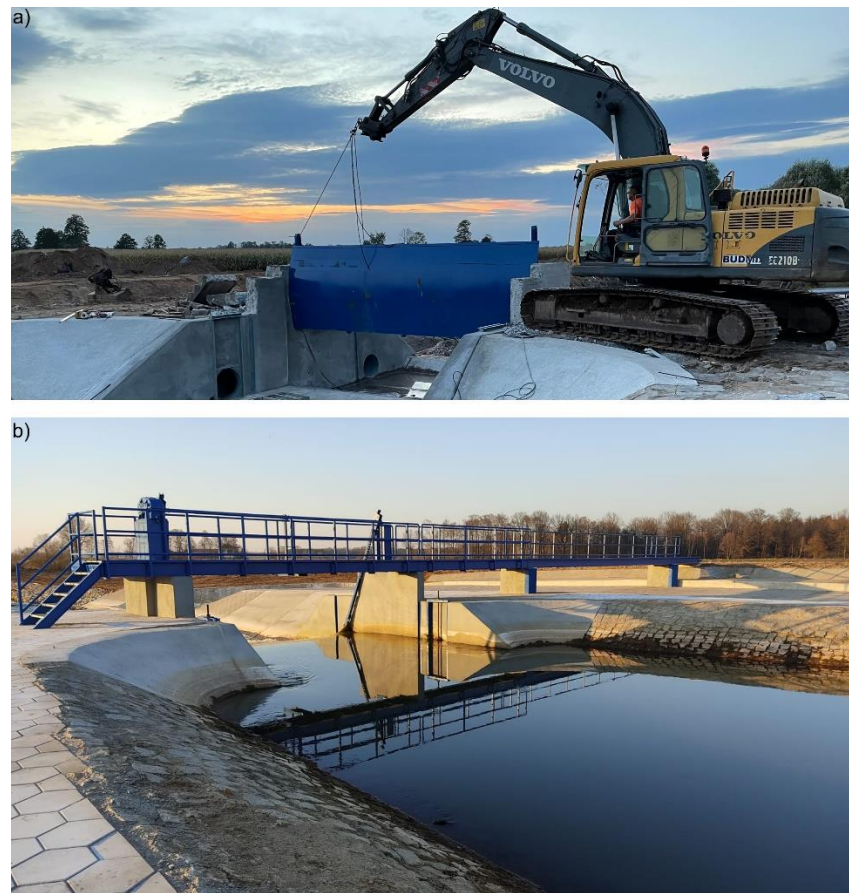
Figure 5. Remodelling (a) and functioning (b) of the Oświęcim Weir (source: State Water Holding Polish Waters).

The incurred costs as a result of the undertaken repair work, resulting from the monitoring of the technical condition of the weir, amounted to EUR 500,000. This investment is undoubtedly justified by the unfavourable hydrological situation characterising the analysed area. The daily discharges of the Prosna River in the hydrological profile of Mirków in the period 1970–2021 were at a level ranging from 0.25 to $84.3 \text{ m}^3 \text{ s}^{-1}$. The average discharge is $SSQ = 5.04 \text{ m}^3 \text{ s}^{-1}$, which, in reference to the surface of the catchment area, translates into a unitary outflow of $q = 4.06 \text{ dm}^3 \text{ s}^{-1} \text{ km}^{-2}$. The 7-day minimum discharge values in the analysed period varied from $0.35 \text{ m}^3 \text{ s}^{-1}$ to $3.10 \text{ m}^3 \text{ s}^{-1}$, averaging $1.47 \text{ m}^3 \text{ s}^{-1}$. They decreased in the years 1970–2021 (the decrease was statistically significant at a level of 0.01), by $0.15 \text{ m}^3 \text{ s}^{-1} \text{ decade}^{-1}$ on average (Figure 6a).
