Article

Locating Hidden Elements in Walls of Cultural Heritage Buildings by Using Infrared Thermography

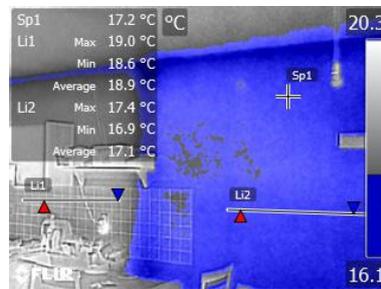
Another example of an outer envelope can be seen in Figure 3, with the area where the insulation is missing colored in blue. It is evident that the wall temperature in the areas with and without insulation vary in the range of 2 °C.

Figure 3. Absence of the outer envelope insulation through a homogenous thermal flow analysis.

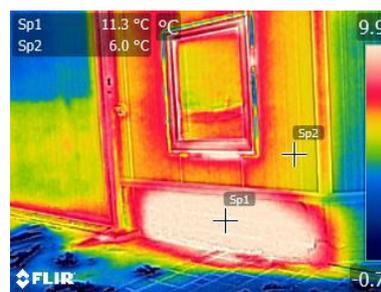
The lack of adequate insulation on the overhead wall of the industrial facility suggests the existence of an omission that resulted in increased thermal loss (Figure 4). The cooler areas on the pavement are the parts covered with water that, by its evaporation, takes away thermal energy and ostensibly represents an area of lower temperature.

Figure 4. Lack of insulation of the outer envelope in front of the radiator.

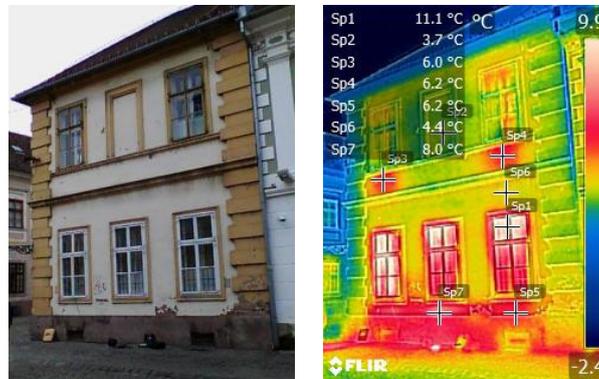
Figure 16. Thermogram of the whole building.

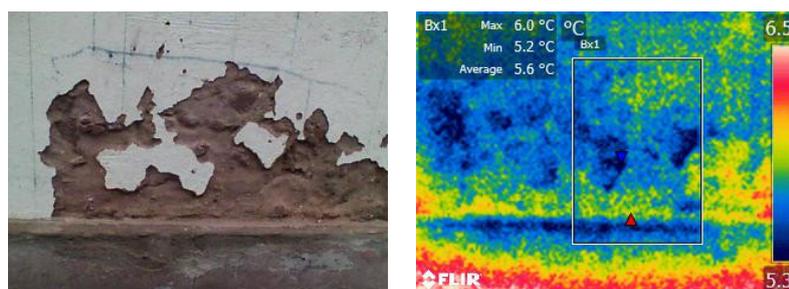
The outer envelope (i.e., the facade) has not been renewed since the 1980s. An additional analysis on the parts of the envelope with visible damage was carried out, but the conclusion that can be provided is that the shape of the damage does not strictly correlate with the thermal pattern (Figure 17).

Figure 17. Analysis of facade damage.

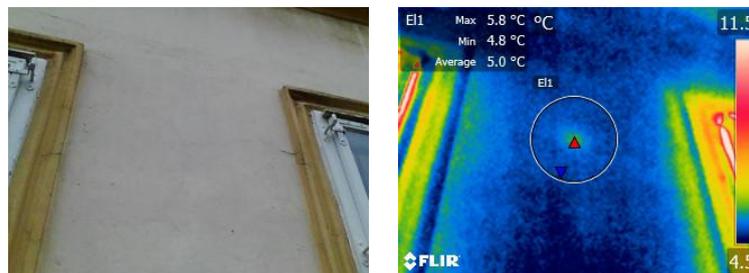
A weak dot heat bridge on the first floor was noticed (Figure 18). This was probably a result of the metallic anchorage (structural element) covered with plaster during the last facade maintenance.

Figure 18. Discovered weak point heat bridge.

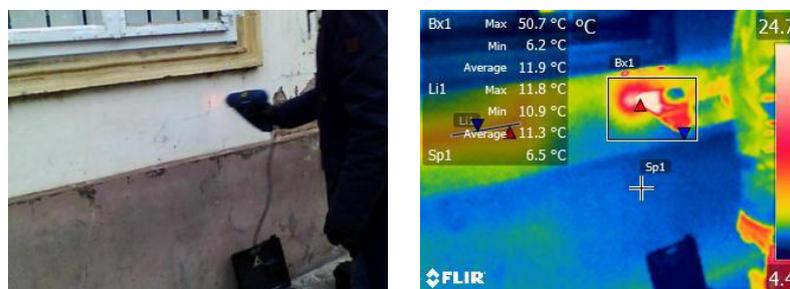
In order to determine the existence of discontinuity in the outer envelope, heating was applied, as is shown in Figure 19.

Figure 19. Initial application moment of thermal excitation.

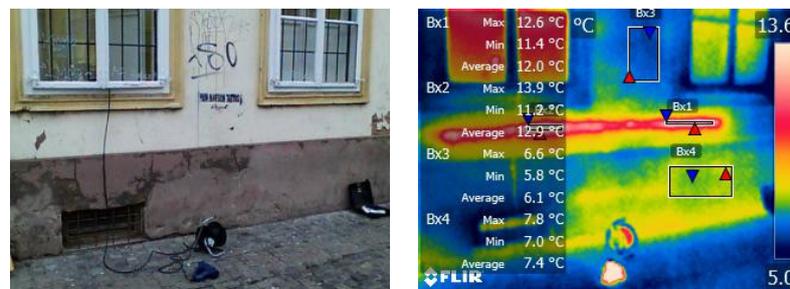
There was not any discontinuity by the analysis of the thermal pattern change. In Figure 20, a linear trace of the heating body, which is continuous and uninterrupted, can be observed.

Figure 20. Homogeneous thermal pattern on excitation along the wall.

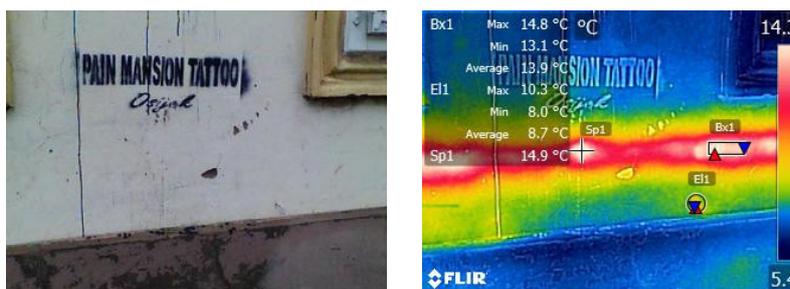
The detail below the left window in the lower left corner of the thermogram reveals that spot facade damage, due to a difference in emissivity, shows a higher apparent temperature (Figure 21).

Figure 21. Influence of damage to the thermal pattern.

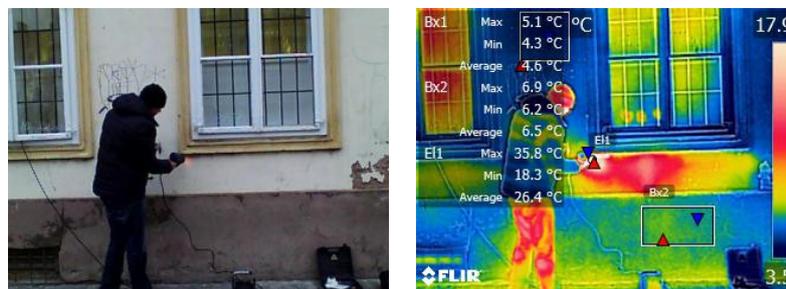
Increasing the area under the thermal excitation did not affect the result. The thermal pattern caused by the excitement was homogenous and uniformly disappeared over time (Figure 22).

Figure 22. Increasing the area of applied thermal excitation.

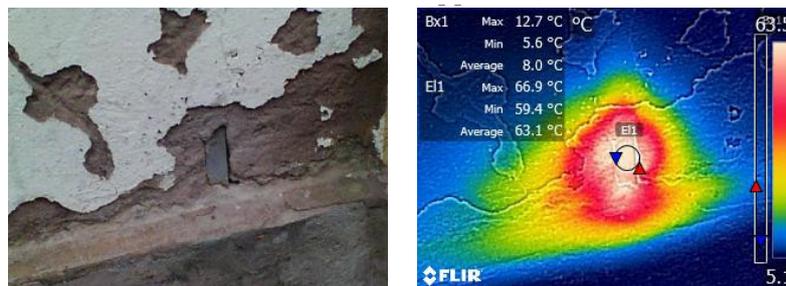
As no discontinuity in structural elements of a building was discovered, the conclusion was that there was no change of the analyzed area, or the method itself is not applicable because of the wall mass and thermal capacity. In the case of heating the lightning protection grounding line, the heating capacity of the wall and the surface character of the applied method were observed (Figure 23).

Figure 23. Thermal excitation of lightning protection installation.

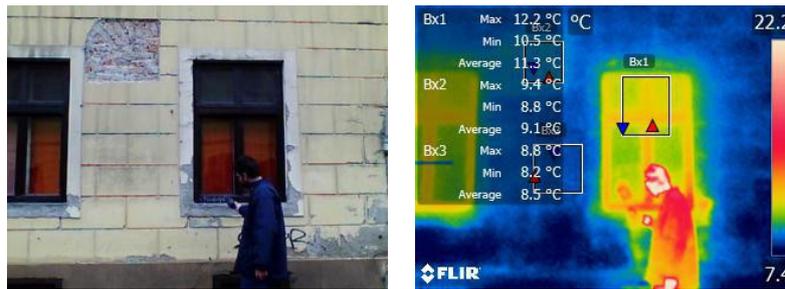
Figure 24. Termogram of Kostić house in 23 Kuhačeva Street.

By analyzing the thermal pattern shown in Figure 24, the difference in the probing area, as a result of the difference in emissivity, is evident. The expected discontinuity observed by probing did not appear during the heat excitation of the parapet wall (Figure 25a). As can be seen from Figure 25b, a further line heating process raised the wall temperature but did not result in a change in the thermal pattern. During the heating and during the time, the thermal pattern seemed to be inhomogeneous, albeit in a manner that corresponds to the presence of moisture, rather than non-discontinuity in the structural elements. By analyzing the smaller parts of the wall, no additional information (as shown in Figure 25c) was obtained.

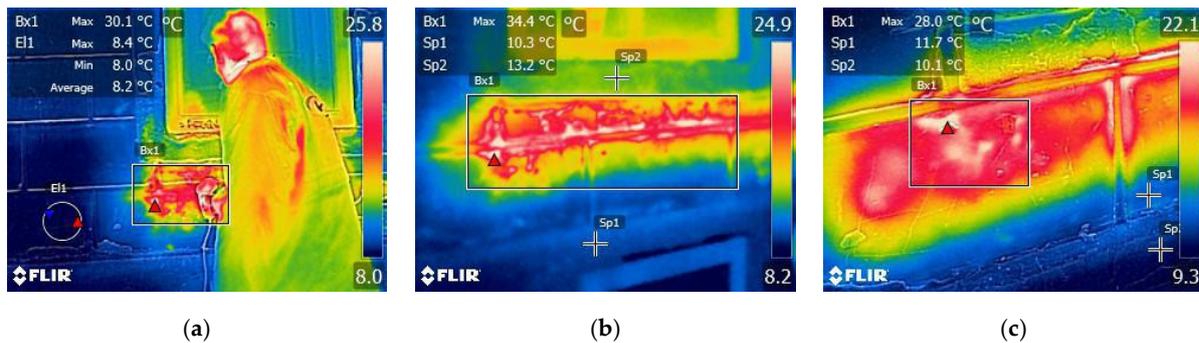
Figure 25. Changing the thermal pattern due to heating.

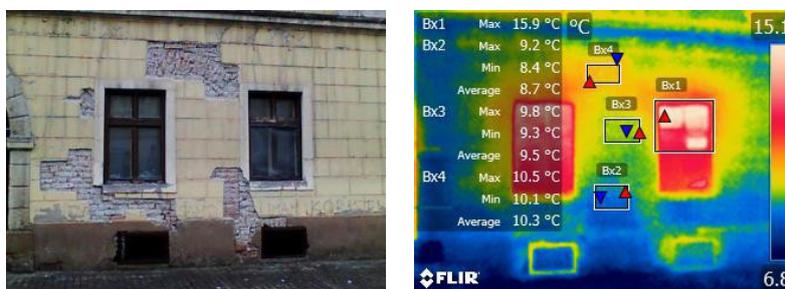
After looking at the bricked up openings as well as wall probing (Figure 26) and the associated thermal pattern, it is obvious that the thermographic analysis was not as effective in finding the bricked up openings in the massive homogeneous structures of the brick wall.

Figure 26. Thermogram of the probing building part of a known wall structure.

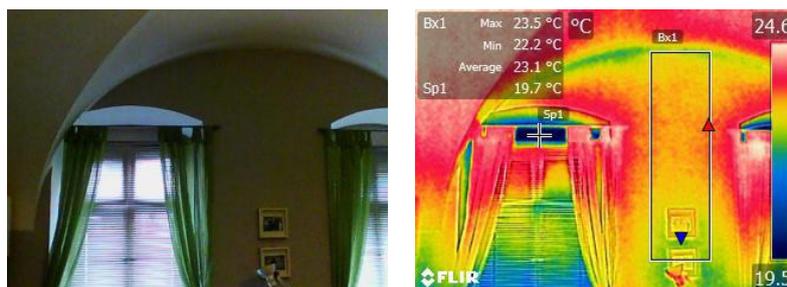
In order to confirm the conclusions, the examined place was checked from the inside of the building. Significant thermal masses and continuous heating have resulted in a constant thermal pattern, presented in Figure 27.

Figure 27. Thermal pattern on the inside of the wall.
