# Primary and Secondary Environmental Effects Triggered by the 30 October 2020, Mw = 7.0, Samos (Eastern Aegean Sea, Greece) Earthquake Based on Post-Event Field Surveys and InSAR Analysis

**Abstract:** On 30 October 2020, an Mw = 7.0 earthquake struck the eastern Aegean Sea. It triggered earthquake environmental effects (EEEs) on Samos Island detected by field surveys, relevant questionnaires, and Interferometric Synthetic Aperture Radar (InSAR) analysis. The primary EEEs detected in the field comprise coseismic uplift imprinted on rocky coasts and port facilities around Samos and coseismic surface ruptures in northern Samos. The secondary EEEs were mainly observed in northern Samos and include slope failures, liquefaction, hydrological anomalies, and ground cracks. With the contribution of the InSAR, subsidence was detected and slope movements were also identified in inaccessible areas. Moreover, the type of the surface deformation detected by InSAR is qualitatively identical to field observations. As regards the EEE distribution, effects were generated in all fault blocks. By applying the Environmental Seismic Intensity (ESI-07) scale, the maximum intensities were observed in n

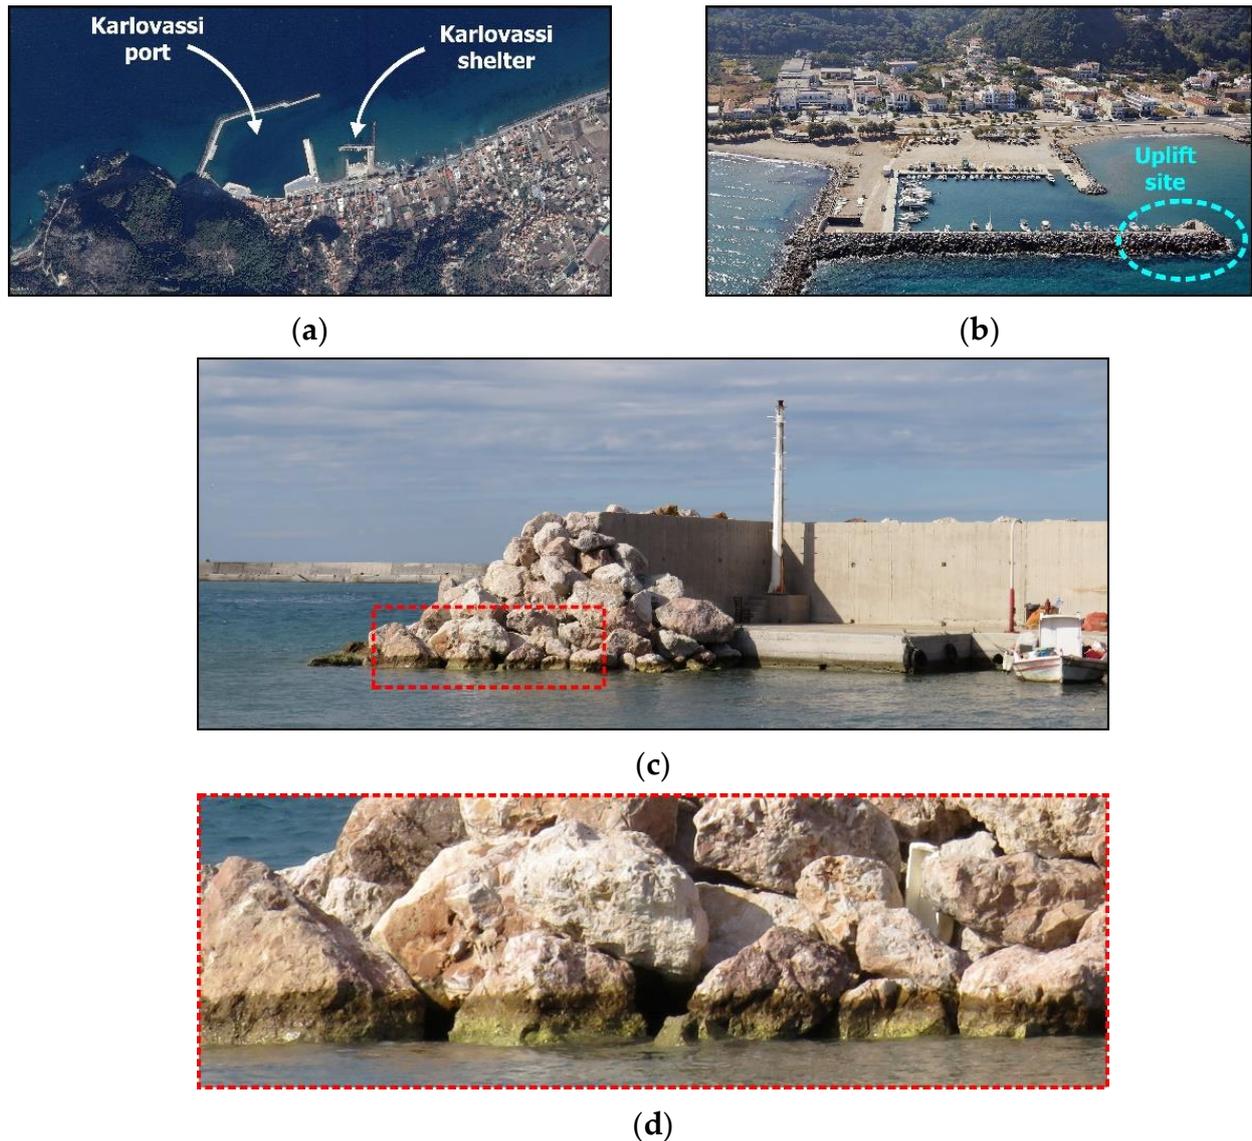
Permanent coseismic uplift was detected at the Karlovasi vessel shelter located east of the Karlovasi port (Figures 7 and 8), at a distance of about 16 km southwest of the mainshock epicenter. The vessel shelter has quay walls with a total length of 295 m, which are protected from strong waves and currents with natural boulders emplaced in the exposed side of the vessel shelter. The detected uplift was imprinted not only on the concrete works of the vessel shelter, but also on the protection boulders (Figure 8). Based on field measurements, the amplitude of the permanent coseismic uplift in this site reached 24 cm.

**Figure 8.** Permanent coseismic uplift was observed in the Karlovasi area (a). More specifically, in the Karlovasi vessel shelter located east of the Karlovasi port (a,b). The uplift reached 24 cm and was detected not only on the concrete works of the vessel shelter (c), but also on the protection boulders (d).

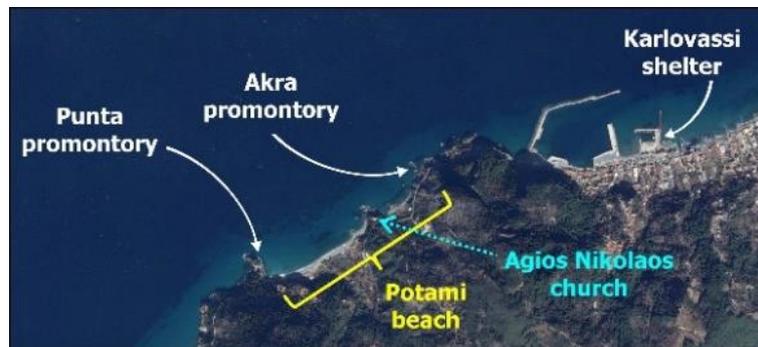
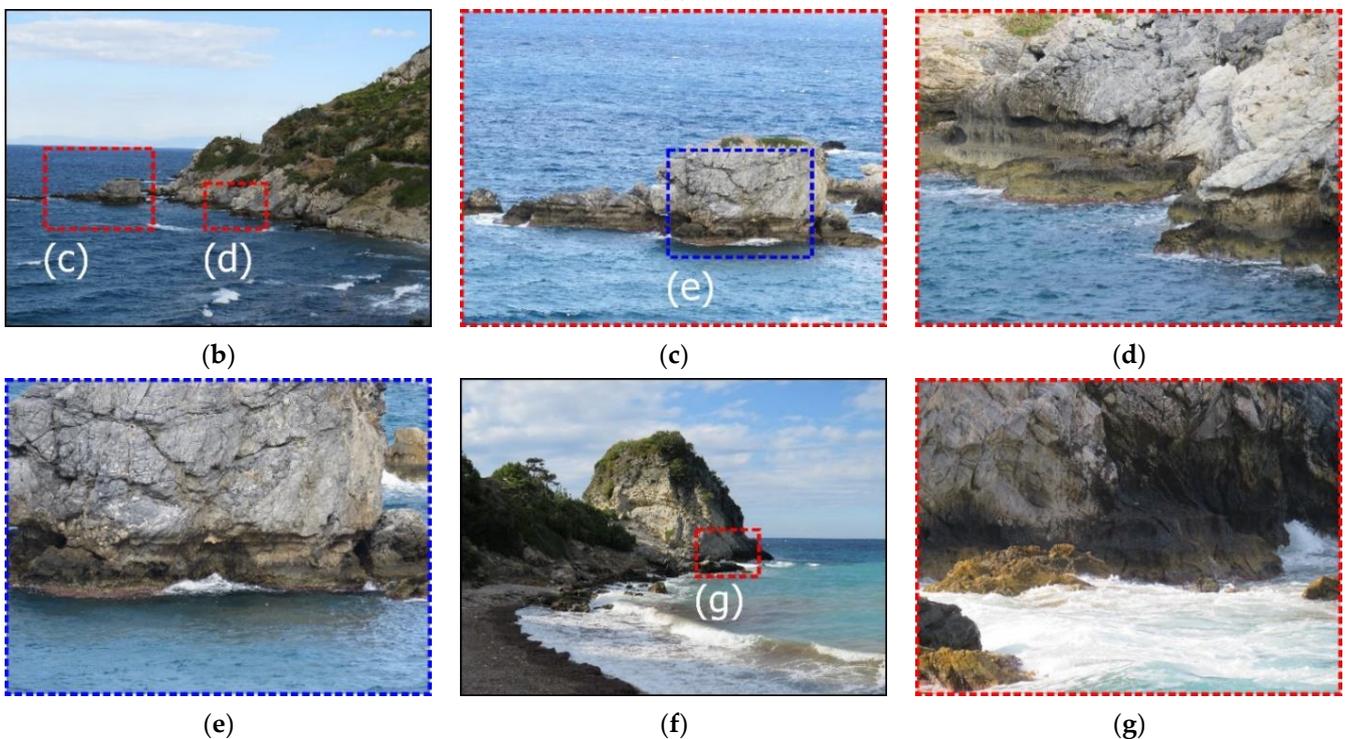
**Figure 9.** (a) Permanent coseismic uplift in the area west of the Karlovassi vessel shelter, at the Akra and Pounta promontories. The uplift was imprinted on the coastal marbles of the Kerketeas unit at the Akra promontory (b–e) and at the Punta promontory (f,g). These locations have high potential for preservation of primary earthquake environmental effects due to their resistant lithology. Notches attributed to previous earthquakes are also observed at these sites (d–g).

A coseismic permanent uplift of 20 cm, which was imprinted on the marbles of the Kerketeas unit, was observed at that site (Figure 9). At the base of the marbles along the rocky coast, the uplift has extirpated intertidal biota (Figure 9).

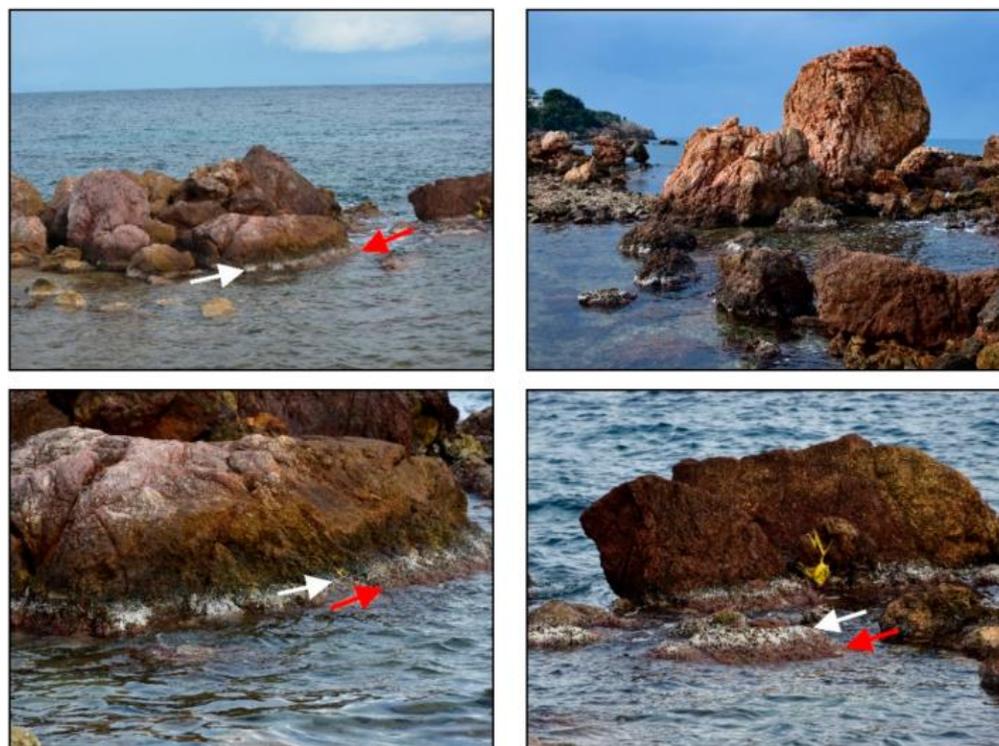
**Figure 10.** The uplift at Ayios Nikolaos was imprinted on the rocky coast. The white stripe on the rocks pointed at with the white arrows corresponds to the uplift of the 30 October 2020 mainshock and the red stripe pointed to by red arrows to the aftershock on 20 January 2021.

In the Ayios Nikolaos bay, local people reported an uplift of coastal rocks observed immediately after the mainshock of 30 October 2020 (Figure 10). The same people observed a further uplift caused by the strong aftershock of 20 January 2021 measuring magnitude  $M_w = 4.5$ .

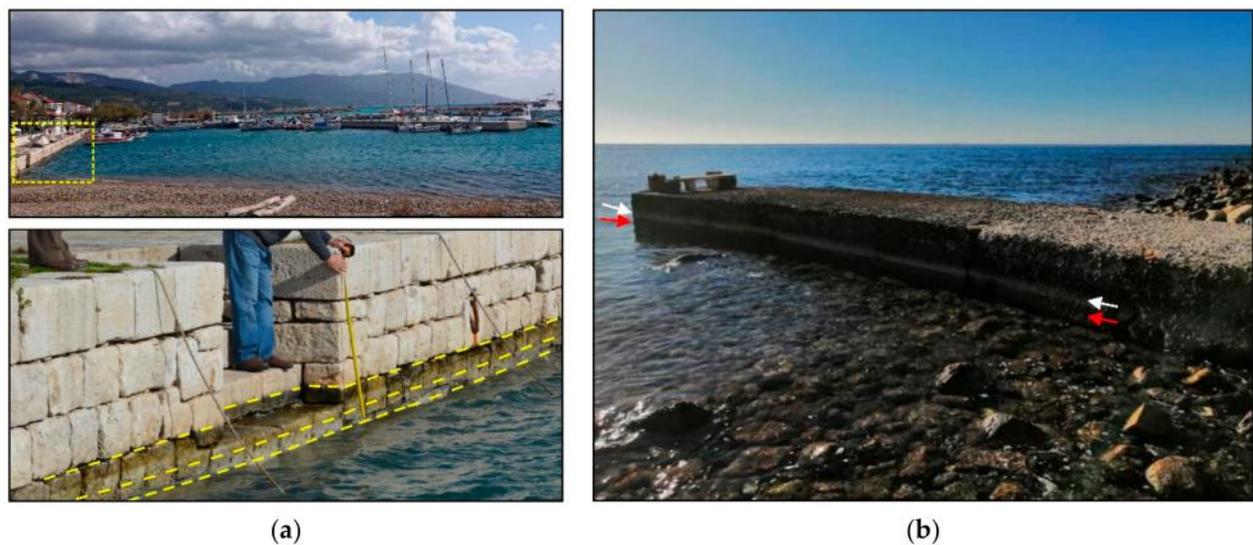
**Figure 11.** (a) The marina of Marathokampos, which was uplifted not only by the mainshock on 30 October 2020, but also by an aftershock on January 20, 2021. (b) The uplift from the mainshock and the aftershock was also imprinted on a small jetty of the Kampos village, located west of Marathokampos village. The white arrow points to the uplift induced by the mainshock and the red ones to the uplift by the aftershock.

The surrounding sands, sand dunes, and alluvial deposits are characterized by low potential for preservation of environmental earthquake effects. Therefore, the area with the permanent coseismic surface deformation has been detected only in engineered structures in the marina of the area (Figure 11). Namely, a local eyewitness, an engineer at the Merchant Navy, reported that an uplift was observed after both the mainshock and the aftershock of 20 January 2021 as exactly was independently reported by the Ayios Nikolaos settlement at the northern coast. We performed a field inspection on 24 January 2021, guided by the eyewitness, and verified the two phases of coseismic uplift imprinted on both the retaining stone wall of the coastal street (Figure 11) and the marina jetty (Figure 11). Due to the rough sea, we were unable to get an accurate measurement of the uplift amplitudes, which, however, were estimated to be about equal to those measured at the Ayios Nikolaos settlement, i.e., 15–20 cm and 8–10 cm corresponding to the mainshock and aftershock, respectively.

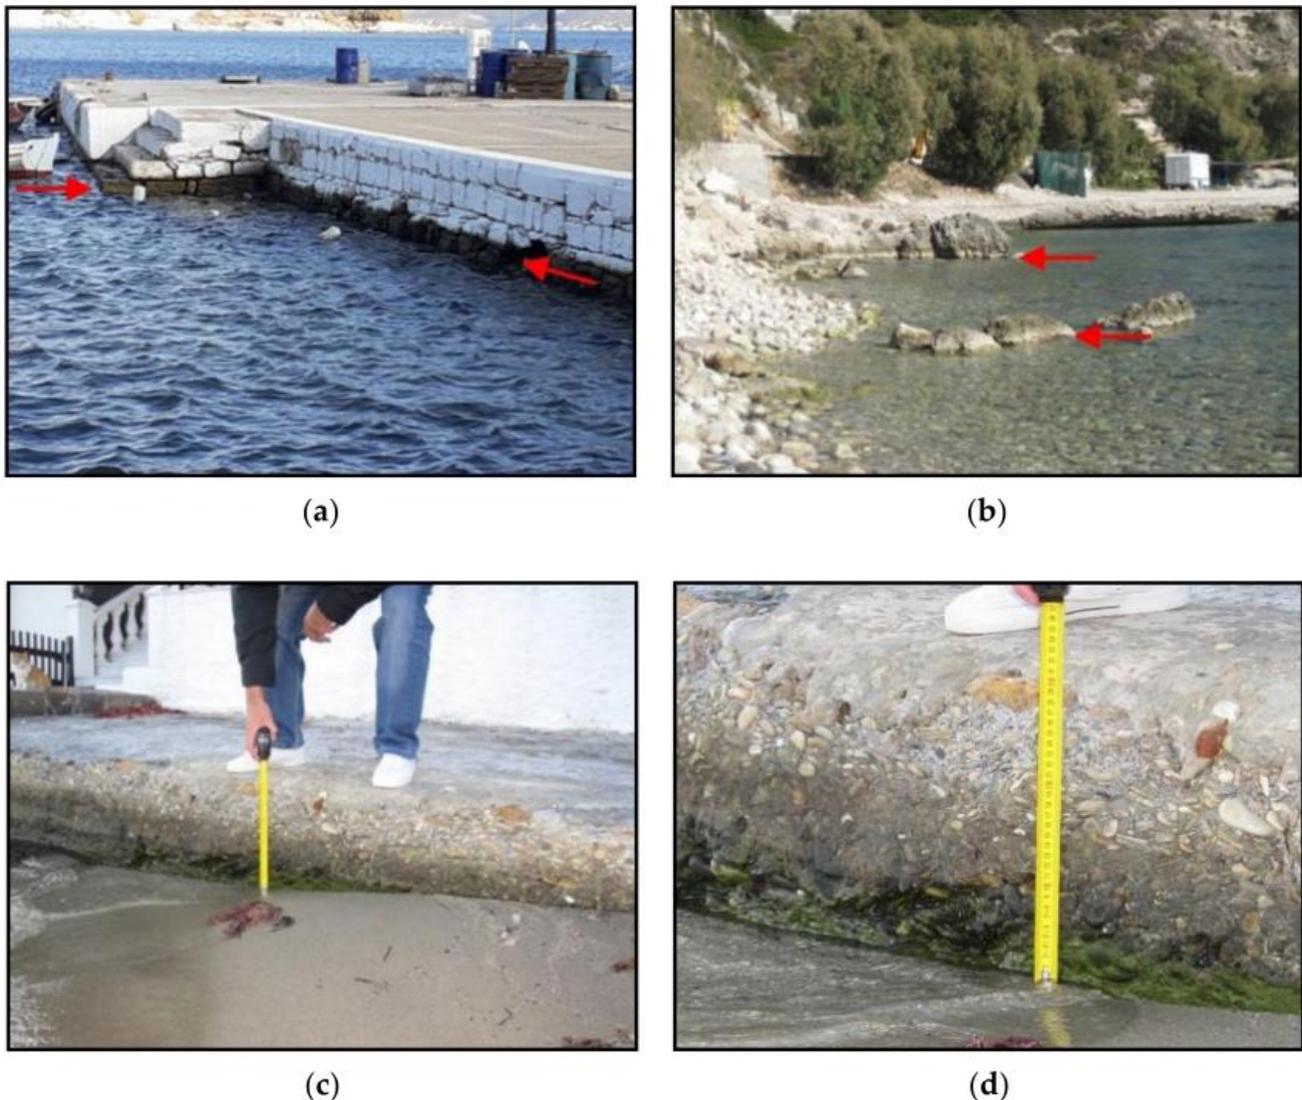
**Figure 12.** (a) Uplift of ~20 cm was detected on a dock in the Pythagoreio area. (b) Uplift from 15 to 20 cm was also imprinted on nearshore rocks close to the dock in Pythagoreio. The amount of uplift attributed to the 2020 Samos earthquake was observed below the white stripe and is pointed to with red arrows. (c,d) Uplift detected on a concrete dock in the Psili Ammos area.

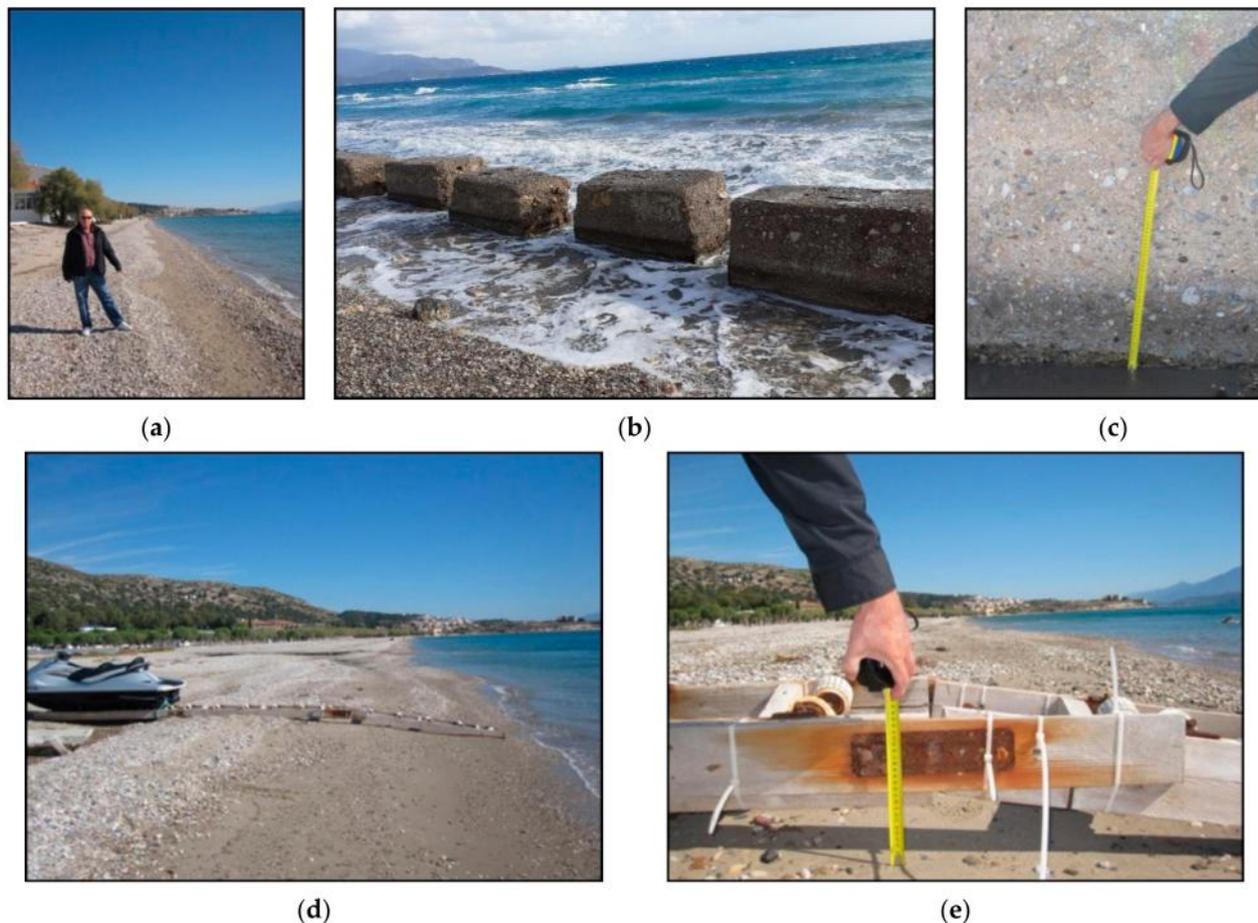
A permanent coseismic uplift was detected at three spots of the Potokaki beach. At the first site, a local resident and owner of the Penelope hotel reported that a permanent sea retreat of ~2.5–3 m was observed after the earthquake event. This observation was verified independently by a couple of German tourists staying in a nearby hotel. All three eyewitnesses showed the old position of the seashore, which is marked by a ridge of gravels and pebbles. A drop of the sea level by ~20–25 cm was roughly estimated in this spot (Figure 13a).

**Figure 13.** Uplift sites in the Potokaki area. (a) First uplift site in front of the Penelope hotel. A permanent sea retreat of ~2.5–3 m was observed after the mainshock. The old position of the seashore is marked by a ridge of gravels and pebbles. (b) The second uplift site in the Potokaki area is situated at distance of ~300 m to the east of the hotel site. This picture was taken on 24 January 2021 and shows both the permanent uplifts caused by the mainshock and the aftershock of 20 January 2021 on a series of cubic concrete blocks. (c) Permanent uplift ranging from ~17 cm to ~20 cm due to the mainshock was measured on the landward side of the concrete blocks on 31 October 2020. (d,e) The third uplift site in the Potokaki area. Before the earthquake, the wooden jet ski trailer was partially placed in the water. It was uplifted and partly broken at the interconnection place due to the earthquake and the abrupt coseismic ground uplift.

Motivated by the eyewitnesses' accounts, we searched for further evidence of coseismic coastal uplift. In a second observation spot, to the east of the first one, we found evidence of a permanent uplift imprinted on a series of cubic concrete blocks used as wave breakwall for the protection of the airport peripheral road (Figure 13b). The blocks lie at a distance of 230–500 m away from the first observation spot and are arranged in parallel to the seashore between the pre-earthquake and post-earthquake positions of the seashore. We inspected this observation spot twice, i.e., on 31 October 2020 and on 24 January 2021. During the first visit, on the landward side of the blocks we measured an uplift mark of ~17–20 cm (Figure 13b). Since the landward side of the blocks is at a distance of ~1 m from the pre-earthquake seashore, an uplift of up to ~25 cm was assumed. At the same spot, a permanent sea retreat was verified by a local resident who swims in the area. During our last visit, we realized that, except for the uplift associated with the mainshock, a second uplift episode is evident, which was attributed to the strong aftershock of 20 January 2021 (Figure 13d). Because of the rough sea prevailing on 24 January 2021, the amplitude of the second uplift episode was only roughly estimated at ~10 cm.

interconnected parts (Figure 13e,f). According to a local resident's testimony, before the earthquake the seaward part of the trailer was partially placed in the water. However, after the earthquake the trailer was found to be completely out of the water, which is evidence of a permanent sea retreat. Additionally, the trailer was uplifted and partly broken at the interconnection place (Figure 13e,f), which can be explained by the abrupt ground uplift. However, it was not possible to reliably estimate the uplift in that spot.

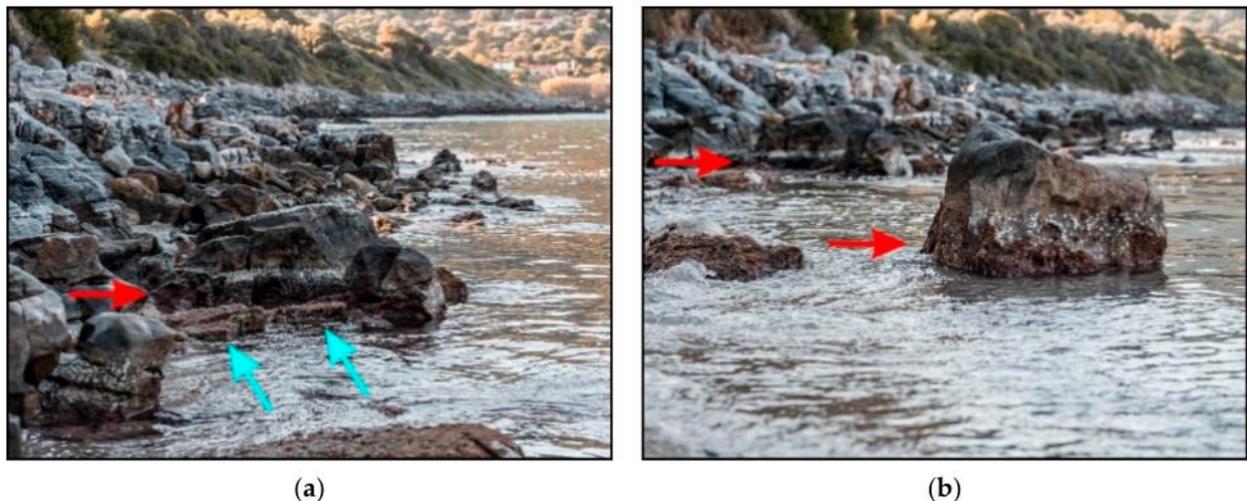
The Asprochorti site is located 23 km southeast of the earthquake's epicenter (Figure 7). It is composed of marbles of the Vourliotes nappe formation [4,24] with beds dipping towards the NE. The dip in the Asprochorti area varies from  $10^{\circ}$  to  $25^{\circ}$  towards the NE. The area of Asprochorti is not directly affected by faults. From the neotectonic point of view, it is located in the hanging-wall of an almost E–W-striking and N-dipping inactive normal fault (7). From field observations, a coseismic uplift was imprinted and detected on marbles along the rocky Asprochorti beach (Figures 7 and 14). The measured uplift amplitude was found to be  $\sim 10$  cm. At the base of the emergent marbles, the uplift has extirpated intertidal biota (Figure 14).

**Figure 14.** Permanent coseismic uplift of  $\sim 10$  cm was also detected at Asprochorti, located in the northeastern part of Samos. (a) The light blue arrows point to emergent rocks. (a,b) The red arrows point to the uplifted part of the rocky coast with the emergent intertidal biota.

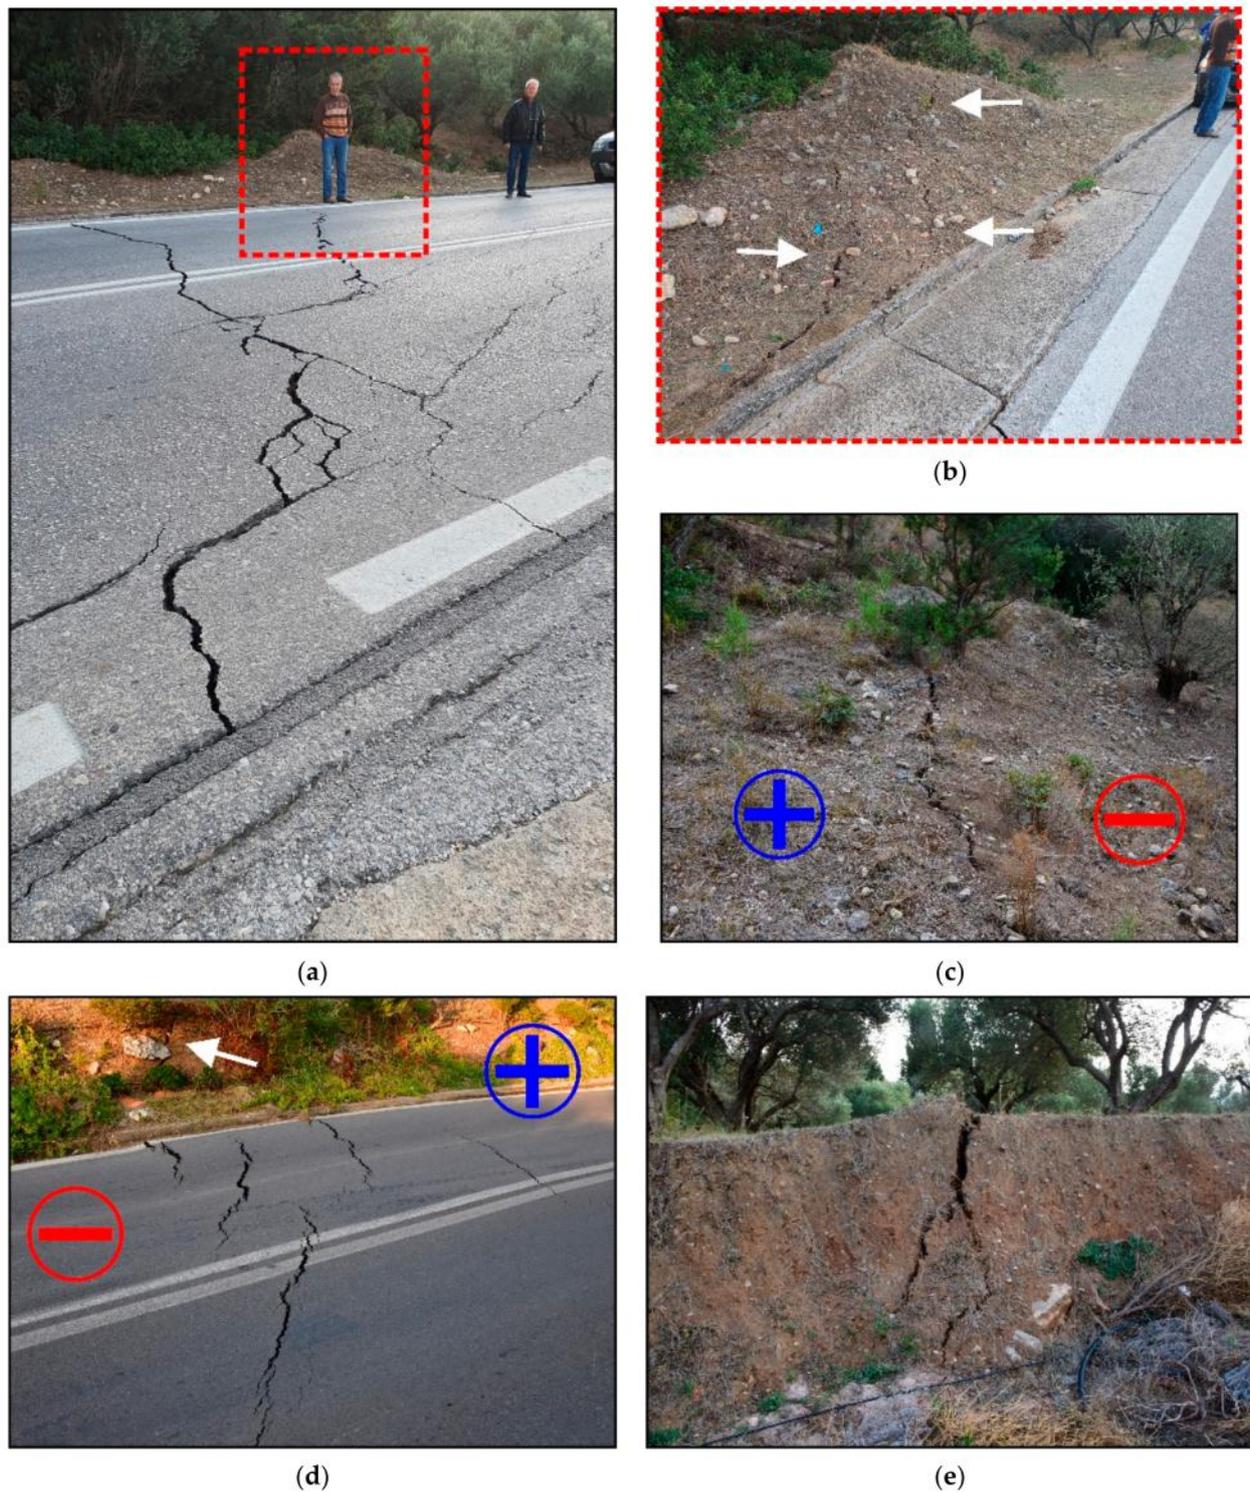
**Figure 15.** Coseismic surface ruptures in the Ayios Nikolaos area. Their strike varied from  $N 40^{\circ} E$  to  $N 70^{\circ} E$ . They presented a vertical offset varying from 5 to 8 cm. They were observed not only on the asphalt road (a,e), but also on adjacent slopes (b–d). The white arrows indicate the continuation of the ruptures on the adjacent slopes, where the vertical offset was detected. The red symbol (–) corresponds to the subsided blocks, while the blue symbol (+) corresponds to the uplifted blocks.

The surface ruptures were observed at the Ayios Nikolaos village and south of it (Figures 7 and 15). They constitute an almost 1-km-long zone. Their strike varies from  $N40^\circ$  to  $N70^\circ$ , while their vertical offset ranges from 5 to 8 cm. The northwestern rupture block had subsided, while the southeastern block was uplifted (Figure 15). The observed surface ruptures cut through the local coastal road of the village, and at higher altitudes they cut through olive fields as well as the northern regional road leading from Vathy in the east to Karlovasi in the west (Figure 15).

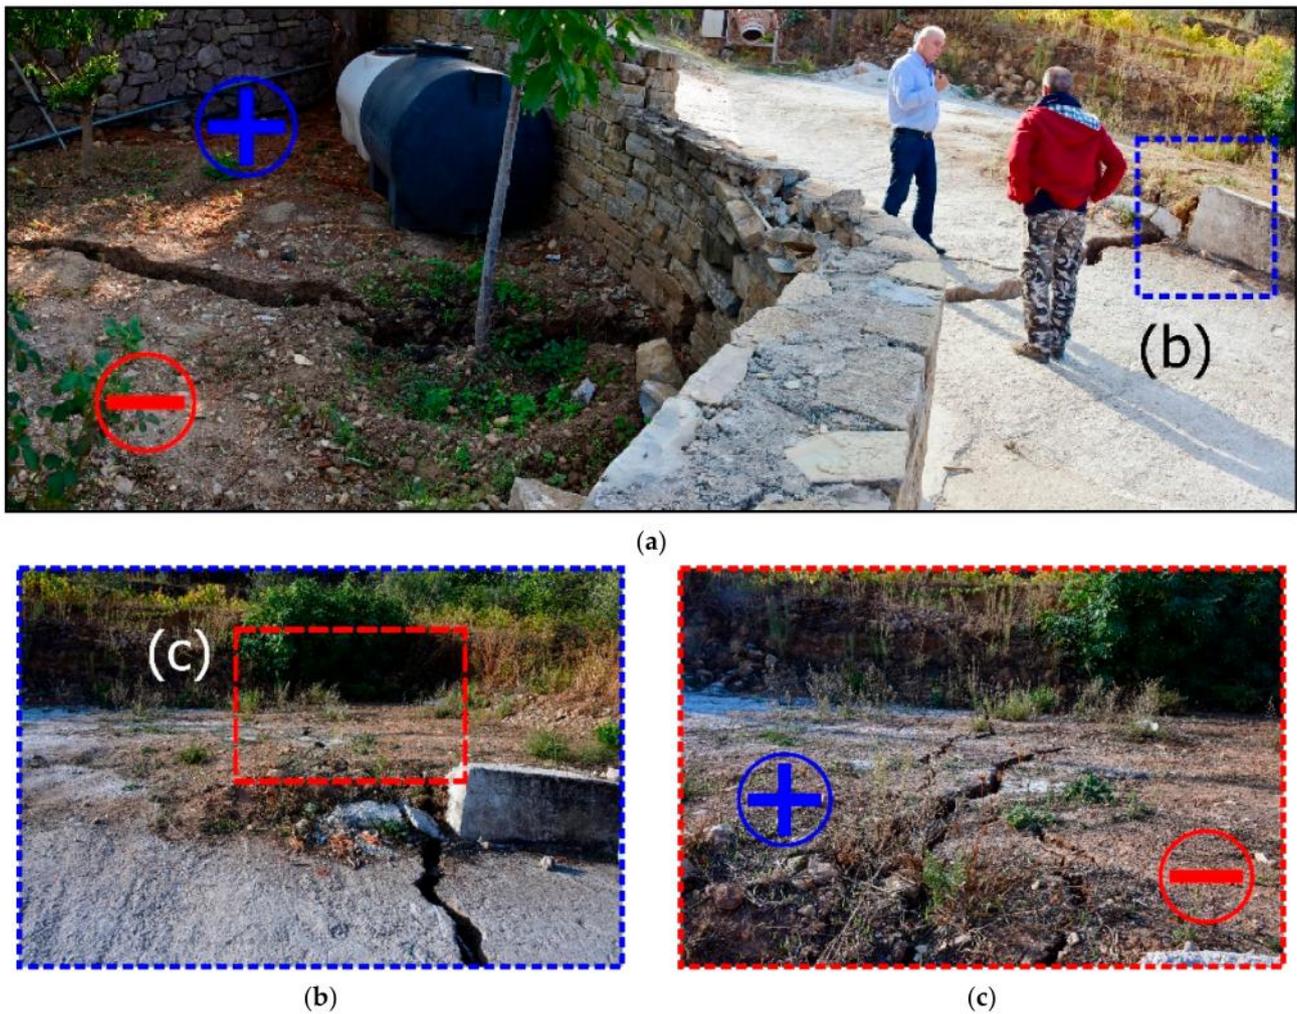
**Figure 16.** Coseismic surface ruptures in the area between the Vrysses village in the west and the Kontakaeika village in the east. They were continuous affecting a perimeter wall, a concrete road (a) and its adjacent slope (b,c). The red symbol (−) corresponds to the subsided block, while the green symbol (+) corresponds to the uplifted block.

The surface ruptures strike NE–SW and dip towards the NW (Figures 16 and 17). Similarly to the Ayios Nikolaos and Ayios Elias sites, the northwestern rupture block subsided and the southeastern was uplifted (Figures 16 and 17). The vertical offset varied from 5 to 10 cm. One of the observed surface ruptures within the village was observed to have caused a wide crack to a concrete road, displacement to the adjacent slope, damage to an adjacent perimeter wall of a garden, and a wide crack in the garden (Figure 16). Surface ruptures of strike, offset, and movement of the rupture blocks similar to those in the previous sites were also observed in an adjacent olive field.

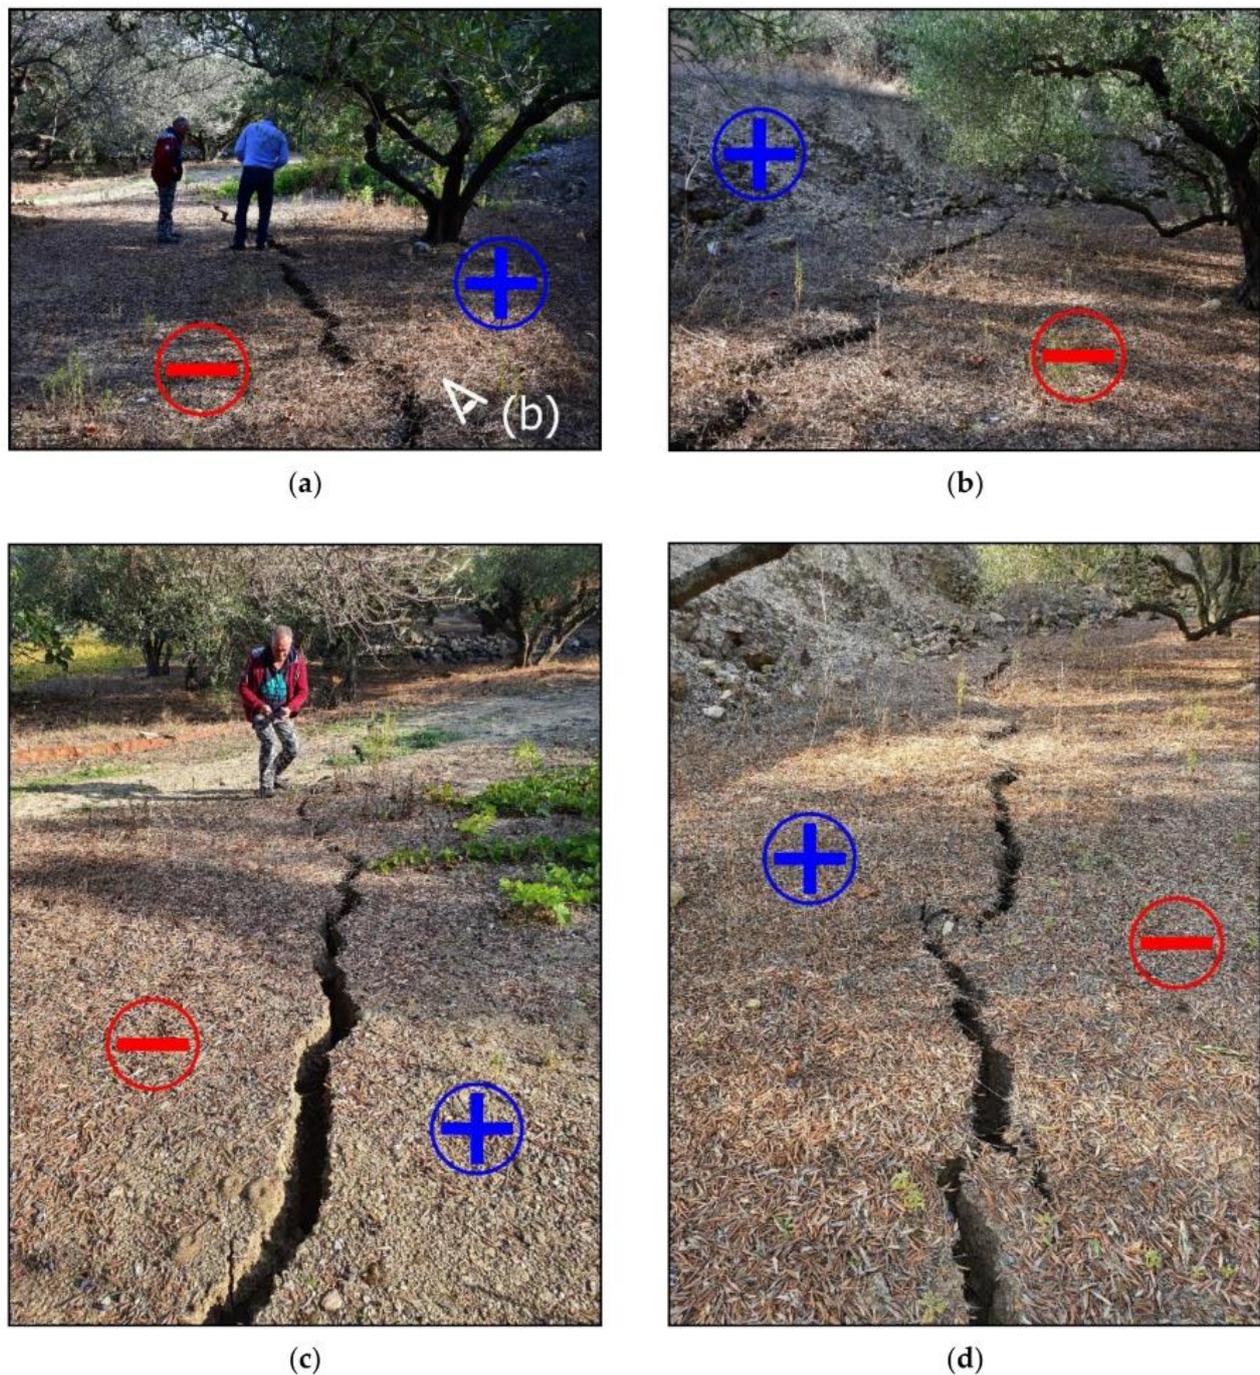
**Figure 17.** (a–d) NE–SW-striking coseismic surface ruptures observed in olive fields in the area south of the Vrysses village. Their vertical offset varied from 5 to 10 cm (a,b) and their width from 5 to 15 cm (c,d). The red symbol (–) corresponds to the subsided block, while the blue symbol (+) corresponds to the uplifted block.

A 0.5-km-long and continuous surface rupture was observed in an olive field to the south of the Vrysses village. This rupture strikes NE–SW and dips towards the SE (Figure 17). Its vertical offset varied from 5 to 10 cm and its width from 5 to 15 cm. Based on the observed displacement, we concluded that the southeastern rupture block had been uplifted, while the northwestern one had subsided (Figure 17).

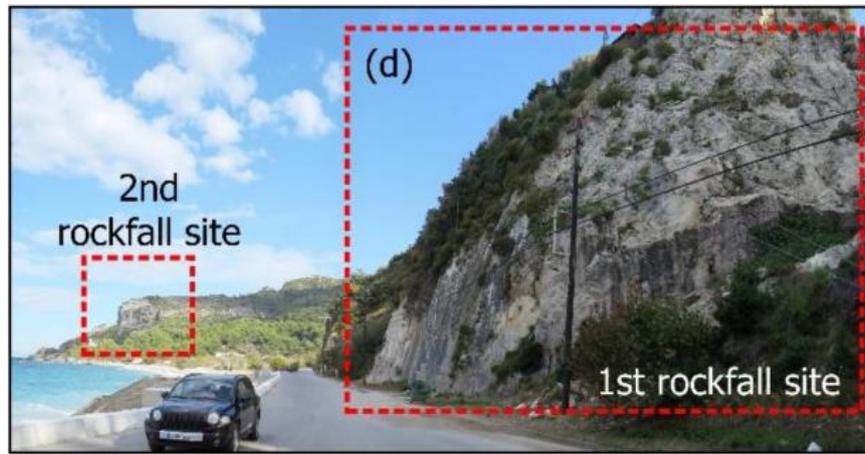
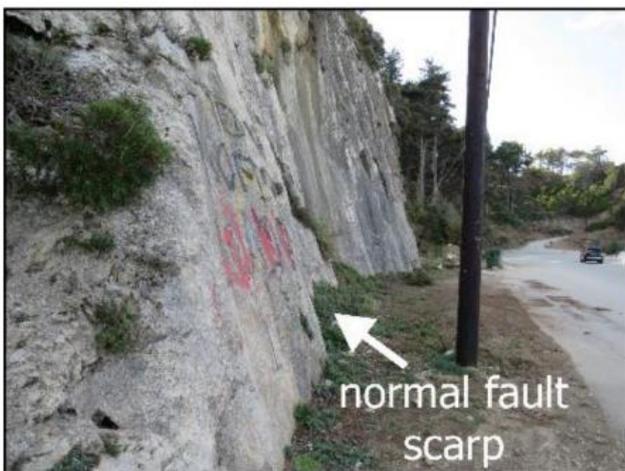
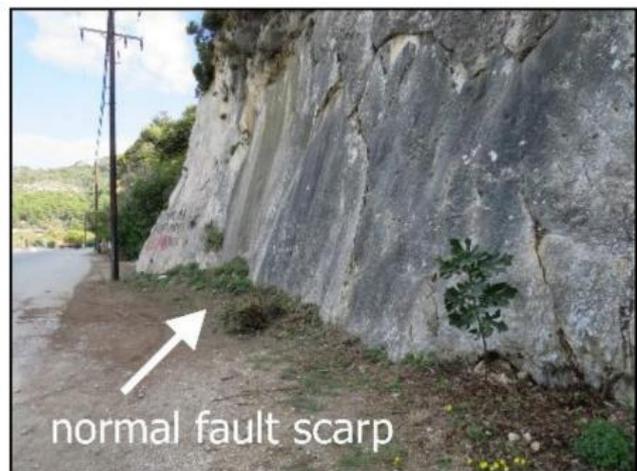
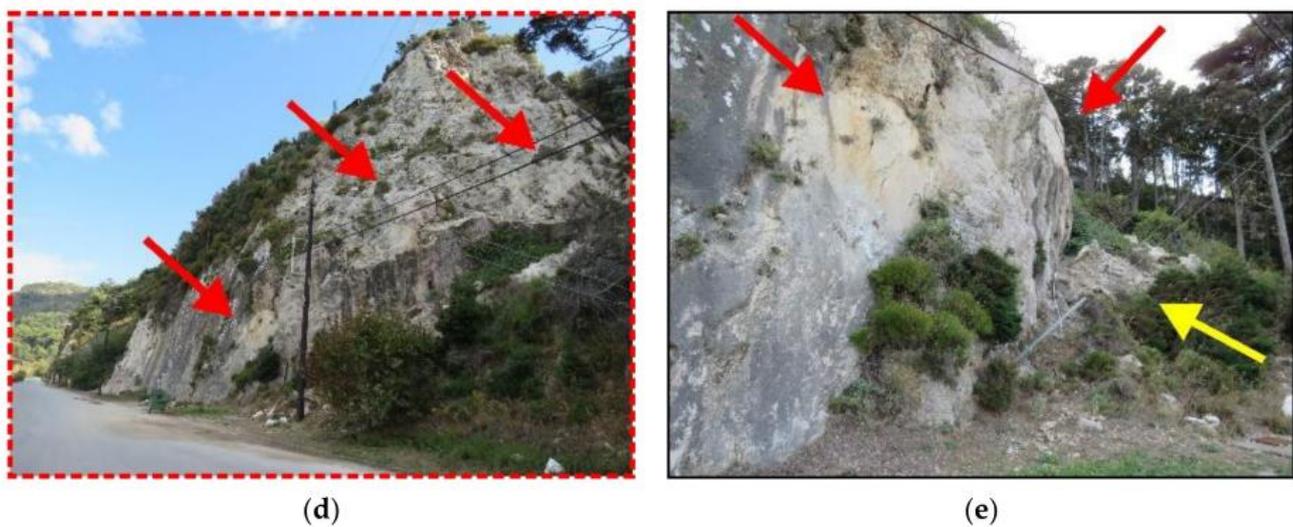
In Section 5.1.1, it is noted that a permanent coseismic uplift was imprinted on metamorphic formations, and in particular in marbles of the Kerketeas unit, at the capes of Akra and Punta. The Potami area was affected by NE–SW-striking and NW-dipping active normal faults. The most important fault in the area is the Karlovasi–Kallithea fault, which dissects the area of Potami, resulting in large and impressive morphological discontinuities corresponding to coastal fault scarps and fault mirrors on marbles of the Kerketeas unit (Figure 19a–c).

**Figure 19.** Earthquake-induced slope failures and affected sites in the Potami coastal area (a). The area is affected by the active Karlovasi–Kallithea fault, which formed morphological discontinuities (a) corresponding to coastal fault scarps on marbles of the Kerketeas unit (b,c). (d) Unstable marble blocks were detached from the upper parts of the slopes and rolled down to the lower parts of the slope but without affecting the nearby coastal road. Red arrows point to the freshly detached surfaces (d,e) and the yellow arrow to the fallen fragments (e).

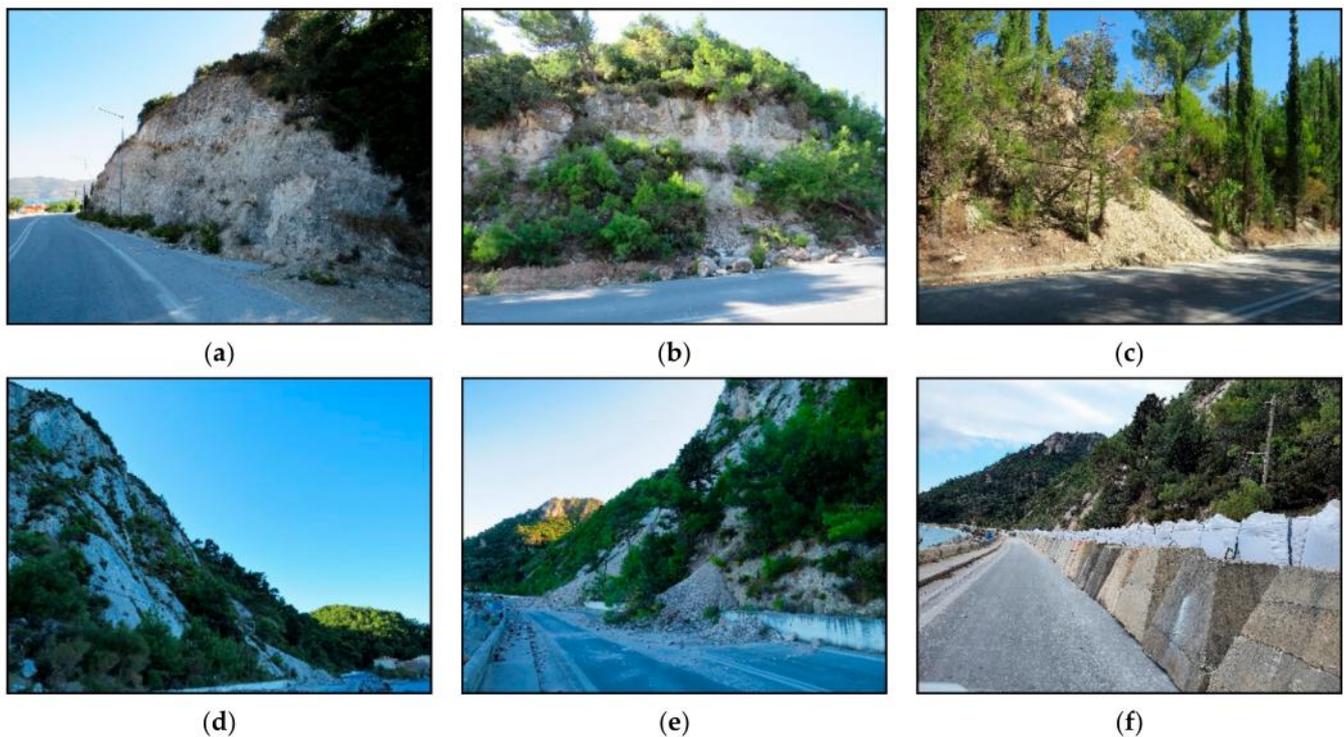
**Figure 20.** Slope failures triggered by the 30 October 2020,  $M_w = 7.0$ , Samos earthquake at several sites of the eastern part of the island. (a–f) Rockfalls and landslides in the northeastern part of Samos: (a) Kedros, (b) Kokkari, (c) Lemonakia, and (d–f) Avlakia. The largest effects were generated at the Avlakia site, resulting in a temporary traffic disruption. Due to reactivation during the aftershock sequence, a barrier made of large concrete blocks was created along the base of the affected slope in order to protect the road and passengers from further slope failures and surface deformation.

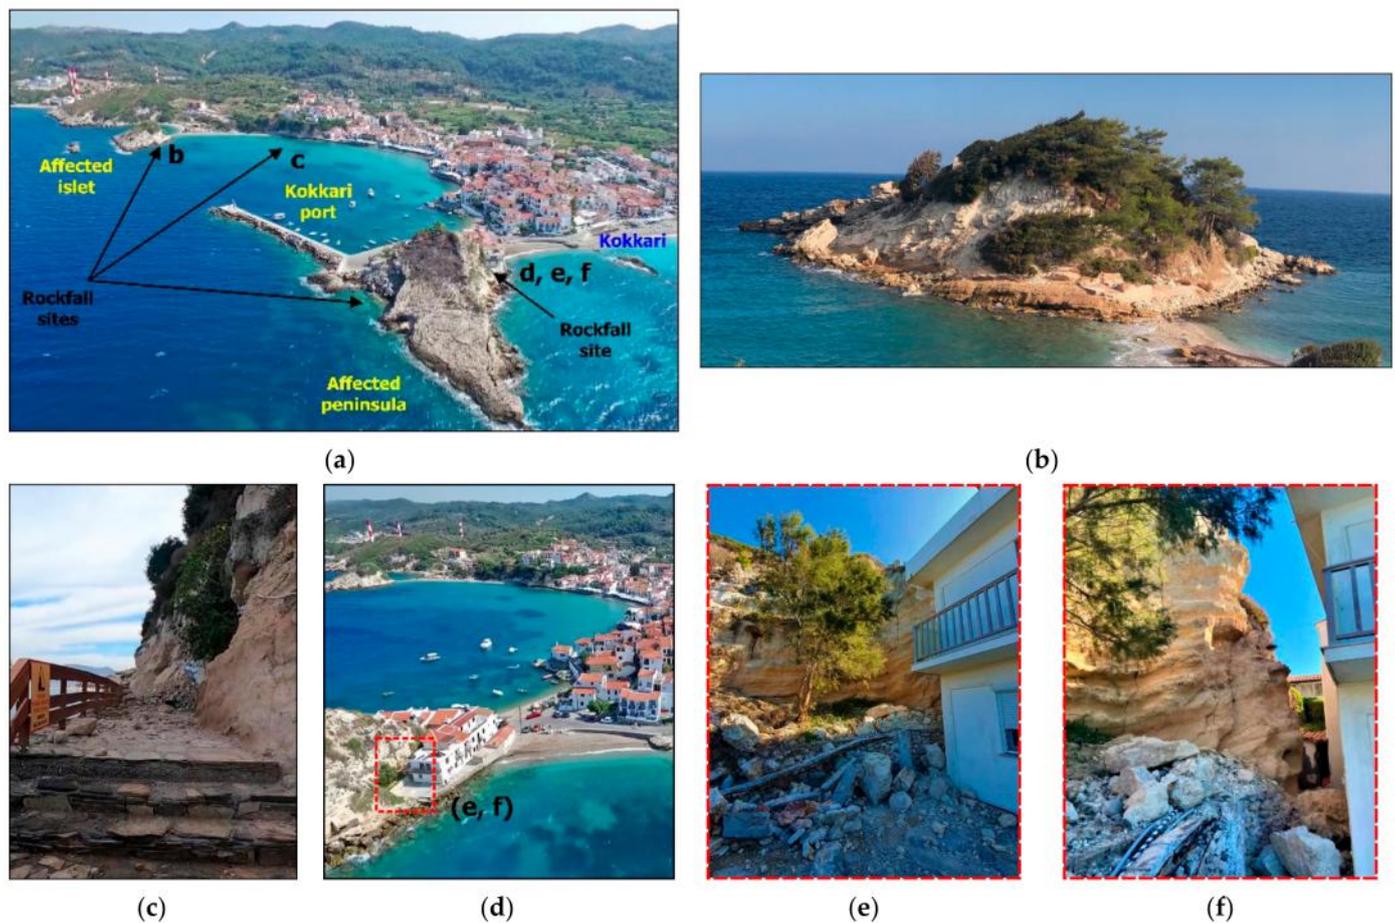
The site of the slope failure comprises schists with layers of marble and it is affected by an E–W-striking and S-dipping normal fault. It is worth mentioning that, in the area north of Ampelos village, surface ruptures were also generated in a similar geometry to the fault.

**Figure 21.** (a) The coastal Kokkari town along with its coastal landforms (peninsula and islet) affected by secondary environmental effects induced by the 30 October 2020, Mw = 7.0, Samos earthquake. Rockfalls were triggered along the slopes of the Kokkari islet (b), along slopes of the port (c), and along the peninsula (d–f). The rockfalls observed on the Kokkari peninsula caused light non-structural damage to the adjacent reinforced concrete building and partial destruction of a wall along the base of the slope (d–f).

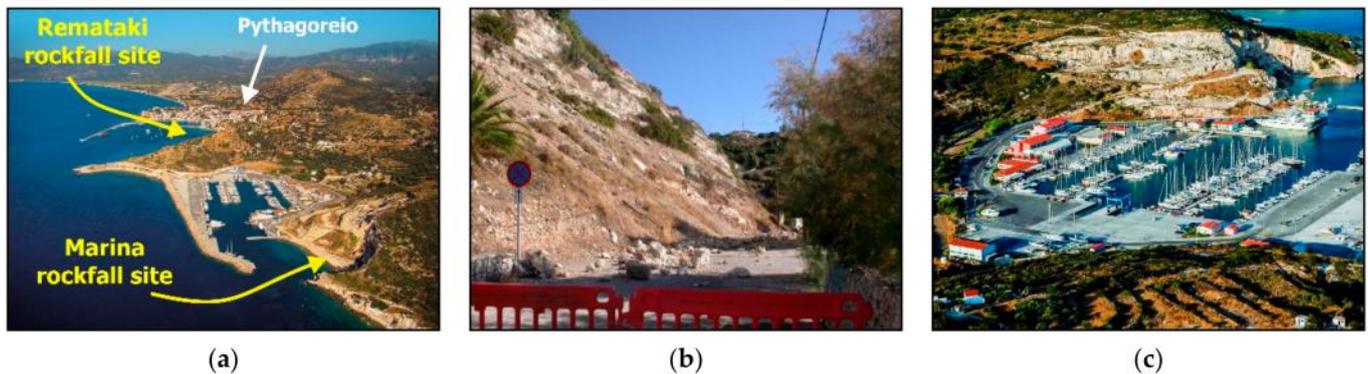
**Figure 22.** (a) Rockfall sites in southeastern Samos: (b) Remataki area and (c) Marina of Samos.

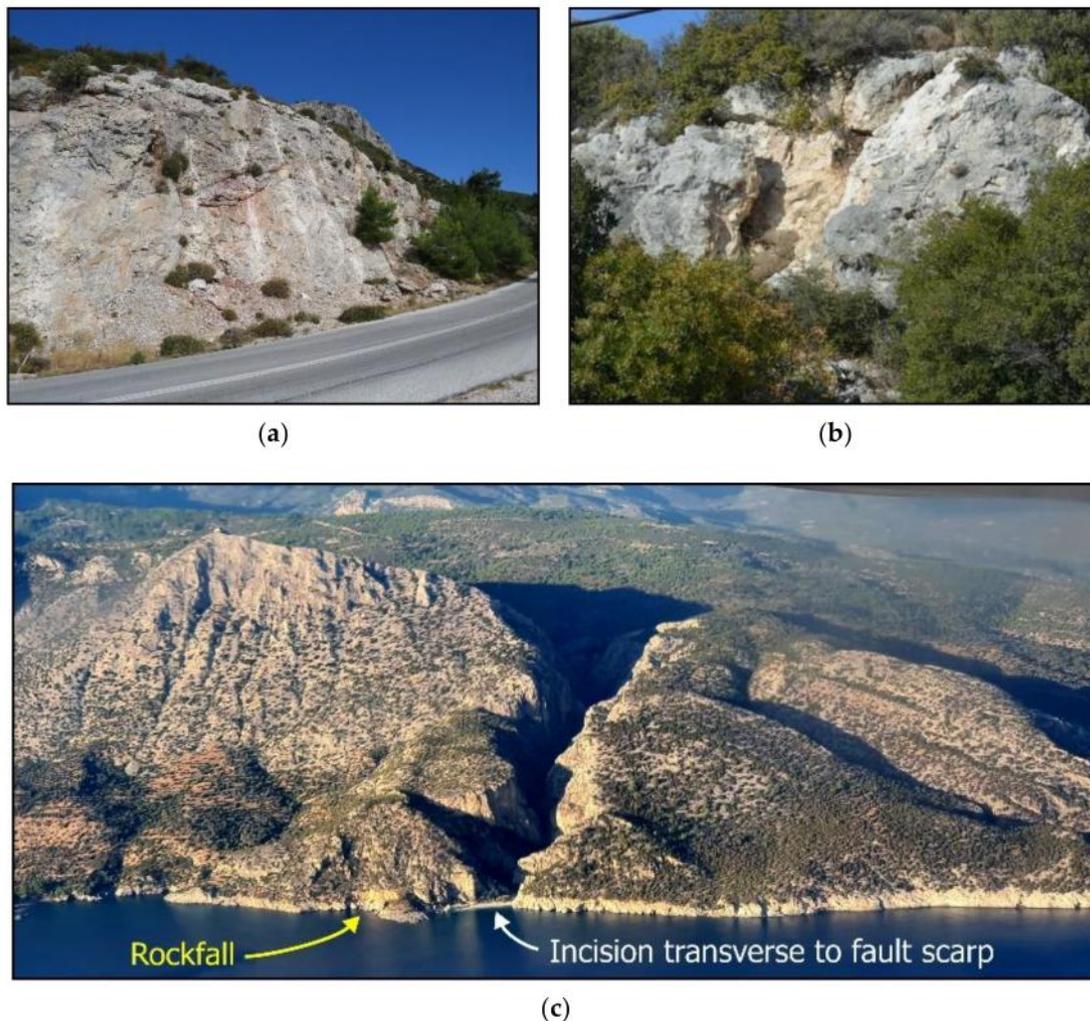
**Figure 23.** Rockfalls at (a) the Platanos area, (b) the Koumaeika area, and (c) Tsopela Cape. All sites are located in southern Samos.

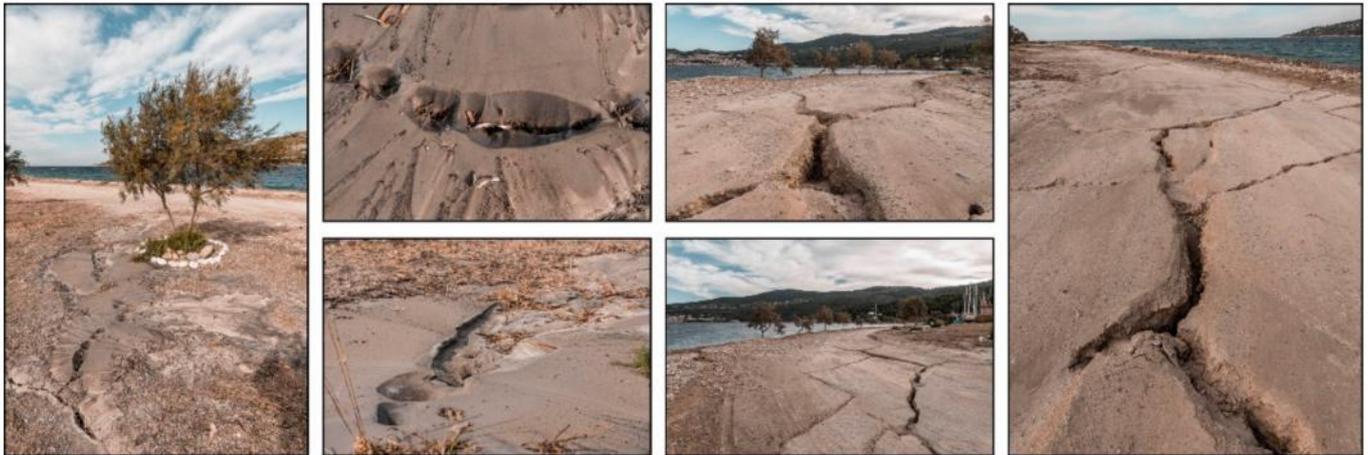
**Figure 24.** Liquefaction in the Malagari coastal area. This area is mainly composed of sands. The induced phenomena comprised ground cracks and ejection of a liquefied mixture of water and sand along cracks. Lateral spreading was also observed along the coast, resulting in subsidence of the coast. The root system of the trees on the right side of the road before the earthquake were found almost at sea level after the earthquake.
