# Primary and Secondary Environmental Effects Triggered by the 30 October 2020, Mw = 7.0, Samos (Eastern Aegean Sea, Greece) Earthquake Based on Post-Event Field Surveys and InSAR Analysis

**Abstract:** On 30 October 2020, an Mw = 7.0 earthquake struck the eastern Aegean Sea. It triggered earthquake environmental effects (EEEs) on Samos Island detected by field surveys, relevant questionnaires, and Interferometric Synthetic Aperture Radar (InSAR) analysis. The primary EEEs detected in the field comprise coseismic uplift imprinted on rocky coasts and port facilities around Samos and coseismic surface ruptures in northern Samos. The secondary EEEs were mainly observed in northern Samos and include slope failures, liquefaction, hydrological anomalies, and ground cracks. With the contribution of the InSAR, subsidence was detected and slope movements were also identified in inaccessible areas. Moreover, the type of the surface deformation detected by InSAR is qualitatively identical to field observations. As regards the EEE distribution, effects were generated in all fault blocks. By applying the Environmental Seismic Intensity (ESI-07) scale, the maximum intensities were observed in n

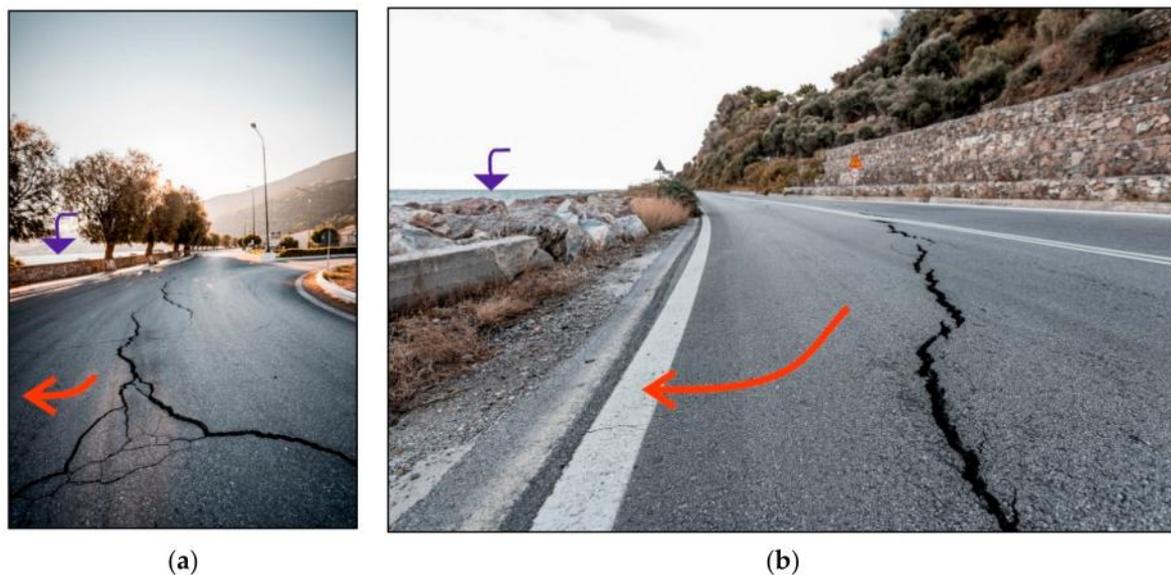
**Figure 25.** Ground cracks in the (a) Malagari and (b) Petalides coastal areas. They were observed on artificial deposits used during works for the widening of the coastal roads. Red arrows indicate the direction of slide towards the sea located in the left part of the images.

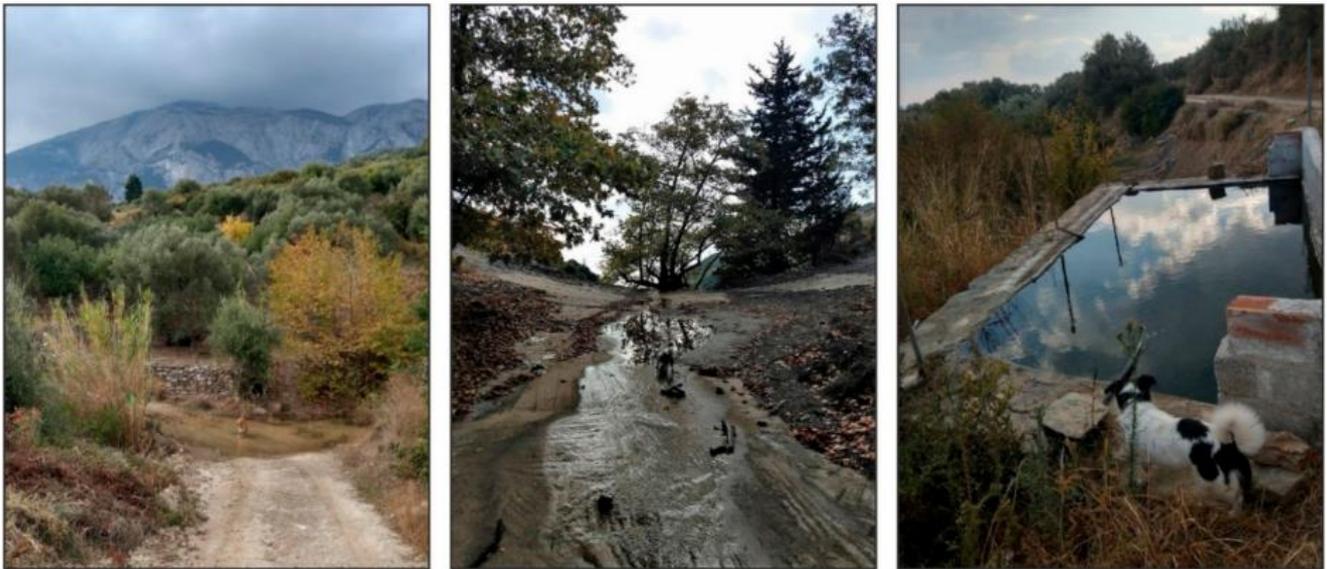
**Figure 26.** Hydrological anomalies at the western part of Kerketeas Mt (Kiourka area). They resulted in a temporary disruption of a pedestrian crossing and filling of empty tanks with water a few hours after the earthquake.
