Comparative Analysis of the Results of Diagnostic Measurements with an Internal Inspection of Oil-Filled Power Transformers

Tomasz Piotrowski¹, Pawel Rozga^{1,*} and Ryszard Kozak²

Keywords: oil power transformers; diagnostic methods; DGA; internal inspection

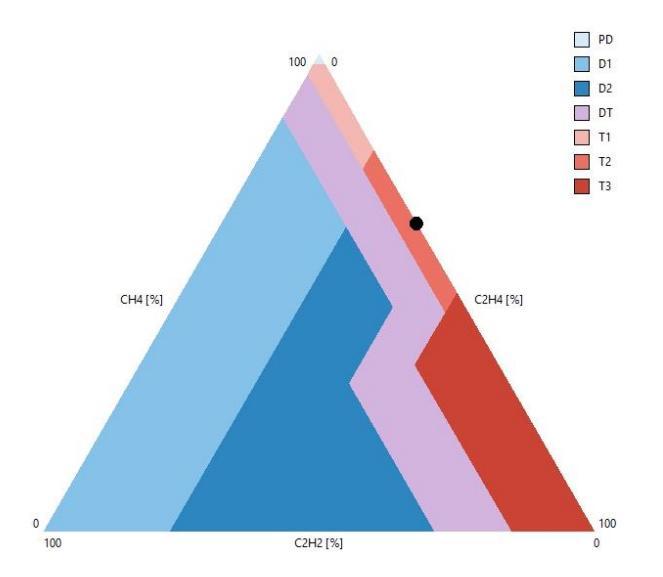
Case Study 1 concerned a generator step-up transformer manufactured in 2004 with a rated power of 30 MVA, a voltage ratio of 110/10.5 kV, and a vector group YNd11. The analysis of the results of the routine measurement of gas concentrations dissolved in oil, performed in accordance with the IEC 60559 Standard [22], and supplemented with analysis of propane (C_3H_6) and propylene (C_3H_8) concentrations [16], indicated the appearance of local overheating, in the range of temperatures between 150 °C and 300 °C. Such a diagnosis was confirmed by the analysis using the Duval Triangle 1, which indicated a T2-type thermal fault in the temperature range of 300 °C to 700 °C (Figure 2).

Figure 2. Defect indicated by the Duval Triangle Method performed as routine measurement for a 30 MVA, 110/10.5 kV power transformer.

Due to the importance of the unit considered for the operation of an electrical power system, the transformer analyzed was left in service, with recommendation of more frequent analysis of gases dissolved in oil, as well as a detailed monitoring of its load. Unfortunately, after five months of operation, the transformer was switched off by the 1st and 2nd levels of the Buchholz gas relay. This situation forced the diagnostic actions. An oil sample was taken from the transformer and sent for checking the typical oil parameters and gas concentrations. The results obtained from these measurements are shown in Table 4 (basic oil parameters) and Table 5 (concentrations of gases dissolved in oil; the results marked as 2nd in Table 5), respectively. Additionally, in Table 5 the results of the first chromatographic analysis mentioned above, which indicated the appearance of local overheating (marked in this table as 1st), have been quoted. The measured values of the oil parameters (shown in Table 4) fulfilled all requirements of the national transformer operation instructions [16] and they did not arouse any suspicions.

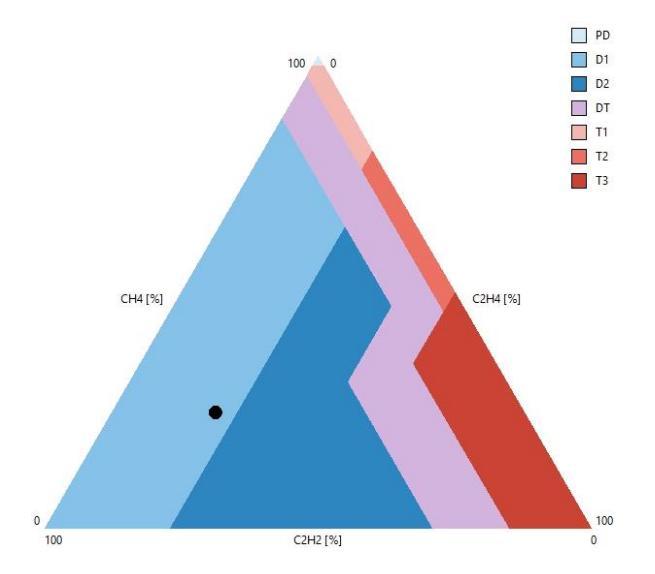
However, the analysis carried out for the gases dissolved in oil sample taken from the transformer after an emergency shutdown, indicated an exceedance of the typical values of concentrations of hydrogen, acetylene, propane, propylene, and carbon oxide. It was also stated that, in relation to the previous measurement, the increase in total combustion gases (TCG) was 656.8 ppm. The ratio method applied in accordance to the IEC 60599 Standard indicated discharge occurrence. This diagnosis was again confirmed by the Duval Triangle Method, which indicated a defect of type D1 (low energy discharges), on the basis of Duval Triangle 1 (Figure 3).

Figure 3. Defect indicated by the Duval Triangle Method for 30 MVA, 110/10.5 kV power transformer performed after an emergency shutdown of the transformer.

As the level of exceedance of the required values was significant, a decision for internal inspection was made. After untanking the transformer, the defects were identified (presented in Figure 4).

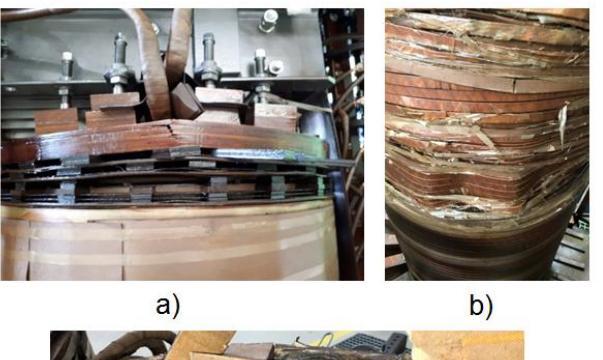
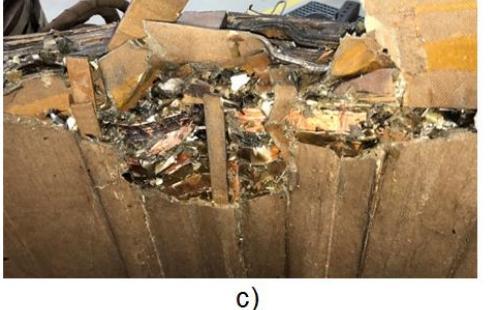
Figure 4. The damages identified during the internal inspection of 30 MVA, 110/10.5 kV step-up generator transformer. (**a**) Loose and damaged clamping elements, (**b**) turn short circuits in primary (high voltage) windings, and (**c**) traces from the electric arc (acting the electro-dynamic forces) in the secondary windings.

First of all, the defect identified was the loose and damaged clamping elements on phase A. Then, during the process of removing the windings from the core, the damage of both primary (110 kV side) and secondary (10.5 kV side) windings of phase A were identified. The traces from the electric arc (acting of electro-dynamic forces) in the secondary windings and the turn short-circuits in the primary windings were also disclosed on the same phase. The internal inspection carried out, confirmed the initial diagnosis regarding the occurrence of discharges in the transformer insulation, which resulted in the carbonization of the paper insulation visible in Figure 4c, and a failure of the phase A winding, due to a short circuit. Since the windings of transformer phase B and C were not destroyed, a decision was made to rewind phase A and after performing the factory tests, the transformer was returned to service.

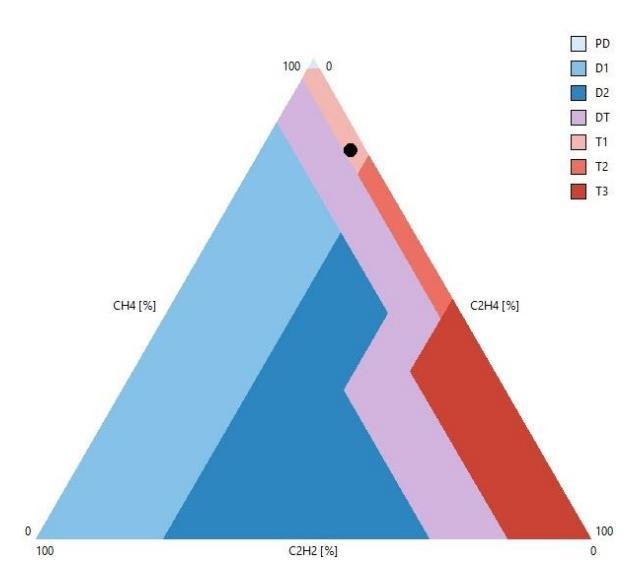
As can be seen, a significant increase of hydrogen, methane, ethane, and propane, and consequently, an increase in TCG were identified. It was stated that hydrogen, ethane and propane exceeded the typical values in accordance to the [16]. As the adopted procedure required the interpretation of the results, the analysis was also done in accordance with the IEC 60559 Standard using the ratio method and was supported by the Duval Triangle Method. The ratio method indicated that the local overheating did not exceed 300 °C. The defect diagnosed by this method as well as the temperature of overheating were confirmed by a simple calculation based on the concentration of propane and propylene ($C_3H_6/C_3H_8 = 0.09$ and $C_2H_4/C_3H_8 = 0.12$), which, in accordance with the data from Table 3, quoted above, indicated the overheating temperature within the range of 150–300 °C. In turn, the diagnosis obtained after the application of the Duval Triangle Method was a T1 type thermal fault, therefore, the obtained fault was in the same temperature range. The result of the analysis using Duval Triangle 1 is shown in Figure 5.

Figure 5. Defect indicated by the Duval Triangle Method for 40/20/20 MVA, 115/16.5/16.5 kV power transformer.

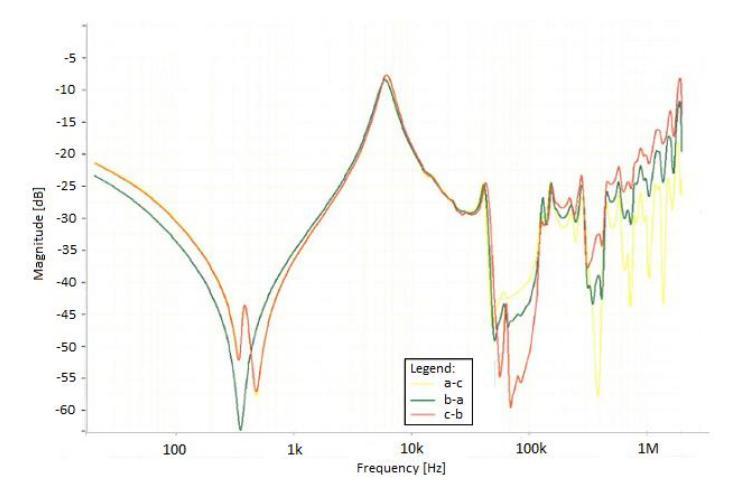
Since the other measurements were made in the considered transformer, the anomalies were identified on the basis of the results obtained using the SFRA method. These anomalies concerned the tertiary windings and the frequency range between 60 and 100 kHz, as shown in Figure 6. In this range of frequency the windings deformation might be treated as the adopted cause of failure.

Figure 6. Results of the sweep frequency response analysis (SFRA) measurements for tertiary windings in an open system.

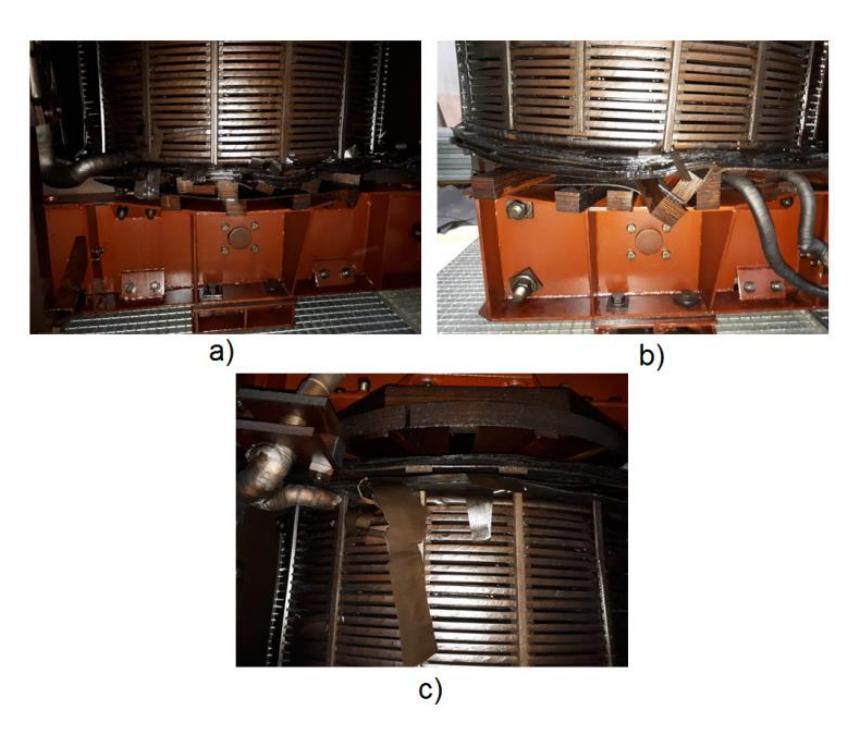
On the basis of the DGA data and the SFRA results, decision for an internal inspection was made. As a result of this inspection, the following defects were identified—loose and damaged of clamping elements, windings deformation, and gaps in the elements of solid insulation (pictorially presented in Figure 7).

Figure 7. The damages identified during an internal inspection of the 40/20/20 MVA, 115/16.5/16.5 kV power transformer: (**a**) Loose and damaged clamping elements, (**b**) windings deformation, and (**c**) gaps in the elements solid insulation.

As in the case Study 1, the internal inspection made possible the recognition of the defect, in accordance with the results of the diagnosis, based on the results of the DGA and the SFRA method. Local overheating clearly resulted from the deformations that occurred, causing a local increase in temperatures, as a result of the limitations of an effective cooling. In turn, the deformations themselves were reflected in the results of the SFRA measurements.

After properly repairing the area of the damaged windings, the transformer was returned to service.

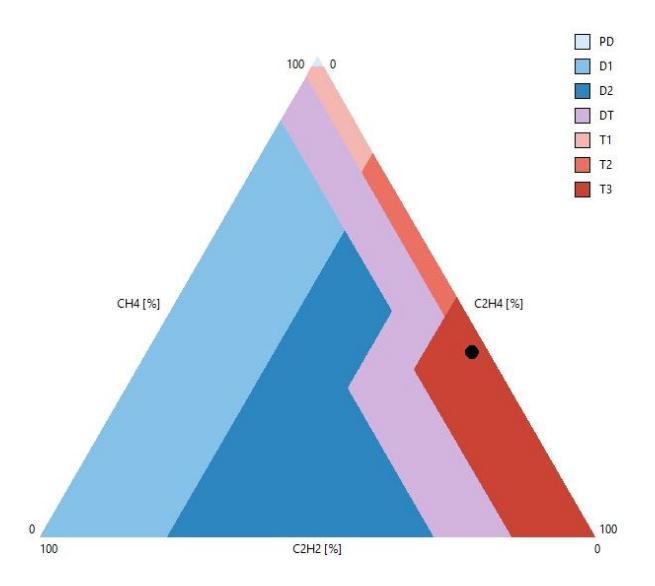
Taking this into account, the evaluation of a potential defect type was carried out on the basis of the recommendations described in the IEC 60559 Standard [22], with simultaneous consideration of the obtained concentrations of propane (C_3H_6) and propylene (C_3H_8) [16] and the results of the analysis of the Duval Triangle Method (Figure 8). In the first two cases, the analysis showed that the potential defect was a thermal one, in the range of temperatures 300–700 °C and in one case (Duval Triangle 1) the defect concerned a temperature above 700 °C.

Figure 8. Defect indicated by the Duval Triangle Method for 10 MVA, 110/6 kV power transformer.

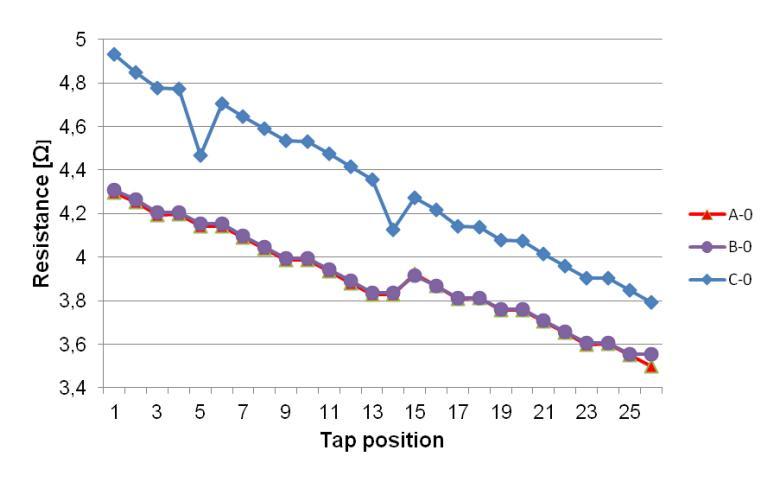
In turn, the results of the winding resistance measurement performed for the HV windings (110 kV) for all positions of the tap changer are shown in Figure 9. The observed increase of resistance for phase C is clearly visible, in comparison to the other phases.

Figure 9. Resistance of the high voltage (HV) windings (110 kV side) of 10 MVA, 110/6 kV network power transformer.

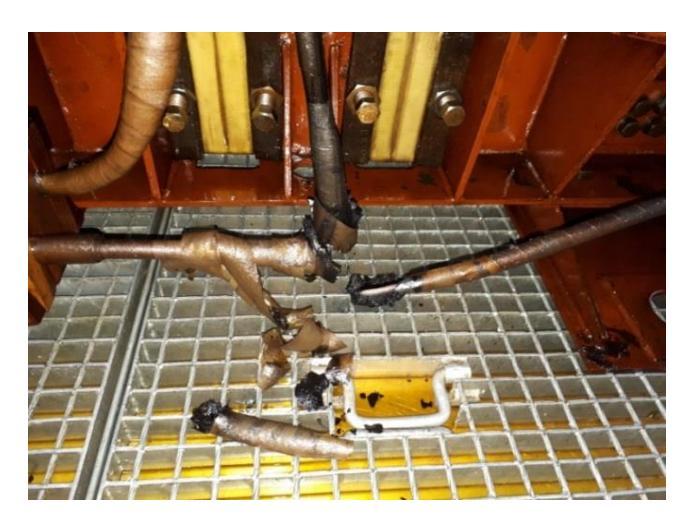
On the basis of the measurement results obtained, the decision for an internal inspection was made. It led to the identification of the burnt lead in phase C of the HV winding. The defect has been pictorially presented in Figure 10.

Figure 10. Damage identified during internal inspection of a 10 MVA, 110/6 kV power transformer.

As was clearly noticed, the local overheating was a result of the identified burnt lead in phase C of the HV winding, which was also apparent in the measurement of the winding resistance. An action was taken and the lead in phase C was repaired. The transformer then passed the comprehensive tests and was returned to service.

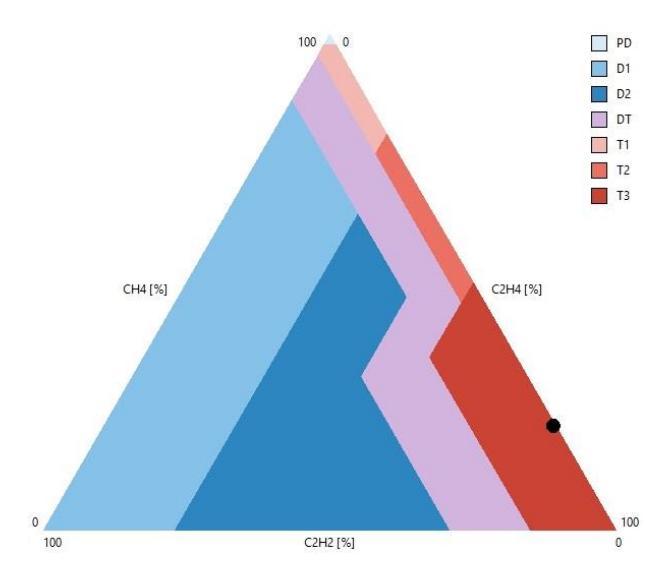
made. Interpretation of the results obtained, made in accordance with recommendations of the IEC 60559 standard [22], indicated a thermal defect in the temperature range of 300–700 °C. Simultaneously, following the recommendations of [16], exceedance of a temperature of 700 °C could not be excluded $(C_3H_6/C_3H_8 = 85.57 \text{ and } C_2H_4/C_3H_8 = 15.06)$, as shown in Table 3. The latter was also confirmed by the diagnosis based on the Duval Triangle Method, where the T3 type of the thermal defect was identified [9,16,18,21,23]. The results of the analysis using Duval Triangle 1 have been presented in Figure 11.

Figure 11. Defect indicated by the Duval Triangle Method for a 2.7 MVA, 30/0.66 kV power transformer for a 1st measurement designated as "routine test".

Since there were no previous measurements of the gases dissolved in oil, the owner of the transformer decided to degas the oil, immediately perform a chromatographic analysis after this, and repeat it after one month. The results obtained in this field are shown in Table 10—the measurements have been marked by numbers 2 and 3 and have been designated as "after degassing" and "1 month later", respectively. As can be seen in this table, the measurements performed one month after oil degassing revealed a significant increase in the gas concentrations. The exceedance of the typical values by the gases such as hydrogen, ethylene, methane, and acetylene was noticed unambiguously. Interpretation of the results obtained, made in accordance with the recommendations of the IEC 60559 standard [22] and the Duval Triangle 1 clearly indicated a discharge of low energy. The results of the analysis using the Duval Triangle 1 have been presented in Figure 12.

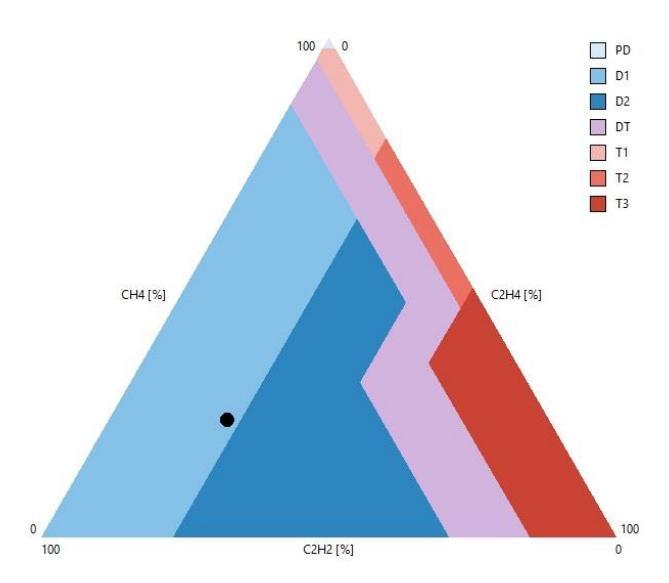
Figure 12. Defect indicated by the Duval Triangle for a 2.7 MVA, 30/0.66 kV power transformer for a 3rd measurement designated as "1 month later".

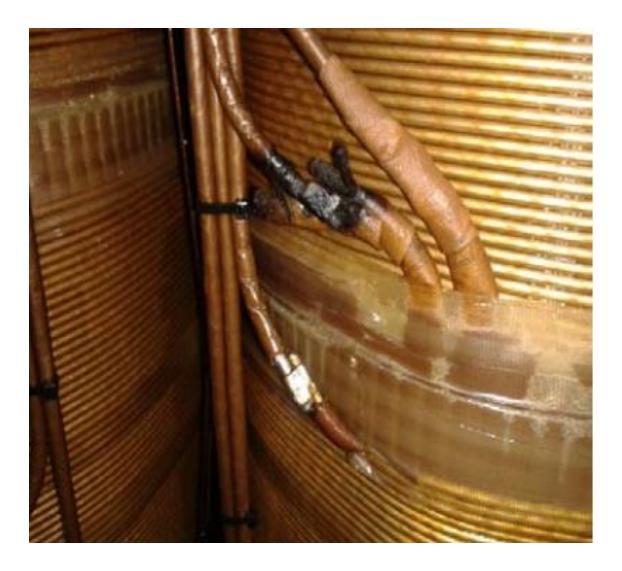
The extremely high increase in the TCG (exceeding 2000 ppm/month) and the suggested type of fault (discharges) caused in directing the transformer towards an internal inspection. As a result, burnt connections (aluminum and cooper) on the regulating windings of phases B and C were identified. Confirmation of this observation can be seen in Figure 13.

Figure 13. Damage identified during an internal inspection of a 2.7 MVA, 30/0.06 kV power transformer.

After repairing the aluminum–copper connection and applying Cu–Al washers, the transformer was returned into service. Chromatographic analysis of the oil performed after 1 and 2 years of repairing the transformer, did not indicate any abnormalities (Table 10—measurement numbers 4 and 5, designated as "1 year later" and "2 years later"). In the case of the other transformers with the same constructional features and rated parameters that have been mentioned above, the original washers used by the manufacturer were also replaced with those made of Al–Cu.
