Article Failure Analysis of a Centrifugal Compressor Impeller Made of 17-4PH Steel in the Moist Hydrogen Sulfide Environment

Jakub Łagodziński *[®], Zbigniew Kozanecki and Eliza Tkacz

Institute of Turbomachinery, Lodz University of Technology, 90-924 Lodz, Poland; zbigniew.kozanecki@p.lodz.pl (Z.K.); eliza.tkacz@p.lodz.pl (E.T.)

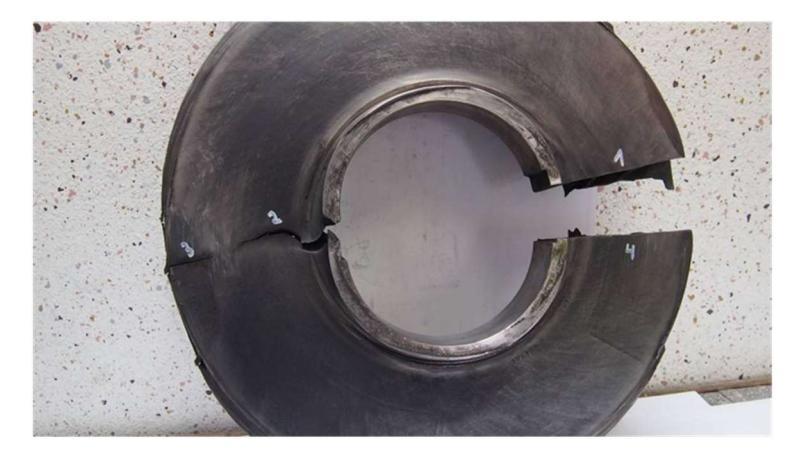
There were six impellers in the compressor and the fracture occurred in the first one, as shown in Figure 1. Their blades were welded using a technique of slot-welding. Then the impellers were mounted on the shaft with a shrink fit and two keyways.

Figure 1. Failed impeller of the first stage.

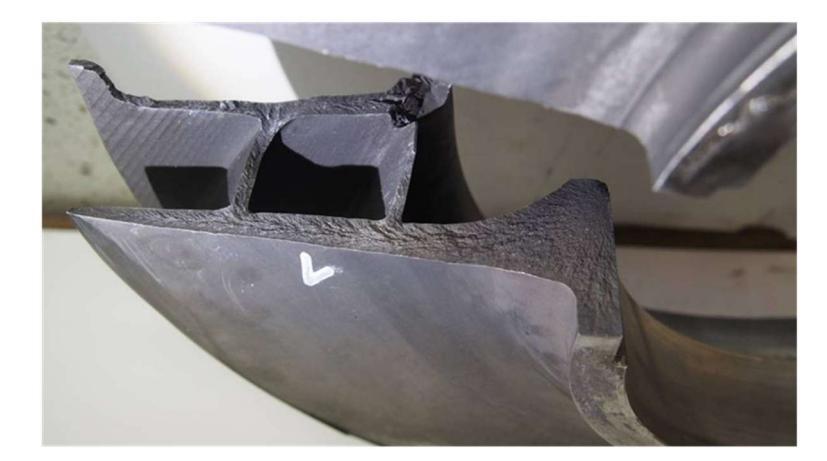
An optical examination of the fracture surface revealed that the crack, initiated from a keyway, propagated diagonally to the external diameter of the impeller wheel. In Figure 2, in cut view, one can see clear chevron marks pointing towards the origin of failure. This examination revealed that the fracture occurred at first in the center hole and then spread out to the blades and the cover. The Strength of Materials Laboratory, after their examination, identified a brittle fracture without visible prior plastic deformation and confirmed that the keyway corner was the initial point of the crack. Moreover, the local hardness of fracture was estimated at 336–342 of the HV10 scale, which is a much higher value than measured in other points of the damaged wheel.

Figure 2. Fractured surface of the compressor impeller wheel.

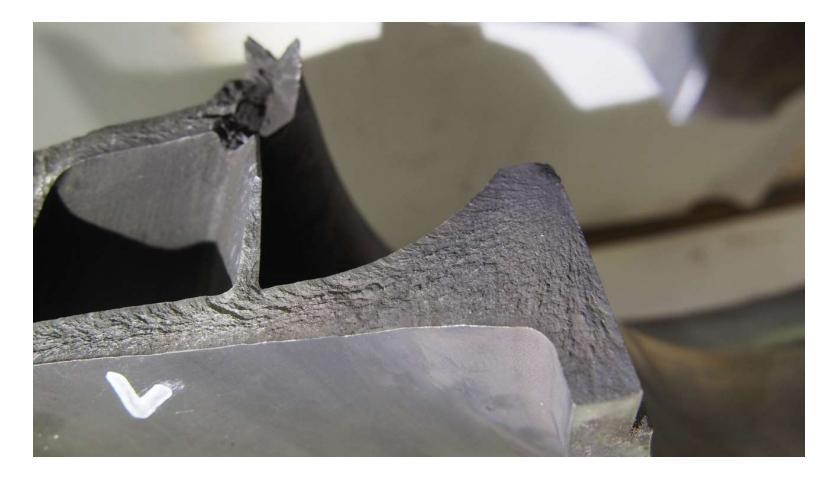
Some important conclusions can be drawn from this fracture surface analysis (Figure 3), namely the chevron pattern and the way this pattern converges in the suspected point of fracture initiation. There are known other cases of the compressor impeller failure with similar fracture morphology, where the main cause of damage was Sulfide Stress

Cracking [3,7,8]. Based on these facts and the local hardening of the section area, it can be concluded that the fracture was caused by excessive fragility resulting from operation in the aggressive environment.

Figure 3. Fracture surface of the damaged impeller.

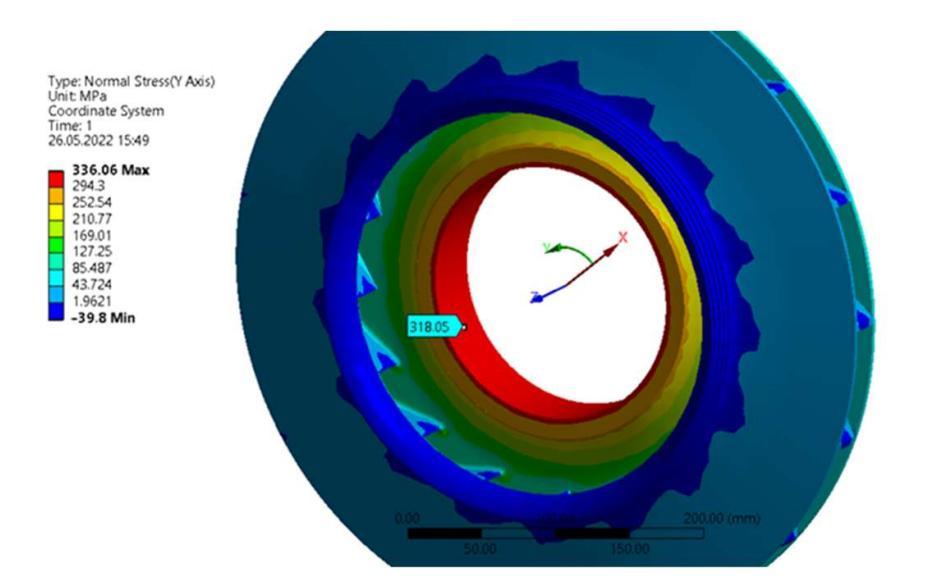
In the first step only the shrink fit was taken into account. This load condition was applied to the model by means of the diameter difference between the shaft and the sleeve. In Figure 6 the equivalent stress distribution is shown. Its maximal value in the inner chamfer, where the stress concentration occurs, was equal to 336 MPa. In the fitting surface the equivalent stress value was around 318 MPa.

Figure 6. Hoop stress distribution in the impeller, caused by the shrink fit.

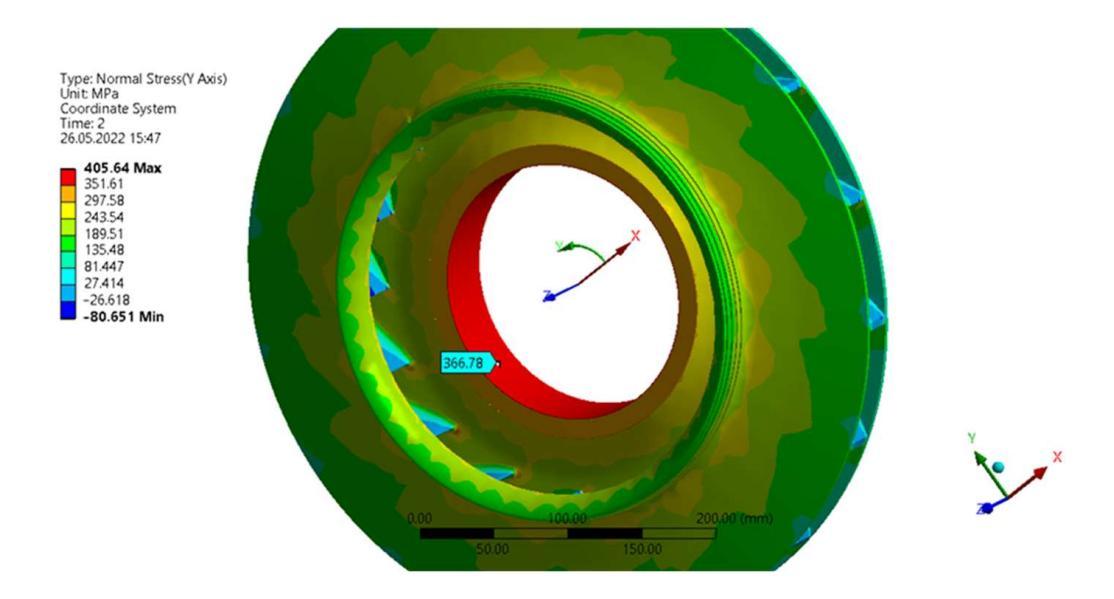
In the second step, both the shrink fit and the centrifugal force were applied to the model. The von hoop stress distribution for these conditions is presented in Figure 7. Its exact maximal value was 406 MPa, which corresponds to 59% of the yield stress ($\sigma_{\rm g} = 689$ MPa). In the fitting surface though, the hoop normal stress value was around 366 MPa, slightly greater than in the first step without centrifugal force acting on the rotor.

Figure 7. Hoop stress distribution induced by the centrifugal force and the shrink fit.

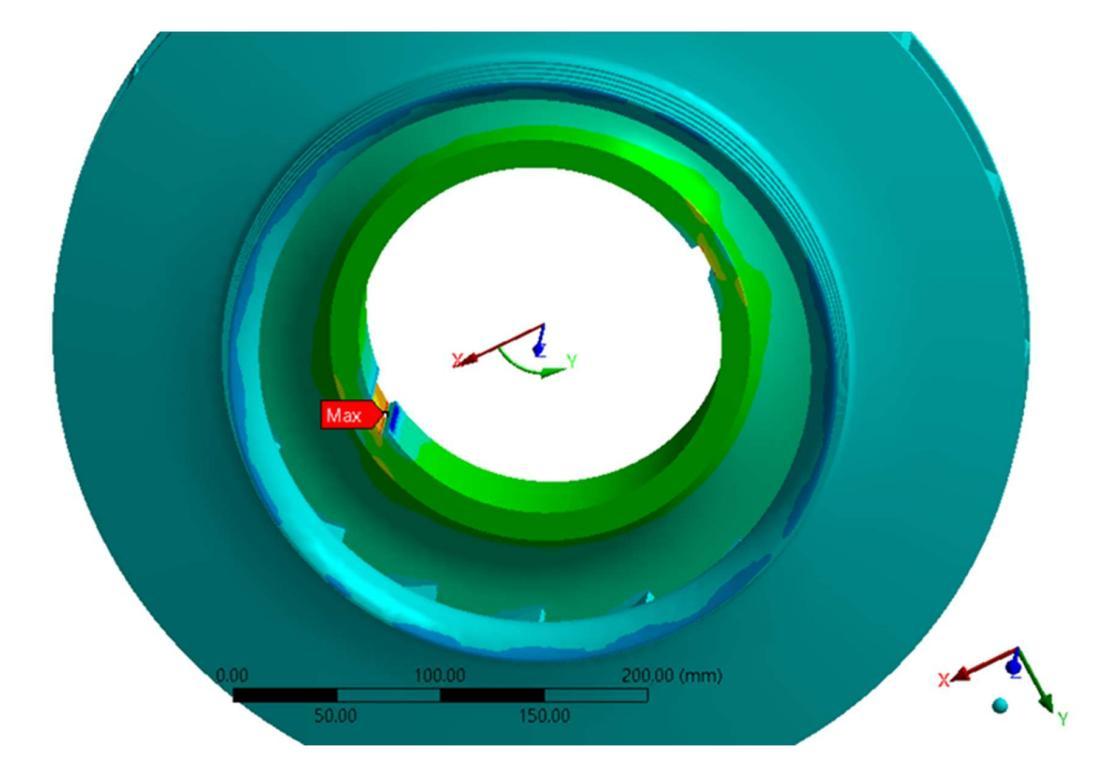
In the third case the shrink fit was taken into account, the same as in the first step but this time two keyways were extruded from the model. The hoop normal stress distribution for this simulation is presented in Figure 8, where the stress level value reached 322 MPa on the fitting flanges. Special attention should be paid to the keyway corners where the stress concentration occurs, indicating the highest stress levels. However, its value is strongly dependent on mesh density and keyways corners radius, the latter only assumed and not precisely measured, so the result presented here is more of qualitative and not quantitative importance.

Figure 8. Hoop stress distribution caused by the shrink fit and the presence of the keyways.

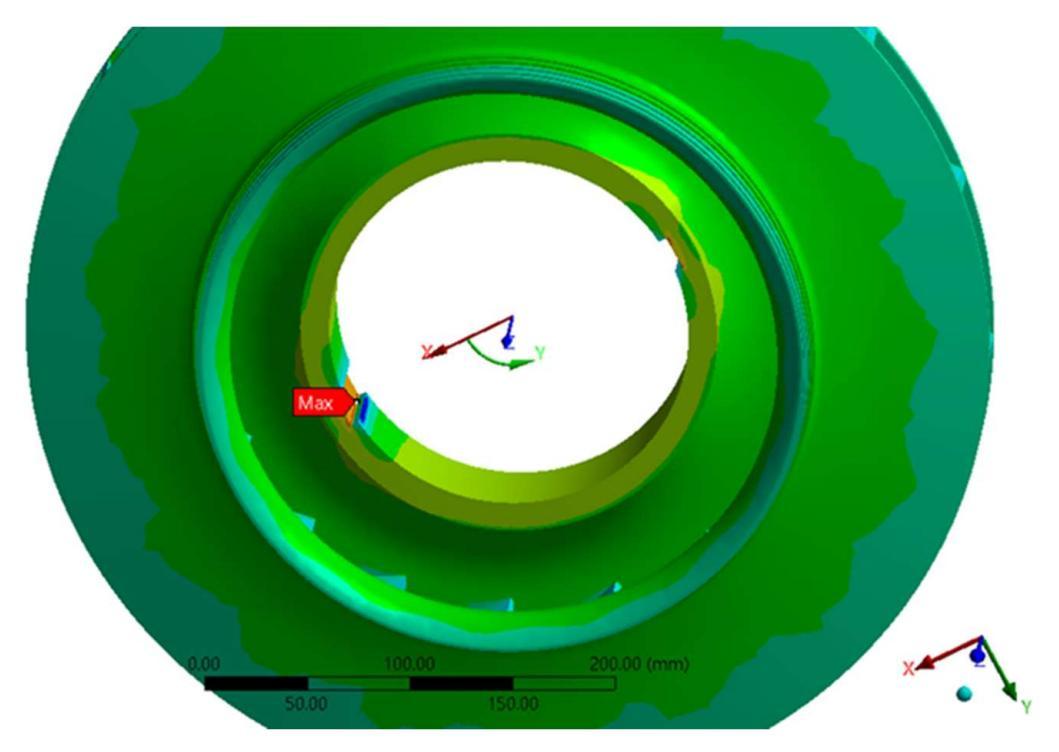
Finally, the last step of the simulation was superposition of the total loading: shrink fit, centrifugal force and keyways. The hoop stress distribution for this complex state is presented in Figure 9. The results show that the stress level in the fitting flange was equal to 394 MPa, which corresponds to 57% of the yield stress for the 17-4PH material, an important stress concentration still being predicted in keyway corners.

Figure 9. Hoop stress distribution caused by the centrifugal force, the shrink fit and the presence of the keyways.

To conclude the numerical analysis results, the method of assembling the impeller on the shaft is probably overdone, meaning that the use of both the tight shrink fit and two keyways is excessive and introduces significant stress levels, especially stress concentration in keyways slots. The impeller design should have been optimized in terms of stress levels and the shrink fit tightness, as well as keyways design and number being parameters of the optimization.

The analysis step by step allowed us to evaluate the influence of each loading state on stress levels. The obtained numerical results confirm undoubtedly the hypothesis that the stress concentration in the keyway corner was the cause and the starting point of the failure mechanism.

To avoid similar compressor failures in the future, it is advised to redesign the way the impeller is mounted on the shaft or select a different material for the impeller wheel in accordance with the ISO 15156-3 standard. Those will be the subject of further investigations.

As an alternative to the above-mentioned suggestions, a surface treatment in a low temperature plasma nitriding process can be considered [12,13]. This treatment introduces compressive stresses to the material and, thus, removes one of three necessary factors for Sulfide Stress Cracking to occur.

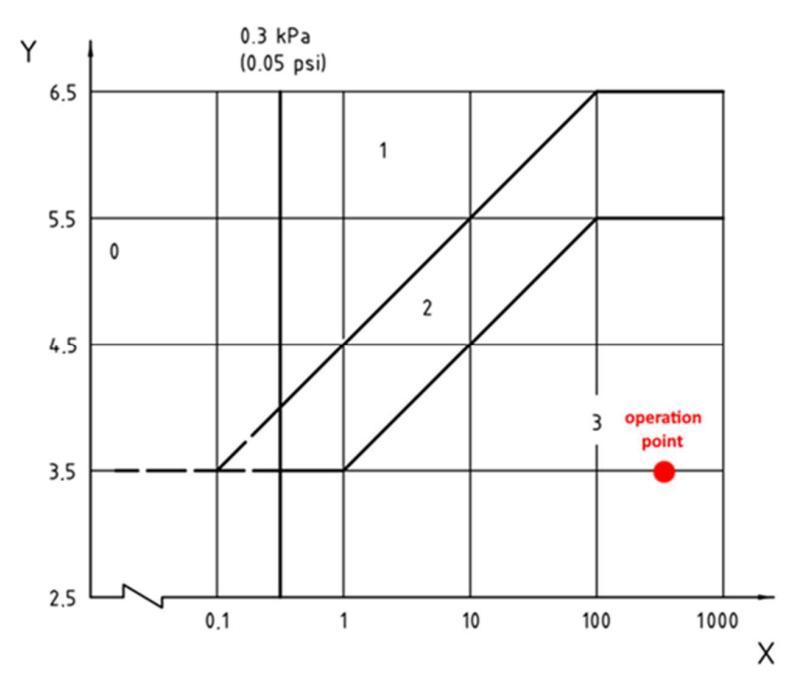
The chart presented in Figure 11 describes four possible levels of environment aggressiveness, namely:

- SSC Region 0, where the H₂S partial pressure is lower than 0.3 kPa. The choice of steel in this region requires no special precautions;
- SSC Region 1, where the H₂S partial pressure is higher than 0.3 kPa. There is a minimal risk of steel cracking;
- SSC Region 2, where the H₂S partial pressure is higher than 0.3 kPa. There is a risk of steel cracking;
- SSC Region 3, where the H₂S partial pressure is higher than 0.3 kPa. The steel is especially susceptible to stress corrosion.

The compressor in the case under consideration was operating in Region 3.

Figure 11. Aggressiveness of the environment, according to [5], (X—partial pressure of H₂S, Y—pH of the environment).

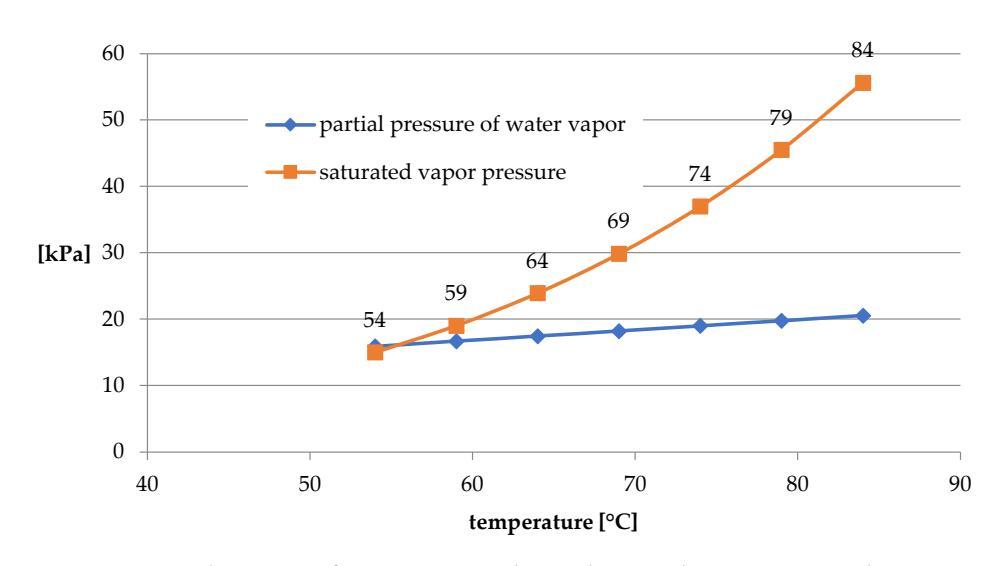
The presence of dry hydrogen disulfide favors development of the Sulfide Stress Cracking process but there is more. Some investigations [3] suggest that the additional presence of liquid H_2O can rapidly increase the crack development. The chart shown in Figure 12 presents the partial pressure of water vapor and saturated vapor at inlets of the consecutive compressor stages. It can be observed that at the first stage inlet, the temperature was 54 °C. Under these conditions, the partial pressure of water vapor is higher than the saturated vapor pressure. This indicates the condensation of the liquid H_2O phase and thus, the compressor first stage impeller might be in contact with humid and acid hydrogen disulfide.

Figure 12. Partial pressure of water vapor in the working medium vs. saturated vapor pressure.

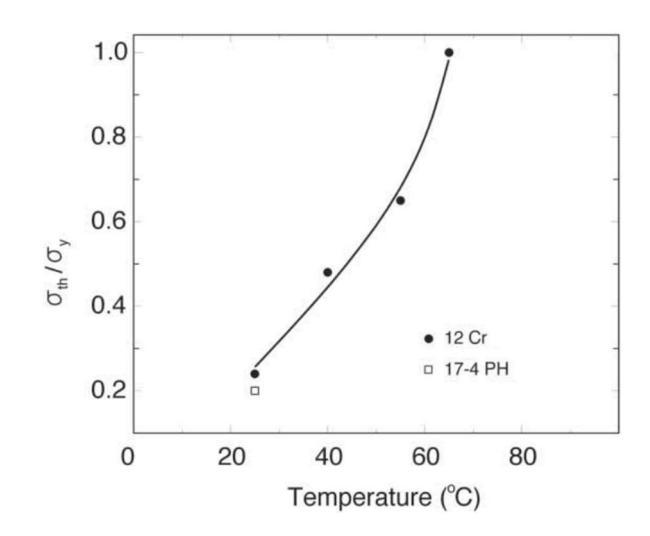
A similar conclusion can be drawn from the chart in Figure 14, which presents a relation between the temperature and the minimal permanent stress level (as a fraction of the yield stress) as the condition promoting the SSC occurrence. For the compressor inlet temperature (54 °C), the permissible stress level is equal to 55% of the yield stress.

Figure 14. Permanent stress level vs. temperature as the condition favoring the SSC occurrence [11].
