Development of Thermal Principles for the Automation of the Thermographic Monitoring of Cultural Heritage

Abstract: The continuous deterioration of elements, with high patrimonial value over time, can only be mitigated or annulled through the application of techniques that facilitate the preventative detection of the possible agents of deterioration. InfraRed Thermography (IRT) is one of the most used techniques for this task. However, there are few IRT methodologies, which can automatically monitor the cultural heritage field, and are vitally important in eliminating the subjectivity in interpreting and accelerating the analysis process. In this work, a study is performed on a *tessellatum* layer of a mosaic to automatically: (i) Detect the first appearance of the thermal footprint of internal water, (ii) delimit the contours of the thermal footprint of internal water from its first appearance, and (iii) classify between harmful and non-harmful internal water. The study is based on the analysis of the temperature distribution of each thermal image. Five thermal images sequences are acquired during the simulation of different real situations, obtaining a set of promising results f

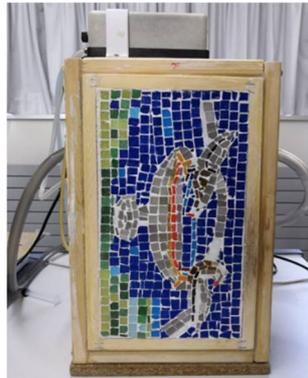
Figure 1 shows the front surface of the mosaic. As can be appreciated, the sample was executed in a wooden frame.

Figure 1. Front surface of the sample to be tested.

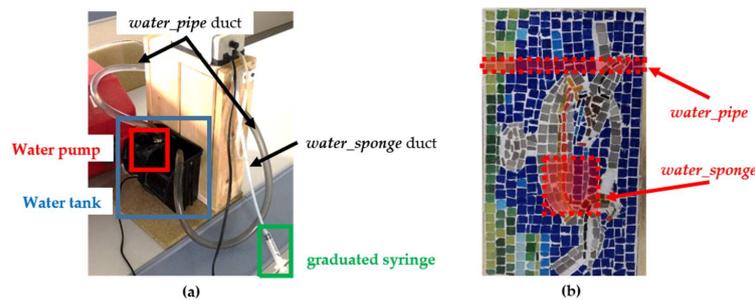
To finish with the description of the sample, Figure 2a shows where the water tank and water pump are located, as well as the *water_pipe* and *water_sponge* ducts and the graduated syringe. In addition, Figure 2b indicates where *water_pipe* and *water_sponge* are positioned with respect to the front surface of the mosaic.

Figure 2. (a) Water tank, water pump, graduated syringe, *water_pipe* and *water_sponge* ducts positions; (b) *water_pipe* and *water_sponge* locations from the front surface of the mosaic.

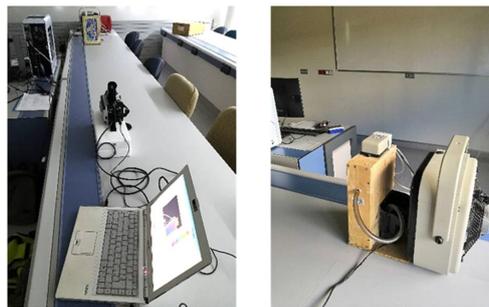
The experimental setup consists on the thermal excitation of the sample with a stove and the recording of the thermal response with a thermographic camera. The thermographic method used is “transmission mode” as shown in Figure 3. The stove used is 3.4 kW, and is placed at the rear of the mosaic, at 30 cm distance to uniformly heat the rear side. The thermographic camera is located 2.4 m from the front surface of the mosaic (the mosaic with the same orientation regarding Figure 1), and it is centred on the centroid of the sample to cover the entire front surface of the mosaic. The thermographic camera specifications are shown in Table 1.

Figure 3. Experimental setup: relative positions of the sample, the stove and the thermographic camera, in transmission mode.

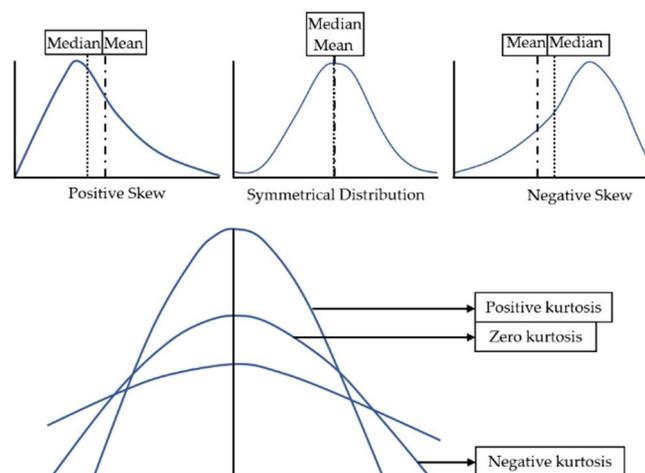
Figure 4. Definition of the possible types of skew and kurtosis in a dataset distribution. Graphical explanation.

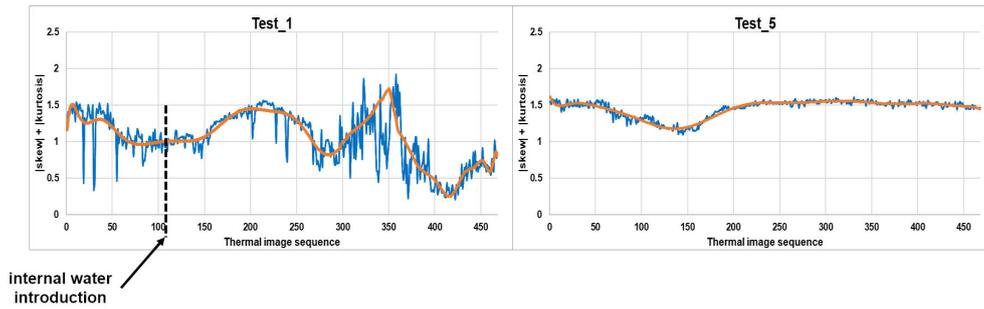
As an example, Figure 5 shows the corresponding evolutions of the skew and kurtosis summation in Test_1 (introducing internal water, at the instant corresponding to the thermal image 120 indicated by means of a discontinuous vertical line) and Test_5 (without internal water) before and after the SG smoothing filter application. Moreover, Figure 6 shows the resulting relative maximums/minimums and slopes, in %, of each test used as input data in this work.

Figure 5. Evolution of the skew and kurtosis summation in Test_1 and Test_5. Before (blue line) and after (orange line) SG smoothing filter application.

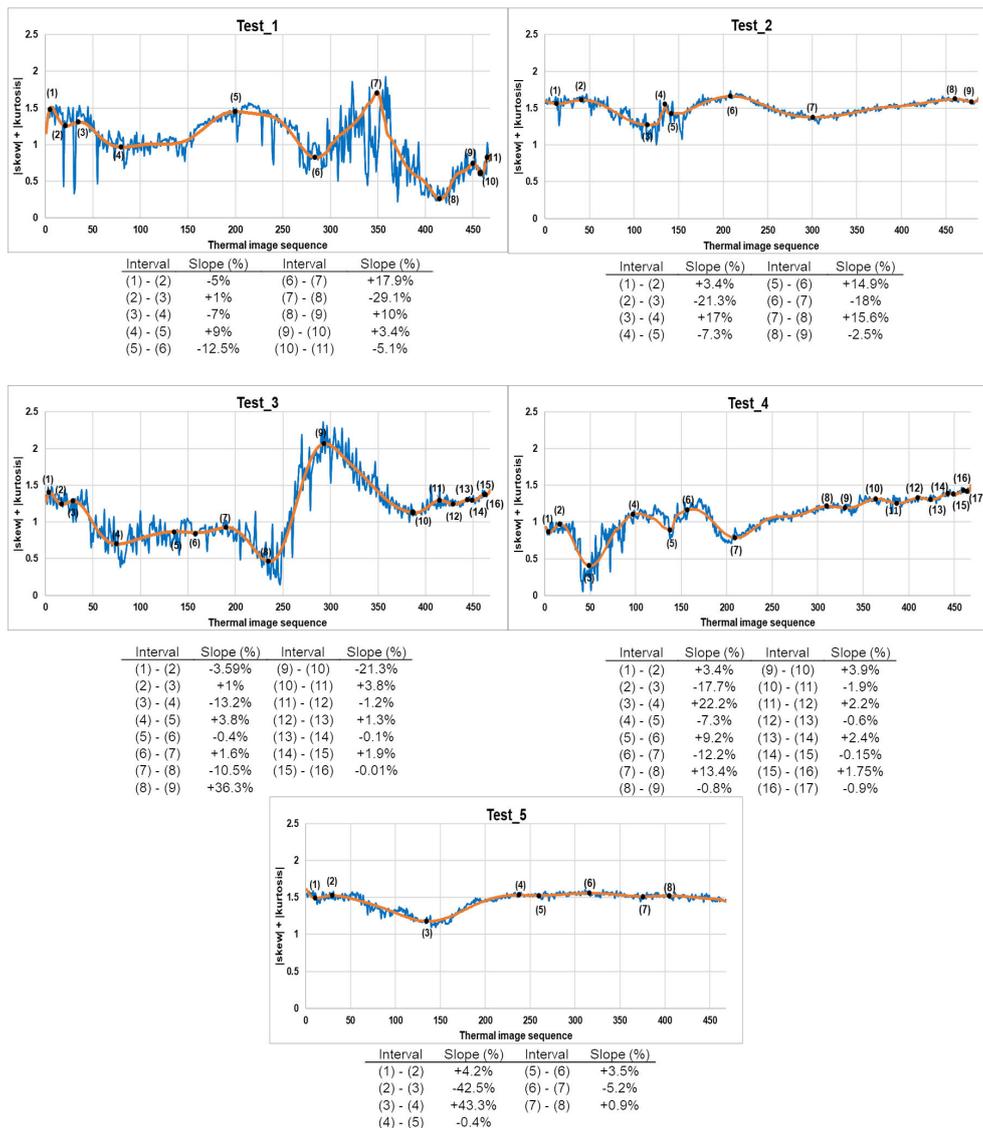
Figure 6. Relative maximums and minimums obtained (numbers indicated in the graph) and slope calculation (table below the graph) following the evolution of each test performed after SG smoothing filter application (orange line). Blue lines indicate the evolutions of the tests performed before SG smoothing filter application.

Analyzing the slopes in Figure 6, together with the information support of the steps followed in each test (Table 2), the following conclusions are reached, with the identification of phases in the evolution of the tests as illustrated in Figure 7:

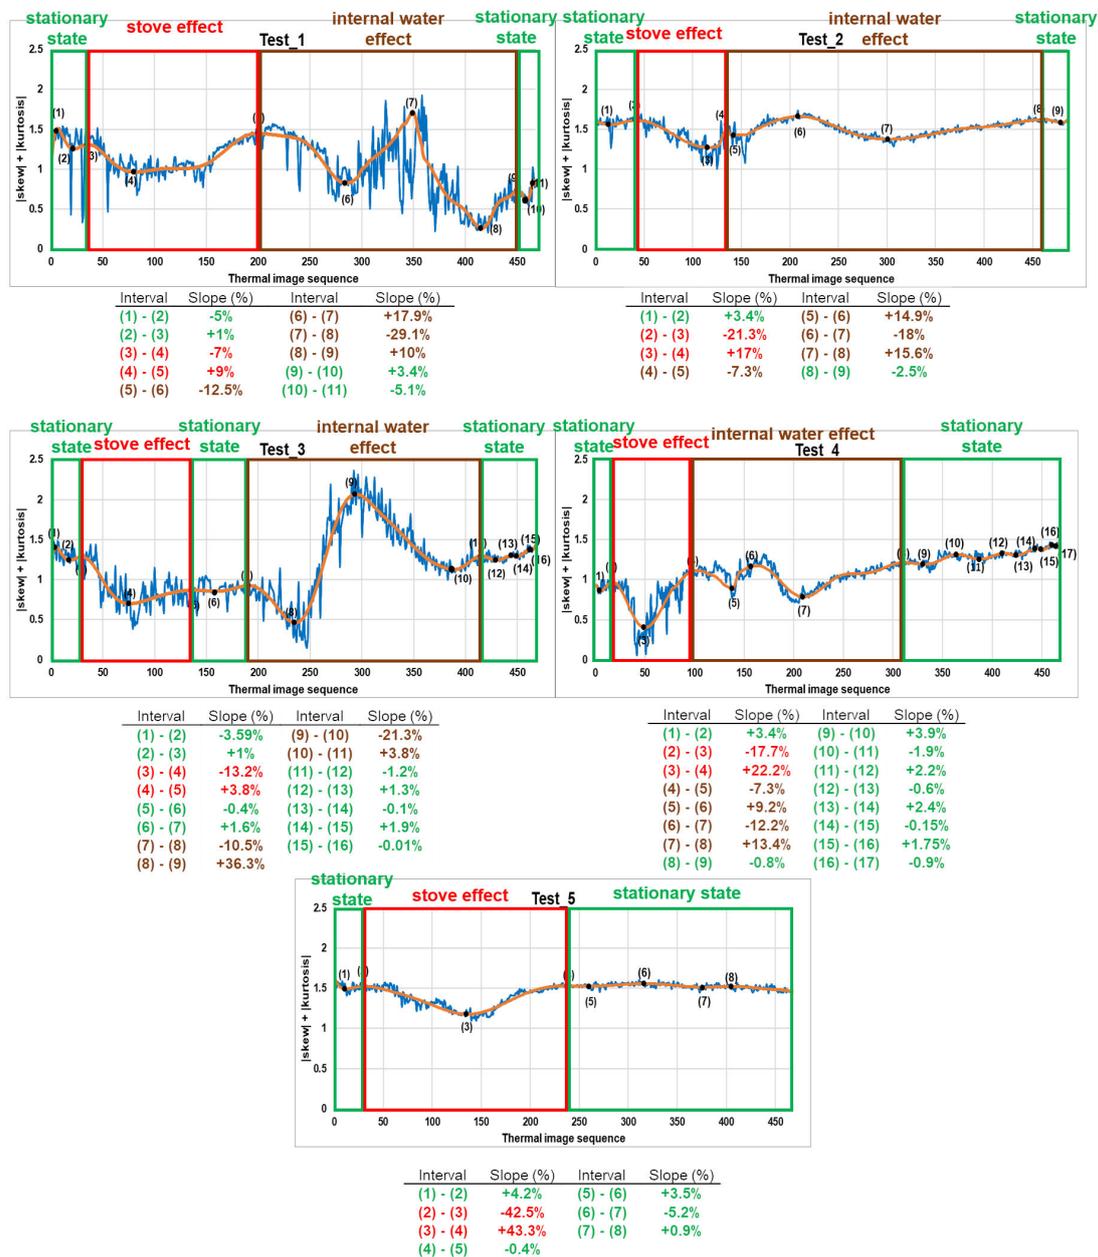
Figure 7. Relative maximums and minimums obtained (numbers indicated in the graph) and slope calculation (table below the graph) regarding the evolution of each test performed after SG smoothing filter application (orange line). Blue lines indicate the evolutions of the tests performed before SG smoothing filter application. The slopes belonging to the stationary state of the mosaic, the stove effect and the internal water effect (*w_shape*) are framed in green, red and brown rectangles in the graphs; and coloured with the same colours as their corresponding rectangles in the tables, respectively. The *reference_points* are the instants just after the beginning of internal water effect, i.e., the thermal images just after the extremes (5), (4), (7) and (4) of tests 1, 2, 3 and 4, respectively.

The Step 3 of this study analyses again the slopes in the evolution of the sum of the absolute values of skew and kurtosis of each test performed after SG smoothing filter application, i.e., Figure 7. If the percentage values of the brown slopes are observed, i.e., the slopes corresponding to the internal water effect, it is possible to say that the values of the second and third slope of w_shape are the highest and the value of the last slope the lowest in the tests using $water_pipe$, in absolute terms. In contrast, the values of the third and fourth slope of w_shape are the highest and the value of the first slope the lowest in the tests using $water_sponge$, in absolute terms.

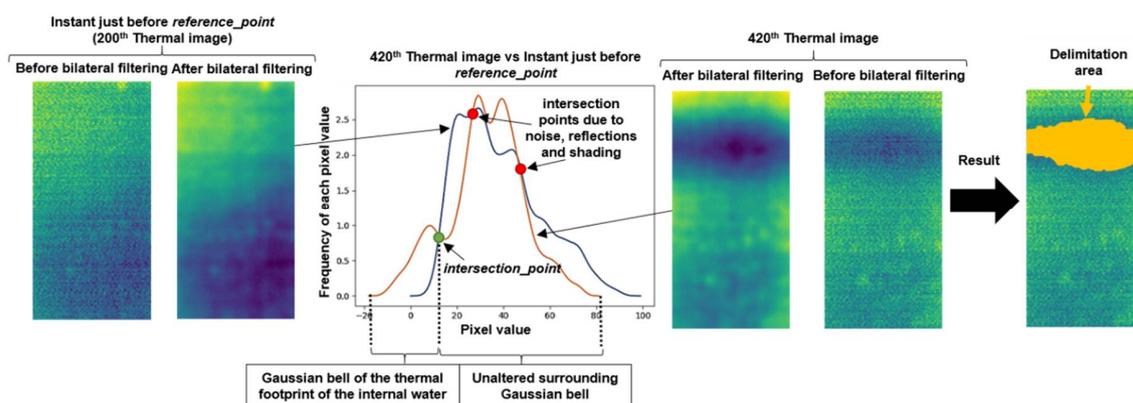
Figure 8 shows a result of this Step 2, taking an overlapping histograms in Test_1 as a reference. The results of all the tests are shown in Section 4.2.

Figure 8. Step 2 result applied to the 420th thermal image belonging to the Test_1.

Figure 8 shows the leftmost intersection point as the *intersection_point* in the overlapping histograms, since the temperature of the volume of internal water is colder than the temperature of the rest of the sample. The same happens to the rest of images of the Test_1, and also to the remaining sequences of this work (see ambient and water temperatures shown in Table 2). The knowledge of the *intersection_point* makes possible the delimitation of the contour of the thermal footprint of the internal water. In Figure 8, the area of the delimitation is highlighted in orange.

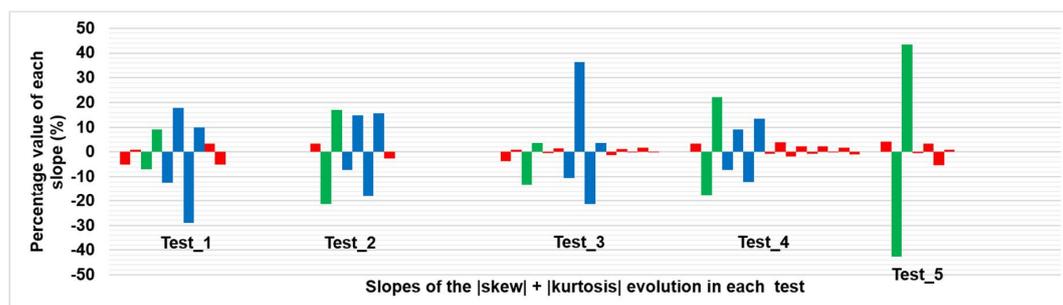
Figure 9 shows another way to graphically represent Figure 7, in order to have a clearer and more direct visualization.

Figure 9. Alternative graphic representation of Figure 7.

From Figure 9, it is easy to differentiate between the slopes corresponding to the stove effect and internal water effect and the slopes when the mosaic is in stationary state. Indeed, the corresponding average and standard deviation values are $2.1\% \pm 1.6\%$ and $16.8\% \pm 10.7\%$ considering all “red” and all “green + blue” bars of Figure 9, respectively. All the percentage values of the slopes are converted to absolute terms for the previous calculations and when setting a threshold value of 4.9% in order to automatically differentiate between “red” and “green + blue” bars. This 4.9% was determined as the intermediate value at the moment of the maximum approximation between the slopes of the stationary state ($2.1\% + 1.6\% = 3.7\%$) and those of the stove effect and the internal water effect ($16.8\% - 10.7\% = 6.1\%$).

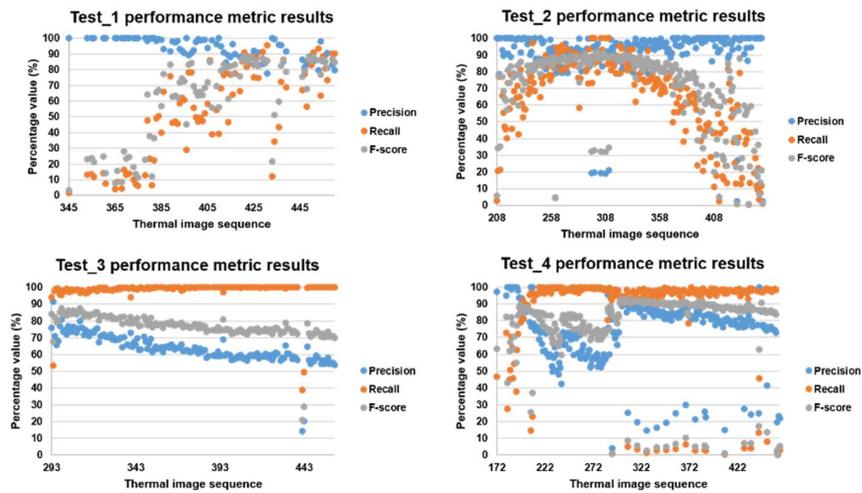
Figure 10 shows different graphs, each corresponding to a different test, representing the corresponding *Precision*, *Recall* and *F-score* values obtained. In addition, with the aim of illustrating the values represented in the graphs of Figure 10, Figure 11 shows the first and the last delimitation obtained from each test, being the delimitation areas highlighted in orange on the corresponding raw thermal images. To illustrate how good the results obtained are according to the analysis in Step 2, Figure 11 also represents the best delimitation according to the *F-score* results together with the corresponding ground truth of each test (also highlighting the delimitation areas in orange).

Figure 10. Precision, Recall and F-score results regarding the delimitations obtained in each test performed in this work.

It should be noted that the horizontal axis of each test in Figure 10 represents the results of the delimitation in the corresponding thermal images from the ending point of the first ascent of the *w_shape* within the sequence. The reason for showing from the ending point of the first ascent of the *w_shape*, and not from *reference_point* according to the analysis of the Step 2, is due to the very poor delimitation results obtained in the thermal images not represented in Figure 10. The cause of these poor results, along with not always having values equal to 100% in the performance metrics represented in Figure 10, is the high reflectivity index of the tested surface of the mosaic. Despite knowing on which side to search for the *intersection_point* in the overlapping histograms, this high reflectivity index may cause a small random variation in the shape of the region of the histograms located on the search side of the *intersection_point*. As a consequence, the *intersection_point* will be less accurate for the delimitation of the contour of the thermal footprint of the internal water, being the tested surface very sensitive to any thermal change in the sample environment. Moreover, the high reflectivity index may cause that there is no point of intersection on the search side on some overlapping histograms. So much that of the results represented in Figure 10, there are 29%, 1%, 5% and 11% of thermal images in Test_1, Test_2, Test_3 and Test_4 from the ending point of the first ascent of their corresponding *w_shapes* that have no delimitation and therefore are not represented in Figure 10, respectively. As an example, Figure 12 illustrates delimitations with a good and a poor result, highlighting the delimitation areas in orange, and a thermal image without delimitation.

Despite the problem of high reflectivity index, an issue that must be mitigated in the mosaic in future works, similar results are obtained in comparison with the results of methodologies that automatically delimit contours of the thermal footprints of moisture from single thermal images [18,22] both in *precision*, *recall* and *F-score*. Table 3 shows the average and standard deviation values of the performance metrics represented in Figure 10:

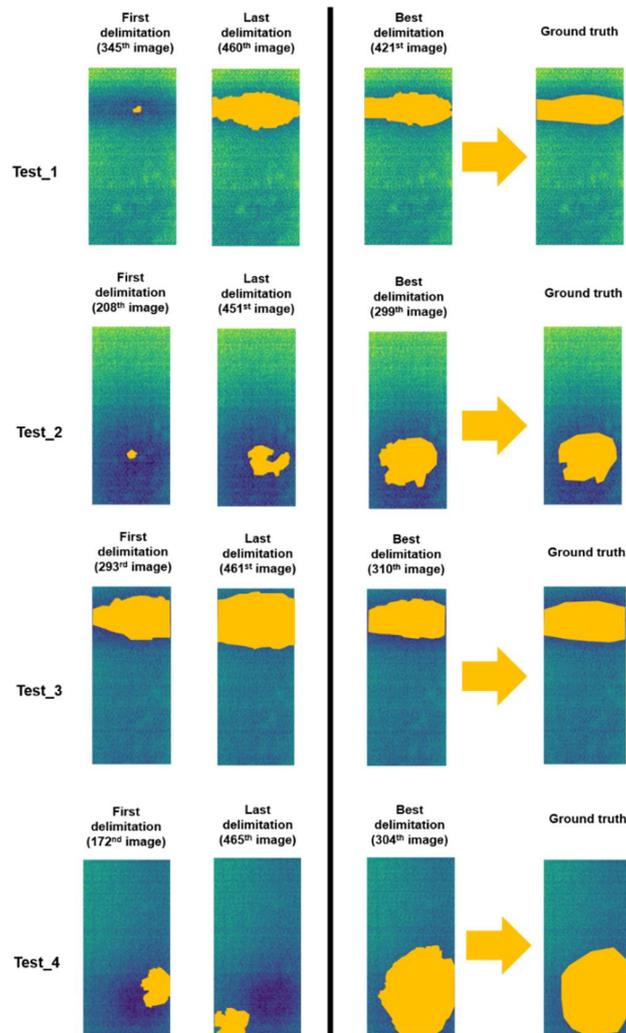
Figure 11. First and last delimitation obtained from each test. The best delimitation according to the F-score results together with the corresponding ground truth of each test are also indicated. All the delimitation areas are highlighted in orange.

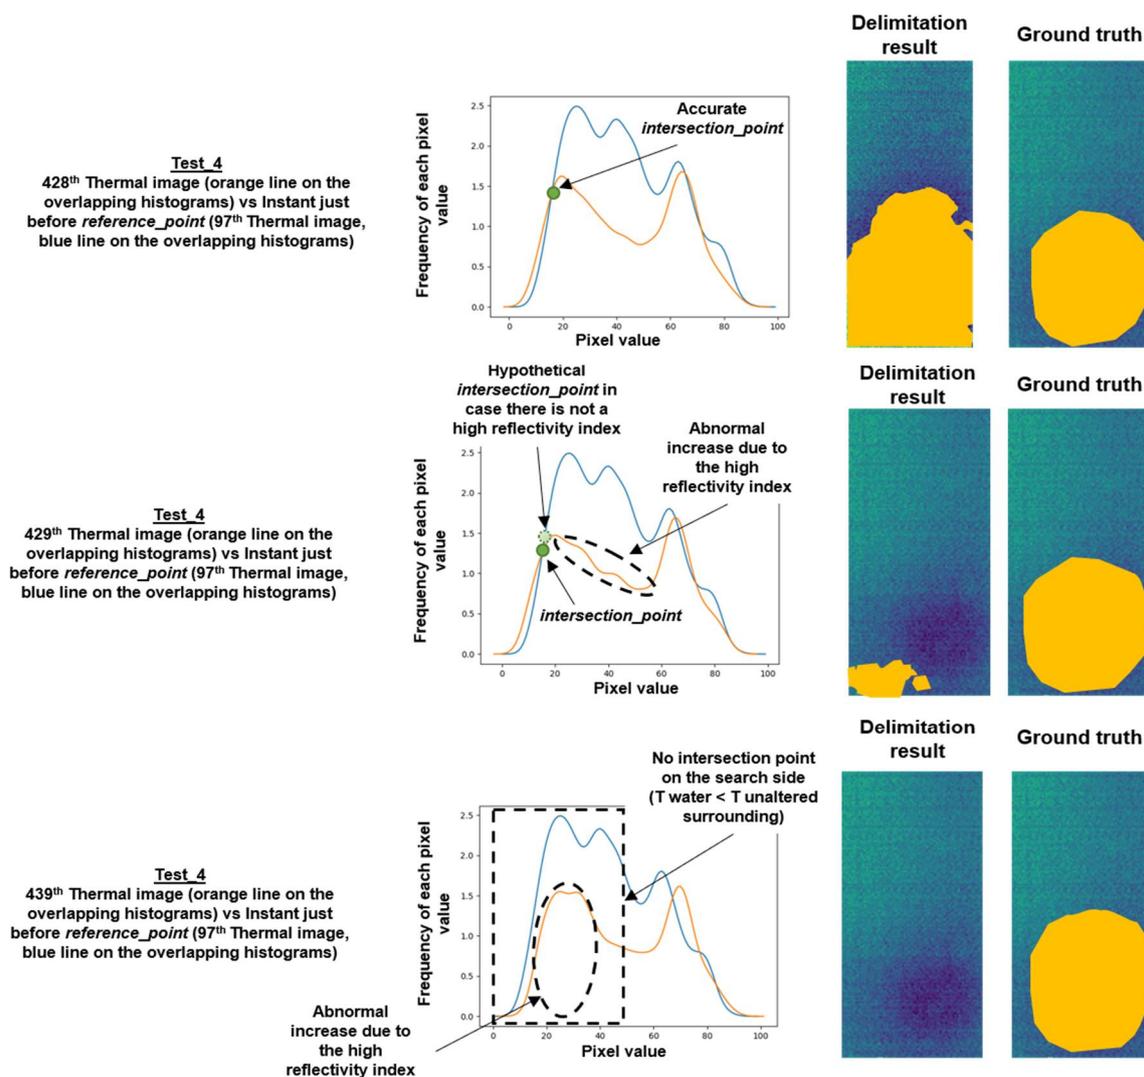
Figure 12. Examples of good and poor delimitation results. Delimitation areas are highlighted in orange.
