Damage Monitoring of Engineered Cementitious Composite Beams Reinforced with Hybrid Bars Using Piezoceramic-Based Smart Aggregates

Citation: Qian, H.; Zhang, Y.; Li, Y.; Gao, J.; Song, J. Damage Monitoring of Engineered Cementitious Composite Beams Reinforced with Hybrid Bars Using Piezoceramic-Based Smart Aggregates. *Sensors* **2022**, *22*, 7184. <https://doi.org/10.3390/s22197184>

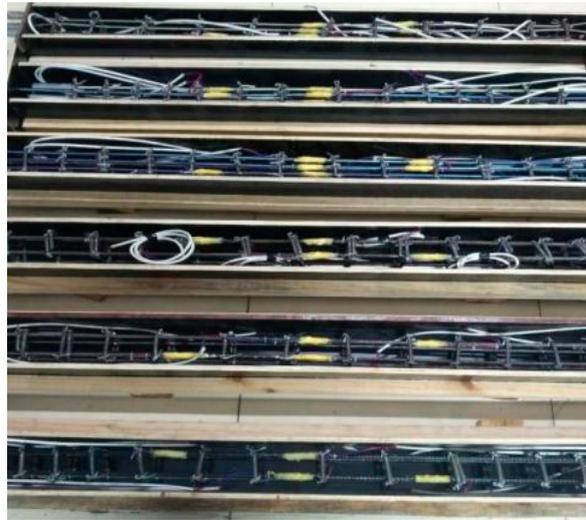
(a) General view

(b) SMA anchorage

(c) Steel strand anchorage

(d) GFRP anchorage

Figure 3. Photo of six beam specimens.

A total of six concrete beams were designed with the same cross-sectional area of 100 mm × 100 mm, and the length was set to 1100 mm, as shown in Table 1. The specimen RC is a reinforced concrete beam, while another five specimens are made of ECC material, and are reinforced with steel rebars, steel strands, glass fiber reinforced plastics (GFRP) rods, shape memory alloy (SMA) rods, and both GFRP and SMA rods, respectively, as shown in Figure 3. The material of both reinforcements and stirrups is HRB 400, and the arrangements of stirrups are the same for six specimens. The crack changes of six beams can be schematically illustrated by Figure 4.

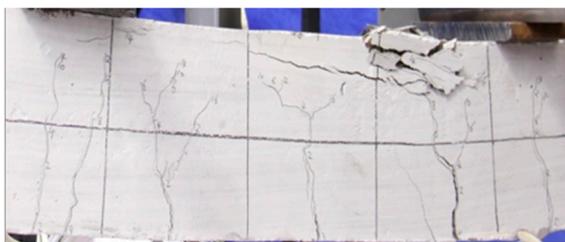
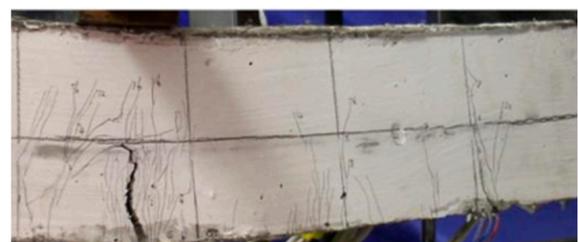
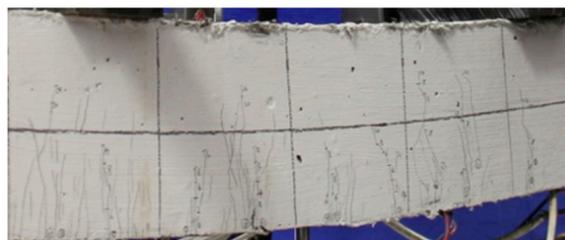
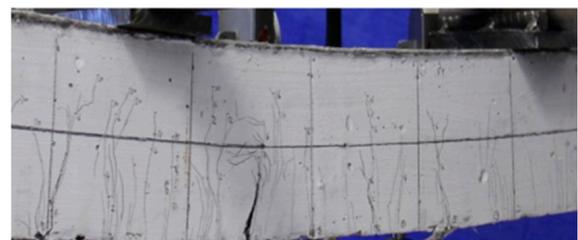
(a) RC 20 mm

(b) R-ECC 26 mm

(c) SS-ECC 26 mm

(d) GFRP-ECC 26 mm

(e) SMA-ECC 26 mm

(f) GFRP/SMA-ECC 26 mm

Figure 9. Failure modes and the crack widths of tested beams.

The obtained failure modes and the crack widths of six tested beams are illustrated in Figure 9. Noticeable cracks from the tension zone at beam bottom until the neutral axis can be observed for each specimen. The termination of the loading process is associated with the occurrence of a major crack, except for specimen SS-ECC. This can be explained by the fact that the rupture of pretensioned steel strands occurred for specimen SS-ECC. It was also noted that only the concrete in the compression zone of the specimen RC was crushed, another five beam specimens exhibit multiple cracking behavior.
