# Effect of Water Condensate on Corrosion of Wires in UngROUTED Ducts

**Abstract:** In the case of existing prestressed concrete structures, information about the actual state of prestressing is an important basis for determining their load-carrying capacity, as well as remaining service lifetime. This is even more important in the case of existing prestressed concrete bridges, which are exposed to a more aggressive environment than the other prestressed concrete structures. The level of prestressing is affected and reduced by prestress losses at a given time. In calculating the internal forces and stresses, required for the assessment of the Ultimate Limit State and the Serviceability Limit State, it is necessary to know not only the prestressing level but also the cross-sectional area of the prestressing steel (wire, strand or cable), which can change in time due to corrosion. In practice, in the case of the pre-tensioned concrete members, it has often happened in the past that cable ducts have been grouted only partially, or not at all, due to poor grouting technology. Experts did not realize what this could cause in the future—the penetration of water with aggressive agents di

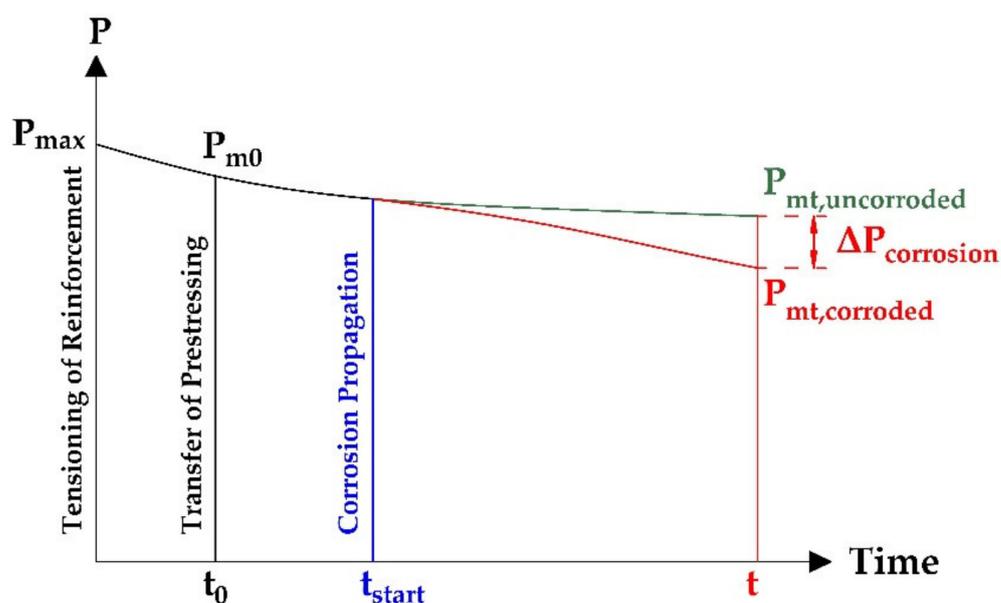
Figure 1. Influence of prestressing steel corrosion on change of prestressing force.

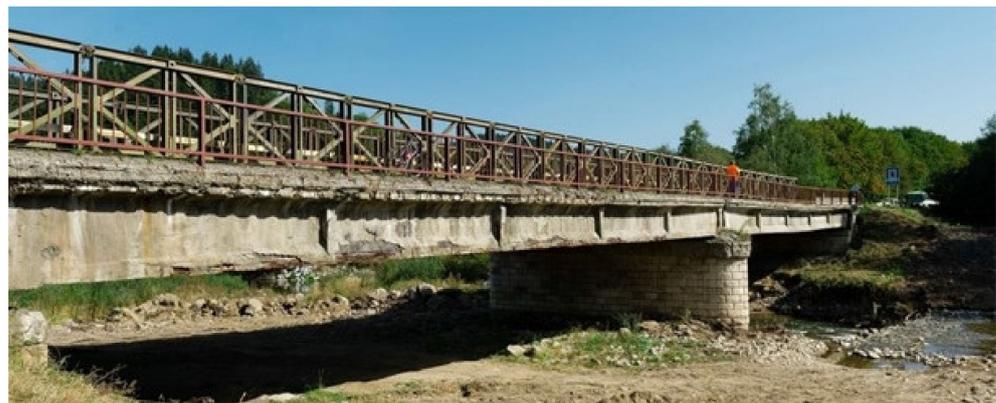
**Figure 2.** View on studied bridge structure in Podbiel.

The pivotal object of the presented study is one of the post-tensioned bridges in Podbiel (north part of Slovakia) from the first generation of prestressed concrete bridges which were built in former Czechoslovakia in the middle of the previous century (in 1956). The investigated bridge is presented in Figure 2.

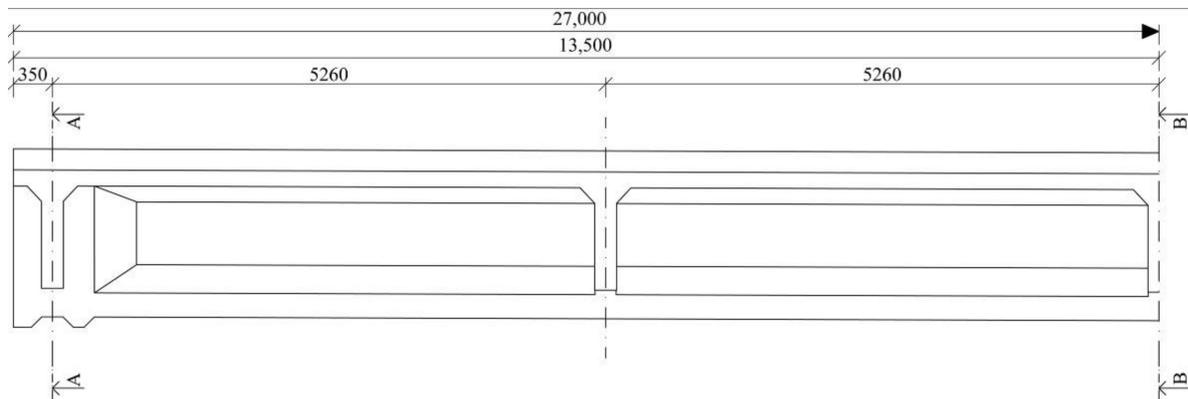
**Figure 3.** Longitudinal layout of post-tensioned beam of investigated bridge.

patented wires with a diameter of 4.5 mm. Prestressing wires were placed in a cable duct of a diameter of 50 mm. Cable ducts were identified as metal tubes [26–28]. Detailed drawings of the bridge used in the analysis are shown in Figures 3 and 4.

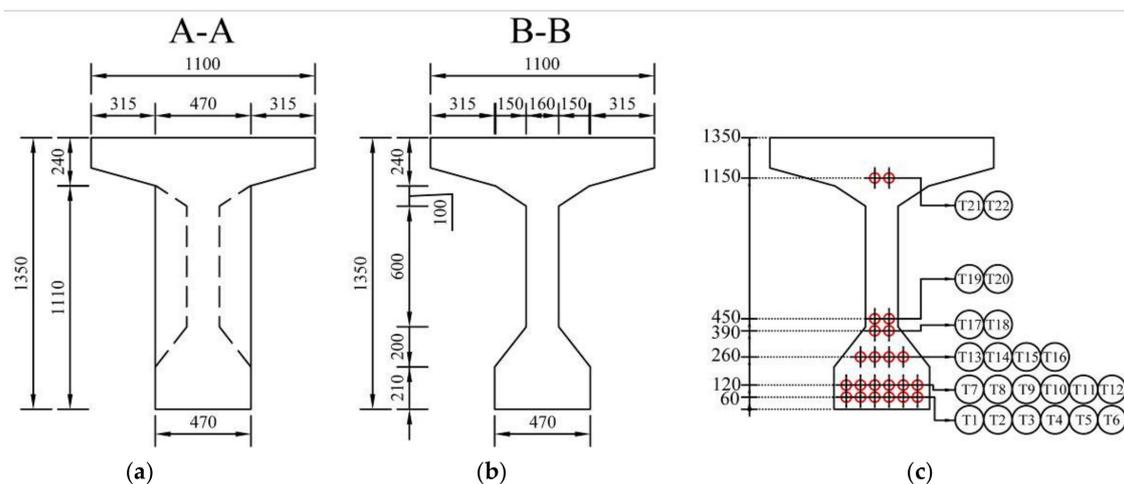
**Figure 4.** Cross-section of the beam: at end A-A (a); mid-span B-B (b); arrangement of tendons (c).

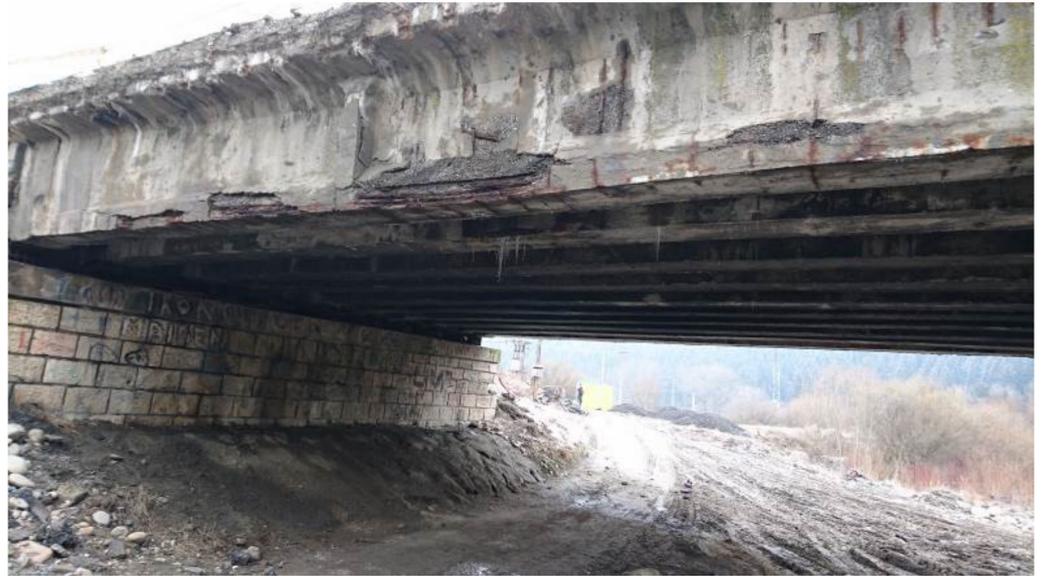
**Figure 5.** Bridge and its state prior to demolition (span No. 1).

The investigated bridge was in a bad state at first sight, so it could be assumed that regular inspections were neglected. The view on the bridge prior to its demolition can be seen in Figure 5. The results of performed inspection required immediate intervention in form of bridge closure for traffic. Completed tests indicated severe propagation of corrosion of prestressing steel (wires and anchorages). This fact dangerously contributed to additional prestress losses and the reduction of the load-carrying capacity of the bridge in question. The state of cement grout in ducts was investigated after the demolition of the bridge, see Figure 6. The conclusions of this investigation were alarming, as the ducts were empty or only partially filled with cement grout. Consequently, the prestressing was unbonded and prestressing steel was exposed to a significant risk of corrosion.

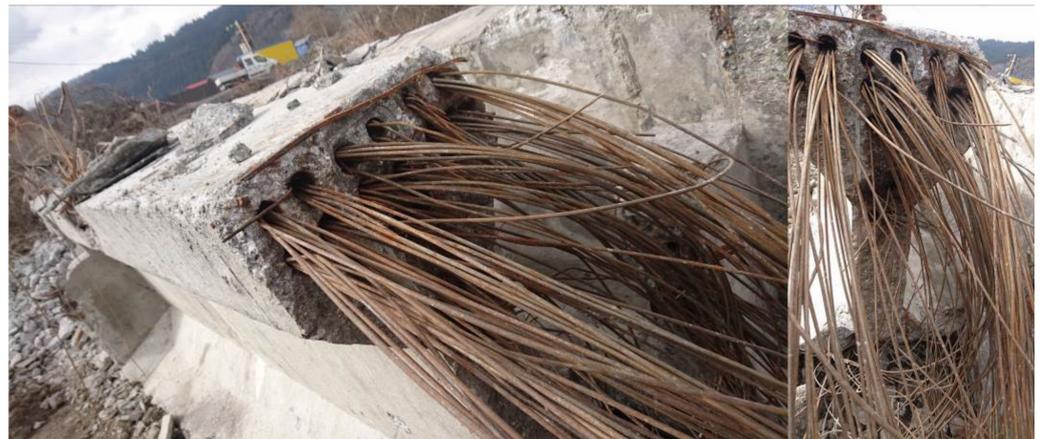
**Figure 6.** View on ducts after the bridge demolition (unfilled ducts and visible corrosion).

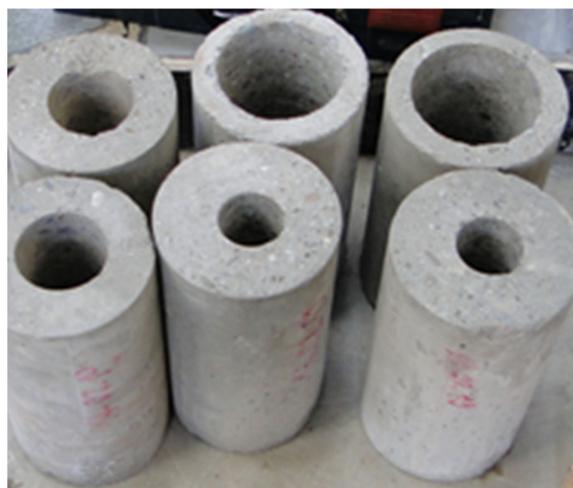
Figure 7. Concrete specimens with varying cover thickness.

Samples of dimensions of  $150 \times 300$  mm (concrete cylinders) served to describe the change in humidity in the duct with no airflow. The cavity in the specimen originated in the longitudinal drilling of holes of different diameters. The holes of diameter 107 mm in specimens with denotation "C21", holes with a diameter of 72 mm in specimens with denotation "C40" and specimens with denotation "C50" with the holes of diameter 51 mm were created (see Figure 7). This marking represents the concrete cover layer thickness "c" (for instance, denotation C21 means the concrete cover  $c = 21$  mm, it is the thickness of the cylinder wall). It simulates the concrete cover layer of the steel duct. The base of the cylinders was modified with a plastic cover so that no moisture could penetrate through them. A miniature multi-sensor module for measuring temperature and humidity from Ahlborn was used in the middle of the cavity. A Pt100 surface temperature sensor from Ahlborn was fitted on the outer surface of the samples.

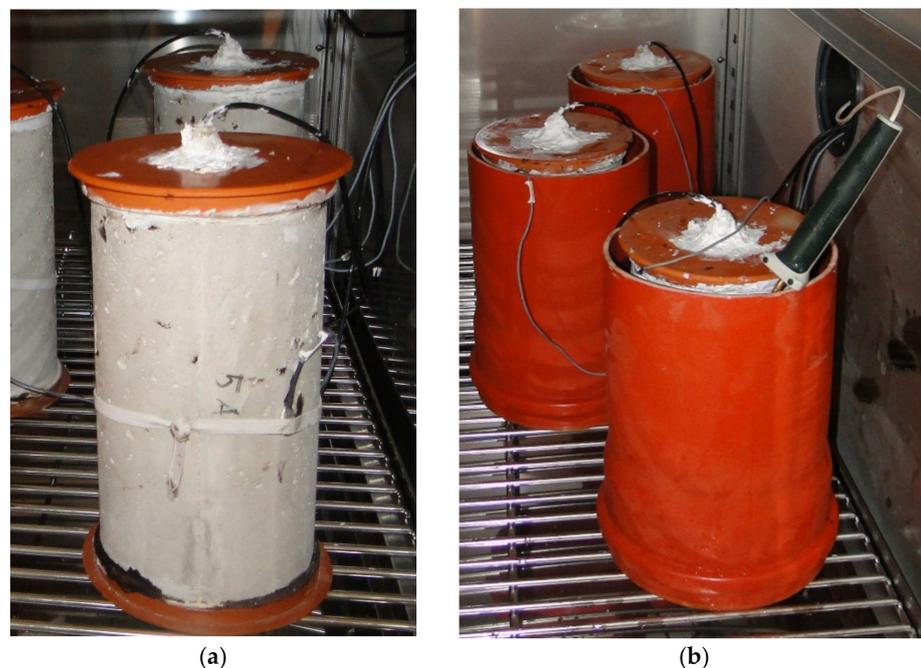
**Figure 8.** Samples in the climatic chamber: (a) atmospheric humidity, (b) water storage.

The temperature for the drying of samples was  $110$  °C ( $230$  °F). After the drying process, they moved to an air-conditioning chamber. The ambient temperature in the air conditioning chamber was the lowest ( $8$  °C), at which it can maintain a humidity of 90% for a long time. The temperature and humidity were independent controlled in the inside space of the chamber. To determine the water absorption, it was necessary to determine the weight of the samples, measured at selected time intervals. After reaching humidity of 75% inside the specimen denoted as C21, the experimental test was terminated. The experiment aimed to determine whether and for how long the moisture in the cavity will reach 75% under constant temperature conditions under the action of atmospheric humidity and what effect the concrete cover thickness of the sample has (Figure 8a). The same samples were used in the second following procedure, as well.

Additionally, we dried identical samples at  $110$  °C ( $230$  °F). After tempering to  $8$  °C ( $46.4$  °F), the specimen moved in an  $8$  °C water storage (water bath). They have been placed in a climatic chamber in the water bath, while maintaining an ambient and water temperature of  $8$  °C. After reaching the desired humidity in the cavity, we measured the weight of samples to determine the water absorption (Figure 8b).

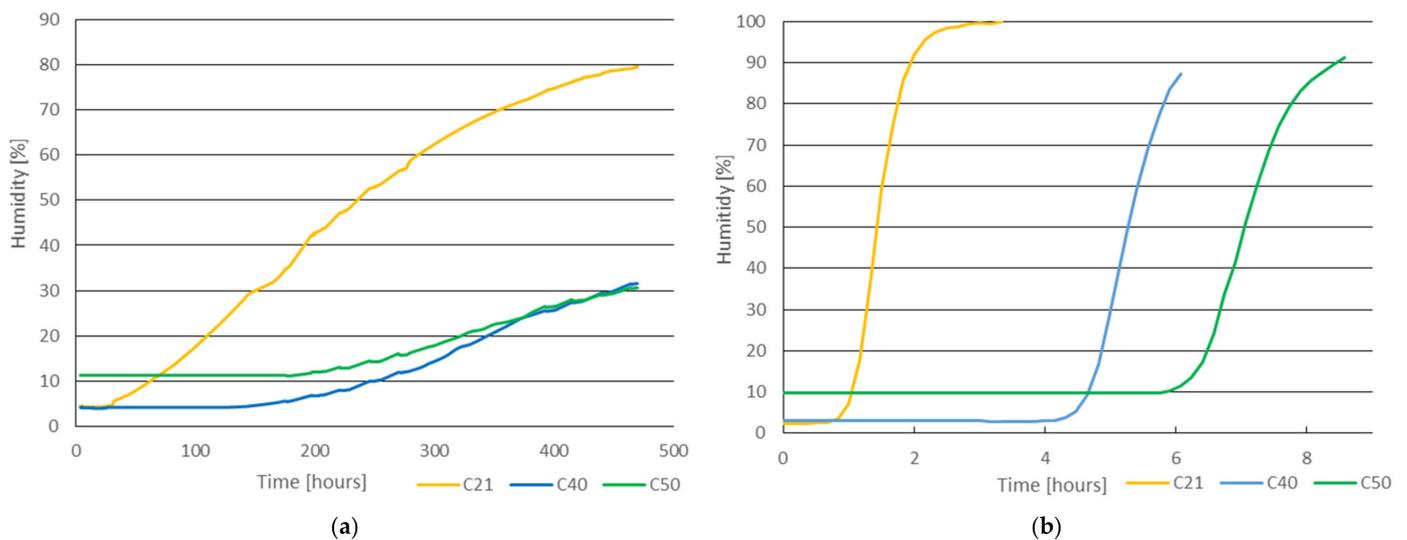
**Figure 9.** Relative air humidity dependence on cavity when (a) exposed to atmospheric humidity; (b) placed in water storage.

Figure 9a shows the humidity dependence on the cavity of a concrete sample when exposed to atmospheric humidity and Figure 9b when placed in a water storage (aqueous environment). The surface temperature of the specimen, the water and the cavity temperature were practically the same throughout. It follows from the depicted dependences that the humidity in the cavity begins to grow in both environments only after a specific time—this time interval can be called the passive stage. In the passive stage, water (water vapor) penetrates into the sample but does not affect the moisture in the cavity.

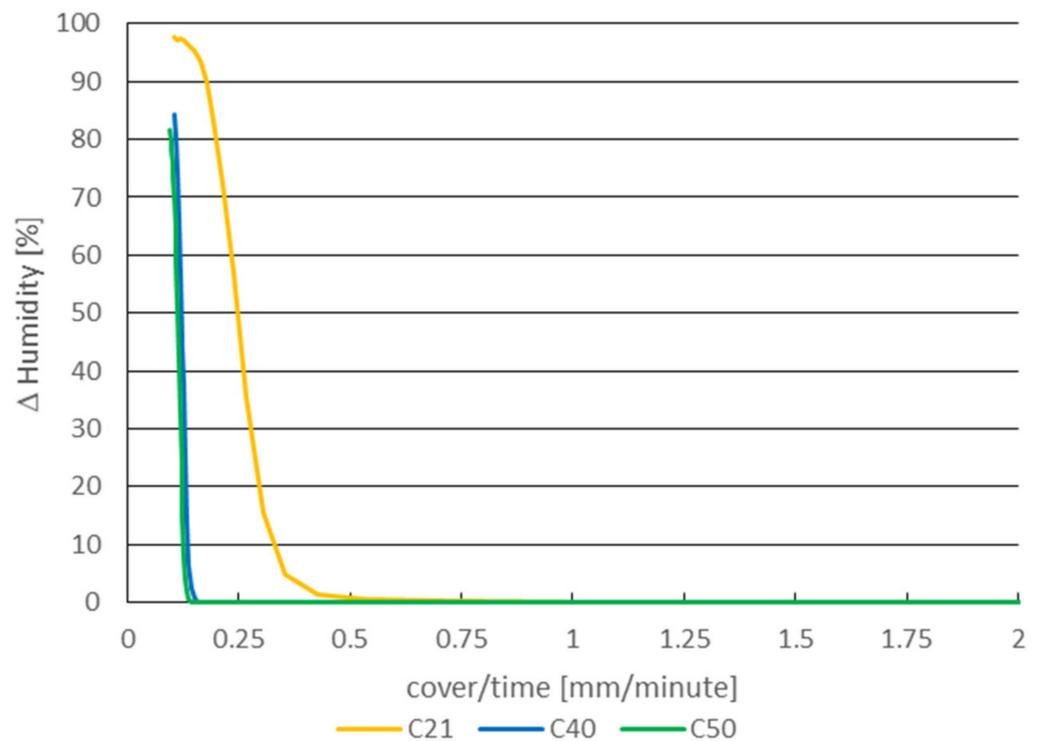
**Figure 10.** Humidity dependence on ratio of thickness of concrete cover and time—samples placed in water storage.

The following Figure 10 shows the change in humidity depending on the ratio of the thickness of the concrete cover (thickness of cylinder wall) and the time of samples in the water storage, i.e., the rate of change of humidity in the cavity.

The inverse value (ratio) represents the rate of moisture penetration during the passive stage (Figure 10), it is 0.463 mm/min for C21, for C40 it is 0.149 mm/min and for C50 it is 0.138 mm/min. The significant difference between the moisture penetration rate in the case of C21 and in the case of C40 and C50 samples is due to the fact that the maximum size of the aggregate used in the concrete of 16 mm. The depth of the C21 concrete cover is 21 mm and the cavities (holes) were created by diamond drilling, where the aggregate was also cut.

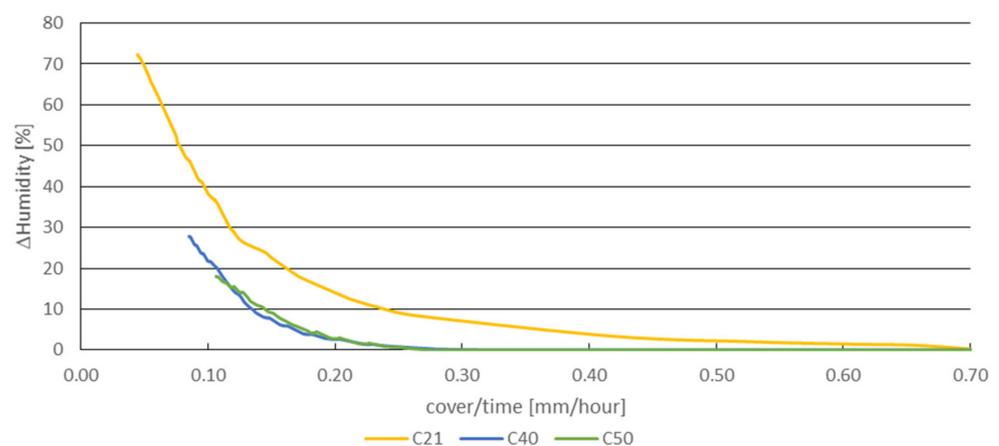
**Figure 11.** Humidity dependence on ratio of thickness of concrete cover and time—samples placed in atmospheric humidity.

Figure 11 shows the change in humidity depending on the ratio of the thickness of the concrete cover and the time of the samples under the influence of atmospheric humidity.

The rate of moisture penetration during the passive stage (Figure 11) in this case is equal to 0.677 mm/h for C21, for C40 it is 0.240 mm/h and for C50 it is 0.236 mm/h.

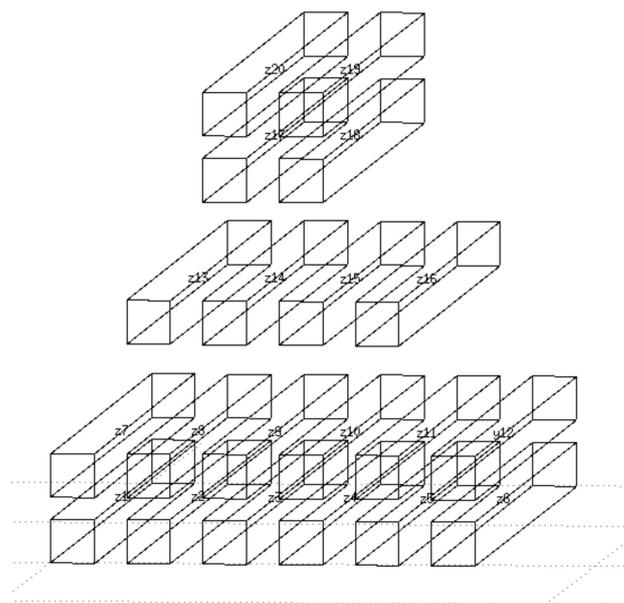
**Figure 12.** Sketch of a simplified simulation model in ESP-r program (consists of 20 zones representing air cavities (ducts) in a 1 m long sample).

The simulation model works with a square cross-section of the air cavity (duct) instead of the original circular shape, enabling creating an orthogonal network of these cavities (ducts). The model, representing the cut-out of a one-meter concrete beam, consisted of 20 air cavities (20 zones model) (see Figure 12) with denotation from Z1 to Z20. The concrete walls between the ducts of appropriate thickness interconnected them. The lower left part of this network is shown in Figure 13. The model's weakness is the lack of a direct connection between the individual concrete walls, which would allow the heat conduction. Without this connection, one wall can be preheated from the sun while the other remains colder. The bulk density of the concrete was considered to be  $2400 \text{ kg/m}^3$ , the computing coefficient of thermal conductivity was  $1.58 \text{ W/m.K}$ , the specific heat capacity was  $1020 \text{ kg/m}^3$ , the absorption of the surface for solar radiation is equal to value 0.6. The simulation does not include the moisture transfer. The orientation of the cavities meets the bridge girder in the east-west direction (as original bridge structure). That means that the sunlight in the simulation fell on the left-hand side. The numerical simulation used the reference climate year of the IWEC (International Weather for Energy Calculations) database for Prague. The zone (duct) humidity was a constant value throughout the simulation period. As described in the previously mentioned experiment, it is problematic to determine the relative humidity of the air in the duct. The relative air humidity in the cavity is more affected by the moisture contained in the concrete than in the outside air. For example, the concrete can absorb air humidity by rain and so it can get wet. Water can enter the concrete beam through the leaky road pavement, as well. Therefore, the simulations considered several levels of relative humidity in the cavity: 65%, 70%, 75% and 80%. It is also expectable that the bridges over the river will be less favorable during the year than over the ground (land).

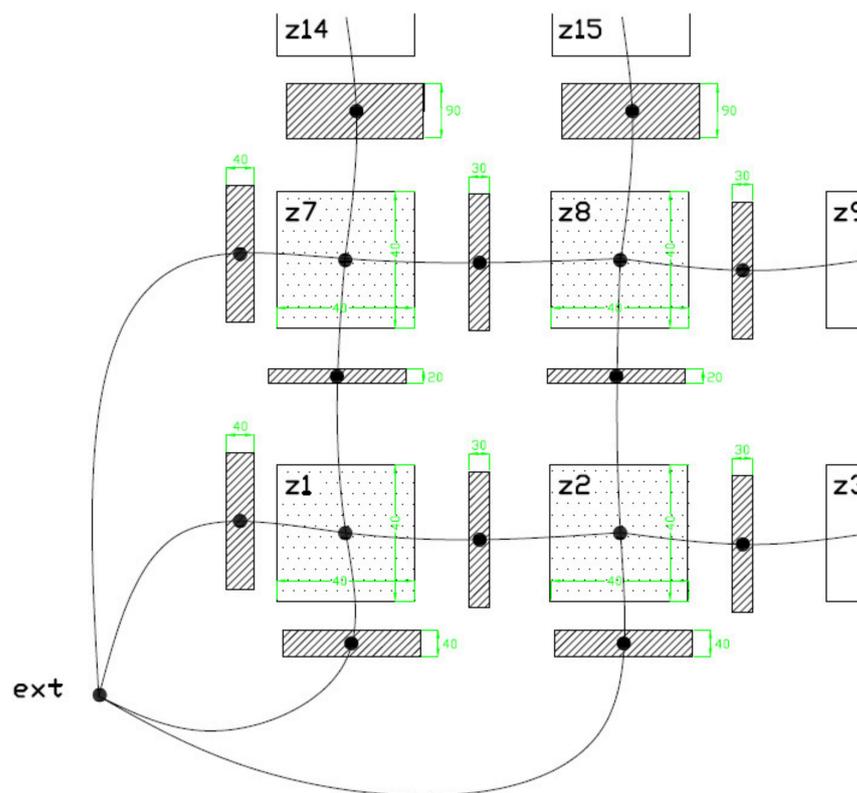
**Figure 13.** Lower left-hand part of finite volume network in simulation program consists of air cavities and surrounding concrete walls (thin solid line shows simulated thermal bonds).

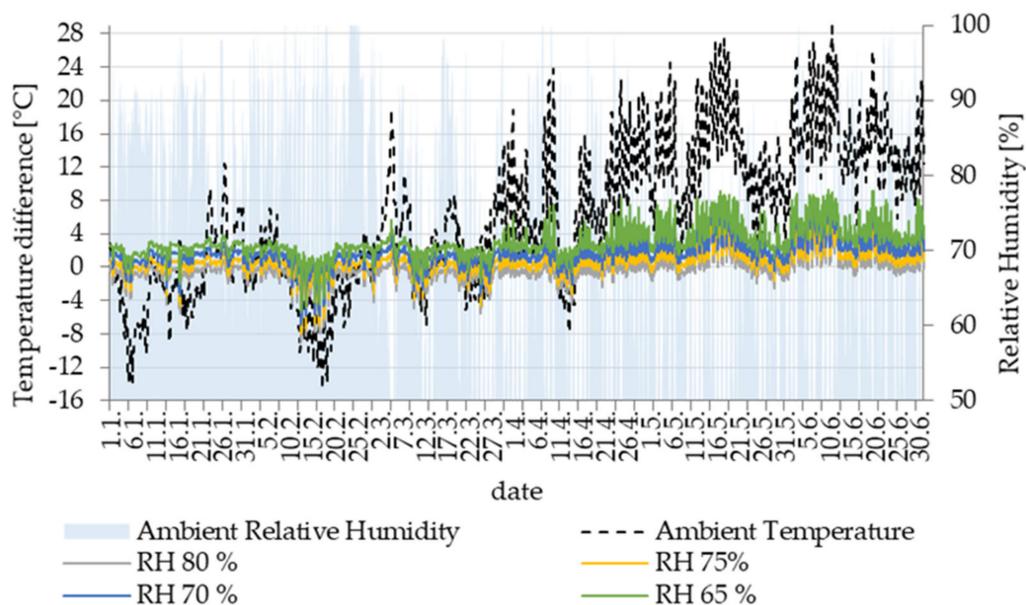
Figure 14. Potential for condensation in Z1 cavity at different considered relative humidity of air in cavity over year.

According to the course for 75% RH of air in the cavity, condensation can occur, especially in the cold winter season. In general, the lower is the air temperature, the greater the condensation potential is. For this reason, the coldest week from 9–20 February, which occurred in the reference climate year, was selected for further analysis in the other cavities. During that period, the relative humidity of the outside air was high for a long time, fluctuating from 60% to 100% (Figure 15).

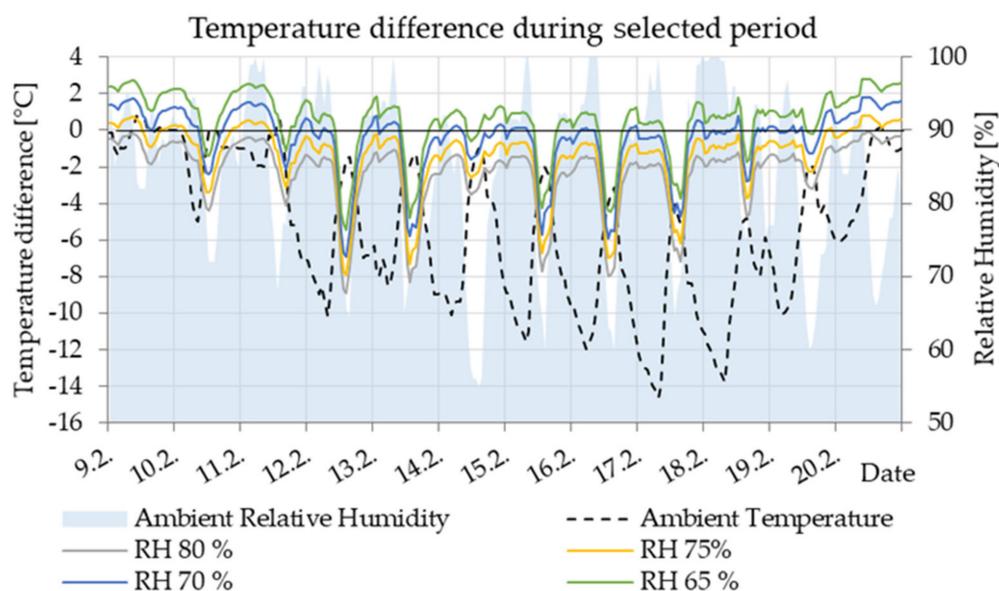
Figure 15. Detail of potential for condensation in Z1 cavity at a different considered relative humidity of air in a very cold period.

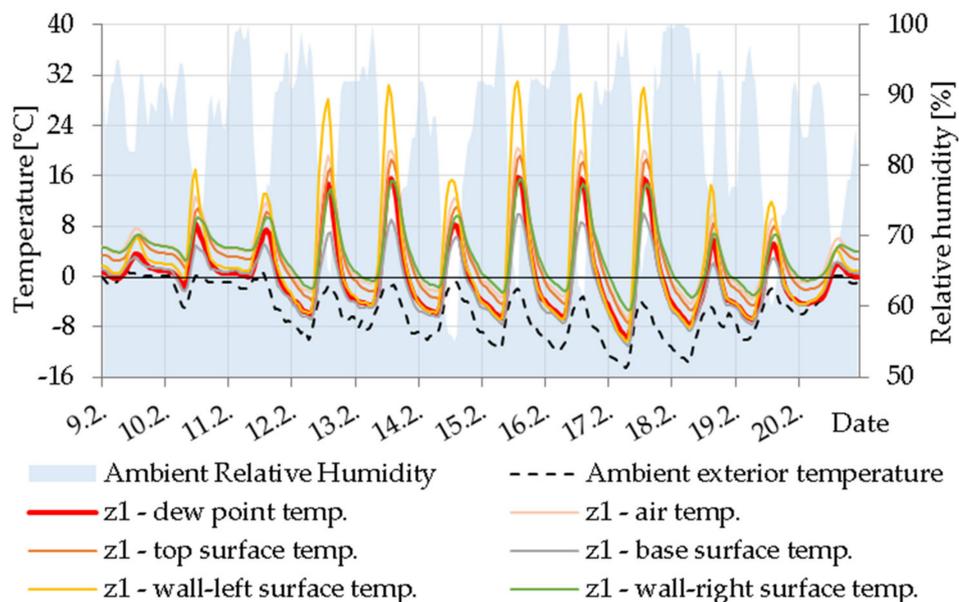
Figure 16. Temperature courses in cavity Z1.

Figure 16 shows a significant difference in surface temperature and dew point temperature practically throughout the day. The air in cavity Z1 heats up quickly from the dazzled side of the beam (wall 1), but the lower part and the inner part of the beam remains cool. The bottom wall (in this case, it is a concrete cover layer) is slightly colder than in reality due to the lack of connection to the wall heated by convection in the simulation.

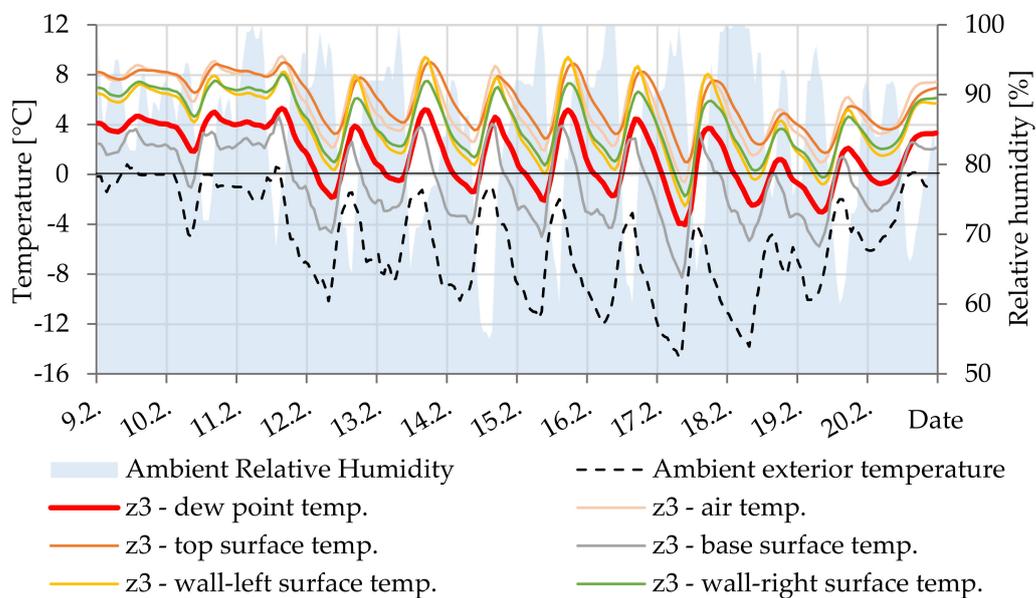
Figure 17. Temperature courses in cavity Z3.

In Figure 17, the difference between the surface temperature and the dew point temperature documents the condensation of water vapor on the lower surface of cavity Z3. By simulation, this surface temperature is always a few degrees lower than the air temperature. At 75% relative humidity in the cavity, this is sufficient to cause condensation.

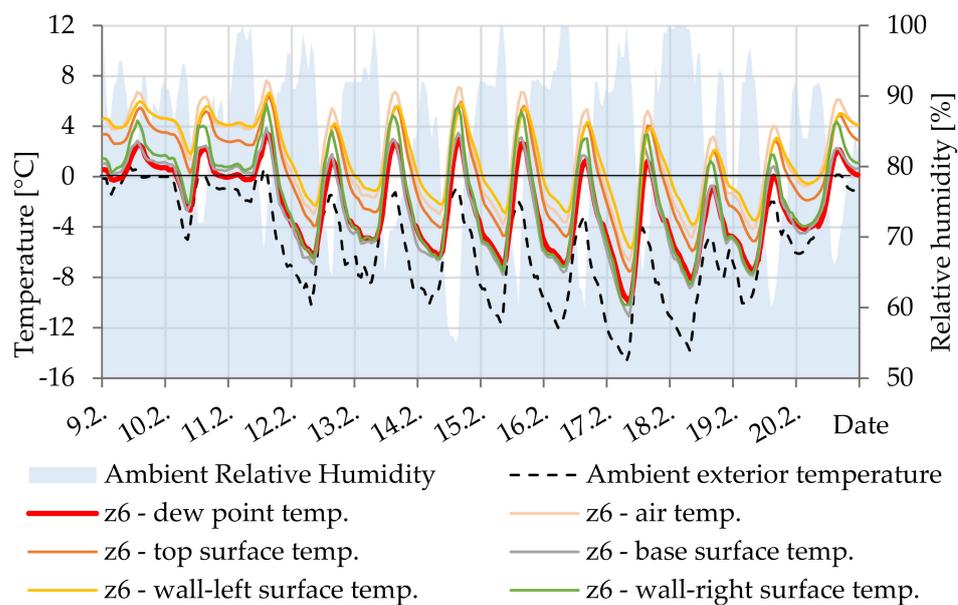
Figure 18. Temperature courses in cavity Z6.

In Figure 18, is shown the difference between the surface temperature and the dew point temperature documenting the possible occurrence of minimal condensation of water vapor on the lower surface of the cavity Z6.

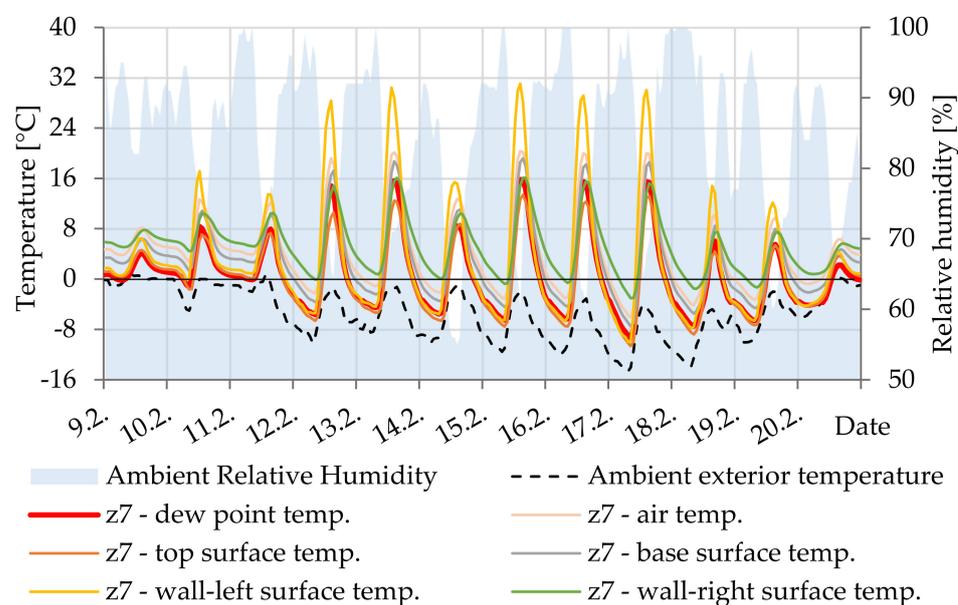
Figure 19. Temperature courses in cavity Z7.

In Figure 19, the difference between the surface temperature and the dew point temperature documents the possible occurrence of minimal condensation of water vapor on the lower surface of the cavity Z7. Inside the beam (surface Z7-base and Z7-wall-right) the temperature is more stable than at the edges (surface Z7-top and Z7-wall-left—“concrete cover”), which are more cooled and heated during the day by the outside environment.

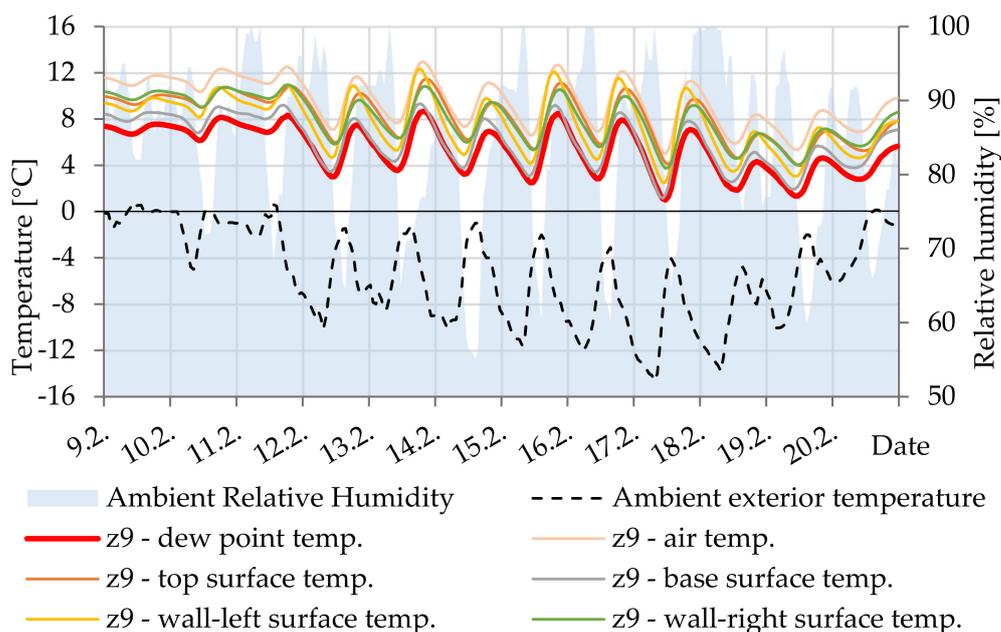
Figure 20. Temperature courses in cavity Z9.

In Figure 20, it is evident that the surface temperature is always higher than the dew point temperature. Due to its storage capacity, the core of the beam maintains at a relatively stable temperature, compared to the outer parts.

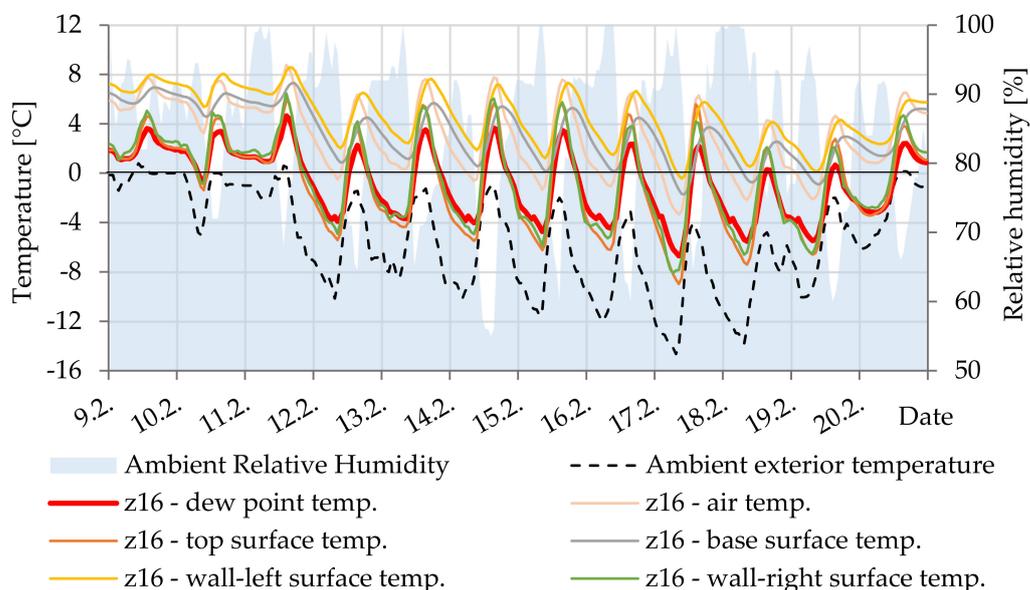
Figure 21. Temperature courses in cavity Z16.

In Figure 21, it is evident that the surface temperature is always higher than the dew point temperature. Due to its storage capacity, the core of the beam maintains at a relatively stable temperature compared to the outer parts.

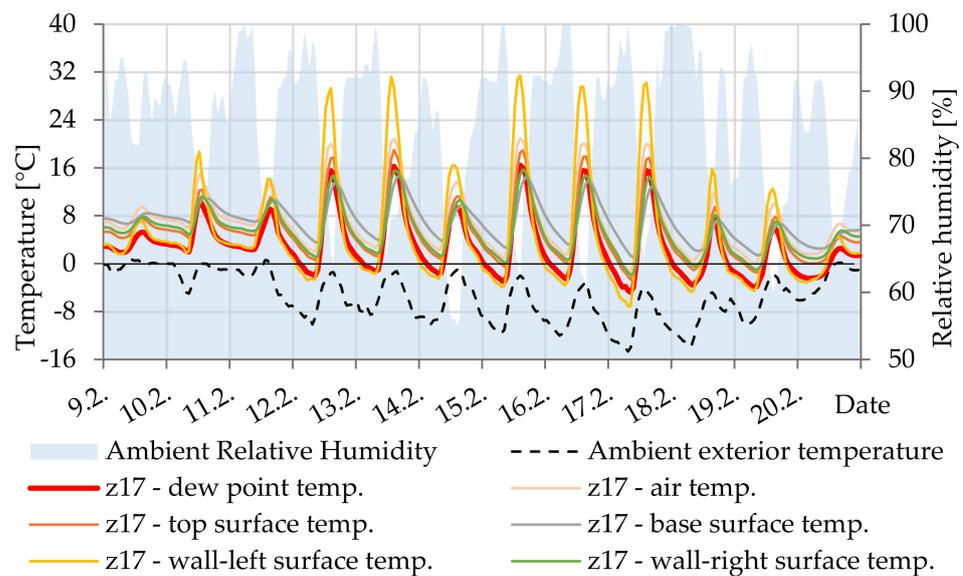
Figure 22. Temperature courses in cavity Z17.

Figure 22 shows that the surface temperature is slightly lower than the dew point temperature. In this case, if condensation also occurs on the concrete surface, it will absorb it. The small amount of condensation does not pose a high risk of corrosion to the steel reinforcement in the cavity.

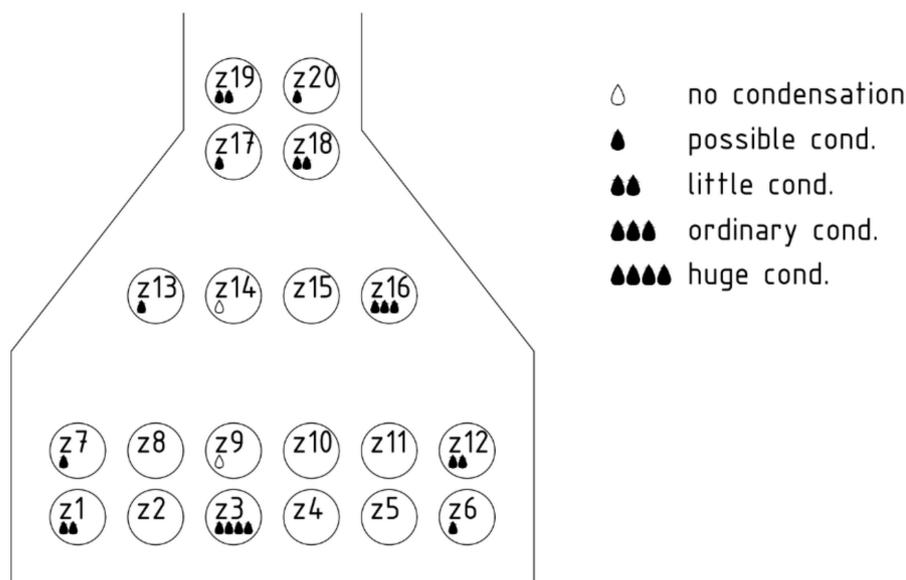
Figure 23. Map of condensation risk from simulation results in selected cavities.
