Degradation Analyses of Systemic Large-Panel Buildings Using Comparative Testing during Demolition

Keywords: large-panel; degradation; NDT; destructive testing; demolition

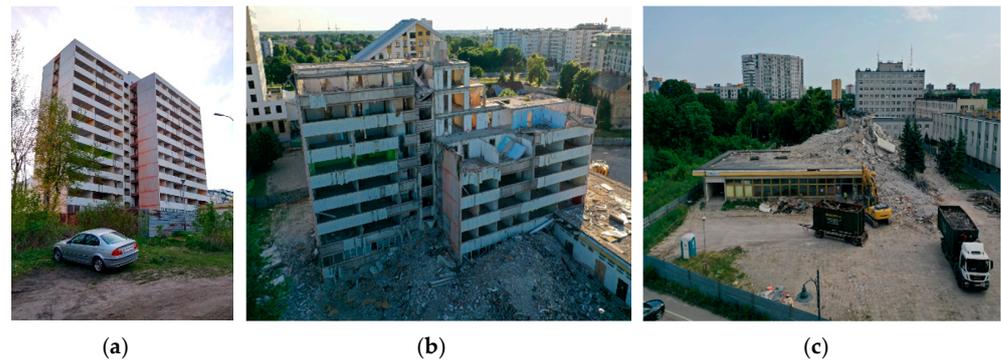
The authors of the present study participated in the demolition of a 12-storey building (Figure 1), where they performed a number of visual, destructive, and non-destructive tests. The obtained results and formulated conclusions may contribute to the improvement of large-panel buildings technical condition assessment. Particularly valuable is the comparison of the results of visual and non-destructive tests with the results of destructive tests, which allows calibration of assessments.

Figure 1. View on the analysed building: (a) before demolition; (b) after demolition of top storeys; and (c) in the last stage of demolition.

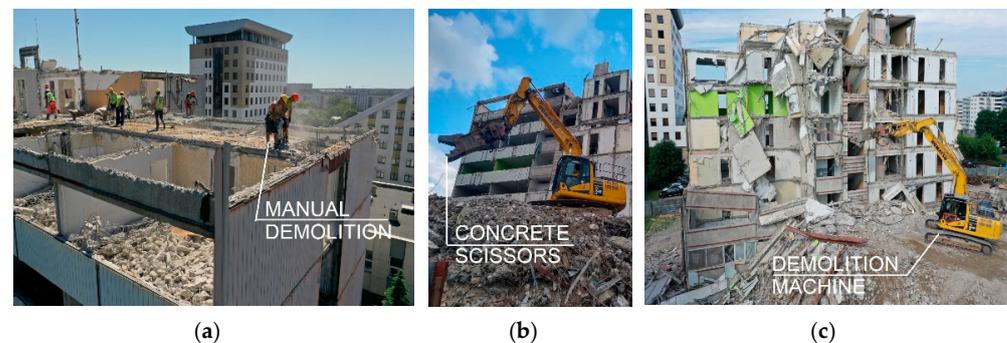
Due to the building's location in the city centre and its proximity to the adjacent building, it was decided to demolish in a way that minimized the inconvenience to neighbouring buildings and their occupants. The use of explosives is characterized by considerable dust, vibration effects on the surroundings, enormous noise, as well as specific requirements regarding the size of the construction site and type of structure. Ultimately, mechanical demolition using demolition excavators (Figure 2b,c) and light equipment in the form of drill hammers and steel circular saws operated by skilled manual workers (Figure 2a) was decided upon. Working in this manner allowed the authors to monitor the ongoing progress of the work and enabled the collection of samples for laboratory analysis and assessment of structural degradation from each stage of demolition.

Figure 2. Demolition of the building: (a) manual demolition; and (b,c) mechanical demolition.

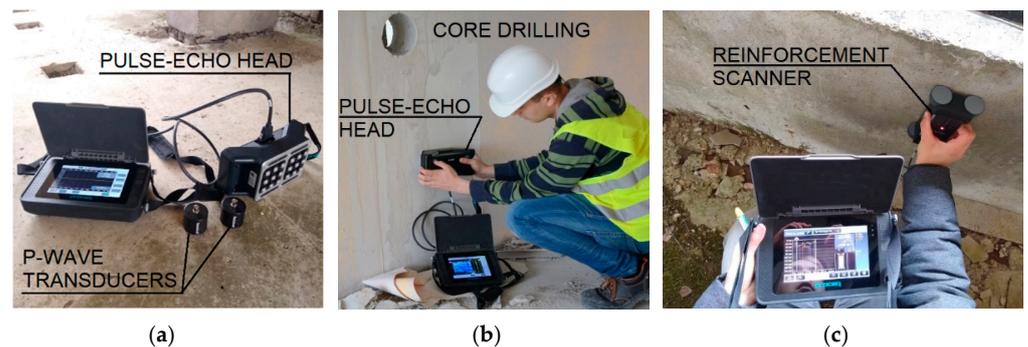
For non-destructive testing, the authors used specialized testing equipment in the form of ultrasound (Figure 3a,b) and ferromagnetic (Figure 3c) methods.

Figure 3. NDT tests: (a) ultrasound testing equipment; (b) vertical joint scan; and (c) ferromagnetic testing.

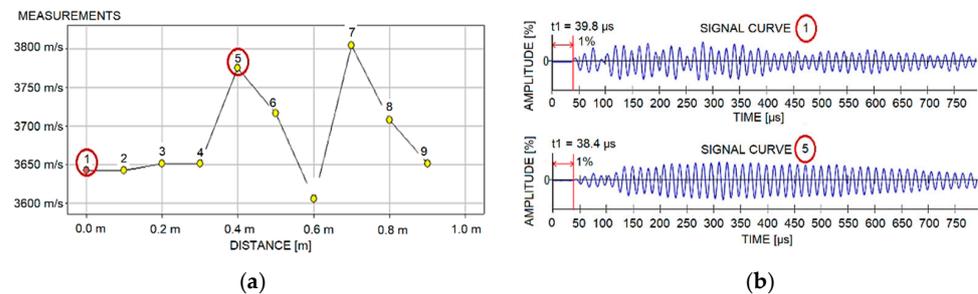
In the first stage, linear scans of longitudinal and transverse walls were made using ultrasound equipment with 54 kHz heads. Two-way access to the elements was used, thanks to doorways and openings created after excavations and core drilling. Five walls on each of floors –1, 3, 5, and 10 were examined. The diameter of the longitudinal wave transducer was 5 cm. The measurement points were marked with wax chalk at 10–15 cm intervals. Considering the dimensions of the transducers, in reality, the spacing between the edges of the heads was between 5 to 10 cm. A measurement grid with this spacing allows the surface under examination to be scanned accurately. Defects that could hide between the measuring points are negligibly small and would not affect the load-bearing capacity of the component. A total of 5 to 10 readings were taken on each wall. The number of readings was due to difficult access and the limited length of the cables feeding the transducers (testing with two-way access was only possible in walls with openings). Wave propagation velocities for all readings taken ranged from 3500 to 4000 m/s. According

to the classification presented in [66], this indicates good concrete quality. The results obtained during the testing of the 5-storey transverse wall, along with two graphs of wave propagation in concrete are presented in Figure 4.

Figure 4. Ultrasound tests: (a) P-wave measurement graph at 10 points; and (b) P-wave propagation graph at points 1 and 5.

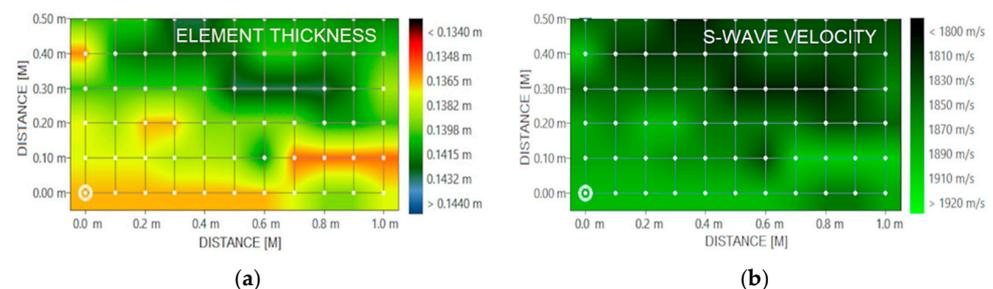
The next stage was surface scans of walls and floors using a Pulse-Echo head. The thickness of the elements and the location of any voids and material discontinuities, as well as the propagation velocities of the shear waves, were analysed. The measurement grid ranged from 50×50 to 50×100 cm, with intervals of 10 cm. The thicknesses of the elements were within the execution deviations, i.e., ± 0.5 cm. No areas indicating the presence of material discontinuities were located on the obtained images. The transverse wave velocity was within the range of 1800–2000 m/s, while the average wave velocity for concrete is usually 2000 m/s [67]. Images of post-surface scans for one of the 3rd floor walls are presented in Figure 5.

Figure 5. Area scans: (a) element thickness; and (b) S-wave velocity.

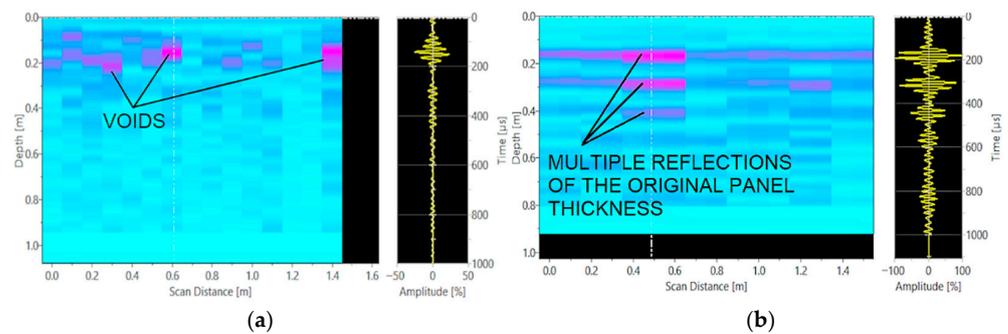
The next stage was to perform B-scans of vertical joints and walls using the Pulse-Echo head. B-scan generates an image of the cross-section of the tested element, perpendicular to the scanning surface. The defects and discontinuities in the presented results are colour-coded from pink to purple. Heterogeneities in the concrete affect the propagation of the ultrasound pulse. They cause scattering of the signal coming from the Pulse-Echo head. The device measures the transit time of the wave and its amplitude. The colour in the image becomes darker as the amplitude of the wave increases. The local maximum of the amplitude results from the reflection of the wave at the boundary between the concrete

and the air filling the structural defect. In the case of the darkest colour (purple), the wave amplitude was the highest. This indicates that the wave encountered significant material heterogeneity in the form of voids or delaminations. B-scans performed revealed the presence of voids and delaminations in the fillings (Figure 6a), which were caused by incorrect placement and compaction of the concrete mix during construction of the elements. In the walls, no irregularities indicating poor concrete structure were detected (Figure 6b).

Figure 6. B-scans: (a) vertical wall joint; and (b) walls.

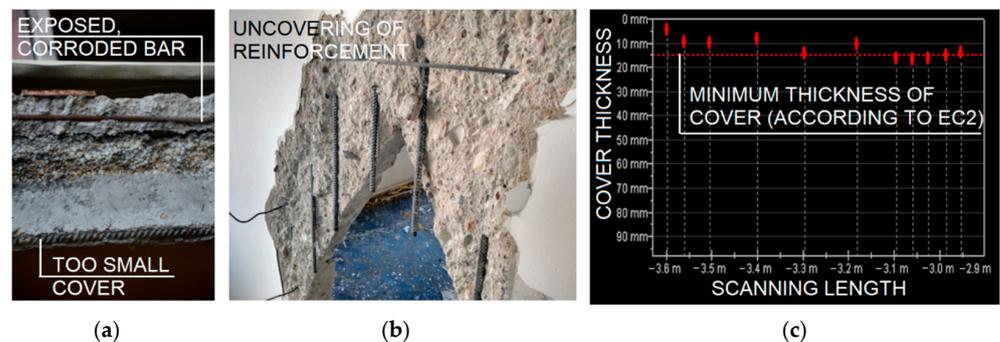
In order to identify the quality of the reinforcement work, line scans (Figure 7c) and area scans were performed using ferromagnetic testing equipment. Line scanning allows to check the quality of the reinforcement work along one line. This measurement mode can be used for scanning beam elements or columns, while area scans should be used for surface elements such as walls and slabs. Measurement is performed on the basis of a defined measurement grid. Area scanning makes it possible to quickly determine the distribution of the reinforcement and the thickness of the coverings over large areas, where the distribution of rebars can be highly variable. Excavations were made at the non-destructive test locations to compare the results.

Figure 7. Determining the quality of reinforcement work: (a) corroded rebar and lack of cover; (b) uncovering of reinforcement; and (c) ferromagnetic scan—distribution of reinforcement and thickness of cover.

The results of the scans indicated insufficient cover thickness locally. The reinforcement distribution was consistent with the available original documentation.

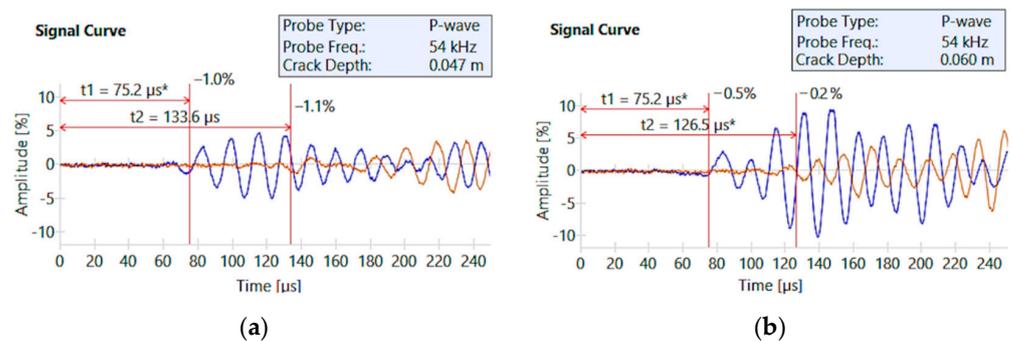
Locally, scratches were observed in the walls above the door openings. The cracks were measured with a Brinell magnifying glass and ranged from 0.3 to 1.1 mm. An ultrasound method was used to identify the depth of the cracks. The longitudinal wave transducers were placed on both sides of the crack. First, each transducer was placed at a distance of $a = 100$ mm from the crack, after which the ultrasound wave transit time was measured.

The transducers were then moved apart to a distance of $2a = 200$ mm and a second reading was taken. Based on the difference in transit times obtained from the two readings, the crack penetration depth was estimated. Debris was removed from the crack using an industrial vacuum cleaner. Cleaning is very important in penetration measurements using the ultrasound method, because wave propagation through the contamination can significantly under-estimate the readings relative to the actual condition. The depth of penetration was determined to be between 20 and 65 mm. An example of crack depth for a longitudinal wall and a transverse wall is shown in Figure 8.

Figure 8. Ultrasound measurement of the crack depth: (a) crack in the longitudinal wall; and (b) crack in the transverse wall.

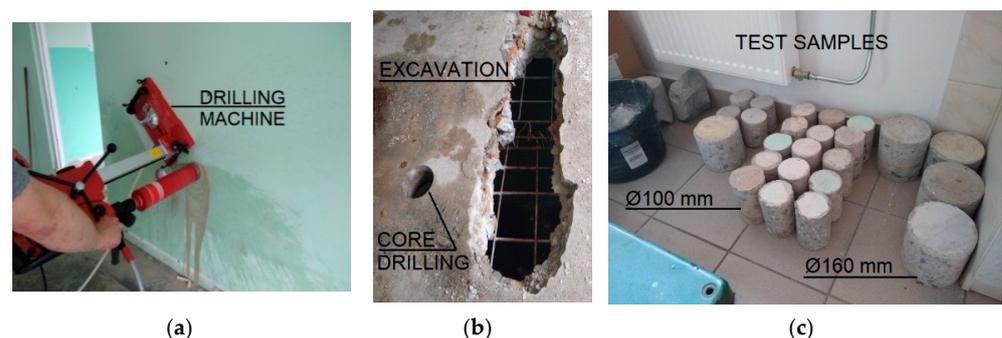
The accuracy of the non-destructive testing results was continuously verified by performing a large number of wall (Figure 7b), beam-wall and floor (Figure 9b) excavations. The building was scheduled for demolition, so the only limitation of the testing was to maintain structural integrity. The rebar exposed in the excavations showed no signs of corrosion. The concrete in the precast elements was of good quality and had no high porosity. Attention was paid to the large dimensions of the aggregate used to make the elements, exceeding as much as 40 mm in places. The thickness of the floor screeds ranged from 35 to 50 mm. Numerous explorations have not revealed excessive thickness values of surface layers added during renovations, which could lead to excessive slab deflection and stippling of the partitions [69].

Figure 9. Drilled cores and excavations: (a) core-drilling machine; (b) view of excavations and drill core in floor slab; and (c) samples in the laboratory.

In order to perform laboratory tests, core drillings were made in different parts of the structure (Figure 9a). The locations and diameters of the drill holes were selected in accordance with EN 13,791 [70]. In the beam-wall elements, the thickness of individual layers was measured in situ. The thickness of the insulation was found to be 5 cm, while the texture layer was characterized by different thickness values, ranging from 3.5 to 7.5 cm, which is inconsistent with the design specification. The differences were not visible from the outside because of the facade made of folded sheet metal attached to the beam-walls with steel strips.

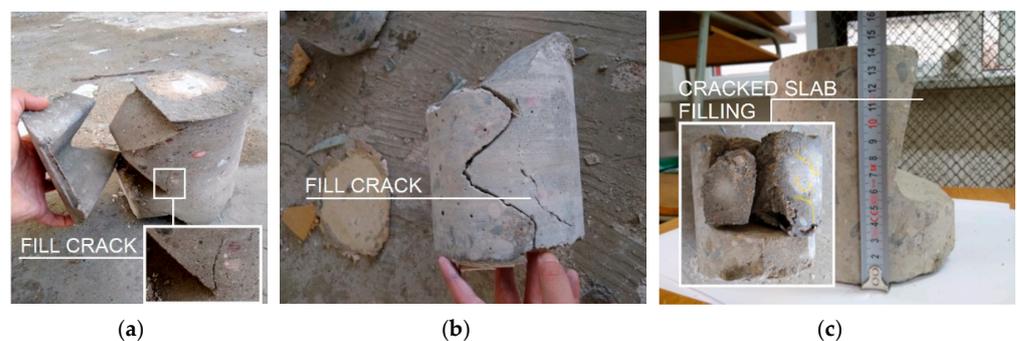
Drill holes were also made at the joints of the floor slabs (Figure 11c) and walls (Figure 11a,b). The quality of the floor slab and wall joints was unsatisfactory. The concrete mix was not carefully placed, and numerous cracks were found inside the concrete structure and in the contact areas of the infill with the wall dowels (Figure 11a,b). The crack opening widths of the samples were measured using Brinell magnifier. The fillings were internal elements (exposure class XC1), for which, according to EC2 [68], the crack opening width is $w_{k,max} = 0.4$ mm. Cracks exceeding the opening width of 0.4 mm have been classified as not fulfilling standard recommendations.

Figure 11. Joints core drilling: (a,b) core drilling of fill with visible cracks; and (c) floor slab joint.

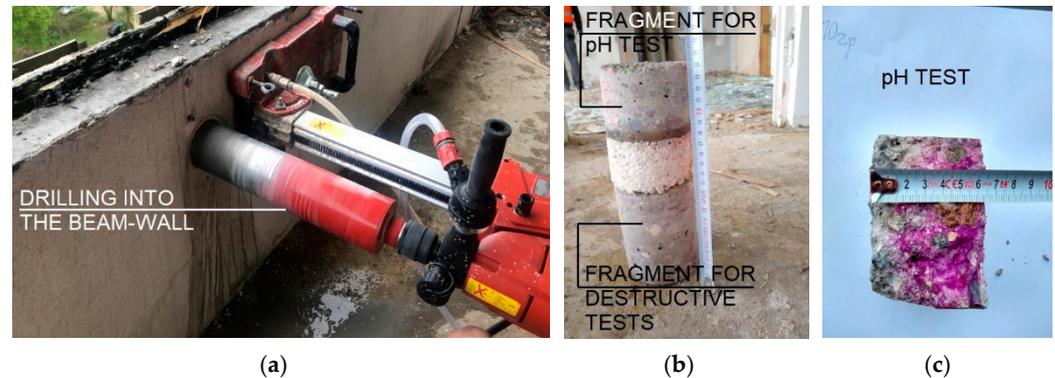
Samples taken from the floor slabs revealed missing rebar cover, which was only 3 mm in places. The pH tests of the concrete were also carried out (Figure 12). The roof slabs were characterized by advanced carbonation. The surface of the concrete was not discoloured throughout the cross-section. The effects and characteristics of carbonation as well as theoretical models to predict its depth have been described in the literature [71,72].

Figure 12. Beam-wall tests: (a) core drilling; (b) sample for testing; and (c) pH test.

Phenolphthalein solution was used for preliminary pH testing. The test is carried out by spraying the substance on a fresh break of the concrete sample. At pH values higher than approximately 9, the indicator turns the concrete red-violet. Only such coloured concrete shows alkalinity sufficient to ensure passivity of reinforcement steel. Testing was conducted in accordance with EN 14,630 [73]. In the tests conducted for the textured layers of all storeys, the obtained results indicated that the layers had corroded concrete that ranged from 15 to 30 mm. In the interior walls and the structural layer of the beam-walls, the depth of carbonation ranged from 13 to 37 mm. Such deep corrosion of concrete in the interior elements is probably due to the non-usage of the building and lack of heating for over 10 years, as well as damages and defects in the window and door joinery, which affected the intensity of the aggressive environmental impact.

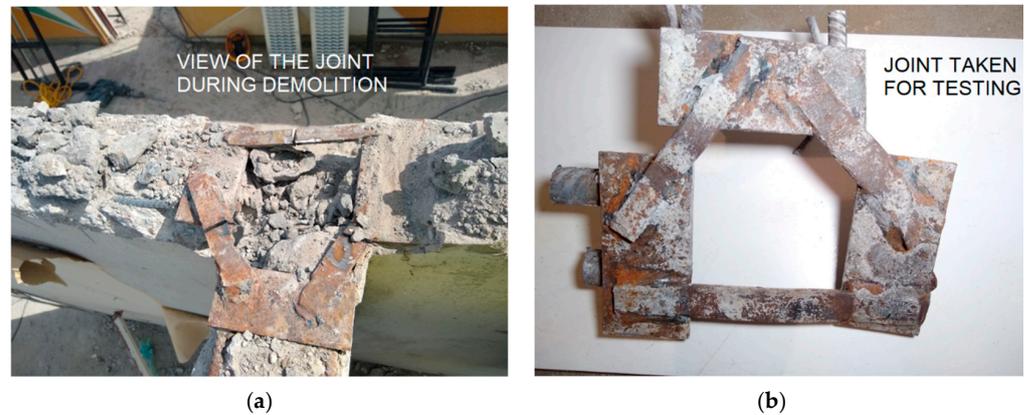
Figure 13. Steel joint 3 internal walls: (a) in the process of demolition; and (b) sample taken for testing.

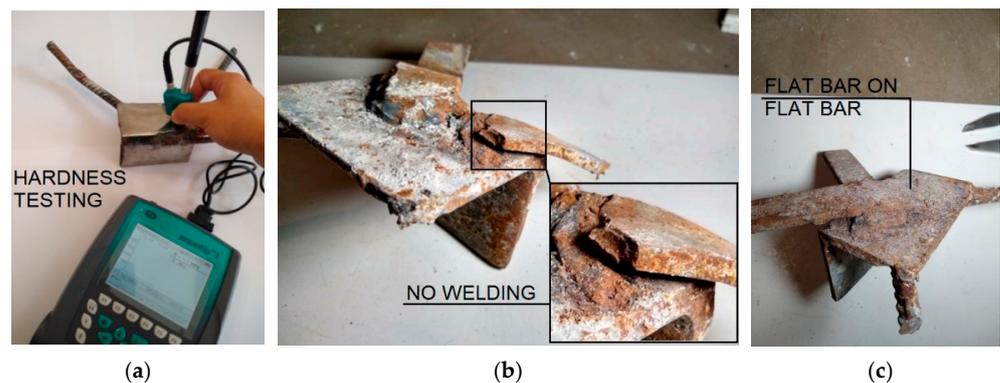
Examination of several dozen specimens collected showed localized missing welds (Figure 14b), both between the tie beam and the steel plate and between the plate and the flat bars. Many of the joints had significant geometric deviations—the plates were bent on site to allow them to be installed on irregularly positioned precast wall elements. Moreover, flat bars were found to be too short and point-welded, contrary to the design's intent. In isolated cases, flat bars were overlapped welded to another flat bar instead of to a plate embedded in the wall (Figure 14c). All plates were covered with only a superficial layer of corrosion, and it is likely that they were installed in this state when the building was constructed. The thickness of the plates, determined mechanically with a micrometer screw and by ultrasound method after cleaning from corrosion products, was in accordance with

the catalog of system joints and was 6 mm. Using the ultrasound hardness tester and the correlation between steel hardness and strength, an average tensile strength of 402 MPa was estimated (Figure 14a). The steel parameters were confirmed by tensile testing in a testing machine.

Figure 14. Connection sheets: (a) hardness testing of steel; (b) missing weld; and (c) incorrectly made joint.
