# Experimental Studies and Numerical Simulations of FRP Poles Failure in the Area of Inspection Hole

Filip Broniewicz \*, Tadeusz Chyży

**Citation:** Broniewicz, F.; Chyży, T.; Czech, K.R. Experimental Studies and Numerical Simulations of FRP Poles Failure in the Area of Inspection Hole. *Materials* **2023**, *16*, 2238. <https://doi.org/10.3390/ma16062238>

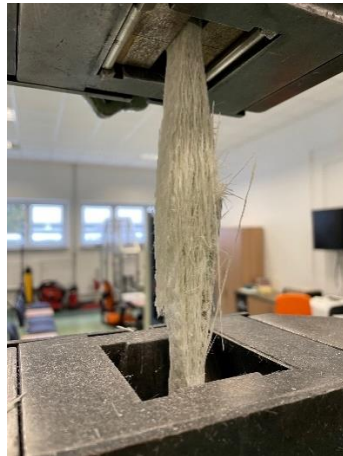
**Figure 1.** The specimen after failure—tensile test.

A BPS-HP004 machine manufactured by ZwickRoell in Ulm, Germany was used for the tensile tests. The tests were conducted with forces up to 100 kN (Figure 1). Table 1 shows the mean values and standard deviations for the static tensile test results. Utilizing linear regression of the experimental strength–strain curves corresponding to elongations between 0.05 and 0.25, it was possible to determine the estimated Young's tensile modulus.

All tested GFRP samples all failed in the same way, i.e., with fiber breakage, at maximum stress in the tensile test. Due to the surface detachment of the fibers and matrix, the failure manifested as an abrupt longitudinal delamination of the laminate in the center. As can be seen in Figure 1, the outcome was that the broken fibers formed a divergent and fan-like shape. The results for  $E_1$  and  $E_2$  were comparable, which allowed drawing the conclusion that the material was transversely isotropic. This type of material is standard in the production of composite elements that do not require an extensive design process and differentiation of material properties depending on the direction. Therefore, it was assumed in subsequent calculations that  $E_1 = E_2$ ; only  $E_1$  is displayed in Table 1.

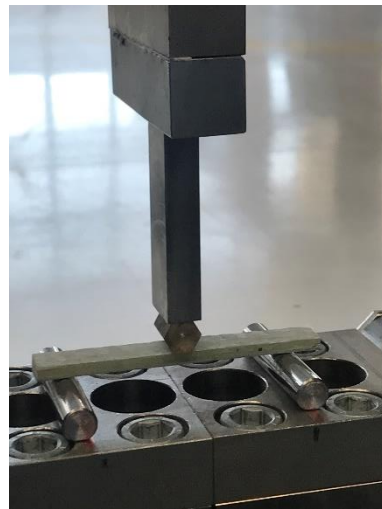
**Figure 2.** The specimen during bending flexural test.

A three-point bending flexural test (Figure 2) was used to evaluate the laminate's bending characteristics. The tests were conducted in compliance with the EN ISO 14125 [27] standard's requirements. Five samples were cut out from each of the experimentally tested columns. The samples were cut out with their axes parallel to the element of a column shaft's cone and were processed in accordance with class II specimen dimensions according to [27]. The outer coating layer was sanded down, as in the tensile test.

The samples were supported with rolling supports. Then, the bending behavior of the GFRP material was examined by applying a bending force to standard specimens at a constant speed until fracture. The obtained results made it possible to calculate the bending strength  $\sigma_{fM}$  and the bending stress at break  $\sigma_{fB}$ . All of the specimens responded elastically under loading until they failed. The characteristic values of the flexural strength  $\sigma_{fM}$  and flexural stress at break  $\sigma_{fB}$  are presented in Table 2.

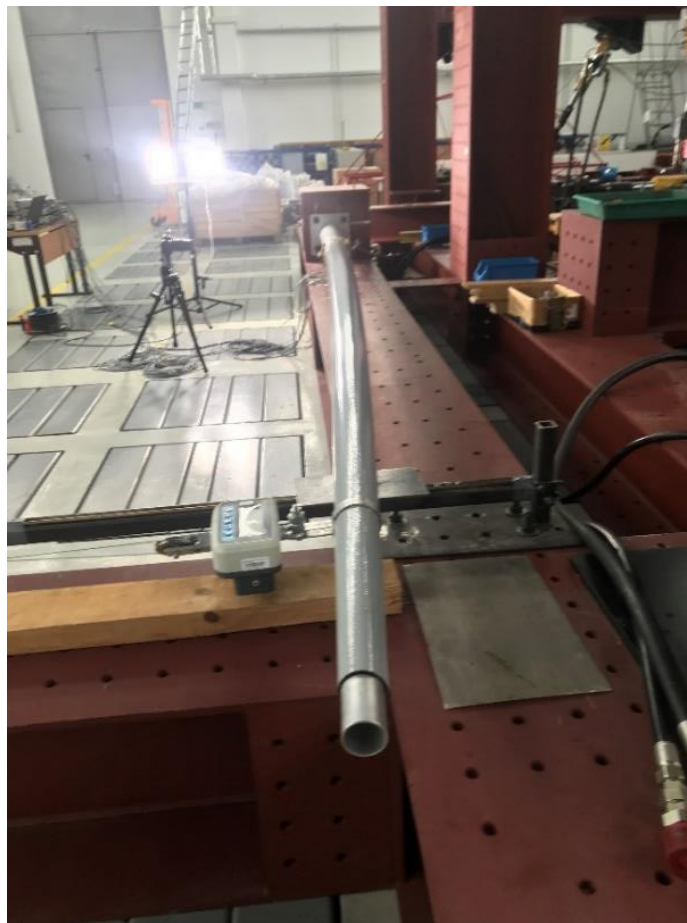
**Figure 5.** View of pole no. 5/2 mounted on the test stand.

The load was applied pointwise to the top of the column in a transverse direction relative to the test stand (Figure 5). The load on the column was gradually increased every 10 N until failure (measurements were preceded each time by a preload of approximately 100 N and a release cycle). During loading, strains and horizontal deflection of the column were measured. The moment of column failure was characterized by a sudden decrease in the load value and a large increase in horizontal deflection. In addition, macroscopic damage to the laminate layers could be observed.
