Article

sUAS for 3D Tree Surveying: Comparative Experiments on a Closed-Canopy Earthen Dam

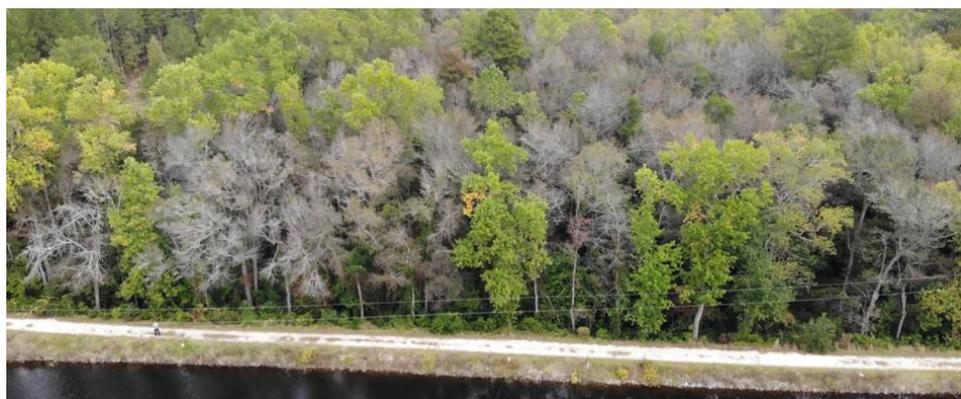
Figure 1. An oblique view of Sweet Bay Pond Dam in Lexington County, SC. This fall-season photo was taken with a Mavic Pro on 25 October 2019.

The dam crest is 180 meters long from the northwest entrance to the spillway at the southwest side. A large number of trees of different sizes grow on its downstream slope. Root cavities, especially from older trees, may cause erosion of soil mass and impact the dam's stability. The most common tree species is black gum (*Nyssa sylvatica*), which is senescent and leaf-off in Figure 1. Other common trees include tulip poplar (*Liriodendron tulipifera*) and loblolly pine (*Pinus taeda*), which remain green. Other tree species are limited.

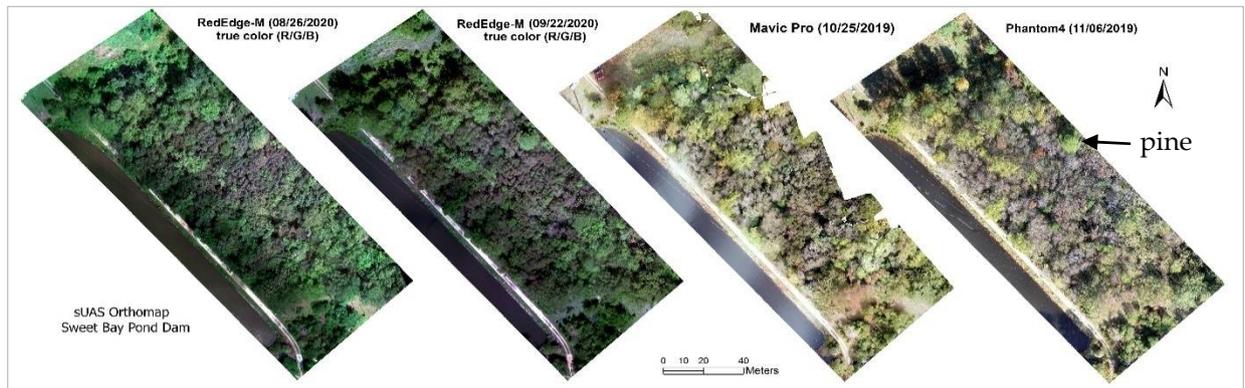
Figure 2. The orthoimages extracted from four flights (RE0826, RE0822, MP1025, and P41106).

The orthoimages clearly depict the overgrowth of trees that grow into a closed canopy at the study site. Individual tree crowns, especially those of tall trees, are still discernable. The images visually reveal different spectral and radiometric characteristics of their sensors. The RedEdge-M images are recorded in 16-bit, while the Mavic Pro and Phantom 4 Pro images are in 8-bit. In a true color view, the RedEdge-M images show a greener tone than those of Mavic Pro and Phantom4 Pro.

The four-stage orthoimage trajectory also reflects the phenological differences of tree species. For example, black gum has shiny, dark green leaves, and is sensitive to drought stress during the hot summers of SC. It starts to show early fall color in a dark brownish tone in August, which becomes more distinguishable in September. Its leaves are senescent and drop off in October–November. Tulip poplar remains green in summer (August–September), then shows its fall color in a yellowish green tone (October–November). Loblolly pine—for example, the one marked in Figure 2—has a large circular crown and remains evergreen, although it has a lighter tone in the Phantom4 Pro image. These phenological variations help to delineate tree crowns in data analysis.

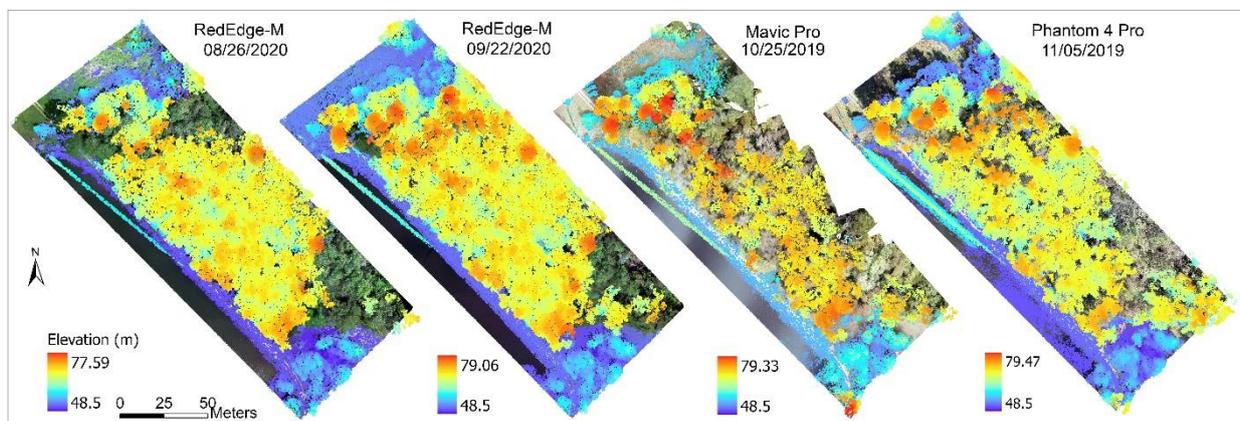
Figure 3. The height-colored point clouds extracted from four flights (RE0826, RE0822, MP1025, and P41106).

Trees grow on the downslope of the dam. The lowest elevation is in deep woodland at 48.4 m ASL. In the sUAS point clouds (Figure 3), all points below this threshold were counted as low noises, and were removed. The tallest point of canopy height is around 79 m ASL. The dam crest and open areas have low elevation with a dark blue tone in the point clouds. Shrubs and short trees surrounding the woodland have higher elevation in a lighter blue tone. The point clouds of the woodland are visually continuous due to their extremely high density, with cm-level spacing between points. Nevertheless, tall trees clearly stand out in a reddish tone and circular shapes. Interestingly, the electric power line above the water is clearly detected by all sUAS point clouds.

Among the four flights, the MP1025 mission did not perform well. Data loss in its point cloud was more dramatic, leaving multiple large gaps within the woodland (Figure 3). The other three missions performed better, although data loss persistently remained, especially the large gap at the southeast end of the mission area. Overall, the RE0922 seems superior, with the largest coverage of its point cloud in the mission area. Given its poor performance in terms of both the calibration (noted earlier), orthoimage and point cloud, the MP1025 was not further examined in this study.

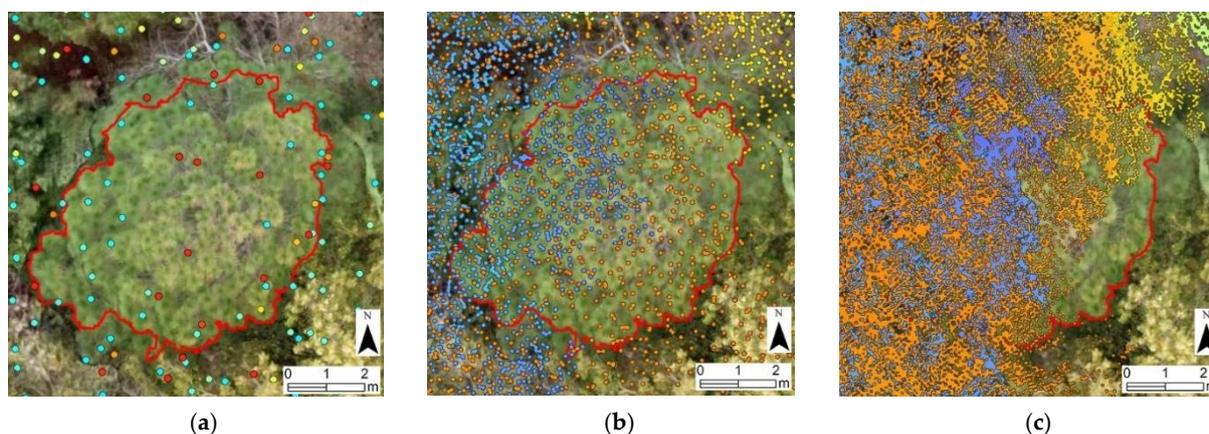
Figure 4. The 3D points of a pine tree extracted from LiDAR (a), RE0922 (b), and P41106 (c).

Within the same flight area polygon (1.606 ha), the USGS LiDAR point cloud has a density of 2.41 points/m². Note that the LiDAR cloud may contain multiple returns at a point and, therefore, its horizontal density is even lower. sUAS point clouds only contain one point at each x-y location. The P41106 point cloud has the highest density of 451.06 points/m², providing the most detail about tree canopies at the study site. At a flight height of 90 m AGL, the RE0922 point cloud reaches a density of 52.26 points/m², slightly lower than RE0826 (59.44 points/m²) at 60 m AGL. Figure 4 demonstrates the improved coverage of sUAS mass points on an example pine tree. Within the tree crown outlined in the figure, only 32 LiDAR points are collected in comparison with hundreds of RE0922 points. These dense sUAS points effectively reveal the tree's structural details.

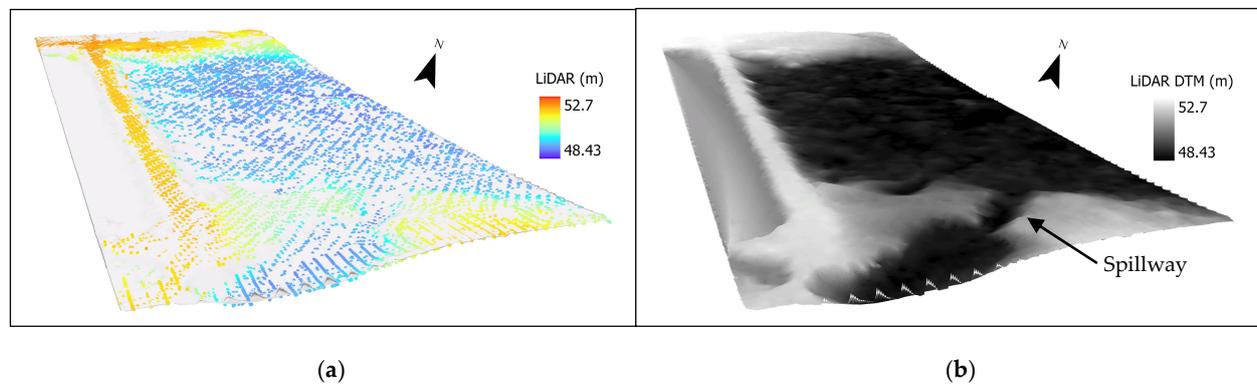
Figure 5. Bare-earth returns from the LiDAR point cloud (a) and the extracted DTM of the study site (b).

LiDAR bare-earth points have a much lower spatial density than the sUAS point cloud, but the sUAS points are generally of the overlying vegetation, and few represent the ground. The density of LiDAR ground points under the tree canopy of the woodland (Figure 5a) was quite adequate for representing the sloped earthen dam. In the created DTM (Figure 5b), the dam crest has a relatively higher elevation than its slope on both sides. The spillway is an important dam structure, which is clear at the south end of the study site (marked in the figure). The dam crest is relatively flat, at an average elevation of around 52 m ASL. The lowest elevation in the deep woodland is 48.4 m, resulting in a maximum drop of 3.6 m from dam crest to downslope.

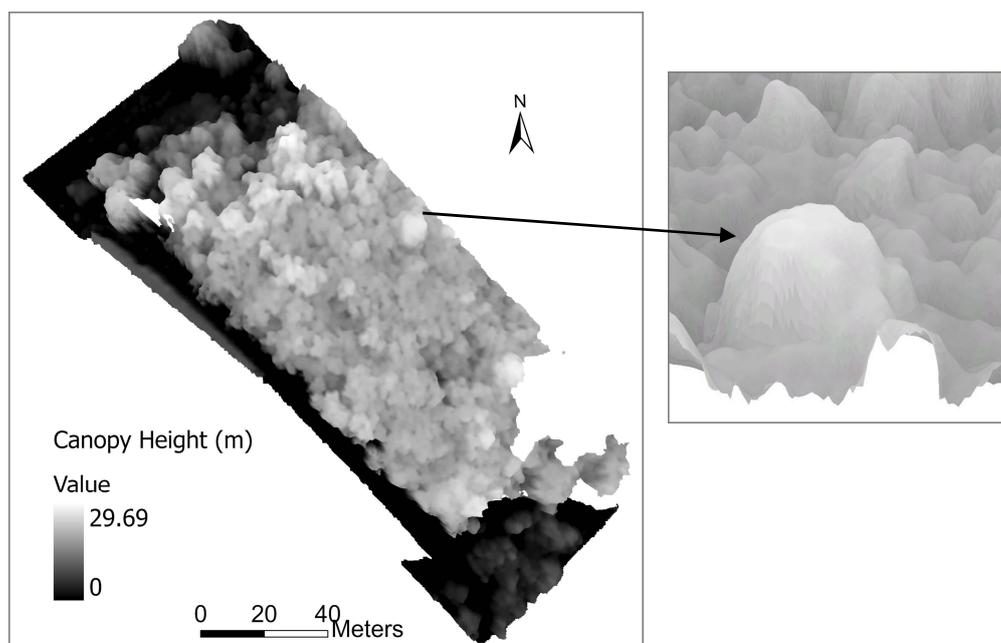
Figure 6. The CHM from the RE0922 mission. The inset shows a 3D view of the example pine tree.

With the densely distributed sUAS point cloud, the extracted DSM of each mission reveals a high level of detail of the 3D tree canopies. Note that all raster layers, including DTM, DSM, and CHM, are at a 20 cm cell size. Figure 6 demonstrates the CHM layer from the RE0922 mission. Similar to the point cloud figure (Figure 3) above, the southwest end of the mission suffers from image calibration errors, and therefore, results in a large data gap. A smaller gap is also observed at the dam entrance in the northwest. The tallest point of the canopy is 29.69 m. The inset of Figure 6 is the example pine tree (marked in Figure 2) with a 3D profile viewed from east to west (high oblique). The tree has an apparent distinguishable circular crown in the CHM. Clumps of shorter trees nearby are also detectable but grow together with a close canopy, reflecting a typical pattern of closed-

canopy overgrowth. The sUAS point cloud only records the topmost points of the tree canopy layer. As opposed to LiDAR returns, ground points from the optical imagery under the canopy are not available. Therefore, the sUAS-extracted CHM is a thin, hollow 3D surface atop the tree canopy.

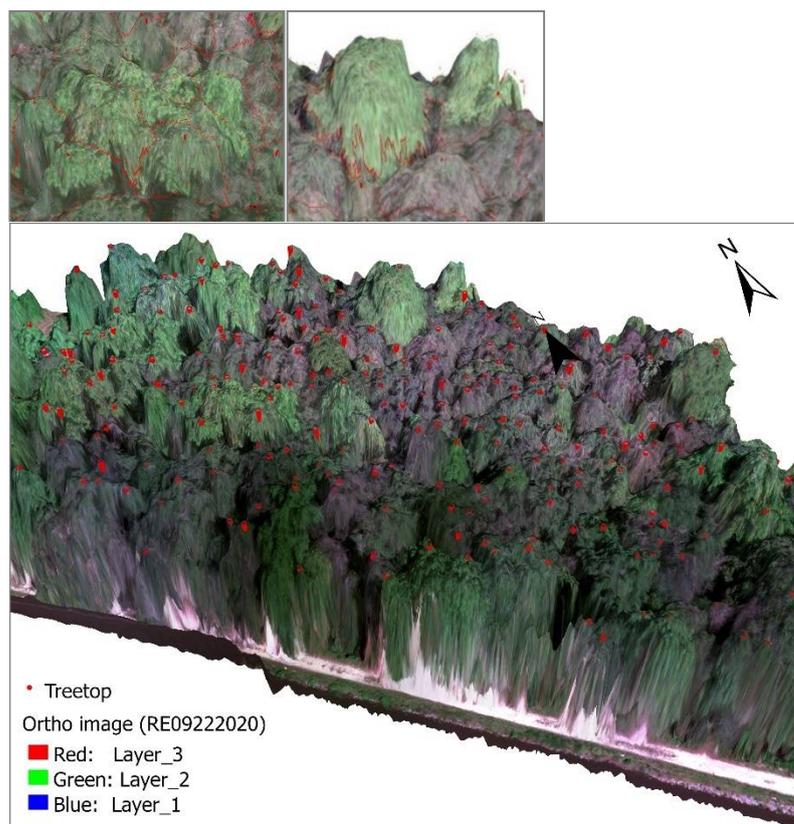
Figure 7. A 3D view of the RE0922 orthoimage embedded with treetops marked as red columns. Two insets show the 3D views of a pine tree and a tulip poplar cluster, respectively.

The sUAS point cloud and the extracted CHM allow the delineation of treetops and crowns from the continuous canopy cover. A treetop is a point with a local maximum in the CHM that represents the topmost point of a tree. One tree is assumed to have one treetop point. A threshold of CHM > 10 m is applied to all CHM layers. Figure 7 displays the 3D view of the treetops extracted from the RE0922 mission and its true color orthoimage. The vertical information (canopy height) is overlaid on the orthoimage to achieve a 3D perspective, which makes the tree clumps more outstanding. Treetops are marked as red columns emerging atop trees. The dam crest is flat in general, but some crest pixels are affected by canopy pixels above them, and are displayed as erroneously taller, white objects.

Tree crowns are delineated from the joint marker-controlled watershed segmentation approach. One watershed segment is associated with a treetop point located in the watershed. For trees with relatively standalone crowns, crowns are extracted with regular shapes (similar lengths in major and minor axes). In areas where trees grow into close canopies, their crowns become irregularly shaped. As shown in the tulip poplar inset of Figure 7, the elongated crowns in the cluster may also indicate missing trees.

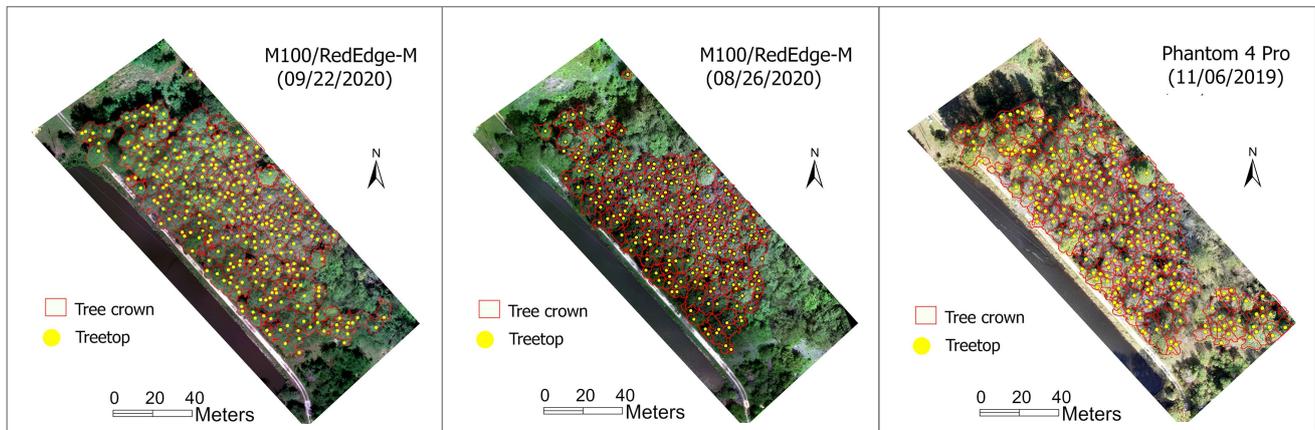
Figure 8. The extracted tree crowns and treetops from three missions (RE0922, RE0826, and P41106). One crown is associated with one treetop.

As revealed in the point clouds, all sUAS flights suffer from calibration-induced data gaps that vary according to systems and flight configurations. Treetops and crowns falling within or adjacent to these gaps could not be extracted. Figure 8 compares the treetops and crown polygons extracted from the three missions. It is clear that standalone trees—for example the example pine tree in previous figures—could be successfully extracted in all missions. However, the effectiveness in closed canopy areas varied among the three missions. Across the study site, 284 trees were identified in the RE0922 mission. The RE0826 mission produced 238 trees, suffering from higher calibration errors in the northeast and southeast areas of the study site. The P41106 mission extracted 251 trees, identifying more trees at the southeast end of the study area, where both RedEdge-M missions suffered from calibration errors. In deep woodland areas where tree canopies were closed, however, it

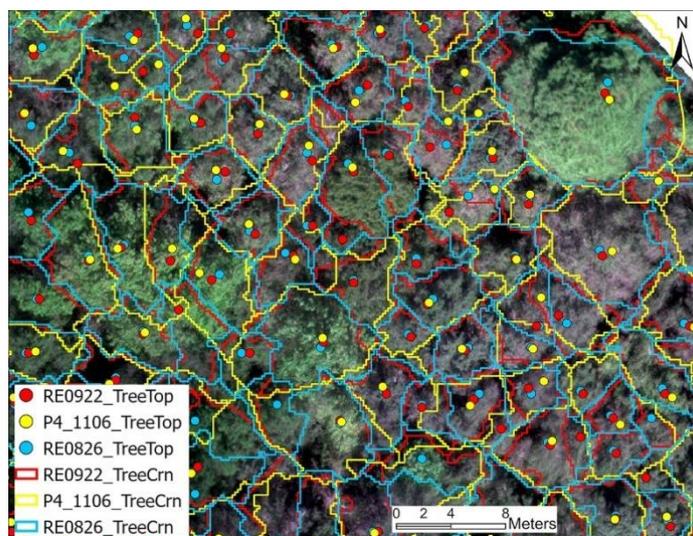
Figure 9. A subset area of the extracted tree crowns and treetops from the three missions. The background is the RE0922 orthoimage.

In a subset area of the woodland (Figure 9), most trees could be extracted from the three flights, although their treetop locations and crown boundaries were slightly shifted. The two RedEdge-M missions produced similar results in both treetop and crown delineation. In the Phantom 4 Pro mission, some trees could not be successfully identified. Thus, the tree crowns of the Phantom 4Pro mission were somewhat larger than those of the RedEdge-M missions.

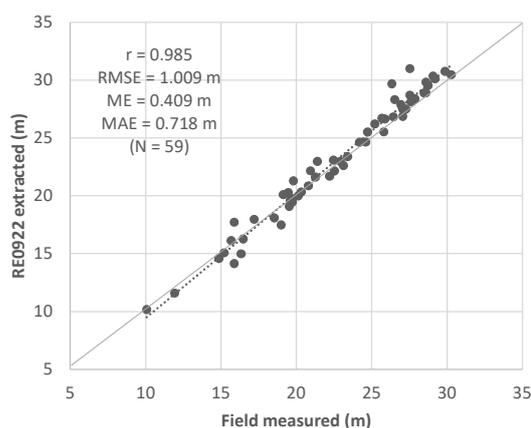
Figure 10. Scatterplot of the sUAS-extracted and field-measured tree heights (RE0922 only) at the validation site.

At the validation site, the sUAS-extracted (M100 only) tree heights were compared with field measurements using a laser rangefinder. The M100 flight was flown 7 days later than RE0922, using the same flight configuration; therefore, it can be counted as the validation of the RE0922 mission. Among the 62 trees at the site, 59 treetops were extracted. The scatterplot reveals a linear agreement between field-measured and sUAS-extracted tree heights with a RMSE of 1 m (Figure 10). The correlation line (dashed) agrees with the 1:1 line. Both the MAE and ME measurements are within 1 m.
