Article

Towards a Preservation–Sustainability Nexus: Applying LCA to Reduce the Environmental Footprint of Modern Built Heritage

Keywords: modern built heritage; preservation; sustainability; life cycle analysis; Athens; social housing

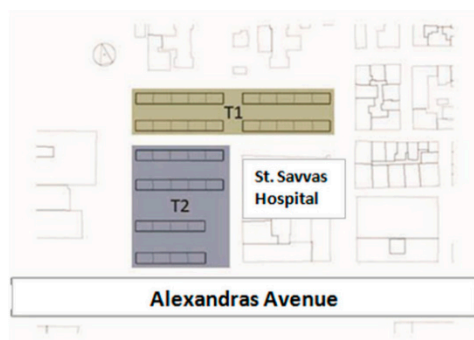
Figure 2. Ground plan of the study area and its location on Alexandras Avenue.

The study area is a residential area in Athens, located in Alexandras Avenue, one of the main axes of Athens, close to the city center (Figures 1 and 2). The neighborhood was created to house refugees from Asia Minor during the 1930s. The deportation of refugees from Asia Minor is one of the main historical events of the 20th century in Greece and is of particular interest for Athenian urban planning since it became the reason for the creation of the first social housing complexes in the city [12]. The building complex of the study area has introduced a series of innovations that fit into the language of the modern movement with strong Bauhaus influences. The site's total area is 14,500 m², comprising a 4500 m² built area and 10,000 m² of free spaces. The total built surface of the flats is 13,500 m² plus 4500 m² of the roof terrace.

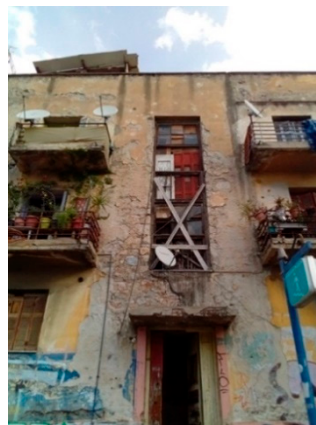
Figure 3. Poor conservation status of buildings.

This characterization is not official. Officially, in 2003, two apartment buildings were declared “monuments under preservation” by the Greek Ministry of Culture and in 2009 the rest of the buildings were also declared “monuments under preservation” (Official Gazette 1747 B/26.11.2003 and Official Gazette 62/13.02.2009, respectively). The building complex was constructed between 1933 and 1935 and designed by the state architect Kimon Laskaris (1905–1978) and the civil engineer Dimitris Kyriakou (1881–1971) working for the Technical Service of the Ministry of Social Welfare that was responsible for housing the refugees from the Asia Minor [13]. There are in total 228 apartments—51 of which are private properties and the others belong to the state. The private houses are in a good conservation state, while these under the public ownership are in a poor conservation state (Figure 3)—some of them are abandoned or even occupied.

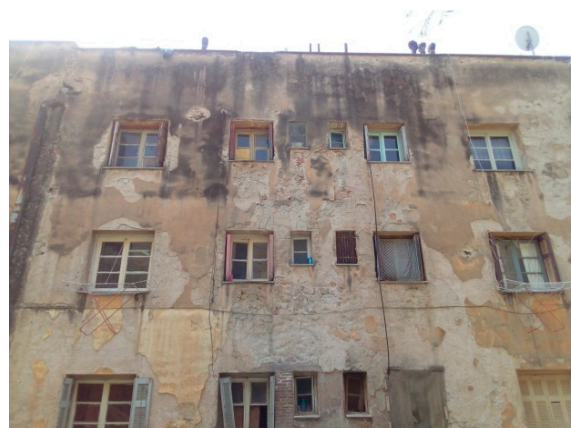
Buildings present simple rectangular parallelepiped geometry constructed both with reinforced concrete and stone masonries. The surfaces were plastered without decorations. Stone masonry was made by using limestones with a clay-lime mortar. The same composition of mortar was also used for plastering the surfaces. Frames were made of wood with single glass, and wood and ceramic tiles were applied for the floors. Additionally, regarding the state of conservation of the buildings, most common decay problems observed are extended decay in plaster, with cracks, flaking, exfoliation and detachment, moisture problems, bio-deterioration, and incompatible conservation interventions such as the use of cement mortars for restoring stone masonries (Figure 4). Also, reinforced steel presented extended decay due to lack of special protection. Other damages were caused due to incompatible conservation interventions by the tenants, such as the extensive use of cement-based mortars, or new openings in the masonries as a remedy of collapsing parts of the initial structure.

Figure 4. Deterioration of historic plaster.

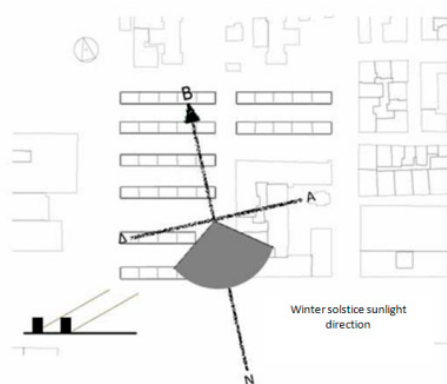
Figure 7. Winter solstice radiation representation.

southern surfaces in winter, and the strong presence of trees creating a pleasant microclimate) (Figure 7). Particular characteristics of the complex as also shown in Figure 7 include the existence of a wide-open space between the buildings, contributing to air circulation and sunlight access throughout the year.

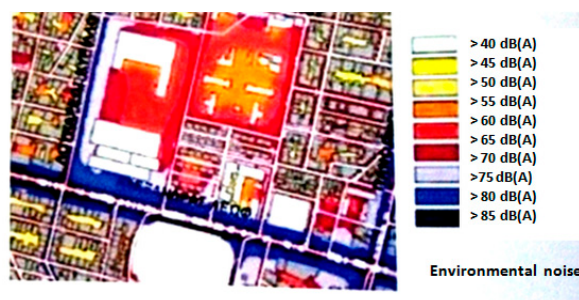
Figure 8. Environmental noise levels in the case study area.

Furthermore, the area is characterized by high environmental noise levels resulting from the strategic noise mapping for agglomerations in Greece, performed by the Ministry of Environment and Energy in 2017 [22]. Due to its vicinity to one of the main avenues of the center of Athens (Alexandras Avenue) with important traffic loads, the levels of noise are really high ($>60\text{ dB(A)}$), reaching a high score of 75 dB(A) (Figure 8).

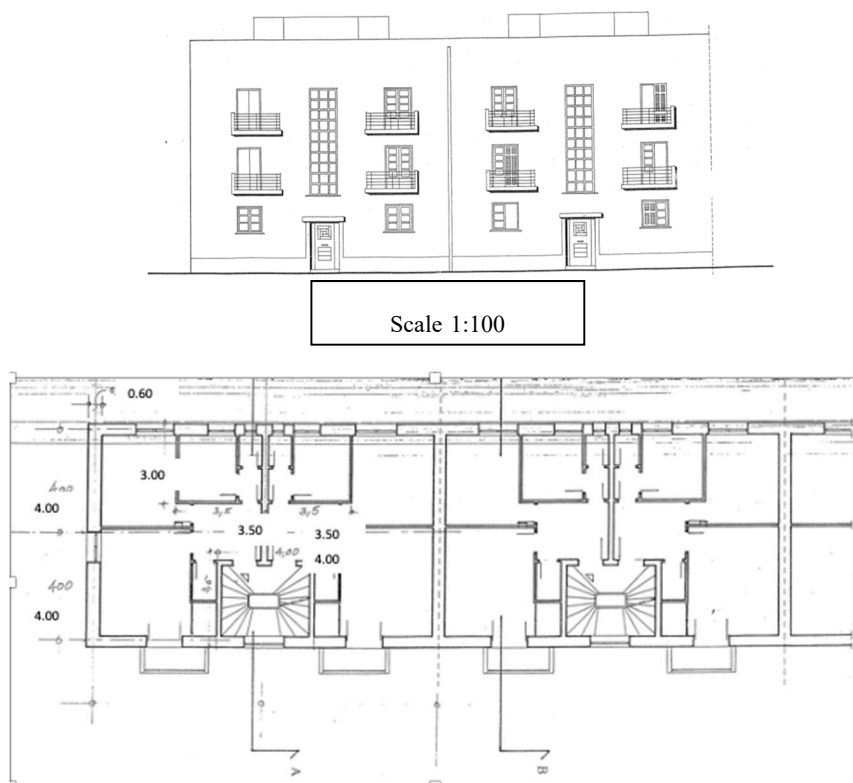
Figure 9. Building designs (façade and typical floor plan) serving as a basis for the functional unit model construction. Source: National Technical University of Athens (NTUA), School of Architecture records.

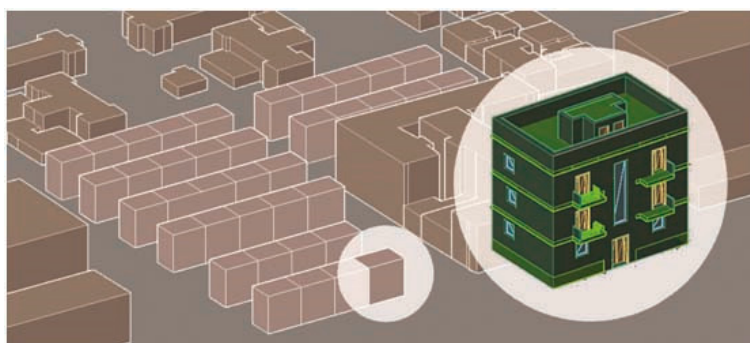
Figure 10. Life cycle analysis (LCA) functional unit development in AutoCAD.

The “functional unit” was defined as a block of six apartments of a gross floor area of 50 m² each, having a common entrance per month. In order to determine the functional unit, designs of the buildings carried out by the School of Architecture of the National Technical University of Athens (Figure 9) were used. The unit was developed as a detailed 3D model (Figure 10) using the AutoCAD software.

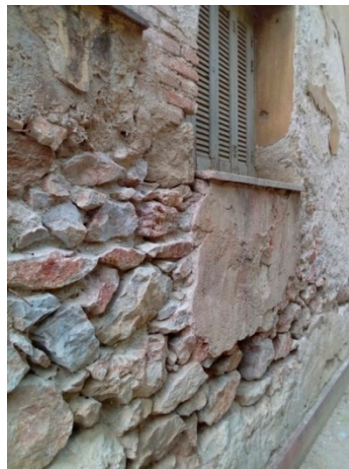
- Stone materials corresponding to 90% of the masonry total volume. The stone used was limestone containing iron oxide admixtures;
- Joint mortars constituted 10% of the total masonry volume. Mortars were clay-lime-based mortars (90% clay and 10% lime);

Figure 11. Morphology of the stone masonries.

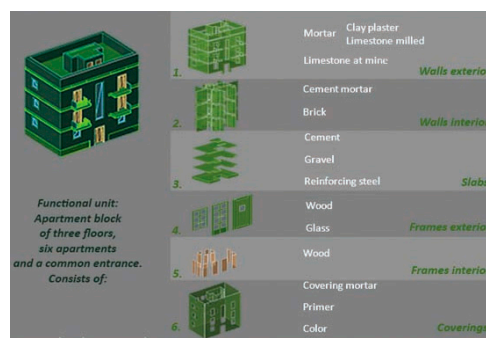
Figure 12. Functional unit—main selected elements.

The next stage was the selection of the building components judged to be important for the study. The components that were selected were: exterior walls, interior walls, slabs, exterior frames, interior frames and coverings (Figure 12).

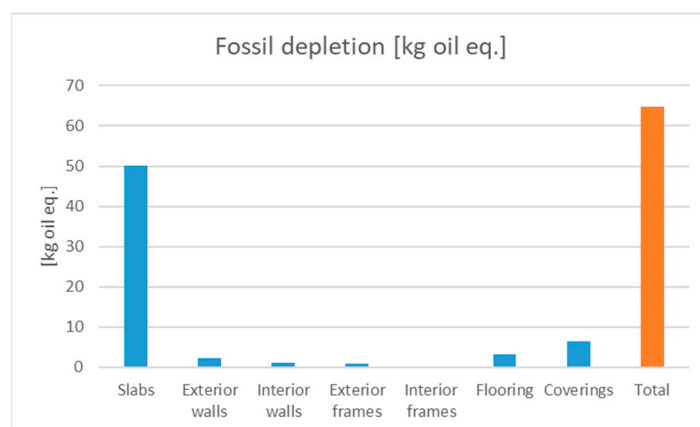
Figure 14. Fossil depletion for the functional unit (apartment block, per month).

Figure 14 presents the fossil fuel depletion categories (concrete slabs, exterior walls, interior walls, interior frames, flooring and coverings). As can be seen, the major category responsible for fossil fuel depletion is the “concrete slabs”. This is also the case for all the other categories as it can be observed in Figure 15.

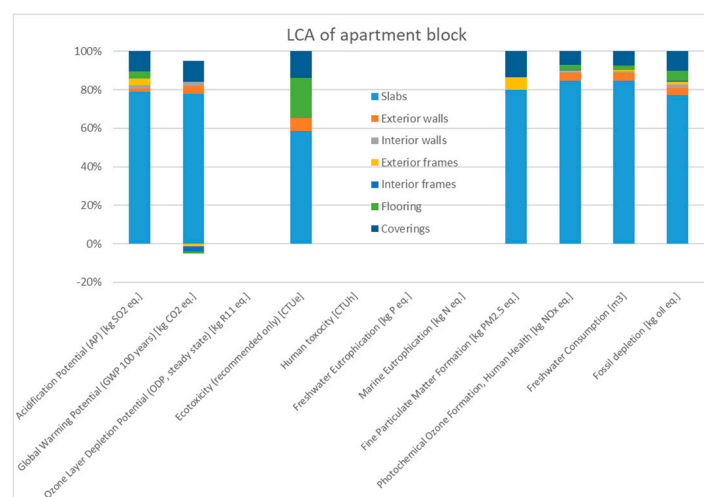
Figure 15. Total footprint analysis of the apartment block, per month. In these figures, the energy consumption has not been taken into account.

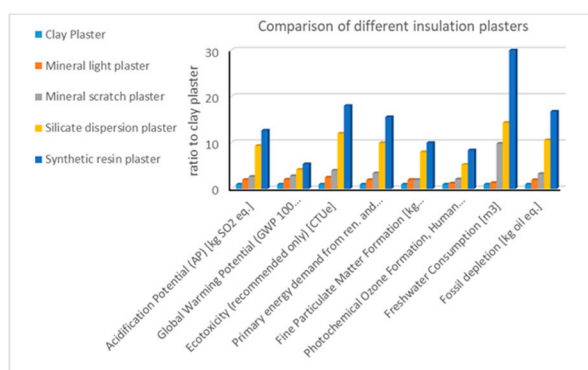
Figure 16. Comparison of the footprint of different plasters for an apartment block.

In Figure 16, the effect of different insulation systems on the different categories is presented (Scenarios A–D). It is evident that the current plaster is clay plaster and there is no thermal insulation layer applied. We should note here that, in Greece, the obligation of using insulation in buildings was introduced for the first time in 1979 (Presidential Decree of 1.6/1979, Official Gazette 362/Δ'/4.7.1979).

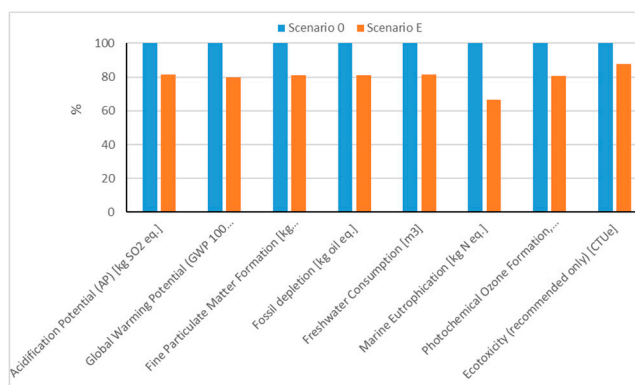
Figure 17. Total footprint of the apartment block for the different scenarios.

Moreover, in the following figure, the use of a thermal insulation layer is taken into account (Scenario E). This insulation layer normally upgrades the energy-saving rating of a building up to two categories, thus energy saving by 20% is a realistic scenario. As has already been noted, cellulose fibers, which have a relatively small environmental footprint, are used as a thermal insulator. When the footprint of heating is taken into consideration, this footprint is responsible for almost 95% of the total footprint in every category. Thus, a considerable decrease in energy demand can lead to significant changes. These changes are presented in the following Figures 17 and 18.

Consequently, one can easily conclude that the use of thermal insulation combined with a new plaster system can lead to a significant decrease in the total footprint of the apartment blocks.

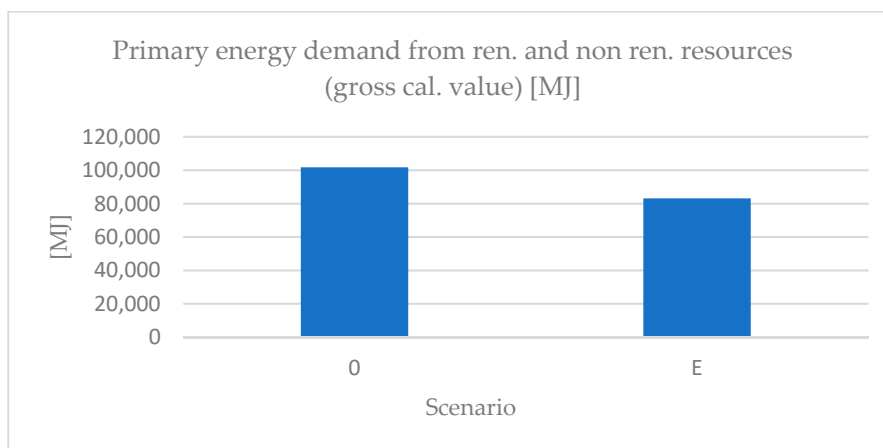
Figure 18. Monthly total energy demand of the apartment block for the different scenarios.
