Article

Correlation of Vulnerability and Damage between Artistic Assets and Structural Elements: The DataBAES Archive for the Conservation Planning of CH Masonry Buildings in Seismic Areas

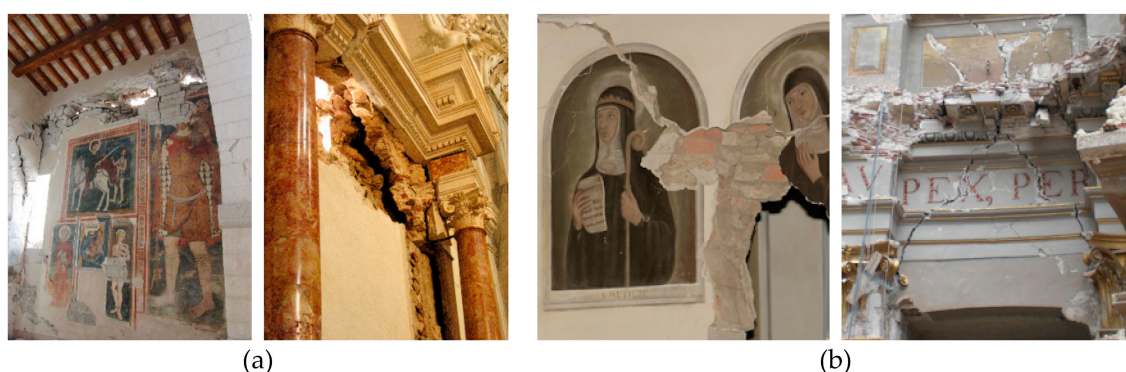
Figure 1. Examples of damage of artworks due to out-of-plane (a) and in-plane (b) mechanisms for frescoes and stuccoes.

As an example, a typical severe and, unfortunately, common condition is that of a fresco borne by a wall that has no constraints (e.g., ties, effective connections with adjacent walls and the floor/roof) to counteract overturning under seismic loads, or has low masonry quality (e.g., multi-leaf rubble section). The fresco is in the highest risk condition, because the structural element (the wall to which the fresco is connected) behaves according to the weakest and most brittle mechanism (i.e., out-of-plane collapse) (Figure 1a). On the contrary, in a building where the activation of overall behaviour is provided by more earthquake-resistant conditions, limited structural damage is expected (e.g., in-plane shear cracking in a wall), although it can provide severe patterns, which could affect the fresco integrity (Figure 1b).

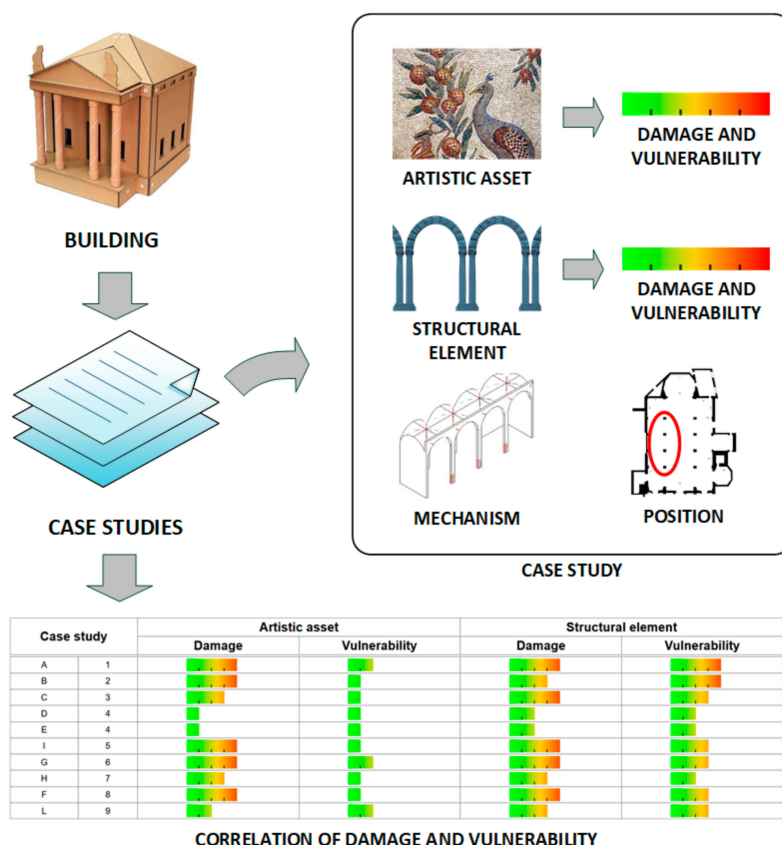
Figure 2. Overview of DataBAES' functioning.

As a result, a table with an overview of the correlation of vulnerability and damage between AA and SE is generated for each building; a scale of colours of five degrees, from green to red, indicates the increasing condition (of damage and vulnerability), so that the most critical artistic assets can be identified and prioritisation measures may be applied if necessary. Levels equal to or greater than three indicate that an emergency threshold has been passed for specific actions to apply to AA and/or SE. Figure 2 shows the process flow diagram of the archive.

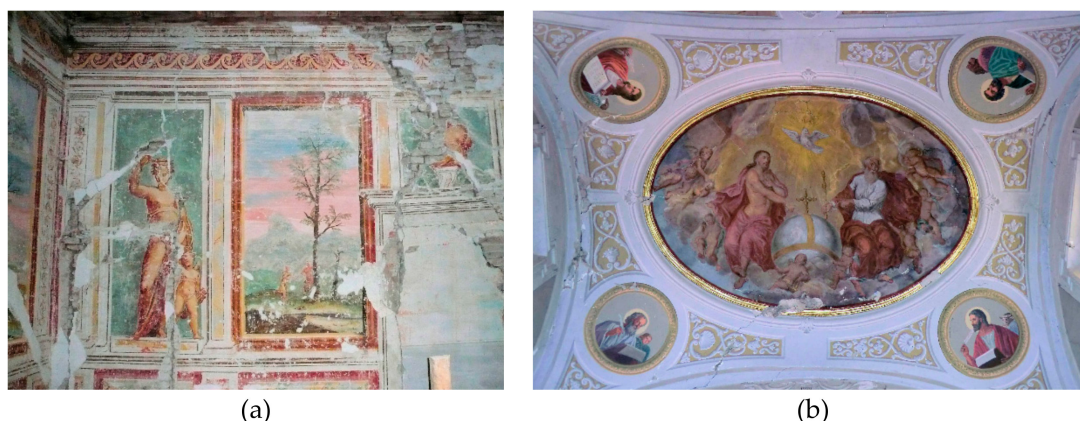
Figure 5. Example of primary and secondary mechanisms associated with a damaged fresco located in apse of a church: (a) apse is subjected to ‘overturning’, but the main mechanism affecting fresco is ‘shear’; therefore, ‘in-plane mechanism of apse’ and ‘overturning of apse’ are, respectively, primary and secondary mechanisms; (b) damage to the vault of the central nave affects the painting as a primary mechanism.

At level II, the form requires the identification of the AA and its related SE with the primary or secondary mechanism having already been identified (Figure 5). In fact, at this level, each of the 28 mechanisms for churches or the 22 mechanisms for the other types of buildings are analysed in detail, both in terms of damage and the presence of specific vulnerability/devices. In the case of non-structural elements supporting artworks (e.g., *camorcanna* vaults), the mechanism should be identified as that of the macro-element, which could affect the one of the non-structural elements in question (e.g., the possible overturning of walls supporting the *camorcanna* vault). For the increasing damage evaluation, a grade from 1 to 5 is required, whereas for the vulnerability assessment the increasing overall scale of 1 to 5 is derived from the detailed evaluation of each item based on a three-grade scale, according to the effectiveness of potentially good construction details and/or earthquake-proof systems (e.g., ties, buttresses, connections and anchors, light bracing, and lintels). This scale corresponds to ‘ineffective’ (any check box marked), ‘moderate’ (grade 1), ‘good’ (grade 2), and ‘completely effective’ (grade 3). Vulnerability concerns the presence of thrusting elements (roof struts, arches, and vaults), slender piers, large openings close to corners, stiff ridge beams, heavy floors/roof, high-span thin vaults, etc., and is expressed on the scale of 1 to 5 corresponding to the grades ‘very low’–‘low’–‘average’–‘high’–‘very high’.

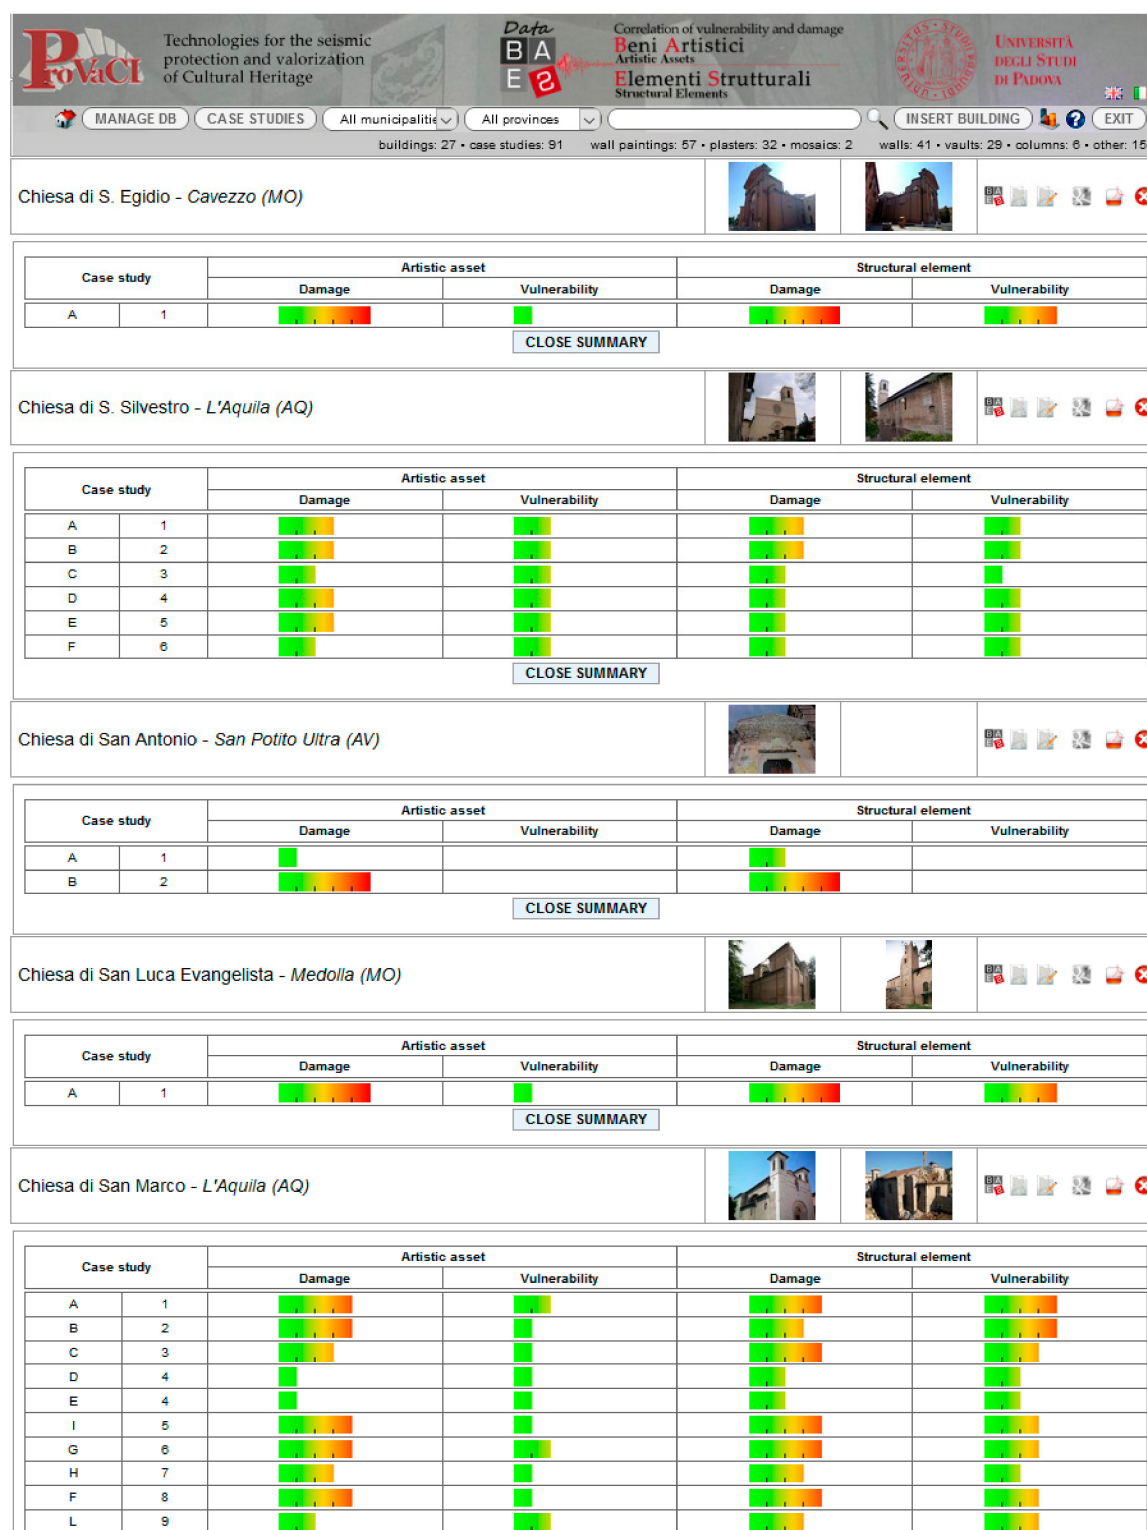
Figure 8. View of the summary of results of case studies for analysed buildings.
