Article

Sustainable Conservation and Management of a 20th-Century Landscape in the Alps: The Former Sanatorium Village of Sondalo

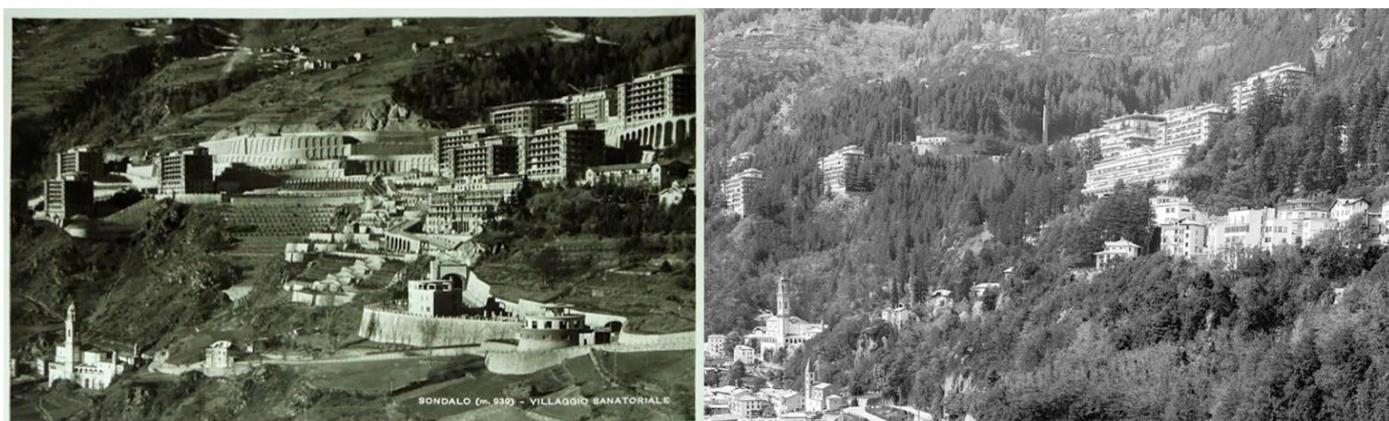
Figure 1. The Sanatorium Village of Sondalo seen from the east, a vintage postcard from 1940 and the current situation in 2020.

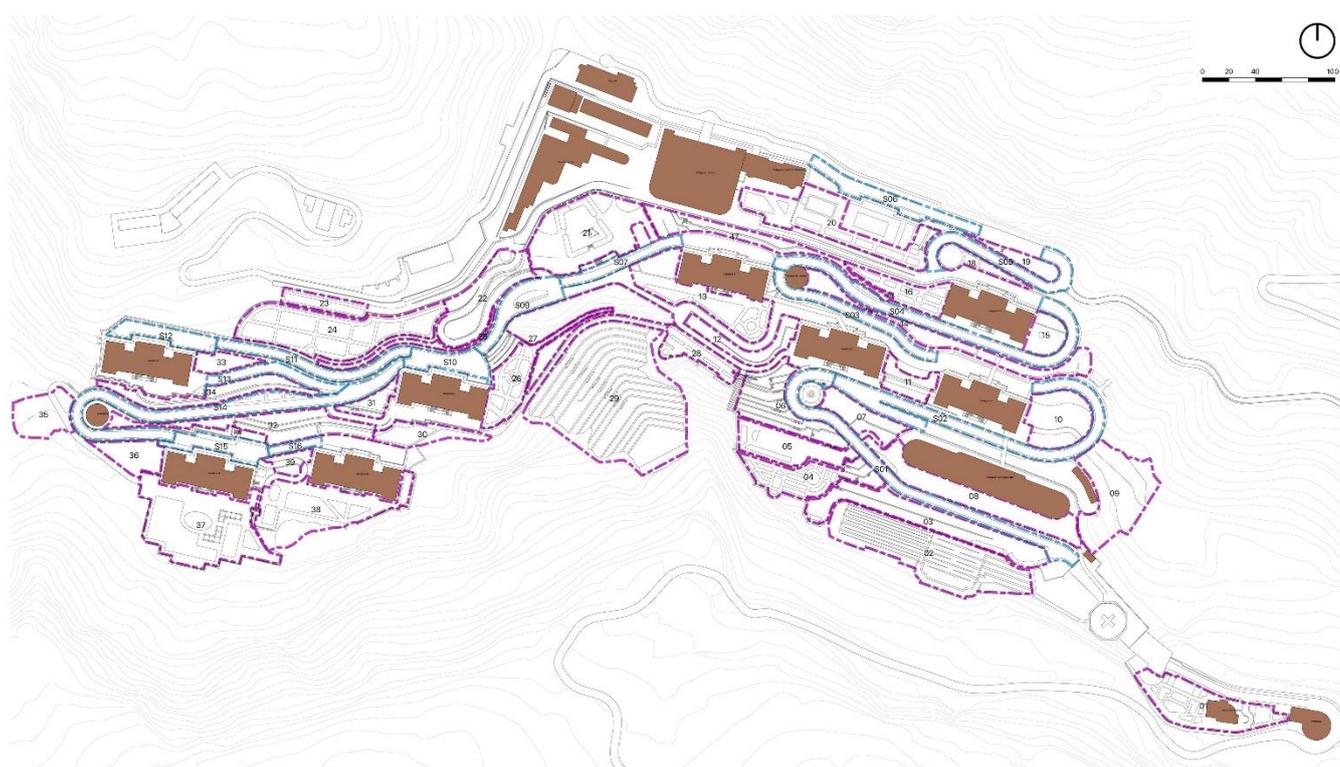
Figure 2. The general plan of the complex: division into areas (in purple the areas referring to gardens and parks, in blue the areas occupied by the road layout, in brown the pavilions).

complex. This is conceived as a natural health machine to guarantee maximum effectiveness from a medical point of view and for the containment of tuberculosis. The complex was built on a mountain slope on which a system of large terraces was set up to house the facilities and the park surrounding them. The choice of the site responded is closely linked to the treatment of tuberculosis, for which a context suitable for heliotherapy treatments and high altitude to facilitate breathing are essential. The complex was built halfway up the mountainside, with massive excavation works on the slopes and the construction of terracing. These housed the pavilions, hospitals, gardens, and other areas created for the safety of the slopes (Figure 2).

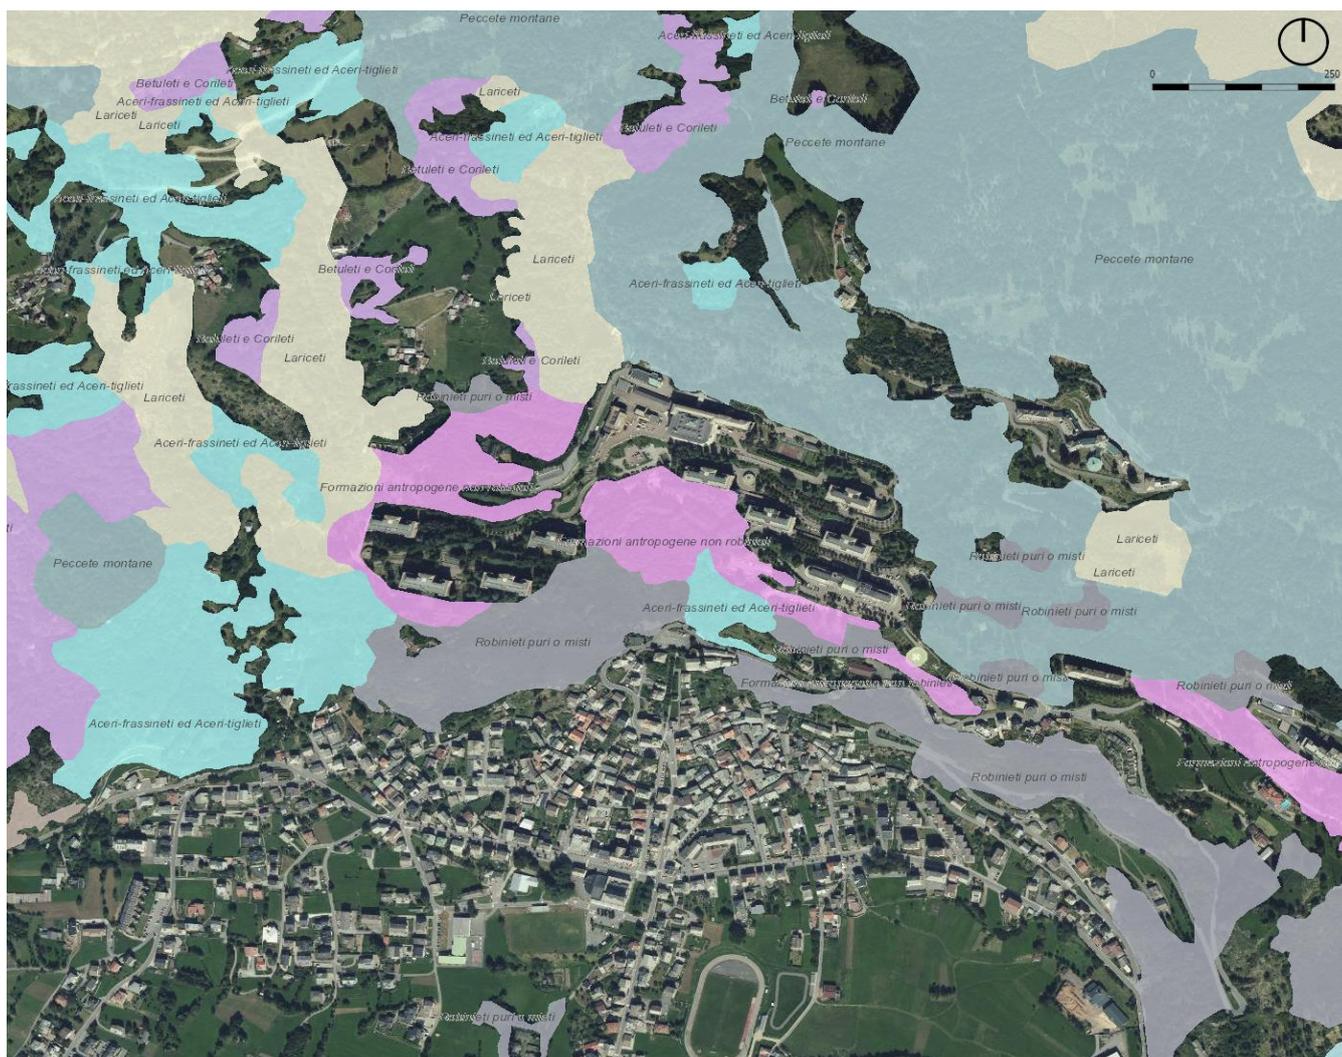
- conifer woods characteristic of the higher altitudes, i.e., mountain spruce (in green), with the presence of larch (in yellow);
- deciduous woods, i.e., a mix of maple-lime and maple-ash groves (in blue);
- anthropogenic formations or reforestation with conifers (in pink);
- formations of pure or mixed locust trees below the complex (in grey).

Figure 3. Elaboration of the map of forest types, Lombardy Region [44], area of the former Sanatorium Village of Sondalo.

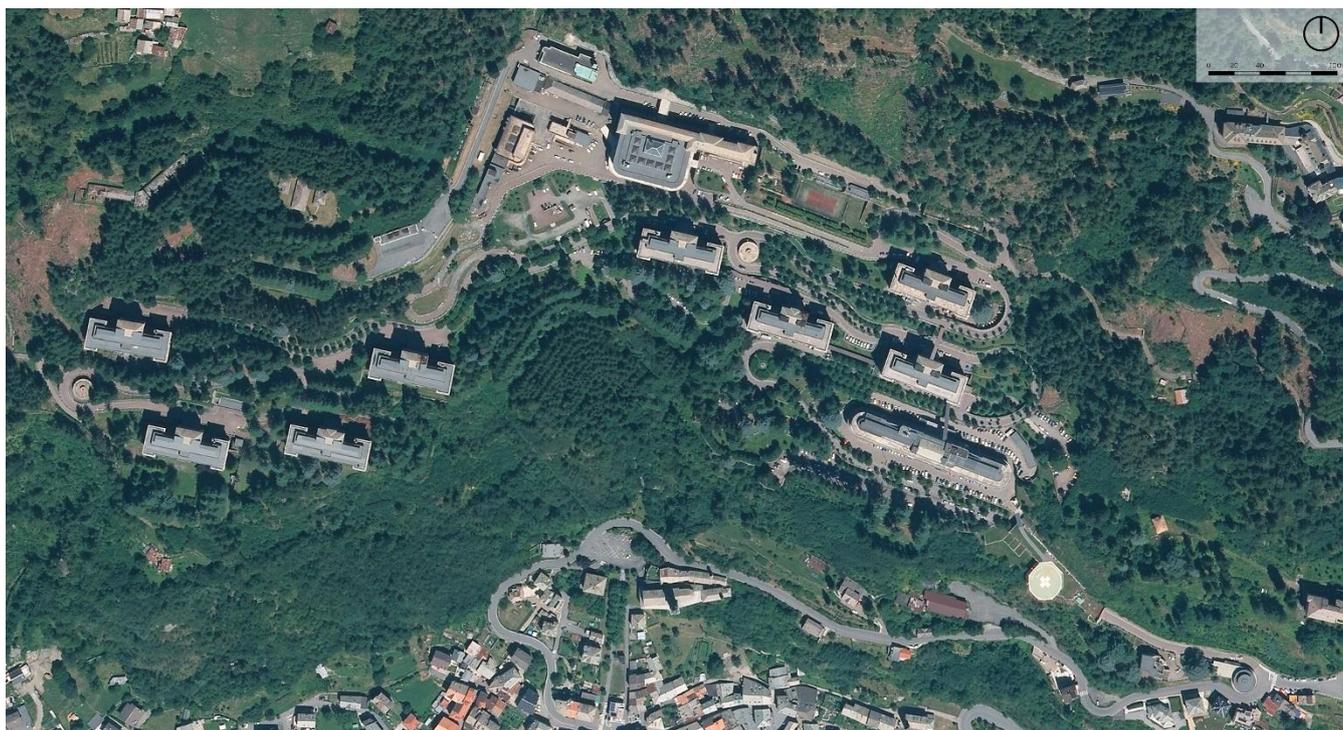
Figure 4. Elaboration of the Ortho-image, Lombardy Region, LiDAR survey, 2015 [45].

The management system has been structured from the beginning of the activities to achieve a common and unified cartographic platform on which to anchor the analysis and insights. However, the numerous maps coming from regional and national geoportals (Figure 4) [45–47] have highlighted some deformations and measurement uncertainties that made further investigation necessary. This need led to the creation of a new aerial photo using image-based photogrammetric techniques applied to photographic shots acquired by drone. A detailed ortho-image (Figure 5) and a Digital Surface Model (Figure 6) resulted from these operations and made it possible to create a solid graphic support for the census activities.

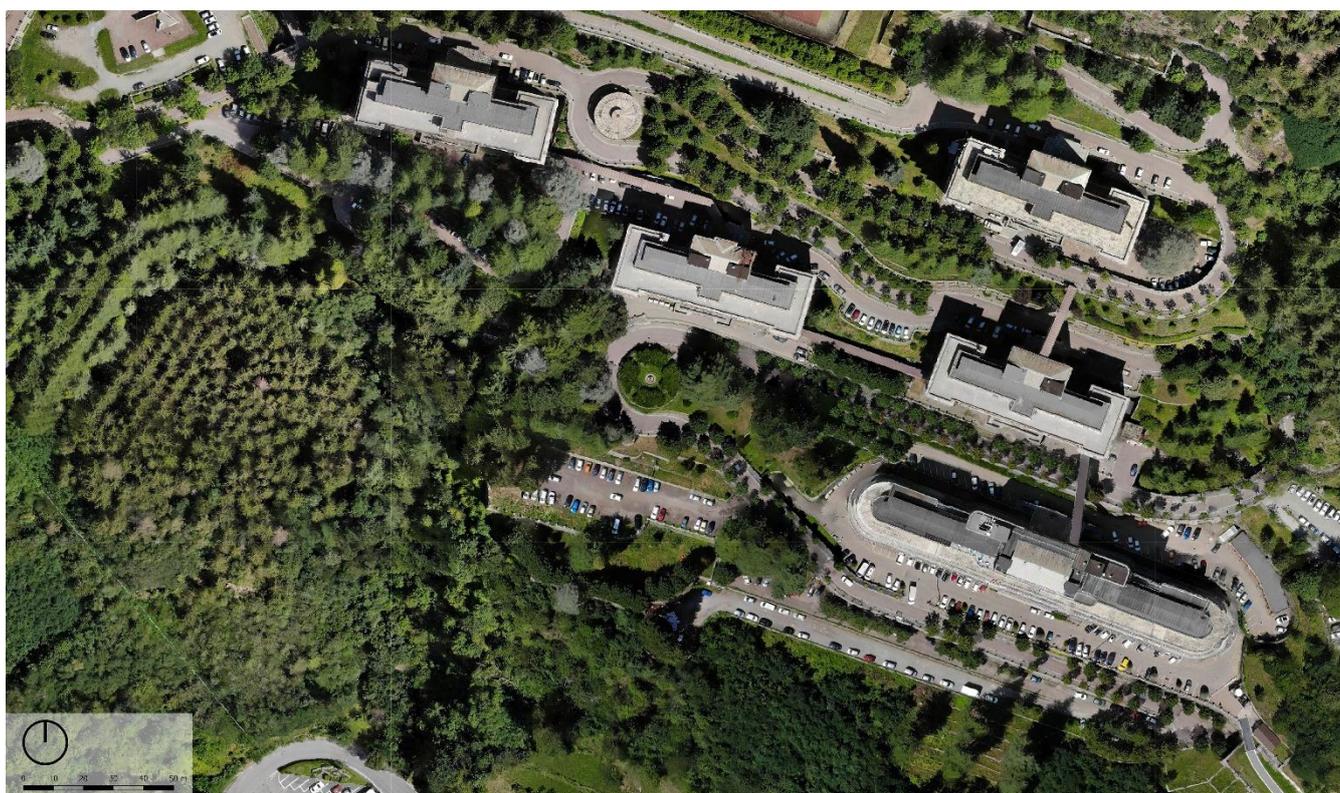
Figure 5. Detail of the orthophoto generated through drone survey in 2019.

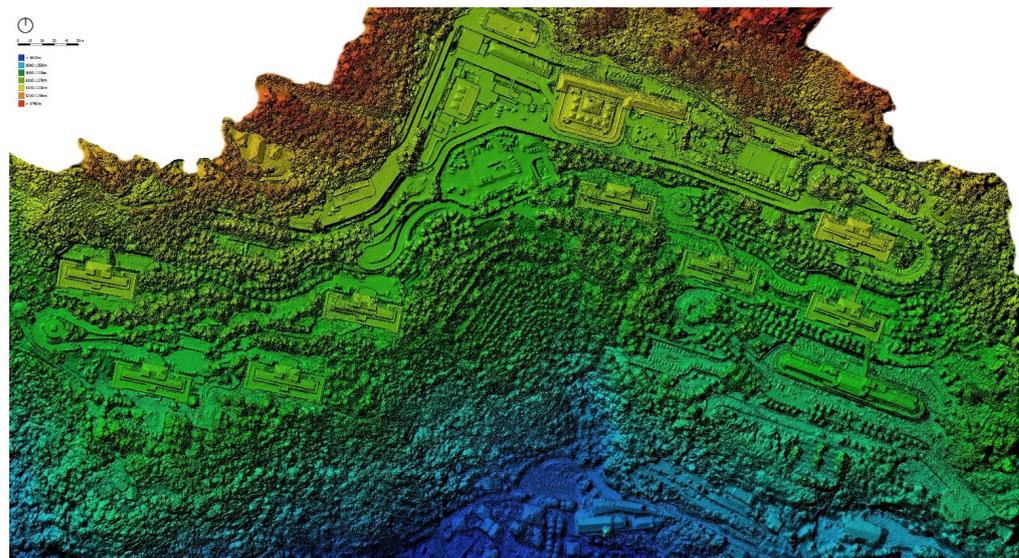
Figure 6. Digital Surface Model (DSM), 2019.

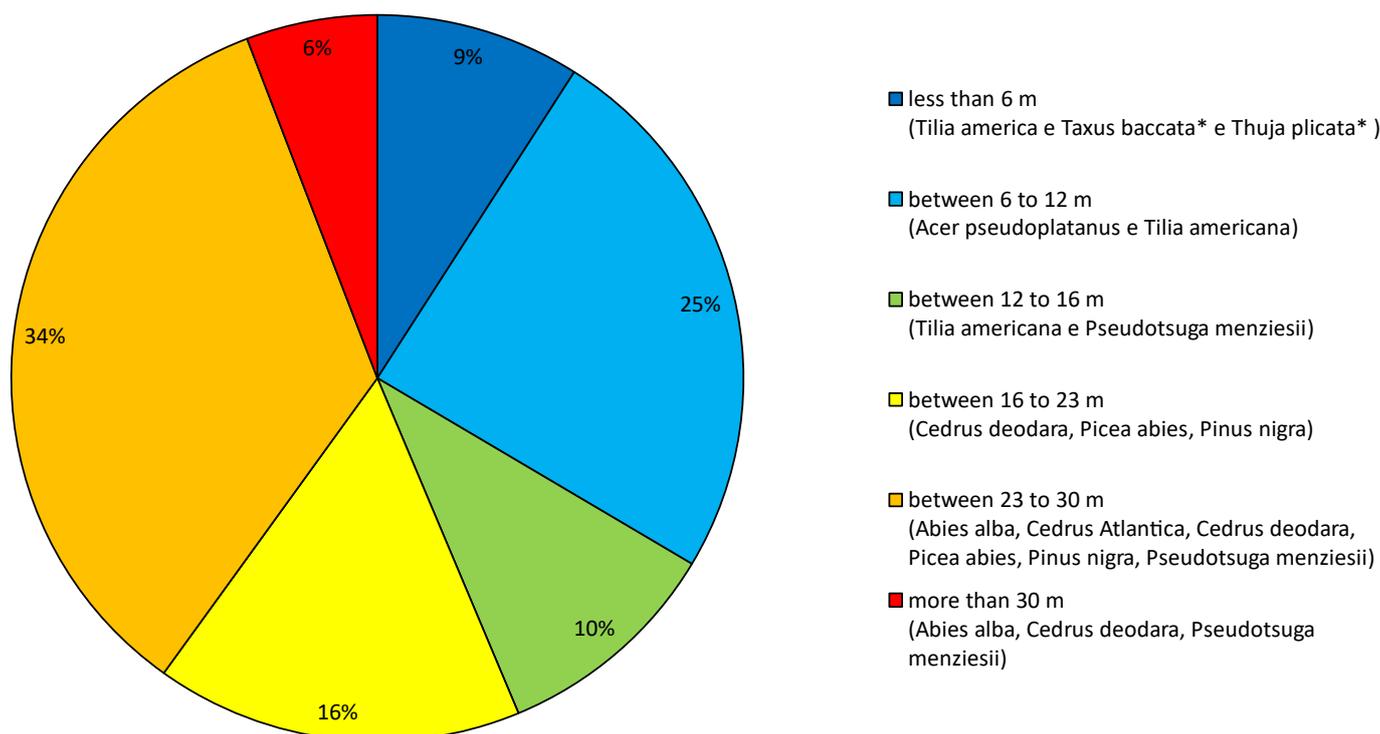
Figure 10. Tree height classes, number of specimens and main species.

Of the trees surveyed, 73% belong to the Gymnosperms group. Among these, the species *Picea abies*, *Cedrus deodara*, *Pseudotsuga menziesii*, *Pinus nigra*, *Thuja plicata*, and *Abies alba* represent 63% of the total. If the *Picea abies* (24.47%) were mainly used in the mitigation forest, today, their presence is significantly reduced compared to the initial quantities. The species *Cedrus deodara* (13.88%), *Pseudotsuga menziesii* (9.43%) and *Abies alba* (3.81%) are important in the park areas. The *Pinus nigra* species (6.78%) is concentrated in the terracing of the playground, where almost all the specimens are found (Figure 10).

The highest trees (over 35 m) belong to the species *Pseudotsuga menziesii*. The specimens west of the Surgical Pavilion reach 42 m in height. In Italy, this species can reach over 60 m; the tree so far recognised as the tallest in Italy is a 62 m high *Pseudotsuga menziesii* located in the Vallombrosa Forest (FI). In Lombardia, very few trees among those included in the list of monumental trees (Law 10/2013) exceed forty metres in height. Among the conifers, there are only the *Abies alba* of Roncobello (BG), the *Picea abies* of Valdisotto (SO), the *Cedrus libani* of Cugliate Fabiasco (VA), and the *Sequoiadendron giganteum* of Varese. Therefore, even the *Pseudotsuga menziesii* of Sondalo Park appears worthy of being included in this list, further enhancing the uniqueness of this botanical itinerary (Figure 10).

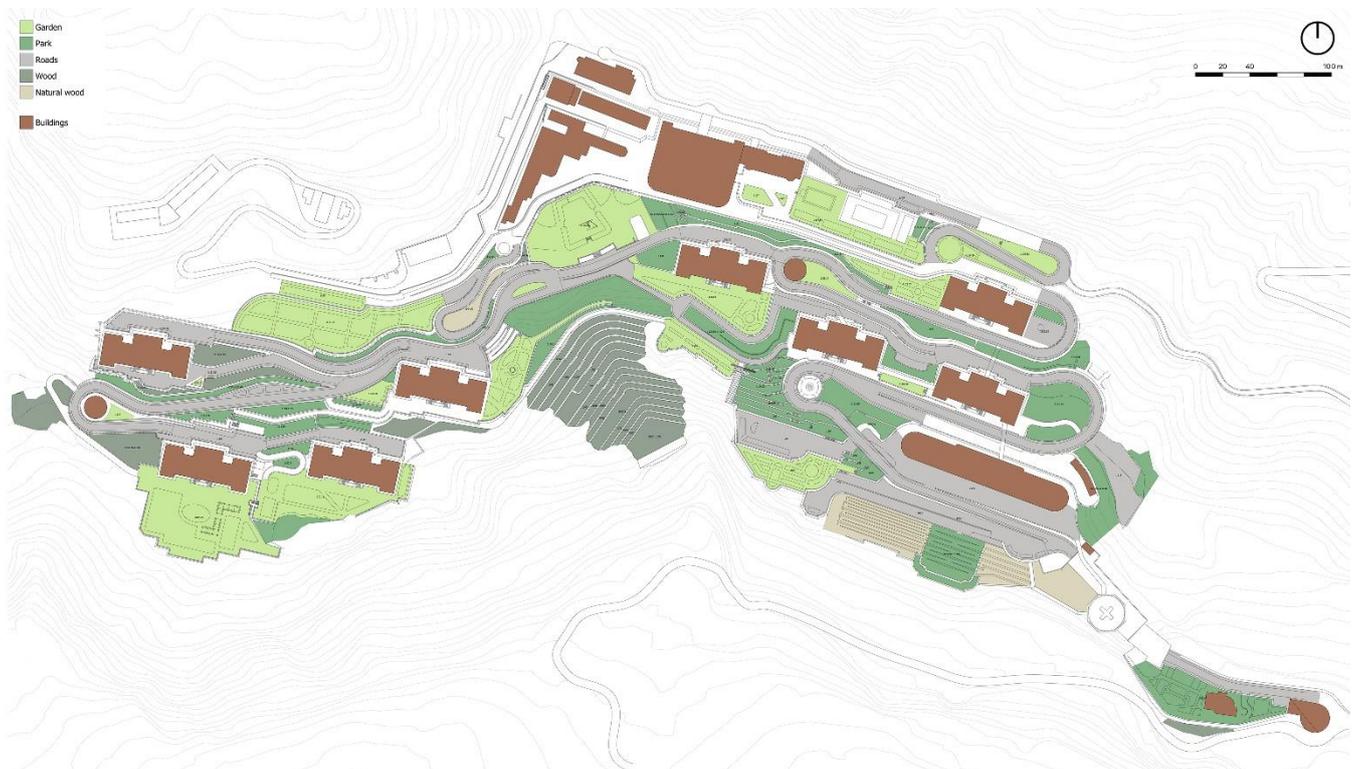
Figure 11. The general plan of the complex. In evidence, the buildings, and the different areas.

The drafting of the tree census, combined with inspections, and the designed GIS analysis tools, made it possible to assess the size of the park and its landscape role in relation to the town below on a map of landscape values. A monitoring map was the result coming from the analysis of the data on the conservation status of the trees, combined with the recognition of some risk elements. It identifies the areas of the park and the tree specimens to be monitored. Finally, guidelines have been drawn up for each area into which the park has been divided to support the technical office's action. The subdivision of the park areas (Figure 11) is based on the role assigned to them in the context of the sanatorium project:

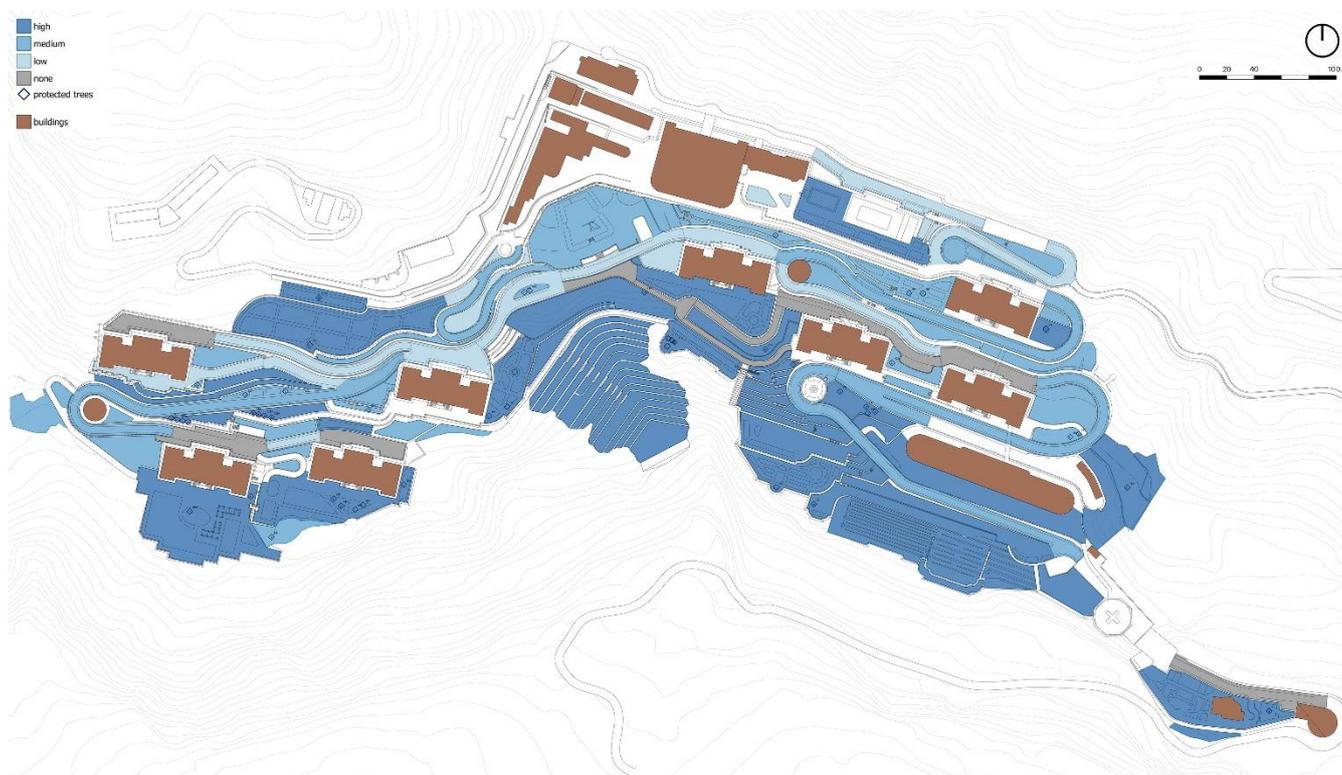
- High: areas with a fundamental role in the perception of the complex from the valley.
- Medium: areas with a partially recognisable landscape perception from the outside of the areas themselves.
- Low: areas with landscape perception limited to users within the areas.

- Null: areas devoid of plant elements.

Figure 12. Landscape values map.

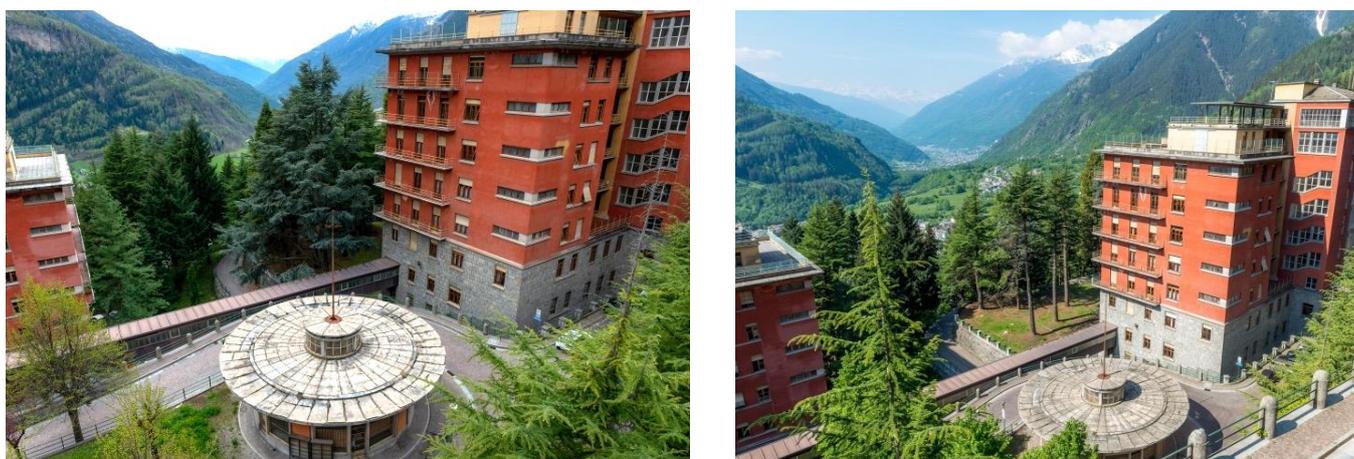
Figure 13. Garden of pavilion n. 5 before (left—photo, April 2019) and after (right—photo, July 2020) the knocking down of the *Cedrus atlantica*.

The specific values and characterising elements are described in the forms relating to every single area. The purpose of the landscape value map is to raise awareness about the impact that extensive operations on the plant system, such as knockdowns, can have on the perception of the entire complex. The garden of pavilion n. 5 gives an example of the situation before and after the knocking down of a *Cedrus atlantica* specimen (Figure 13).

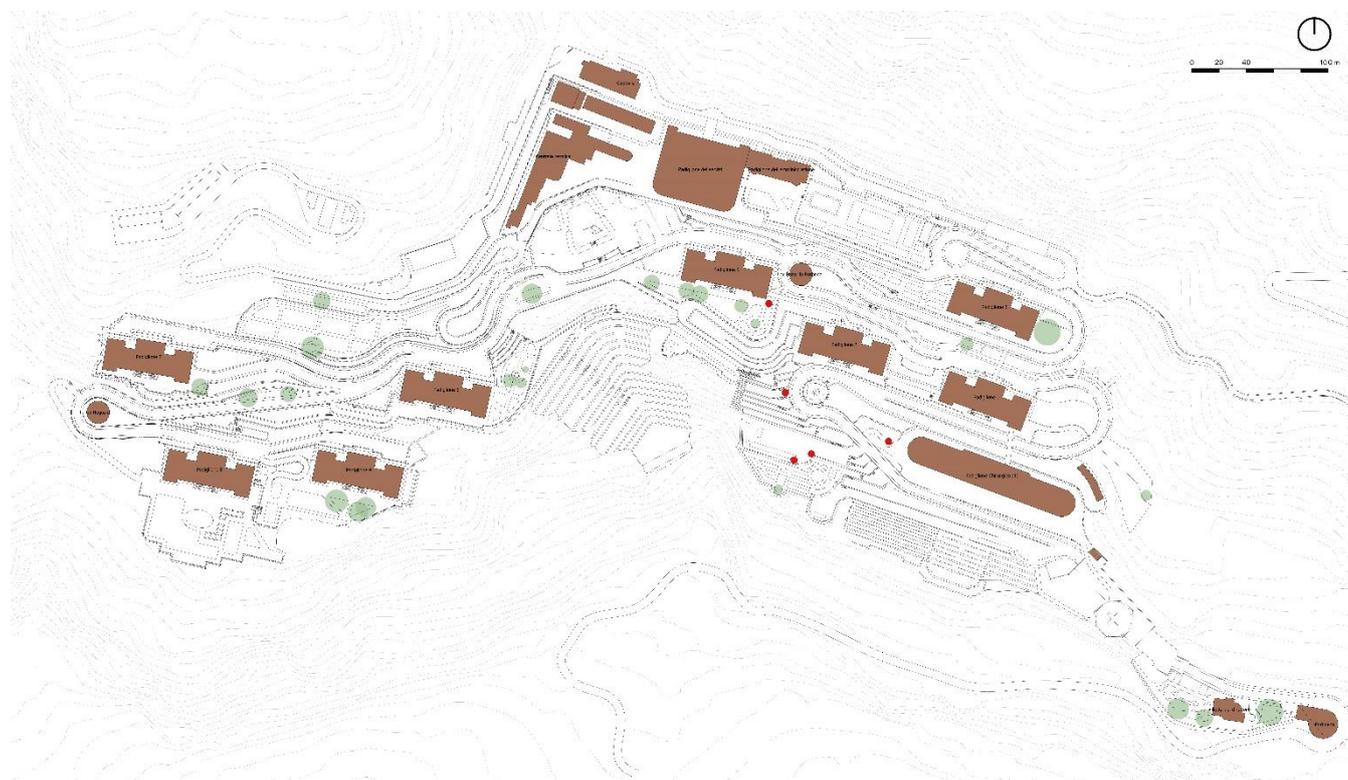
Figure 14. *Cedrus atlantica* still present (in green) and knocked down (in red).

has a landmark value and guides the visitor inside the park. The specimens are positioned near the buildings and in visible positions, accompanying those who walk along the main network of roads. Some of these specimens have been knocked down recently (2015–2019) for safety reasons, compromising the immediate understanding of the role assigned to this species in the park (Figure 14).

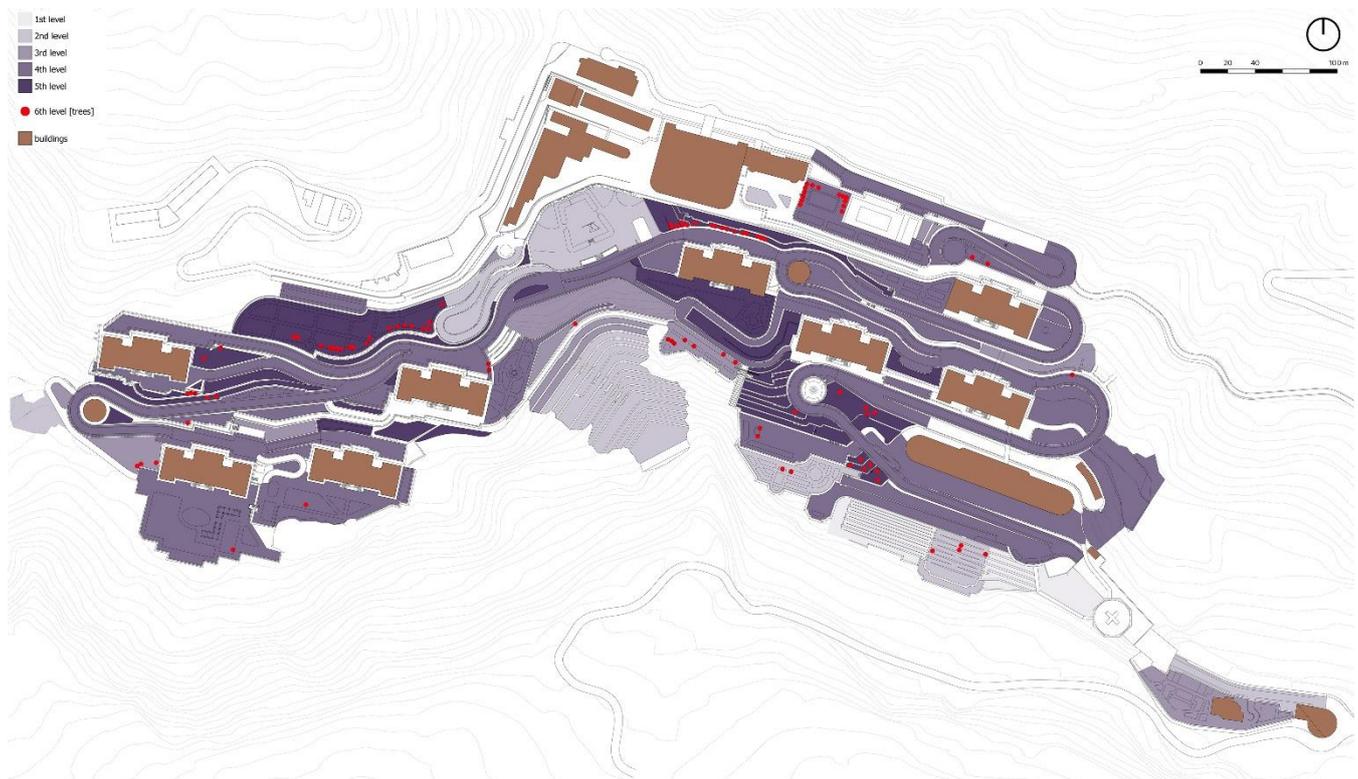
- Level 1: areas rarely frequented and without assets that can be damaged by the fall of the tree.
- Level 2: areas only sporadically frequented and with assets of little value that can be damaged by the fall of the tree.
- Level 3: areas with moderate traffic and the presence of assets that can be damaged.
- Level 4: road system of the park frequented and with target assets of significant value.
- Level 5: heavily frequented areas with target assets of high economic value.
- Level 6: tree specimens that need a specific evaluation due to their state of conservation and the position in which they are placed.

Figure 15. Monitoring map.

The monitoring map identifies six levels that can be associated with the different areas of the park (Figure 15), according to the following values:

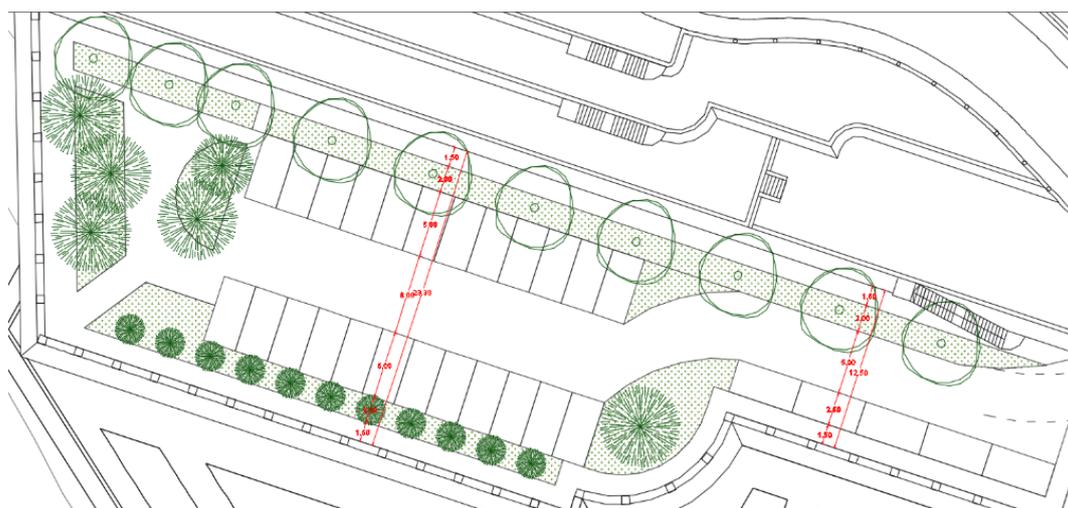
Figure 16. Project for the "Piazzale della maternità", Form n. 5, Solution B.

For some areas of the park, it was decided to propose some solutions aimed at securing the tree's safety and recovering some heavily compromised areas. In particular, the solution for the "Piazzale della maternità" (Form no. 5, Figure 16) proposes a reorganisation of the parking space obtained from the dismantling of the garden, in order to recover the landscape features and rearrange the parking areas. The proposed solutions foresee the recovery of the rows of lime trees and conifers as elements for the organisation of the space and the planting of a *Cedrus atlantica glauca* in place of the two trees that were knocked down. Compared to the original configuration, it was decided to decrease the number of specimens, expand the planting distances among the trees, and use the *Tilia tomentosa*, which is more adaptable to the park conditions than the *Tilia americana*.
