# Deterioration of Novel Silver Coated Mirrors on Polycarbonate Used for Concentrated Solar Power

**Abstract:** The lifetime of mirrors in outdoor conditions is crucial in the correct operation of any concentrating solar power (CSP) installation. In this work, the corrosion behavior of two types of metallized surfaces was studied. The first was made of a flexible polymer having a deposited reflective silver metallic film. The second was made of the same surface type with a dielectric SiO<sub>2</sub> protection coating by an atmospheric pressure plasma jet. Polycarbonate sheets were used as substrates on which metallic silver was deposited by the Dynamic Chemical Deposit technique. This electroless technique allowed producing the mirror finishing under environmental conditions by sequentially spraying; as aerosols projected towards the substrate surface, the activation and reducing-oxidizing solutions with rinsing after each one. The silver coatings were about 100 nm thick. Environmental and accelerated weathering degradation and salt and sulfide fogs were carried out. XPS analyses show that the corrosion products formed were Ag<sub>2</sub>S, AgCl, and Ag<sub>2</sub>O. It was obser

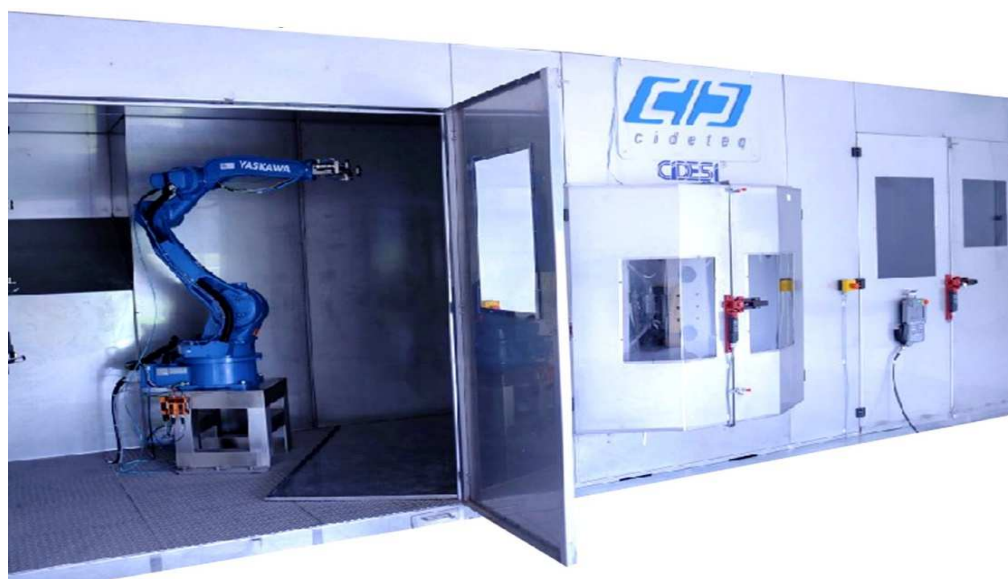
**Figure 1.** Automated facilities to metallize and coat mirrors for CSP systems. The electroless metallization cabin (left side), entrance, and automatic polycarbonate sheets switching where the heat surface pre-treatment is applied (center), and APPJ cabin (right side).

Polycarbonate sheets of  $10 \times 10$  cm were used as a substrate on which metallic silver was deposited by the Dynamic Chemical Plating (DCP) technique with a coating thickness of approximately 100 nm. DCP has been used within automatized facilities (Figure 1). The importance of quality control for the layers of the mirror is emphasized. The automated facilities allowed the fabrication and reproducibility of mirrors in big areas, such as  $1.2 \text{ m} \times 1.2 \text{ m} \times 0.0015 \text{ m}$  of mirrors for heliostats and  $1.2 \text{ m} \times 2.4 \text{ m} \times 0.006 \text{ m}$  in the case of mirrors for parabolic trough solar concentrators. The surfaces were cleaned and pre-treated with a flame to improve adhesion between the metal layer and the substrate. The surface treatment with a flame was conducted to insert functional groups on the surface as an alternative, similar to corona electrical arc discharges and plasma surface pre-treatments. This was applied to all the pieces until homogenous wettability was obtained. This was conducted in the central section of the facilities shown in Figure 1.

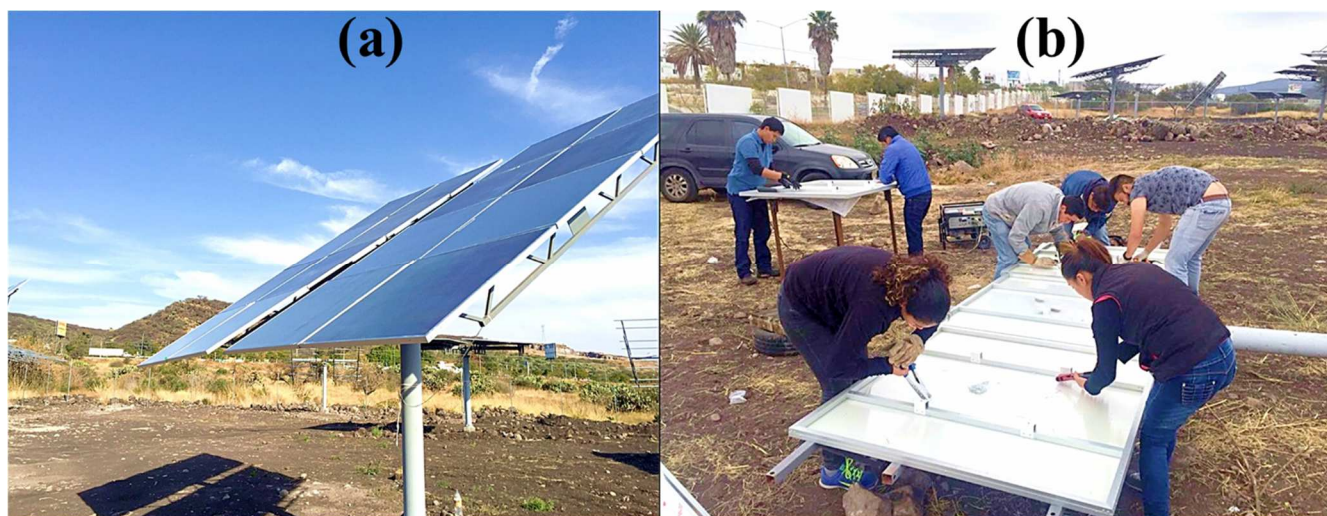
**Figure 3.** (a) Sixteen mirrors of solid polycarbonate conforming a heliostat. (b) Mirror sheets at the moment of being installed with aluminum frames.

Samples of first-surface solar reflectors with and without protective coatings were tested after exposure to the environment for six months. Figure 3 shows the installed pieces on heliostats. Figure 3a shows the heliostat with sixteen sheets of mirrors and automatic sun-tracking. Figure 3b shows the assembling of mirror sheets with their aluminum frame on a steel structure.
