# The Characteristics and Seepage Stability Analysis of Toppling-Sliding Failure under Rainfall

**Abstract:** Toppling-sliding failure is a typical mode of deep-seated toppling failure. In this mode, massive collapsed rock masses form the main sliding body, which is sensitive to rainfall events and prone to instability under rainfall due to its unique slope structure. In the present study, based on the detailed investigation on the geology and deformation characteristics, we studied the deformation and failure mechanism of a large-scale deep-seated toppling in Nandongzi Village, Pingquan City, Hebei Province. We constructed an engineering geology model to describe the toppling-sliding failure under rainfall. In addition, based on the saturated–unsaturated seepage theory and using the SLOPE/W and SEEP/W modules in the GeoStudio software, we explored the seepage law and factors controlling the seepage failure of toppling-sliding under rainfall. From surface to interior, the slope can be divided into toppling-falling zone, strong toppling zone, slight toppling zone, and non-deformation zone. The geological structure consisting of an upper strong slab and an underlying weak rock layer

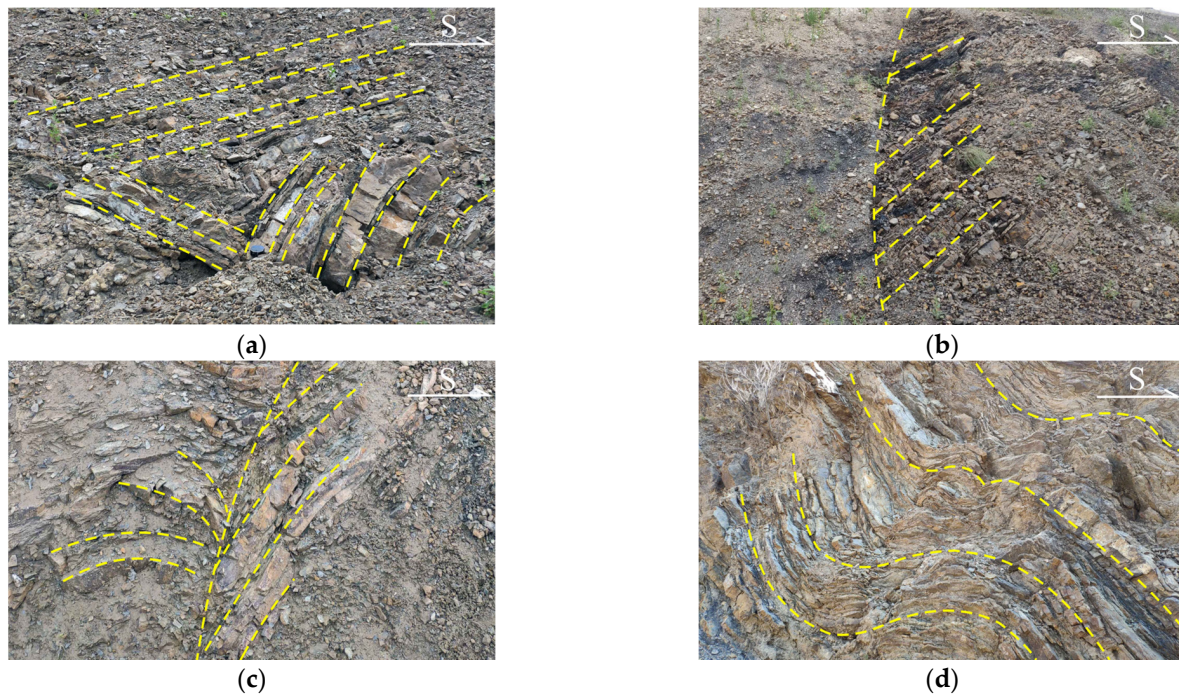
**Figure 3.** Typical bending and fracturing of the rock layers exposed on the slope surface. (a) complete fracturing; (b) different weathering degree; (c) obvious bending and fracturing; (d) bending folds.

Both the obvious bending folds and even the entirely fractured rock layers are highly developed in the Nandongzi toppling because it is located on the tectonically active south-east flank of the Huangzhangzi syncline and next to the Nanlaodong fault (Figure 3). Based on the varying rock quality designation (RQD) revealed by borehole drilling (the location of boreholes can be found in Figure 4), the degree of fragmentation and weathering rate is gradually getting higher from interior to the surface (Figure 5). The borehole drilling results, when combined with the detailed field investigation, revealed four distinct zones of the Nandongzi toppling: the toppling-falling zone, strong toppling zone, slight toppling zone, and non-deformation zone (Table 1). The toppling-falling zone ranges from 630 to 680 m asl and is mainly composed of quartz sandstone with loose cataclastic structures. The strong toppling zone ranges from 619 to 645 m asl, primarily consisting of siltstone and shale with apparent bending. The dipping angle of the rock layer in the middle of the toppling is nearly horizontal, while that in the north boundary of the toppling is  $70^\circ$  (Figure 6). Therefore, we suggest that the toppling direction is southwest. In addition, most of the borehole drilling results reveal a layer of wet and plastic silty clay with a thickness of about 20 cm at the bottom of the toppling-falling zone, indicative of the possible sliding surface (Figure 7).

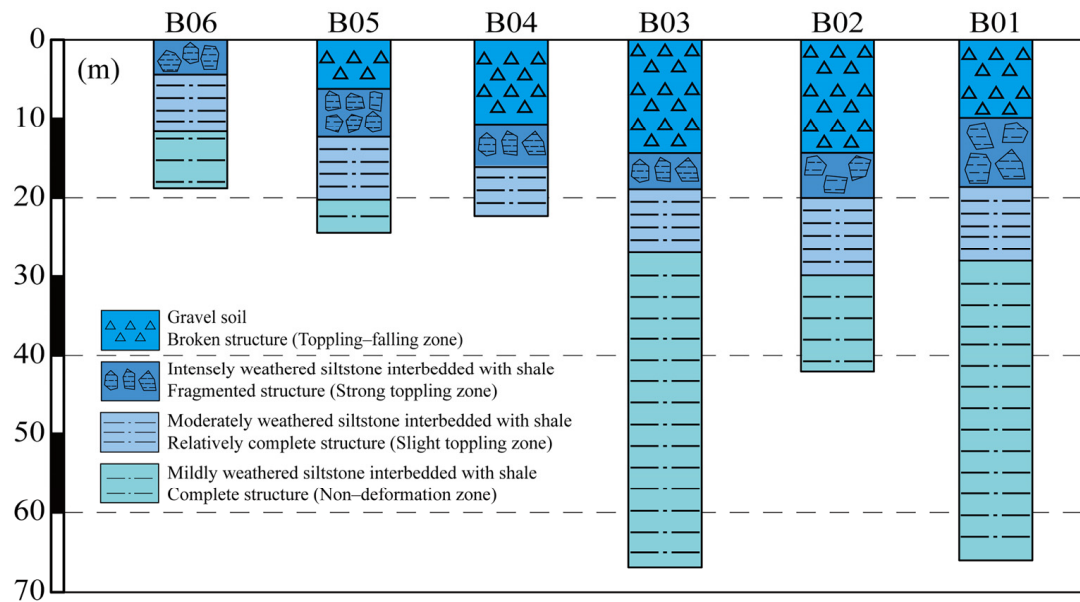
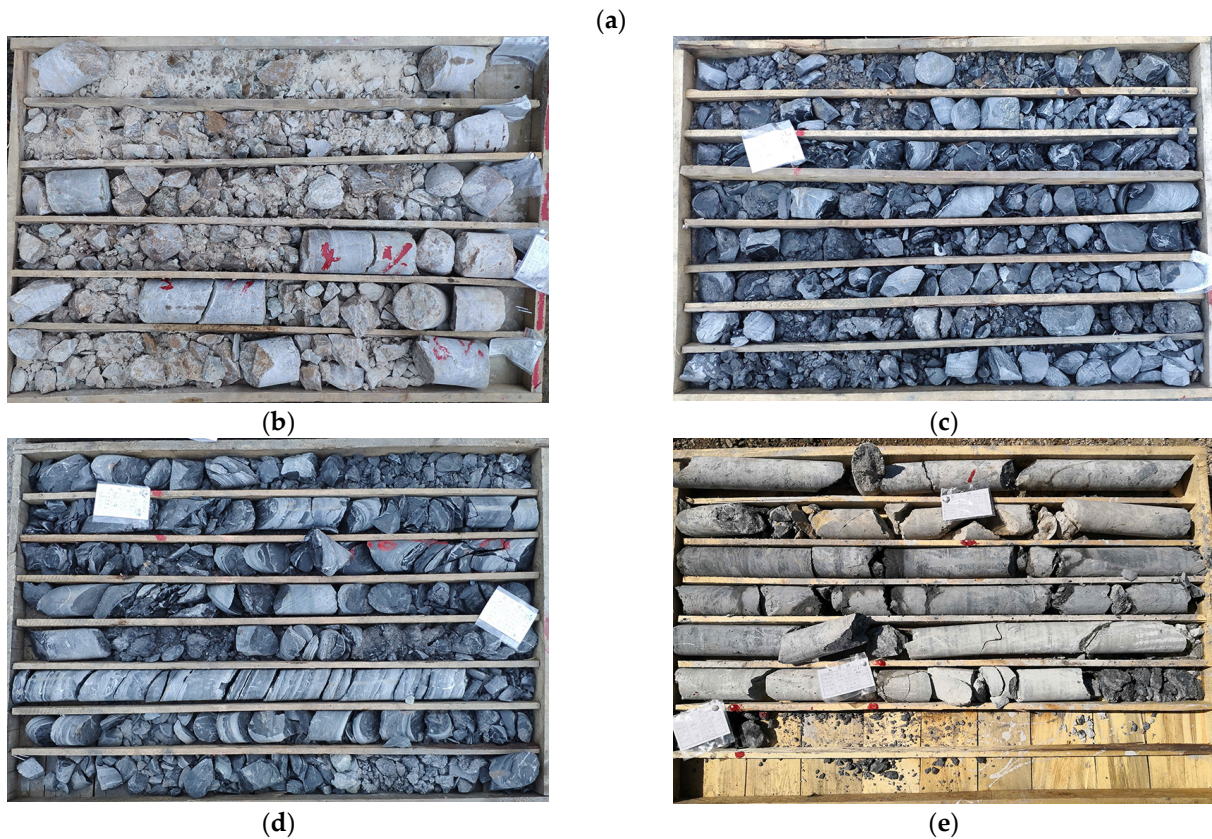
**Figure 5.** Lithological sections of six boreholes (a) (the locations of boreholes are shown in Figure 4), and typical photographs of drill core quality in toppling-falling zone (b), strong toppling zone (c), slight toppling zone (d), and non-deformation zone (e).

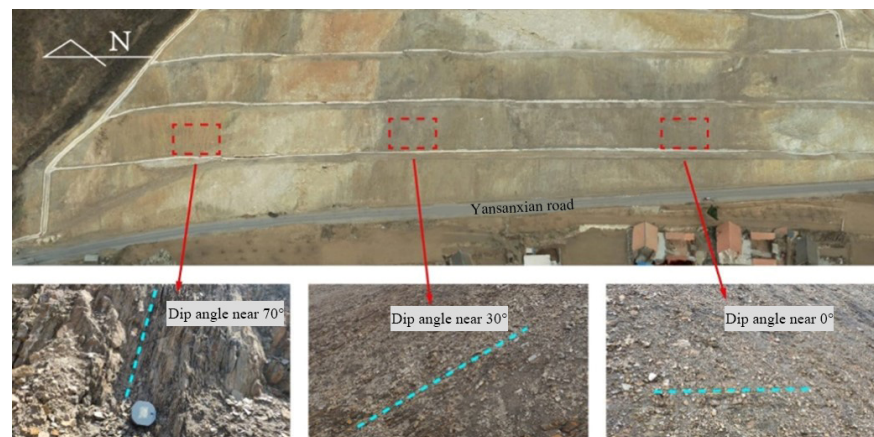
**Figure 6.** The deflection angle of the rock layer exposed on the slope surface, i.e., the evidence for the toppling.

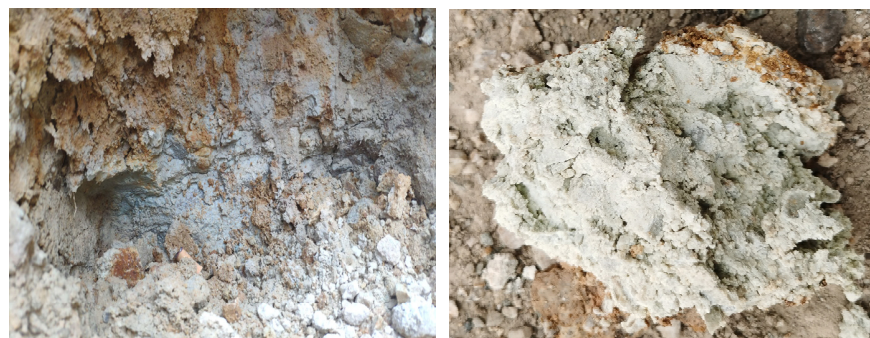
**Figure 7.** Grayish white–white silty clay revealed by borehole drilling results at the bottom of the toppling-falling zone.

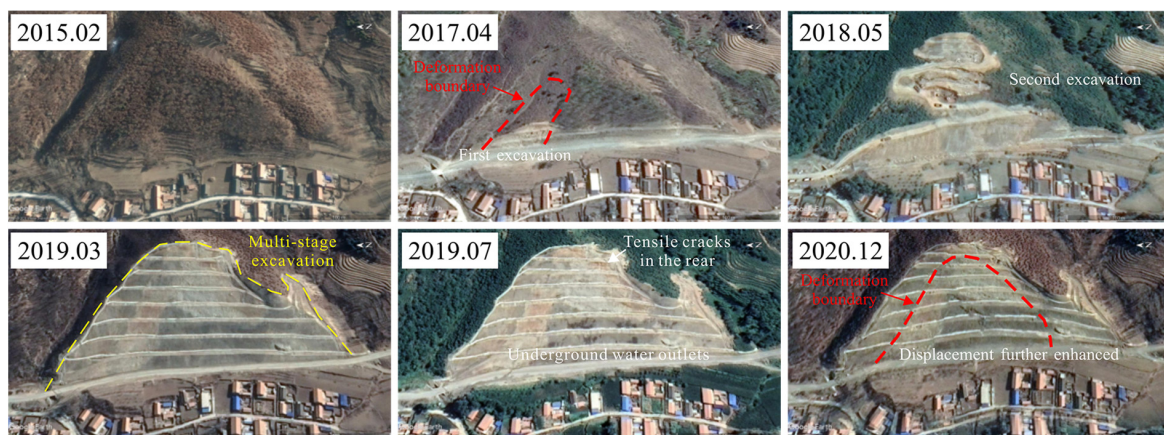
**Figure 8.** Deformation process revealed by remote sensing.

The formation process of the Nandongzi toppling is recorded by satellite imagery. In June 2016, a road named Yansanxian was excavated at the foot of the Nandongzi slope. Due to the excavation-induced unloading effect, the Nandongzi slope toppled again in 2017. A tensile crack with a width of 5–10 cm was developed at the rear edge, with a range from 619 to 645 m asl. The necessary countermeasures consisting of multi-stage excavation and drainage to improve the stability of the Nandongzi slope were implemented in 2018 and completed in the beginning of 2019. However, in July 2019, heavy rainfall induced new displacements in the Nandongzi slope. Based on detailed field investigations carried out in May and August of 2020, there are apparent underground water outlets in the foot of the slope (from 1st step to 3rd step). In August 2020, the magnitude of displacement

was further enhanced, and the shear and tensile cracks expanded rapidly (Figure 8). The fractures can be divided into three types: (i) 2–3.5 m high headscarp with a length of about 30 m in the rear of the toppling; (ii) tensile fractures characterized by 1.3–1.5 m openings which have a total length of about 60 m developed in the middle of toppling; and (iii) side shear fractures which cut off drainage ditches (Figure 4).

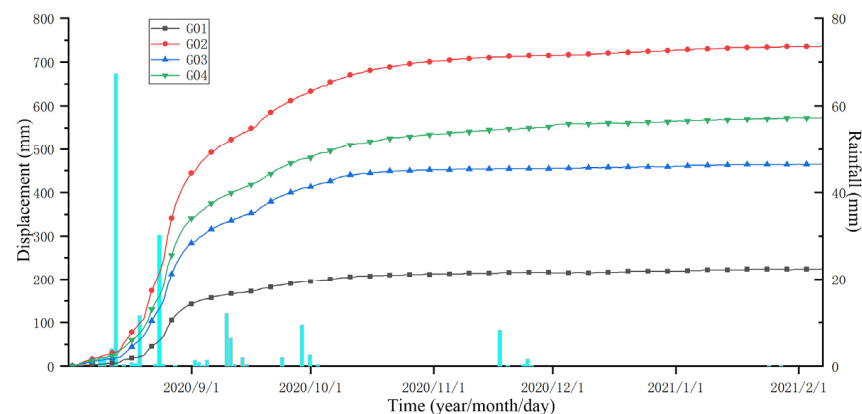
**Figure 9.** New displacement of the Nandongzi toppling and the in situ rainfall from July 2020 to February 2021.

In addition, a high correlation was found between the displacement and rainfall data acquired at the Nandongzi toppling in 2020. The displacement increased sharply after the rainfall events in August, and remained in the nearly same level when there was no rainfall. Because the displacement results acquired by G02 and G04 are larger than those from others, we set their connection direction ( $275^\circ$ ) as the main sliding direction of the Nandongzi toppling. These data show that rainfall seepage plays the most dominant role in the deformation and failure of the Nandongzi toppling at this stage (Figure 9). As a result, it can be concluded that the toppling-falling zone will be saturated under rainfall due to its high permeability; however, the rock mass in the strong toppling zone is relatively intact and results in low permeability. Therefore, the pore-water pressure at the junction zone between the toppling-falling zone and strong toppling zone will sharply increase, thereby significantly reducing the slope stability under rainfall (Figure 10).

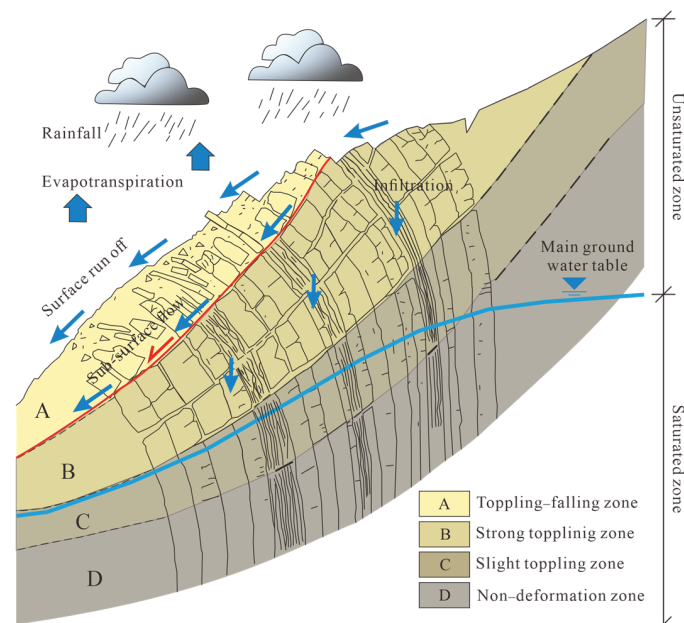
**Figure 10.** Engineering geology model displaying the toppling-sliding failure mechanism under rainfall (modified from Huang et al., [10]).

The formation process of the Nandongzi toppling basically includes two stages. Firstly, the progressive deformation of the Nandongzi toppling was controlled by geological structure, which consists of an upper strong thick-layer quartz sandstone and an underlying weak thin-layer siltstone interbedded with shale. The failure mode is compressing-bending-toppling [29]. Due to poor mechanical properties, the siltstone interbedded with shale is subject to bending under the compressive loading from the overlying strong quartz sandstone. Many release fractures in the quartz sandstone develop as a consequence of pre-failure progressive deformation in the underlying weak layer. Second, based on the high

degree of toppling, the toppling-falling zone slides along planar rupture planes dipping in the same direction as the slope under the influence of excavation and rainfall, during which the failure mode switches to creeping-cracking.

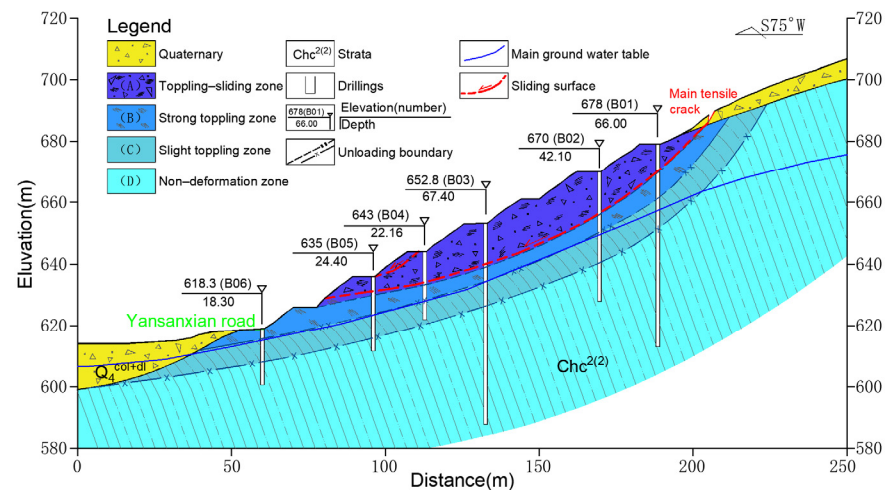
Figure 11. Geological profile of the Nandongzi toppling.

The two-dimensional finite element program SEEP/W, which can model both saturated and unsaturated flows under steady-state and transient conditions, was adopted in the present study. According to the material composition, structural characteristics, and deformation characteristics, the numerical model of the Nandongzi toppling for seepage stability analysis was successfully constructed (Figure 11). The model comprises 1467 nodes and 1415 quadrilateral mesh elements (Figure 12). At the beginning of the transient seepage analysis, a hydrostatic condition was established based on the groundwater level revealed by borehole drilling. The water table assigned at 2 m below the ground surface would undoubtedly produce a realistically negative pore-water pressure (27 kPa) near the surface [30]. The left and right edges below the water table were assigned as head boundaries with pressure heads equal to 28 m and 90 m, respectively. In contrast, the left and right edges above the water table, as well as the bottom edge of the model were specified as no-flow boundaries. The rainfall-induced seepage was simulated by applying a unit flux ( $q$ ) of varying intensities on the exposed slope surface.

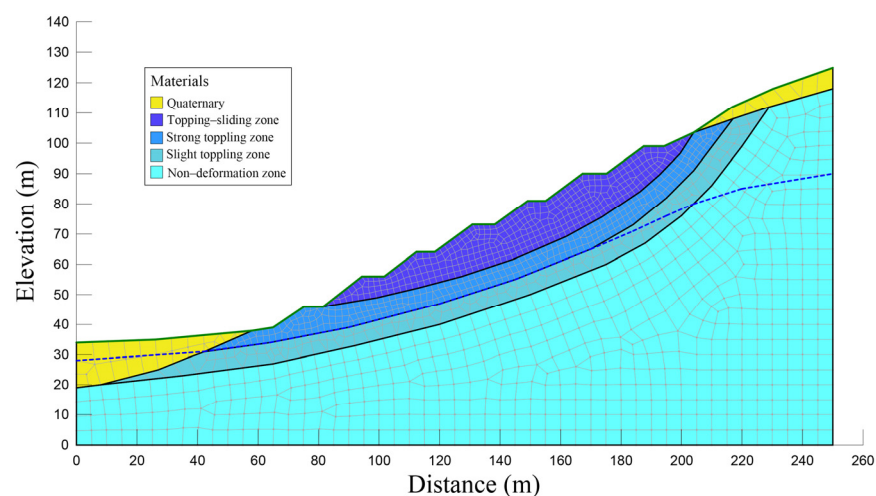
Figure 12. Numerical model of the Nandongzi toppling for seepage stability analysis.

the pore-water pressure profile computed from the seepage analysis using SEEP/W was then integrated into slope stability analysis using SLOPE/W and deformation analysis using SIGMA/W. The horizontal displacement was fixed on the left and right edges of the model, while the vertical displacement was fixed on the bottom of the model. The factor of safety was obtained using the Bishop's simplified method that employs a modified Mohr–Coulomb failure criterion to realize the rainfall seepage-induced shear strength variation in the toppling-falling zone.

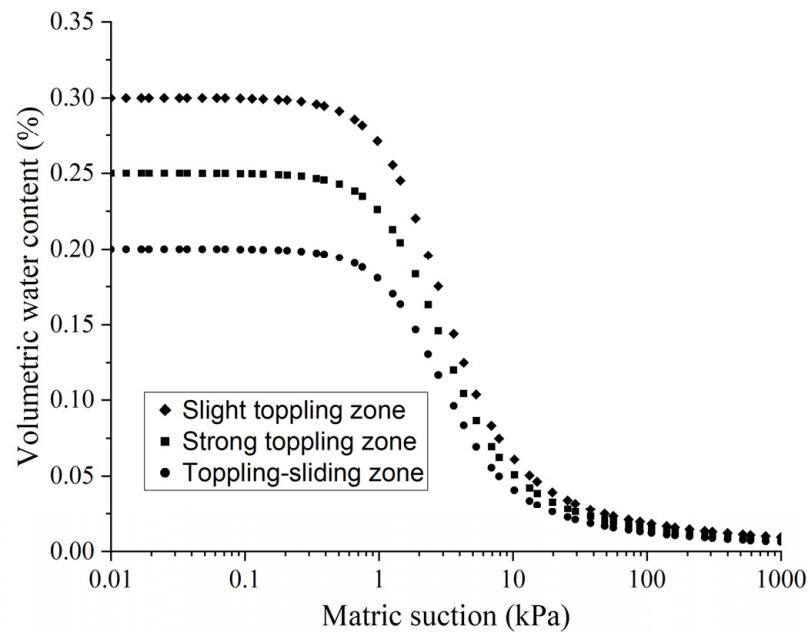
Figure 13. Permeability curve of the materials of three different zones.

In this study, we assumed that the transient water flow through unsaturated soils under rainfall infiltration obeys Darcy's law [32]. In unsaturated flow, the coefficient of permeability (hydraulic conductivity) is a function of water content or matric suction in unsaturated soils, which is conventionally assumed to be a constant in saturated soils [26].

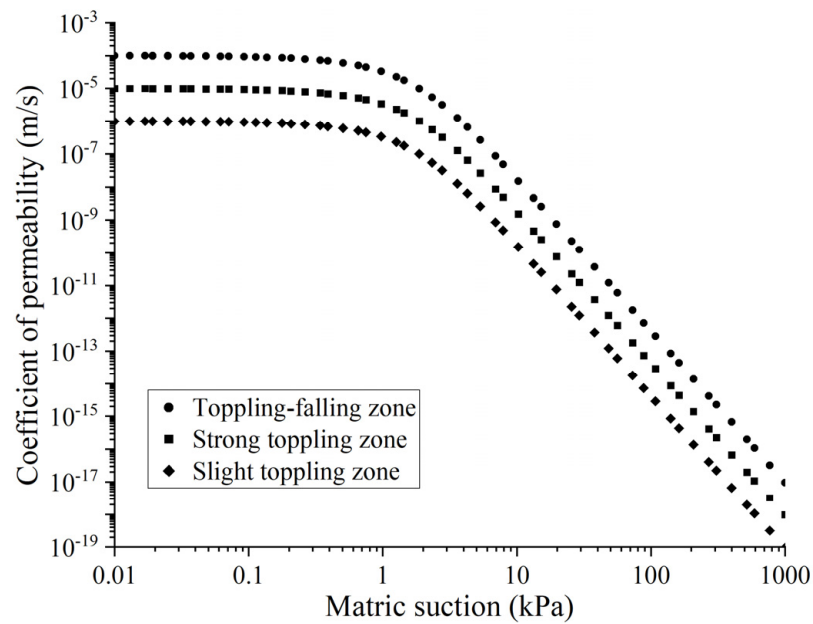
Figure 14. Soil-water characteristic curve (SWCC) of three different zones.

SEEP/W includes a set of sampled volumetric water content (VWC) functions for soils with varying textures. The VWC functions adopted here correspond to gravel material with saturated water contents of 0.2, 0.25, and 0.3 for toppling-falling zone, strong toppling zone, and slight toppling zone, respectively (Figure 13). Based on the double-ring seepage tests operated in the toppling-falling zone and differential zonation characteristics of the toppled rock masses, the soil–water characteristic curves (SWCC) were then estimated using the Van Genuchten method [33], in which the saturated hydraulic conductivity ( $K_{sat}$ ) was specified as  $1 \times 10^{-4}$  m/s,  $1 \times 10^{-5}$  m/s, and  $1 \times 10^{-6}$  m/s for toppling-falling zone, strong toppling zone, and slight toppling zone, respectively (Figure 14). The Mohr–Coulomb model was applied in the toppling-falling zone, strong toppling zone, and slight toppling zone, while the “solid” model was utilized in the non-deformation zone. Based on the standard testing methods consisting of direct shear tests and unconfined compression tests operated in the laboratory, the strength and physical properties of rock and soil materials in different zones were determined through the trial-and-error “back analysis”. The trial-and-error “back analysis” was performed in terms of the monitored maximum rainfall (67.4 mm). We applied a flux value ( $Q$ ) of  $7.8 \times 10^{-7}$  m/s at the boundary for 24 h. The properties listed in Table 3 provided the modeled results (Figure 15) that best reproduced the real stability state and displacement from the field survey and monitoring (Figure 9). In detail, the overall factor of safety is 1.229 (Figure 15a), but the local factor of safety is 0.959 (Figure 15b), which almost coincides with the secondary sliding zone developed within the Nandongzi toppling (Figure 16); in addition, the maximum deformation displacement is approximately 0.85 m near the foot of slope (Figure 15c), which almost coincides with the monitored data from G02 (i.e., 0.73 m), and the deformation displacement is 0.43 m at the G04 monitoring site.

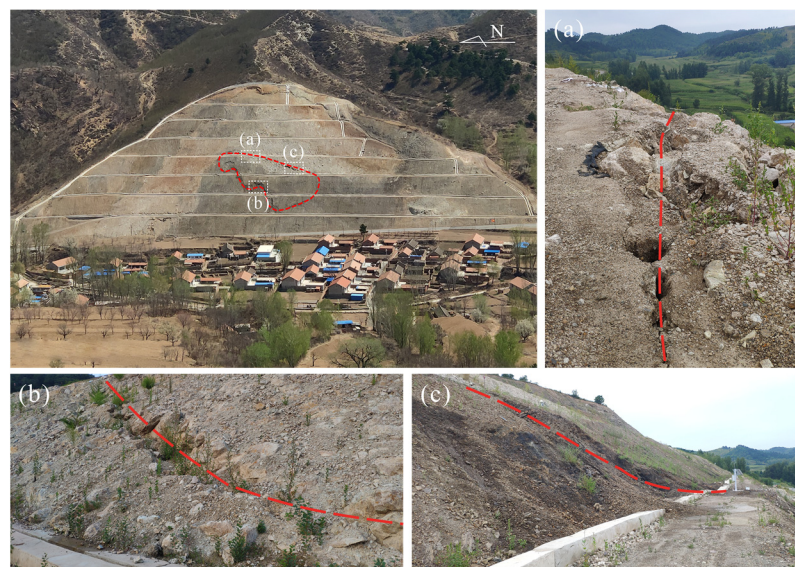
**Figure 16.** A secondary sliding zone developed within the Nandongzi toppling showing the connection of the (a) steep tension fractures at the rear edge of the secondary sliding zone, (b) shear fissures along the bottom sliding surface and (c) lateral scarps.

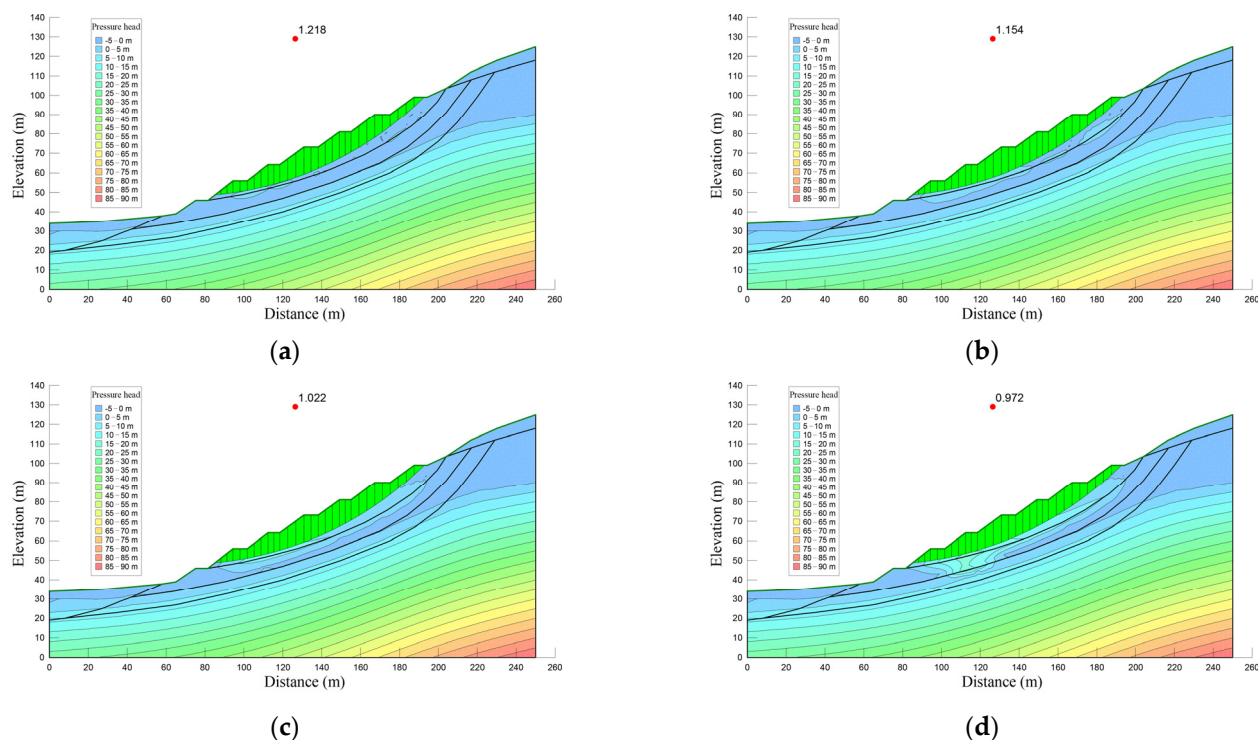
**Figure 17.** Slope stability under different rainfall intensities. (a) 5 years return period storm; (b) 20 years return period storm; (c) 50 years return period storm; (d) 100 years return period storm.

It appears that matric suction will not disappear and soils will hardly become saturated when the steady state rainfall is essentially less than the saturated hydraulic conductivity of the toppling-falling zone under five years return period storm (108 mm/day). The water flow direction is approximately perpendicular. Due to the soil's low moisture content and hydraulic conductivity, the rainwater seepage occur very slowly in the early stage of rainfall. The factor of safety changes slightly with the deepening of the wetting band until the wetting band reaches the strong toppling zone. Furthermore, the variation of hydraulic

conductivity forms a perched water zone, and high pore-water pressure is observed at the boundary between the toppling-falling zone and strong toppling zone. The amount and extent of pore-water pressure at the boundary between the toppling-falling zone and the strong toppling zone rise as rainfall intensity increases, thus leading to an increase in rainfall intensity and a reduction in the factor of safety.

For the 176 mm/day rainfall intensity (20 years return period storm), the factor of safety decreases to 1.154 which indicates a basically stable state. For the rainfall intensity of 220 mm/day (50 years return period storm), the pore-water pressure can be observed across the boundary between the toppling-falling zone and strong toppling zone, hence the factor of safety dropped to 1.022 (marginal stable state). For the rainfall intensity of 256 mm/day (100 years return period storm), seepage results in the rise of the main groundwater table, and hence the factor of safety further decreases to 0.972 (unstable state). Overall, rainfall intensity has a strong influence on the stability of the Nandongzi toppling, i.e., when the rainfall intensity exceeds 220 mm/day (50 years return period storm), the factor of safety will fall below 1.05 and the failure may be triggered.

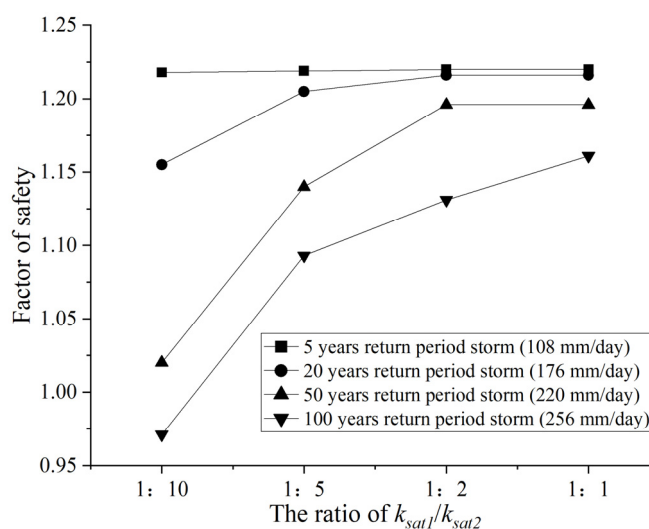
Figure 18. Slope stability under different rainfall intensities and the ratio of  $k_{sat1}/k_{sat2}$ .

In addition, different saturated coefficients of permeability of the strong toppling zone (i.e.,  $k_{sat1} = 1 \times 10^{-5}$ ,  $2 \times 10^{-5}$ ,  $5 \times 10^{-5}$ , and  $1 \times 10^{-4}$ ) were applied to study the effect of the ratio of  $k_{sat1}/k_{sat2}$  on the stability of the Nandongzi toppling, while saturated coefficients of permeability of the toppling-falling zone ( $k_{sat2} = 1 \times 10^{-4}$ , i.e., the ratio of  $k_{sat1}/k_{sat2} = 1:10$ ,  $1:5$ ,  $1:2$ , and  $1:1$ , respectively) and other conditions remain unchanged. It can be seen in Figure 18 that the factor of safety increases as the ratio of  $k_{sat1}/k_{sat2}$  increases, but the increase rates are affected by rainfall intensity. Notably, these rates are significantly greater in high rainfall intensity, suggesting that the ratio of  $k_{sat1}/k_{sat2}$  and rainfall intensity control the pore-water pressure, which the safety factor of the Nandongzi toppling is susceptible to, developed at the boundary between the toppling-falling zone and strong toppling zone.
