Supplementary information

Shrinkage of Nepal's Second Largest Lake (Phewa Tal) Due to Watershed Degradation and Increased Sediment Influx

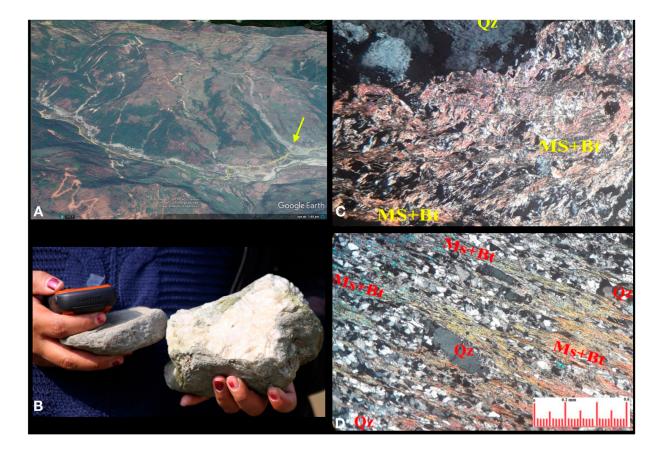
Figure S5. (a) A 2015 landslide sourced in the Kuncha formation and nearly reaching Harpan Khola, composed of rocks such as these (b) shown in the thin section (crossed polarizers): (c) the pelitic schist and (d) psammitic schist, commonly forming meta-conglomerate ((b), right). In (c) and (d), Qz = quartz, Ms = muscovite, and Bt = Biotite, and the scale bar is 0.6 mm. Panel (a) is a DigitalGlobe scene projected in Google Earth (acquisition date 10 March 2016).

Geology— along with slope and precipitation factors considered by Dhakal (2016)— is an underpinning of both the suspended sediment load of the Phewa watershed and of the landslide and debris flow production and delivery of sediment to the watershed's rivers, such as Harpan Khola. Bedrock formation nomenclature, stratigraphic positions, and tectonics are inconsistently mapped in Nepal's Lesser Himalaya, including Pokhara Valley. Older mapping-though still in use-consider the whole area of the Pokhara Valley's bedrock to be in the Seti formation (gray to greenish gray phyllites, gritty phyllites, quartzites with minor conglomeratic layers and basic intrusions; Hada 1982). Newer mapping considers the Phewa watershed bedrock to be divided between the Kuncha formation (meta-sandstone, phyllite, and conglomerate; also termed the "Ranimata formation") and Fagfog Quartzite (quartzite-phyllite-amphibolite) (Koirala et al. 1998, Paudel and Arita 2000, DeCelles et al. 2004, Martin et al. 2011, Cross 2014). Our observations indicate that phyllite, psammitic (sand-derived) and pelitic (mud/silt-derived) mica schist, metaconglomerate, and quartzite dominate the Harpan Valley and its main tributary, the Andheri Khola valley. Examples from a 2015 landslide in the Harpan Valley, derived from the Kuncha formation, are highlighted in Figure S5. Though conglomerate and coarse-grained quartzite is present, the mineralogical content of most rocks observed in the area include a preponderance of silt-size quartz, as well as mica minerals, muscovite and biotite. The preserved bedding and metamorphic schistosity may lend itself to rock failure along those micro- and meso-structural contacts; furthermore, high-energy landslides may tend to break down along the contacts and grain boundaries of the micaceous rocks to produce large amounts of silt composed mainly of the minerals seen in Figure S5. That fine material is then carried in suspension by the Harpan/Andheri River system to Phewa Lake.

Koirala et al. (1998) mapped a large number of active and old landslides; most are within the Kuncha formation. Disproportionately far fewer landslides are developed in the Fagfog Quartzite—though these include the largest 2015 landslide—and most of those are located very near the contact with the Kuncha formation. Many other large landslides in Nepal are also developed in the Kuncha formation, such as the giant Jure landslide. The Harpan watershed's largest 2015 landslide (detailed in Figure S3) occurs on the axis of an anticlinal fold. The anticline and other folds extend up the Harpan Valley from Phewa Lake to that landslide. Newer geological mapping indicates that a major tectonic thrust—the Ramgarh Thrust—cuts through the area. The major tectonic features may have weakened the rocks and juxtaposed contrasting lithologies, which can contribute to landslide development. The fact that the same landslides are repeatedly reactivated in the Harpan-Andheri valley indicates that the weakness vulnerabilities extend deep into the bedrock, as, of course, the main tectonic structures do. Conditioning and triggering of landslides by earthquakes, road building, and monsoon precipitation are expected to be frequent reoccurrences and to affect the Kuncha formation disproportionately and mainly spare the Fagfog Quartzite, except near its stratigraphic contact with the Kuncha formation. Larger landslides than those of 2015 are possible and could cause big spikes in the siltation of Phewa Lake.

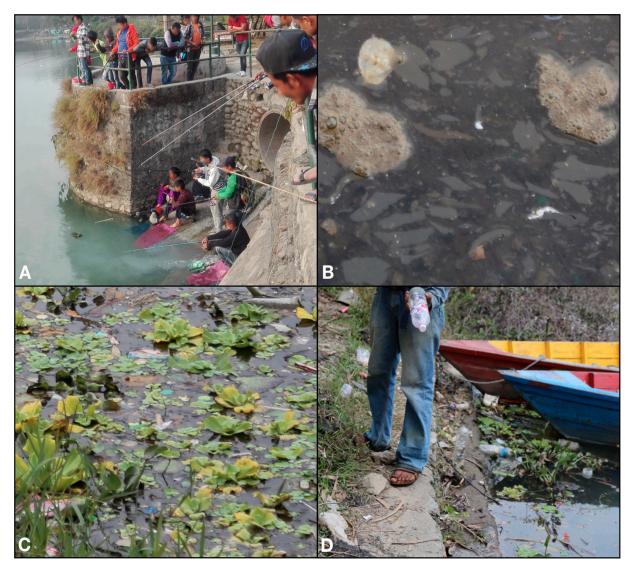
Figure S6. Environmental water quality and ecological problems of Phewa Lake. (a) Outlet pipe emits wastewater into the lake, where fishermen extract fish. (b) Evidence of the wastewater effects on water quality. (c) Water hyacinth, an aggressive invasive species from the Amazon Basin has invaded Phewa Lake. (d) Plastic pollution and water hyacinth.

The rampant growth of water hyacinth is maximised by high aqueous organic content, such as in sewagecontaminated sites (Rezania et al, 2015), and by water temperatures in the 25-30°C range (Kasselmannn 1995), thus suggesting that urban growth of Pokhara, poorly treated effluent discharges into Phewa Lake, and climate warming (cf. Figure 3e) could act to increase the water hyacinth problem.
