Article

Forgotten Nazi Forced Labour Camps: Arbeitslager Riese (Lower Silesia, SE Poland) and the Use of Archival Aerial Photography and Contemporary LiDAR and Ground Truth Data to Identify and Delineate Camp Areas

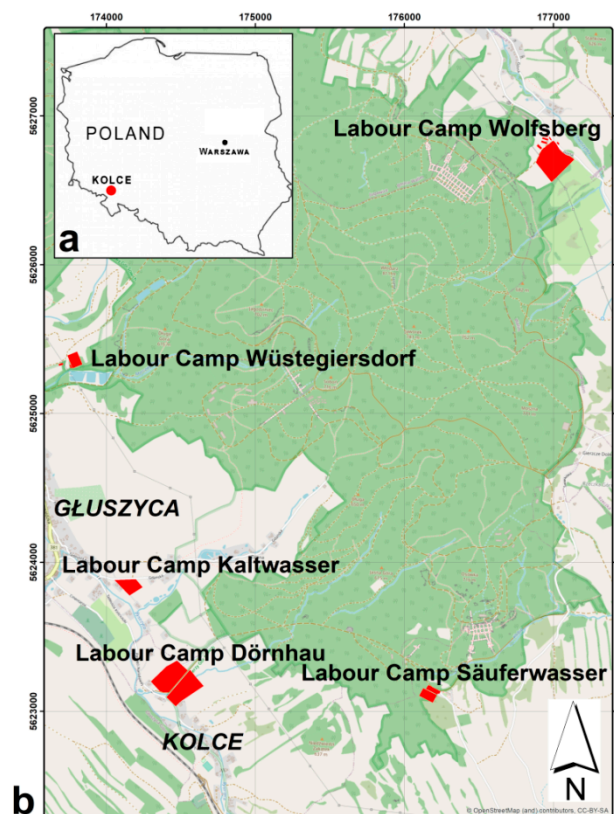
Figure 1. Study Area: (a) overview map with the marked location (red point) (b) and map with the former camps selected for the study. Coordinate grid: UTM Zone 34 N (EPSG: 32634). © OpenStreetMap.

The area in question is situated in Central Sudetes (Figure 1), which constitutes the northern part of the Bohemian massif. The area is on the border between two physiographical units, the Nowa Ruda Depression and the Owl Mountains (Góry Sowie in Polish or Eulengebirge in German). The mountainous part is called the Włodarz massif and consists of five peaks: Włodarz (Ger. Wolfsberg), Soboń (Ger. Ramenberg), Moszna (Ger. Mulenberg), Osówka (Ger. Säuerhöhen), and Ostra (Ger. Spitzenberg). This massif, as well as other parts of the Owl Mountains, is mainly composed of migmatites and gneisses of Cadomian origin [28]. The area to be investigated encompasses four Gross-Rosen auxiliary camps and auxiliary camp where forced laborers working for the local Friedrich Krupp AG branch were held. The exact borders and locations of the chosen spots have not been established with complete certainty until now. Immediate identification and confirmation are required.

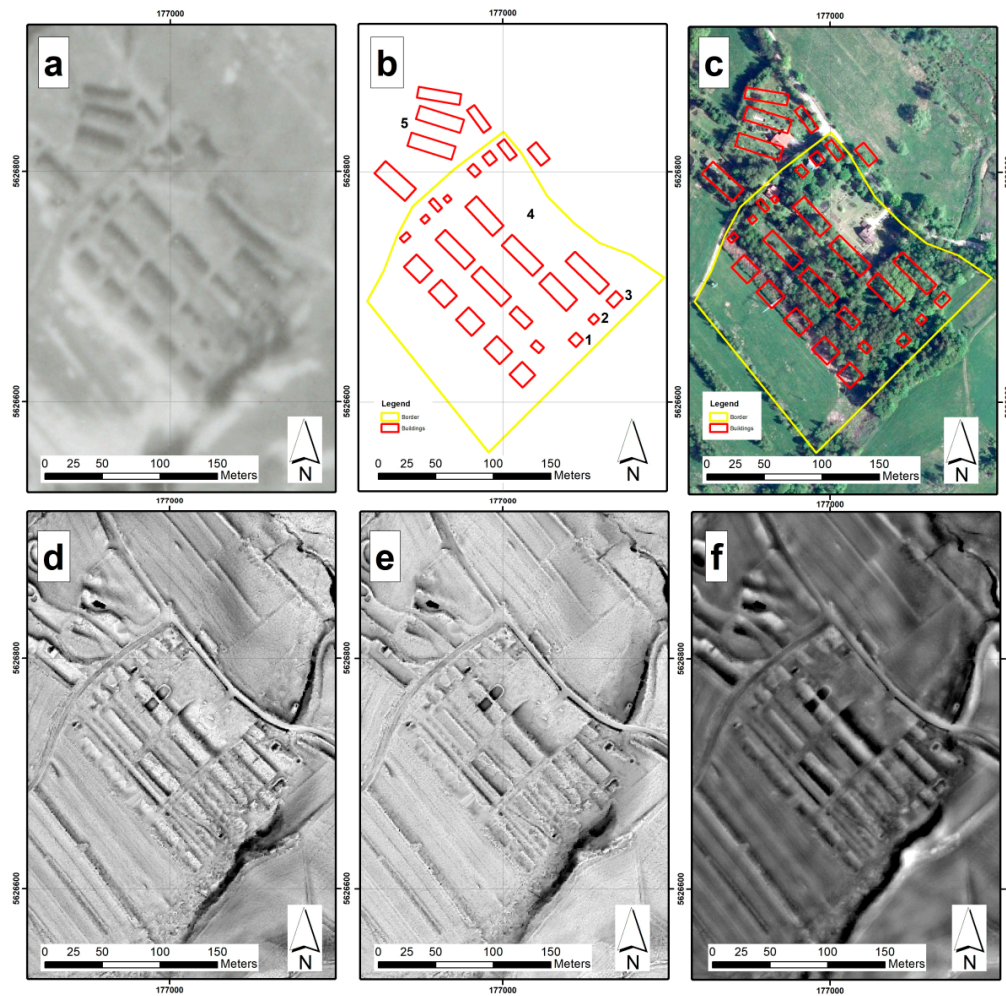
The scale of the aerial photo does not allow for the application of direct features to delineate the camp area. Therefore, indirect features were used in that task: the surrounding roads, the footpaths, and the general outline of the buildings seen on the archive photo (Figure 3a) that received the SVF treatment (5 m: Figure 3d), which additionally emphasized the topography of the terrain. The area of the camp, when established via use of the aforementioned processes, amounted to 3.60 hectares. The authors were able to identify 29 buildings, which ranged in size from 30 sq. m to around 490 sq. m (Figure 3b). It was not possible to locate some of the camp objects mentioned by witnesses in their testimonies; the location of the small wooden huts with a round base, as well as that of the dugouts, was never established. Such small objects are not visible on the 1945 photo, and the changes to the land did not withstand the passage of time. At the moment, the southern part of the former camp area is covered by trees, as can be seen on the orthophotomap (Figure 3c). It is there that one can find the remains of the camp buildings: the foundation for the barracks and the kitchen (Figure 4), the lavatory, the water tank (Figure 5), the garbage dump, and the sump. The wooden and metal elements of the barracks were looted, and one can observe many signs of conscious salvage of brick material on many surviving buildings. Different sizes and divisions of the former camp buildings allow for the formation of a hypothesis that the buildings were put up very rapidly by an unskilled workforce consisting of prisoners. It seems that the construction was carried out according to executive orders and not construction plans or blueprints. The fact that there was no outside plastering on the buildings points to their temporary nature and the limited timeframe of their usage (1–2 years). Now, there are some single-family houses located in the remainder of the former camp area.

Figure 3. Labour camp AL Wolfsberg: (a) Aerial photo taken in February 1945 (© NARA), (b) reconstruction of camp based on '45 photo: 1—bath, 2—kitchen, 3—water tank, 4—assembly ground, 5—barracks of the camp HQ and the staff, (c) recent orthophoto of camp area with outlined camp plan (© Head Office of Geodesy and Cartography in Poland), (d) SVF image (radius 5 m), (e) Openness positive image (radius 10 m), (f) Local Dominance image (min./max.: 10 m – 10 m). Coordinate grid: UTM Zone 34 N (EPSG: 32634).

- (1) The lack of specific plans of camps is visible on the layout of the structure and foundation of its elements (e.g., Figures 3 and 9). The camp facilities are located randomly and against their functionality and operational safety. Camp kitchens and food warehouses, as well as the baths, are often situated in low grounds and morasses. Camp baths were located as close as possible to streams or surface intakes (common in depressions) of water, not taking into account sewage outflows (corresponding slopes). The camp barracks were placed not in regular rows at appropriate intervals but tightly in favorable terrain, which adapted to the needs of the camp at the lowest cost of the work done.

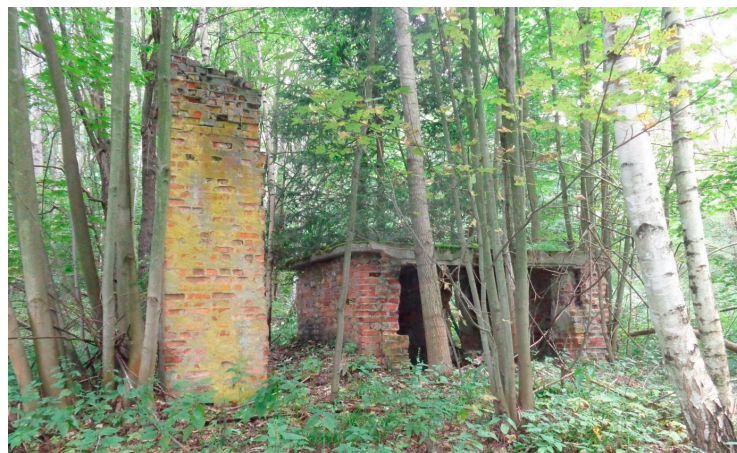
Figure 4. Remains of the camp kitchen, AL Wolfsberg; photo P. Lewandowski.

- (2) The lack of proper load-bearing walls and low quality of concrete structures were observed (Figure 4). Exterior walls with a height of 1 to 1.5 meters made of brickwork having a thickness of 25 to 40 cm; the cement-lime mortar layer is uneven and varies from 1 to 3 cm thick. Partitions were made from a single brick wall. Concrete constructions lacked steel reinforcements. The concrete mix contained ill-sorted aggregate composed of local rocks: Carboniferous gravel (weathered Carboniferous conglomerate) and broken fragments of Neogene basalts.

- (3) Lack of proper horizontal and vertical leveling of external walls (Figures 4 and 7)—the levels were transferred using formwork boards.
- (4) The primary building materials for building the most of the camp facilities were mortar-bonded bricks and wooden elements (recently not present). The red ceramic brick (Figure 4) was bonded using mortar made of cement mixed with lime and ill-sorted aggregate. Not less than 20% of

- (5) No traces of plastering were found (Figure 4).
- (6) Freestanding chimneys (Figure 16) built without foundation footing and internal reinforcement, no refractory brick inside.
- (7) Lack of installation elements of metal plumbing.
- (8) Camp prisoners used raw water collected from neighboring streams and ponds rather than water wells. No traces of water treatment installations have found during archival research as well as a field survey.

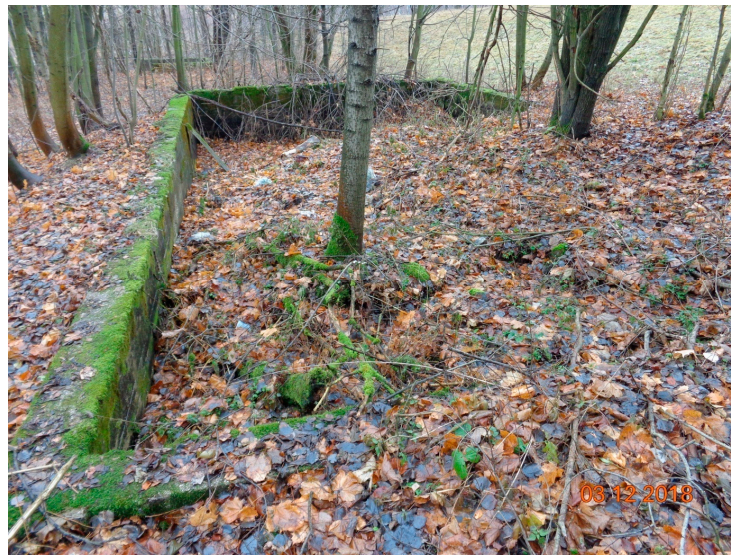
Figure 5. Remains of the camp's water tank, AL Wolfsberg; photo P. Lewandowski.

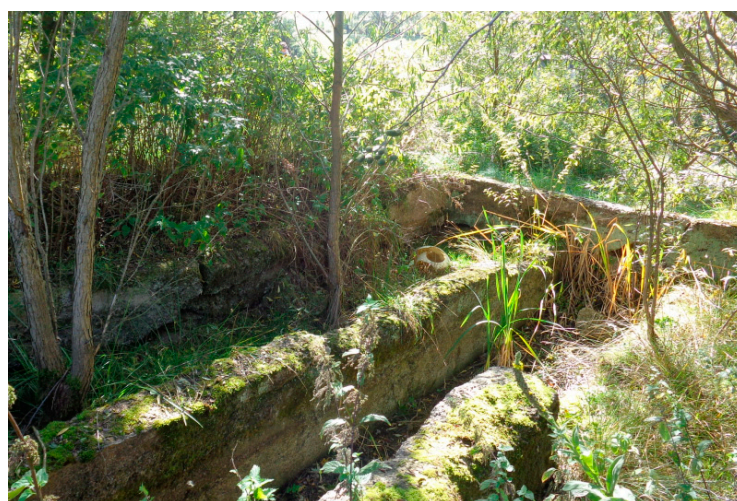
Figure 7. Concrete remains of the presumed cesspool, AL Kaltwasser; photo P. Lewandowski.

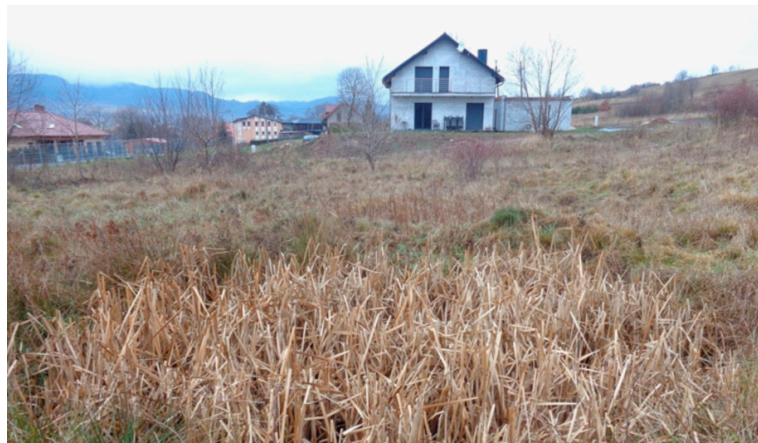
Figure 8. Contemporary house built on the site of the former AL Kaltwasser camp; photo P Lewandowski.

Two smaller buildings are also visible; however, their function was impossible to establish with certainty. The outlines of the buildings established based on the aerial photo were compared using an OP (10 m: Figure 6e), which allowed for the partial modification of their outlines. One of the smaller buildings (recognized on the aerial photo: Figure 6a) has remained in good shape until today. A field analysis allowed to identify it as a cesspool/overflow separator (concrete, constructed using formwork), which transported sewage outside of the camp area (Figure 7). Clay pipes connect to the separator. The camp's fence was delineated using indirect features, the surrounding roads and camp infrastructure. The camp area was around 1.12 hectares (Figure 6b). Most of the fence elements in the analysed labour camps consisted of wooden poles that supported a razor wire framework. The entry gate was also made of wood. Due to their makeshift nature, the fence and gate were the first structures to fall to looters shortly after the War. Despite the fact that within the area of the former Kaltwasser camp one can still recognize fragments of the foundation of the camp's buildings, the terrain was divided into smaller plots (the southwestern part of it), probably in order to prepare them for sale. At the southeastern border of the camp, a single-family house was built (Figures 6c and 8).

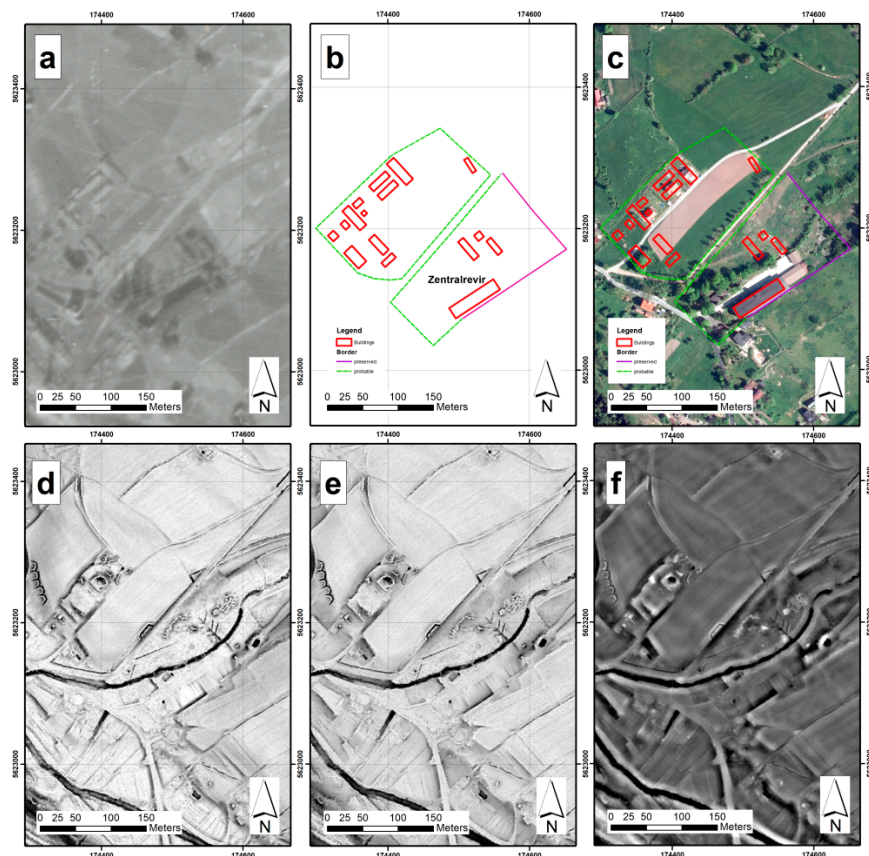
The camp was located by the road from Dörnhau (now called Kolce) to Tannhausen (now Jedlinka). The photo from 1945 (Figure 9a) shows two separate camps: one in the north with camp barracks and one in the south, where a linen textile factory was located (Figure 10a).

Figure 9. Labour Camp AL Dörnhau: (a) '45 aerial photo (© NARA), (b) reconstruction of camp based on '45 photo, (c) recent orthophoto of camp area with outlined camp plan (© Head Office of Geodesy and Cartography in Poland), (d) SVF image (radius 5 m), (e) Openness positive image (radius 10 m), (f) Local Dominance image (min./max.: 10 m – 10 m). Coordinate grid: UTM Zone 34 N (EPSG: 32634).

The remains of the barbed wire fence that surrounded the southern part of Dörnhau from the factory side are still visible today (Figure 9c). The fence was constructed using premade concrete elements that supported a razor wire framework (Figure 10b). The latter is also still visible today.

The orthophotomap also shows the fence (Figure 9c), which is not visible on the photo from 1945. The objects in the northern part of the camp (the barracks) were dismantled after 1945 and today the area is covered in private houses. However, in the areas that were not built over, even today one can still see a few elements of the camp's foundations. Very often, the outline of the camp's barracks can only be identified by using terrain irregularities and spotting individual bricks lying around that used to form the foundation. The existing construction materials have been damaged through exposure to the elements.

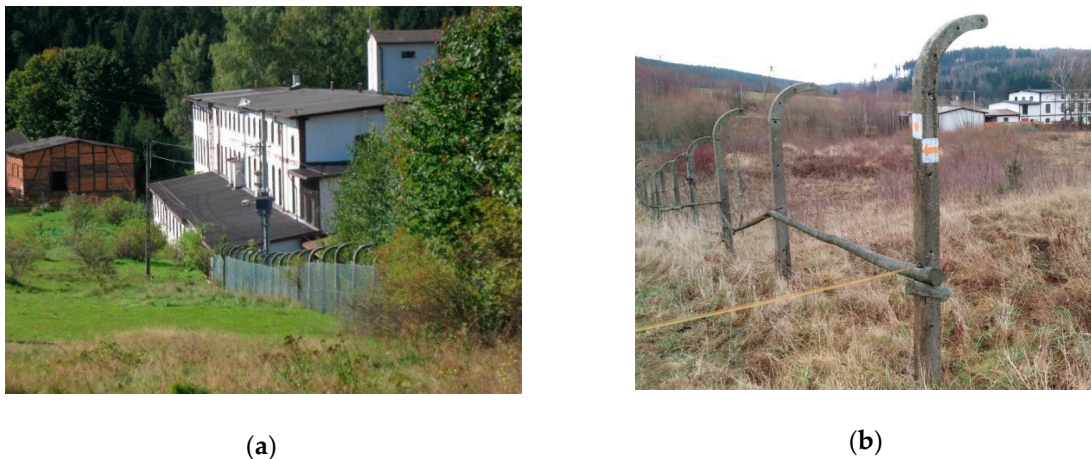
Figure 10. The remains of the fence surrounding the former AL Dörnhau camp: (a) the southern part of the factory building (white walls) and a row of concrete fence posts with modern fencing mesh; (b) the row of concrete post fence is restricting the former camp area from the northeast; in the background factory buildings; photos: A. Burakowski.

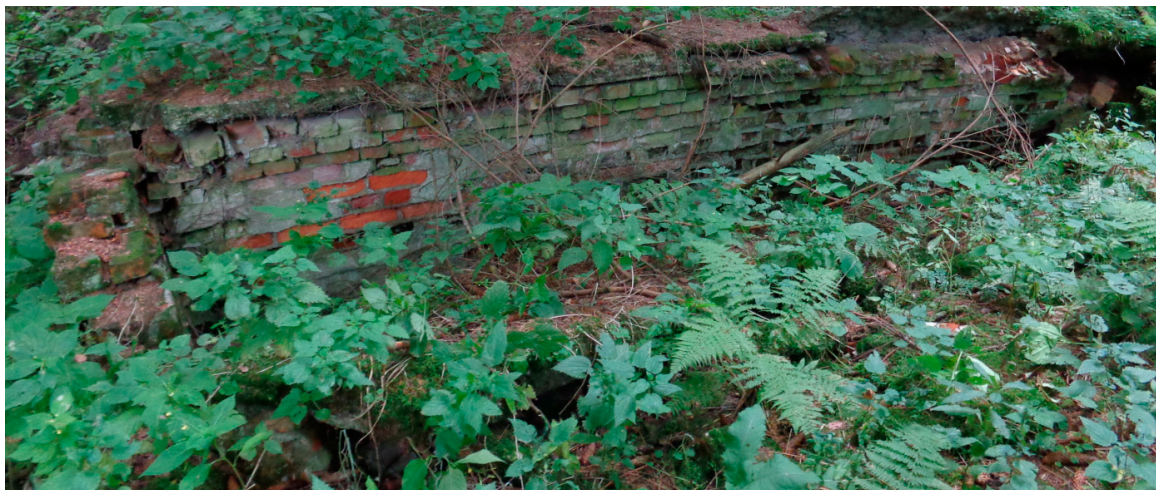
Figure 12. Remains of the barrack's brick underpinning, former AL Säufewasser camp; photo P. Lewandowski.

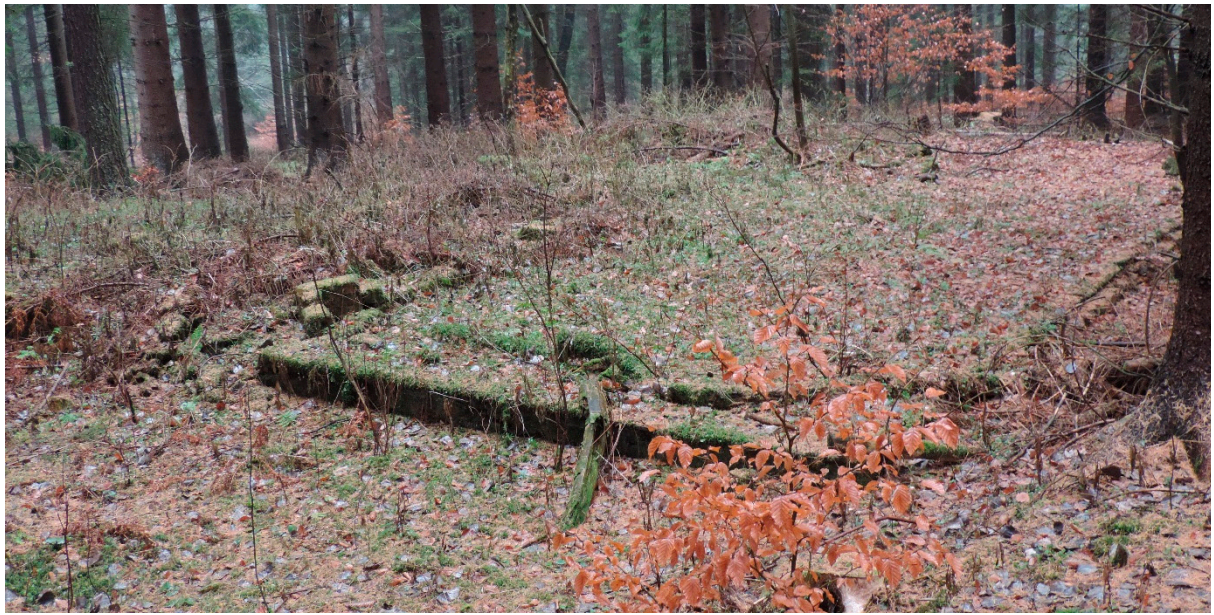
Figure 13. Remains of the barrack's foundation, AL Säufewasser; photo P. Bylina.

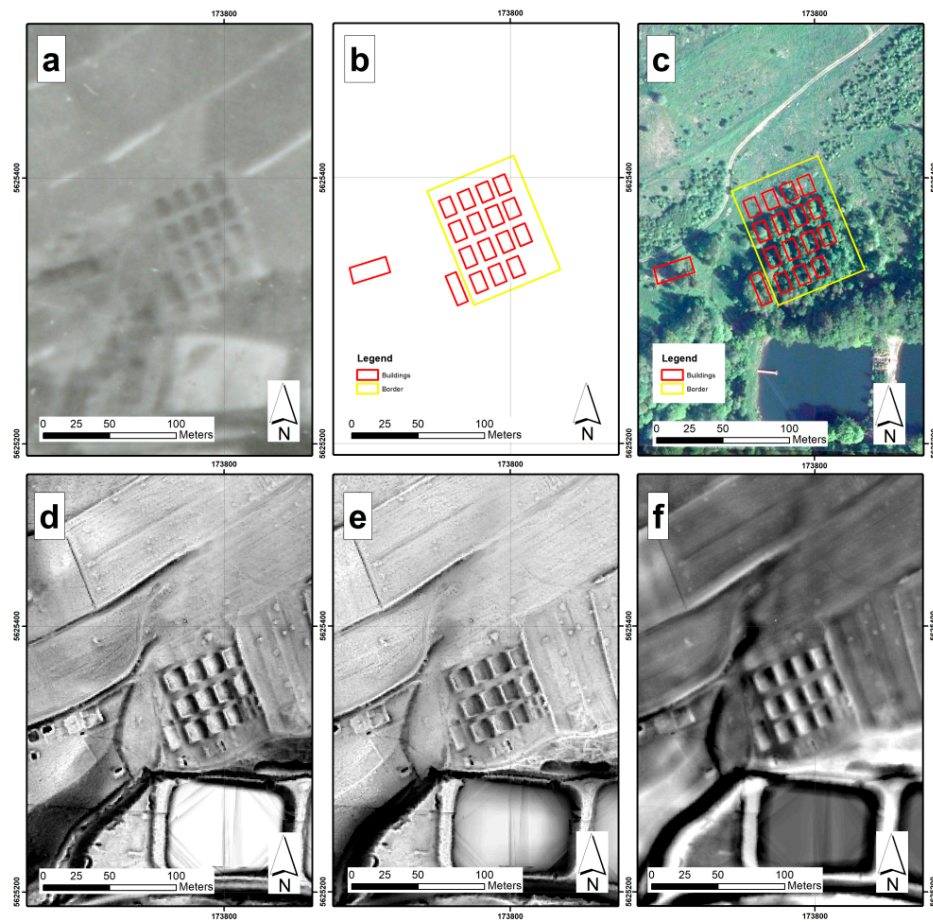
The photo from 20 February 1945 (Figure 14a) shows the camp in the last stage of its functioning. Most probably, the camp where the forced laborers were kept was not evacuated in February 1945 but continued operating until May of the same year. Seventeen camp buildings were located in the process of interpreting the photos (Figure 14b). They were surrounded by a fence. The camp area was around 0.65 hectares. Apart from the area for the forced labourers, two other buildings were also located nearby: one close to the western border of the camp (most probably the headquarters building) and another one, whose purpose was difficult to establish. After a SVF (5 m: Figure 14d) and OP analysis, the second building turned out to have been a cluster of three buildings, instead of, as was previously assumed, a single entity. It could have functioned as the kitchen, the workshop, and the warehouse. Some elements of the former camp survived to the present day (Figure 14c). The foundation of the barracks and administrative buildings is still visible. The area is covered by a mixed forest in the south and is one of the few camps whose remains are still visible today (Figures 15 and 16) and where the terrain was not built over. It is believed that, in the future, Wüstegiersdorf can be appropriately commemorated because the problem of purchase of land with existing buildings would not exist here.

Figure 14. Presumed forced labour camp for Krupp factory in Wüstegiersdorf (Krupp Lager für die Zwangsarbeiter Wüstegiersdorf): (a) '45 aerial photo (© NARA), (b) reconstruction of camp based on '45 photo, (c) recent orthophoto of the area with outlined camp plan (© Head Office of Geodesy and Cartography in Poland), (d) SVF image (radius 5 m), (e) Openness positive image (radius 10 m), (f) Local Dominance image (min./max.: 10 m – 10 m). Coordinate grid: UTM Zone 34 N (EPSG: 32634).

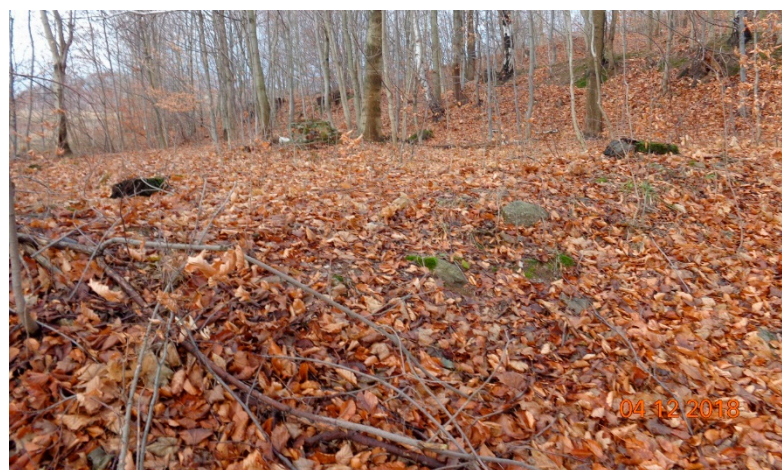
Figure 15. Artificially formed terraces with remains of a chimney, Krupp LZA Wüstegiersdorf; photo P. Lewandowski.

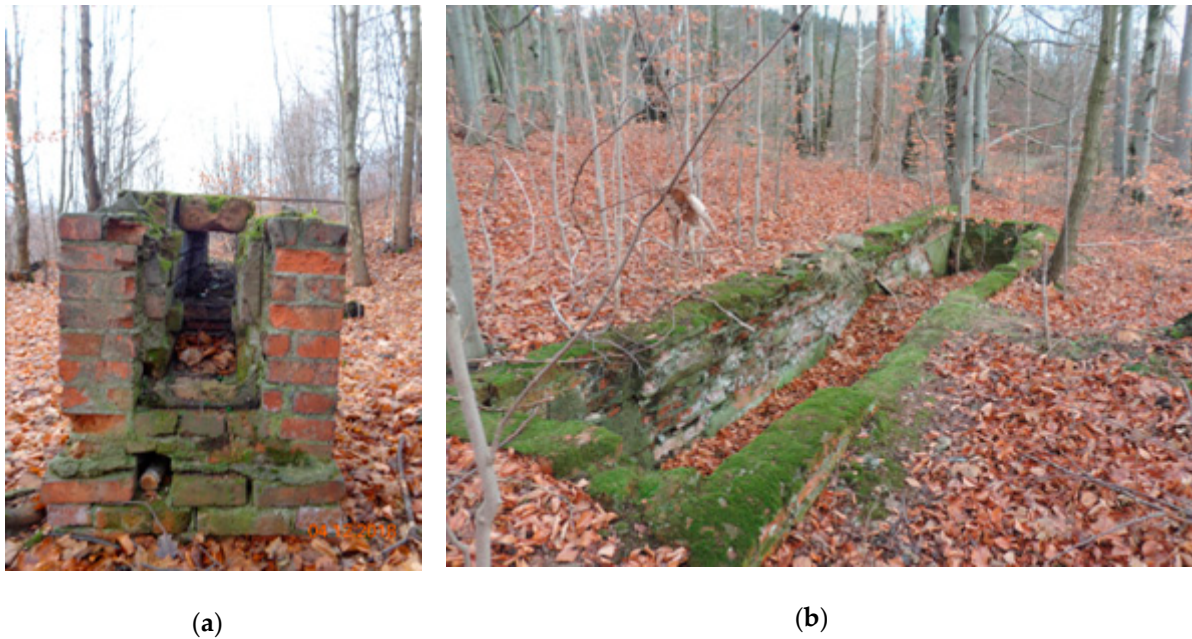
Figure 16. The remains of the barracks of the Krupp LZA Wüstegiersdorf: (a) remains of the chimney; please, note the two-sided access to the furnace, photo P. Lewandowski; (b) the remains of the presumed pantry, photo P. Bylina.
