# A Quantitative Analysis of Surface Changes on an Abandoned Forest Road in the Lejowa Valley (Tatra Mountains, Poland)

**Abstract:** The main aim of this research was to determine the magnitude of geomorphologic changes within a section of a forest road. The research was carried out in the Lejowa Valley in the Tatra Mountains. The measurements of the surface of the road were performed using a RIEGL VZ-4000 terrestrial laser scanner (TLS). TLS models for 2017, 2018, and 2019 served as the basis for the determination of quantitative and spatial relief transformations. The net annual change on the studied road within the first period equaled  $-884 \text{ m}^3 \text{ ha}^{-1} \text{ year}^{-1}$ , and for the second period  $-370 \text{ m}^3 \text{ ha}^{-1} \text{ year}^{-1}$ . Changes across the accumulation fan ranged from  $-265 \text{ m}^3 \text{ ha}^{-1} \text{ year}^{-1}$  to  $+36 \text{ m}^3 \text{ ha}^{-1} \text{ year}^{-1}$ . The average rate of erosion on the studied abandoned road is similar, and sometimes even greater than that on roads which are still in use. Our research shows that improper road location may lead to irreversible changes to the natural environment. The

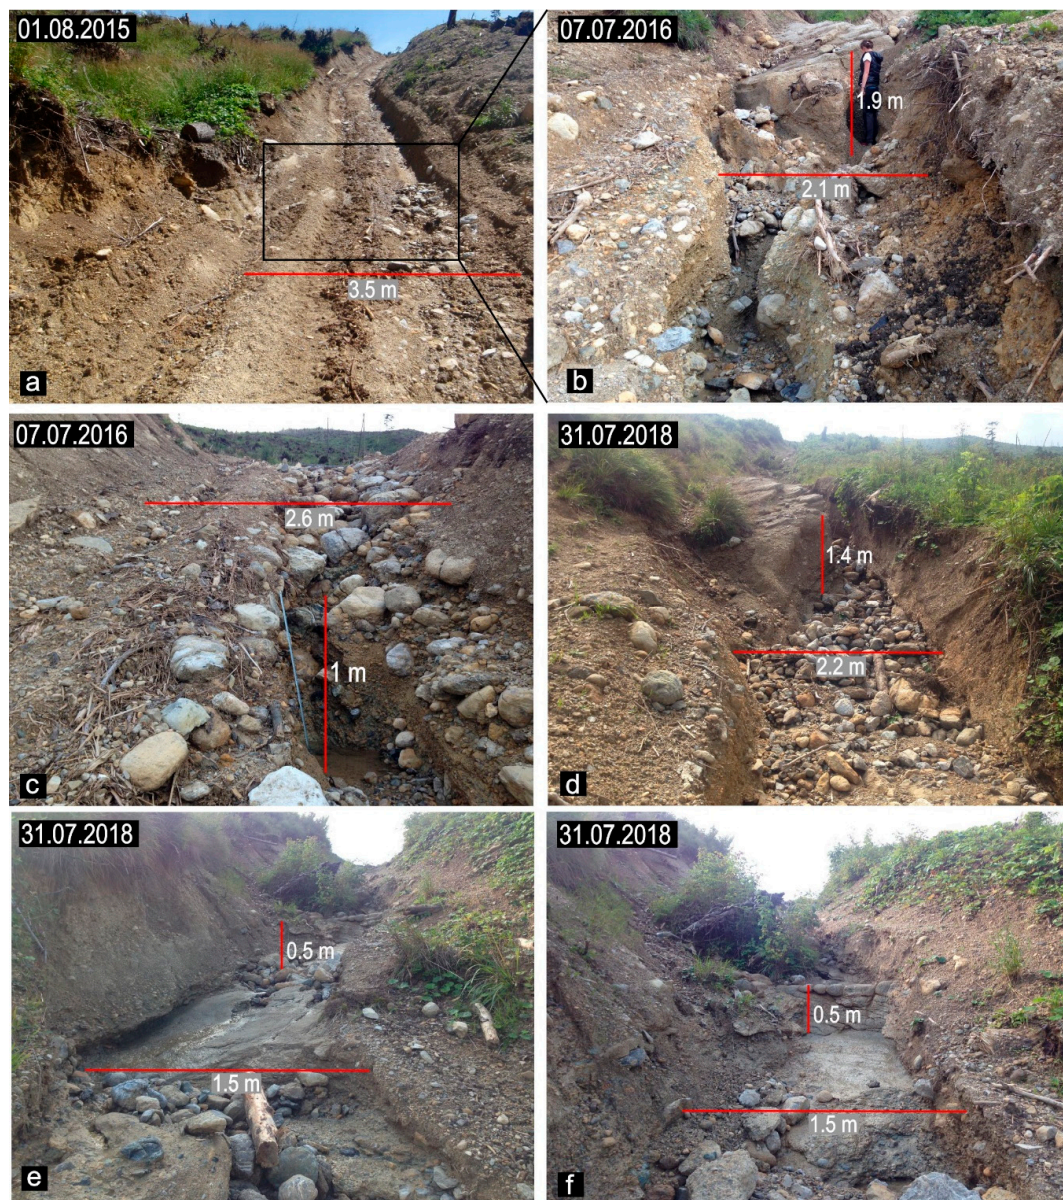
**Figure 2.** Changes on the surface of the studied road, explanations: the road in use in the first year after its construction (a); deep incisions formed after heavy rainfall, which contributed to exclusion the road from usage (b,c); strong relief transformations on the road two years after exclusion the road from usage (d–f).

in 1.07.2016. Maximum precipitation intensity reached 62.6 mm over 5 hours (data source: the Institute of Meteorology and Water Management - National Research Institute, Poland) (Figure 2b,c).

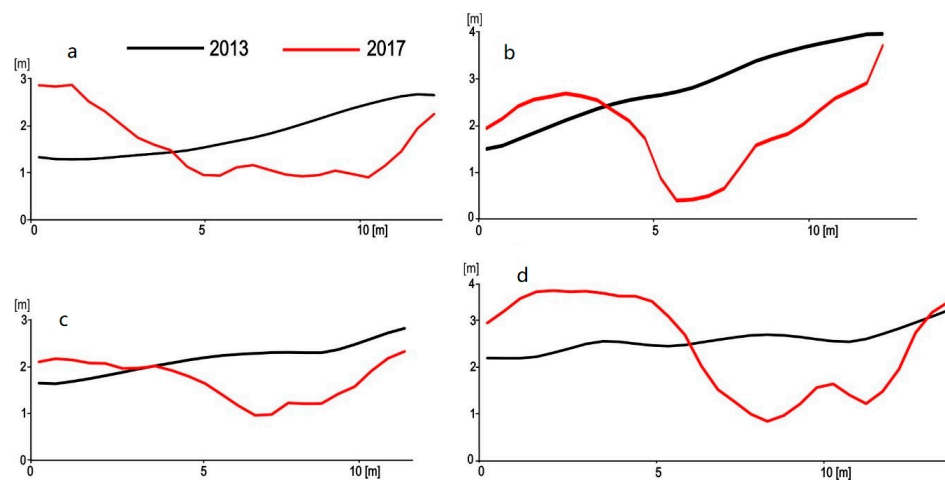
**Figure 4.** Cross section profiles within the analyzed forest road with embankments within the left-hand side of each profile; black line shows year 2013 (before road construction), red line shows year 2017 (after road abandonment). The road surface (red line) without clearly developed erosive cuts (a,c). The road surface (red line) with clearly developed erosive cuts (b,d). Locations of the profiles are marked on Figure 3.

Deep incisions in the surface of the road are visible at all measurement sites (Figure 4). On average, the road surface was cut into the slope between 0.77 m (profile c) to 1.5 m (profile b), and the maximum depth was 1.3 m (profile c), 1.5 m (profile a), 1.8 m (profile d), and 2.5 m (profile b). An embankment formed by the material removed while the road was being constructed was also observed. The average thickness of that deposited material was from 0.3 m (profile c) to 1 m (profile d).

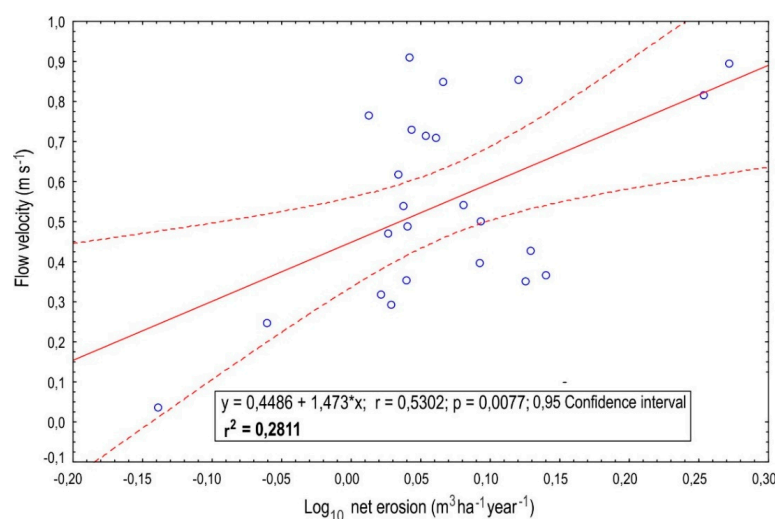
**Figure 8.** Relationship between the flow velocity and net erosion within the erosion gully formed within the investigated road.

Significant correlation between flow velocity and net erosion was found. Flow velocity explains 28% of variation in the net erosion ( $r^2 = 0.28$ ) (Figure 8). This relationship is the most apparent in the lower part of the road (road segments 2, 4, 5, 7, 8).
