Assessing Conservation Conditions at La Fortaleza de Kuelap, Peru, Based on Integrated Close-Range Remote Sensing and Near-Surface Geophysics

Abstract: We combined datasets from multiple research projects and remote sensing technologies to evaluate conservation conditions at La Fortaleza de Kuelap, a pre-Hispanic site in Peru that suffered significant damage under heavy seasonal rains in April 2022. To identify the causes of the collapse and where the monument is at further risk, we modeled surface hydrology using a DTM derived from drone LiDAR data, reconstructed a history of collapses, and calculated the volume of the most recent by fusing terrestrial LiDAR and photogrammetric datasets. In addition, we examined subsurface water accumulation with electrical resistivity, reconstructed the stratification of the monument with seismic refraction, and analyzed vegetation loss and ground moisture accumulation using satellite imagery. Our results point to rainwater infiltration as the most significant source of risk for La Fortaleza's perimeter walls. Combined with other adverse natural conditions and contemporary conservation interventions, this led to the 2022 collapse. Specialists ne

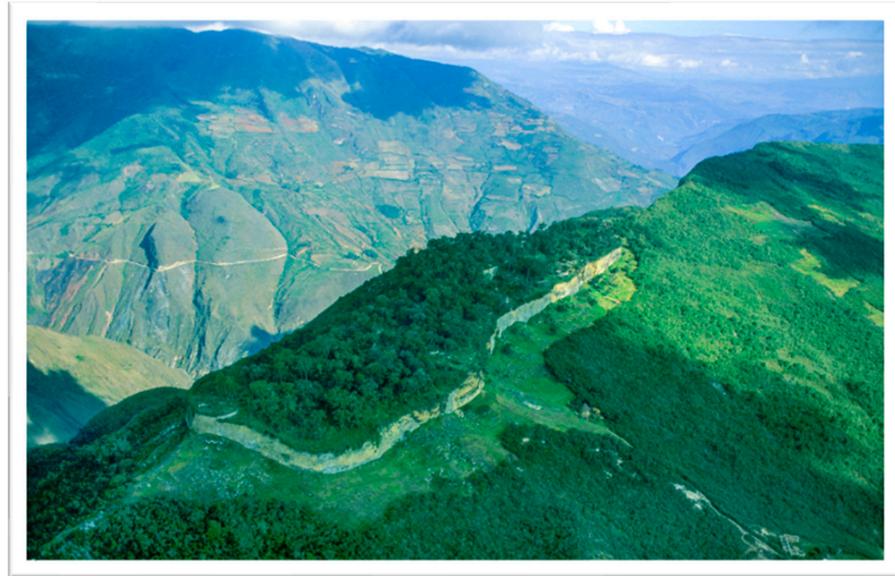
Figure 1. Aerial photograph of La Fortaleza, spring 2000. Associated archaeological sites on the sloping plateau below La Fortaleza were concealed by forest at the time. Copyright Gordon Wiltsie.

La Fortaleza de Kuelap is among the most impressive structures ever built by an Indigenous Andean society (Figure 1). Located at 3000 m.a.s.l. in Peru's northeastern Andean tropical montane rain forests, it consists of an immense walled platform extending 550 m north–south with a maximum width of 150 m. Perimeter walls made of stone

blocks, 300–2000 kg each, attain heights of 20 m, enclosing the rocky summit of Cerro La Barreta and an estimated 600,000 m³ of stone and clay fill that supports 5.11 ha. of platform surface [1–3]. A settlement of approximately 420 circular stone habitations and five special-purpose buildings is found on top of the platform.

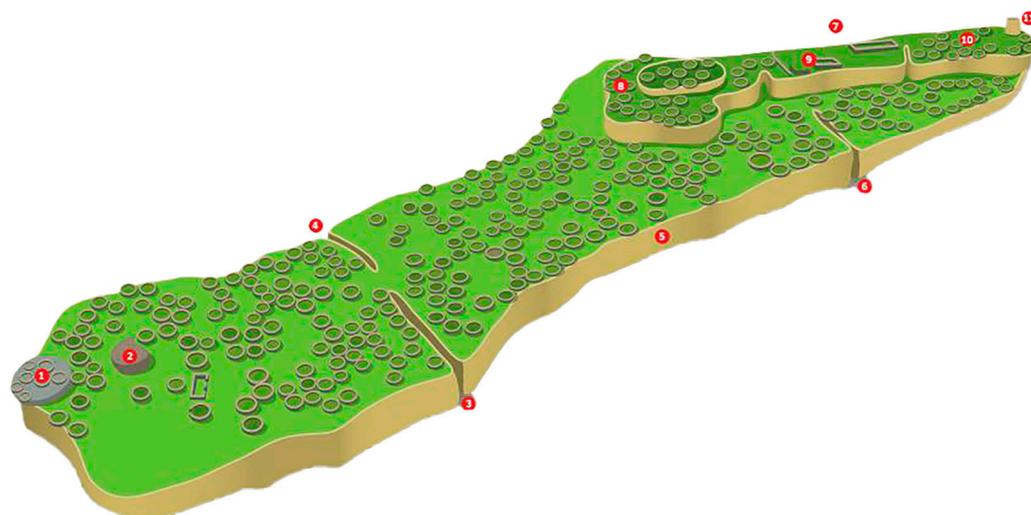
Figure 4. An artistic rendering of La Fortaleza and its main buildings. (1) Circular platform; (2) Main Temple/El Tintero; (3) Access 1; (4) Access 2; (5) Perimeter wall; (6) Access 3; (7) Upper Town/Pueblo Alto; (8) Upper Town Southern Sector; (9) Upper Town Central Sector; (10) Upper Town Northern Sector; (11) The Turret/Torreón. Courtesy of MINCETUR Peru.

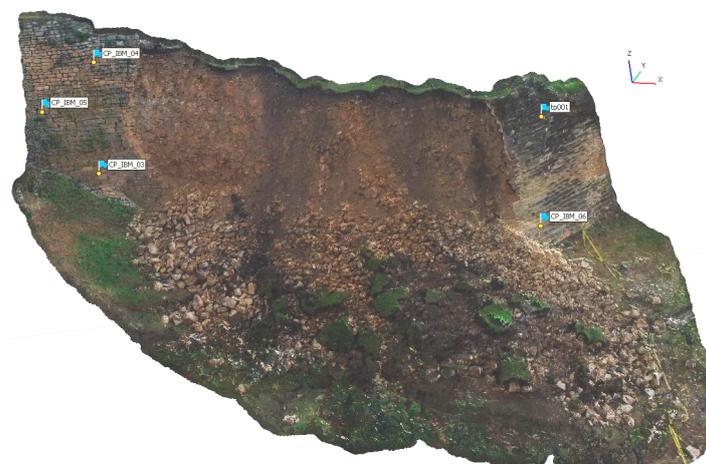
Figure 7. Image-based model (IBM) of the collapsed southern perimeter wall of La Fortaleza. Elaborated by Kucera from photographs by R. Vigo and N. Vargas.

We analyzed data from three UAV-based photogrammetric surveys conducted after the 2022 collapse. On April 12th, Roger Vigo used a DJI Mavic Mini 2, with a 1/2.3" CMOS sensor and 24 mm (35 mm format equivalent) lens that produces 4000×2250 size images. On April 30th, Napoleon Vargas flew a DJI Mavic Air equipped with a 1/2.3" CMOS sensor and a 24 mm (35 mm equivalent) lens that produces 4056×3040 size images. Both surveys recorded the collapsed area on the southeastern corner of the site before it was sheltered with protective roofing. On June 14th, 2022, Ghezzi and Contreras used a DJI Phantom 3 equipped with a Sony EXMOR 1/2.3" CMOS sensor and a 20 mm (35 mm equivalent) lens to produce 4000×3000 size images of the southeastern corner of the site. These surveys produced data suitable for IBM models of the collapse (Figure 7).

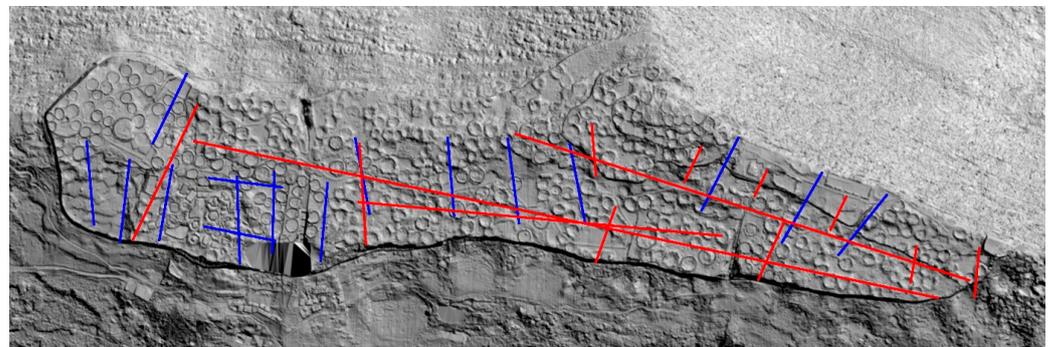
Figure 8. Location of geoelectrical profiles complementing each other. Blue—ALEPH [69]; Red—Mori [9]. Data assembled by Kościuk.

Thirteen ERT profiles (Figure 8) were plotted over the hydrological maps using their georeferencing information. These allowed direct comparisons between the hydrological risks modeled using the DTM and evidence of increased subsurface humidity from the resistivity measurements. For example, the left red arrow on Figure 15 shows coincidence between a main rainwater runoff line and a zone of increased subsurface humidity. The right red arrow on the figure shows how a Chachapoya circular building forms a depression that tends to collect water and favor infiltration, and matches increasing subsurface soil moisture. The blue arrow seen below in the section profile points to detected increased humidity within the structured fill directly behind the perimeter wall of La Fortaleza.

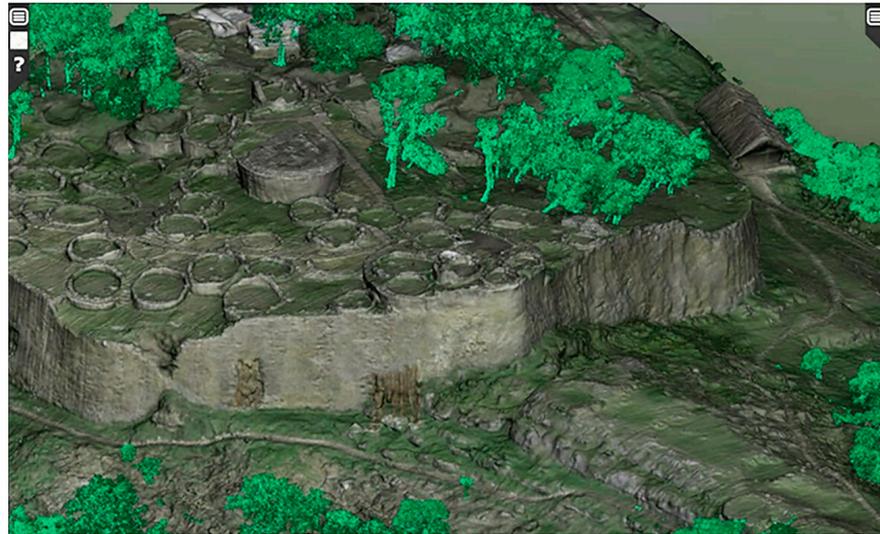
Figure 10. Filtered and classified LiDAR data covering La Fortaleza. Data previously reported by Righetti and colleagues [6,65].

Our source for analyzing La Fortaleza was the data collected during the LiDAR survey by MEDS. Primary data filtering and classification were conducted with MEDS proprietary software ATLAS 1.3.7 2019 (Figure 10). The data, in *.las format, were categorized as: “never classified” (mostly high vegetation, but also relics of vertical and sloping walls), “ground”, and “low vegetation” as described by Righetti et al. [6,65]. However, in a terrain characterized by nearly indistinguishable clumps of vegetation and walls with varying degrees of damage, a reclassification was required and mostly executed automatically in Cyclone 3DR v. 2023.1, but manually in some instances. Two additional classes were introduced: “ground and architecture” and “vegetation on walls”. These interventions

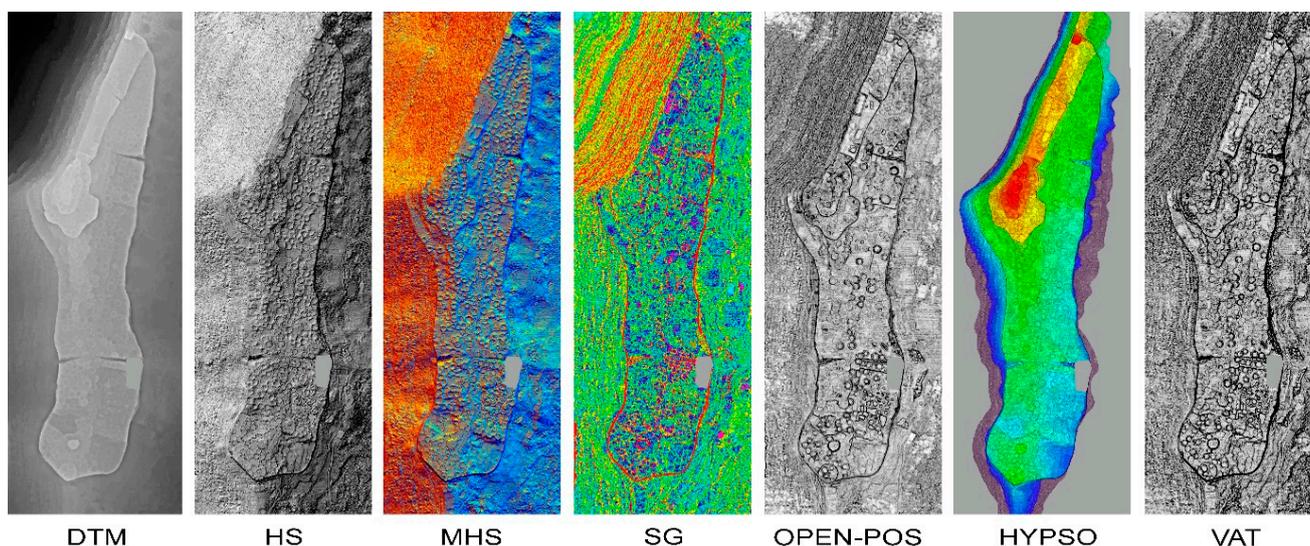
Figure 12. Different DTM visualization modes. HS—unidirectional hill-shading (azimuth 315° , vertical 35°); (MHS) multidirectional hill-shading (8 directions, vertical 30°); (SG) slope gradient; (OPEN-POS) openness-positive (search radius 10 pixels, 16 search directions); (HYPISO) 5 cm resolution 3D model colored with elevation data; (VAT) general terrain Archaeological Mixer (sky-view factor, multiplication 25% opacity blending mode; openness-positive, overlay 50% blending mode; slope gradient, luminosity 50% blending mode; analytical hill-shading, normal blending mode 100%). LiDAR data from MEDS. Prepared by Ćmielewski and Kościuk.

We used postprocessing tools for detecting La Fortaleza's buildings and archaeological features, specifically the Relief Visualization Toolbox v.2.0 [77], an application to further process the DTM. The choice of analytical tools included: Unidirectional hill-shading [78] (p. 41), Multidirectional hill-shading up to 64 azimuth directions, Principal Component Analysis of hill-shading [79] (p. 472), Slope gradient [80] (p. 47); [81] (p. 285), Simple local relief model, Sky-View factor, and Anisotropic Sky-View factor [82] (p. 402); [77], Openness (negative and positive), Sky illumination [83], and Local dominance. Because of the diversity of the features in the DTM, deciding which visualization modes will effectively detect and emphasize the desired features [84] (p. 288), [80] (p. 47) requires the analyst to experiment with different algorithms and settings. In our case, the most effective visualization modes are illustrated in Figure 12. Each represents different aspects and features of the terrain. Important additional data that characterize the area are supplied by hypsometry (Figure 12 HYPISO). However, the most detailed information was obtained using a Mixer mode, allowing the combination (with a degree of transparency) of up to five different visualization modes (Figure 12 VAT). The resulting images were used as thematic layers in the GIS system and as raster references in CAD projects, providing different backgrounds against which individual problems can be analyzed.

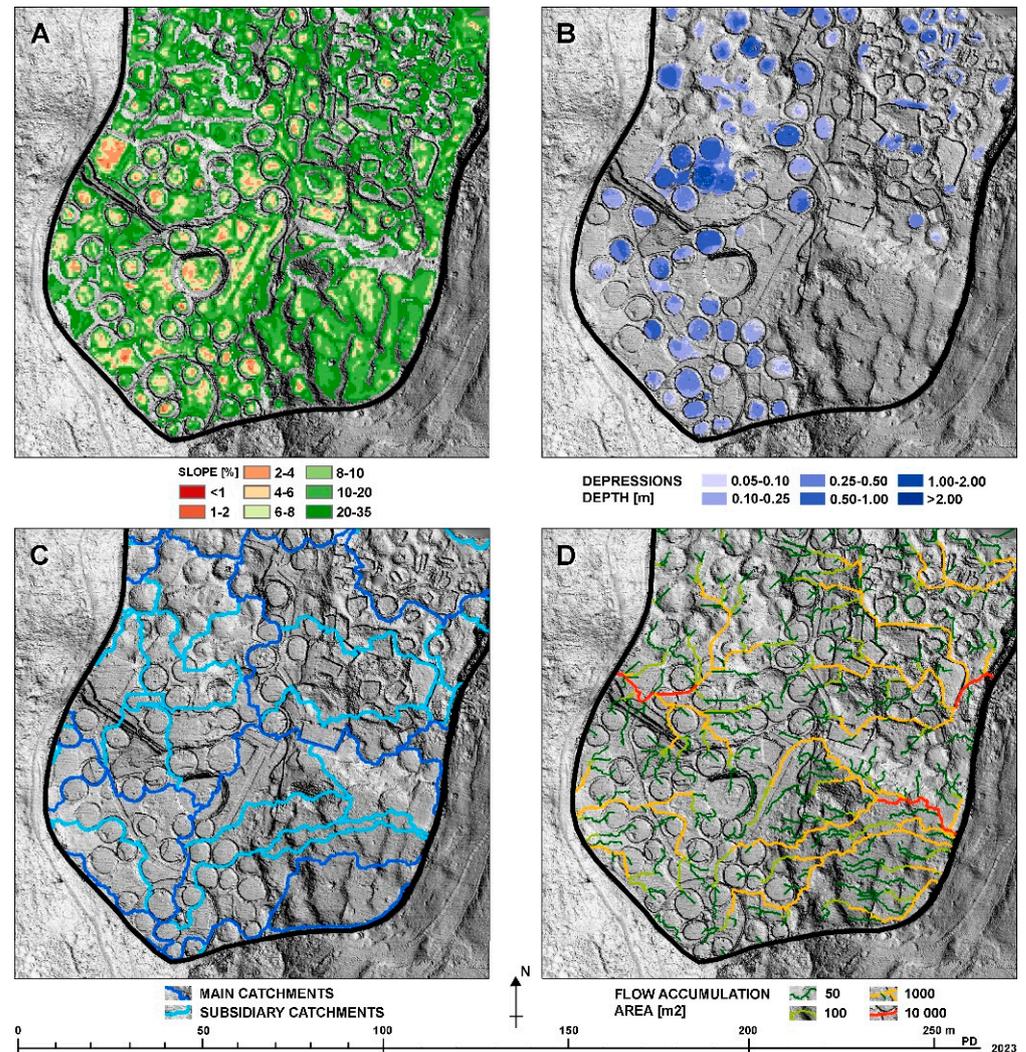
Figure 13. Samples of hydrological analyses for the southernmost part of La Fortaleza: (A) slope gradient; (B) local depressions; (C) boundaries of water catchments; (D) rainwater runoff lines. Hydrological analysis by Dąbek; data assembling by Kościuk.

Drainage projects require hydrological analyses. These can be done on a DTM to determine the main elements of the system: slope gradient which, along with other parameters, will indicate the relative proportions of surface runoff and ground infiltration (Figure 13A); local depressions, where rainwater can only evaporate or soak into the ground (Figure 13B); boundaries of individual water catchments and their areas, necessary as input data for calculations of the drainage system (Figure 13C); and main rainwater runoff lines (Figure 13D).

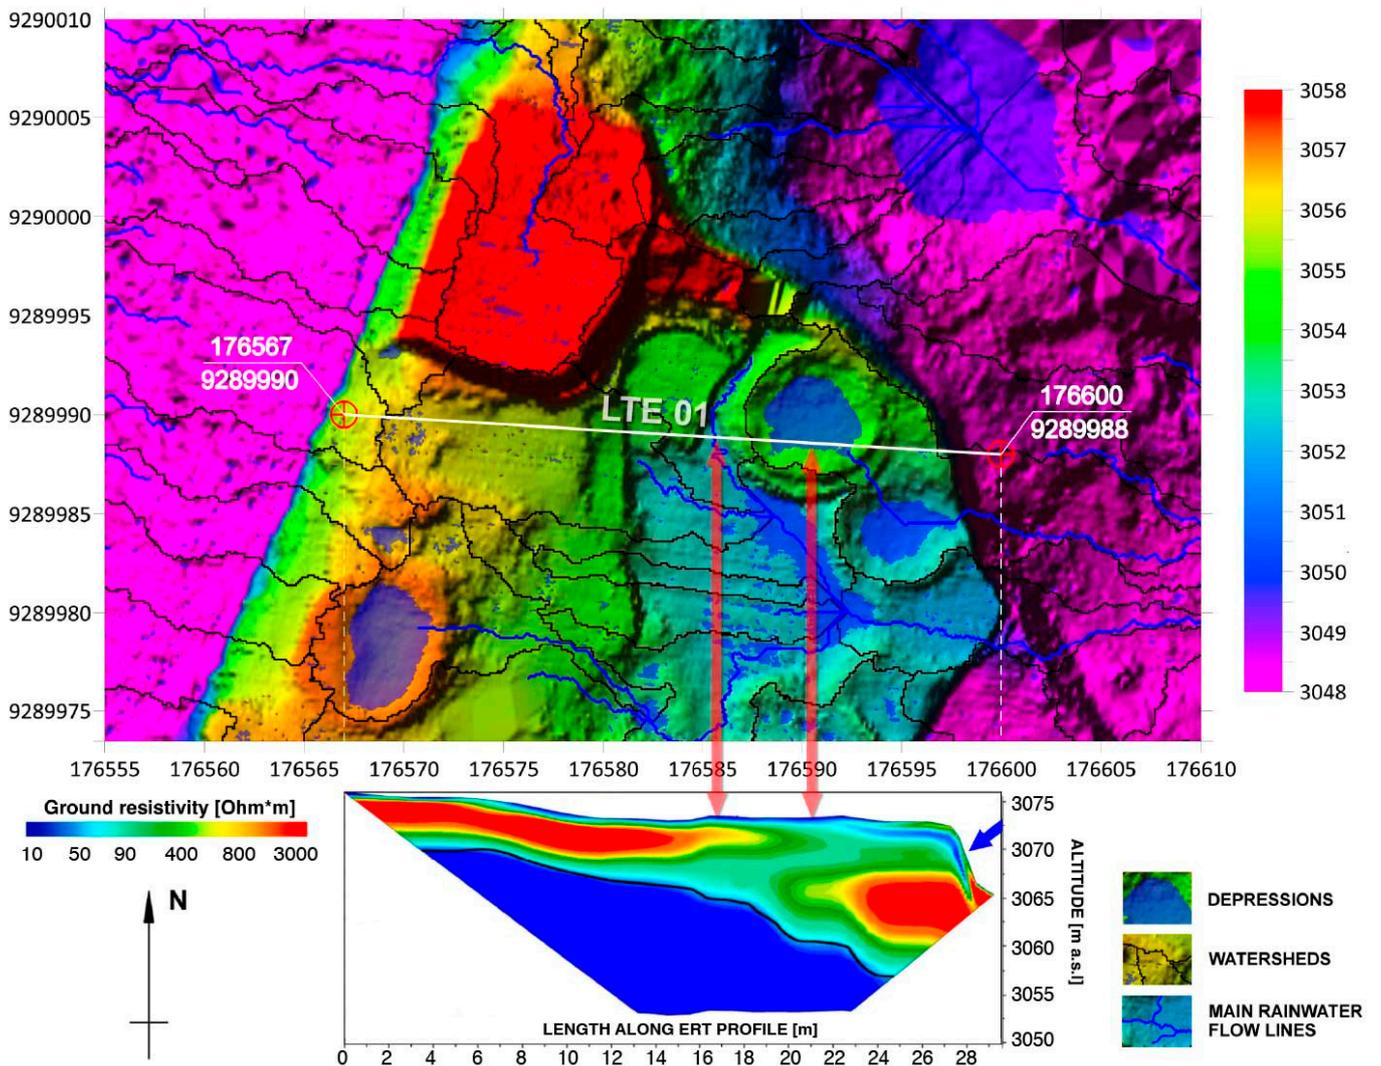
Figure 15. ERT LTE 01 profile, plotted against the background of hydrological analysis on a hypsometric map. In the range of 10–90 Ohm*m, the resistivity measurements identify a high concentration of humidity associated to debris formed by limestone blocks and soil. Hydrological analysis by Dąbek; ERT profile by Mori; hypsometry and data assembling by Kościuk. UTM Zone 18S, WGS84.

When the results of ERT surveys were plotted over the hydrological maps, we found good alignment between them. The layers of soil lying below local depressions and main rainwater runoff lines have a correspondingly higher level of humidity, as measured by a lower electrical resistivity value (Figure 15).

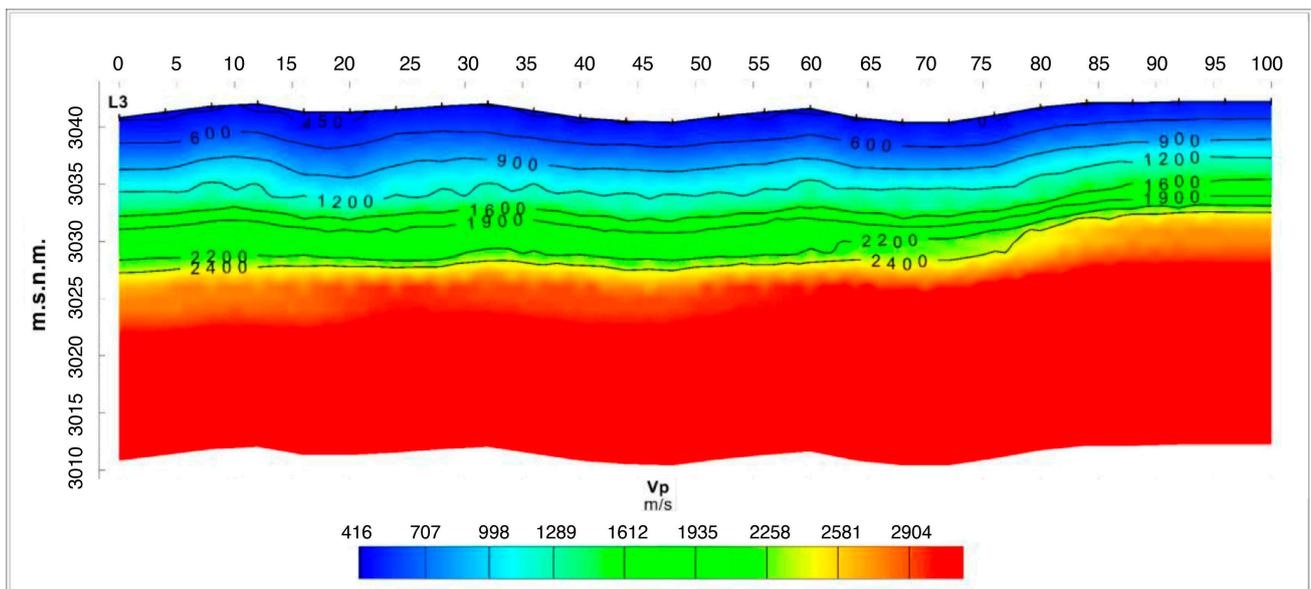
Figure 16. Geoseismic profile LS-03, representative of La Fortaleza. Elaborated by Mori [70].

The measured variations in the propagation speed (velocity) of the primary compression waves (V_p) generated by the SR lines were processed using the applications SeisImager2D, version 3.3, and Easy Refract, version 20.4.518, to generate 2D geoseismic profiles of La Fortaleza (Figure 16). The compactness of the materials present in the stratification was defined according to the V_p : (1) $900 \text{ m/s} > V_p$: medium dense to densely compact material; (2) $900 \text{ m/s} \leq V_p < 1300 \text{ m/s}$: densely compact material; (3) $1300 \text{ m/s} \leq V_p < 2200 \text{ m/s}$: very densely compact material; (4) $2200 \text{ m/s} \leq V_p$: contact with bedrock [70].

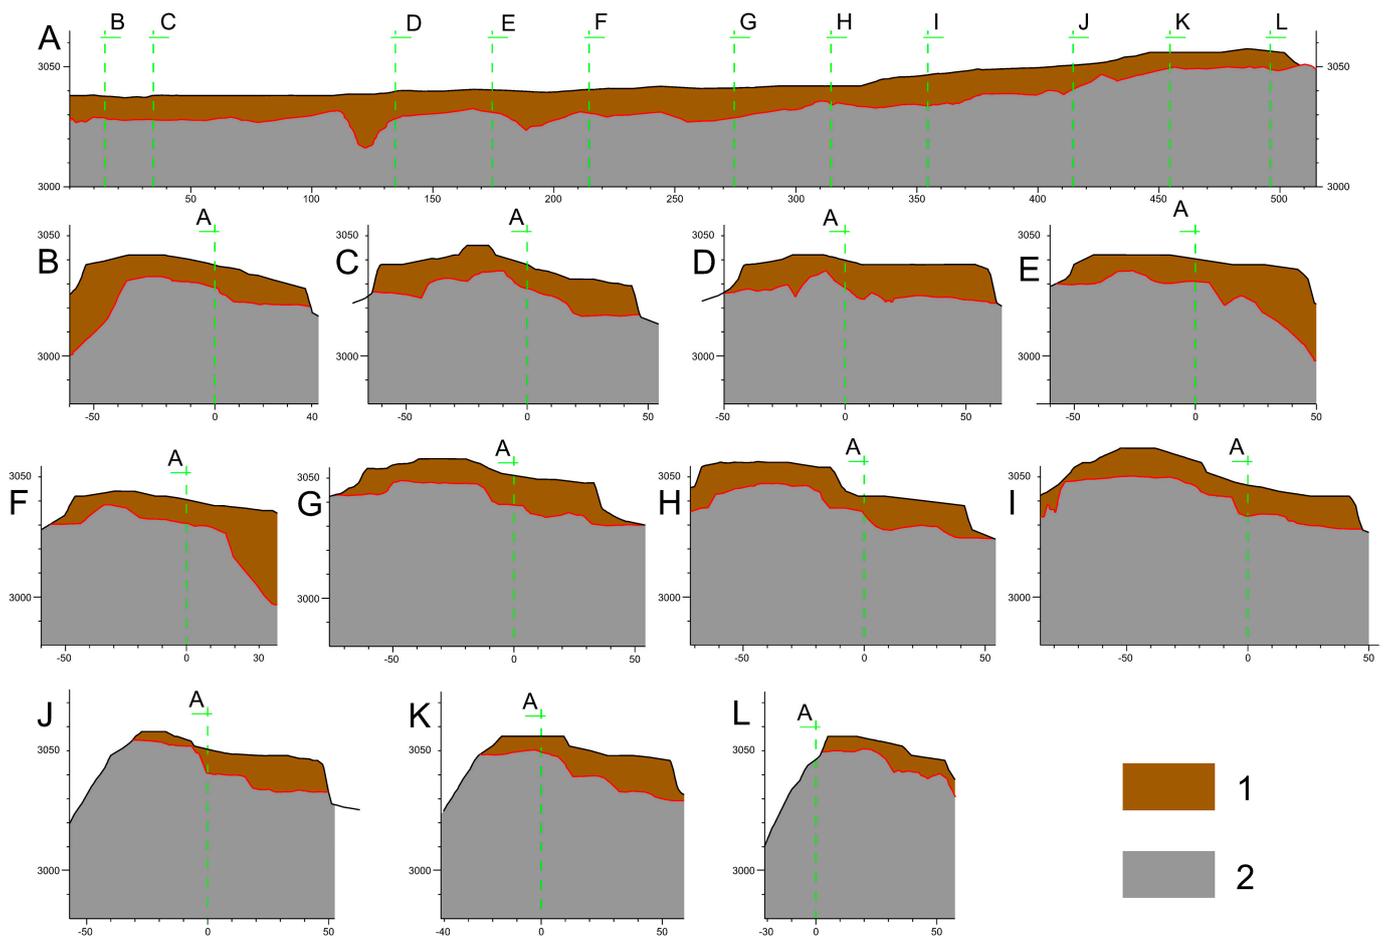
Figure 17. Stratigraphic sections of La Fortaleza based on the processing of seismic refraction data. (1) Construction fill; (2) Limestone bedrock; (A) Longitudinal section. (B–L) Transversal sections. Data assembling by Mori; redrawn by Kościuk.

To estimate the volume of the construction fill, Mori used a V_p speed of 2200 m/s as a point of contact with the bedrock and reclassified the strata into two units (Figure 17): the construction fill, composed of limestone blocks and argillaceous clay plus the topsoil ($900 \text{ m/s} \leq V_p < 2200 \text{ m/s}$), and the underlying bedrock ($2200 \text{ m/s} \leq V_p$). Then, he used Oasis Montaj, version 9.3, to model the surfaces of both La Fortaleza's platform and the bedrock in high resolution 3D. Finally, these 3D surfaces were analyzed in AutoDesk Civil 3D 2023 and, by considering the mathematical difference between both, Mori arrived at the volume of the existing construction fill at approximately $600,000 \text{ m}^3$.

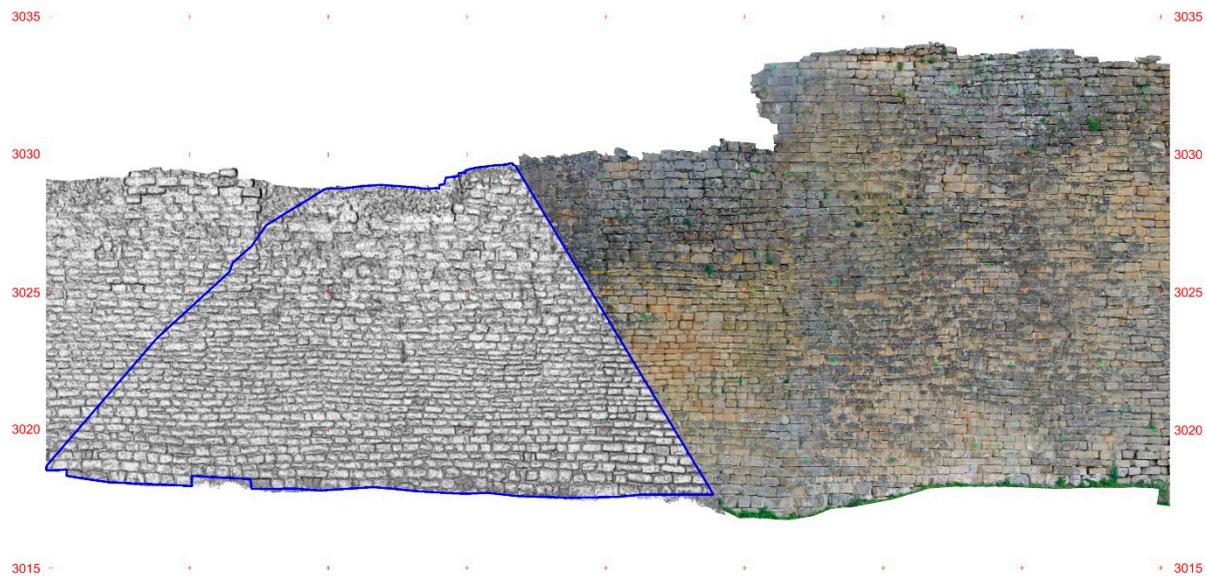
Figure 18. Sample of the fusion of digital photogrammetry and TLS data at the southeastern corner of La Fortaleza’s perimeter wall. Blue lines—overlap between TLS and photogrammetric projects; green crosses—ground control points for photogrammetric project. TLS 3D point cloud data from Kucera, VanValkenburgh, and Rojas. Elaborated by Kościuk.

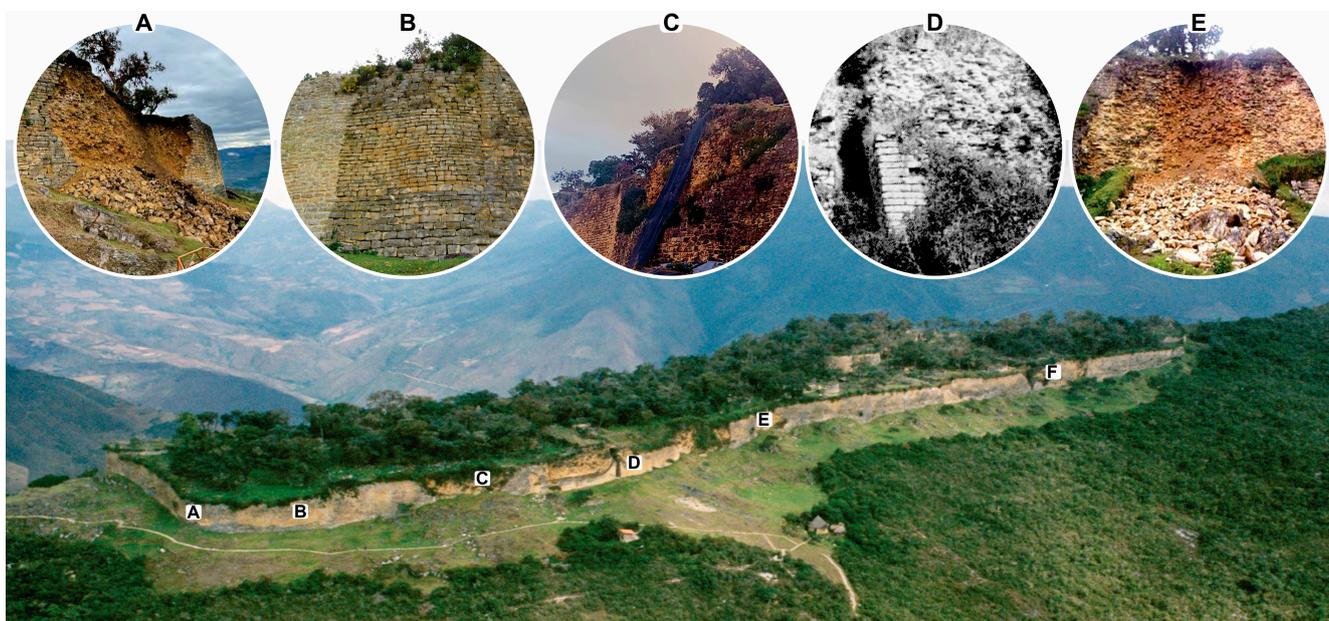
Figure 20. Aerial view of La Fortaleza in 1995, indicating some documented episodes of collapse. (A) 10–11 April 2022; (B) Pre-Hispanic collapse and repair; (C) June–July 2023; (D) 1910–1933; (E) 31 March 2013; (F) Date unknown. Photograph by M. Chumbe (1995). Elaborated by Contreras.

Historical sources and ground-truthing of features detected by remote sensing reveal structural deterioration and stability problems at La Fortaleza reported since the late 19th century. We also separately documented a long history of collapses of the perimeter wall [64]. Obviously, the record is incomplete, and most information pertains to the past 100 years. Nonetheless, we identified a pre-Hispanic collapse involving an area of 210 m² on the southeastern perimeter wall (Figure 20B). Photographs published in visitor reports [4,58,59,61–63] reveal a collapse on the eastern perimeter wall, just north of Acceso 1, between 1910 and 1933 (Figure 20D). The March 2013 collapse affected the eastern perimeter wall 30 m north of Acceso 1 (Figure 20E). Of course, the April 2022 collapse prompted our present study (Figure 20A).

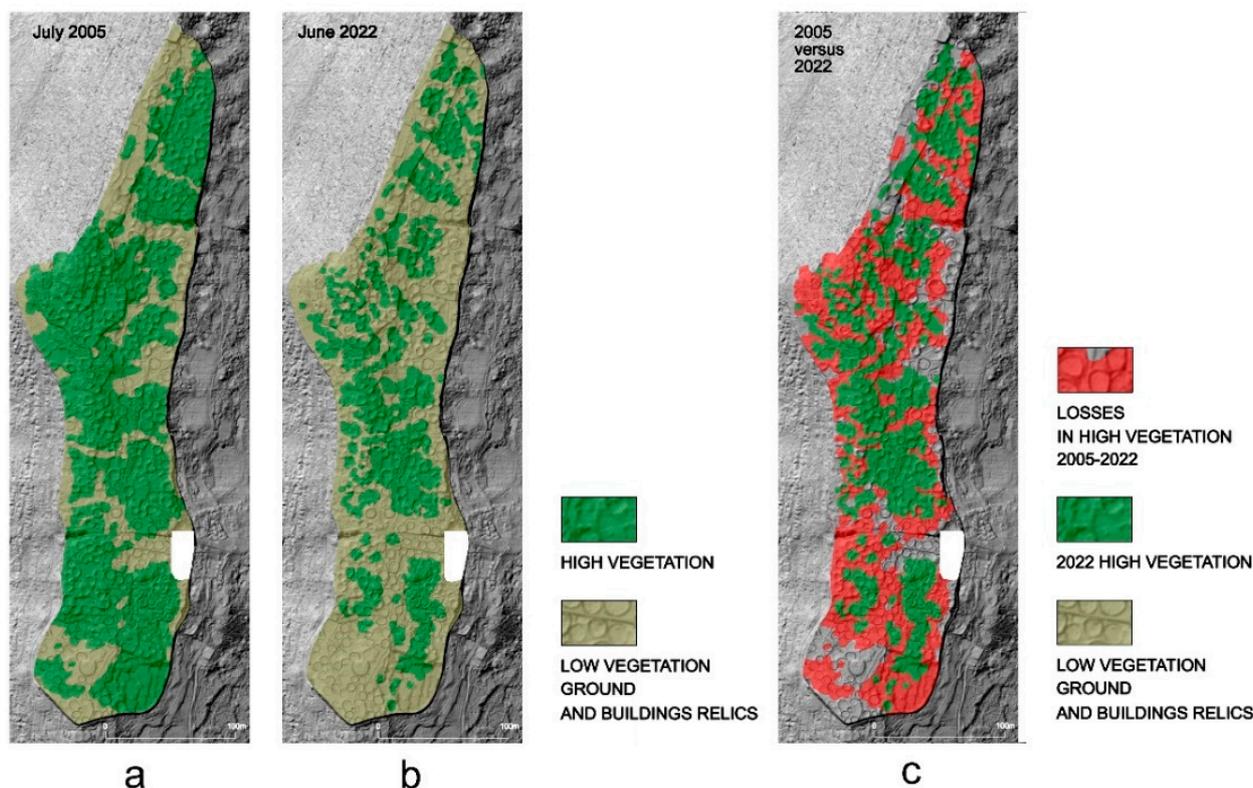
Figure 22. Deforestation at La Fortaleza: (a) High vegetation extent, 2005; (b) High vegetation extent, 2022; (c) Changes in high vegetation extent between 2005 and 2022. Prepared by Kościuk.

Historical satellite images of the 21st century prove useful for documentation of a significant change in forest cover at La Fortaleza. As shown by Figure 22, the area covered with tall vegetation decreased approximately 30% between 2005 and 2022. More dramatic changes can be seen by comparing present conditions in forest cover to aerial photographs from 1995 (Figure 20) and 2000 (Figure 1), when most of the platform was densely covered by vegetation, except for deforested areas around the entryways and special buildings.

The management of heritage sites is a compromise between protecting the built heritage and its natural context [99], yet the changes observed (Figure 22) in forest cover at La Fortaleza presumably affected the ground's direct exposure to rainfall, permeability and absorptivity. Regarding the protection of built heritage at Kuelap, a distinction must be made between problems with the vegetation growing on walls, and the vegetation growing on the surface. On the walls, roots penetrating and expanding cracks accelerate their destruction. Water may accumulate in such cracks and, in climates like Kuelap's where temperatures may fall below 0 °C, the effects of the water's freezing and expanding further weaken wall masonry. On the other hand, every conservator can cite examples where old-growth root systems have become integrated with masonry and even contribute to stabilizing a wall. This applies particularly to walls with earth or clay mortars, or dry masonry constructed without mortar. Therefore, it is even recommended that:

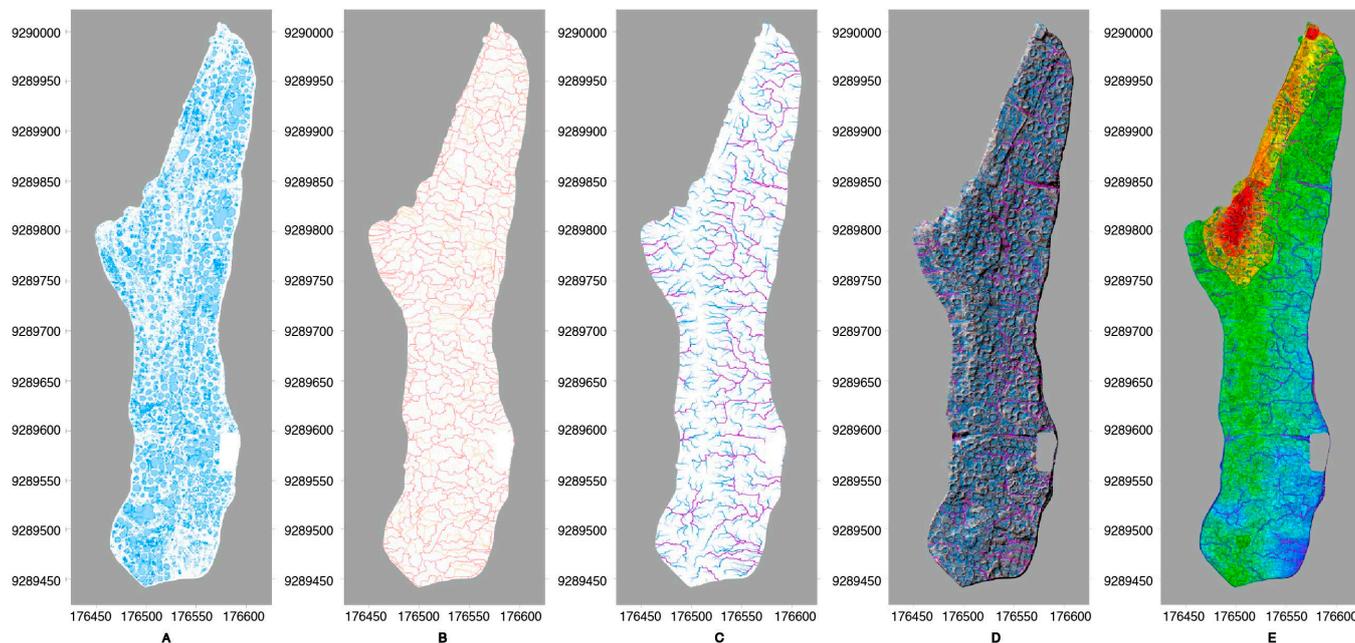
Figure 23. Hydrological analysis based on DTM: (A) local depressions; (B) primary and subsidiary catchments; (C) rainwater flow accumulation lines (the intensity of the colors represents the catchment size from which rainwater is drained); (D) depressions, catchments, and flow lines superimposed on a hill-shaded 3D model; (E) the same as (D) but with the hypsometric model in the background. Prepared by Dąbek and Kościuk. UTM Zone 18S, WGS84.

classification of the slope gradient or the size of the catchment area can be freely modified. A variety of analyses (Figure 23) constitutes the basic input for conducting further study, including development of risk maps that illustrate the impacts of rainfall on La Fortaleza. The software SURFER v. 22.3.185 [103] was also used to prepare these input data, as well as contour lines and cross sections through the terrain.

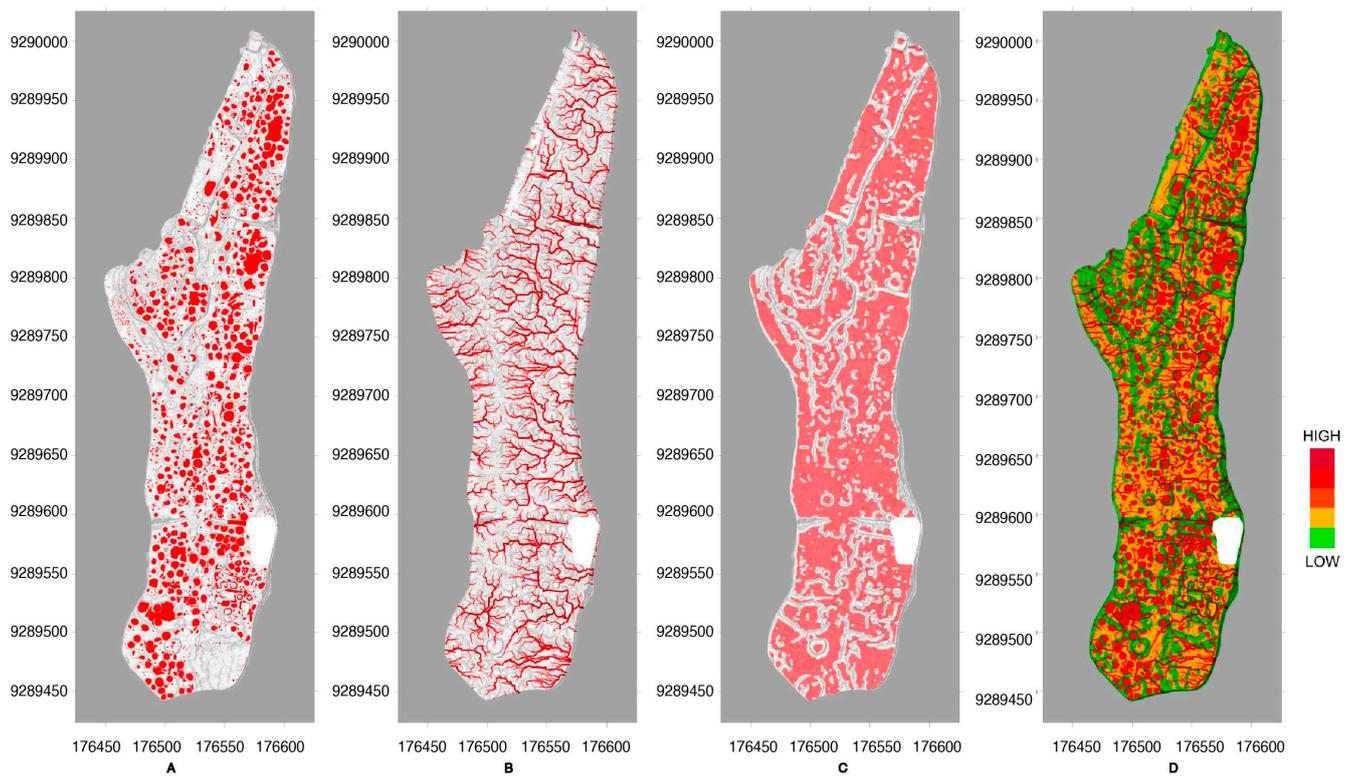
Figure 24. Precipitation risk maps, with terrain as background: (A) Depressions; (B) Rainwater flow accumulation lines; (C) Terrain with average slope $< 5\%$; (D) Accumulated risk. Prepared by Kościuk. UTM Zone 18S, WGS84.

The cumulative results are shown in Figure 24D. These results are qualitative, not quantitative, due to the lack of data on the absorptivity of soil, infiltration rate, the nature of the ground surface, and consequently the surface water runoff rate dependent on these parameters. Lack of data prevents us from calculating the hydric balance and the areas of individual catchments. For now, we have conservatively calculated five risk classes. This cumulative risk map, and our other observations on the conservation conditions of La Fortaleza, provide a useful tool to guide short- and long-term mitigation solutions necessary to improve La Fortaleza's structural integrity and permit its sustainable public use.

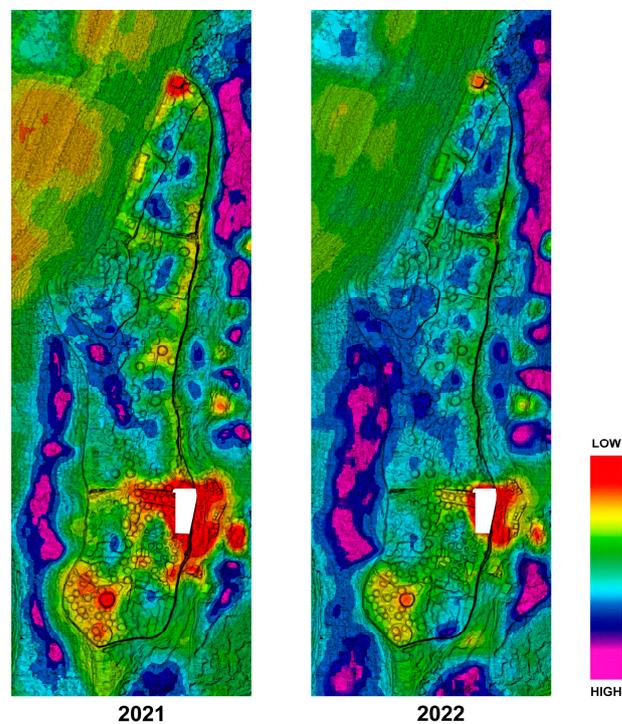
Figure 25. Ground moisture analysis based on Normalized Difference Water Index (NDWI). Primary data source: Sentinel-2 L2A satellite. Prepared by Kościuk.

The NDWI allows for the estimation of soil moisture content and sheds additional light on this problem. Such data analyzed year after year, even if only qualitatively (Figure 25), are amenable to hydric balance calculations.

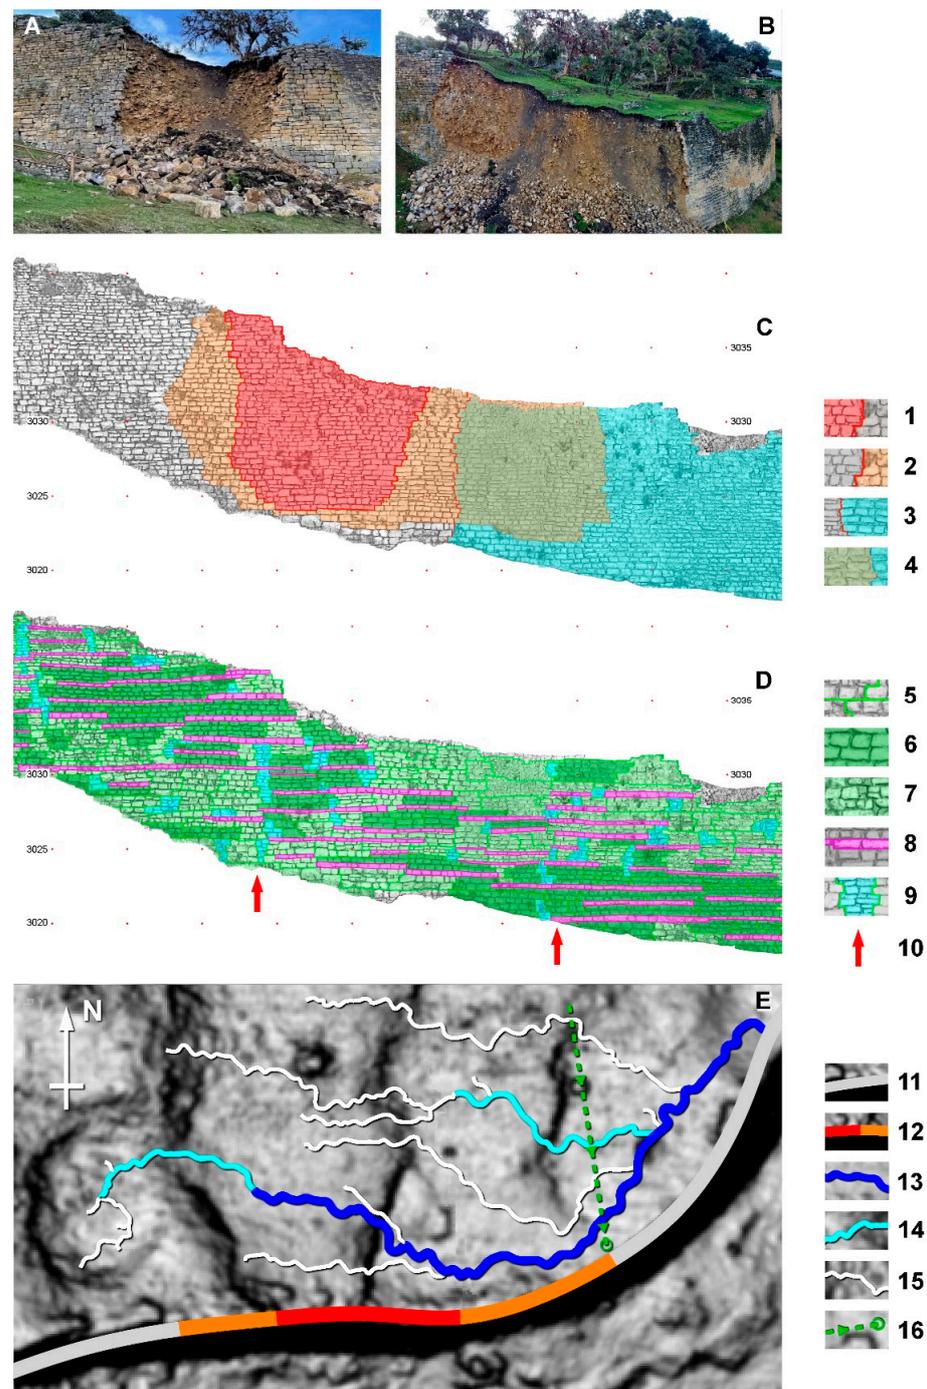
During April 2022, a total of five subsequent collapses brought down a large part of the southern perimeter wall at La Fortaleza (Figure 26A,B). The first occurred on April 10th, directly west of the margins of part of the wall with contemporary conservation (repointed with modern mortar). Nearly 12 m of wall collapsed, and only 2–4 lower courses of stone blocks remained in situ (Figure 26C, 1). The area of damage was 116 m², but an additional 80 m² were weakened. This led to subsequent collapses, progressing towards the east, and the total area of destruction reached 285 m² (Figure 26C, 2), including nearly 85 m² of the repointed wall (Figure 26C, 4). The mean thickness of the stone wall is 0.68 m, as calculated from 15 randomly chosen facade blocks, which results in 193 m³ of fallen wall face. Thanks to the unrolling of the 3D model from TLS data, we reconstructed the arrangement of blocks in the missing part of the wall and proposed first estimates of techno-morphological studies (Figure 26D).

Sections of coursed masonry sometimes border with sections of uncoursed stonework (Figure 26D, 7). In the latter instance, adjacent blocks have different heights, ranging 13–65 cm. Such stonework occurs in sections 0.6–1.3 m high and 2.5–5 m long and can be postulated either as belonging to a primary stage of construction of the wall section, or as subsequent repairs.

Long sections of wall are built over a layer of ashlar (Figure 26D, 8). Their lengths extend up to a dozen meters, and they usually overlap fragments of coursed and uncoursed masonry. The height of the stone blocks used in these layers varies from flat slabs 9 cm thick to ashlar 35 cm high; however, within one layer, the height differences are small, so that their upper surface forms a common plane. We interpret this as leveling layers, merging the underlying stonework fragments and equalizing the upper working surface. The vertical distance between such layers ranges 0.5–1.2 m and averages 0.8 m, matching the height to which even a heavier stone block can be comfortably lifted.

Figure 26. The area of the perimeter wall collapse on April 2022: (A) the southern perimeter wall after the first collapse of April 10th (Photo: N. Anazco); (B) the same area after the subsequent series of collapses (Photo: R. Vigo); (C) margins of the collapses, TLS data by Kucera, VanValkenburgh, and Rojas, 3D modeling and surface unrolling by Kościuk; (D) techno-morphological study, elaborated by Kościuk; (E) ground view of the collapsed area; (1) collapsed part of the wall; (2) damaged and unstable part of the wall resulting from the 1st collapse on April 10th; (3) part of the wall repointed with modern mortar; (4) part of the repointed wall fallen down in subsequent collapses; (5) margins of technological and/or chronological phases; (6) coursed masonry; (7) uncoursed masonry; (8) leveling layers; (9) patches of irregular masonry; (10) red arrows point to zones of vertical concentration of patches; (11) perimeter wall; (12) collapsed parts of the perimeter wall; (13) main rainwater flow lines; (14) subsidiary rainwater flow lines; (15) minor rainwater flow lines; (16) modern drainage disposing water just behind the perimeter wall. Prepared by Kościuk.

The last type of stonework consists of scattered small irregular patches (Figure 26D, 9). Their width is 1–2 m, and their height usually does not exceed 1.5 m. The choice of stone materials is based on expediency, and their horizontal joints do not correspond with bordering fragments of masonry. These are either filling of gaps left between larger sections of works or traces of repairs that appear to have been made ad hoc. The concentration of these patches on the margins of the collapse from April 2022 (Figure 26D, 10) marks a zone where there would have been previous stability problems, and the whole wall section was already weakened (see Section 4.5.3).

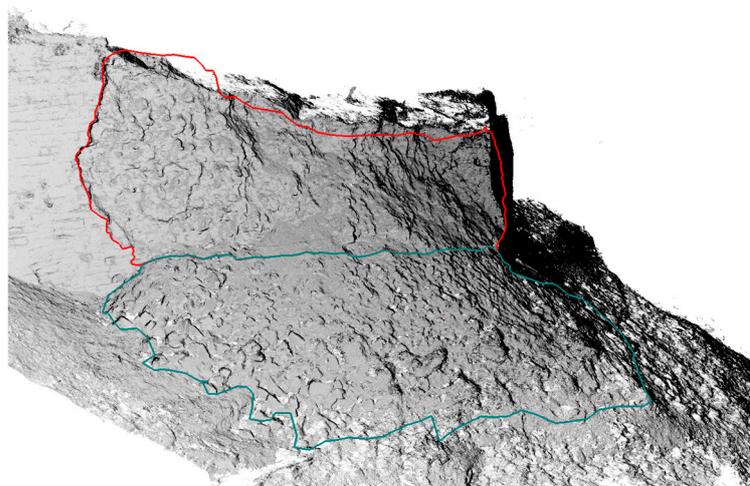
Using integrated TLS and IBM data, Kucera calculated the collapsed part of the perimeter wall of La Fortaleza as an overall mass movement of $466 \pm 25 \text{ m}^3$ (Figure 27). Using Kościuk's calculations of the volume of the stone masonry and fallen structure, the fill that slid together with the wall face would have consisted of approximately $273 \pm 25 \text{ m}^3$.

Figure 27. Integrated TLS, ALS, and IBM model of the collapsed perimeter wall (red outline) and corresponding debris (green outline) on the southeastern corner of La Fortaleza, centered on the collapsed area. Prepared by Kucera. Image data courtesy of R. Vigo and N. Vargas.

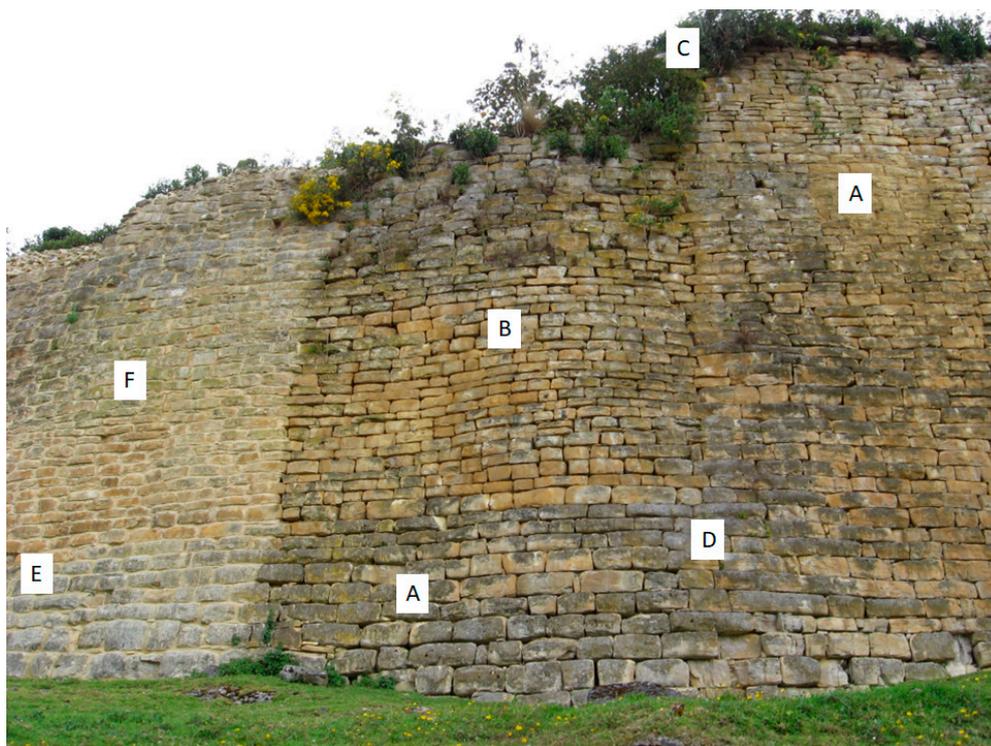
La Fortaleza's surface area above the sequence of 2022 wall collapses labeled Las Terrazas in site plans, is described as terraced and sunken in relation to the Templo Mayor and purportedly lacks additional constructions because of its ritual function [49]. We have already mentioned a pre-Hispanic collapse on the eastern end of this sector where evidence suggests an affected surface area of 210 m^2 . The signs of destruction recorded on DTMs and photographs indicate that in pre-Hispanic times a collapse greater than that of 2022 affected at least 1250 m^3 of the perimeter wall and corresponding fill. Its rebuilding left marked differences between the original and repaired segments (Figure 28).

Figure 28. Evidence of pre-Hispanic collapse and rebuilding on the southeastern perimeter wall. (A) perimeter wall in its original height and condition (notice the original eaves at the top of the wall); (B) partially rebuilt perimeter wall, with stonework different from (A); (C) drop in wall height between original (A) and rebuilt (B) sections, Figure 18; (C,D) zig-zagging vertical margin between the original (A) and rebuilt (B) perimeter wall sections; (D,E) horizontal margin, or leveling layer, between the original (A) and rebuilt (B) perimeter wall sections; (F) rebuilt perimeter wall, with conservation mortar added by repointing. Prepared by Ghezzi; photograph by Church (2007).

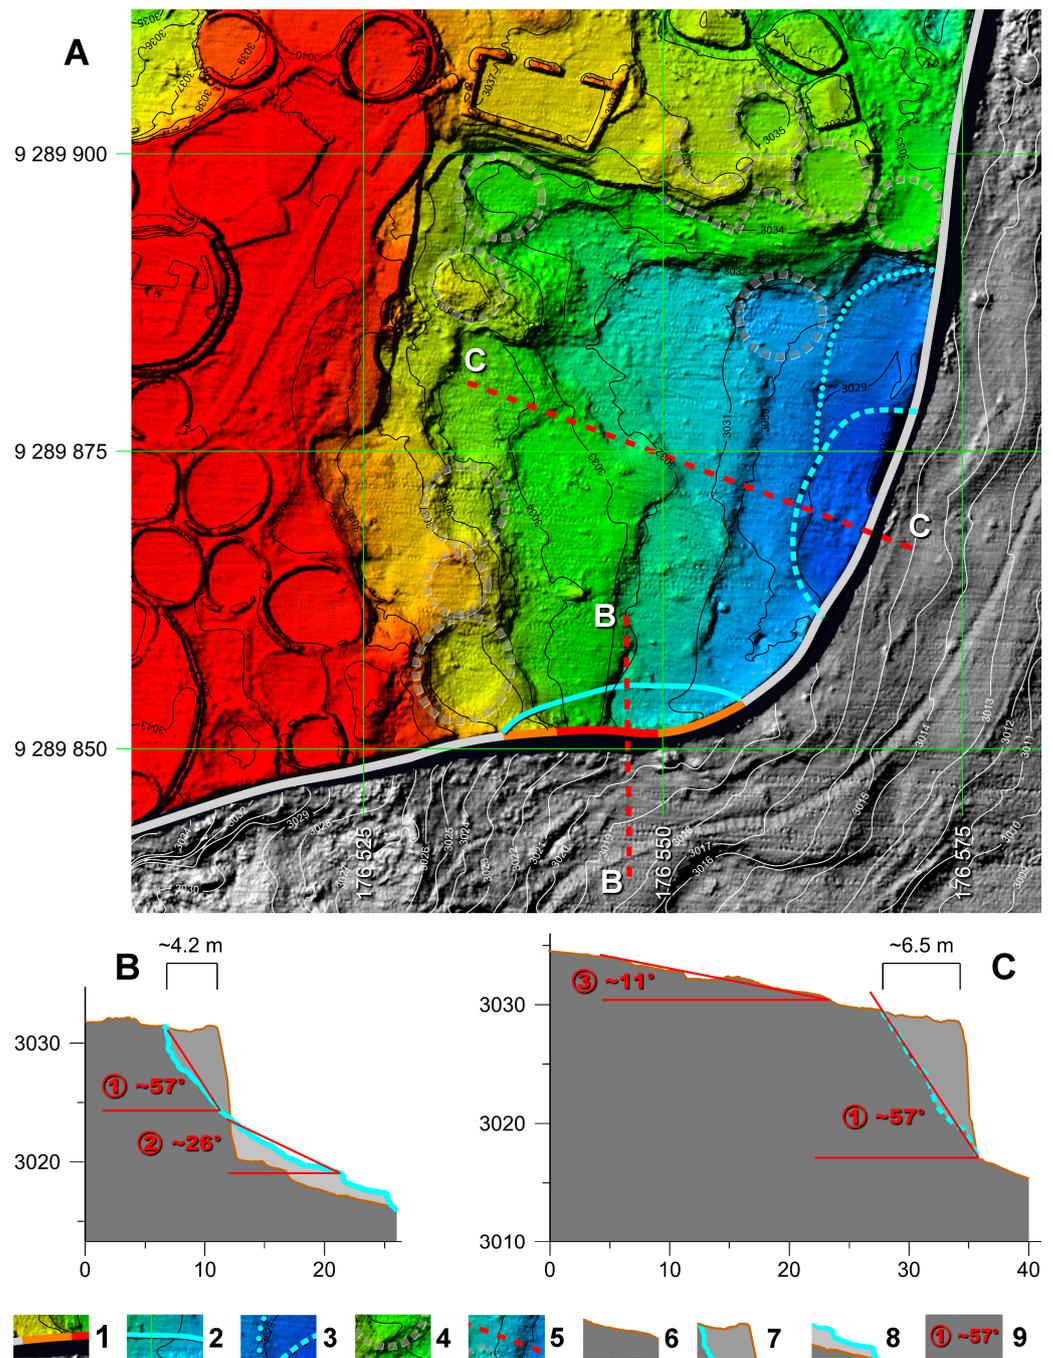
The lowest zone of Las Terrazas, Area III (blue, navy blue, Figure 29A), lacks traces of earlier buildings. As detailed above, its perimeter wall was once rebuilt. If this indicates that a collapse occurred in the past, and we assume that the split wedge angle was similar, then the horizontal extent of the landslide would be 6.5 m. Thus, its hypothetical margins coincide with the visible ground edge of the deepest part of Area III (Figure 29A). These are probably traces of a collapse that was not fully refilled when the wall was rebuilt.

Figure 29. The region of the April 2022 collapse in the southeast corner of La Fortaleza: (A) hypsometric plan; (B) profile B-B (data by Kucera); (C) profile C-C; (1) collapsed part of the perimeter wall; (2) horizontal extent of the April 2022 collapse; (3) horizontal extent of hypothetical pre-Hispanic collapse and its northern extension; (4) ground imprints from dismantled or destroyed circular buildings; (5) profile locations; (6) preserved surface of the platform; (7) splinter wedge; (8) loose landslide debris; (9) slope inclination angles. Elaborated by Kościuk. UTM Zone 18S, WGS84.
