Assessing Conservation Conditions at La Fortaleza de Kuelap, Peru, Based on Integrated Close-Range Remote Sensing and Near-Surface Geophysics

Abstract: We combined datasets from multiple research projects and remote sensing technologies to evaluate conservation conditions at La Fortaleza de Kuelap, a pre-Hispanic site in Peru that suffered significant damage under heavy seasonal rains in April 2022. To identify the causes of the collapse and where the monument is at further risk, we modeled surface hydrology using a DTM derived from drone LiDAR data, reconstructed a history of collapses, and calculated the volume of the most recent by fusing terrestrial LiDAR and photogrammetric datasets. In addition, we examined subsurface water accumulation with electrical resistivity, reconstructed the stratification of the monument with seismic refraction, and analyzed vegetation loss and ground moisture accumulation using satellite imagery. Our results point to rainwater infiltration as the most significant source of risk for La Fortaleza's perimeter walls. Combined with other adverse natural conditions and contemporary conservation interventions, this led to the 2022 collapse. Specialists ne

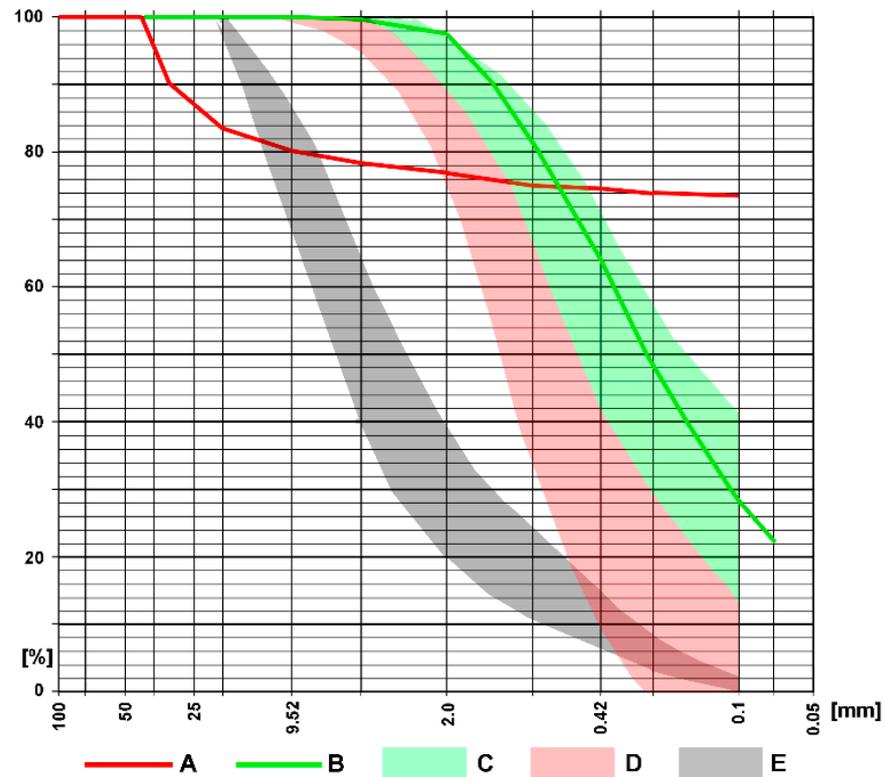
Figure 30. Grain size curves of mortar samples from La Fortaleza (source data UNESCO [71]); (A) original mortar; (B) average of conservation mortars; (C) typical curves of sandy-clay soil and loam-clay soil; (D) typical curves of sandy-clay soil and sandy-gravel soil; (E) typical curves recommended for contemporary construction mortars. Elaborated by Kościuk.

should be to keep the walls in good technical condition, while maintaining a historically accurate visual appearance to the degree possible.

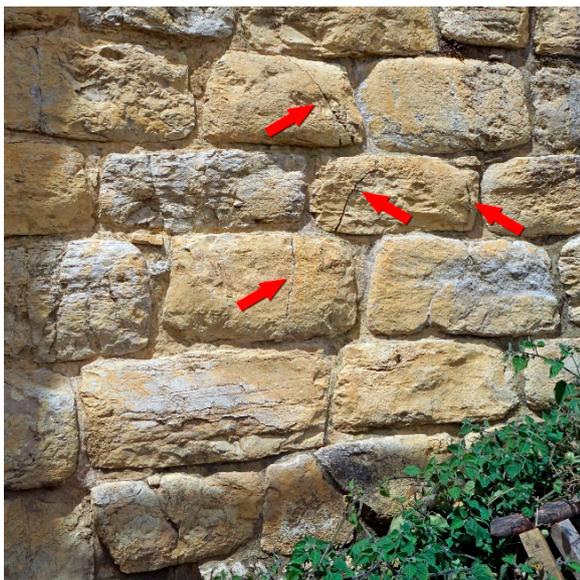
Figure 31. (A) Cracks (red arrows) in the stone blocks of the perimeter wall observed in 2022; (B) Machu Picchu, an example of repointing a wall using clay-earth mortar. Photos by Kościuk.
