Article

Detection of Barely Visible Impact Damage in Polymeric Laminated Composites Using a Biomimetic Tactile Whisker

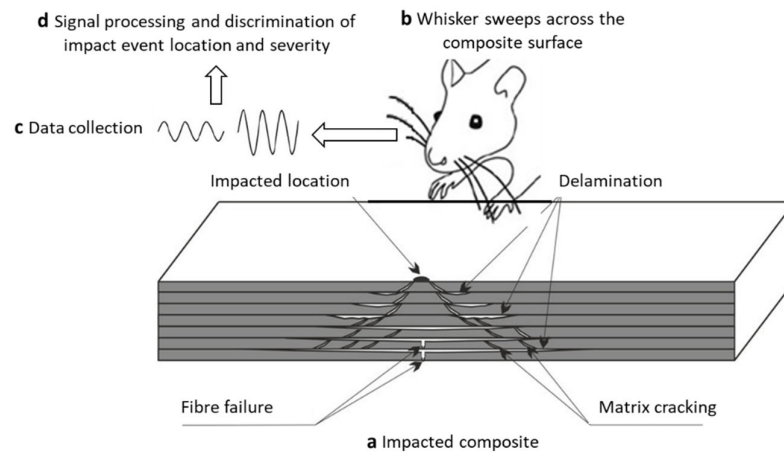
Figure 1. Overview of the project, and a schematic of a typical damage mechanisms in BVID.

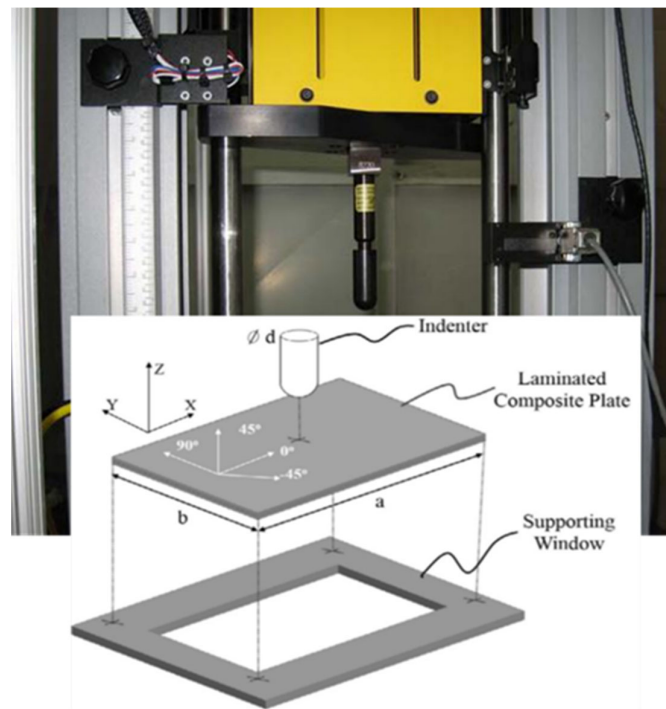
LVI tests were carried out using an Instron Dynatup 9250 HV drop-weight impact tower, manufactured by Instron based in Norwood, MA, USA, and according to the ASTM D7136 standard [32]. The test samples were simply supported on a $125 \times 75 \text{ mm}$ window with four rubber-tipped clamps, as illustrated in Figure 2. The impact energies used were 8 J, 12 J, 36 J, and 64 J, respectively. The impact load and deflection were measured by a single accelerometer inside the tup, and the measured data were processed by a 4 kHz filter of the console software to reduce the noise and oscillations. Ultrasonic C-scan was used to understand the damage mechanisms occurring during the impact events.

Figure 2. Experimental set up for the LVI tests.

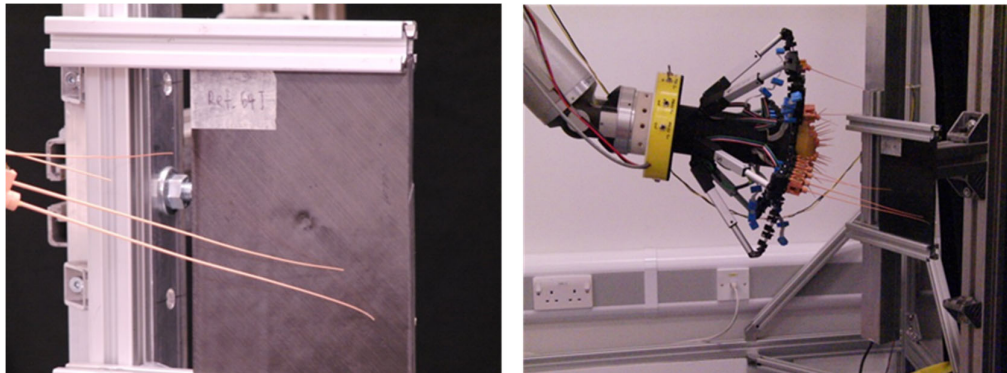
An array of whisker sensors was positioned using a robot manipulator arm (Barrett WAM, Newton, MA, USA), 7 degrees of freedom) and held so that two whiskers could impinge on a single plate as shown in Figure 3.

Figure 3. Whisker scanning set-up.

In each test sequence, the material specimen was impacted 20 times by the whiskers at a frequency of 2 Hz to generate training data for the machine learning algorithm. In each sequence, the first and last whisks were discarded as there were observable differences in the data at the start and end of each run, probably due to the control system. Data were collected at 2 kHz for each “whisk”—a movement of the whisker through an angle of about 70 degrees and touching the test surface at a point near to the furthest protraction position in the swing. In this way, the contact is very light, and repetitions are constrained to be as similar as possible. In subsequent data processing and classification procedures, only one whisker was used as it was found that successful classification could be performed with a single whisker. The longest whisker in the row (the one on the left of Figure 3) was used in the classification experiments.

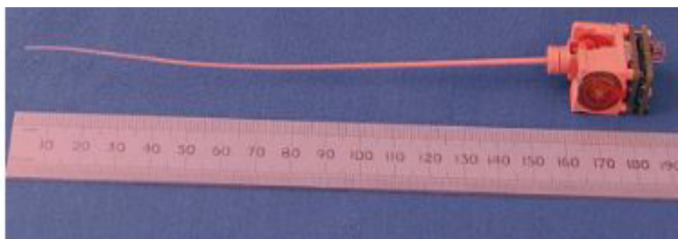
Bristol, UK), provided by EnvisionTEC in the UK, and digital light processing technology to achieve a smoothly tapered whisker with fine tip size coupled with sufficient strength and toughness to withstand repeated impact against surfaces (see Figure 4). The largest dimensions of the whiskers used were 155 mm length, 1.5 mm base diameter, and 0.3 mm tip diameter.

Figure 4. The largest utilized whisker sensor.

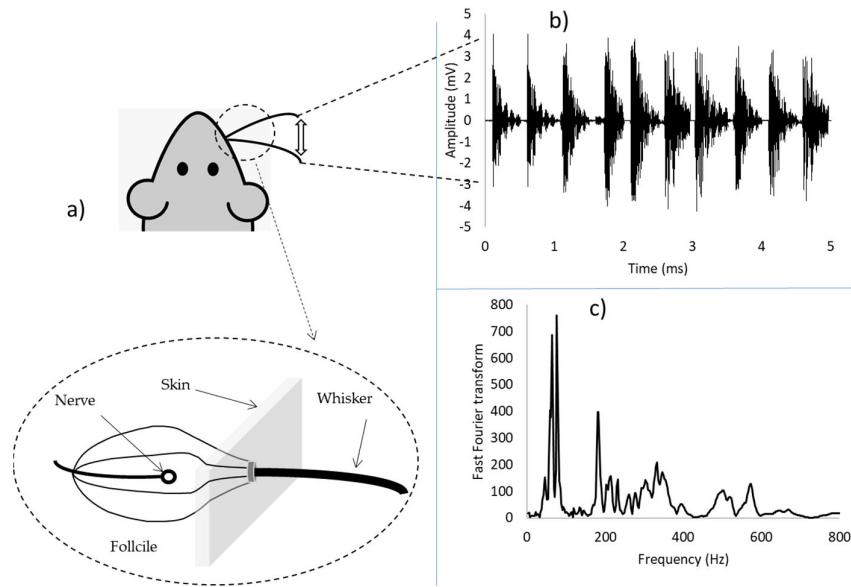
The approach used aims to take advantage of the non-stationary frequency characteristics of the intermittently contacting whisker signals. In particular, time-frequency analysis, using the Time frequency toolbox [33] to derive feature vectors for classification. Figure 5 shows typical transient signals obtained from the whisker sensor, and a fast Fourier transform analysis on a collected signal.

Figure 5. (a) Schematic of the whisker sensor, (b) Typical transient signals obtained from the whisker sensor, and (c) representation of a signal after applying fast Fourier transform analysis.

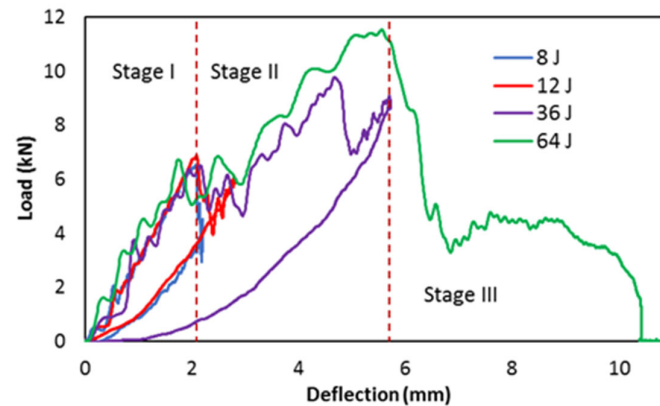
Figures 6 and 7 show comparisons of energy absorption and load-deflection plots obtained during the LVI under increasing impact energies. The data were extracted from Instron Dynatup 9250 HV drop-weight impact tower (Norwood, MA, USA), where a piezoelectric force transducer was used to measure the load, a position transducer and optical encoder were used to measure displacement and velocity. Three stages of the load-deflection can be seen from the load-deflection plots in Figure 6. Stage I is associated with linear behaviour in the early stage of the loading process with an elastic response, and no underlying delamination damage in the laminate. Stage II is related to the initiation and unstable propagation of BVID (mainly delamination) and is distinguishable from the load drops. With the increasing load in Stage II, the number and size of delamination increases. In stage III there is another load-drop due to fibre failure at the back face of the specimen that is under tension. The impact energies were chosen to induce BVID to check the ability of the whisker technology in detecting such damage. The specimens impacted with 8 J, 12 J, and 36 J experience just Stage I and Stage II, due to the lower level of impact energy that causes initiation and propagation of delamination. In these impact energies, the specimens are still integral, and the deflection goes close to zero after the impact. In the 36 J

case, there is a second load drop on the load in Stage II that corresponds to a second unstable delamination propagation that is presented in the post-impact C-scan results in the next section. For the specimen impacted with 64 J, all the three stages exist. This specimen experienced delamination initiation, propagation and fibre breakage in the tension side.

Figure 6. Comparisons of load-deflection plot generated from the drop-weight impact for the investigated laminates at different energy levels.

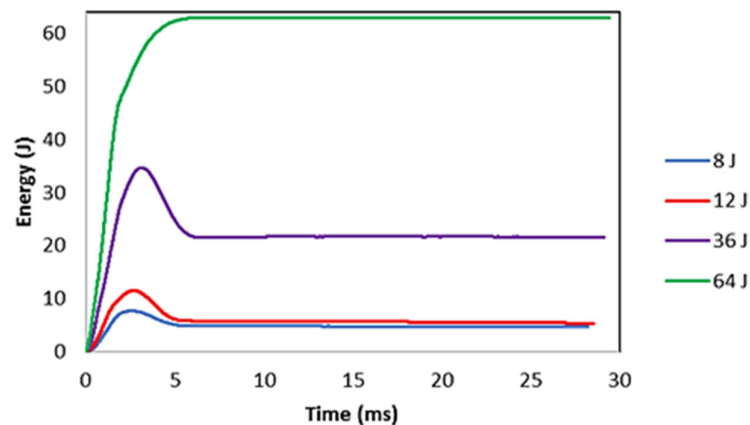
The energy absorption in composite laminates is through the damage mechanism. Comparing the absorbed impact energy at different energy levels, the induced damage in higher impact energy levels is clearly reflected by a difference in absorbed energy (see Figure 7). For the 64 J, the highest impact energy absorption and consequently the highest damage level is expected.

Figure 7. Comparisons of energy-time plot generated from the drop-weight impact for the investigated laminates at different energy levels.

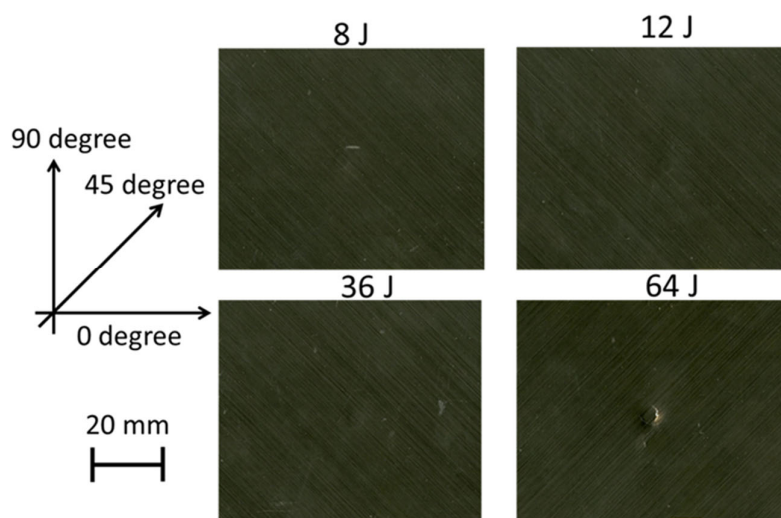
An EPSON scanner, supplied by EPSON in the London, UK, was used to take clear pictures of both the impacted face (Figure 8) and the back face of the samples (Figure 9) after the LVI test at different energy levels. The visual impact damage of the samples is shown on both the front and back surfaces. The impacted side of the samples does not reveal any significant damage, rather than a small dent, with no tangible difference in the different impact energy levels. It is the same for the back face of the laminates, except for the 64 J that an obvious fibre breakage is observable due to the high tensile strains. Comparing the visually observable pictures in Figures 8 and 9 with the C-scan results illustrated in Figure 10, there is a huge difference between the internal damage and the visible

Figure 8. Images of samples that taken from the impacted surface at different impact energy levels using EPSON scanner.

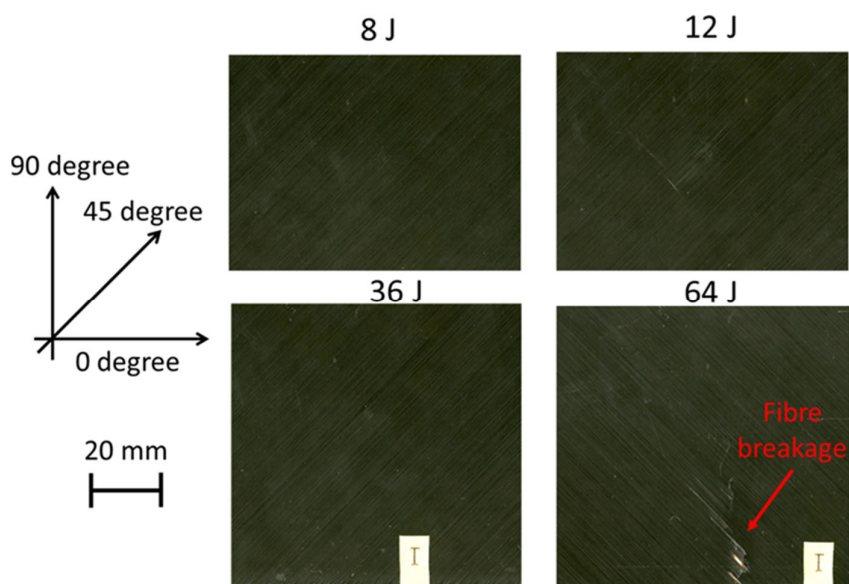
Figure 9. Images of samples that taken from the back face at different impact energy levels using EPSON scanner.

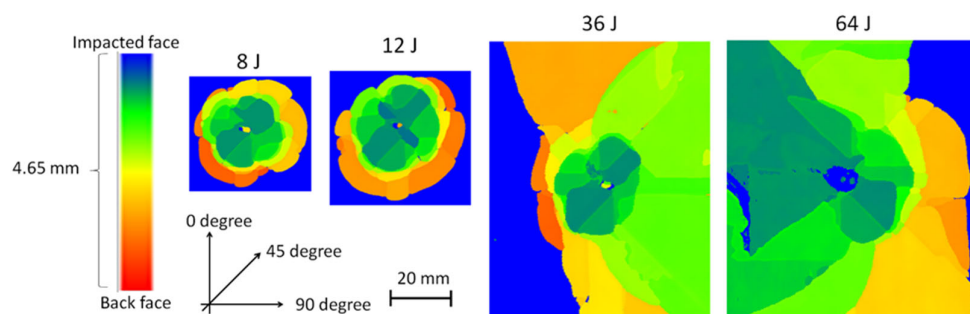
damage on the impacted face. The C-scan results confirm the existence of the BVID in all the impact energy levels, with an increasing trend in the damage size by increasing the impact energy level.

Figure 10. C-scan images of the laminate with various impact energies.

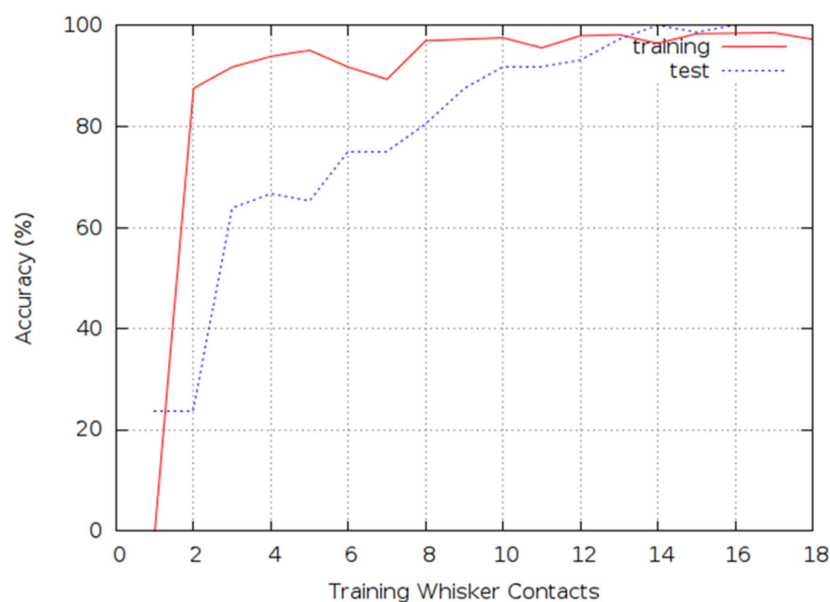
In order to reduce the possibility that other surface irregularities were responsible for correct classification in recognizing the four classes of impact damage from the available four test pieces, the composite samples were rotated 90 degrees in-plane compared with the orientation during training. The 90 degrees rotation was done mainly to make sure texture of the surface ply, due to the directional properties of the composite, does not affect the classification results. It was found that progressively increasing the number of training contacts resulted in increasing classification accuracy of both cross-validation and test data. It is particularly striking that test results after training for 13 whisker contacts or more approached 100% classification accuracy as illustrated in Figure 11.

Figure 11. Classification accuracy for the training and test data.

From the results in Figure 11, the whisker technology was able to distinguish different impact energy levels in the specimens with an accuracy level of almost 100%. Similarly, the whisker technology was able to classify the damaged and undamaged surfaces with 100% accuracy. Even though the damage was barely visible, moving a fingertip on the impacted location, one can say if the sample was damaged or not, however, it was not possible to differentiate the impact energy levels by simply rubbing fingers on the damage location. This reflects the high capability of the whisker outperforming the manual tactile inspection both regarding the accuracy of the method and the potential for automation. It is worth noting that only the impacted face of the specimens was scanned during each experiment, which shows that simply scanning one part of the specimen could provide enough information for successful classification showing the power that the biomimetic whiskers have in terms of providing information. The whisker technology can be extended to large scale composite structures, as it detects any changes on the surface. So, for any given laminate size, impact event can be detected if it results in dents and surface texture variation. However, there will be a need for calibration and reliable training dataset for each case study.

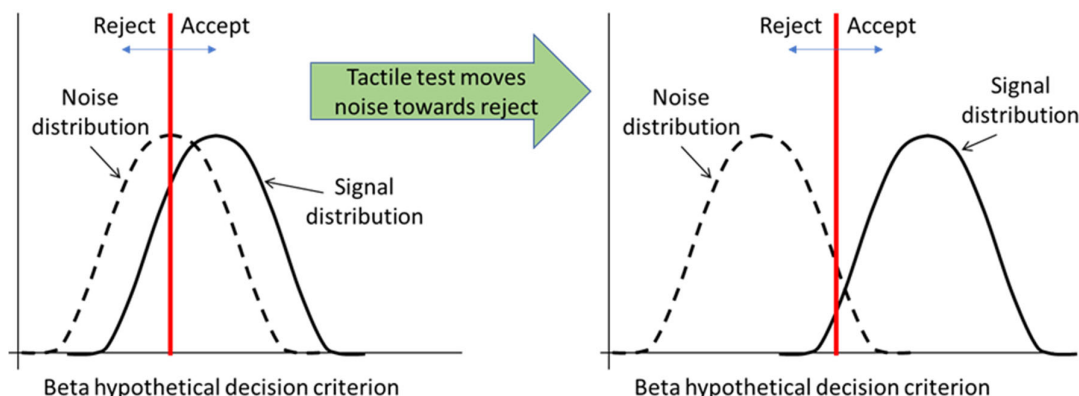
developed for decision making purposes [41]. This hybrid inspection approach looks very promising for large scale composite structures such as aircraft panels and wind turbine blades, where a quick and fast visual scanning can highlight critical areas, and the whisker scanning can provide more localized and detailed information from the critical areas. This hybrid inspection approach can potentially provide accurate and reliable information on BVID and its extent, and may result in a fast, but a comprehensive scan of composite surfaces with reliable data for autonomous decision making.

Figure 12. Tactile test improves visual inspection’s reliability by strengthening the “signal” component (damage) and filtering the “noise” component.
