Article

Shore Protection Structures Increase and Evolution on the Northern Tuscany Coast (Italy): Influence of Tourism Industry

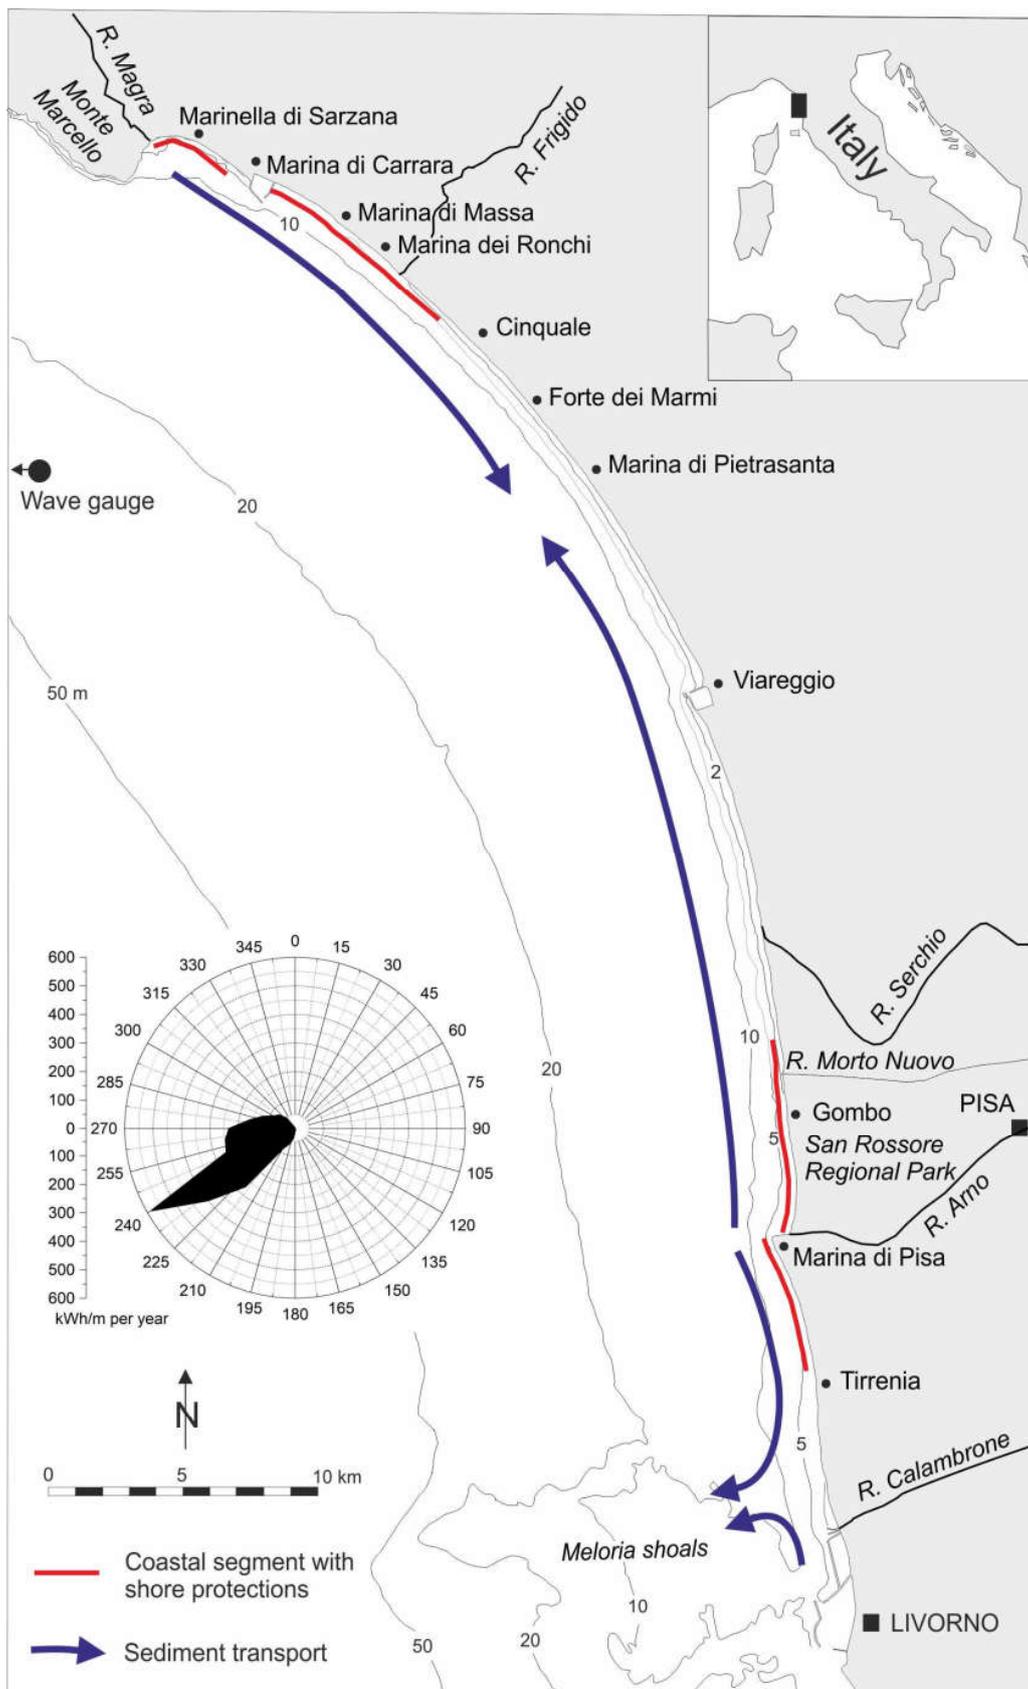
Figure 1. Location map of the study area with longshore transport directions [46]; wave data from “Rete Ondametrica Nazionale”—La Spezia gauge December 2009–December 2014.

A continuous 63.5 km-long sand barrier connects Monte Marcello promontory to the Livorno rocky salient (Figure 1), where the largest harbour of Tuscany was constructed in the 16th century. Three main rivers empty on this coast, R. Magra, close to Monte Marcello, R. Serchio, 39 km to the south and R. Arno, 11 km from the southern limit of the physiographic unit. The latter is the main feeder river of this coast, with approximately 1,524,000 t/year of total load [42], R. Magra contributes with 632,000 t/year to the coastal sediment budget [43], whereas R. Serchio, whose watershed is in large parts on limestone gives a limited input (approx. 23,000 t/year, [43]). River Magra, coming down from high mountains close to the coast, brings mixed sand and gravel sediments, whereas R. Arno, crossing the Florence and Pisa plains, deposits all its coarse sediments before reaching the sea. Present input is far lower than that of the previous centuries: for example, R. Arno sediment yield is only 37% of that estimated for the 1500–1800 AD period [44].

Wave climate is characterized by a limited wave angular dispersion, with storms coming exclusively from the SW (Figure 1). Longshore transport diverges at the River Arno delta apex and sediments from this river feed the coast as far as Livorno and up to Marina di Pietrasanta, where a convergence with sediments coming from the R. Magra was identified via morphological, sedimentological, petrographic and numerical models [44,45]. The littoral unit is divided into four main littoral cells [46] (Figure 1), from north to south these are:

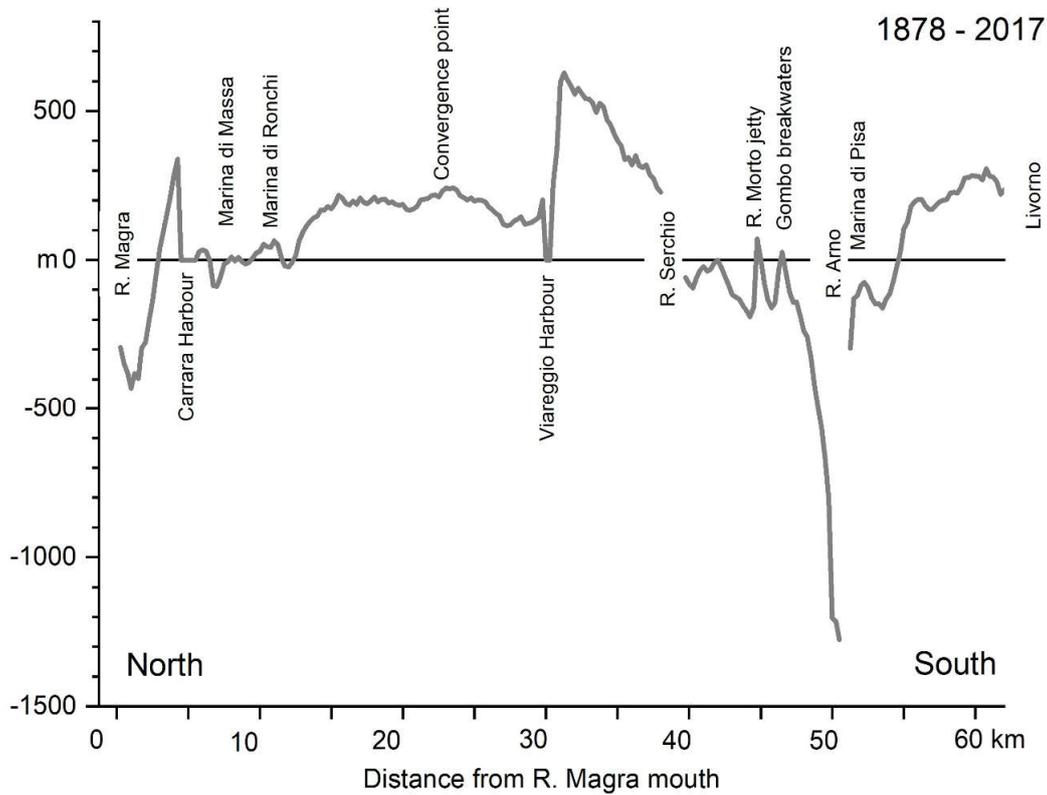
Figure 2. Shoreline displacement along the study area from 1878 to 2017 (from south of Marina di Pisa to Livorno the period is 1881–2017).

Approximately 1.5 km to the north occurs the Fiume Morto Nuovo (New Dead River) outlet, an artificial mouth of the Fiume Morto draining the northern Pisa plain, which was diverted to the south in 1926–1930 to shorten its course and favour water discharge. In 1933, jetties were built, which were further extended with several projects. This had a strong feeding effect and now the downdrift beach is some 260 m narrower than the updrift one (Figure 2).

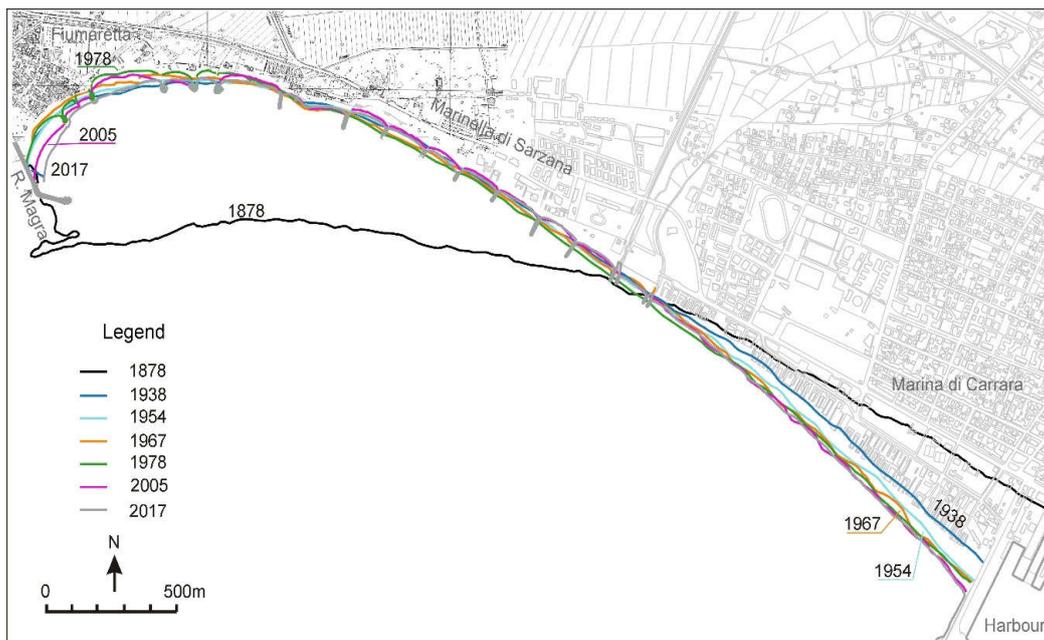
Figure 3. Shoreline evolution from 1878 to 2017 between the R. Magra mouth and Marina di Carrara harbour.

On the northern side of the coast (Figure 3), the R. Magra never built a real delta but the Istituto Idrografico della Marina Italiana (IMI) 1881 nautical chart shows a salient in correspondence with the 5 and 10 m isobaths [56]. In 1938 approximately 3 km of coast to the south side of the river mouth were eroded, with a recession of more than 500 m; on the IIMI 1954 nautical chart the salient is no longer present [56].

When erosion nearly reached Marina di Carrara (Figure 3), harbour construction began. The project was redacted in 1920 but work started in 1922 [57] and the beach of this locality—otherwise destined to be eroded—started to expand so much that today it is approximately 300 m wider than in 1920s (Figures 2 and 3). This favoured and accelerated erosion processes on southern coastal sectors (i.e., downdrift of the harbour, Figure 2), where now 10 km of intensively developed coast is severely eroding and a variety of shore protection structures have been built.

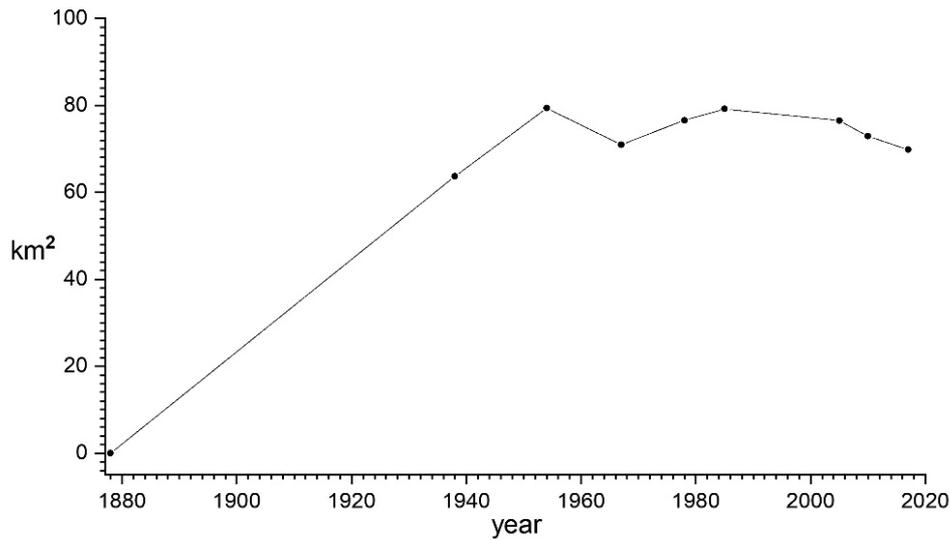
Figure 4. Mean shoreline trend of the study area compared to 1878.

Over the whole coast (Monte Marcello—Livorno), available data shows that the beach surface grew until 1954 with a mean shoreline displacement of approximately 80 m (Figure 4). The 1967 survey was performed to evaluate damages done by intense storms, which concurrently occurred with the November 1966 flood in Florence and a mean shoreline retreat of 8.3 m was registered. However, in the following years, part of this loss was recuperated and the total beach surface in 1985 was approximately the same as in 1954. Post this, a gradual surface reduction took place and, in 2017, the total beach

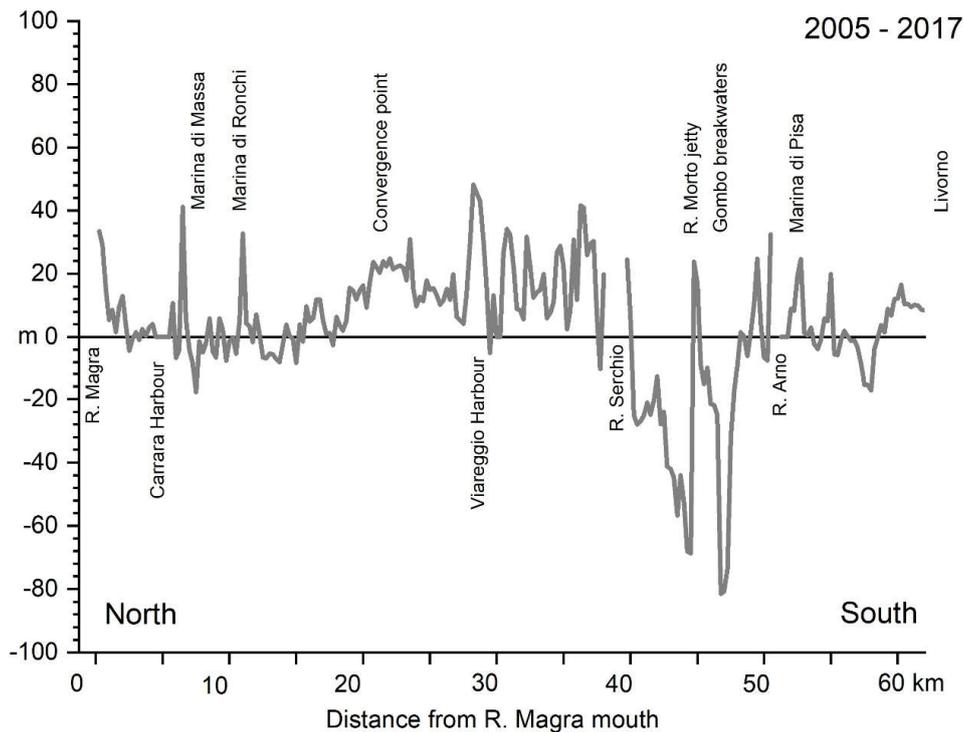
Figure 5. Shoreline displacement along the study area from 2005 to 2017.

In the last years (2005–2017; Figure 5) some projects gave positive results: south of the Magra River sediment bypassing from the river terminal course to the beach allowed beach expansion (Figure 3). This sediment movement was possible because, after several decades of river dredging prohibition, the natural sedimentary dynamics was restored and sediments were able to arrive to the mouth.

At Marina di Ronchi emerged and submerged groins were built and a few nourishment works carried out: this allowed to revert a decennial negative trend. Similar structures stopped coastal erosion north of R. Arno mouth where erosion recorded values of 10 m/yr during the 1997–2000 period. Gravel nourishment at Marina di Pisa returned the beach to this town after one century. The opposite is still the situation updrift of the R. Morto Nuovo jetty and between Marina di Pisa and Tirrenia but the largest erosion is observed at Gombo, where a project based on an artificial tombolo built with

a geotextiles failed and up to 80 m of shoreline retreat was registered during the 2005–2017 period (Figure 5).

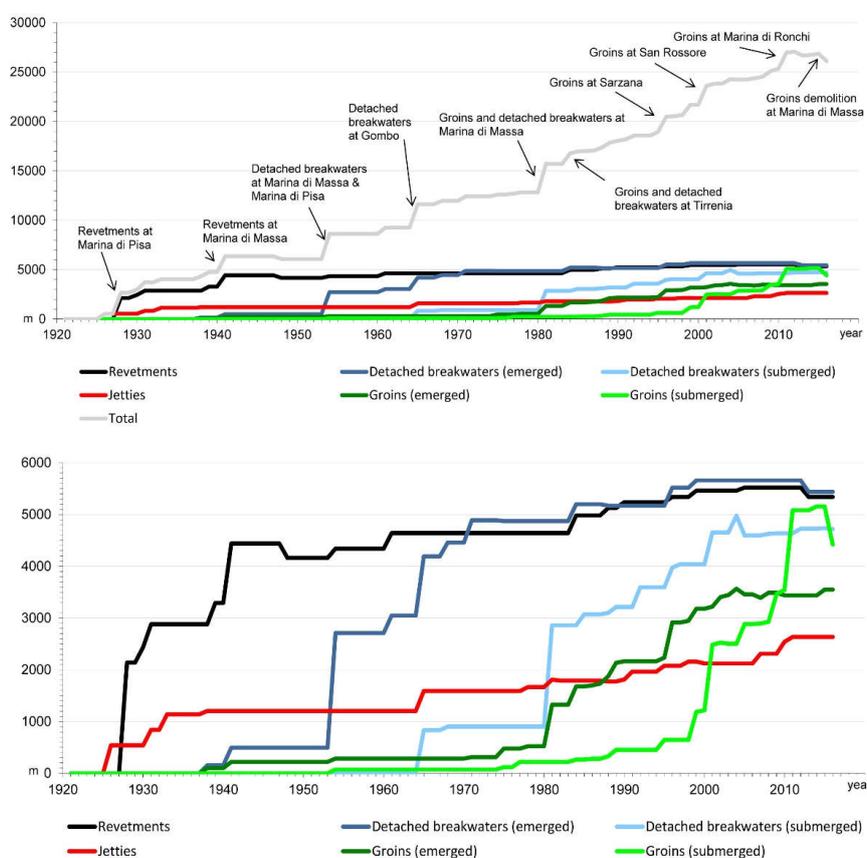
Figure 6. Cumulative length of the various shore protection structures from 1920 to 2016. Main interventions are indicated. **Top:** with total length; **Bottom:** without it to better show each structure types length.

To the south, at Marinella di Sarzana (Figure 3), eight groins were built between 1989 and the mid-1990s and three of them were extended with submerged segments in 2005, within a major defence project which was never finished. It is in these years that orthogonal structures exceed revetments in length (Figure 6).

As previously stated, coastal erosion was approaching Marina di Carrara beach when harbour construction started in 1922 (Figure 3); the updrift coast inverted its trend but the downdrift sector was severely eroded. Here, 300 m of coast was protected with a revetment and detached breakwater in 1930, both being progressively further expanded to the south to reach respectively 500 and 800 m in 1939 (Figure 6).

These defences gradually evolved into a more structured project performed in the 1960s to arrive at ten detached breakwaters, some of which were connected to the coast with groins: each kilometre of coast was protected by 2.3 km of rock. It is in this period that detached breakwater length overpassed that of revetments in the study area (Figure 6).

Groins (after the transient case of Marina di Pisa in the 1920s) were not frequent along this coast until the 1980s, being limited to those of Marina di Massa; but later they experienced an accelerated expansion and in 2011 their total length was greater than that of detached breakwaters. However, the last project at Marina di Massa, aimed at reducing the landscape impact of defensive structures and increasing beach quality, which resulted in a small decrease in their total length (Figure 6).

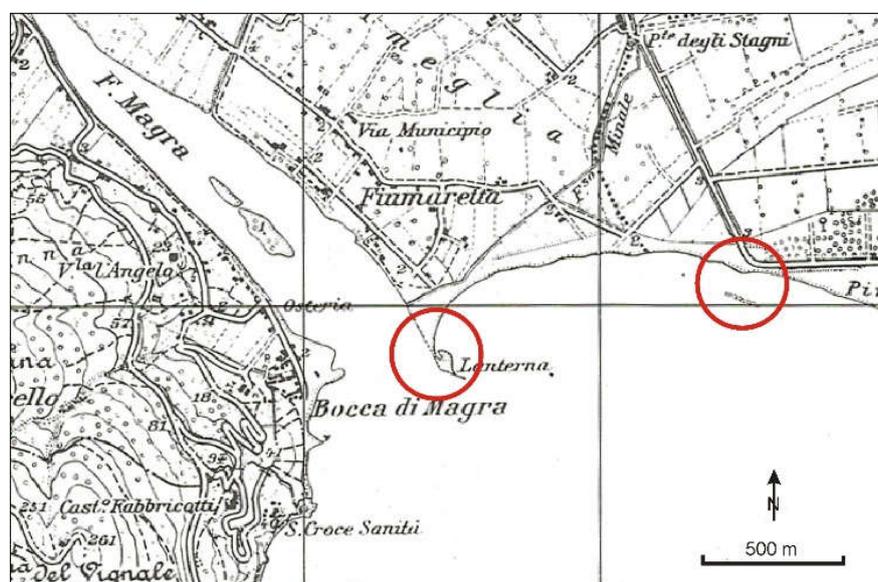
Figure 7. The first two structures (red circles) built on the northern coast and present on I.G.M. 1:25,000 map surveyed in 1938: post-1928 detached breakwater and 1931 jetty.

On the 1938 IGM map a detached breakwater is present on the northernmost sector, where the road connecting Sarzana with Marina di Carrara turns to follow the coast (Figure 7); this structure was built after 1928 and, although deteriorated, still exists. On the same map a *circa* 300-m-long jetty is present on the R. Magra outfall's southern side; it was built in 1931 to prevent river mouth siltation both to favour river discharge during floods and to allow boat access to shipyards located along the river's terminal stretch.

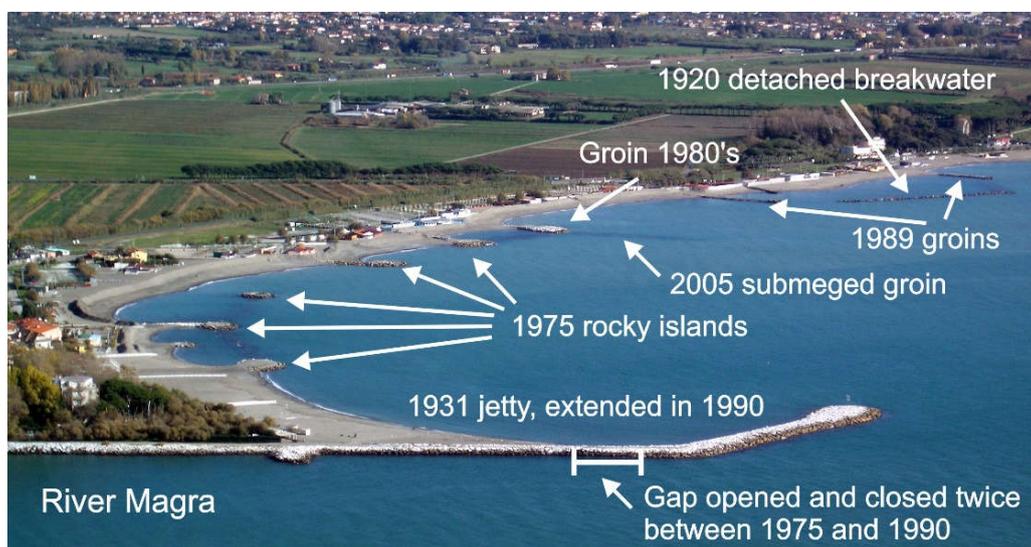
Figure 8. River Magra jetty and Fiumaretta beach (November 2005).

submerged breakwaters or connected to the shore with short groins (Figures 3 and 8). Further changes to the structures were carried out in the 1980s, adding and reshaping elements and in 2005 an artificial island was extended seaward with a submerged groin. In 1982 a gap was opened in the jetty at the river mouth to allow sediments to feed the beach but due to induced sea water pollution and stakeholders' complaints, it was closed in 1990.

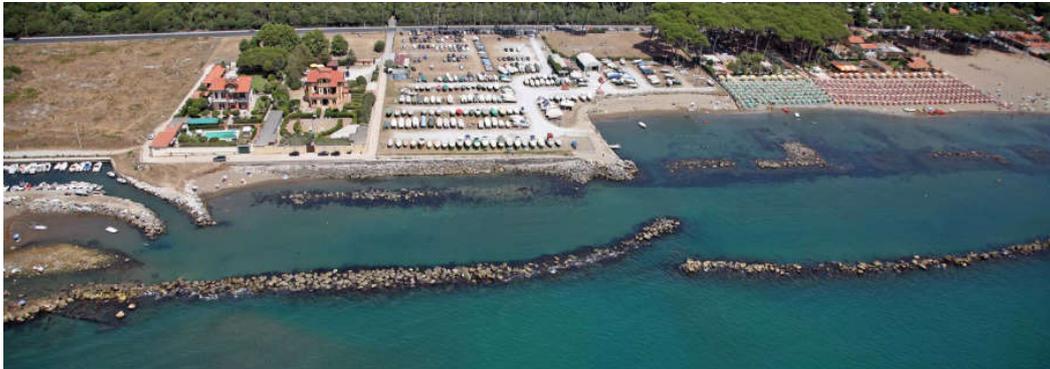
Figure 9. Marina di Carrara: area downdrift of the harbour with different defence structures (Photo Provincia di Livorno).

At the beginning of the following decade shore protection expanded more to the south for approximately 2 km, with revetments and detached breakwaters and at the end of the 1950s the coast south of the harbour was defended for more than 3 km (Figure 9). Not only revetments and detached breakwaters were extended but they also needed several maintenance works and strengthening.

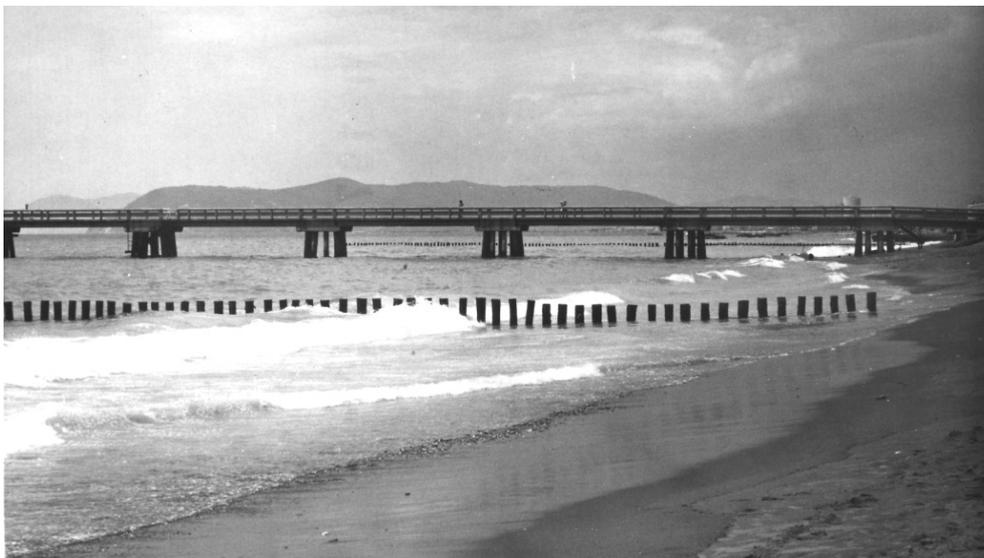
Figure 10. Marina di Massa: permeable groins in a picture taken in 1968 (the pier in the background).

Further south, where the beach was accreting until 1938, in 1954 it was approximately 100 m narrower. Here coastal road and houses were far from the shoreline but the back beach was occupied by bathhouses fronting a beach surface on which to locate sun umbrellas. This surface gradually reduced and structures, at that time built with timber, were continuously set back, until the road prevented any further retreat. Permeable groins with timber poles—but also with iron bars—were built but no information remains except from some old photographs (Figure 10).

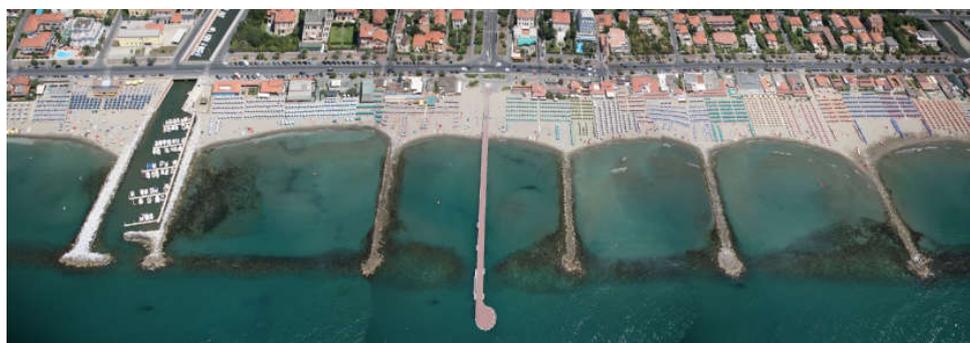
Figure 11. Groins with tips connected by submerged breakwaters. On the left the Brugiano R. with jetties; on the centre the Marina di Massa pier (Photo Provincia di Livorno). Summer shot captures sun umbrella density.

Coastal armouring proceeded to the south with nine very closely spaced groins (average Length/Distance = 1) unable to intercept longshore transport (see [60] for a functional design of groin systems) and the beach continued to be eroded even if a submerged breakwater was constructed to connect their tips. Only rising it to the mean sea level favoured effectiveness of the defences and the beach expanded for approximately 16 m on average [61]: very fine sand enters in suspension into the protected area during storms producing a not very attractive tourist beach but one which is very appreciated by concessionaires that are able to rent more sun umbrellas (Figure 11).

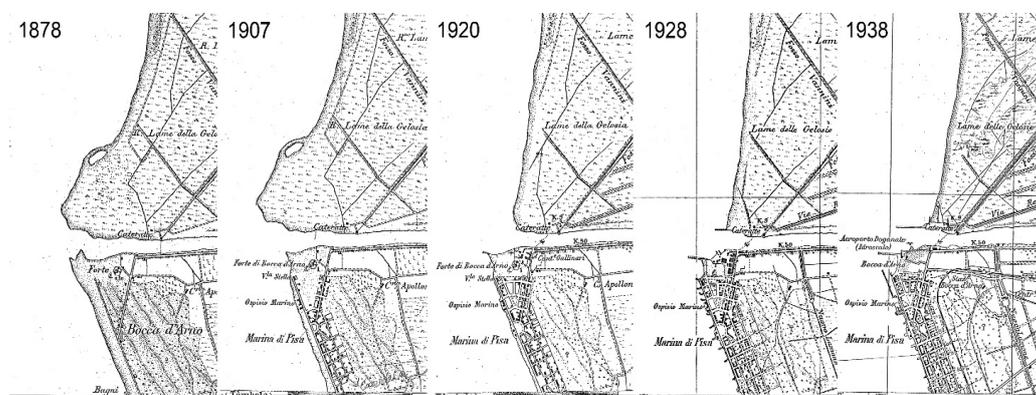
Figure 12. Coastal occupation, armouring and progressive beach disappearance at Marina di Pisa on IGM maps between 1878 and 1938 (in 1907 an update was performed on the southern coast only).

But it is the coast at Marina di Pisa, which gave origin to the first structure proliferation in this littoral unit. Maps dated 1878, 1907 and 1920 (Figure 12) showed no structures in front of the town but analysing old photos and postcards, it is possible to observe perishable structures (permeable wooden fences and groins) on the beach fronting the recently built settlement, which can be dated to the very early 20th century (Figure 13).

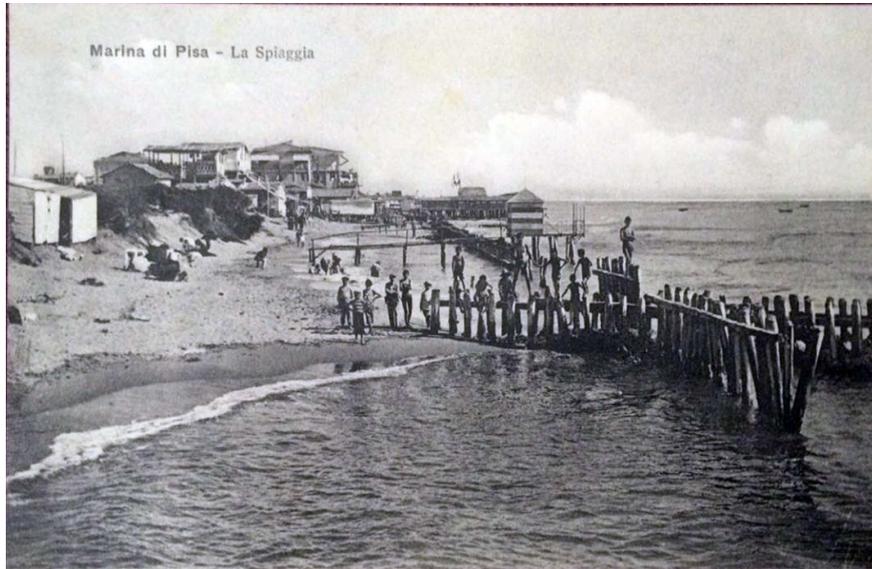
Figure 13. Permeable structure at Marina di Pisa in a *circa* 1915 postcard.

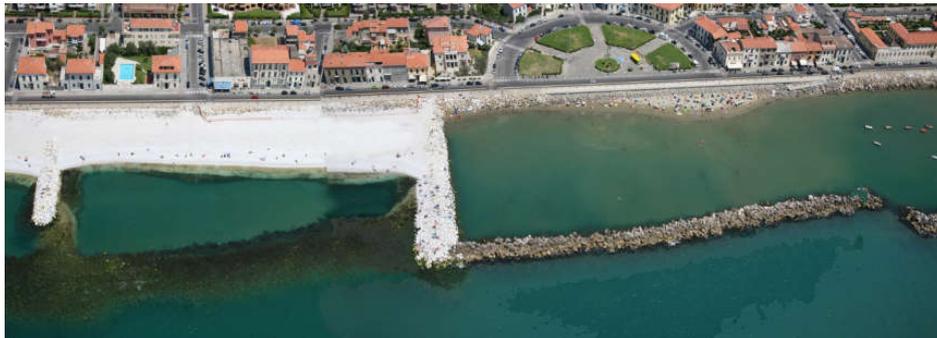
Figure 14. Marina di Pisa: on the right the old defence system with revetments and detached breakwater and on the left the new one with gravel beaches and submerged breakwaters (Photo Provincia di Livorno).

The shoreline position was fixed but erosion continued on the submerged profile: at the external foot of the detached breakwater a depth of 7 m was reached, both for the general sedimentary deficit and for basal scouring, as in Reference [64]. These breakwaters become inadequate to protect the settlement and their elevation from 2.0 m to 3.5 m was postulated, when the need for softer shore protection structures was growing in Tuscany under the motto "Back to the beach" [65]. A new project started with lowering of the old breakwaters to 0.50 m below mean sea level and widening their crest;

a 30 m wide gravel beach was created to absorb the overpassing wave energy. Currently four of the ten breakwaters have been converted by transforming 940 m of emerged structures into submerged ones (Figure 14).

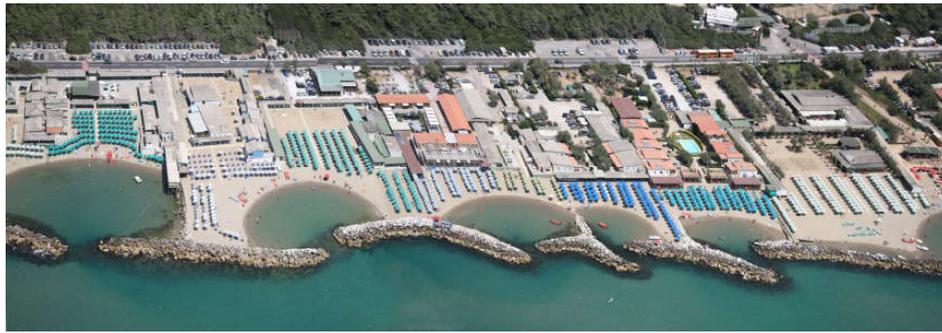
Figure 15. Between Marina di Pisa and Tirrenia: coastal armoring following emergency, un-coordinated interventions (Photo Provincia di Livorno).

On the southern side of the town, shore protection structures expanded towards Tirrenia, not to protect the road or the houses but to maintain the beach in front of the numerous beach establishments. It is not known how many defences were unauthorized but it is accepted that they did not follow a general project. Now detached breakwaters, oblique and shore-connected structures and traditional groins limit safe access to the sea, producing low quality water and they have transformed a sandy coast into a rocky one (Figure 15). The value on this coast in terms of tourism income was strongly reduced and all this was done simply to support tourism.

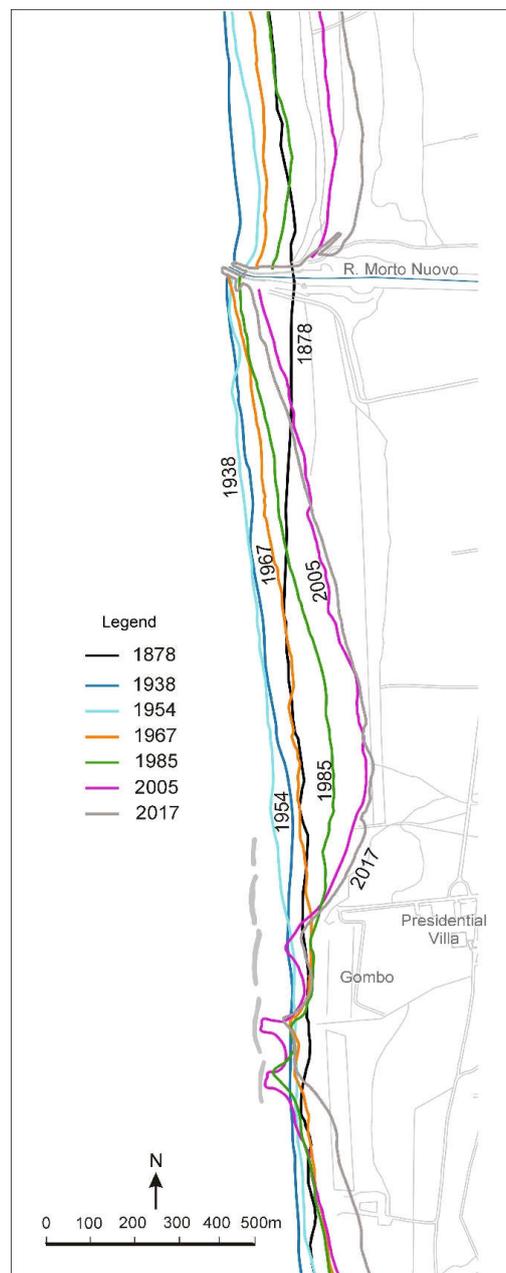
Figure 16. Shoreline evolution at Gombo from 1787 to 2017.

Four kilometres north of the Arno River mouth (Figure 16), the five detached breakwaters were built between 1962 and 1968 to defend Gombo beach, in front of the Presidential Villa of San Rossore (now part of a Regional Park). The house was more than 300 m far from the shoreline and only two huts were present on the beach: the project was carried out exclusively to maintain beach facilities for park employers more than for the Italian President.

However, results were limited and 20 years later only smooth salients were formed. In 1984 four out of the five breakwaters were elevated and extended: resulting immediately in four tombolos, which fitted well with model predictions of beach response to structures geometry [66]. Longshore transport was interrupted by the tombolos and downdrift beach caused severe erosion; here the deepening of a spiral bay induced updrift erosion, destroying the tombolos and leaving the breakwaters too far offshore to be effective [67].

On the right-hand side of the R. Arno mouth, nature was untouched until 1300 m of land was lost; in 2001 emerged groins with submerged extensions were built to protect the Regional Park wetlands. A completely different approach was taken a few kilometres north, at Gombo, where detached breakwaters were positioned in the 1960s to defend the privileges of a few people (Figure 16).
