Article

# Biopolymer-Reinforced Levee for Breach Development Retardation and Enhanced Erosion Control

The Andong River Experiment Center (REC) of the Korea Institute of Civil Engineering and Building Technology (KICT) performed a full-scale test to verify the effect of biopolymer-mixed soil layers on the stability of levees in overflow conditions. The biopolymers used in this study were polysaccharides that have been shown to have no adverse effects on local ecosystems. In the experimental setup, a practical overflow-induced levee breach was emulated under two conditions: in Case 1 the sand levee was not treated with biopolymer, and Case 2 consisted of biopolymer–soil mixture cover and vegetation survival. The biopolymer–soil mixture was sprayed on the levee crown and inland-side levee slope. Upon completion of the experiment, pixel-based image analysis was performed to capture the levee breach events under the experimental conditions. The breach retardation effect was analyzed quantitatively, and the results were presented.

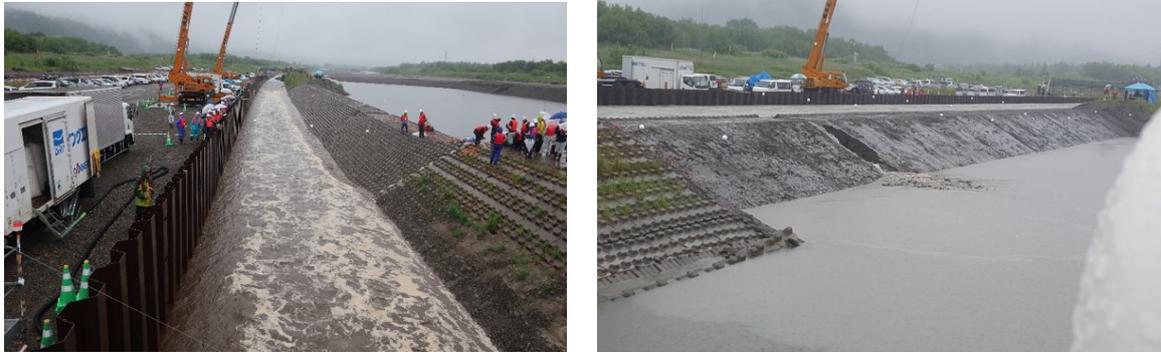
**Figure 1.** Levee Breach Experiment of Chiyoda Channel, Japan [23].

In Japan, the Hokkaido Regional Development Bureau and the Civil Engineering Research Institute for Cold Region jointly launched a project to construct the world's largest facility devoted to various levee experiments. The size of the facility enabled the simulation of actual flood events (Figure 1). This facility is a full-scale experimental flume that can control a volumetric flow rate of 150 m<sup>3</sup>/s or

higher using an upstream hydraulic gate operating system; it can reproduce any naturally occurring water events without relying on the scale effect. Various experimental studies have been conducted in this facility, such as improvement of the techniques to counter overflow-induced levee breach and assessment of the performance of levee protection systems [23].

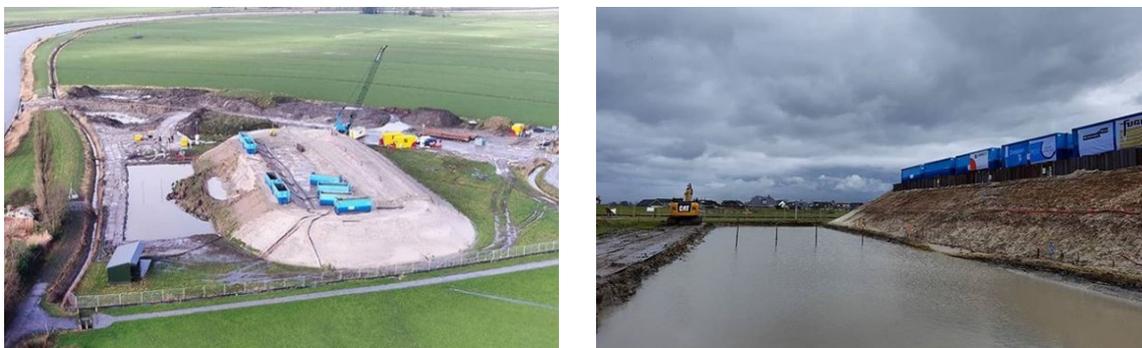
**Figure 2.** Levee Breach Experiment of Eemdijk, Netherlands [24].

In the Netherlands, the Dutch Flood Protection Program (HWBP) has been initiated to complete levee reinforcement along a stretch of 1100 km by 2028. According to the HWBP, it aims to present an optimized solution for levee parameters such as thickness, arrangement, shape, and position through real-scale testing of the technique of reinforcing sheet pile walls embedded in levee structures (Figure 2). A levee measuring 60 m (length)  $\times$  5 m (height) was installed, and the levee deformation was measured in real time via various types of sensors under the experimental conditions of water seepage and application of vertical load [24].

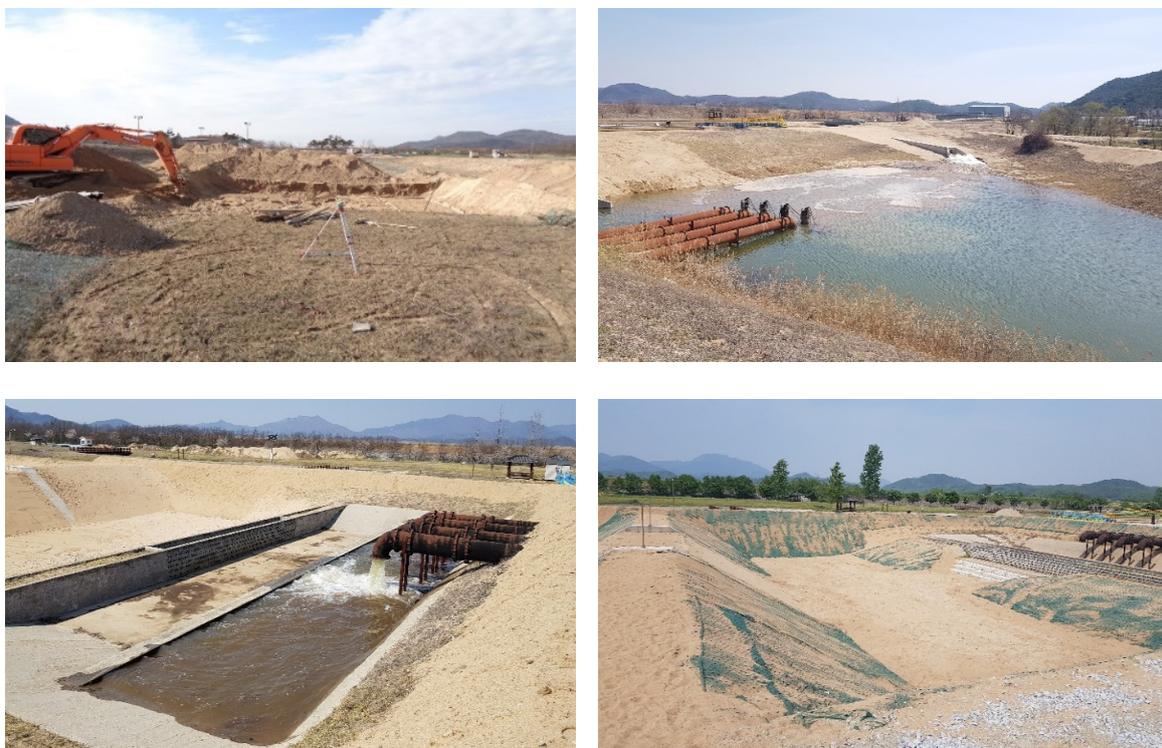
**Figure 3.** Construction of the Levee Lab.

The Levee Lab was constructed in two stages: (1) civil foundation work for levee model construction and overflow reproduction and overall experimental safety inspection through a trial run; (2) reinforcement work in segments with safety concerns, such as flow feeder and pump inspection, reinforcement of scour zone associated with flow rate, installation of vegetation mats to reduce seepage into slope soil, reinforcement of the circulation flume for smooth drainage, and construction of access roads for heavy equipment for model production (Figure 3).

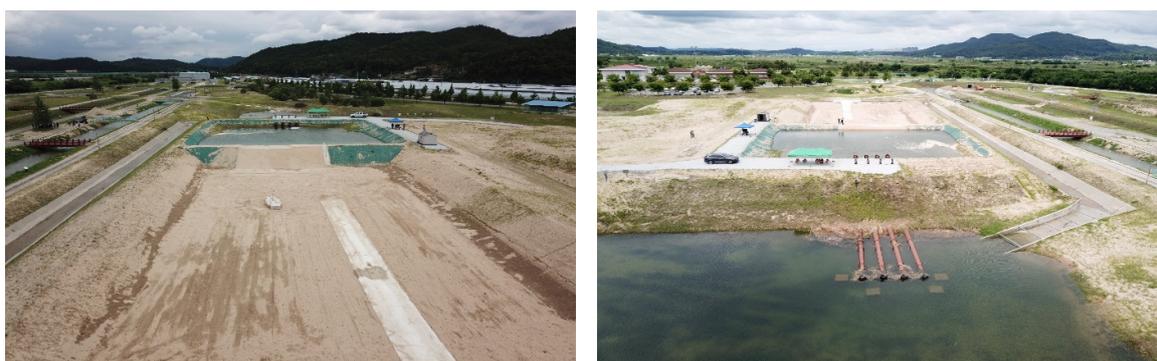
**Figure 4.** View of the final completed Levee Lab.

Figure 4 shows the panoramic view of the completed Levee Lab. The flume is 100 m long (inland and river side land) and 50 m wide, and the upstream pump system can control volumetric flow rates of up to 2 m<sup>3</sup>/s. Seepage, overflow, and piping experiments can be performed by installing a levee model up to 3 m high and 30 m wide. Additionally, by predetermining the experimental conditions (levee height, width, and supply flow rate), other experiments, such as the verification of a natural method and new concept, identification of breach mechanism, and improvement of measurement technology, can be conducted.

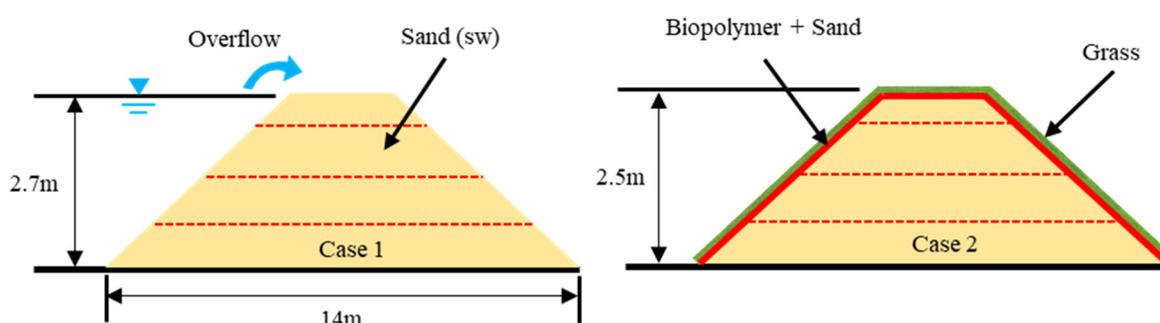
**Figure 5.** Experiment specifications and conditions.

Two overflow breach experiments were conducted to develop an optimal levee protection technology by gaining the stability of the new material levee method through verification experiments. Case 1 was a control case consisting of river sand. Case 2 was an experimental case in which a new 5 cm thick material layer was sprayed on the levee crown and inland side slope, and the turf was laid down. Case 1 was composed of a levee with a height of 2.7 m, slope gradient of 1:2, overflow section of 10 m, and total length of 14 m. Case 2 was constructed with a height of 2.5 m, lowered to control the overflow depth in the latter part on the assumption that the levee breach would be retarded compared with Case 1 (Figure 5). The steady-state water discharge supplied from the upstream pump station into the experimental setup was 1.0 m<sup>3</sup>/s.

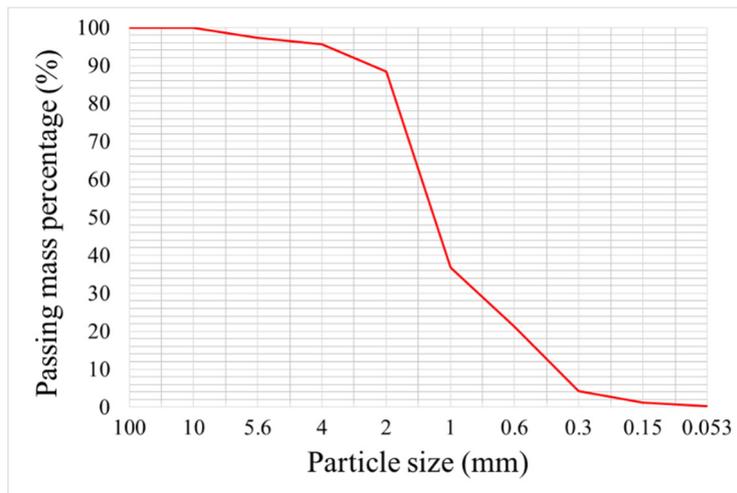
Figure 6. Grain size distribution of levee material.

We used well-graded sand (SW), which had a uniformity coefficient of 5.2 and a coefficient of curvature of 1.1, as the material for the test levee of the same condition (Figure 6). The optimal water content in the levee was 11.7%, and the maximum dry density was 1.853 g/cm<sup>3</sup>. The levee foundation was formed with two heavy equipment vehicles, and the compaction was performed at 50 cm intervals using a vibration compactor. After blending the new material according to the recipe provided by the Korea Advanced Institute of Science and Technology (KAIST), namely 1 kg biopolymer, 30 kg water, and 100 kg soil, the turf (18 × 18 cm) was directly laid down on the blended soil. Six sprinklers were then installed to supply water for a month in order for the vegetation to take root, and the preparation for the overflow breach experiment was terminated (Figure 7). The experiment began with the overflow onset and ended with the completion of the overflow-induced levee breach. Unfortunately, as a biopolymer that has polysaccharide properties, the type of bacteria (chemical composition of the biopolymer) cannot be revealed due to copyright issues.

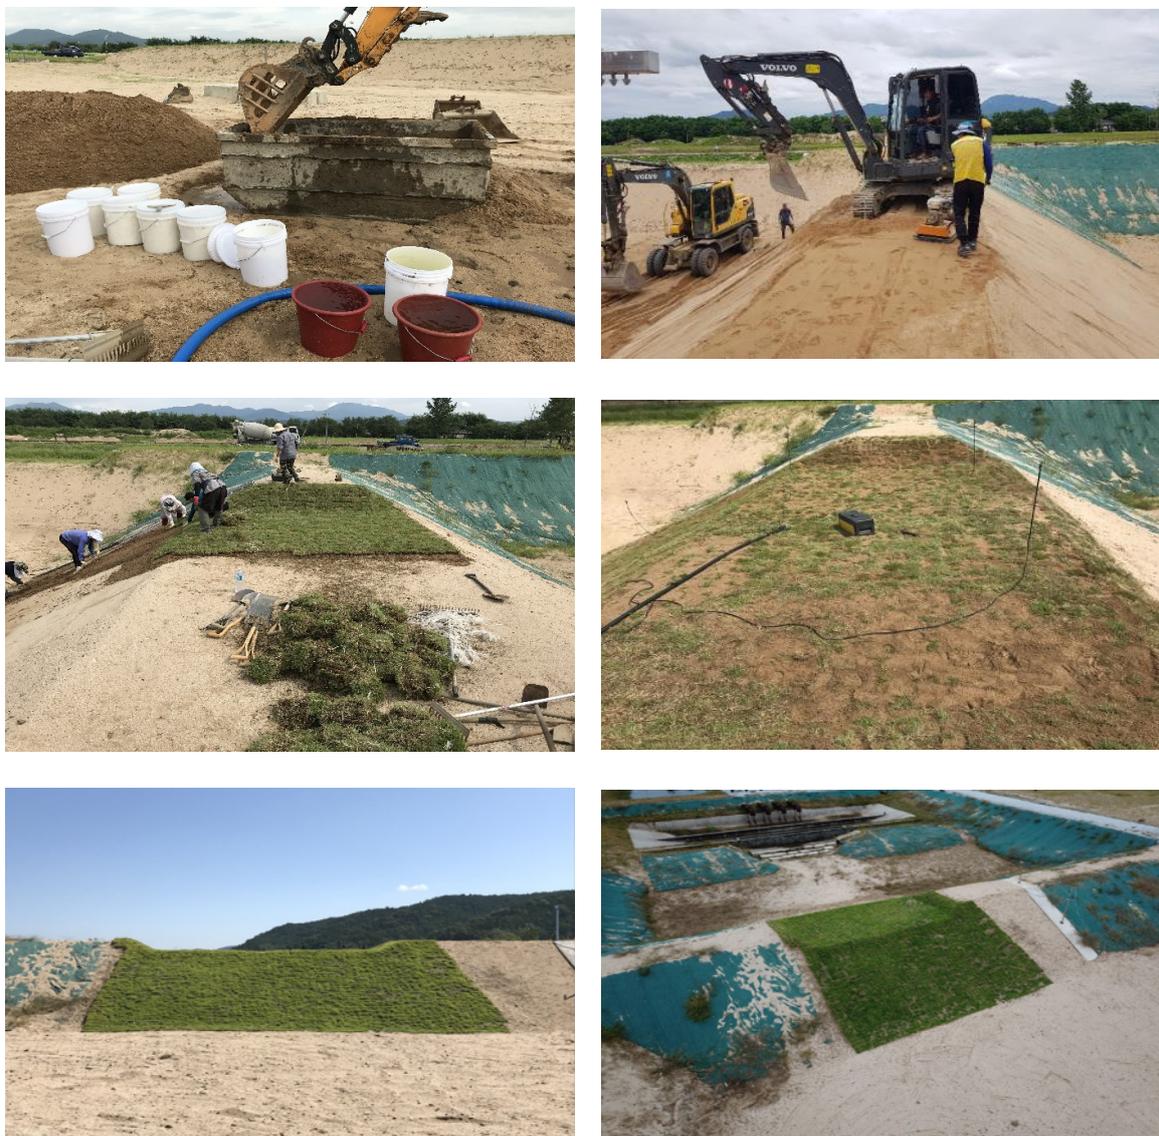
Figure 7. Construction of levee model and grass planting.

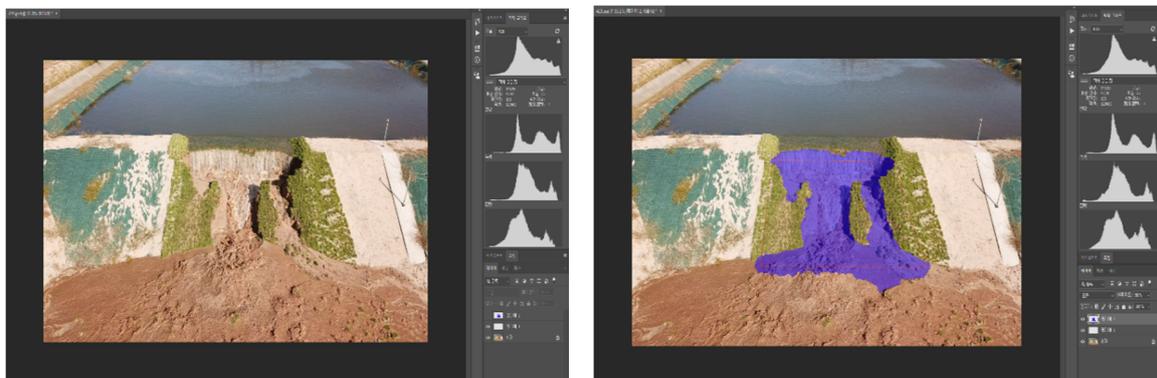
Figure 8. Image process and analysis of breach scale.

We installed a water level sensor (OTT Orpheus Mini water level logger, OTT Hydromet, Kempton, Germany) to record the change in water level within the flume following the levee breach. The entire process was captured in real time with multiple cameras and drones (DJI MAVIC PRO, DJI, Shenzhen, China). Given the difficulty of calculating the amount of soil discharge following the levee breach, the time-series surface loss rate was analyzed by selecting the inland-side levee slope as the quantitative analysis sample. The analysis was conducted by capturing and correcting the image every 30 s using motion graphics software (Adobe After Effects, Adobe, California, CA, USA), and data uploaded to Photoshop were subjected to digitization for the determination of the range of breach. Then, we calculated the surface loss rate by measuring the change in the number of pixels relative to the total number of pixels based on the range of breach calculated every 30 s. By comparing the range of breach in terms of the number of pixels between the biopolymer-treated experimental model and the untreated control model, we quantitatively presented the breach-mitigating effect of the reinforcement with the new material (Figure 8).

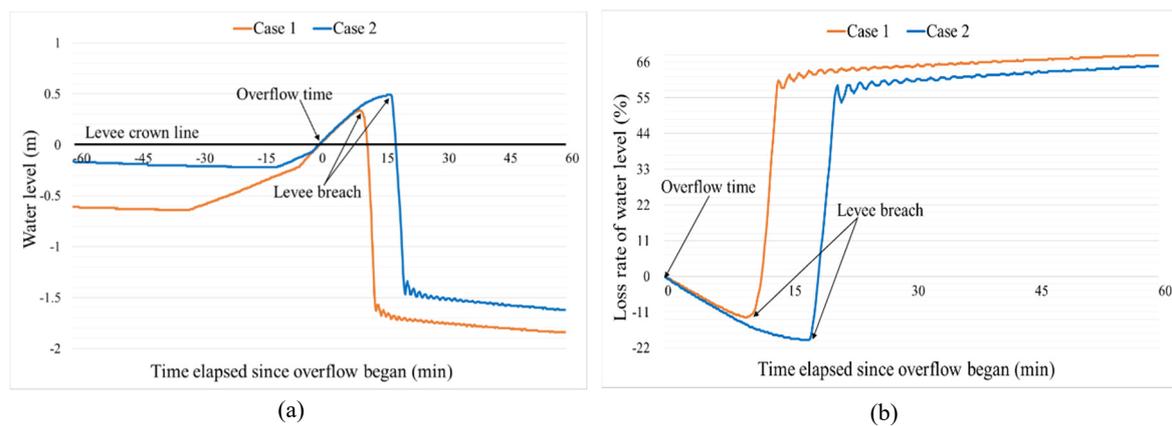
**Figure 9.** (a) Water level with overflow times synchronized. (b) Loss rate of water level based on levee height over time.

Figure 9a shows that the water level curve steeply rose immediately after the onset of the overflow. This may be ascribed to the steady increase in the overflow depth at the early phase of the overflow until the levee crown breach. The early-phase time interval during which the water level steadily increased was longer in Case 2 than in Case 1, which implies that the development in the breach section was slower in the biopolymer-treated levee. In turn, this demonstrates the breach retardation effect of the new material reinforcement.

In Figure 9b, Case 1 exhibits the onset of the steep curve of the water level reduction rate due to levee breach 12 min after the onset of the overflow. Case 2 exhibits the same result after 19 min. In addition, the maximum water level reduction rate according to the levee height in Case 2 was 64.8%, which is approximately 4% lower than in Case 1 (68.2%). In other words, Case 1 experienced a more drastic change in water level after the onset of the overflow than Case 2, presumably because of the increased peak outflow due to the development of the breach area. After the initial overflow, the levee was breached abruptly with the levee crown breach and concurrently with the levee slope breach.

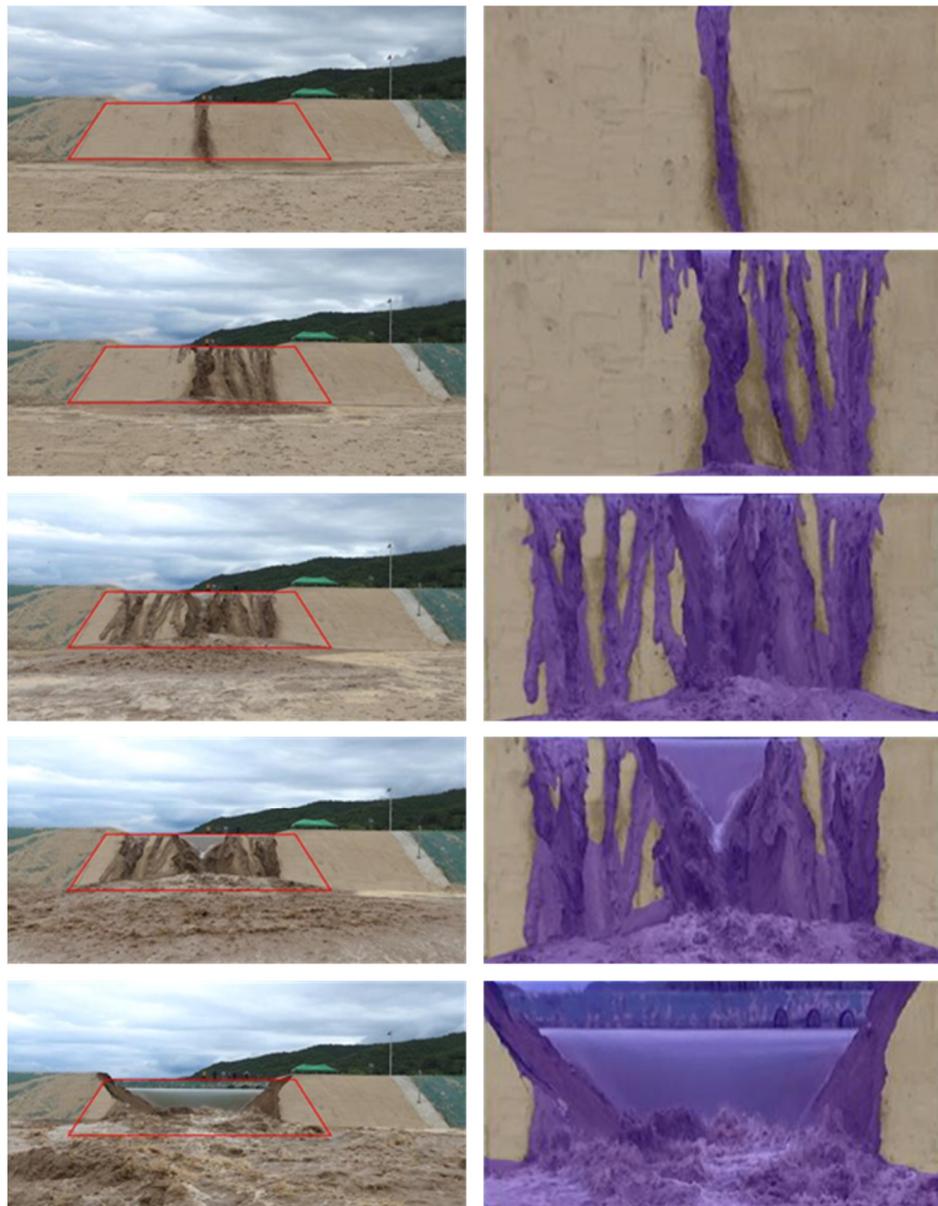
Figure 10. Time-series (1 min interval) comparison of levee slope loss rates (Case 1).

Tables 1–3 show the time-series slope loss rate of each test condition, and the analysis results are as follows. In Case 1, the breach began at the joint between the levee crown and the slope, resulting in more than 4% surface loss 30 s into the overflow onset. This can be seen as the stage in which an early flow pattern forms on the levee slope and develops into the main flume, causing erosion. At 120 s after the overflow onset, the surface loss reached 30% and further accelerated to reach over 70% 240 s after the overflow onset. In this stage, the breach widened, causing the overflow rate to increase and consequently expedite the erosion process. A perpendicular erosion also occurred at the cross-section of the overflow. This was followed by a deep breach surface due to complete levee breach and a rapid increase in the overflow rate, and the maximum breach width was reached by the tractive force. The complete breach, with a loss rate of nearly 90%, occurred at 360 s after the onset of the overflow with all parts of the levee destroyed, including its slopes.

In Case 2, the slope loss did not occur even 100 s after the onset, and the levee slopes began to erode only 120 s after the onset. At this point, the breach area began to increase at the levee center and toes. Nevertheless, the progress of the breach was mostly retarded compared with Case 1. The energy generated by the tractive force of the water spilling over to non-vegetated turf was transmitted to the deep soil, giving rise to the phenomenon of soil scour. This occurred only approximately 300 s after the onset of the overflow, in which over 50% surface loss had occurred. The time of slope breach slowly rose to 480 s. The slope collapse developed eventually, and over 70% surface loss occurred 510 s after the onset. Local scour was observed at the center of the slope due to the strong vertical flow generated from the overflow resistance, causing the breach to proceed in the form of vertical erosion, which accelerated the erosion of the levee crown. At 600 s after the onset of the overflow, a complete breach occurred with a loss rate close to 90% (Figures 10 and 11).

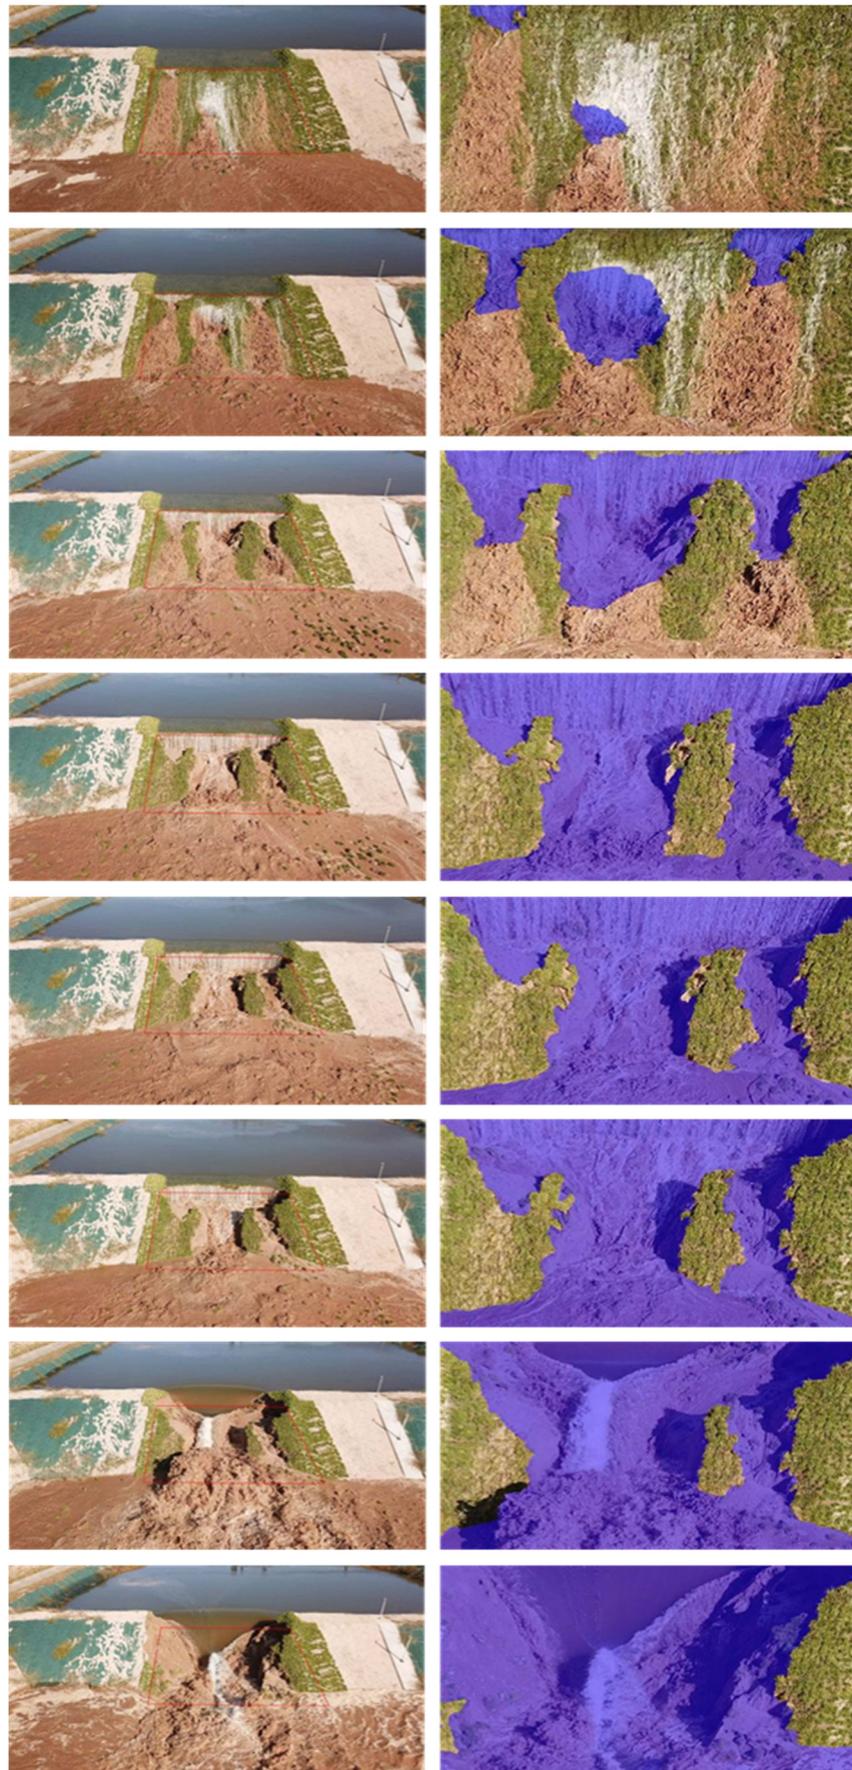
Figure 11. Time-series (1 min interval) comparison of levee slope loss rates (Case 2).

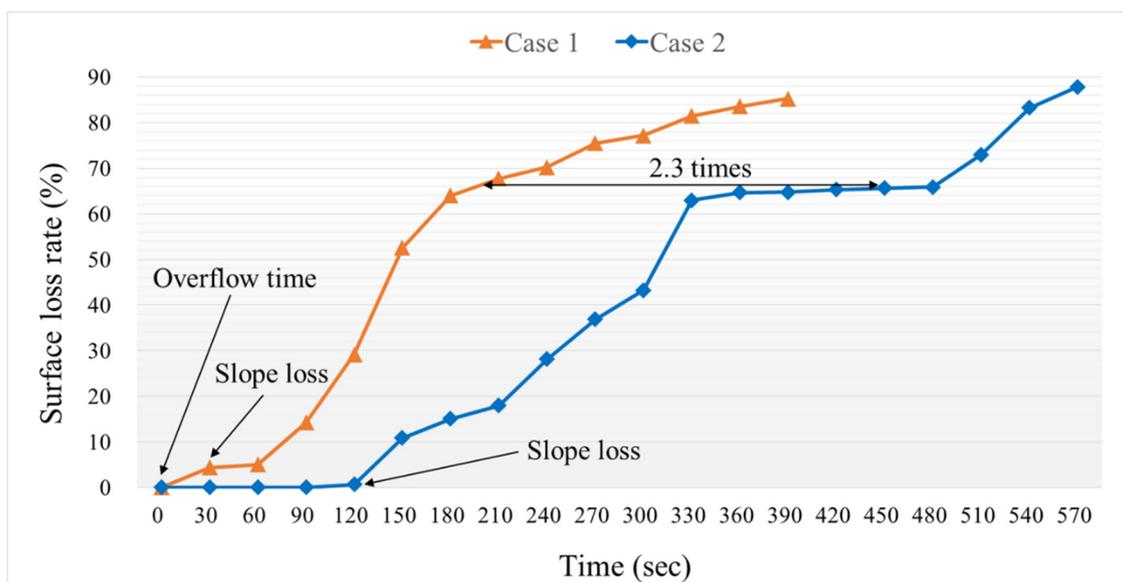
Figure 12. Comparison of surface loss rates over time in each experimental condition.

In Case 2 (biopolymer-treated soil), since the levee crown did not erode in the early phase of the overflow, the overflow rate was significantly lower than that of Case 1 (untreated soil), even under the progressive slope breach (increasing loss rate) induced by the overflow. Figure 12 shows the time-series comparison of the levee slope loss rates between the untreated soil levee and the biopolymer-treated levee. The slope loss rate of Case 2 was retarded 1.5 to 2.3 times over time as compared to Case 1.
