Article

# Differing Levels of Forestry Best Management Practices at Stream Crossing Structures Affect Sediment Delivery and Installation Costs

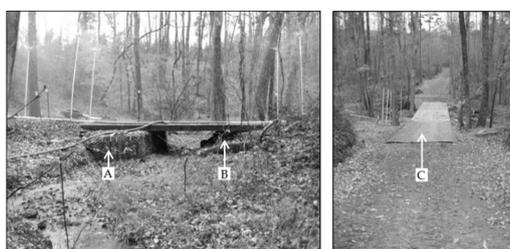
**Figure 1.** Left: Bridge during rainfall simulation on best management practice (BMP+) treatment with gabion basket (A) as an abutment (left of stream) with the native slope as the opposite abutment (B) and the road running surface and bare soil rocked; Right: Bridge prior to application of rock over the geotextile fabric (C) on the running surface of the road (BMP-std); picture shows geotextile prior to rock application which completed the BMP-std treatment.

The original legacy ford stream crossing consisted of steep approaches with poor alignment, which often required four-wheel drive usage and resulted in substantial channel disturbance. In order to improve trafficability and reduce maintenance and risk of erosion from the road network, a wood panel bridge was installed. The bridge consisted of three white oak (*Quercus alba*) panels 7.3 m long, 1.2 m wide, and 0.2 m thick. The panels were combined to form a bridge 7.3 m in length and 3.6 m wide (Figure 1). The bridge spans a distance of 2.8 m, with approximately 2.25 m of bridge extending beyond the abutments on each side. The eastern abutment for the bridge was constructed using two gabion baskets (0.9 m × 0.9 m × 3.6 m) that were placed along the edge of the stream channel. Approximately 0.6 m of fill was required behind the gabion baskets to allow for the desired grade on the bridge approach. The native Fairview soil series [50] was used for fill behind the gabion baskets. The eastern abutment utilized a near-vertical stream bank that was stabilized by the roots from surrounding trees. Geotextile fabric was applied on both abutments. Approximately 5 cm of Virginia Department of Transportation (VDOT) #5 (1.25–5 cm stone) drain rock was applied on the geotextile to aid drainage and increase the longevity of the permanent bridge.

At the bridge crossing, the first series (high, then medium, then low intensity) of rainfall simulations was conducted on the BMP– treatment approximately 2 months after construction. The road surface and exposed soil were left bare within the simulation area. The second rainfall simulation series was conducted on the BMP-std treatment, which consisted of the application of geotextile for 20 m on each side of the bridge surface with approximately 5 cm of #357 stone on the entire road running surface within the simulation area. The BMP-std simulation was conducted the same day as the addition of gravel. The final rainfall simulations were conducted on the BMP+ treatment, which was characterized

by all bare soil being covered and armored with approximately 30 cm of rip-rap (approximately 10–30 cm stone). The BMP+ rainfall simulations were also conducted within the same day as construction.

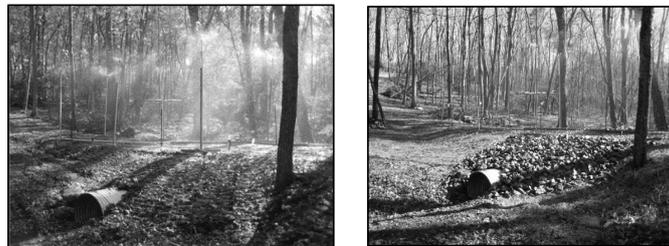
**Figure 2.** **Left:** Culvert after installation and during BMP– rainfall simulation; **Right:** Culvert prior to BMP+ rainfall simulation with rocky running surface and fill slopes and seed and mulch on bare soil.

The culvert crossing replaced a legacy road ford with steep approaches and a soft non-reinforced streambed which often required four-wheel drive for travel. The alignment of the road leading to the crossing resulted in excessive curvature. The relocation and realignment of the road centerline shifted the location of the culvert approximately 10 m below the original ford. The relocation improved the horizontal curvature of the road, thereby improving both trafficability and grade of the approaches (Figure 2). The Virginia Department of Forestry (VDOF) BMP guidelines [51] suggested using a 0.9-m culvert for the 17-ha watershed and a 10-year return interval storm event. Two 6.1-m culverts were joined into a 12.2-m pipe. This length facilitated desired road alignment and provided sufficient length to allow gentle fill slope ratios above the culvert. For installation, the stream channel was excavated using a New Holland TN750 farm tractor with a 3-point mounted backhoe. The culvert was aligned with the native channel with approximately one-third of the culvert being below the natural streambed to allow for coarse bed load material to fill the bottom of the pipe and facilitate travel of aquatic species. Fill material was moved and compacted with a John Deere JD450 bulldozer. Upon completion of the earth work, the bulldozer was used to compact and grouser track the fill slopes, which increased surface roughness and storage.

For the culvert stream crossing, the initial rainfall simulations were conducted on the BMP– treatment, which consisted of the fully constructed culvert with bare soil on the road surface and fill slopes. The second series of rainfall simulations was applied to the BMP-std treatment, which consisted of the application of #357 rock to the road running surface on top of geotextile. The final treatment that received rainfall simulation, BMP+, consisted of applying rip-rap to the fill slopes as well as the application of grass seed and straw mulch to the bare soil near the road surface and fill slopes (Figure 2). The culvert BMP- rainfall simulations were conducted approximately 2 weeks after construction, the BMP-std rainfall simulations were conducted within a week of gravel application, and the BMP+ rainfall simulations were conducted the day of rip-rap and mulch addition.

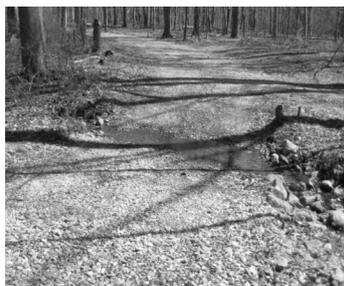
**Figure 3.** Ford crossing with BMP+ treatment, including rocky running surface and Geo-Web in the channel.

An existing unimproved ford on the legacy road was reinforced and improved (Figure 3). The existing ford had a semi-rocky bottom. The road was not perpendicular to the stream channel and the upstream tire track in the stream was often soft, resulting in vehicle tires sinking several inches into sediment which had settled in the wheel track. The crossing was improved by re-aligning the road to allow for a crossing that is nearly perpendicular. The steep stream banks were smoothed to allow for an easier transition when traveling through the crossing. The streambed was reinforced utilizing Geo-Web to stabilize the VDOF-specified VDOT #5 gravel which was placed in the stream channel. In order to maintain the native stream gradient, the streambed was excavated 15.2 cm. After the Geo-Web was placed in the excavated area, it was backfilled with VDOT #5 gravel to the top of the Geo-Web.

For the ford crossing, the first rainfall simulations commenced with the BMP– treatment. For BMP–, the stream banks were angled and smoothed with the backhoe to allow for easier travel through the crossing, and approaches were graded with a bulldozer. BMP– resulted in approximately 50% bare soil due to the native rock fragment. The second series of rainfall simulations was conducted on the BMP-std treatment. The BMP-std treatment did not improve the streambed; however, #357 stone was applied to the running surface of the approaches. The final series of rainfall simulations was conducted on the BMP+ treatment, in which Geo-Web and rock were applied to the stream channel and all bare soil near the crossing was covered with native stone or gravel (Figure 3). The ford BMP– rainfall simulations were conducted one day after construction, BMP-std rainfall simulations were conducted approximately one week after construction, and the BMP+ rainfall simulations were conducted approximately one week after construction.

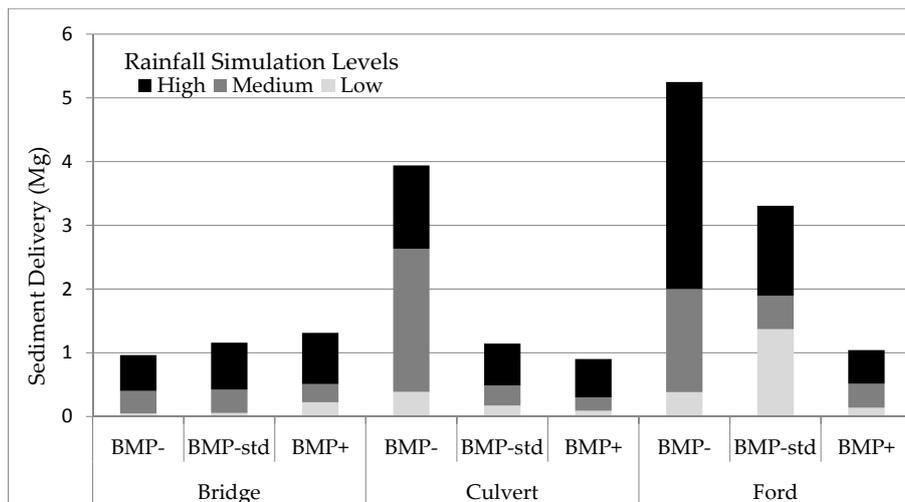
**Figure 4.** Total sediment delivery (Mg) during the 50-min period beginning with initiation of the 30-min rainfall simulation and for 20 min after completion of rainfall simulation by crossing and BMP level.

Sediment concentration of each crossing was influenced by the intensity and duration of the rainfall simulation. Sediment concentrations start with low sediment levels at the initiation of rainfall, peak approximately 15 to 30 min into the rainfall simulations, and again decrease to the baseline levels. Ford and culvert crossings showed a decrease in total sediment delivery with increasing levels of BMPs (*i.e.*, BMP– to BMP-std to BMP+), while the bridge showed little change through all levels of BMPs (Figure 4).
