Article

Climate Change Mitigation and Preservation of the Cultural Heritage—A Story of the Municipal Park in Rumia, Poland

Monika Trojanowska

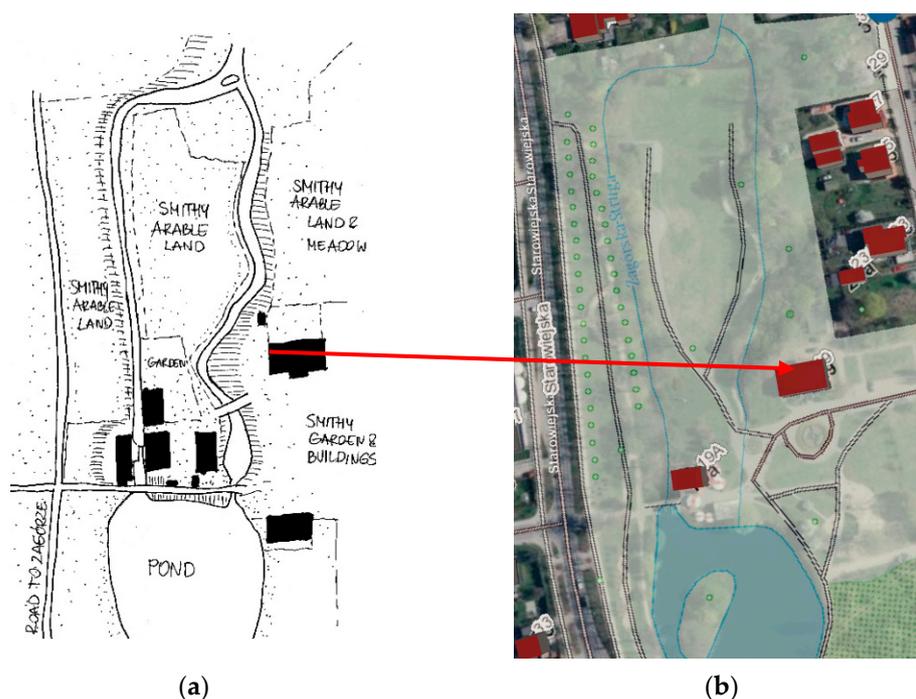
Figure 3. The case study area: (a) in the XIX century—a manor house from the second half of the 18th century, a residential house from the first half of the 19th century (demolished in the 1970s), a granary, a barn, a pigsty, and a stable next to Mickiewicz Street, and further away—a factory building, a factory office, an oven, a farmhouse, and a pond designated as “public water” Source: author drawing, according to A. Sadłowski [15] and historic map from 1829/66/664—Königl. Domänenrentamta in Brück zu Zoppot, Wojewodzkie Archiwum Państwowe w Gdańsku; (b) today—there is only one building remaining from that period—the manor house and a new building constructed next to the pond, designed to resemble historic watermills, orthophoto map, source: [18].

The water smithy was the largest industrial plant in Rumia, of great economic importance until the 19th century [15]. (Figure 3)

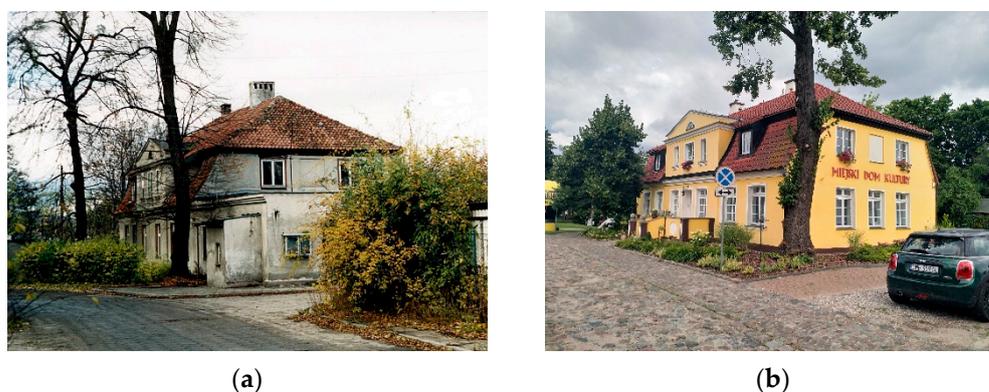
Figure 4. The manor house “Dwór pod lipami” from the second half of the 18th century; (a) before the renovation, source: [16]; (b) and after (picture from the summer of 2021), source: author.

In the second part of the XVIII century, a residential house was built, later referred to by the local community as a manor house “under the linden trees.” After the cease of industrial use in the 1950s, the poorly maintained manor house slowly fell into disrepair until the municipality took it over (Figure 4).

The reconstruction of the manor house started in 1995. Some additions were demolished to restore the original functional plan changed to accommodate the offices on the first floor and apartments on the second floor. Only the foundation, basement walls,

exterior walls, and some of the interior partitions were preserved. All the floors, stairs, and roof construction needed to be removed and replaced. New foundations under the new construction walls and a chimney were added. The original walls needed to be cleaned, and the destroyed bricks were replaced.

The monument bears visible traces of arches and vaults preserved in its walls. The arched slab over the basement was renovated. Locally, a layer of reinforced concrete was added from above in inevitable places. The stairs and the slab of the first floor were reconstructed using reinforced concrete. The steel beams support the slab. The second floor and the roof were carefully reconstructed using wood. It is a hipped Mansard roof with a collar-and-purlin wooden structure with a ridge purlin in the axis of the building. The new lintels are made of reinforced concrete or steel. The exterior walls were insulated with mineral wool—7 cm.

The windows were reconstructed with triple glazing. The interior decoration was preserved, renovated, or reconstructed if necessary [19].

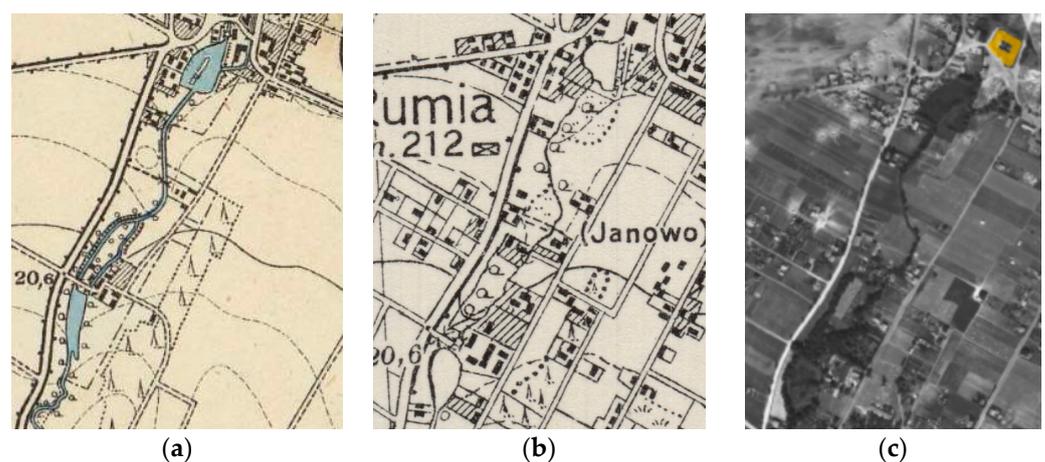
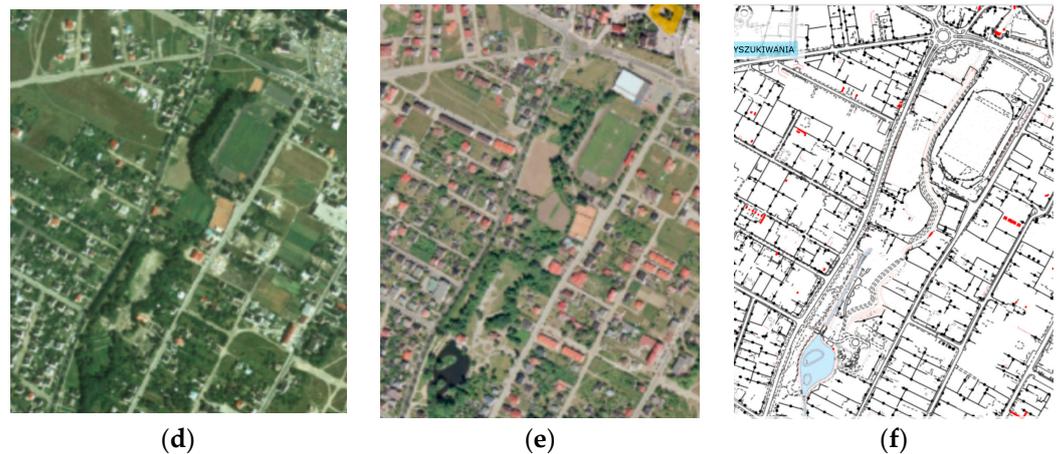
Figure 5. Cont.

Figure 5. Location of water smithy and ponds: (a) map from XIX century, source: digital archives [21]; (b) map from 1938, source [22]; (c) historic airplane photo from the IIWW, source [23]; (d) historic orthophoto map from 1997, source [23]; (e) 2005, digital archives of the city of Rumia, source [23]; (f) today, orthophoto map, source: [12].

The area between the streets Starowiejska, Adama Mickiewicza, Dębogórska, and Józefa Wybickiego gradually become a public park. The schematic design was prepared by Autorska Pracownia Projektowa “Kwadrat”. In 1998, the pond of the former forge and its weir were reconstructed. The historical maps evidence the pond’s changes in location and size (Figure 5). Its size and shape vary on different maps, however. That may result from the changes in water level due to seasonal droughts or man-induced enlargement and deepening (Figure 6).

The historic airplane photographs from the WWII period show that the pond was dried. It was more of an open green area until the 90s.

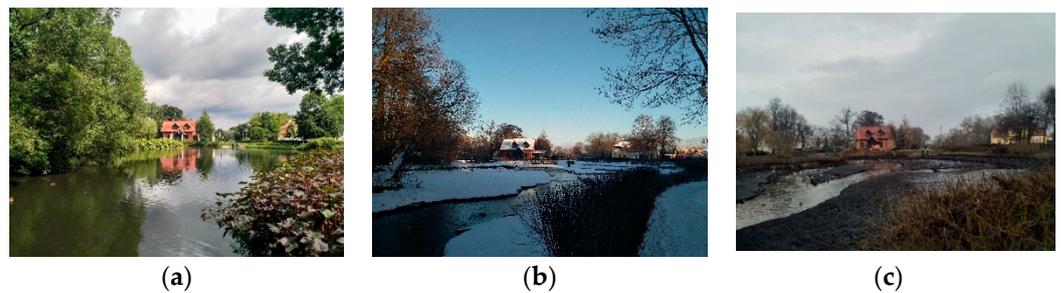
Figure 6. The reconstructed pond seasonal changes in water level (a) during summer (b,c) winter. Source: author.

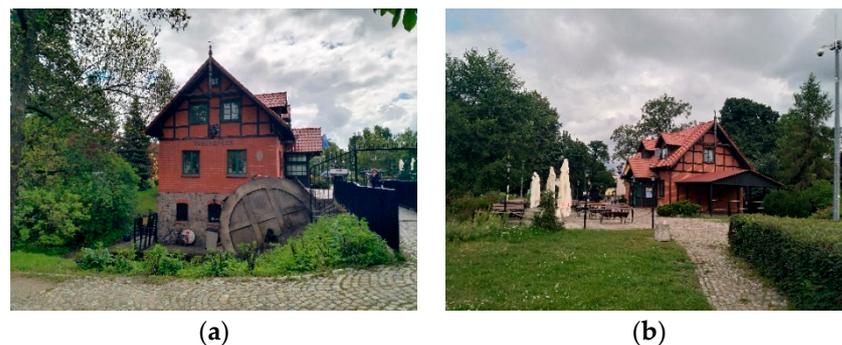
Figure 7. The water mill—a restaurant in the place of historic forge. (a) View from the riverside. Source: author; (b) View of the restaurant garden. Source: author.

In the place of the historic forge, in 2002, a water mill was built—today, the seat of the Kashubian-Pomeranian Association (Stowarzyszenie Kaszubsko-Pomorskie) and a restaurant with a name in the Kashubian language “Svantopolk” (Figure 7). Protection of Kashubian cultural heritage is vital. Next to the mill, the grinding wheel was reconstructed. The park became the place for education about the local history and heritage.

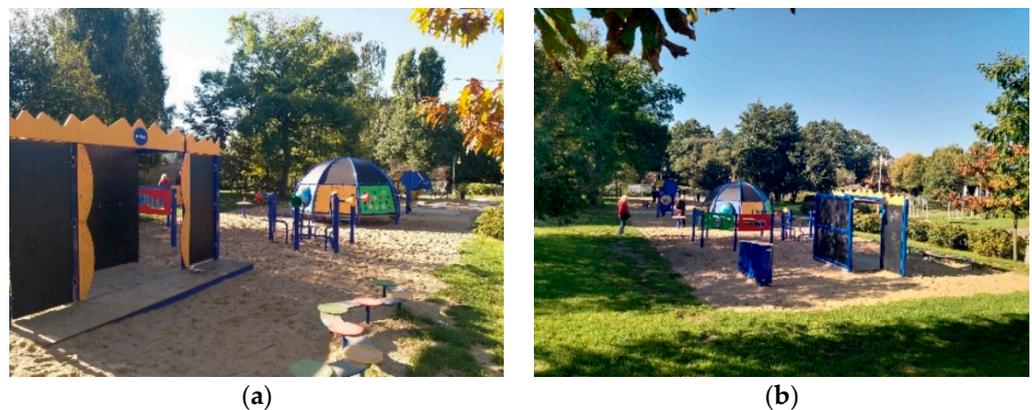
Over forty-two thousand Rumia inhabitants voted to build a talent playground in the park. They voted for Rumia in a championship organized by the Nivea company, which promised to install a playground called “podwórko Nivea”, worth 250,000 PLN in town, which obtained the largest number of votes. It is a fascinating example of social participation and proof of inhabitants’ place attachment. The playground has three zones: sports, science, and art. The recreational infrastructure aims to bridge the intergenerational gap and develop various skills [25–27] (Figure 8).

Figure 8. The talent playground in the summer of 2021 (a,b), source: author.

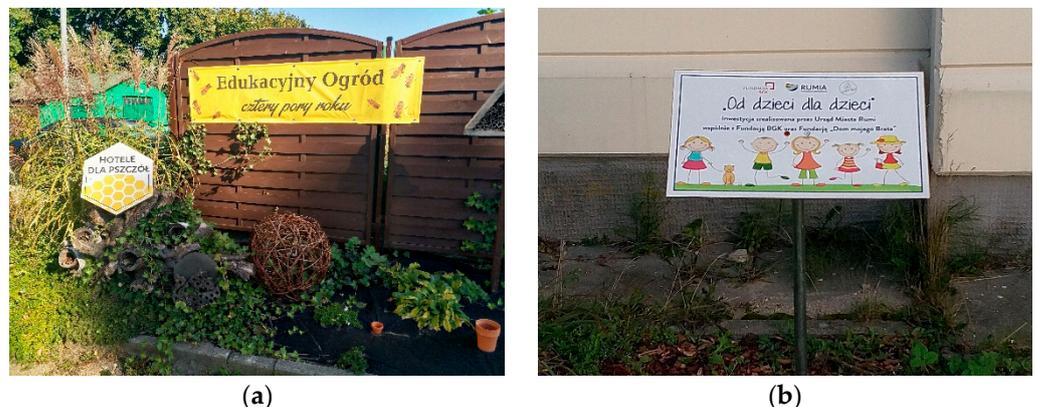
Two educational gardens were installed in the park, a popular place among schoolchildren. One, themed on biodiversity protection, is placed next to fencing and a small parking lot adjacent to the manor house—today MDK (a). It has an insect hotel with educational tables teaching children and adults about the importance of pollinators. The other, themed “from children to children”, is placed against the sports hall wall, next to recreational infrastructure and pedestrian path meandering along the banks of Zagórska Struga—local river and the fenced area of a local team soccer field. It offers a flower bed and educational tables (Figure 9).

Figure 9. The 1st educational gardens in the summer of 2021 (a,b), source: author.

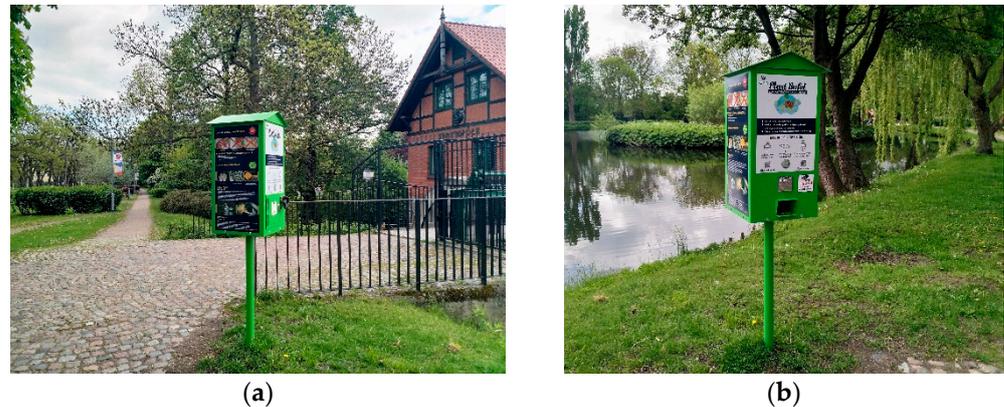
The reconstruction of historic ponds created a bird-friendly environment. However, the birds' stomachs are not prepared to digest bread and cakes. Therefore, special vending machines with birds' food were placed strategically where bird feeders usually gather. They are instructions explaining which grains can be given to feed the birds. They are selling a handful of mixed grains for a small amount of money (Figure 10).

Figure 10. The 2nd educational gardens in the summer of 2021 (a,b), source: author.

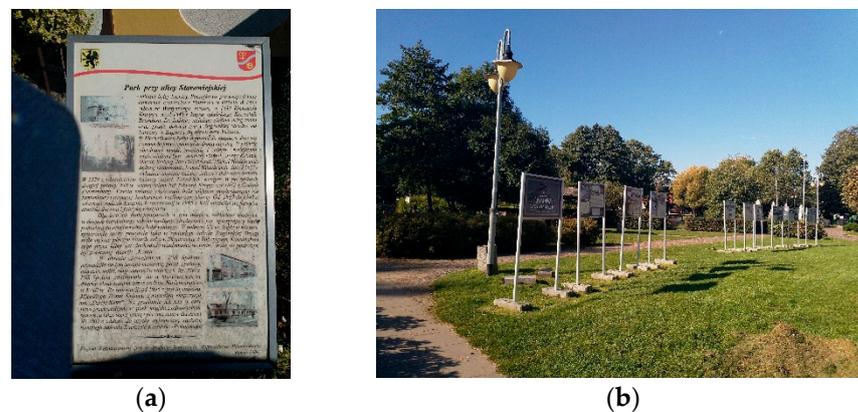
In front of the manor house, next to the main entrance, is a permanent table with a short description of the park's history and a few historical images. The lawn in front of the manor serves temporary exhibitions dedicated to local history (Figure 11).

Figure 11. Educational tables in front of the manor house (a) permanent table with a short description of the history of the park; (b) temporary exhibition dedicated to local history, source: author.

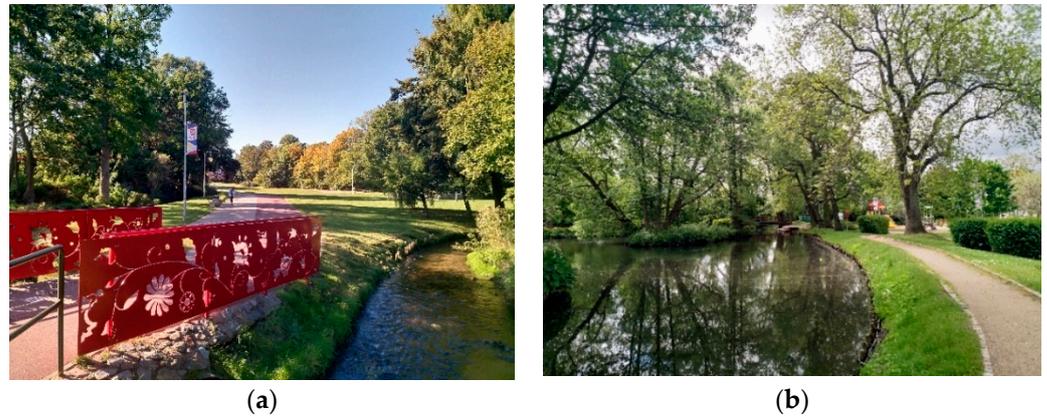
Figure 12. (a) There are some points of interest to facilitate the creation of mental maps and wayfinding. The bridge railing cutouts resemble the Kashubian embroidery style. Source: author; (b) The paths in the park are comfortable, have even surfaces, and provide interesting views with long vistas. Source: author.

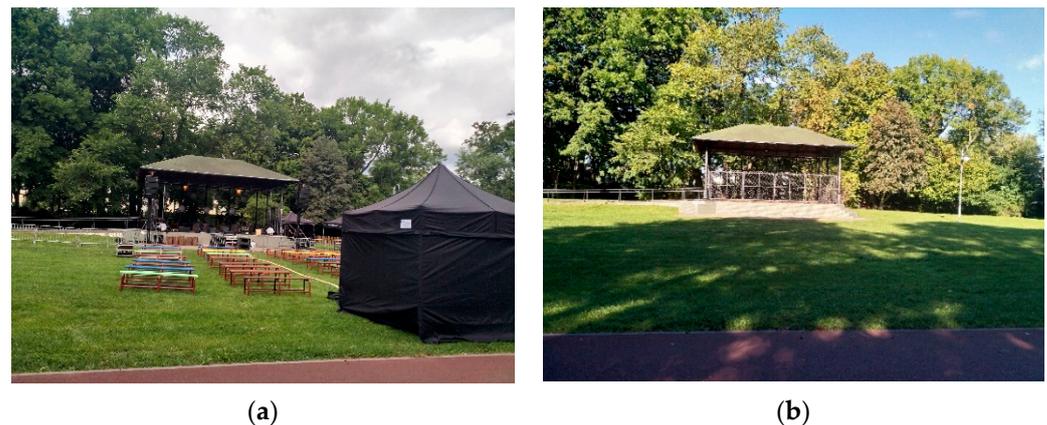
Figure 13. Open-air scene. (a) During organized event. Source: author; (b) As seen every day in the summer. Source: author.

Among the other most popular gathering spots, the open-air stage was a favorite gathering spot for teenagers on weekdays when it was not used for events (Figure 13).
