Check-Dams and Silt Fences: Cost-Effective Methods to Monitor Soil Erosion under Various Disturbances in Forest Ecosystems

Aristeidis Kastridis *

Laboratory of Mountainous Water Management and Control, School of Forestry and Natural Environment, Aristotle University of Thessaloniki, 54124 Thessaloniki, Greece

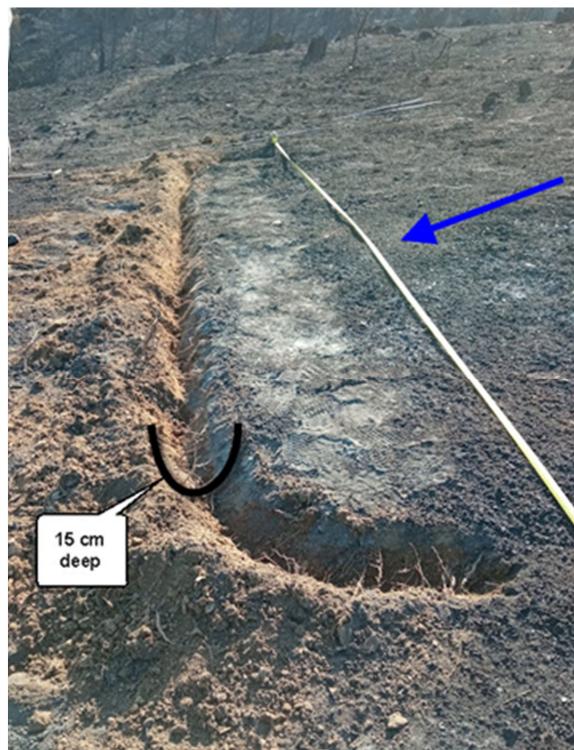
The silt fences were installed in the defined areas for each examined disturbance case. First, a 5 m long trench was opened parallel to the contours, with depth and width of 10–15 cm (Figure 2). The ends of the trench should be slightly inclined to the upslope direction, to avoid the loss of sediments (Figure 2). The excavated earth material was positioned at the downslope side of the trench, for the subsequent use in trench backfilling.

Figure 2. Silt fence installation process: hand-dug trench to insert the geotextile. The blue arrow indicates the runoff direction.

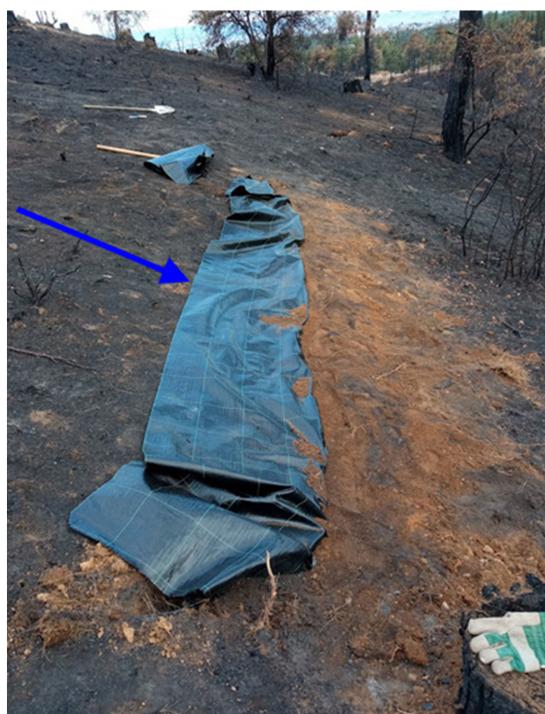
The silt fence is set down along the trench, covering both the bottom and the upslope side of the trench (Figure 3). To avoid the pull out of the silt fence due to water and wind forces, the excavated earth material is used to backfill the trench and a sledgehammer is needed to compact the earth in the trench and seal the silt fence in the ground.

Figure 3. Silt fence installation process: the geotextile compacted with earth material in the trench. The blue arrow indicates the runoff direction.

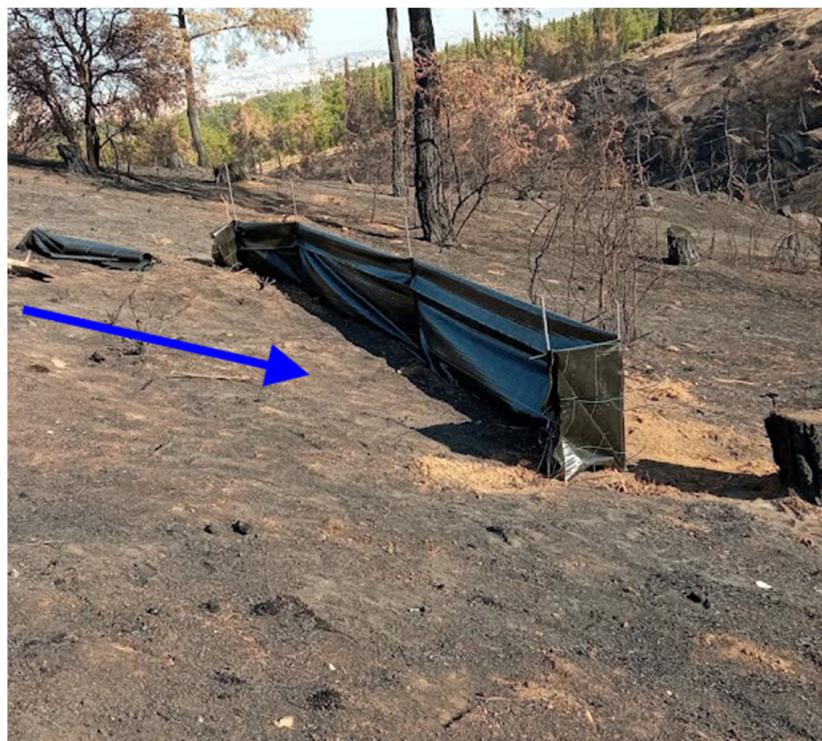
Subsequently, for each plot, five (5) metal rebars of 1.20 m long (10 mm diameter) were inserted in the ground to at least 30 cm depth, in order to uphold the silt fence (Figure 4). The number of the rebars was initially defined taking into account the cost and the transporting difficulties of such heavy equipment. Before the installation, the rebars should be thoroughly sharpened in one edge, to make easier the penetration in the ground. Small cable ties were used to fasten the silt fences on the rebars. Four or five cable ties were used for each rebar, while the lowest cable tie should be 25–30 cm above the ground to avoid tearing in the gathering area of the fence.

Figure 4. Silt fence installation process: the silt fence was fastened on 5 metal rebars. The blue arrow indicates the runoff direction.

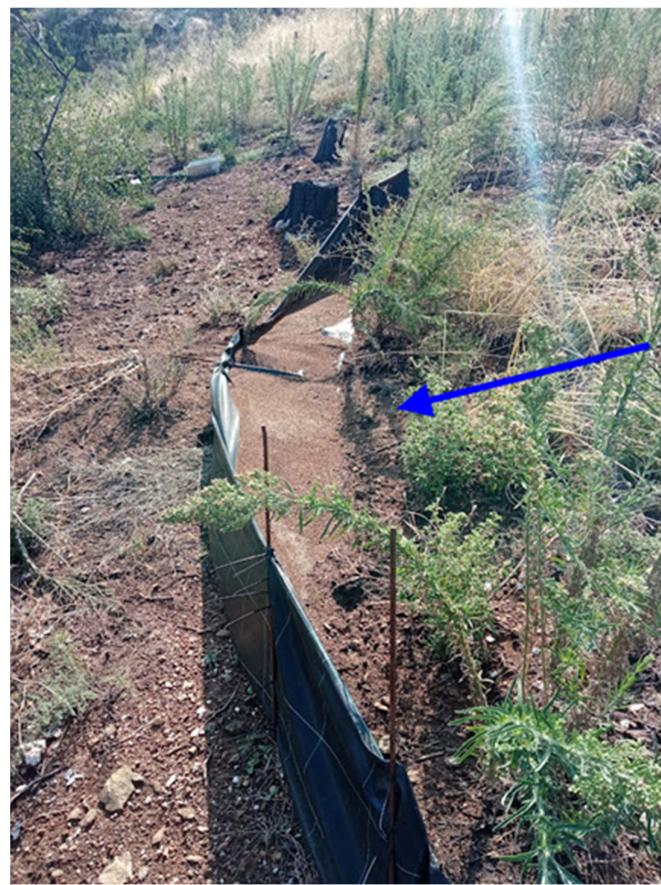
The most significant limitation was recorded in the recently (July 2021) burned areas and mainly after the highly intense rainfall events. During these episodes, the metal rebars in one plot have been proven to be inefficient to withstand the weight of the water and sediments, and eventually bended to the downslope direction, losing an unknown amount of sediments (Figure 6). Thus, denser rebars placement is necessary for study areas of high erosion rates and areas after wildfire. The height of the silt fence is also very crucial in burned plots, since a short silt fence would be easily overtopped. However, a too high fence would be susceptible to the action of wind gusts. An average beneficial solution should be found, depending on the plot characteristics and the expected sediment production. It is proposed that the silt fences should not exceed one meter in height. In cases of extreme sediment production, it is proposed to install a second silt fence just below the first one. Furthermore, based on this failure, it is revealed that at least 3 plots for each examined case are necessary to ensure the consecutiveness and reliability of field measurements.

Figure 6. Silt fence operation: the silt fence has bended under the weight of sediment material. The blue arrow indicates the runoff direction.

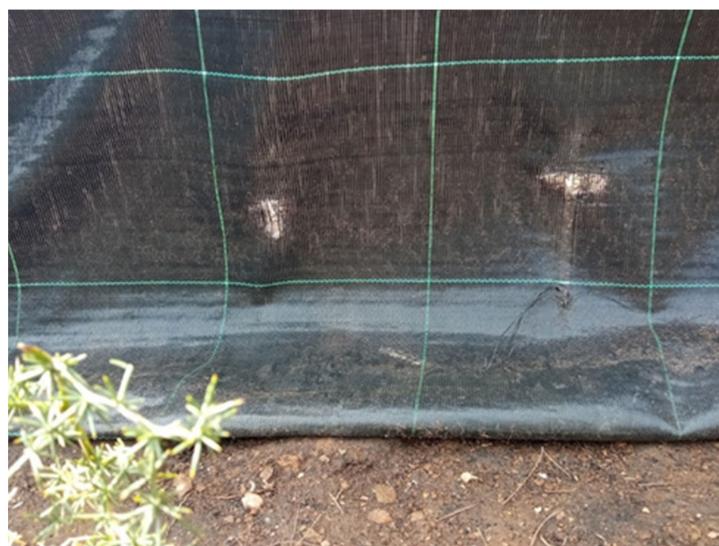
Animal activity and human curiosity/interference have been proven two significant problems during the operation of the silt fences in the study area. Concerning the animals, the most significant problem was caused by wild boars, which in many cases caused damages and holes on the silt fences (Figure 7), while in parallel, disturbed the soil surface. Unfortunately, the management of this threat has not been proven feasible. In fact, the only solution was the frequent check and timely repair of the silt fences regardless of the programmed monitoring attendance after the rainfall events.

Figure 7. Large holes on the geotextile caused by wild boars.

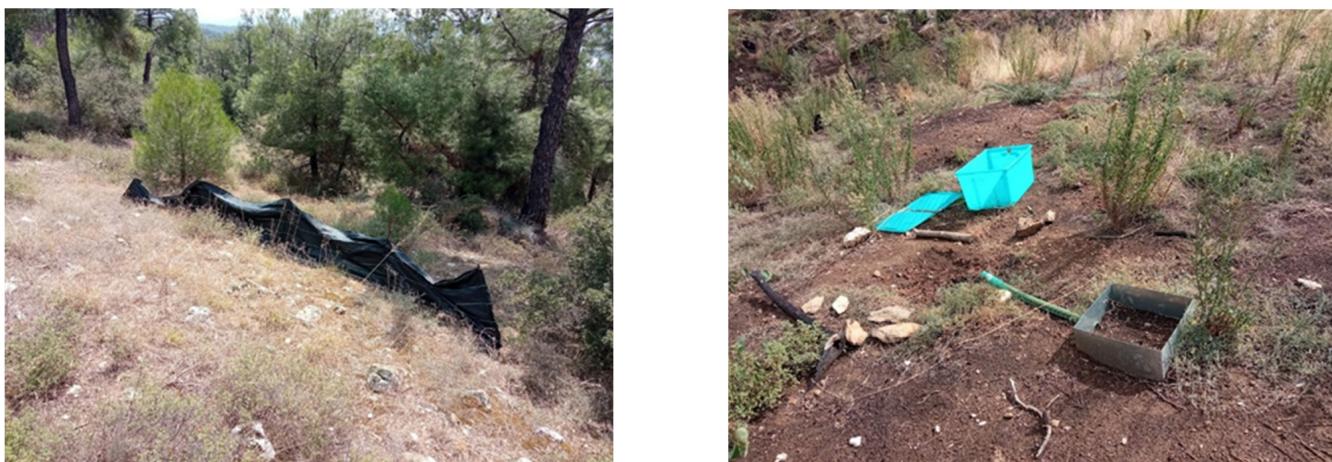
Regarding the human curiosity/interference, the damages mainly concerned stealing of the metal rebars and parts of silt fence materials, and various other types of damage (destruction of the structure), despite the installation of relevant signs and good cooperation and information sharing with the forest service staff (Figure 8). Most of the damages were observed in silt fences that were installed close to paths and forest roads, where the human activity is more intense. The solution to this problem was the relocation of silt fences to locations less adjacent to human activity and less visible to humans.

Figure 8. Silt fence which was damaged by humans trying to pullout the metal rebars and geotextile (**left**). Damage to the experimental setup for the measurement of runoff (**right**).

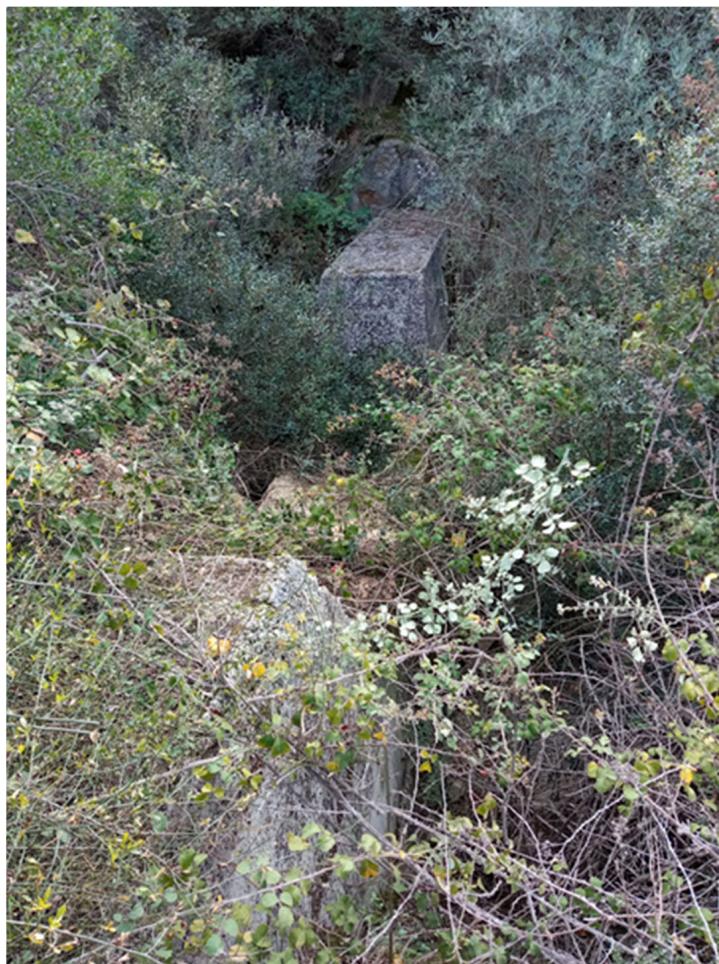
Check-dams were built in 2001, almost 3 years after the forest fire. The dimensions of each check-dam were accurately measured (height, length, width, etc.) and the sediment wedges behind each check-dam were thoroughly recorded. The recommended measurement methodology has been described extensively in the study of Margiorou et al. [13]. At least two persons working as a team are needed to conduct the field work, since it is highly demanding both in detail of recording and physical strength. In general, check-dams are easily accessible in areas that are recently burned or in arid landscapes where the vegetation is sparse [46,47]. However, 20 years after the forest fire and under Mediterranean climate, the vegetation has almost fully recovered in the study area. Moreover, the ability of check-dams to retain significant water amounts during rainfall, resulted in development of extremely dense vegetation on the stream bed and banks, especially upstream of check-dams (Figure 9), causing difficulties of access.

Figure 9. Check-dam in the study area which is almost totally covered by dense vegetation.

This is the most significant problem and limitation of the methodology, since the difficulties of locating and approaching the check-dams make the monitoring tasks time consuming and laborious. On the other hand, the recording of depositions that have been retained by the check-dams is exceptionally important, because the scarcity of erosion measurements and the absence of sediment transport gauges is a very common problem in many areas [48,49]. Another limitation of this methodology is the importance of knowing the date of check-dams' construction. The researchers should be aware of the precise time of check-dams construction to avoid miscalculations of mean annual soil erosion rates and their evolution.

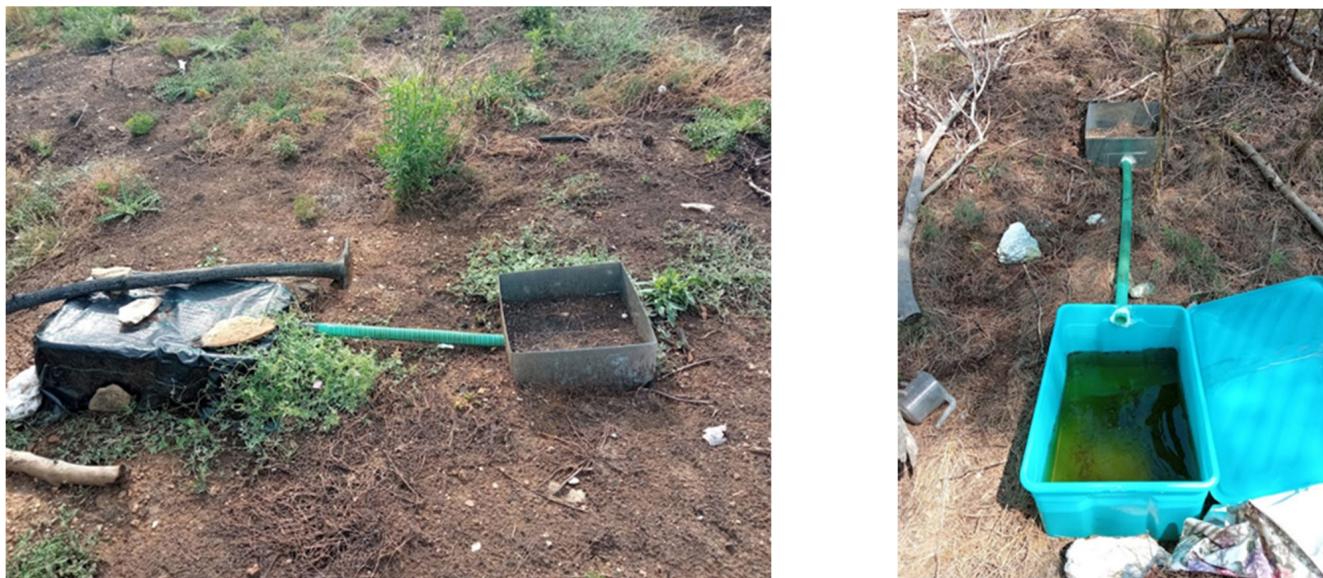
In the present study, a low-cost method of measuring runoff is presented. In the study area and very close to the silt fence plots, smaller experimental plots (micro-plots) were installed (one for each examined disturbance case), in order to measure the surface runoff. Specifically, the experimental setup included a stainless steel frame, a flexible plastic tube and a plastic tank (Figure 10).

Figure 10. Experimental setup for the measurement of surface runoff (**left**). Water gathered in the plastic tank after an intense rainfall event (**right**).

The dimensions of steel frames were 0.40×0.40 m and 0.25 m high. In one of the sides, there was a hole of 4 cm diameter in order for the plastic tube to be attached. The steel frames were inserted in the ground to a 5 cm depth. The tanks had a 100 l capacity and half of the tank inserted in the ground. The flexible plastic tube was used to connect the steel frame with the tanks. The connections between the elements were sealed with silicon. The cost of all the necessary materials is listed in Table 2. The total cost was 560€ and could be considered as relatively low. After the intense rainfall events or periodically (weekly, monthly), along with silt fences evacuation, the tanks were checked and the gathered water (if any) was quantified using a volumetric tube.

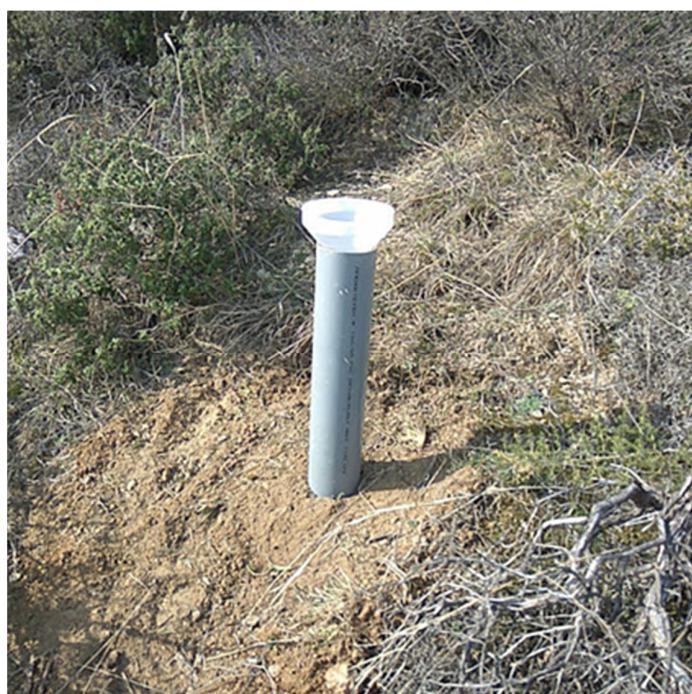
The precipitation data were obtained by the existing automated meteorological station located in the area of “Eptapyrgio”, which is operated by National Observatory of Athens [54]. Due to the distance between the “Eptapyrgio” station and the study area and their altitude difference, a second cumulative rain gauge (Figure 11) was installed in the study area to confirm the data.

Figure 11. View of the installed cumulative rain gauge in the study area.

It is highly recommended to install a precipitation gauge very close to the field plots. The rain gauge was installed far from large trees or high bushes to ensure that there are no obstacles that would influence the natural rainfall direction. Furthermore, the vegetation in a radius of three meters around the gauge was cleared and maintained in low height. In the present study, we have tried to limit the cost, and for that reason a simple cumulative rainfall gauge was installed near the field plots. The cumulative rainfall gauge consisted of a large plastic cylindrical bottle (of 4 l water capacity), a plastic funnel which was attached on the bottle neck, and a PVC tube aiming to stabilize the rain gauge and protect the bottle (Figure 11). The total cost to construct the rain gauge was 10€. The gathered water in the rain gauge was measured after every rainfall event, in order to collect enough data, aiming to establish a strong linear relation with the data from the “Eptapyrgio” station. During every measurement, the gathered water amount was transferred to a volumetric container, to accurately assess the rainfall height. The correlation between the two stations showed a slight underestimation of precipitation values from the “Eptapyrgio” station, which could be attributed to the altitude difference. More details relevant to that are provided in study [14].
