Article

Earthquake Safety Assessment of Buildings through Rapid Visual Screening

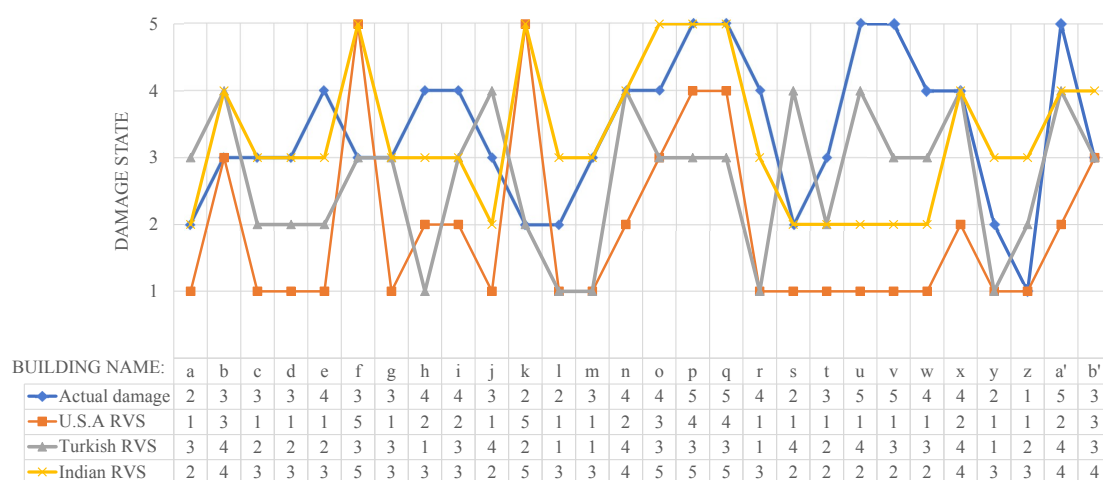
Figure 1. Damage state of selected building data from RVS methodologies.

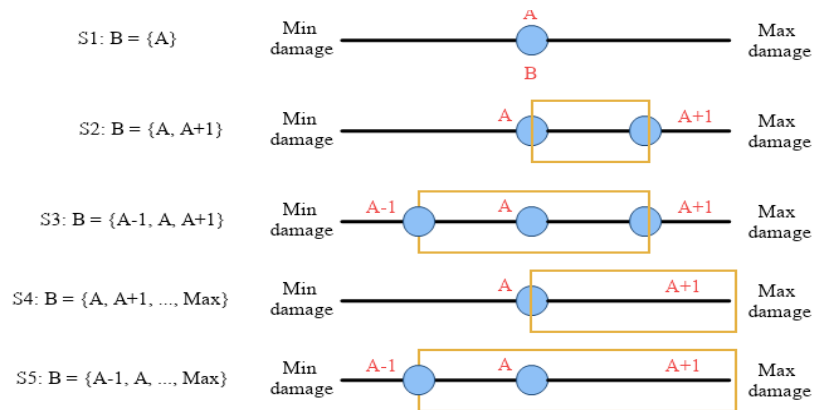
Figure 2 illustrates the set representation of each similarity where A indicates the actual damage, B is the RVS damage, $+1$ or -1 indicates the increase and decrease in damage, respectively. Achieving final decisions based on similarity 1 alone is not advisable, as the results may not always be exact. Similarity 4 should be considered if safety was of primary concern irrespective of cost and time it takes for a detailed assessment of more buildings. Similarity 2 and 3 provide closeness of RVS methodology to actual damage. Similarity 5 was performed only to check how many building estimates were

Figure 2. Set representation of each similarity.

Similarity 1: Number of buildings in RVS methodology giving exact damage as that of actual damage.

Similarity 2: Number of buildings in RVS methodology giving exact damage as that of actual damage + number of buildings with one-step severe damage. For example, if actual damage was four and RVS methodology gave three, which was one step more severe than four, that will also be counted in this similarity.

Similarity 3: Number of buildings in similarity 2 + number of buildings within one step damage. For example, if the actual damage was four and RVS methodology gave any of three, four, or five, then it will be counted in this similarity.

Similarity 4: Number of buildings in RVS methodology giving exact damage + number of buildings with more severe damage. For example, if actual damage was four and RVS methodology with four, three, two, and one, the damage state will be counted in this similarity.

Similarity 5: Number of buildings in similarity 4 + number of buildings with one step less severe or two steps more severe damage. For example, if actual damage was three and RVS methodology gave any of four, three, two, and one, then it will be counted in this similarity.

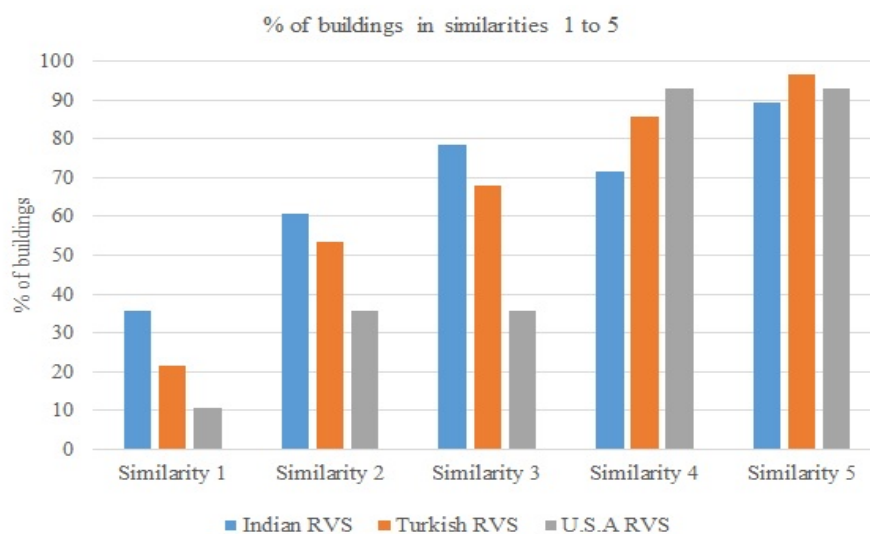
It has been inferred from the graph that in similarity 1, 2, and 3, Indian RVS presented a large amount of buildings as did Turkish RVS, but FEMA P-154 addressed a fewer number of buildings in the first three similarities. In similarity 4 and 5, FEMA P-154 assessed 93 percent of buildings, Turkish RVS addressed 80 percent of buildings, and Indian RVS presents a fewer number of buildings compared to the other two RVS methodologies shown in Figure 3.

Figure 3. Percentage of buildings in each similarity from RVS methodologies.

inaccurate. As the results from similarity 5 are more than 90 percent of buildings, it has not been used for conclusion purposes. The results for all five similarities from three RVS methodologies are illustrated in Figure 3.

It is clear that FEMA P-154 gives higher damage grade even for buildings with fewer negative influential parameters, although the damage may not be severe. On the other hand, in Indian RVS, similarity 2, 3, and 4 are close to each other with only 10 percent, indicating most of the buildings that were in similarity 4 were also in similarities to 2 and 3. This means Indian RVS provided closer results to the actual damage followed by Turkish RVS. It would be of interest to check the numbers of buildings categorized in damage state 1 by RVS methodologies before coming to a conclusion. This damage state included both damage grades 1 and 2, and hence, the damage state 1 from RVS methodologies will be compared against grades 1 and 2 of actual damage. The RVS methodology with the most accurate assessments of damage versus actual damage can be considered the most efficient methodology.
