Ultrasonic Assessment of the Concrete Residual Strength after a Real Fire Exposure

Roman Wróblewski ^{1,*}

¹ Faculty of Civil Engineering, Wrocław University of Science and Technology, 50-370 Wrocław, Poland

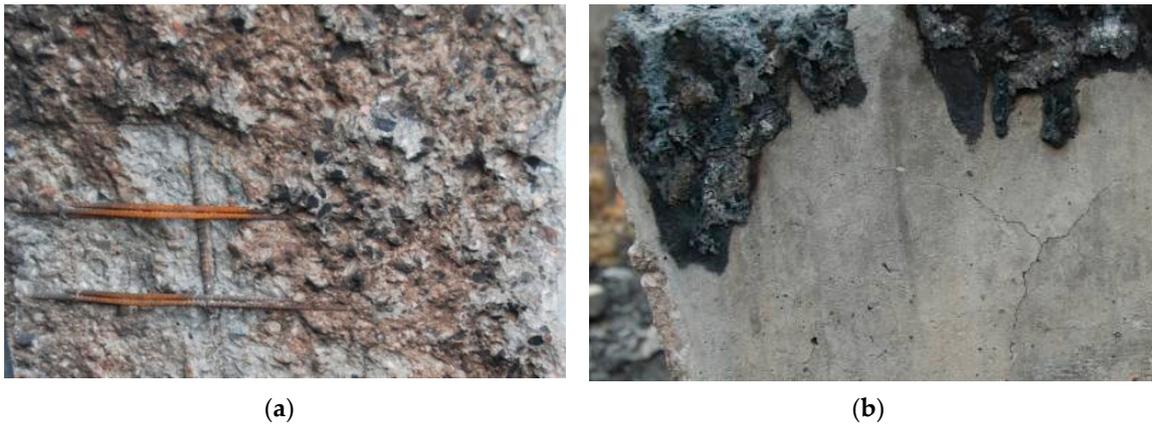
The time of temperature interaction in the structure is very diverse; thus, the effects of concrete heating and cooling are different. Moreover, sudden changes in temperature, e.g., when pouring hot concrete with water, the concrete cracks, splits, breaks, and destroys (Figure 1).

Figure 1. (a) Split and (b) cracking of concrete cover after firefighting.

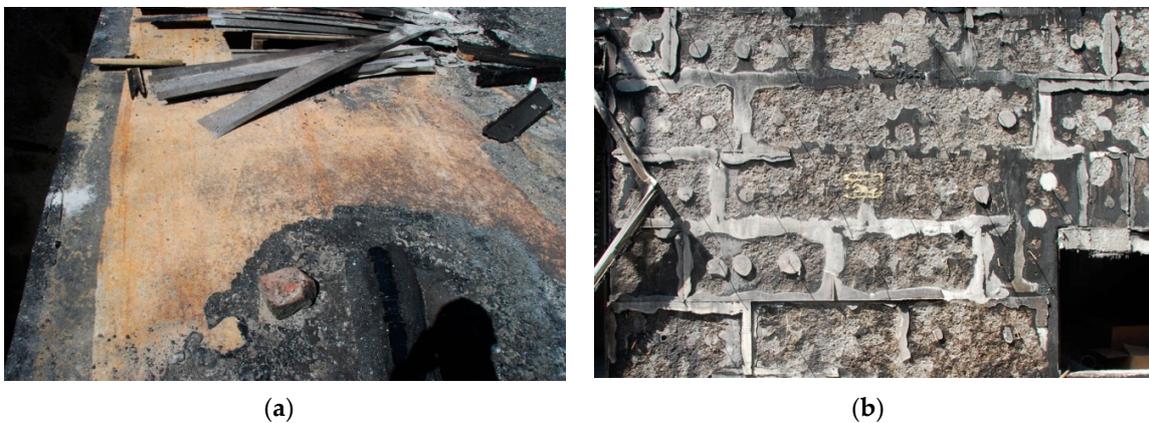
If cracked or not, the surface of concrete can be unavailable for direct observation when covered with remains of bituminous material or thermal isolation (Figure 2). Some information can be drawn from the concrete colour change [4] as presented in Figure 3. However, after the fire, the crucial question is what is the concrete strength in the zone, which no longer has visible cracks, or the cracks are different than the fire origin.

Figure 2. Concrete surfaces after fires: (a) top surface partially covered with watertight bituminous material, (b) vertical surface insulated with Styrofoam.

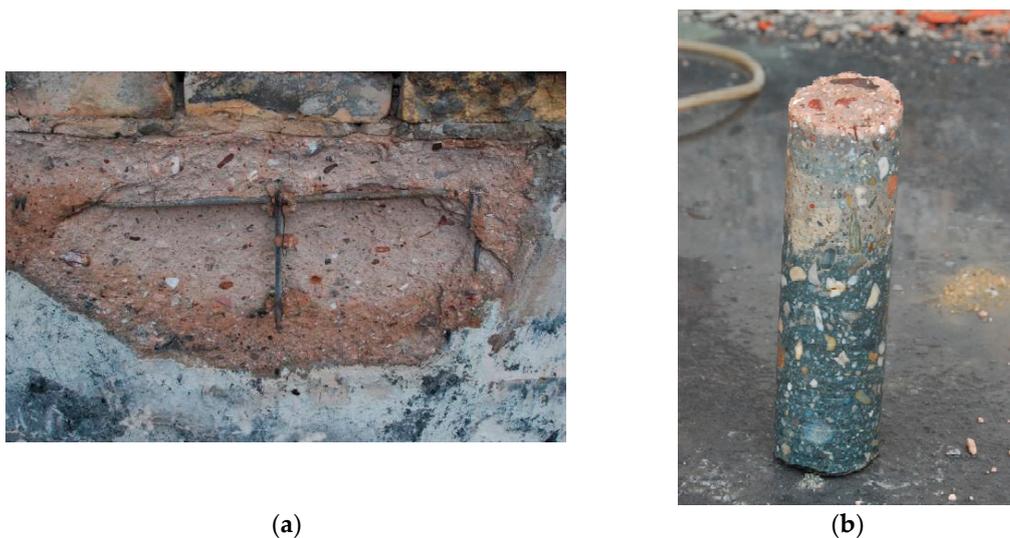
Figure 3. Concrete colour change after the fire. (a): concrete surface after cover splitting (b): colour change over the thickness based on a core sample.

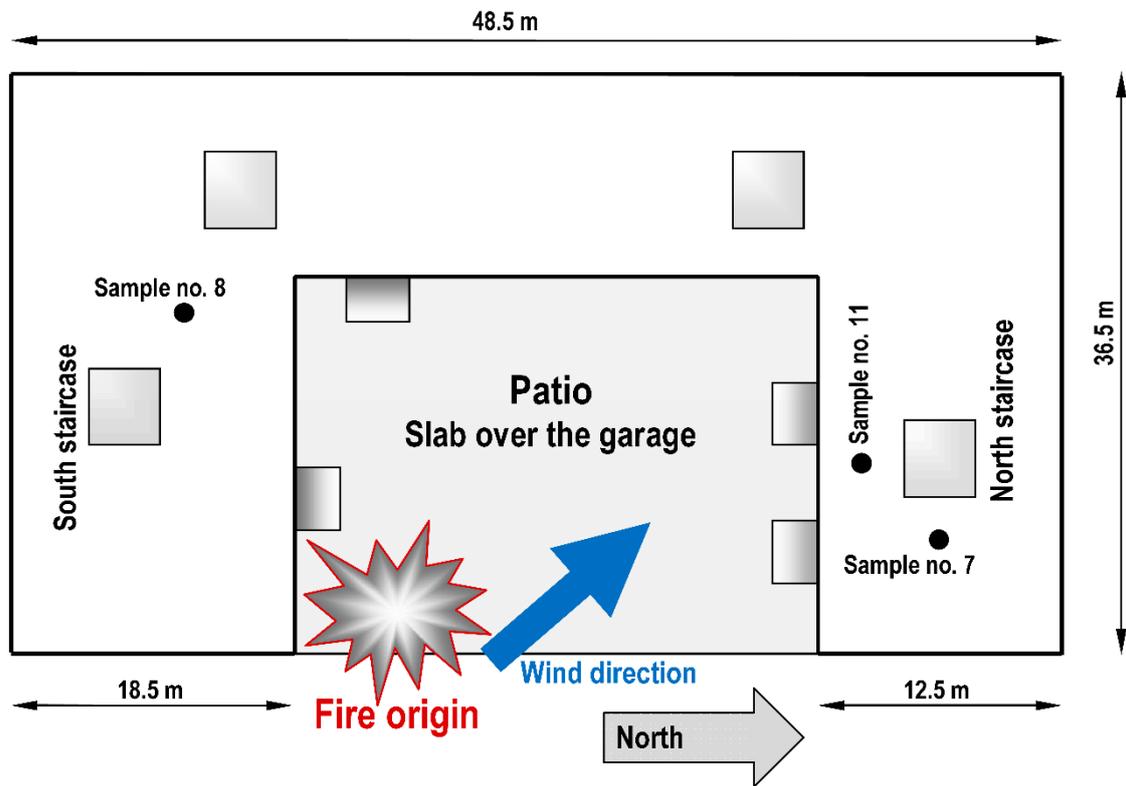
The fire appeared in the 64-apartment building under construction presented in Figures 4 and 5. Weather conditions favoured the fire spread, i.e.:

The effects of the fire were mainly observed outside the building within the patio of four staircases (Figures 4 and 5). i.e., on the top surface of the slab above the garage, façades surrounding the patio and on the roofs of the northern and southern parts. To a much lesser extent, the effects were also visible in some rooms adjacent to the patio. The remaining part of the building (also all staircases) was not exposed to the fire.

Figure 4. Diagram of the building damaged during the fire.

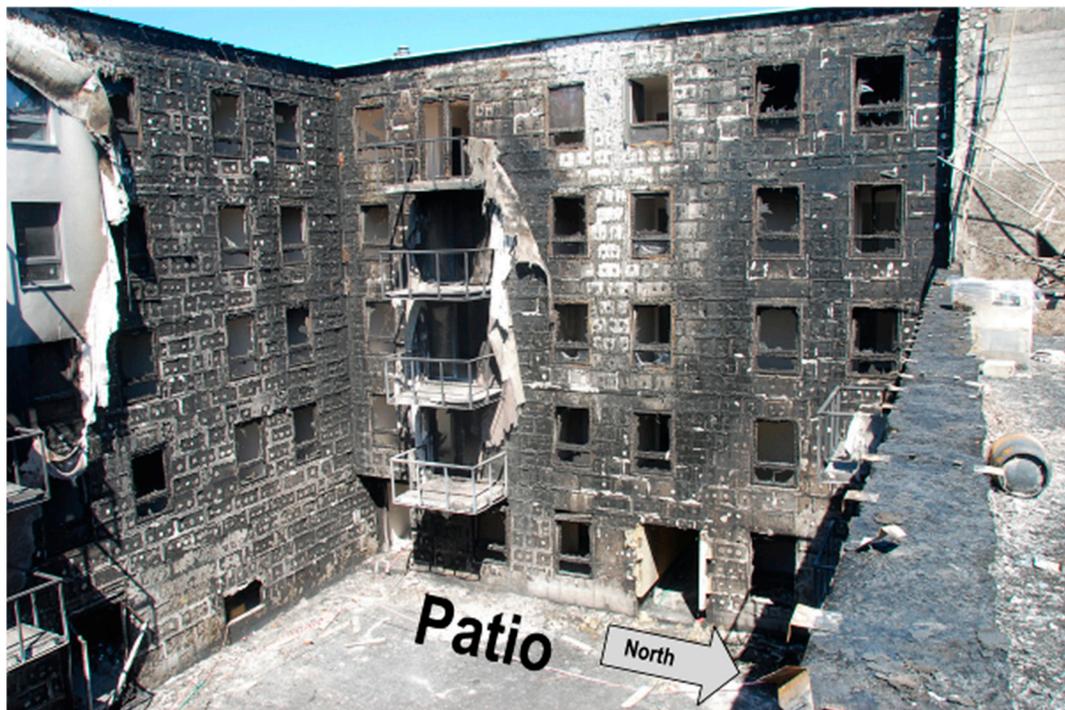
Figure 5. Façades after the fire.

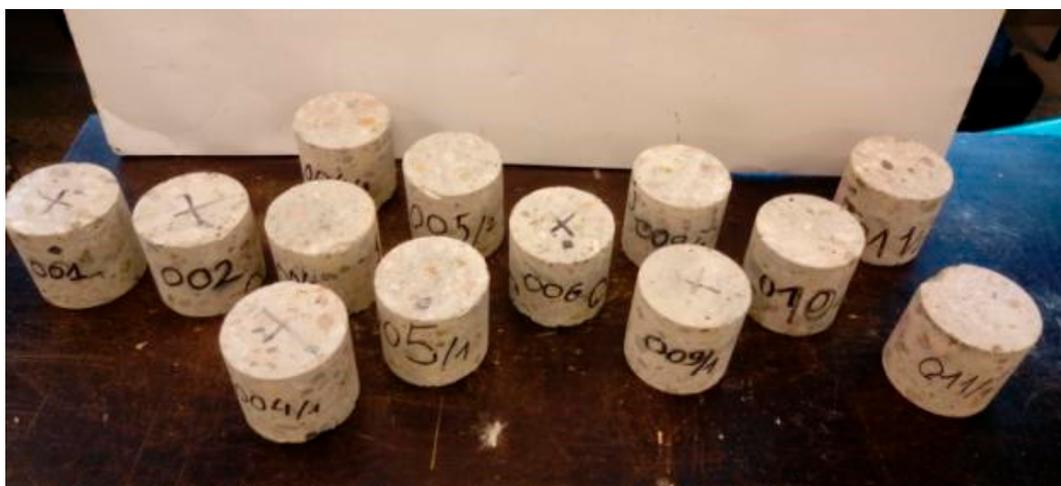
According to documents, concrete C25/30 and C30/37 were delivered to the construction site. After the fire, long concrete core samples ($\varnothing 100$ up to 350 mm) were taken from various structural elements as indicated in Table 2. Then some of these samples were split to prepare two or three new smaller samples ($\varnothing 100/100$ mm) to test the in-situ compressive strength $f_{ck, is}$ (Figures 6 and 7) according to [31].

Figure 6. Core samples prepared for the strength test (height 100 mm).

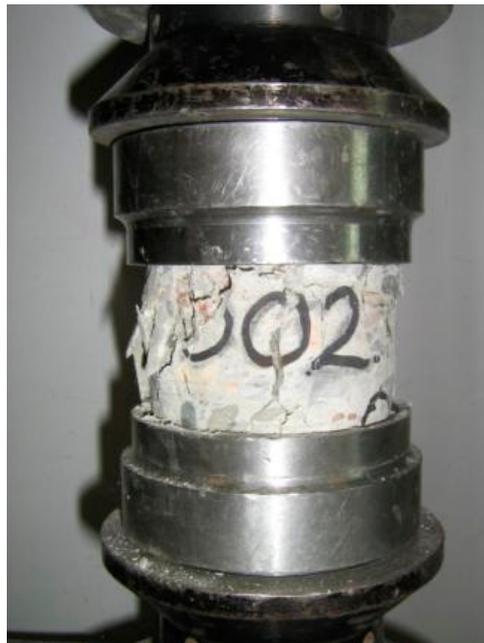
Figure 7. Sample no. 002 during the strength test.

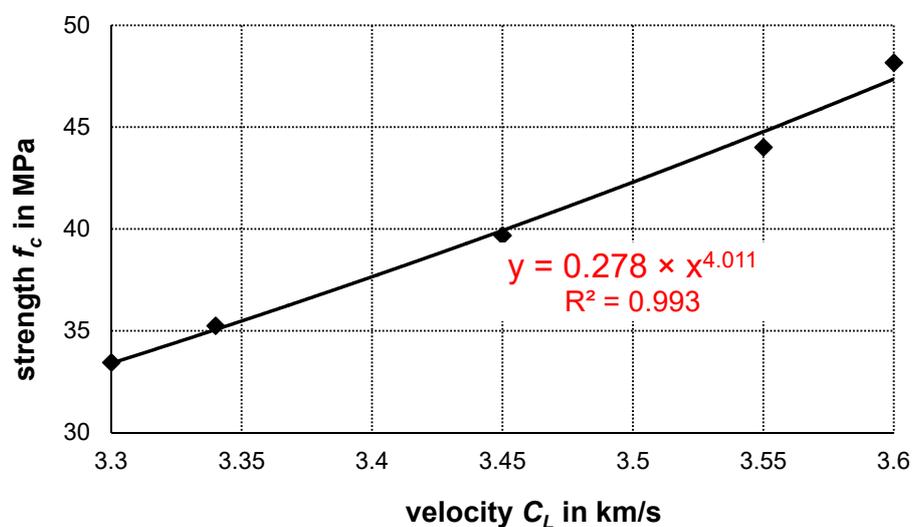
To determine the strength of concrete in the core samples, i.e., varying strength over the slab depth, the relationship $f_c = f(C_L)$ between the tested ultrasonic wave velocity C_L and the compressive strength of concrete f_c was established on the samples that were subsequently destructed. That relationship is presented in Figure 8. Based on the regression analysis exponential function was found to fit the best to experimental results.

Figure 8. Correlation of concrete compressive strength an ultrasonic wave velocity.

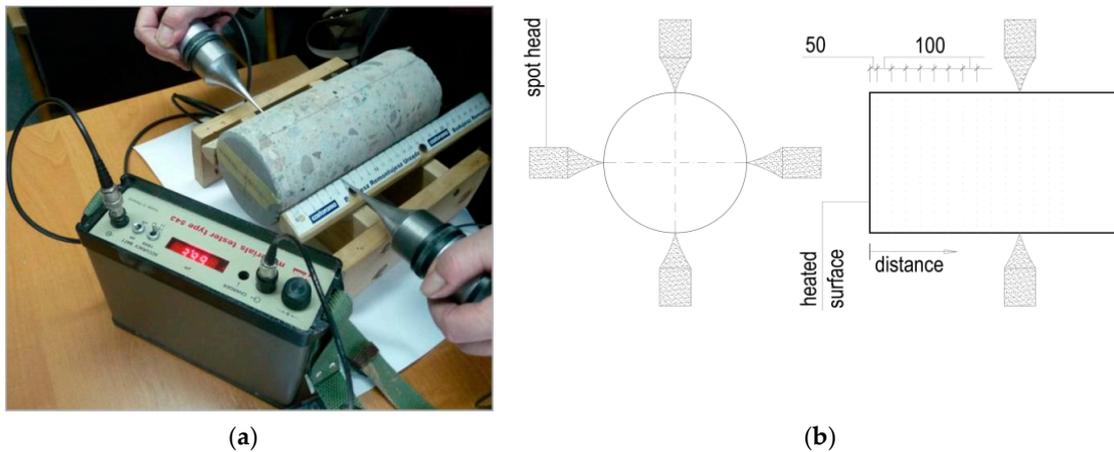
The tests were carried out with the Unipan 543 digital device and 40 kHz point ultrasonic heads (Figure 9a). They were performed on the samples no. 7, 8, and 11 (Table 2). With a simplification, each sample was exposed to unknown fire temperatures for an unknown period. After the humidity stabilized at the air-dry level, the samples were examined, and the heads were applied at distances of 5 mm from the top surface and every 10 mm in the subsequent measurement planes (Figure 9b). The ultrasonic wave velocity C_L was determined as the mean for two measurements in two perpendicular directions.

Figure 9. (a) Ultrasound Pulse Velocity (UPV) measurements with Unipan 543 and 40 kHz spot heads; (b) the head positions during testing.

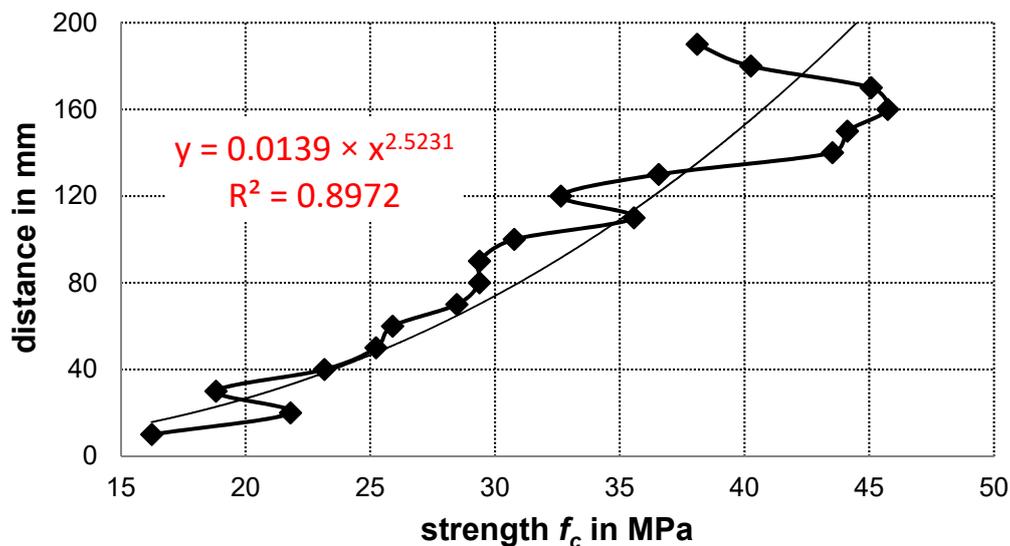
Figure 10. Compressive strength distribution in the sample taken from the slab heavily loaded with the fire (sample no. 008).

The strength close to the surface exposed to the fire in sample no. 008 is low 15.5 MPa (Figure 10) and then almost uniformly increases to 46.0 MPa in the layer 160 mm away from the top surface. However, the layers between 160 and 200 mm exhibit lower strength (37–46 MPa). A power function was found to best fit the results of that sample, as presented in Figure 10.

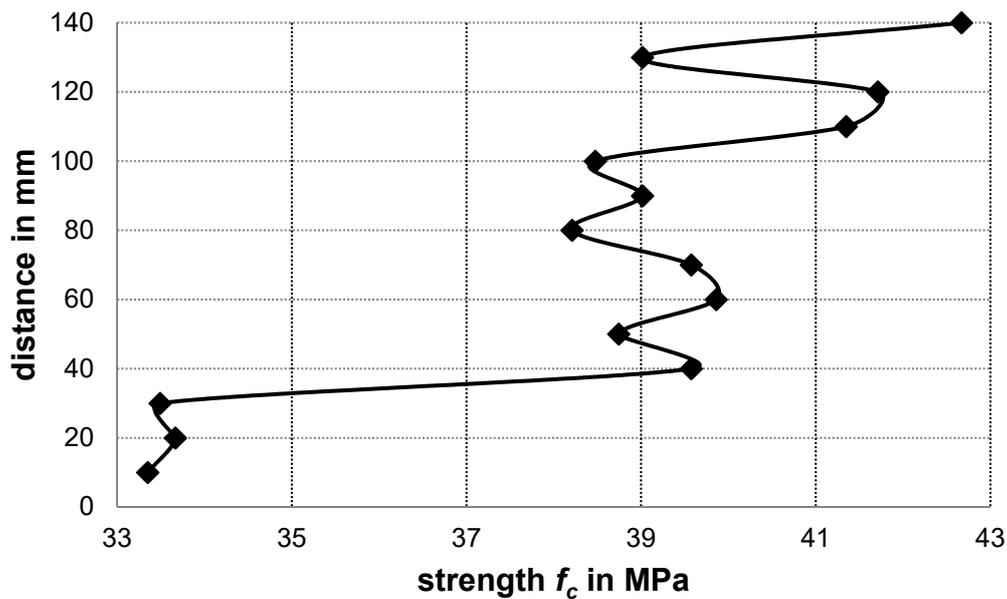
Figure 11. Compressive strength distribution in the sample taken from the slab loaded with the fire for a short period (sample no. 007).

In the top zone, the results obtained from the sample no. 007 (Figure 11) loaded with fire for a short period, does not follow the strength distribution of the sample no. 008. In the 25–30 mm top zone the strength is significantly reduced to 33 MPa, while in the remaining part of the sample the strength reaches 38–43 MPa. The bottom 40 mm part of was not available because the sample was broken on the bottom reinforcement.

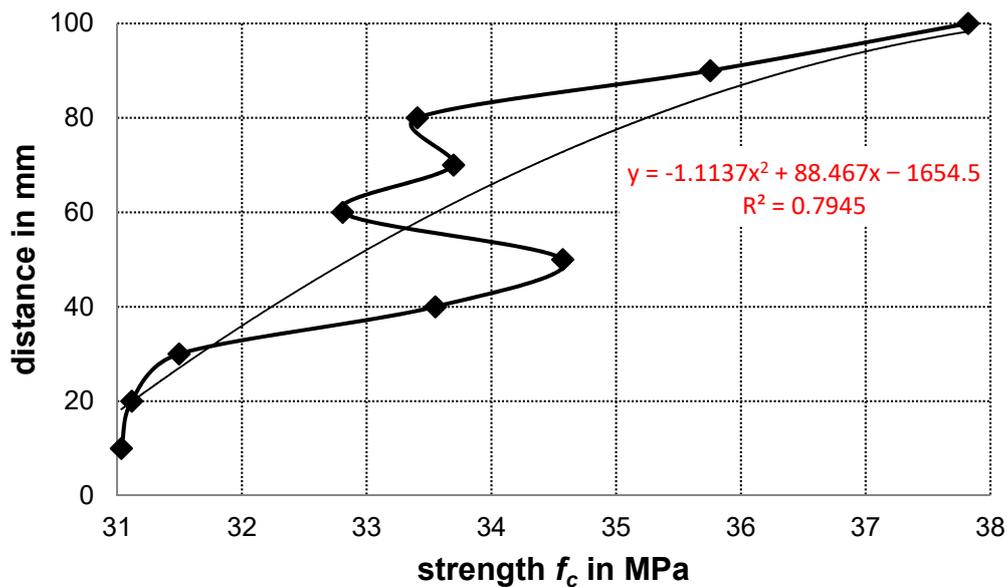
Figure 12. Distribution of compressive strength of concrete in the sample not exposed to the fire (sample no. 011/2).

The tested sample no. 011/2 was not directly exposed to the fire and the strength reduction is small, i.e., 7 MPa–18% of 38 MPa (Figure 12). Therefore, the observed variation is considered as a natural effect associated with the porosity change in the conventional concrete [27,28].

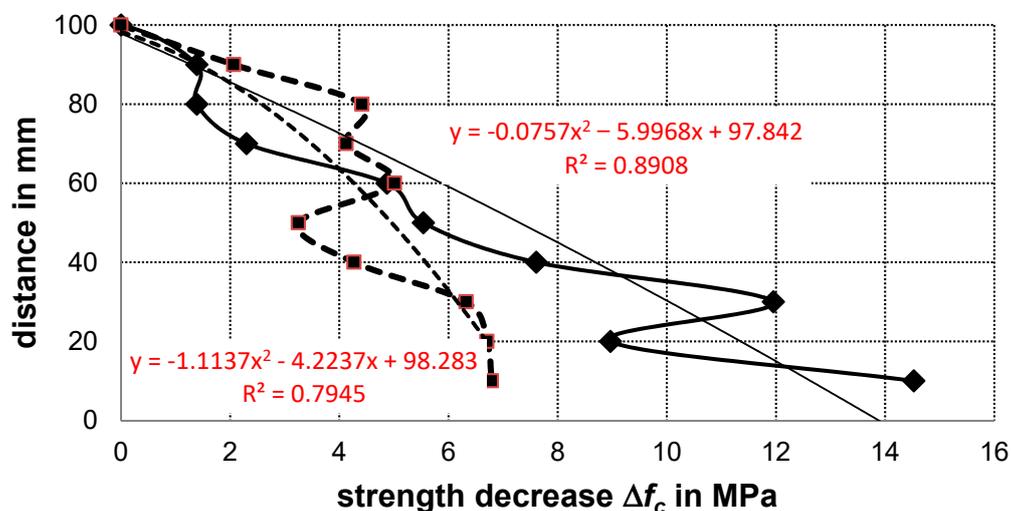
However, when the results of the unaffected sample (no. 011/2) are directly compared with the results of the sample no. 008, it appears that temperature influence reaches 60 mm as presented in Figure 13, because at that depth the strength decrease ($\Delta f_c = f_c(\text{depth} = 100 \text{ mm}) - f_c(\text{current depth})$) in the sample no. 008 became greater than in the sample no. 011/2. If the regression functions are compared that depth reaches 85 mm. However, that result should be statistically verified.

Figure 13. Distribution of compressive strength decrease in the samples no. 008 (continuous line) and 011/2 (dashed line). ($\Delta f_c = f_c(\text{depth} = 100 \text{ mm}) - f_c(\text{current depth})$).

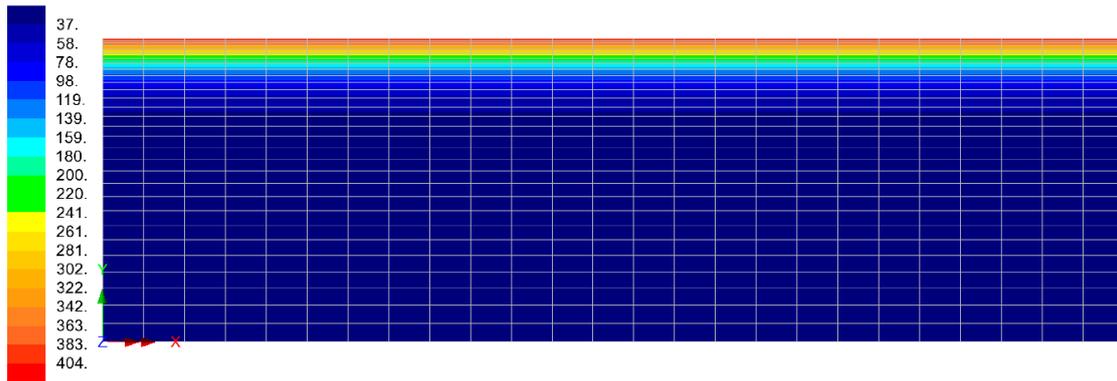
Assuming that the concrete compressive strength begins to descend at the temperature of 200°C it is possible to estimate the time of fire exposure or concrete surface temperature. Therefore, if an external fire model according to [32] is considered, the time of fire exposure is not longer than 2400 s to 3600 s (with the maximum temperature of 680°C). This time was estimated based on the transient temperature finite element analysis of the 300 mm thick concrete slab performed in the software [33]. An example of the results is presented in Figure 14. The temperature distribution plots were then used to assess the development of the zone where temperature excites 200°C as presented in Figure 15.

Figure 14. Roof slab (300 mm thick). Temperature distribution at time 2400 s.

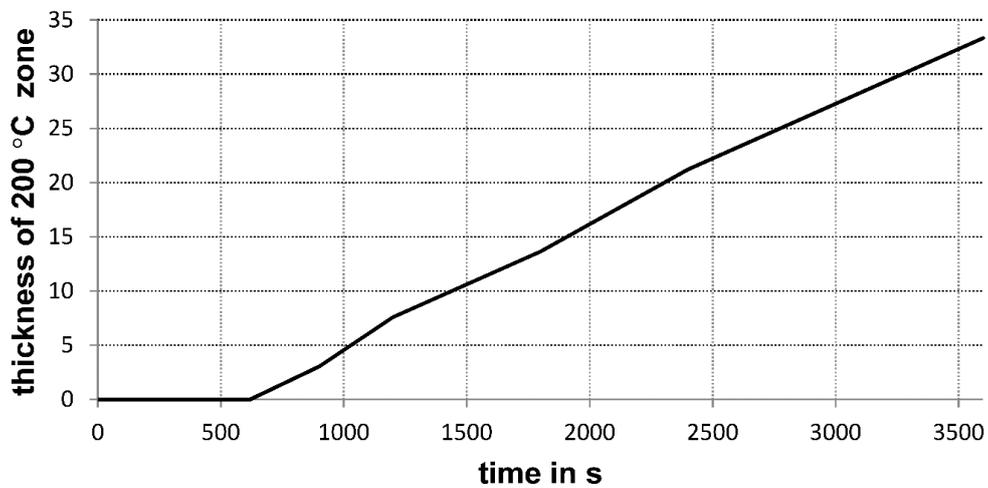
Figure 15. Roof slab (300 mm thick). Time development of the zone where temperature exceeds 200 °C.

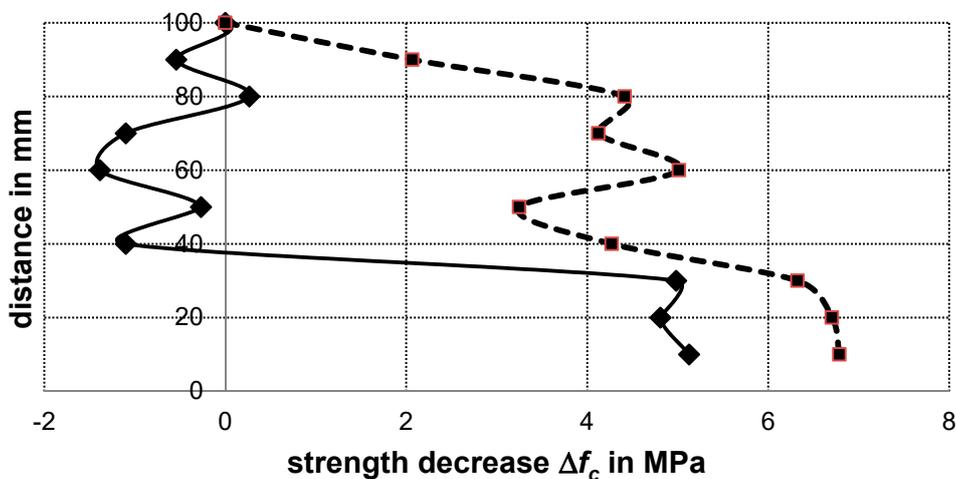
The obtained strength decrease in the samples no. 007 and 011/2 are considered as natural effects because the decreases are only 25% and 18%. The abrupt strength change in the top layer of the sample no. 007 (in the distance of 25–30 mm in Figure 11) can be a result of smaller concrete density in that layer. Figure 16 supports that statement, because the decrease in sample no. 007 is even smaller than in the unaffected sample no. 011/2.

Figure 16. Distribution of compressive strength decrease in the samples no. 007 (continuous line) and 011/2 (dashed line). ($\Delta f_c = f_c(\text{depth} = 100 \text{ mm}) - f_c(\text{current depth})$).
