Article

Fatigue Behaviour of Aluminium Members with Different Notch Root Shapes

Keywords: notch; aluminium profile; fatigue; wind action; stress concentration; unitised curtain wall

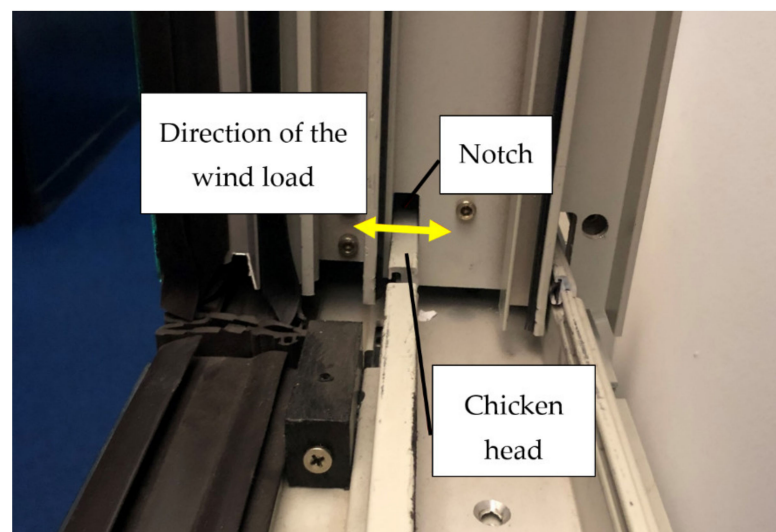
One of the common interlocking principles is the engagement of a “chicken head” feature in the transom of the lower unit into the notch in the mullion of the upper unit. The notch is exposed to the horizontal load at its tip, where the load (Figure 2) is transferred through the contact point from the vertical mullion of the upper unit to the chicken head of the lower unit. The notch is a stress riser, and the highest stress concentration occurs at the root of the notch.

Figure 2. Stack joint between vertical units of a curtain wall.

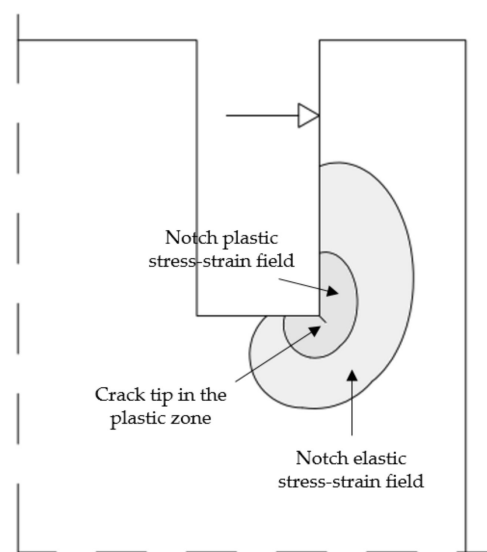
A crack may nucleate from a sharp notch rather quickly due to elevated stress at the notch root. Since the deformation at the notch root is plastic, the crack initiates under conditions of local plasticity. For cracks growing into the plastic stress–strain field of a notch, the rate of the crack growth is initially high, but decreases as the crack grows further away from the notch root. As the crack exceeds 10–20% of the notch radius, the notch geometry has little influence on the stress–strain field of the advancing crack and can stop growing once it has grown out of the notch-influenced region [6]. If the crack keeps growing, it may grow into the elastic zone (Figure 3). Crack growth through a notch stress–strain field may represent a major or minor portion of the total fatigue life [7]. After the crack grows out of the plastic zone, it may grow to become significantly long.

Figure 3. Phenomenology of crack growth through a notch stress–strain field.

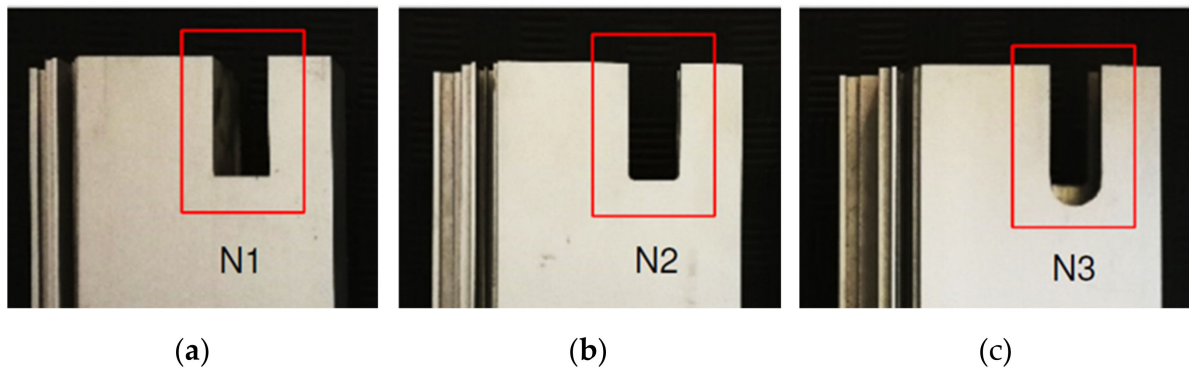
It was known that the most structurally resilient root shape in this case would be a semi-circle with a diameter equal to the width of the notch (Figure 4c). Due to a requirement to minimise the cross-section of the frame, the semi-circular root was not practical, as it would reduce the available vertical gap for the movement, as discussed later. Hence, root corners were rounded with a radius equal to the radius of the milling bit, typically close to the thickness of the aluminium wall (Figure 4b), which corresponds to the diameter of the

smallest bit typically used for the milling of aluminium. Machining by sawing results in sharp corners on the notch (Figure 4a), which is known to be the worst condition for stress concentration. All three geometries of the notch (Figure 4) were tested, and the results were compared to numerical models. It is important to note that the width of the notches was constant, but the shape of the root of the notches was variable: sharp corners, rounded corners, and the full semi-circular root.

Figure 4. Shape of root notch: (a) sharp, N1, (b) rounded, N2, (c) semi-circular, N3.

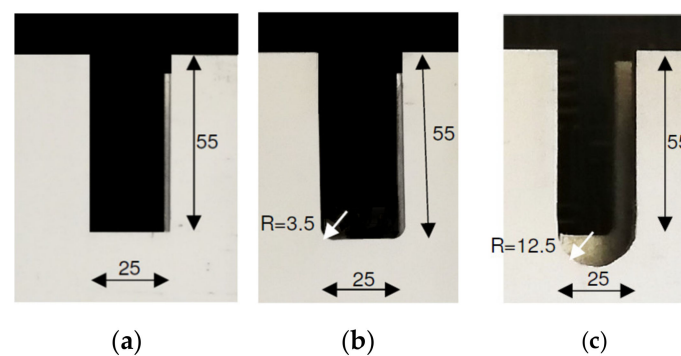
The geometry of the notches is shown in Figure 6. The width of the notch was 25 mm, which enabled a close fit of the chicken head. The depth of the notch was 55 mm. This enabled ± 20 mm of vertical movement in the stack joint.

Figure 6. Geometry of the (a) sharp notch, N1, (b) rounded notch, N2, and (c) semi-circular notch (mm).

It should be noted that the total depth of the semi-circular notch was 67.5 mm, which allowed for a straight length of 55 mm plus a radius of 12.5 mm for the semi-circle. In practice, the semi-circular notch was not used due to geometric constraints. The vertical section through the stack joint between two façade units is shown in Figure 7a. The enlarged detail in Figure 7b shows the vertical movement capacity of the stack joint when the gap between two units closes. The grey chicken head shows the nominal position as-designed. The blue chicken head shows the closed position if the rounded notch was used. The red chicken head shows the closed position if the semi-circular notch was used. It can be observed that the movement capacity of the semi-circular notch (sc) was smaller than that of the rounded notch (rnd), as the movement of the chicken head was limited by the contact

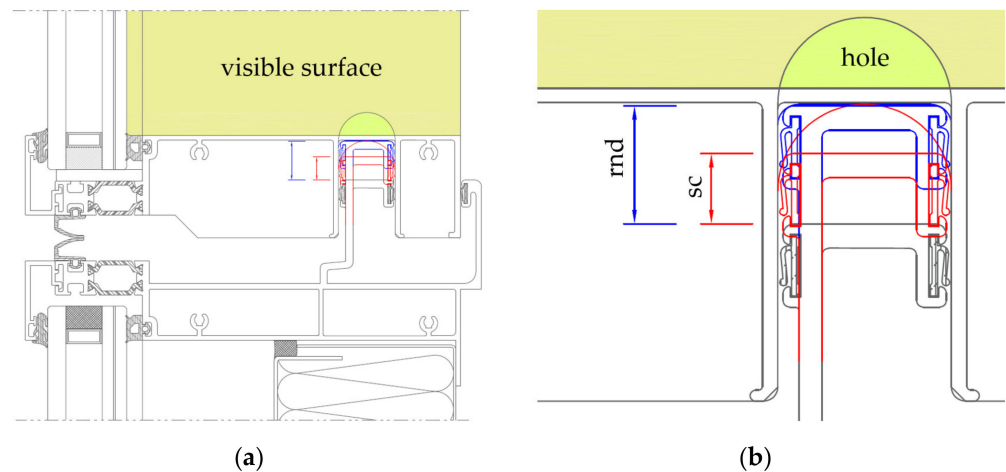
with the semi-circular notch (red contour in Figure 7). The position of the semi-circular notch would need to be higher to enable the same movement capacity as the rounded notch, but this is not possible, as, in that case, the semi-circular part of the notch would protrude over the horizontal transom and enter the area visible to the user (green hole in Figure 7), leaving it open for the passage of air and water into the building. However, the semi-circular notch was investigated as well for comparison. For test, specimens with a semi-circular notch at a total depth of 67.5 mm were used. Numerical modelling was performed for both semi-circular geometries, at 55 mm and 67.5 mm of the notch depth.

Figure 7. (a) Stack joint; (b) enlarged detail showing the vertical movement capacity.

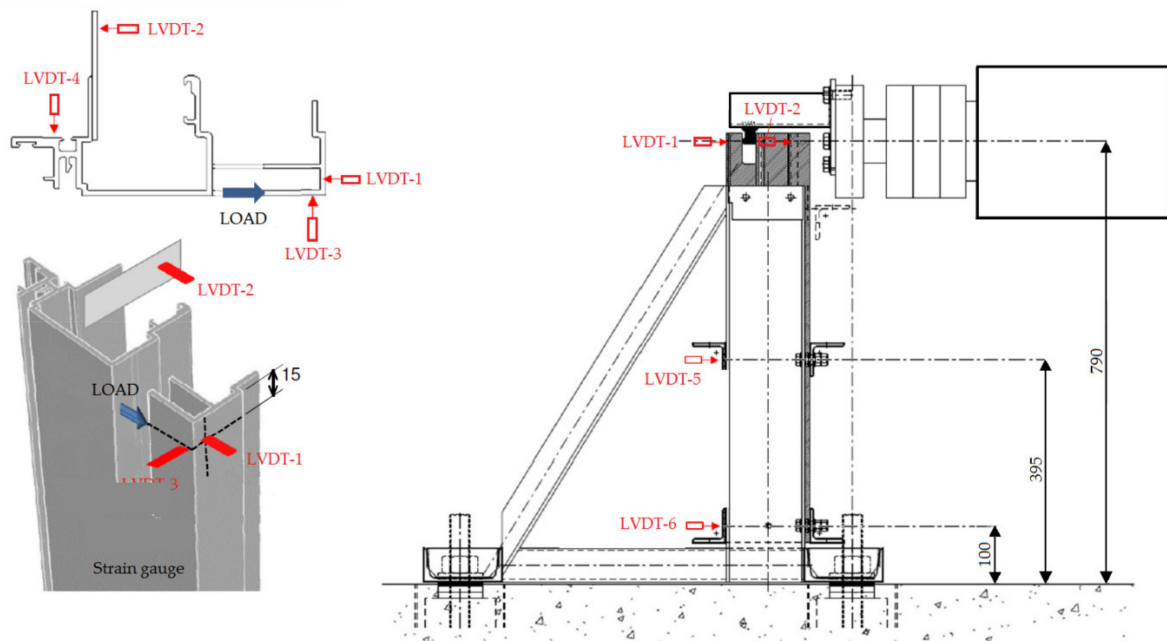
The deformation of the specimen was measured in 6 positions. The measurement data was collected using a datalogging device that recorded all measurements at 0.01 s intervals. Displacements were measured using Linear Variable Displacement Transducers (LVDT) with an accuracy of 0.2%, as shown in Figure 9.

Figure 9. Positions of LVDTs.

- LVDT-1,2,3,4 were located at the level of the application of the load.
- LVDT-1—absolute displacement at the back of the profile behind the notch in the direction of the load.
- LVDT-2—absolute displacement at the tip of the specimen in the direction of the load
- The differential of LVDT-1 – LVDT-2 measures the opening of the notch under the load.
- LVDT-3—absolute displacement at the back of the profile behind the notch perpendicular to the direction of the load.

- LVDT-4—absolute displacement at the top end of the specimen perpendicular to the direction of the load.
- The differential of LVDT-3 – LVDT-4 measures the rotation of the tip of the specimen under load.
- LVDT-5—absolute displacement of the upper support of the specimen in the direction of the load (upper angle in the steel frame).
- LVDT-6—absolute displacement of the lower support of the specimen in the direction of the load (lower angle in the steel frame).
- The displacements of LVDT-5 and LVDT-6 are used to confirm the sufficient stiffness of the supporting steel frame.
- The differential of LVDT-5 – LVDT-6 determines the rotation of the supporting steel frame in order to distinguish between movement at the tip of the specimen due to the rotation of the support and movement due to the bending of the specimen.

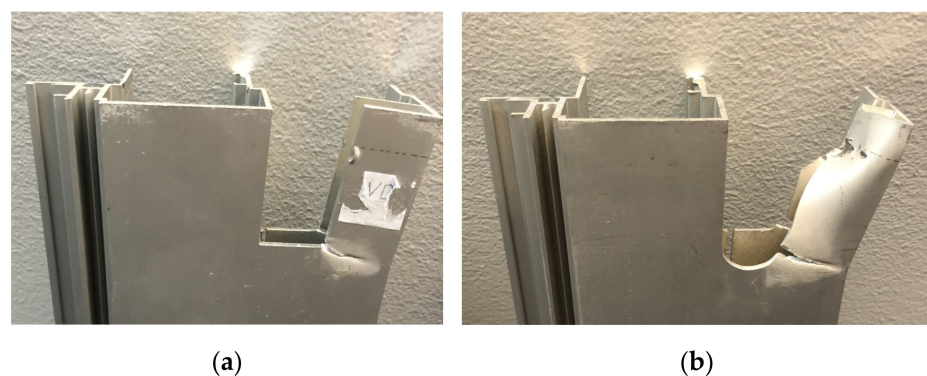
It should be noted that specimens with the sharp notch (Figure 10a), as expected, had lower breaking forces (6.78 kN and 6.99 kN), which was, on average, 82% of the breaking force for specimens with rounded or semi-circular notches (8.08 kN, 8.61 kN, and 8.45 kN). Since the opening of the notch was measured at the time of the fracture, there was a notable difference for various specimens. This value depended on the mode of the breakage and comprised localized plastic effects; for M_N3, this value was highest as the wall buckled, which can be seen in Figure 10b.

Figure 10. Fracture in monotonic tests: (a) Sharp notch specimen M_N1_1; (b) Semi-circular specimen M_N3.

Specimens with the sharp notch failed through the crack at the root of the notch due to the concentration of tensile stress (Figure 10a). Specimens with the rounded or semi-circular notch experienced local buckling of the aluminium wall at the load application point prior to the fracture, so the material at the root of the notch was exposed to the combined stress due to the rotation of the aluminium wall (Figure 10b). The rotation of the aluminium wall was a secondary effect caused by the buckling of the wall, which shifted the application point of the load out of the plane of the wall.

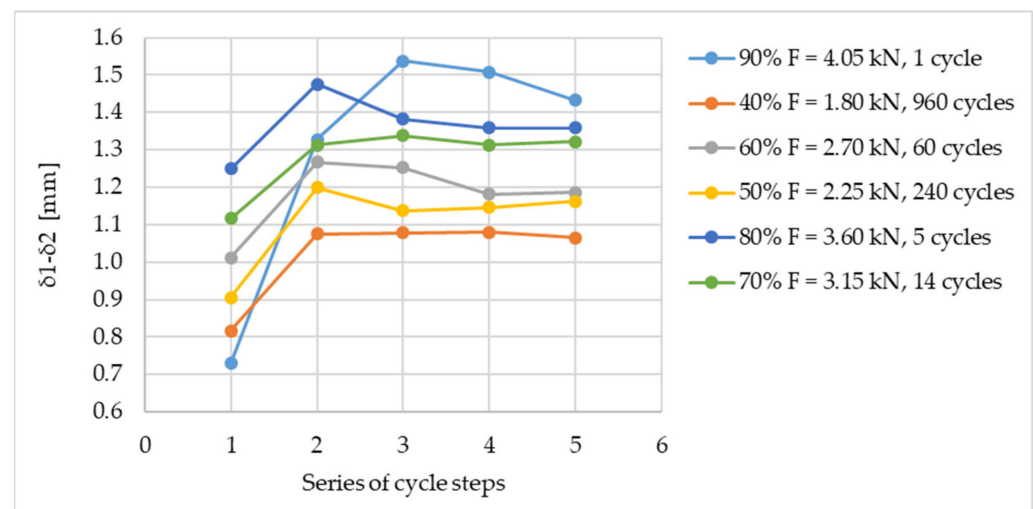
Figure 11 shows the diagram of the maximal opening of the notch, expressed as the difference between deflections δ_1 and δ_2 (readings of LVDT_1 and LVDT_2, respectively) for each set of cycles (single F_i) in each series for the specimen with the sharp notch (C_N1_1). It can be noted that there was a slight increase in the opening of the notch ($\delta_1 - \delta_2$) after the first series for $F_i = 90\%$ F and $F_i = 40\%$ F load cycles. This could be caused by the onset of the crack in the root of the notch, but this pattern was not observed on other specimens and there is no definite proof of that hypothesis. For subsequent series of cycle steps, it can be observed that a stable value of measured deflections and slight fluctuations were attributed to the tolerance of the applied force due to the precision limits of the hydraulic press.

Figure 11. Opening of the notch, sharp notch specimen C_N1_1.

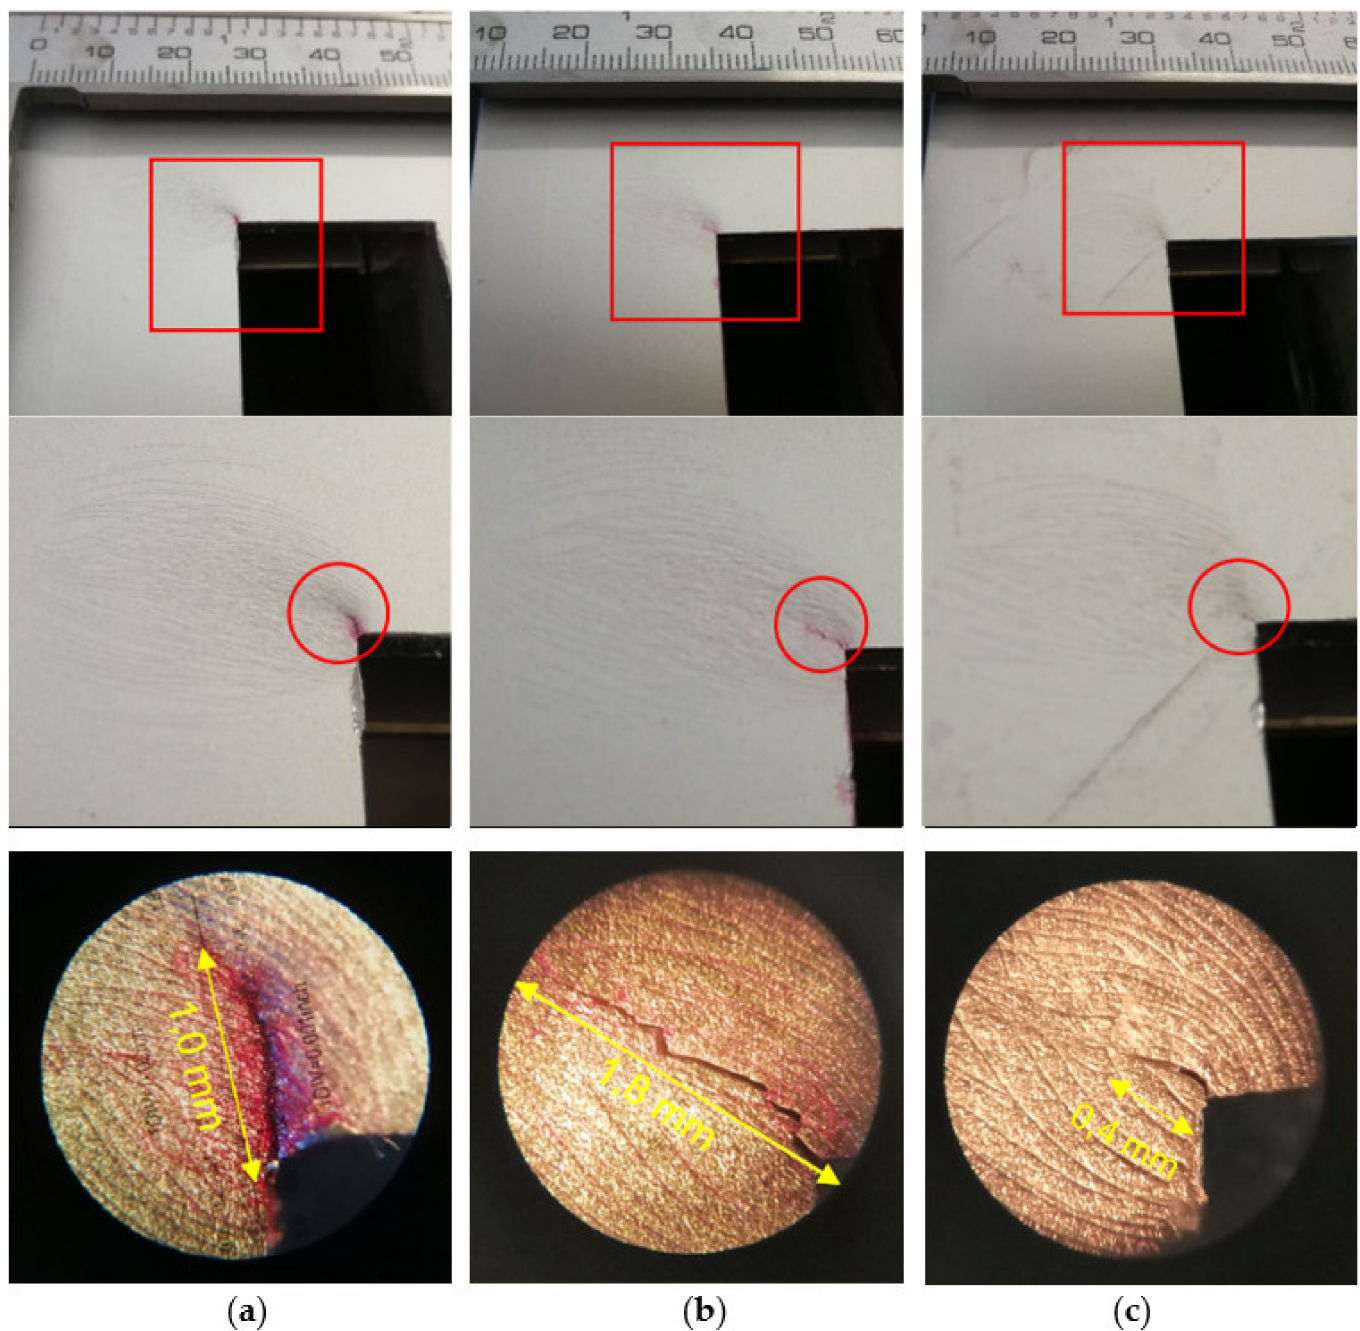
In all 3 specimens with the sharp root notch (C_N1_1, C_N1_2 and C_N1_3), a crack developed at the root of the notch (Figure 12). The stress concentration during the cyclic loading caused the crack propagating 1–2 mm in the direction bisecting the internal corner of the notch, which was in the range of 35° to 55° . The length of the fracture was measured using a microscope Elcometer 900 graduated $\times 50$. It was not possible to identify the cycle at which the crack appeared nor its propagation rate. The apparent slight differences in the colour of surfaces in Figure 12, enlarged details, are due to the light conditions and to residues from the red liquid penetrant used to emphasise surface irregularities; in fact, all samples had the same surface finish.

Figure 12. Cracks in specimens with the sharp root: (a) C_N1_1, (b) C_N1_2, (c) C_N1_3.

In tested specimens with a sharp notch, this behaviour was observed. The nucleation of the crack happened early during the test, but throughout the entire cycling, it remained stable. It is assumed that the crack remained within the plastic zone (Figure 3), and did not grow out of it. This was confirmed by numerical modelling, which showed that the plastic zone was much deeper (20–40 mm) than the length of the cracks, which were experimentally determined in the range of 1–2 mm; see Figure 12.

All specimens with the sharp root notch exhibited full-penetration cracks propagating at 45° for a length of 1–2 mm. The crack geometry was consistent in shape for all 3 specimens. It should be noted that the propagation of cracks was very limited to the vicinity of the sharp internal corner and the length of cracks was lower than the thickness of the aluminium wall (2.5 mm). This indicates that such a situation should remain stable for the duration of the building's design service life and that repeated loading would not result in progressive collapse of such a detail. Thus, specimens with a sharp notch fulfil the requirements for the damage-tolerant design according to [21]. Buildings with such a notch design can be deemed safe for use. This reasoning does not take into account other non-structural performance requirements, such as possible breach of the air barrier, possible water penetration, or aesthetical issues related to such a crack.

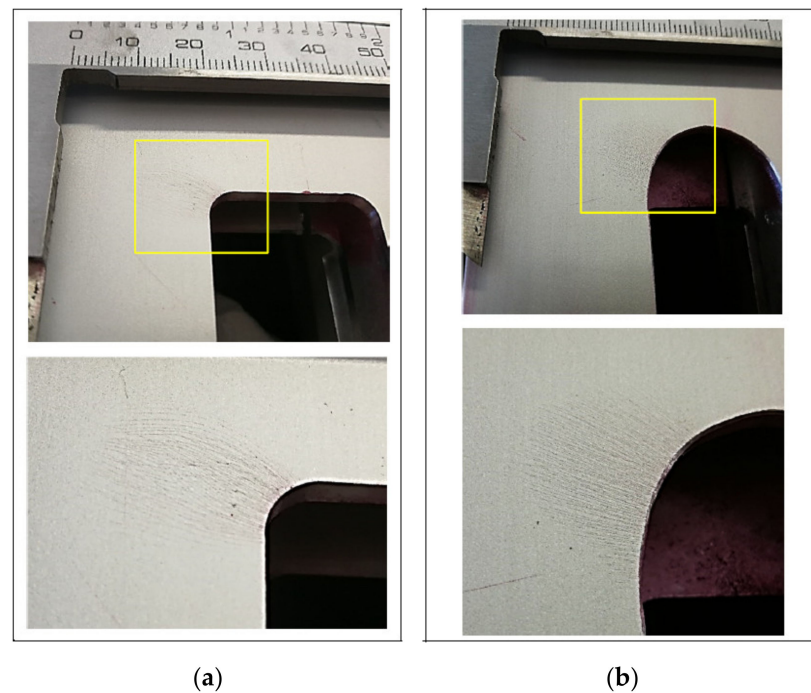
Cracking of the specimens with the rounded (Figure 13a) and semi-circular roots (Figure 13b), did not occur. In the zone approximately 20 mm around the crack, a net of microcracks radiating from the internal corner of the notch was visible. It is important to note that all specimen surfaces were anodized with aluminium trioxide, which has a higher modulus of elasticity and higher hardness than the parent material below. For high strains, the anodized surface will crack before the alloy material below. It is not uncommon for anodized surfaces with a thickness of around 30 μm or more to experience microcracking caused by the temperature expansion of the parent material. Such a surface becomes “crazed” with crisscrossing lines. This also happened in this test, but due to the high strain. Microcracks are present only in the surface finish (anodization), while the material below was not cracked, apart from a main crack that grew through the full thickness of the aluminium wall and was observable from both sides of the aluminium wall.

This microcracking of the surface finish was also visible on specimens with rounded roots and with semi-circular roots. However, on these specimens, no cracks in the aluminium alloy wall occurred. The aluminium material around the root of the notch did undergo a yield, observable from the residual deformation, which is approximately 1 mm at the opening of the notch, but without initiating cracks (Figure 13a,b).

Figure 13. Microcracking of the surface of specimens with the rounded and semi-circular root: (a) C_N2_1; (b) C_N3_1.

It was observed that all specimens exhibited microcracks in the surface finish. This has no structural implications and is not deemed to be a failure, but rather, an acceptable working condition. Such microcracks cannot cause the onset of corrosion due to the healing properties of the aluminium and due to its favourable exposure being internal to the air barrier. Specimens with the rounded and semi-circular notches did not exhibit any

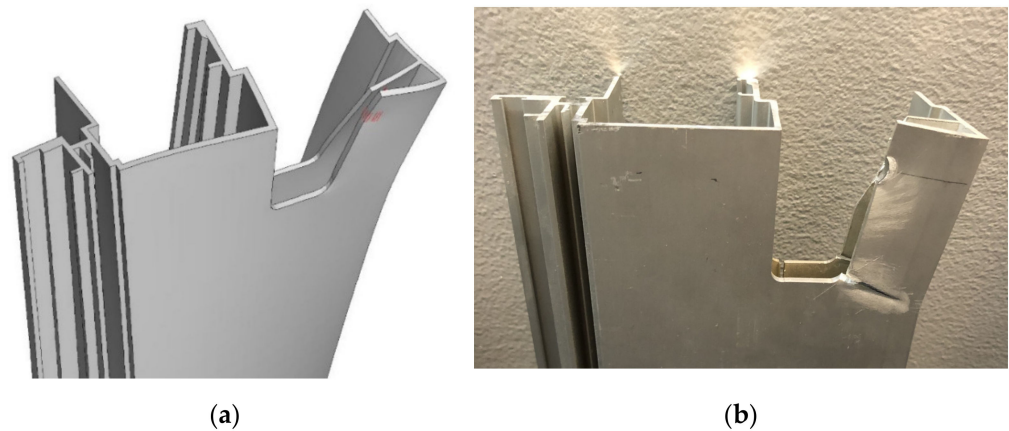
The deformed shape obtained by numerical simulation is shown on Figure 16a, and the deformation of the profile obtained by testing is shown in Figure 16b.

Figure 16. Deformed shape of the specimen N1: (a) numerically and (b) experimentally obtained.

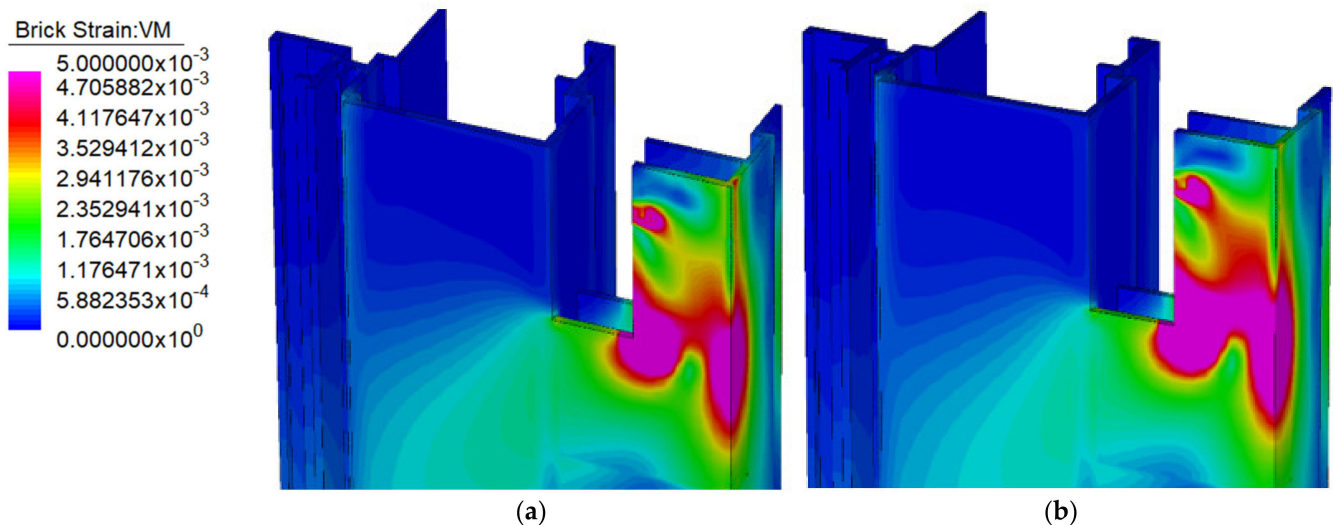
The highest achieved force for models using the true stress–strain curve was 5.5 kN, and the highest achieved force for models using the standardised stress–strain curve (alloy EN AW 6063 T6) was 5.0 kN. Models of the semi-circular notch at 67.5 mm achieved 0.5 kN less force: 5.0 kN and 4.5 kN. The distribution of the strain for all models is shown in Figures 17–20. The wide area of the yielding can be seen (magenta) around the root of the notch.

Figure 17. Strain in the model of the sharp notch: (a) True stress–strain curve (coupon A11), load 5.5 kN; (b) standardised stress–strain curve (alloy EN AW 6063 T6), load 5.0 kN.

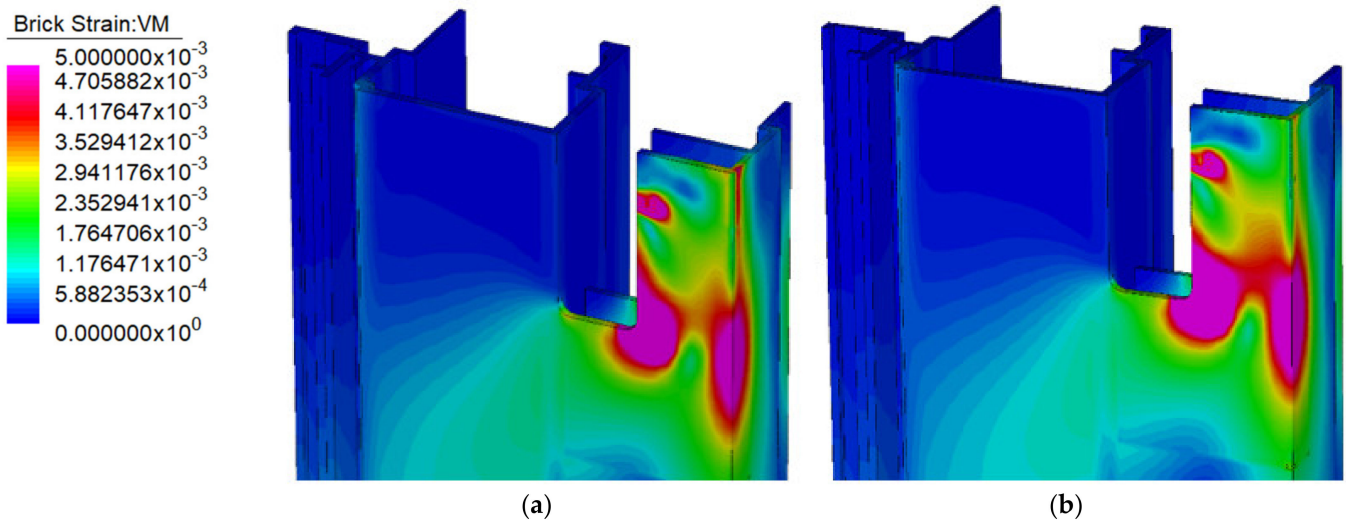
Figure 18. Strain in the model of the rounded notch: (a) True stress–strain curve (coupon A11), load 5.5 kN; (b) nominal stress–strain curve (alloy EN AW 6063 T6), load 5.0 kN.

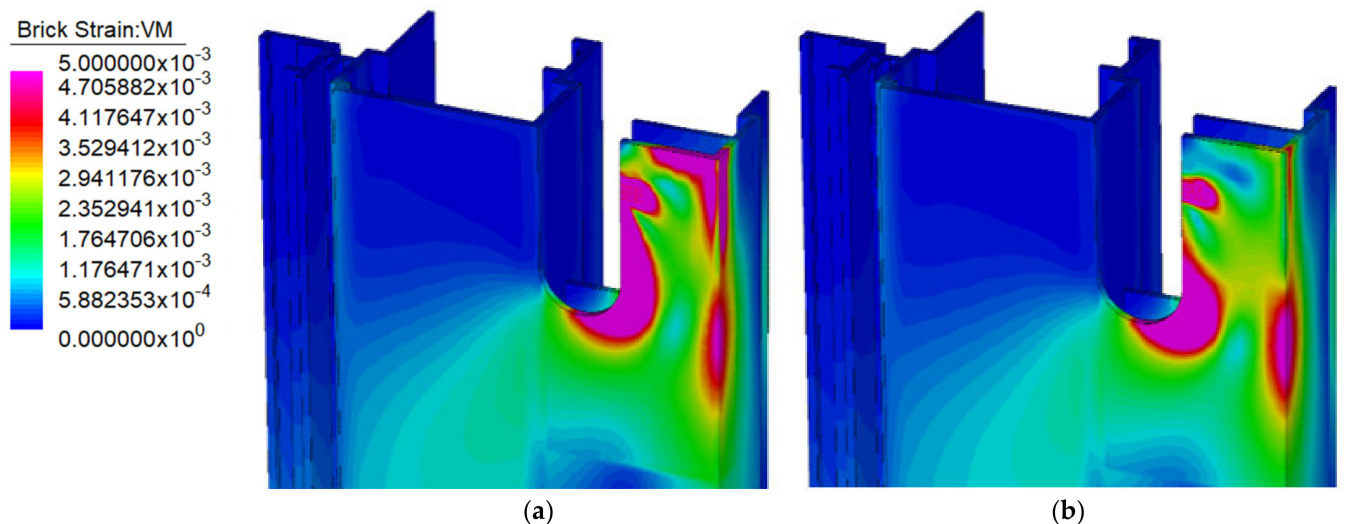
For the semi-circular notch, two different geometries were modelled, Figures 19 and 20. The difference between them was the total depth of the notch. Tested specimens had an initial depth of 55 mm, to which a semi-circular machining with a radius of 12.5 mm was performed, resulting in a total depth of 67.5 mm. In order to match the total depth of the other two geometries, an additional model with a semi-circular root was created, which had a total depth of 55 mm, including the semi-circular part, equal to the sharp and rounded notches. Hence, a 67.5 mm notch was representative of tested specimens, whereas a 55 mm notch had the same notch depth as other tested geometries.

Figure 19. Strain in the model of the semi-circular notch 55 mm: (a) True stress–strain curve (coupon A11), load 5.5 kN; (b) nominal stress–strain curve (alloy EN AW 6063 T6), load 5.0 kN.

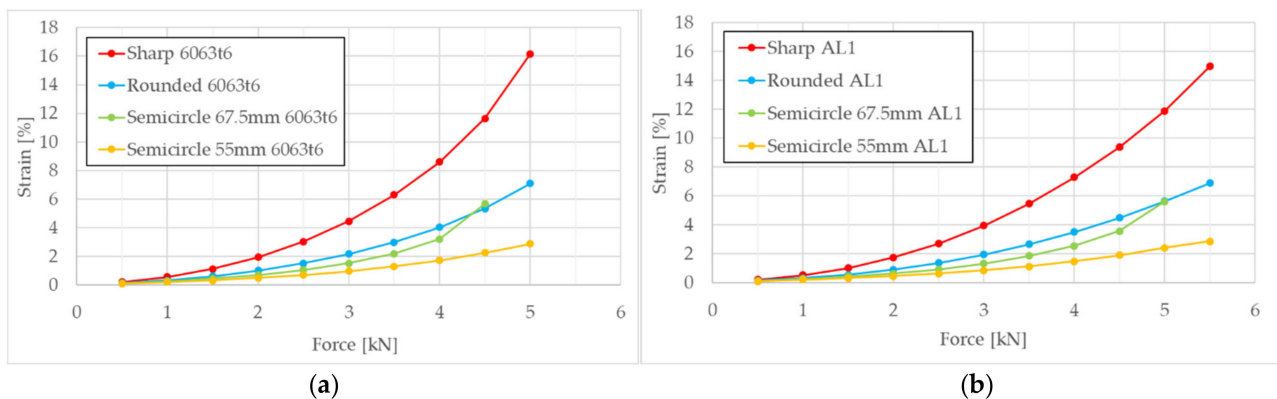
Figure 21 shows that, when a standardised stress–strain curve was used, the highest maximal strains occurred at the sharp notch and the lowest maximal strains occurred at the semi-circular notch.

Figure 21. Strain-force curves for the (a) nominal and (b) true stress–strain curve.

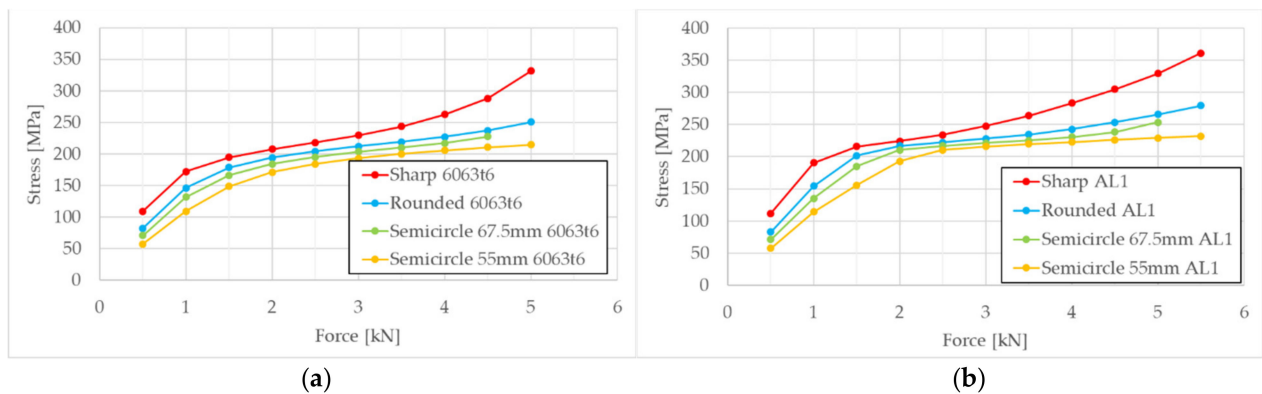
Figure 23. Von Mises stress–strain curves for the (a) nominal and (b) true stress–strain curves.
