Case Report

Performance of Epoxy-Injection and Microorganism-Based Crack-Healing Techniques on Cracked Flexural Members

Citation: Khan, S.U.; Ayub, T.; Khan, S. Performance of Epoxy-Injection and Microorganism-Based Crack-Healing Techniques on Cracked Flexural Members. *Buildings* **2023**, *13*, 2697. <https://doi.org/10.3390/buildings13112697>

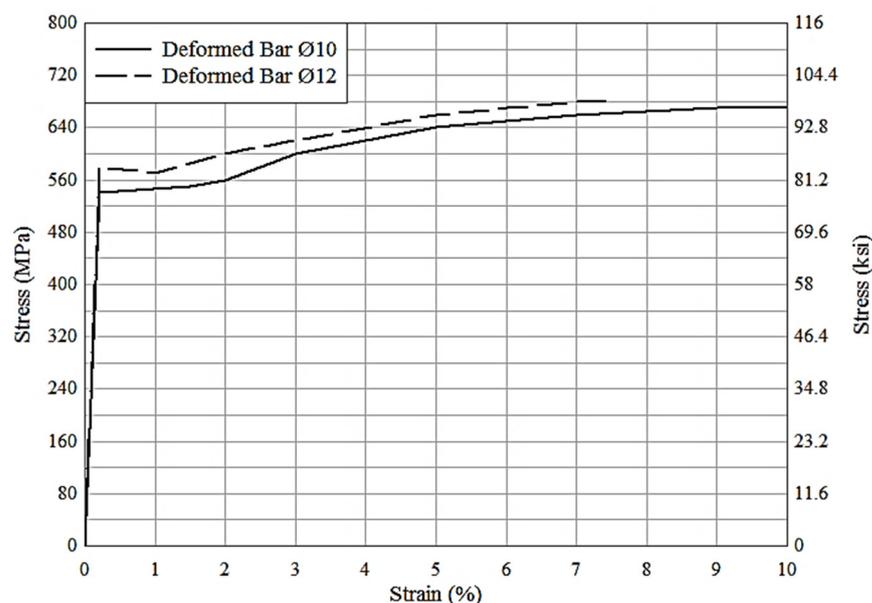
Figure 1. Tensile stress–strain response of the steel reinforcing bars.

ASTM Type I ordinary Portland cement (OPC) [26] was used to prepare the concrete. In all of the concrete mixes, the maximum size of the coarse aggregates was 20 mm. River sand smaller than 4.75 mm with a fineness modulus of 3.55 was used as the fine aggregate. BASF-Master-Rheobuild-Naphthalene-Sulphonate-based high range water reducing admixture (HRWRA) of 1% of the total weight of cement was also added to obtain the desired workability. A water/binder ratio of 0.45 was used in all of the mixes. Two types of deformed steel bars of grade 60 with diameters of 10 mm and 12 mm (labelled as Ø10 and Ø12) were used as the top and bottom reinforcements of the beams. The complete response of steel bars under tensile load in a Universal Testing Machine (UTM) is shown in Figure 1. The load and deformation were obtained through a data logger attached with UTM and with KYOWA Transducers DT-A. The yield strengths for the 10 and 12 mm diameter bars were found to be 540 MPa and 560 MPa, respectively, and the ultimate strengths were observed to be 677 MPa and 681 MPa, respectively. Likewise, the yield strains for the 10 mm and 12 mm diameter bars were calculated as 0.0027 (for yield strength = 540 MPa) and 0.0028 (for yield strength = 560 MPa), respectively, using a standard elastic modulus value of steel as 200 GPa.

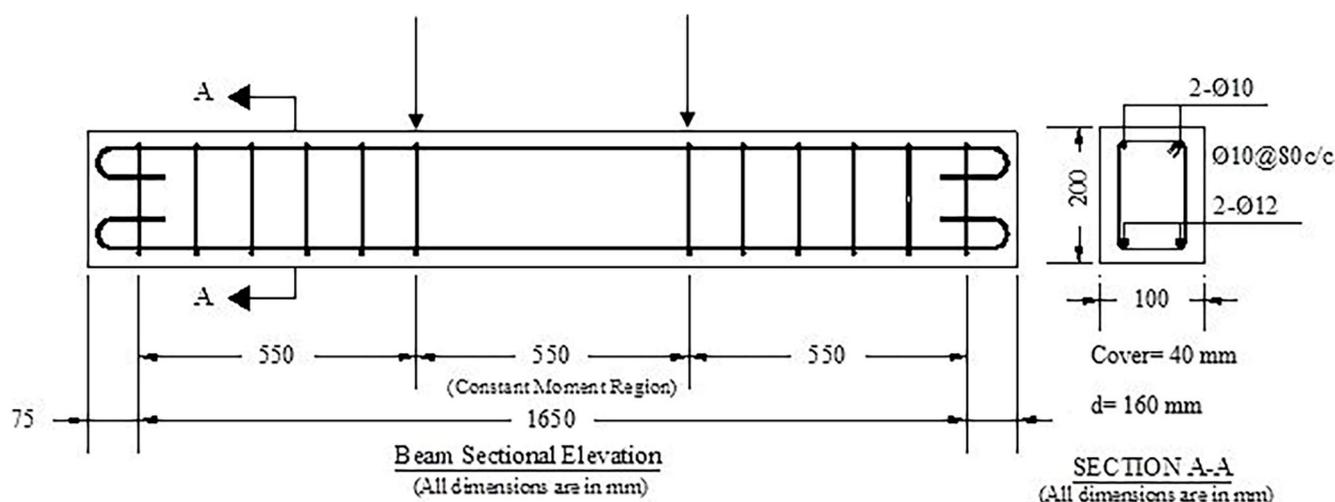
Figure 2. Reinforcement Detail of All Beams for Flexural Mode of Failure.

A total of three RC beams with a total length of 1800 mm and cross-sectional dimensions of 100 mm \times 200 mm were cast. All beams were designed identically in flexure, as per ACI 318R-05 [27] provisions. The reinforcement detail of the beams is shown in Figure 2. For testing, the supports were adjusted such that the testing span for all beams was 1650 mm with a fixed shear span to depth ($\frac{a}{d}$) ratio of 3.4. Two-point loads were applied at the top of the beam at $L/3$ distance, which was 550 mm. In order to measure the deflection, a KYOWA Transducer DT-A was placed at the beam bottom and touched the bottom face at middle span and at the location of point load of the beam. All of the beams were tested in displacement control mode with a displacement rate of 0.01 mm/s.

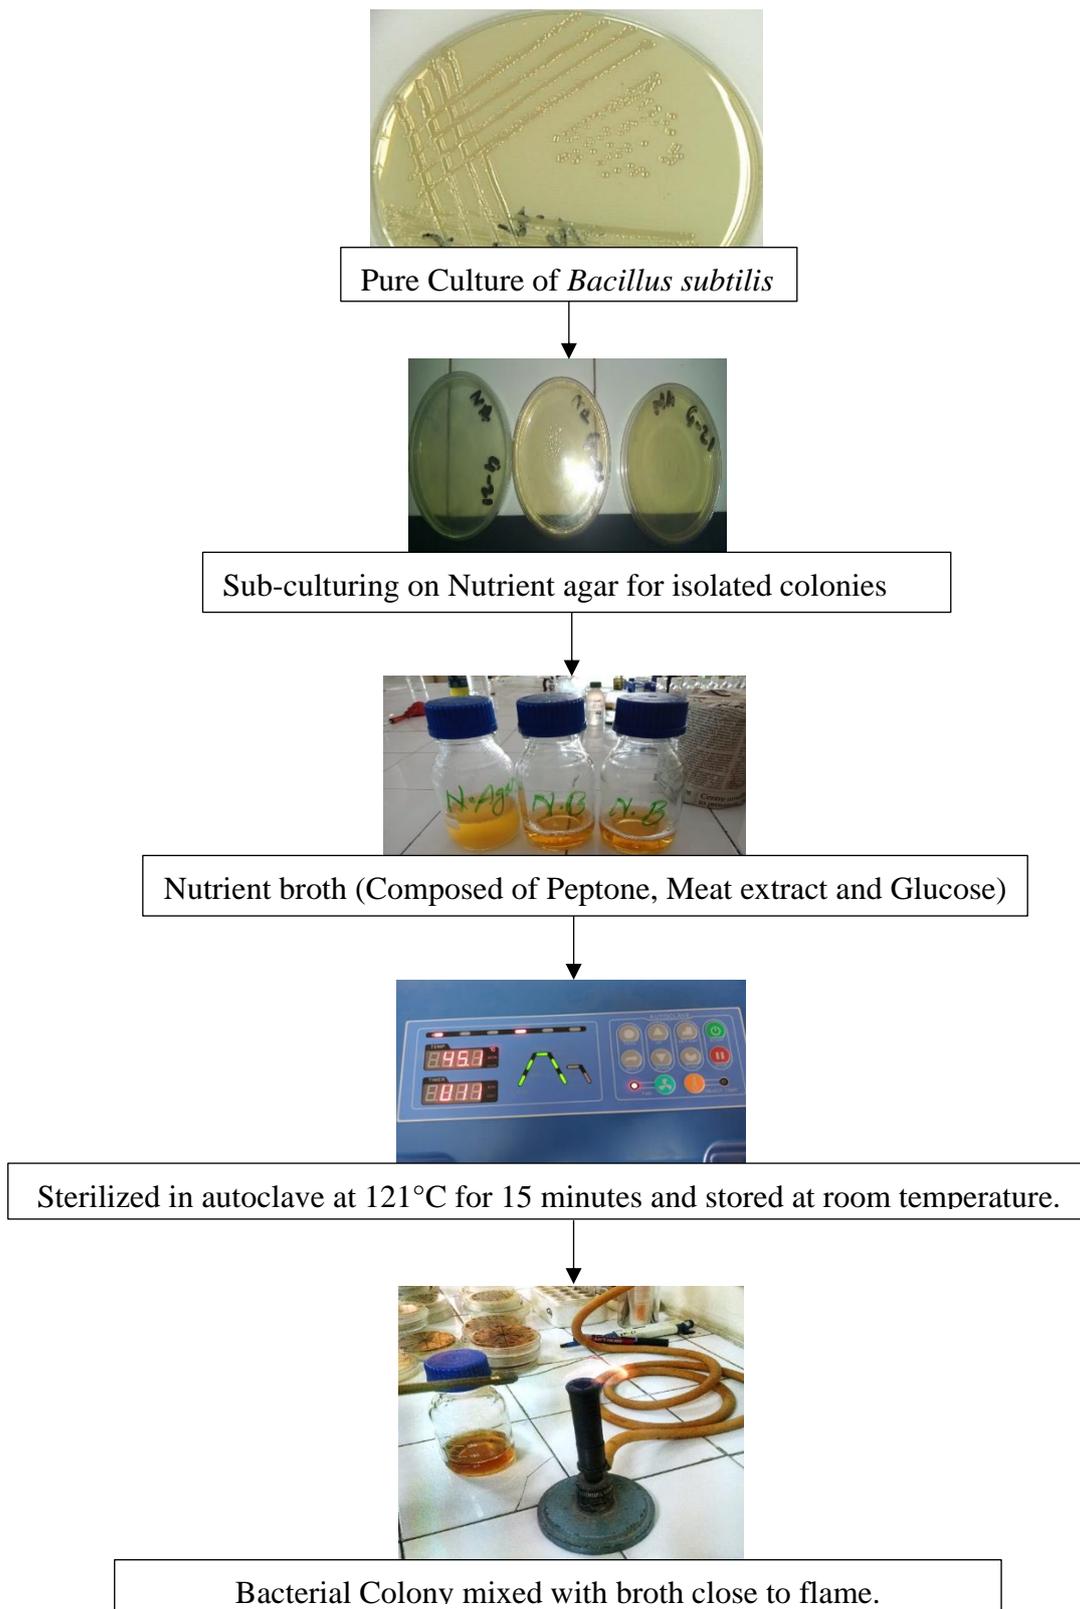
Figure 3. Complete process for the preparation of the healing solution.

The bacterial colony was moved to the freshly developed agar medium. A wire scrapper was created red hot over a flame (to assassinate bacteria), cooled, and shifted slowly over the colony for growth on the wire. It was then moved and spread slowly over the freshly developed agar medium to transport the bacteria into the stock medium. All these processes took place close to a flame. The agar plate was left for 24 h to check for contamination. As there was no contamination of other species, the fresh cultures were ready to use. A small quantity of the bacterial colony was scraped using a wire scrapper and mixed in the broth close to a flame. The broth medium was also left for 24 h to check for contamination. The composition of the broth medium is shown in Table 2. The complete process is shown in Figure 3.

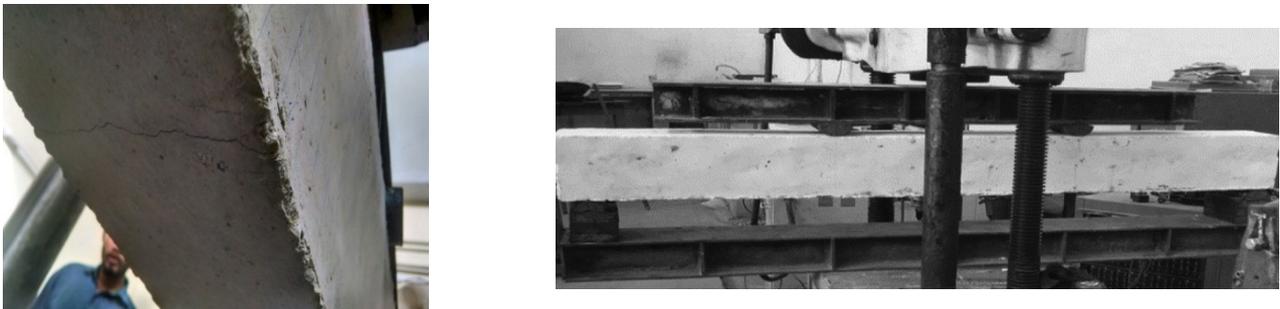
Figure 4. Testing Setup of Beams under Four-point bending Loading and Crack Appearance.

All of the beams were intended to fail under four-point bending conditions. One of the beams did not receive an application of crack repair and was named “control”. Three of the remaining four beams were tested until the appearance of a crack 0.3–0.5 mm in width formed, and were then treated with the crack-healing solution (named beams “TCHS”); meanwhile, the remaining beam was also tested until the appearance of a crack 0.3–0.5 mm in width, and was then treated with epoxy injection (named as Beam “TEIM”). The specimens were tested under four-point bending loading to develop a pure flexure region in the mid-third of the span, as shown in Figure 4. All specimens were loaded statically to produce micro-cracks of 0.3–0.5 mm width. The crack width was monitored using a crack-sensing camera, which is hand-held device and requires no setup. Beams marked as TCHS and TEIM were then repaired using the crack-healing solution and epoxy injection, respectively, as discussed in the following section. The specimens were left to heal for 28 days and then tested until failure under four-point bending loading.

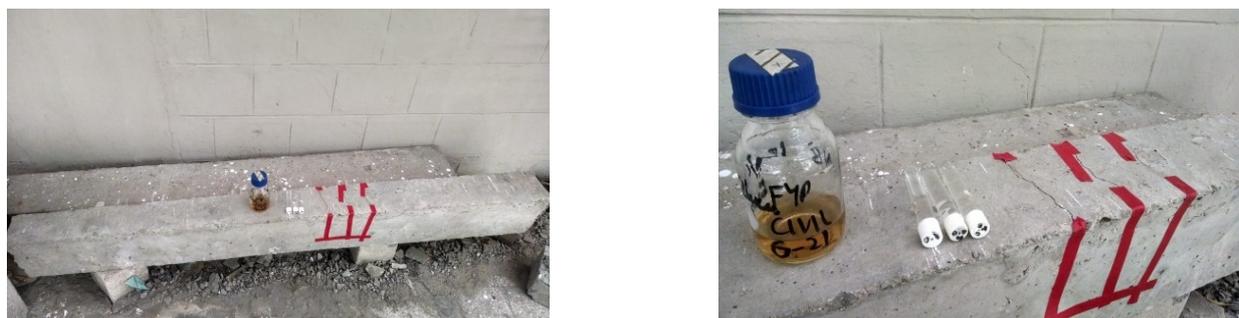
Figure 5. Crack-healing solution application on Beam “TCHS-1”.

On the first cracked beam, the formerly prepared crack-healing solution (mixture of broth of *Bacillus subtilis* and calcium nitrate) was applied directly, as shown in Figure 5. It was injected into the cracks and then the whole layer of cracks was covered with plastic tape. The specimen was then left for 28 days so that bacteria growth and crack-healing process could take place. The beam was exposed to an open environment. The temperature and relative humidity were observed during the period, ranging 35–40 °C and 60–75%, respectively.

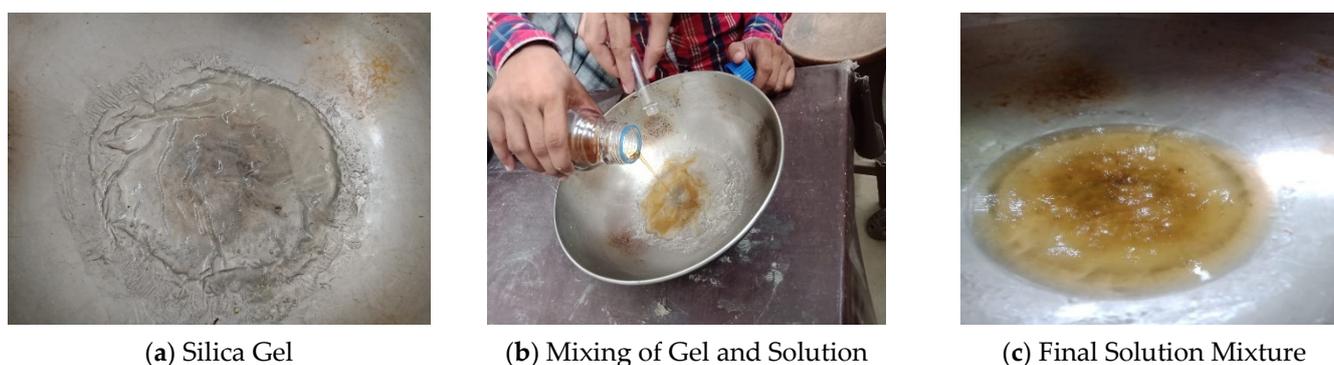
Figure 6. Formation of the silica gel plus crack-healing solution for application on Beam “TCHS-2”.

This beam was treated with a mixture of sodium silicate gel and crack-healing solution, which itself contained a mixture of broth medium of *Bacillus subtilis* and calcium nitrate, as shown in Figure 6. First, all the cracks were cleaned with water and dried for half an hour. The gel was then applied to the cracks and after some time (about 20 min) the gel hardened. This beam was left for 28 days so that bacterial growth within the gel took place and the crack-healing process occurred.

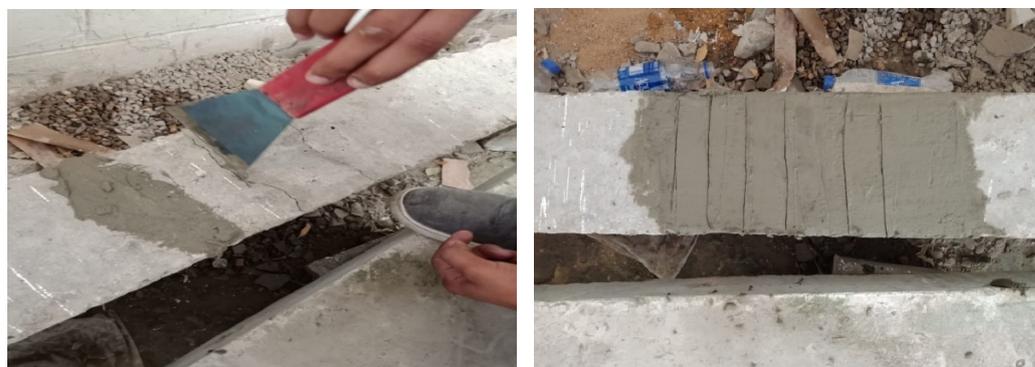
Figure 7. Application of Crack-Healing Solution with Cement Slurry on Beam “TCHS-3”.

On this beam, the crack-healing solution mixed in a cement slurry was applied to the cracks (refer to Figure 7) and was left for 28 days to cure.

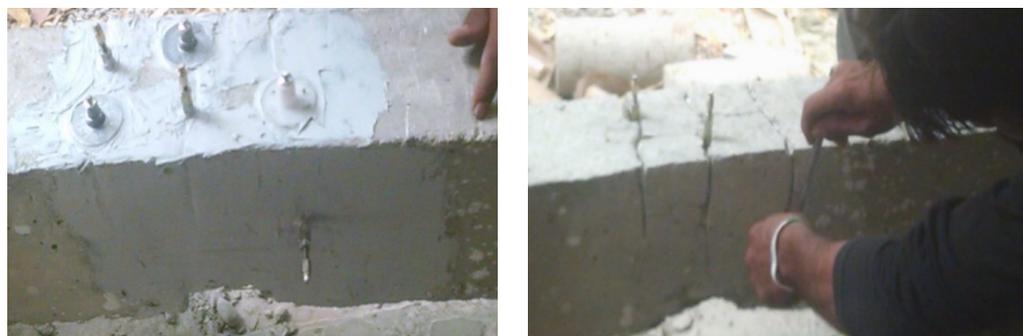
Figure 8. BASF epoxy resin application on Beam “TEIM”.

The beam was prepared for treatment by sealing the cracks and attaching injector packers at different locations of cracks (refer to Figure 8). The epoxy was pressurized into the packers. The epoxy was highly penetrative and cured within a few minutes to form a permanent and rigid seal against the ingress of corrosive substances.

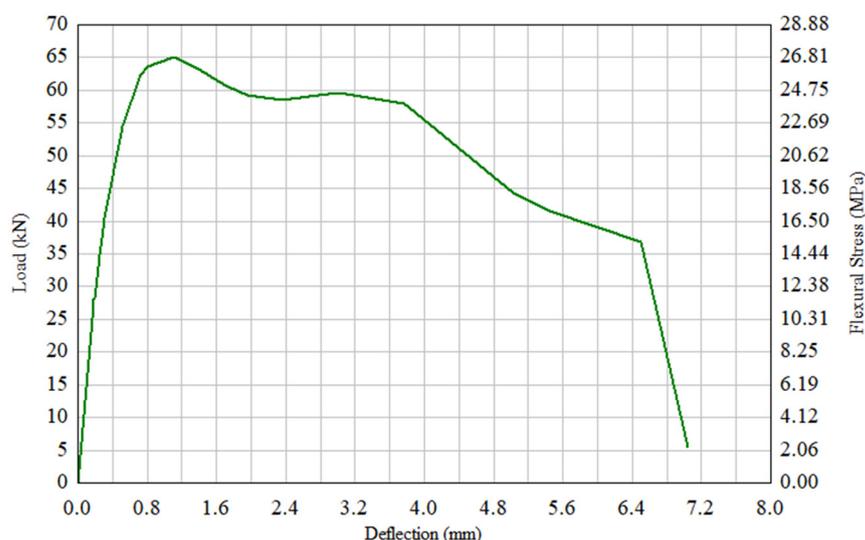
Figure 9. Load–deflection response of the control beam.

Figure 9 shows the load–deflection response of the control beam. There was an almost straight-line response until the appearance of cracks on the surface of the beams, causing the load–deflection to start curving. However, the load kept increasing until the full load-carrying capacity of about 65 kN was attained, after which the steel began to yield, followed by a gradual descending branch where the load continuously decreased, while a substantial increase in deflection was observed.

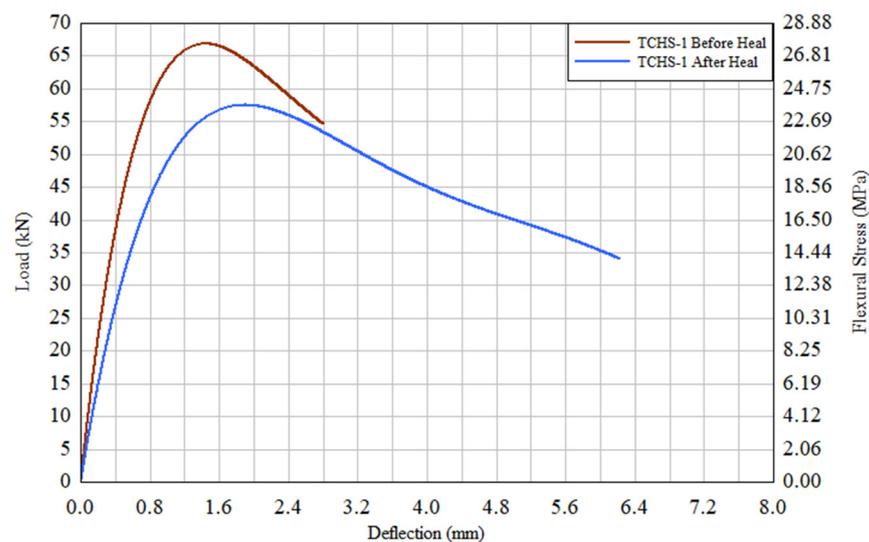
Figure 10. Load–deflection response of Beam “TCHS-1” using the crack-healing solution.

Before the application of the healing technique, Beam TCHS-1 was tested until a crack width of 0.3 mm of visible crack. A peak load of 64.54 kN was attained at about 1.28 mm deflection (refer to Figure 10). The beam was treated through the application of

a crack-healing solution and was cured until the designated period. After treatment, the beam was tested again, as shown in Figure 10. The ascending branch was found to have a lesser slope, pertaining to the drop in stiffness after healing. A peak load of 57.35 kN was obtained, which was 11% less than the load before healing. This could be due to the insufficient availability of moisture as the beam was cured in an open environment with humidity less than 50%, during the summer season. However, the descending branch was quite smooth and followed the traditional RC beam response. Figure 11 shows the healing effect of the crack-healing solution on the crack that appeared on Beam TCHS-1 with a width of 0.3 mm. Although the crack was filled with the precipitation of CaCO_3 due to *Bacillus subtilis* growth and metabolic activity, the healing was not sufficient as the same crack opened during re-testing of the beam.

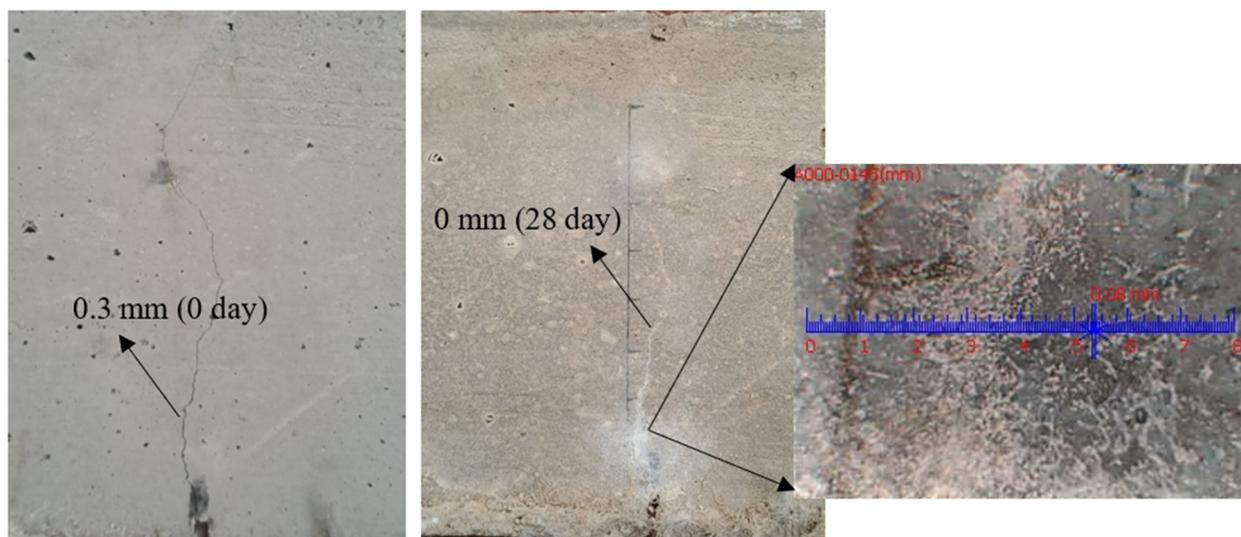
Figure 11. Crack width healed in Beam “TCHS-1” using the crack-healing solution.

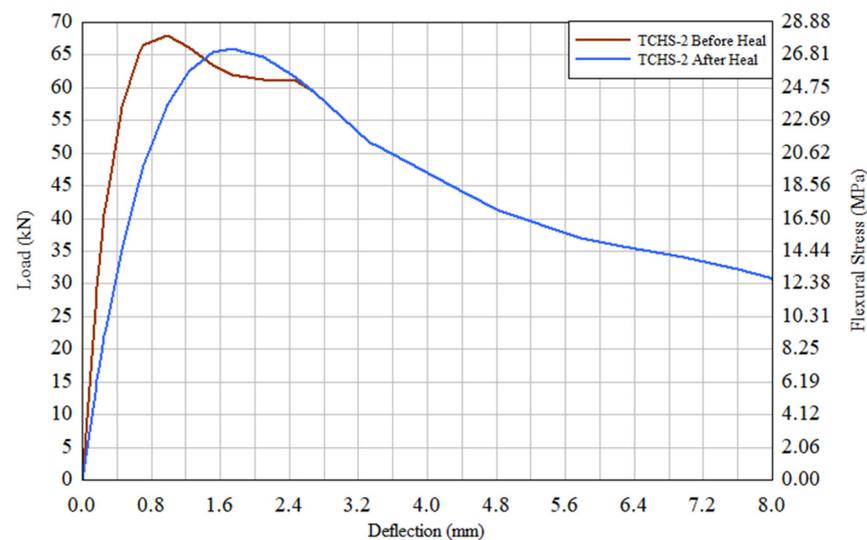
Figure 12. Load–deflection response of Beam “TCHS-2” strengthened using the silica gel plus crack-healing solution.

Beam TCHS-2 was also tested until a crack width of 0.3 mm. A peak load of 65.15 kN was attained at about 0.7 mm deflection (refer to Figure 12). The beam was then treated with silica gel plus crack-healing solution and was cured until the designated period. After treatment, the beam was tested again, as shown in Figure 12. The ascending branch was

found to have a lesser slope, similar to TCHS-1. This was a sign of stiffness loss after healing. A peak load of 61.2 kN was obtained, which was 6% less than the load before healing. This was better than beam treated with the crack-healing solution only (Beam TCHS-1). This could be because Beam TCHS-2 was kept moist by sprinkling water periodically; thus, there was moisture available during the curing period in the less humid, hot summer season. The descending branch was also similar to the Beam TCHS-1 response. Figure 13 shows the healing effect of the silica gel plus crack-healing solution on the crack that appeared on Beam TCHS-2 with a width of 0.3 mm. The crack was filled with the precipitation of CaCO_3 due to *Bacillus subtilis* growth and metabolic activity; however, the same crack opened during re-testing of the beam.

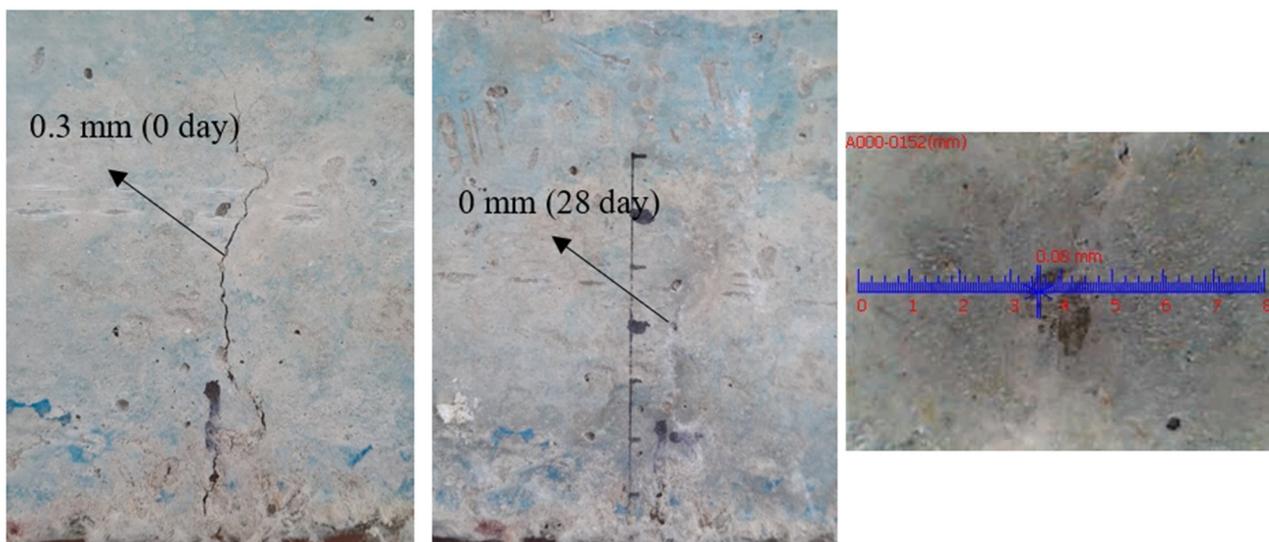
Figure 13. Crack width healed in Beam “TCHS-2” using the silica gel plus crack-healing solution.

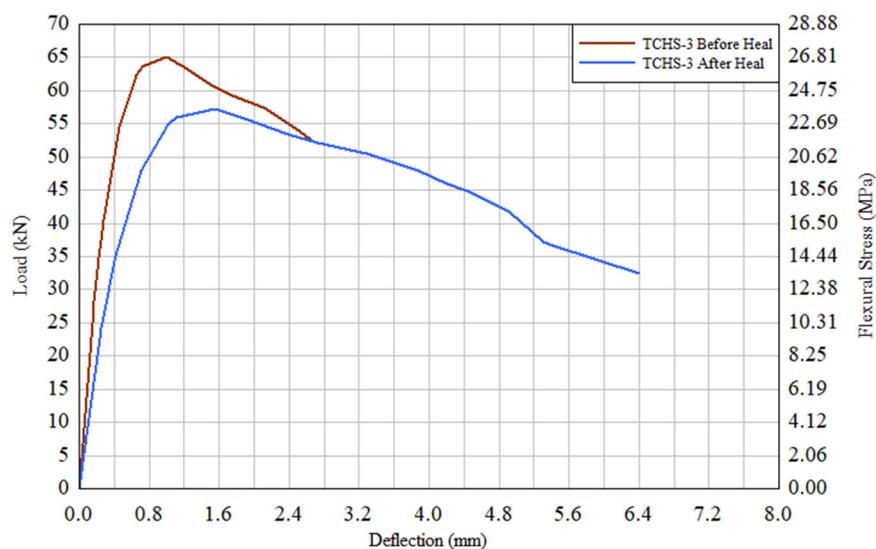
Figure 14. Load–deflection response of Beam “TCHS-3” strengthened using the bacteria cement slurry.

Beam TCHS-3 was also tested up to a crack width of 0.3 mm. The peak load of 63.27 kN was attained at about 1.24 mm deflection (refer to Figure 14). The beam was again tested after the application of the crack-healing solution mixed with cement slurry and was cured until the designated period, as shown in Figure 14. The ascending branch was found to

have a lesser slope, similar to TCHS-1 and TCHS-2. A peak load of 55.68 kN was obtained, which was 12% less than the load before healing. This was lower than Beams TCHS-1 and TCHS-2. This could be because Beam TCHS-3 was treated with cement slurry, which blocked the air entrainment into the crack for the necessary metabolic activity of *Bacillus subtilis* mixed as the crack-healing solution. The surface was kept moist by sprinkling water periodically; however, it was not substantially significant in this case. The descending branch was also similar to the response of Beams TCHS-1 and TCHS-2.

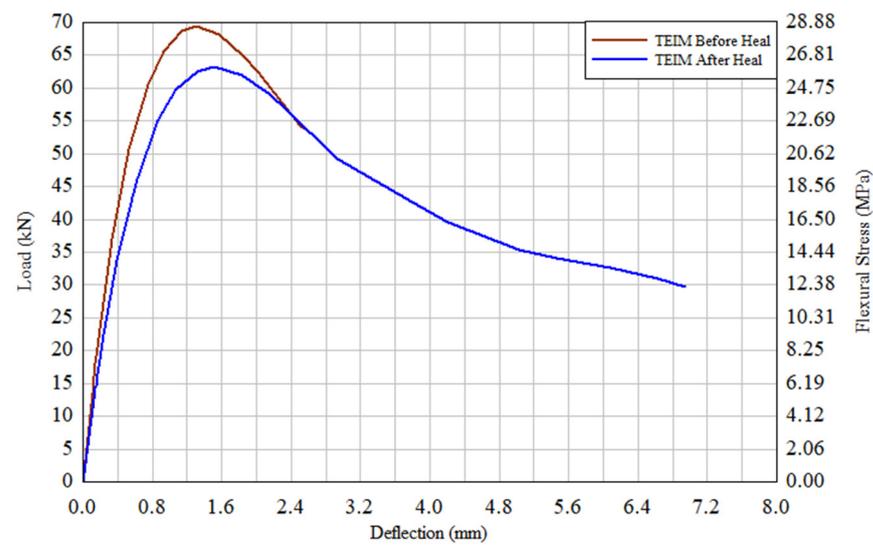
Figure 15. Load–deflection response of Beam “TEIM” strengthened using the epoxy-injection method.

The Beam TEIM was also tested up to a crack width of 0.3 mm. The peak load of 68.15 kN was attained at about 1.58 mm deflection (refer to Figure 15). The beam was treated with the application of epoxy injection and cured until the designated period. After healing, the beam was tested again, as shown in Figure 15. The ascending branch was found to have a lesser slope, similar to the beams strengthened by *Bacillus subtilis* in Beams TCHS-1 to TCHS-3. This is a sign that loss in stiffness was inevitable and the crack healing technique seemed to have no impact on the outcome. Additionally, the crack width of 0.3 mm was large enough to bring the beam into the non-linear zone; therefore, it was not possible to achieve complete recovery of stiffness after healing. A peak load of 60.47 kN was obtained, which was 11% less than the load before healing. This was similar to the beam treated with the crack-healing solution only (Beam TCHS-1). The reason might be that Beam TEIM tended to display cracks branching out the existing crack that was injected with epoxy, thus causing crack opening and widening at an early stage. The descending branch was also similar to the beam TCHS-1 response.
