Article

The Zagreb (Croatia) M5.5 Earthquake on 22 March 2020

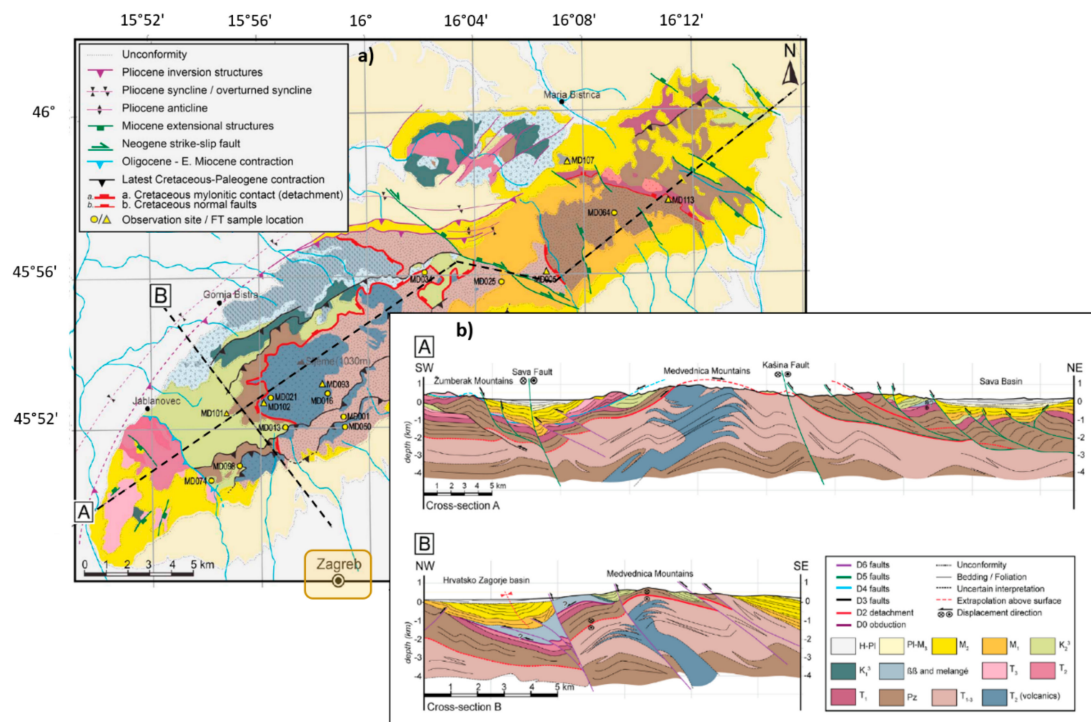
Figure 1. (a) Geological map of the Medvednica Mountains. The map shows the location of the cross-sections A and B; (b) Cross-sections across the Medvednica Mountains: (A) longitudinal (SW–NE) and (B) transversal (NW–SE) (after [11]).

The Medvednica Mountains are composed of a Paleozoic to Mesozoic metamorphic core overlain by non-metamorphic Mesozoic and Cenozoic rocks ([13–15]; Figure 1a). All units are truncated by normal and reverse faults and are surrounded by the Miocene–Quaternary deposits of the Pannonian Basin.

Using the previously described methodology, a primary fault plane was modeled (Fault 1) based on the dataset containing 45 hypocenters, including most of the highest magnitude events in the Zagreb 2020 earthquake sequence. The fault is characterized by an orientation similar to the southeast-dipping instrumentally calculated fault-plane solutions of the main shock and the strongest aftershock (Figure 4). The rupture along Fault 1 propagated towards the northwest, apparently along a deep-rooted southeast-dipping thrust fault (125/31, dip direction/dip angle). The thrust fault can be projected to the surface where it virtually appears in the central part of the Hrvatsko Zagorje basin (Figures 1b and 13).

A system of south-dipping longitudinal reverse faults has been mapped on the surface along the Medvednica Mountains [15] and interpreted in one of the latest tectonic models as the youngest (Pliocene to Quaternary) system of reverse faults ([11]; Figure 1) that are probably still active [7]. The reverse slip of the primary ruptured fault (Fault 1) of the Zagreb 2020 earthquake sequence (Figure 13; Supplement 1) generally corresponds to the frontal reverse fault striking along the northern foothills of the mountain (Figure 1b). However, the interpreted steep frontal reverse fault does not match the modeled gently inclined primary fault that is here interpreted as a thrust fault (Figure 13). Thus, a fault that could accommodate such a movement is probably a southeast-dipping thrust fault that completely dissects the basement of the central part of the Medvednica Mountains. This master thrust could represent a basal detachment (décollement) of the system of steeper reverse faults striking along the Medvednica Mountains. It could be steeper in the frontal part and thus could match the North Medvednica reverse fault, or it could be buried below the Neogene Hrvatsko Zagorje basin (Figure 1b; Figures 12 and 13).

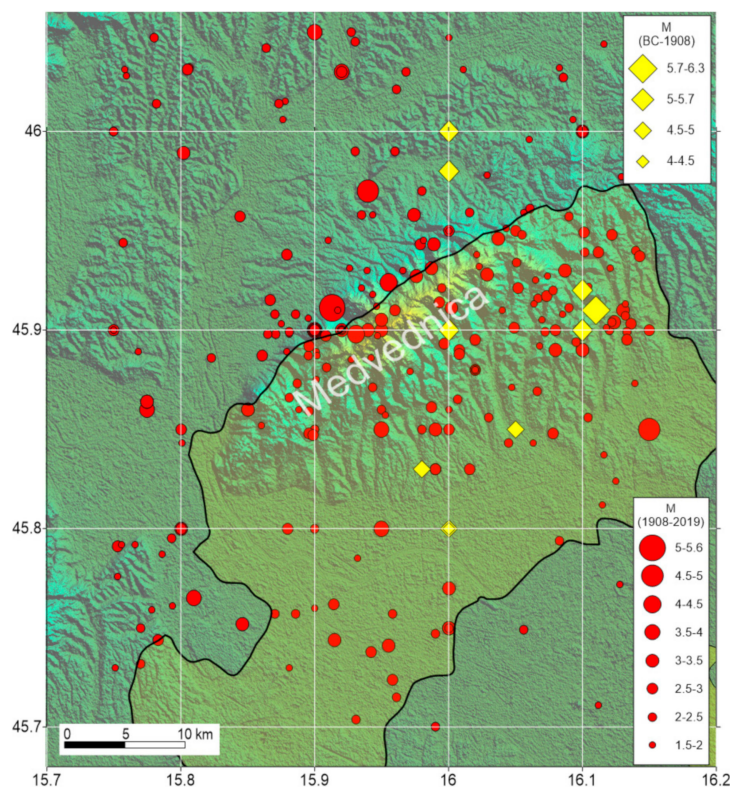
Figure 2 displays the locations of the epicenters of all earthquakes that have occurred in the wider Zagreb area (BC to 2019).

Figure 2. Spatial distribution of earthquakes with locations in the wider Zagreb area from BC to 2019 (according to the updated version of the Croatian Earthquake Catalogue, first described in [18]). The urbanized Zagreb city area is displayed with yellow shadowing.

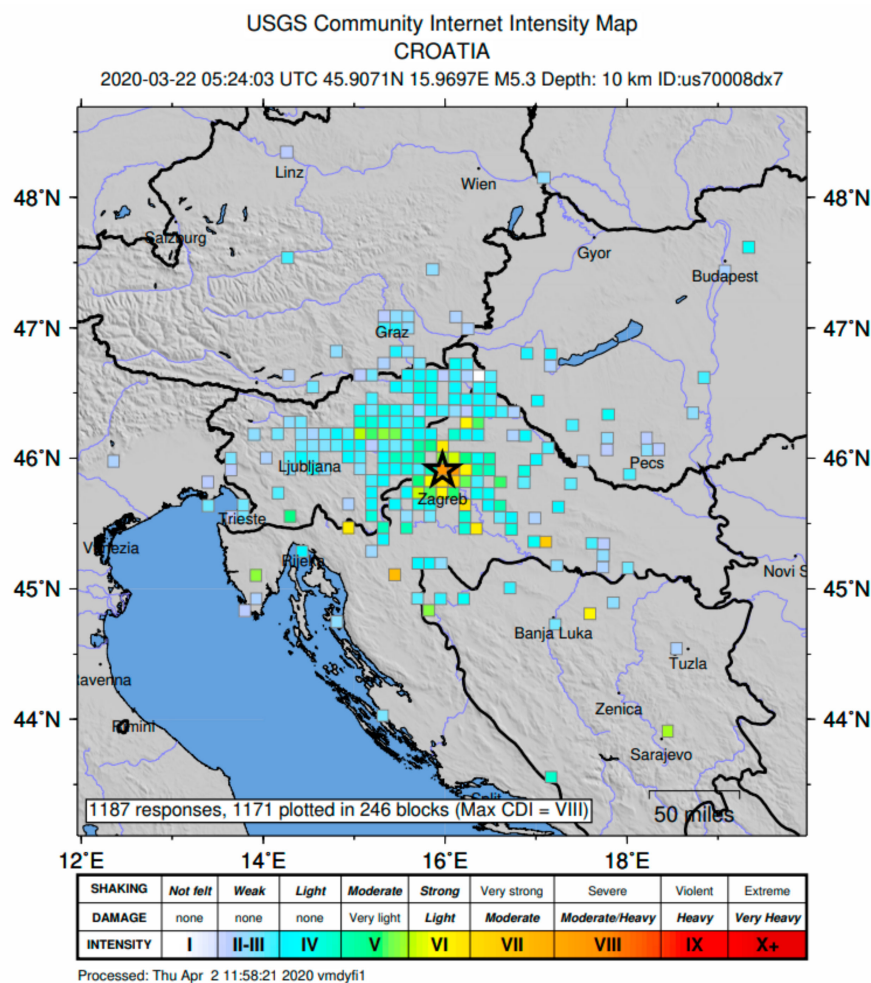
Figure 3. Intensity map according to data collected by USGS [19].

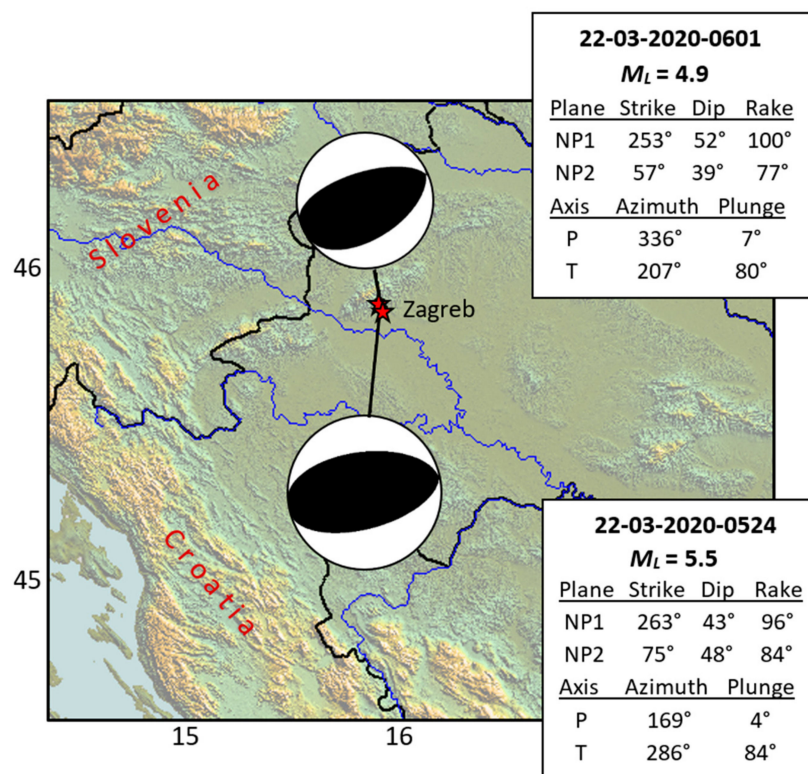
Based on the analysis of data recorded in Croatia and around the world (waveform data taken from the USGS National Earthquake Information Center [20]), the focal mechanisms of the main earthquake and the strongest aftershock were calculated (Figure 4).

The fault-plane solution of the main shock indicates that the earthquake occurred on a reverse fault whose fault plane dips at an angle of 43° to the south-southeast or at an angle of 48° to the north-northwest. The axis of maximum tectonic pressure (P) was horizontal and in the SSE-NNW direction, while the axis of maximum tension (T) was almost vertical. The calculated fault mechanisms will be described in greater detail in Section 4.5 and linked to the geological features of the study area.

Figure 4. Fault-plane solutions of 22 March 2020 earthquakes at 05:24 UTC and 06:01 UTC. The focal sphere is shown in stereographic projection.

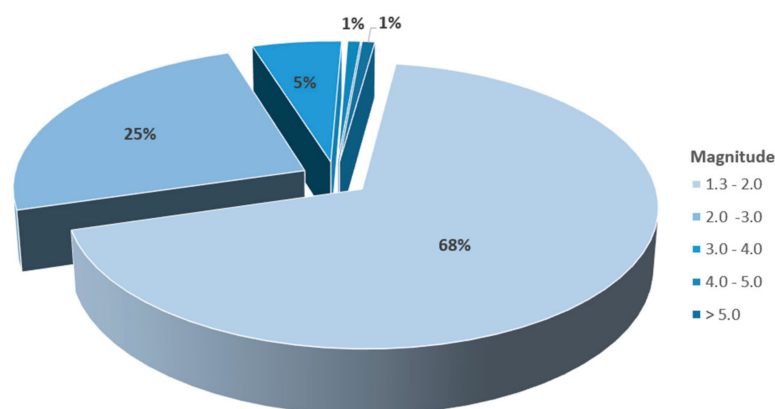
Since no one knows how much accumulated energy is released through a main earthquake, the aftershock activity is normal and not uncommon. Figure 5 presents the number of earthquakes of a certain magnitude (greater than 1.3) that occurred after the main earthquake of 22 March 2020 at 05:24 UTC.

Figure 5. Percentage of earthquakes of each magnitude interval that occurred in the epicentral area of the Zagreb earthquake in the period from 22 March to 1 April 2020.

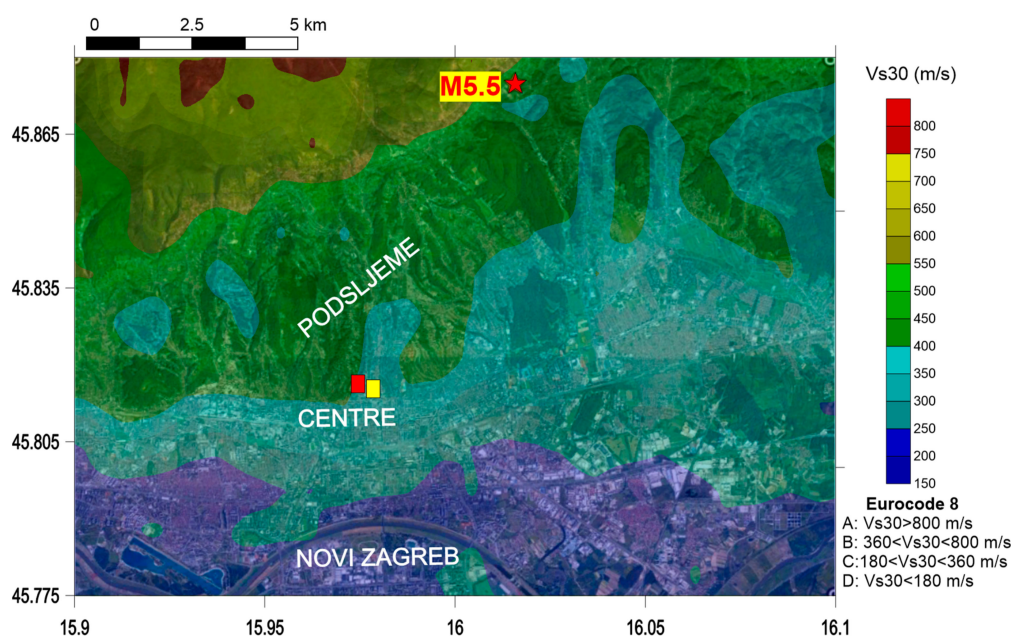
Interestingly, the first scientifically explained observation of the local soil amplification effects and variable earthquake damage due to different local geological units during shaking was presented by Stur [44], who analyzed the Klana (Croatia) earthquake sequence with the main shock on 1 March 1870 ($I_{max} = VIII$ °MSK), presenting a detailed report on building construction and observations of the unequal distribution of earthquake damage related to soil conditions with geological sketches, damage locations of objects and a map of the shaken area. Herak et al. [45] presented their macroseismic study of this earthquake sequence and measured the horizontal-to-vertical spectral ratios (HVSRs) of ambient noise at six locations to compare estimates of soil response in the epicentral area with observations of site effects [44] during the Klana earthquake. Presented findings and observations from [45] are similar to the observations of [44] about local site effects in Klana and Studena. Similarly, we attempted to assess the seismic site amplification distribution that occurred during the Zagreb M5.5 earthquake to possibly correlate it with observed damage in the city area and local site effects. For the first-order assessment of seismic site conditions, we used maps of the average shear velocity down to 30 m (V_{S30}), which is correlated with topographic slope [46], as displayed in Figure 8.

Figure 8. V_{S30} map of the Zagreb area obtained based on approximation via correlation to topographic slope ([46]; source: [47]). Locations of Zagreb Cathedral (yellow square) and Croatian Parliament (red square) are shown. The M5.5 epicenter location is marked with a red star.

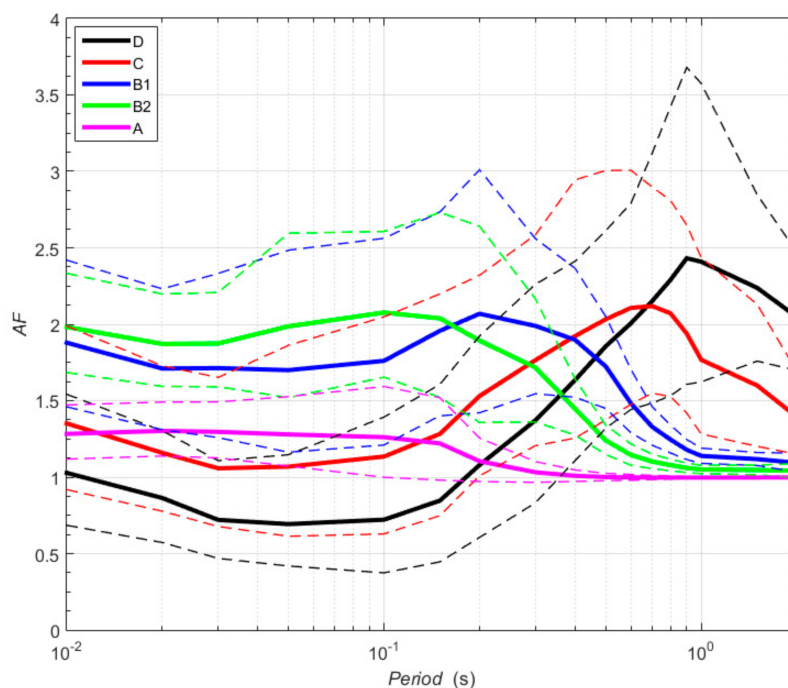
the well-known properties of random vibration theory (RVT) and seismological source theory [52], PGA_{ROCK} values for the M5.5 Zagreb earthquake were estimated (from the Fourier amplitude spectrum (FAS)). The input motion in the RVT-based method is typically defined by Brune's [53] omega-squared point-source stochastic model. The stress drop was set to the prescribed constant value of 100 bar (e.g., see [54]), the focal depth was taken as $h = 10$ km, the average value of crustal shear wave velocity was equal to 3.5 km/s and the density was 2800 kg/m^3 . Frequency-dependent attenuation, the $Q(f)$ value, was adopted from [55] as $Q_c(f) = 78f_c^{0.69}$, and the near-site attenuation parameter $\kappa_0 = 0.028 \text{ s}$ was adopted from [56]. We chose to select locations near epicentral area and set the epicentral distance to vary from 1 to 5 km. The corresponding target values of PGA_{ROCK} were calculated in the range of 0.159–0.185 g. Based on these results, we estimated the median site amplification factor (± 1 standard deviation) using the Stanko et al. [48] model for V_{S30} categories defined by Eurocode 8 (Figure 9). Standard deviation of median site amplification describes site response variability as the effect of variations in ground motions and local site parameters. For site class B, we used two bins, 360–600 m/s (B1) and 600–800 m/s (B2), consistent with the findings of [57]. As underlined in [58], profiles with relatively shallow surface layers underlain by hard bedrock surfaces may have high impedance contrasts leading to strong resonance effects, which is the case for the Zagreb Podsljeme zone. The dominant period/frequency of the ground motion and the natural period/frequency of the soil are especially critical for possible resonance effects during earthquakes, which can result in heavy destruction. Therefore, knowing the building resonance frequency is important for structural stability during earthquakes and for limiting the extent of resonance damage. If the period of ground motion matches the natural resonance of a building, it undergoes the largest oscillations possible and suffers the greatest damage [30]. In general, the Zagreb residential area in terms of V_{S30} categories is in categories B1 (Podsljeme) and C (city center and Novi Zagreb), which show site amplifications most prominent between 0.1–0.5 s (2–10 Hz) and 0.4–0.9 s (1.1–2.5 Hz). Compared to the period–building relationship of $T = 0.016H$ presented in [59], these periods correspond to family houses and 3- to 4-story (B1) and 4- to 15-story buildings (C1).

Figure 9. Median site amplification factors [41] for V_{S30} site classes based on Eurocode 8 with (± 1 standard deviation (dashed lines) for the PGA_{ROCK} in the range of 0.159–0.185 g.

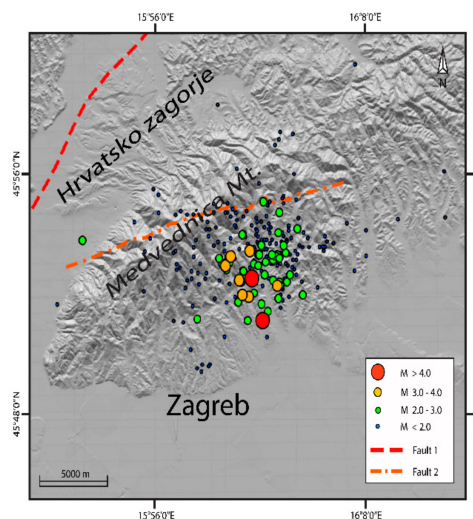
A set of 257 measurements was analyzed both spatially and temporally and processed for import into geological 3D modeling software. To achieve better visual insight, the hypocenters were scaled based on magnitude values (M_L) into four intervals: <2.0, 2.0–3.0, 3.0–4.0 and >4.0 (Figure 12).

Figure 12. Spatial distribution of earthquake epicenter locations in the period from 22 March to 1 April 2020 (the Zagreb 2020 earthquake sequence). Fault lines are simple projections of the two modeled fault plains from the deep subsurface of the Medvednica Mountains to the surface (see Supplement 1 and Figure 13).

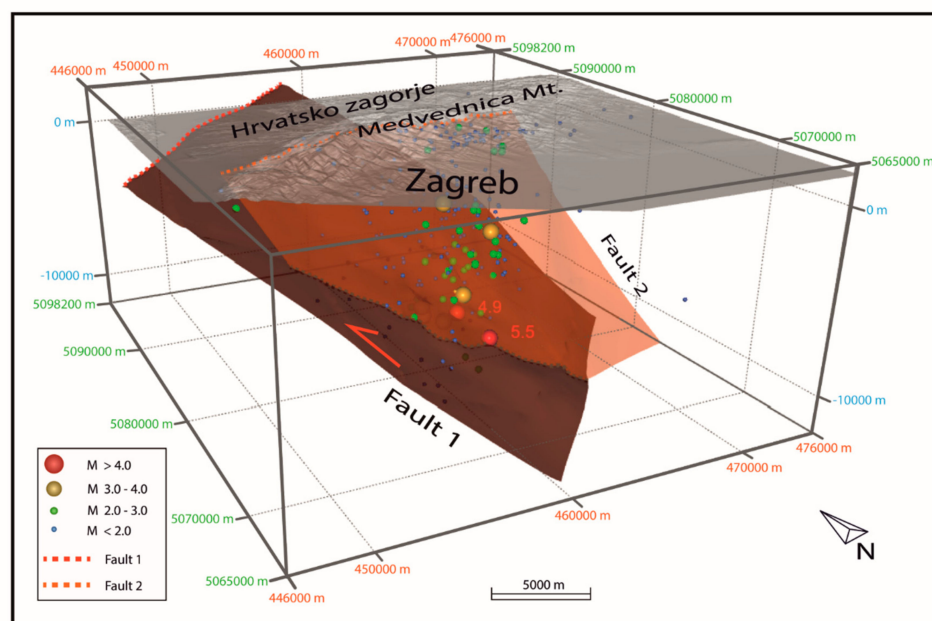
Figure 13. Preliminary structural 3D model of the Zagreb 2020 earthquake sequence. Coordinates are shown in HTRS96/TM coordinate system, and the elevation is in meters (no vertical exaggeration). Fault 1 is interpreted as a primary thrust fault, and Fault 2 is interpreted as a secondary (reverse?) fault.

Based on the selected datasets, two major faults were modeled using inverse distance weight (IDW) interpolation of the preselected datasets (hypocenters). The faults represent the preliminary structural model of the Zagreb 2020 earthquake sequence (Figure 13).

In addition to Fault 1, a generally south-dipping fault (166/57) of unknown character (Fault 2) was modeled based on a dataset with 77 hypocenters situated above the main shock. Fault 2 includes most of the moderate magnitude events of the earthquake sequence.

The secondary fault (Fault 2) is a south-dipping, east–west striking fault of unknown character that dissects the mountain generally across the highest peaks (Figure 13). There are similar faults that are interpreted on the published geological maps as reverse faults [13,14], but further analyses and focused investigations are needed.
