Force-Based Seismic Evaluation of Retrofitting Interventions of Historic Masonry Castles by 3D Rigid Block Limit Analysis

Abstract: This paper deals with the force-based assessment of collapse mechanisms and strengthening interventions of the historic masonry castle “Bussi sul Tirino” (Abruzzi, Italy) using rigid block limit analysis (RBLA). The structure, which is a fortified palace dating back to the 11th century, has experienced severe earthquakes over the centuries and was hit once again in 2009 by the L’Aquila earthquake. Based on the historical analysis and the results of in situ investigations, a spatial rigid block model of an entire structural unit was generated using the in-house software LiABlock_3D. The software is a MATLAB® based tool for three-dimensional RBLA, which provides as outputs collapse failure modes and collapse load multipliers. In addition, a specific routine was developed for the purpose of the study to compute the participating mass ratio and the spectral acceleration that activated the failure mechanisms. The results of the numerical analysis were used to address three different retrofitting interventions, based on the use of connection elements and ti

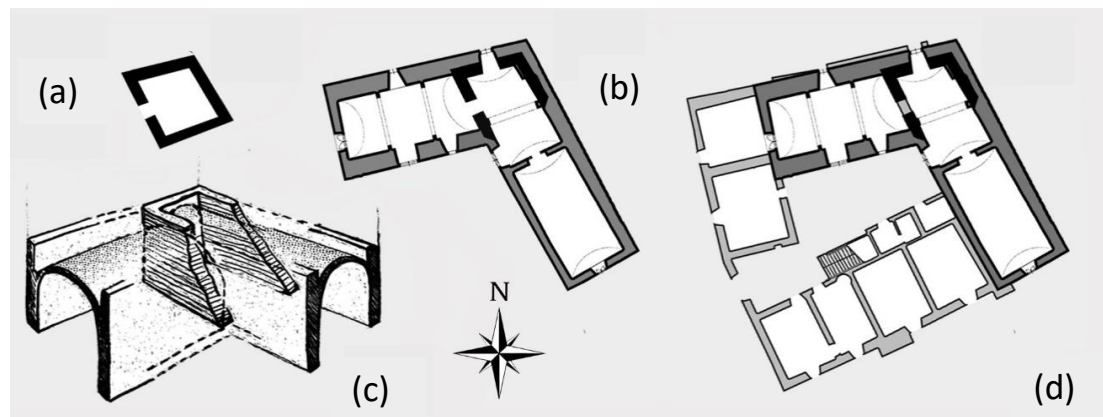
Figure 2. The historical development of the castle: (a) the original watchtower, 11th century; (b) the enlargement made in the 14th century; (c) a sketch of the construction around the tower ruins; (d) castle plan in the late 16th century.

This building can be classified as a “fortified palace”, a specific class of ancient buildings characterized by massive structures and equipped with fortification elements, of which the actual configuration is the result of subsequent transformations that have occurred over time [38]. Indeed, the Bussi Castle was transformed and extended over the centuries, via drastic formal amendments, substantial changes, and enlargements not only to repair the extensive damage suffered over the centuries due to recurrent severe earthquakes, but also to adapt the original construction to residential use [38]. The palace originated in the 11th century as a watchtower (Figure 2a) erected for defensive purposes.

occurred on 24 April 1593, and the subsequent restoration works, carried out under the government of the Medici family, were essentially devoted to repairing the damages and adapting the original fortress to a residence for nobility. Two additional wings were built and the castle assumed its final configuration, characterized by a square plan with an internal courtyard (Figure 2d). A stairway was built in the court to access the lodge on the first floor, which connected the different portions of the castle and, in particular, was an entrance to the main hall.

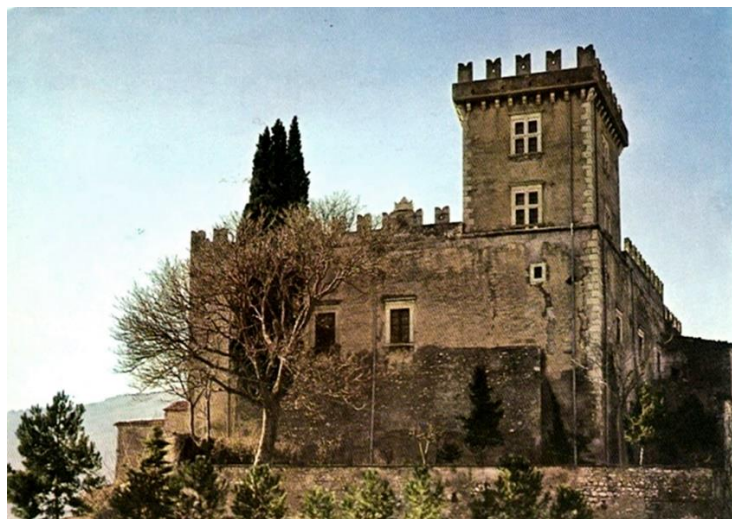
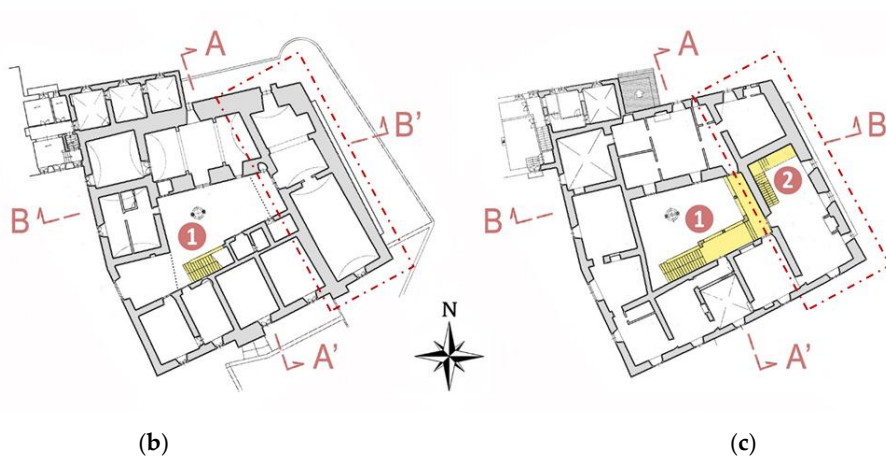
Figure 4. The actual configuration of the castle: (a) the north-east façade in the second half of the twentieth century (photo courtesy of the Municipal Historical Archive of Bussi); (b) the plan of the ground floor; (c) the plan of the ground floor; (d) elevations.

Several partition walls were built within the castle to increase the number of residential environments, altering the original distribution. Figure 4 displays the actual configuration of the castle.

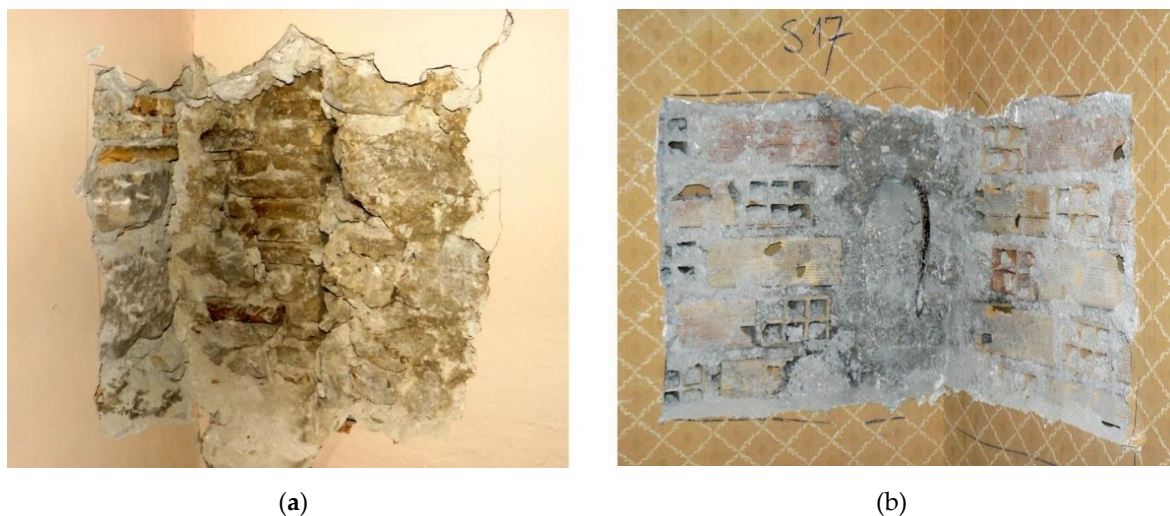
Visual inspections were carried out on bare masonry walls, removing a small amount of plaster in selected zones (Figure 5a). In particular, the goal was to properly identify the stone and mortar typology and condition, the masonry texture, and the bonding condition between orthogonal walls. Additionally, endoscopic tests revealed the masonry composition throughout the thickness.

Broadly speaking, the masonry is mixed, disordered, and of poor quality, made of soft stones, travertine, and bricks.

At both the ground level and the first story, two-leaf masonry walls are present. Both the leaves are characterized by a thickness of 500 mm and are not transversally connected with one another. These walls are made of rubble limestone kept together by air lime mortar joints with a thickness of about 10 mm.

Figure 5. The walls of (a) the main body of the castle and (b) the tower.

The tower presents 500 mm thick two-leaf walls that are made of perforated bricks organized according to the Flemish bond type (holes laying in the horizontal direction with perforation percentages ranging between 45% and 65%), kept together by 15 mm thick cement mortar joints. The tower vertical walls are effectively connected to each other, as was evidenced by the removal of plaster portions (Figure 5b).

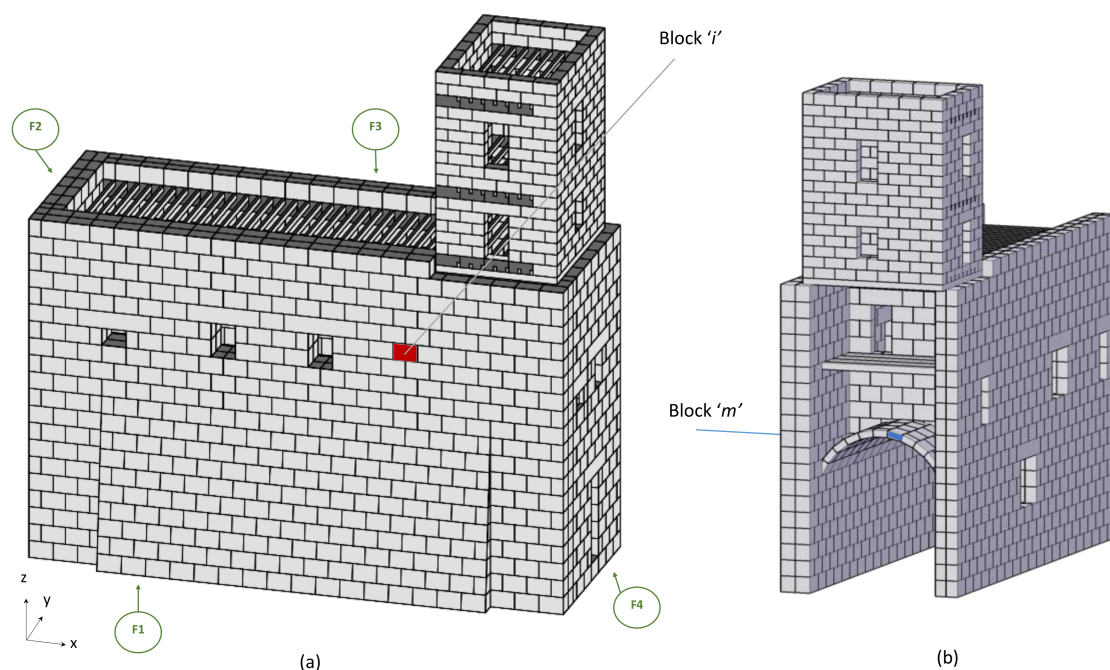
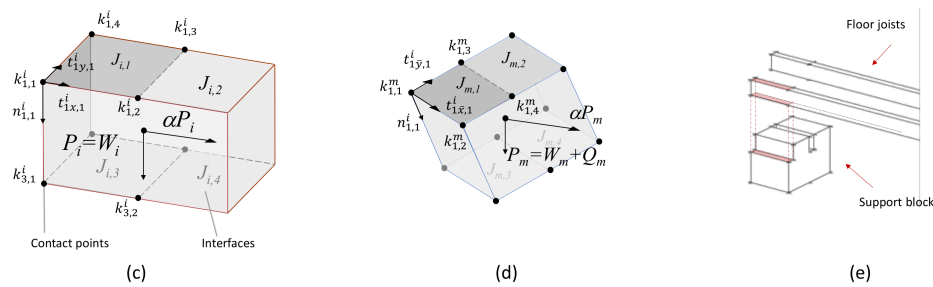
The numerical model of the selected structural unit of the castle included four external façades, the tower, the barrel vault of the ground floor, the internal walls, and the floors (timber and reinforced concrete slab at the first and second floors, respectively). Floors were modeled through joists connecting masonry blocks. Figure 6 displays some exterior and interior views of the numerical model.

Figure 6. The numerical model of the castle: (a) exterior north-east view with labeled façades; (b) interior south-east view; (c) a sample of the adopted rigid block model and loading condition. The block type “i” presents six interfaces $J_{i,1-6}$ of four contact points $k_{j,1-4}^i$ each. Normal forces $n_{j,1-4}^i$ and two shear forces ($t_{jx,1-4}^i, t_{jy,1-4}^i$) act at each contact point along the local block axis. The self-weight W_m and the live loads αW_m are applied at the centroid of the block. (d) A voussoir block type; (e) details of the rigid block shapes for the rigid blocks supporting the floor joists.

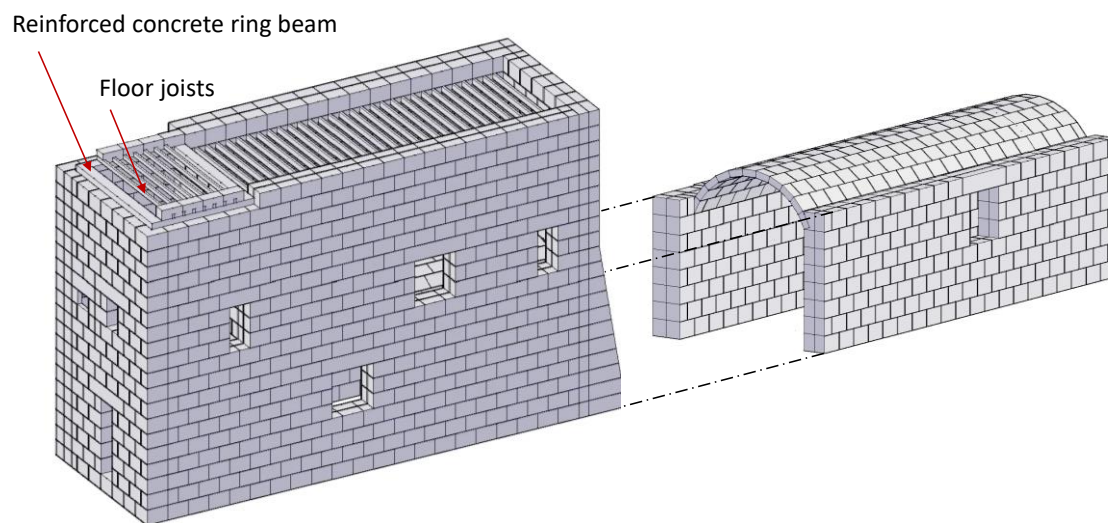
Figure 7 reports some details of the numerical model.

Figure 7. Details of the rigid block model.

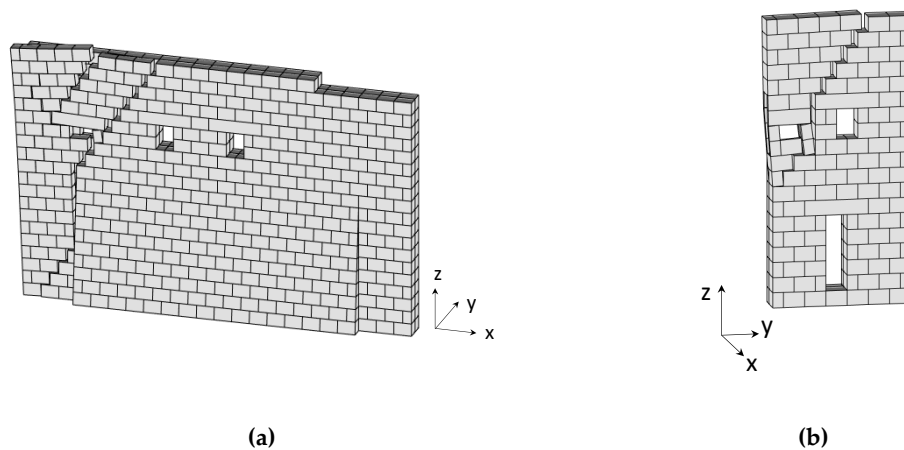
As expected, the most vulnerable mechanisms were the ones activated for out-of-plane loading actions. A global overturning mechanism was generally observed, due to the lack of transversal connections between the leaves. For in-plane loads, the mechanisms were triggered due of the presence of openings or following the variation of the wall thickness due to the presence of the buttress (see Figure 8). It is worth noting that a major benefit provided by LiABlock_3D is to immediately return the first local mechanisms that are activated by live loads acting in the wall plane. Conversely, analytical methods would require several hypotheses to be formulated concerning the slope of the failure plane, thus requiring a huge number of calculations that are not necessary when the LiABlock_3D software is used.

Figure 8. The in-plane collapse mechanism provided by LiABlock_3D: (a) the F1 for live loads along the negative x-axis; (b) the F4 façade for live loads along the negative y-axis.

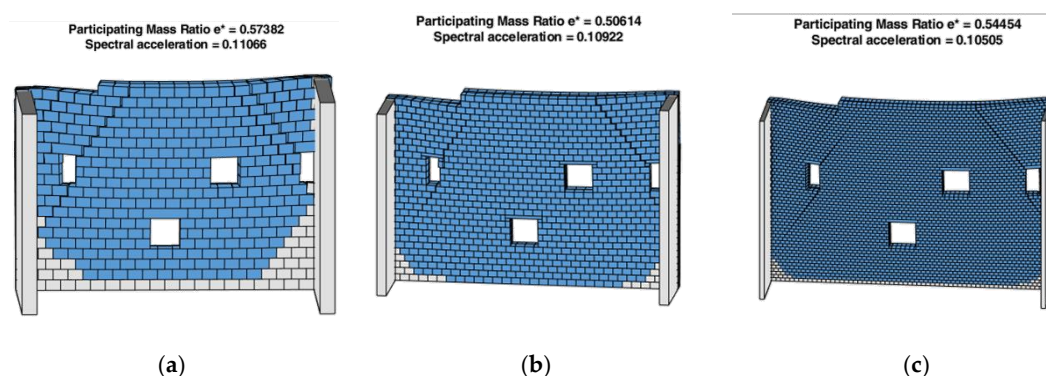
The participating mass ratio module, which was developed for the first time for the study presented in this paper, provided the participating mass ratio e^* and the spectral acceleration a_0^* activating the mechanism. Table 2 reports the results for the out-of-plane collapse mechanisms.

Figure 11. The out-of-plane collapse mechanisms of the F3 façade with participating mass in blue for the meshes (a) M1, (b) M2, and (c) M3.

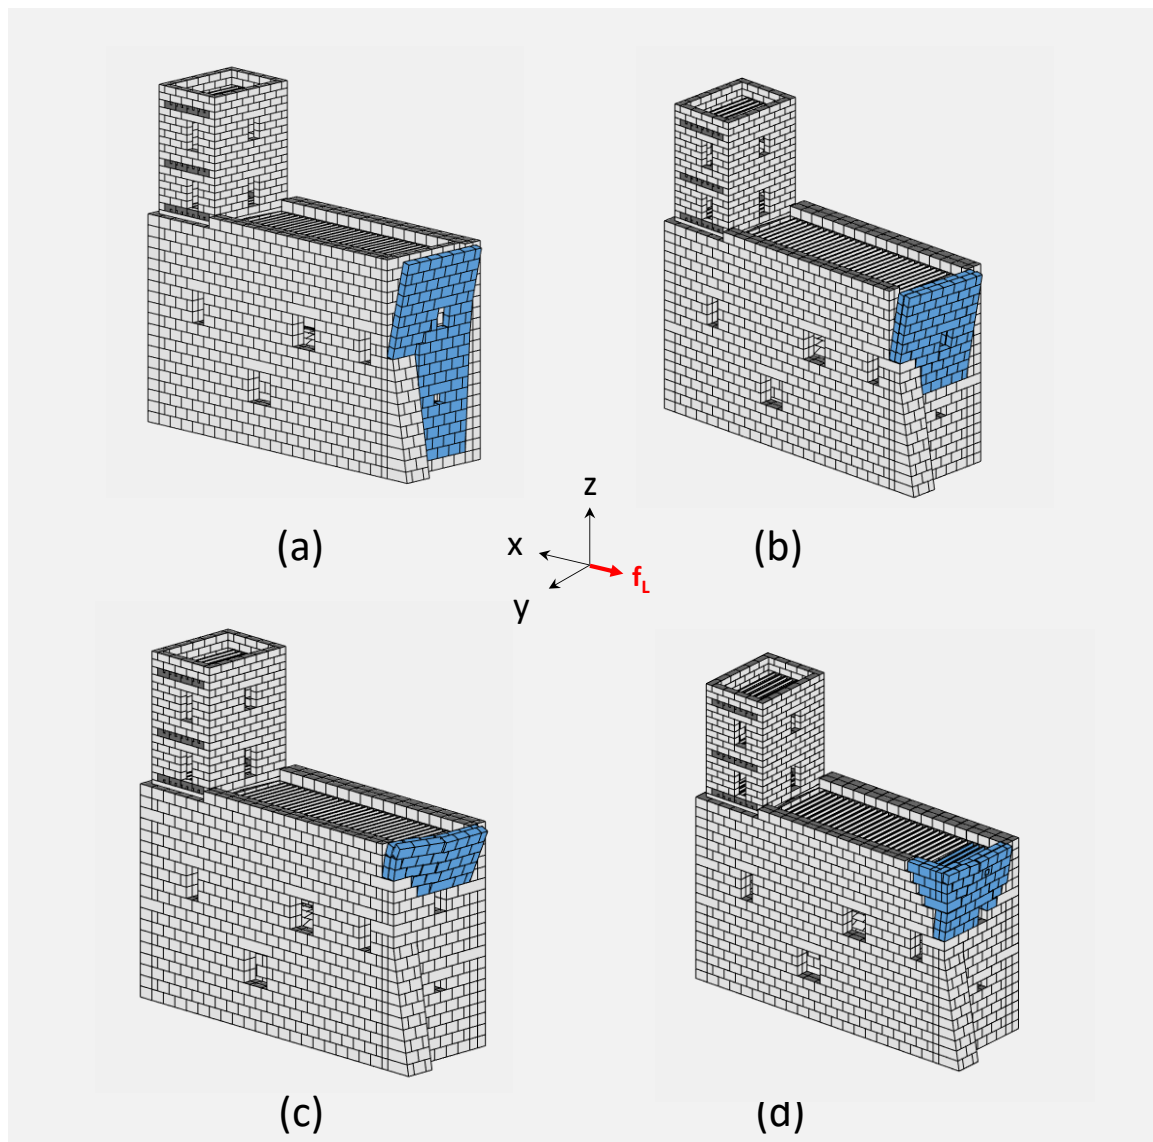
Generally speaking, it was possible to observe that the responses of the castle wing in its present condition (Figures 12, 13, 14 and 15a) essentially involved out-of-plane failures of the façades due to overturning or delamination for very low seismic demands (see Table 4 for the obtained results). This was mainly due to the lack of connections between the transversal walls. With reference to the façade F2 and the load case LC1 (Figure 13a), the collapse mechanism detected by the software was a complex inward overturning of the superior part of the walls. In this case, the mechanism developed at the second floor only, because, at the first floor, the presence of the whole vault provided a lateral stiffness to the model that prevented any displacement of the walls above the height of the vault. In contrast, at the second floor, the timber floor was modeled by means of joists only. No slab was introduced in the model. As such, the joists transferred the floor loads to their supporting rigid blocks but they did not provide any lateral stiffness to the second story, so the façade F2 was free to move in the inward direction. It is worth noting that the same façade, F2, presented a completely different behavior for the load case LC2 due to the presence of the buttress. Following the results of the analysis in the present condition, the first non-invasive intervention (R1, visible in Figures 12, 13, 14 and 15b) was considered by inserting corner quoins between all the façade walls at the first floor (red quoin blocks in Figure 12b). In this case, the overturning of the upper part of the walls was observed for

Figure 13. Collapse mechanisms and participating masses (in blue) provided by LiABlock_3D for the load case LC1 (live loads f_L along the positive x-axis): (a) the castle wing in its present condition; (b) retrofitting intervention n.1 (R1); (c) retrofitting intervention n.2 (R2); (d) retrofitting intervention n.3 (R3). Quoins in red; washer-bearing plates in green.

As for the second retrofitting intervention (R2), additional quoins (red blocks in Figure 13c) were inserted at the level of the second floor (Figures 12, 13, 14 and 15c). In such a case, similar but more limited collapse mechanisms were observed in the load cases LC1 and LC3 (along the x-axis and positive y-direction). Conversely, the analysis for LC2 and LC4 (negative x-, y-axes) revealed a quite different behavior of the construction, which tended to experience global collapse mechanisms.

Figures 12d and 13d report the collapse mechanisms for the load cases LC1 and LC2 (along the x-axis) where a single tie force was applied to the washer-bearing plates located on the F2 and F4 façades. Figure 14d and d highlights the failure modes for the load cases LC3 and LC4 (live loads along the y-axis), considering the effects of two ties applied to the four plates located on the F1 and F3 façades. In such case, global mechanisms were obtained with a damage distribution along the whole structure.

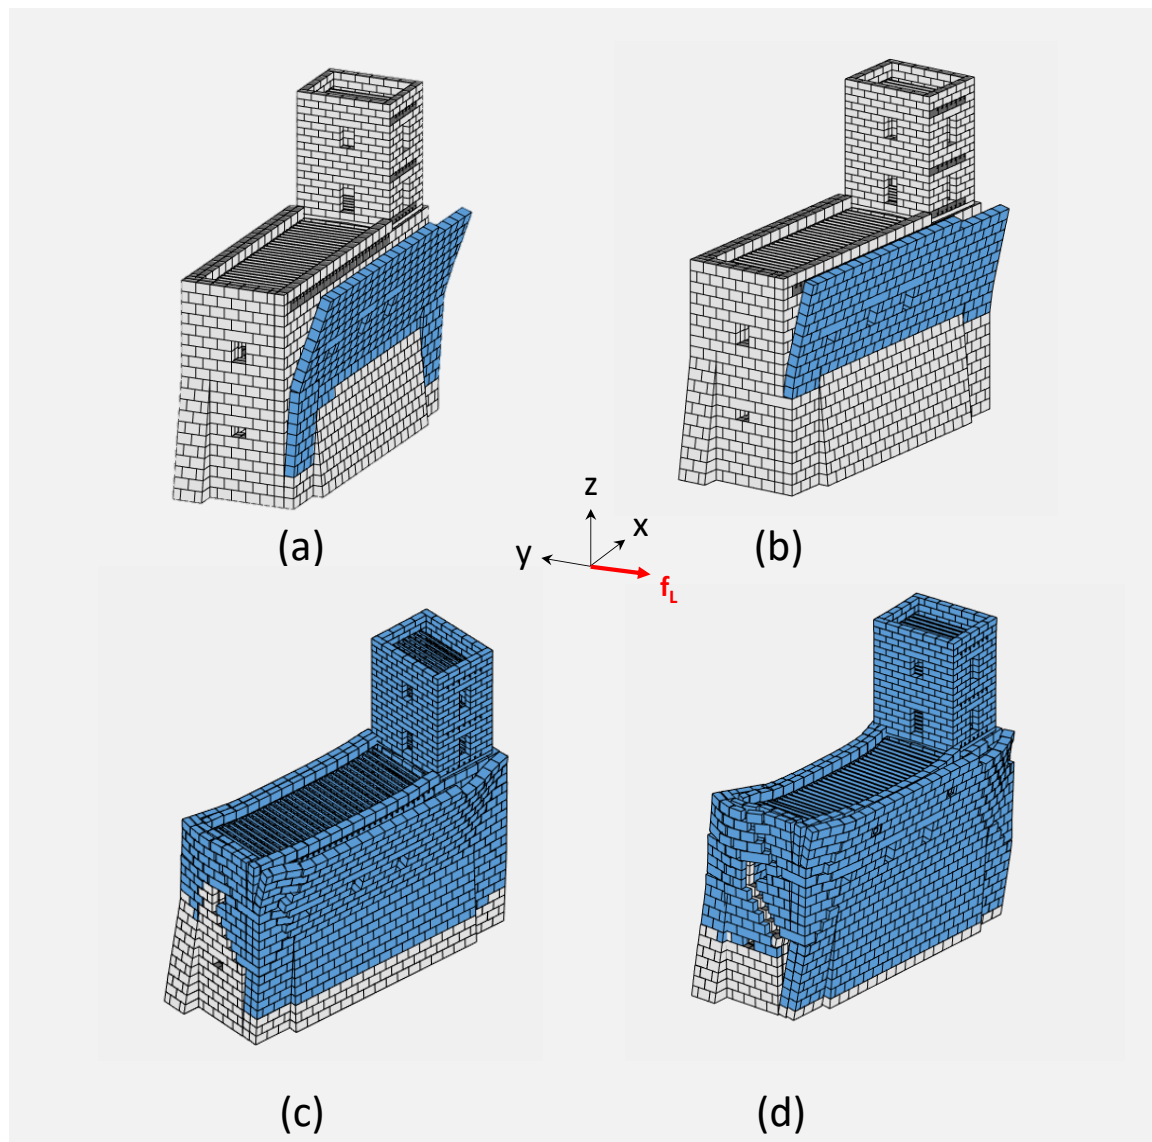
Figure 15. Collapse mechanisms and participating masses (in blue) provided by LiABlock_3D for the load case LC1 (live loads f_L along the positive x-axis): (a) the castle wing in its present condition; (b) retrofitting intervention n.1 (R1); (c) retrofitting intervention n.2 (R2); (d) retrofitting intervention n.3 (R3). Quoins in red; washer-bearing plates in green.

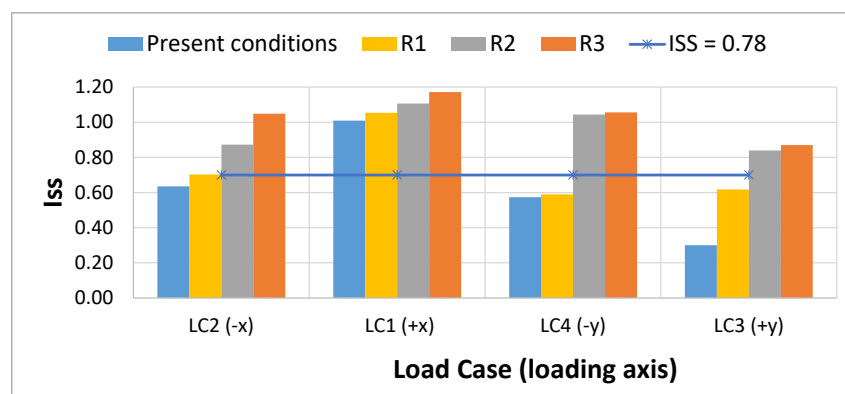
Finally, a comparison in terms of seismic safety index is carried out. In particular, assuming a value of T_1 equal to 0.38 s (according to the simplified formulation $T_1 = 0.05 \cdot Z^{3/4}$), the spectral acceleration for the elastic design at the castle location corresponding to the main period of the castle was equal to 0.55 g. Figure 16 reports the seismic safety indexes for the whole set of analyses carried out.

As it is possible to observe, all the applied retrofitting interventions allowed incremental increases of the structural capacity of the castle unit under investigation and, although the seismic safety indexes were less than 1 for the majority of cases, the retrofit R3 allowed the minimum value of 0.78 to be achieved, which is considered acceptable in cases of historic construction [32].

Figure 16. Seismic safety index for the present conditions and for the three retrofit interventions.
