# Model Test of Micro-Pile Group Reinforcing High Steep Landslide

**Abstract:** High steep landslides are a major concern for infrastructure construction in the mountainous areas of Western China. The micro-pile technique has been gradually used to prevent landslides, due to convenient construction and good performance. However, the application of the micro-pile technique on landslide prevention was generally implemented on the front edge of landslides, which is not applicable for the high steep landslides due to the limited operation space. In this study, a large-scale model test on the performance of a micro steep pile group on the prevention of high steep landslides was conducted in order to implement the micro-pile on the top of landslides. The force-deformation characteristics and failure modes of the steel pipe micro-pile group reinforcing high steep landslides were investigated. The test results showed that the landslide thrusts acting on the micro-pile group showed a triangle distribution. The maximum soil earth pressure was observed near the slip surface during landslides. The resistance of the micro pole group was distributed in an inverted triangle, mainly in the upper

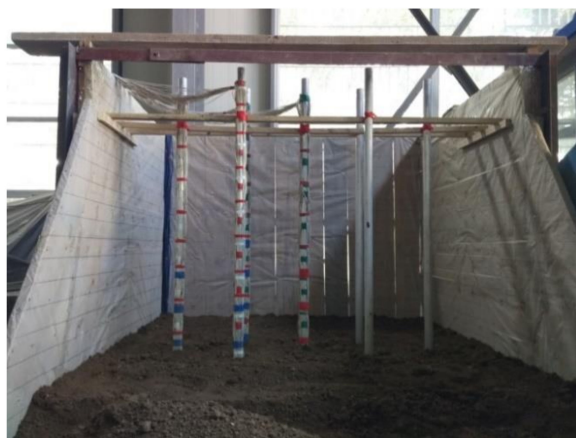
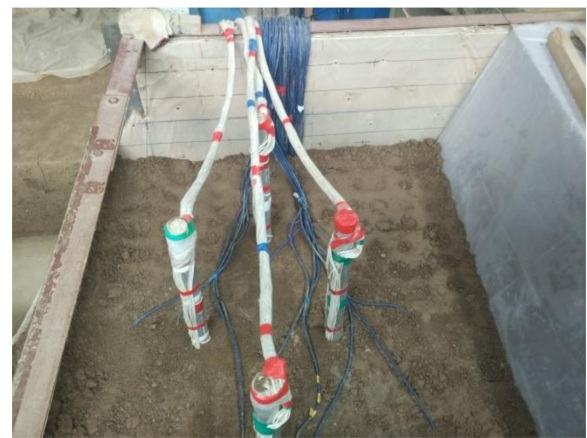
**Figure 2.** Filling of soil: (a) layered filling of sliding bed; (b) layered filling of sliding body.

The landslide was filled by layers of loess. After layered filling, the sliding bed and sliding body were compressed to a target density. The main physical and mechanical parameters of the test model soil are shown in Table 1. The soil filling is shown in Figure 2.

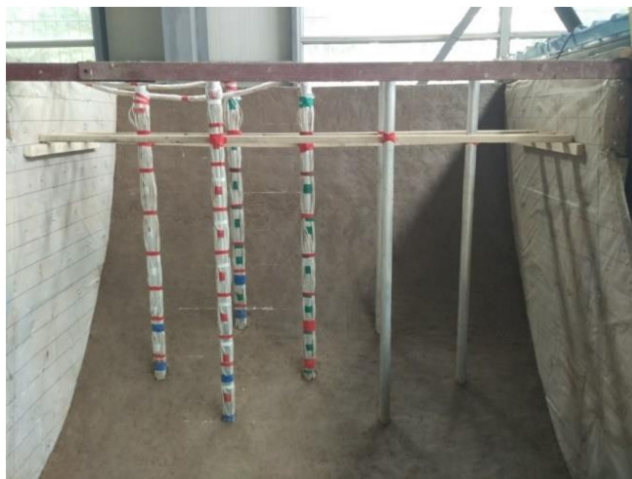
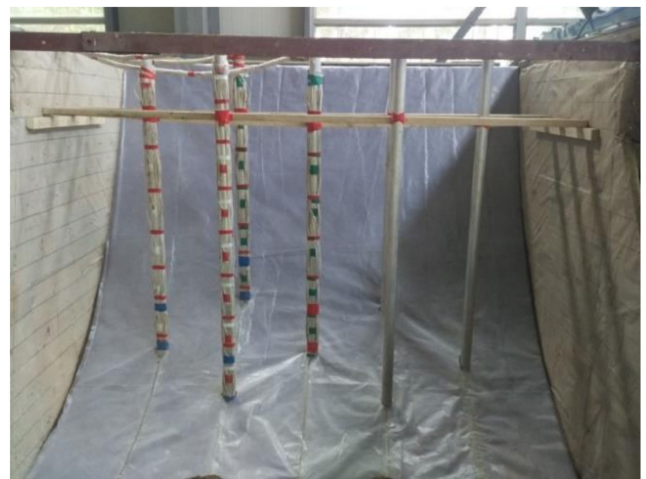
**Figure 3.** Schematic diagram of sliding surface: (a) the sliding surface; (b) double-layer plastic films were put on the sliding surface.

After filling the sliding bed soil, the sliding surface was made according to the shape of the designed sliding surface, and double-layer plastic films were placed on the sliding surface to simulate the sliding zone. The sliding surface is shown in Figure 3.

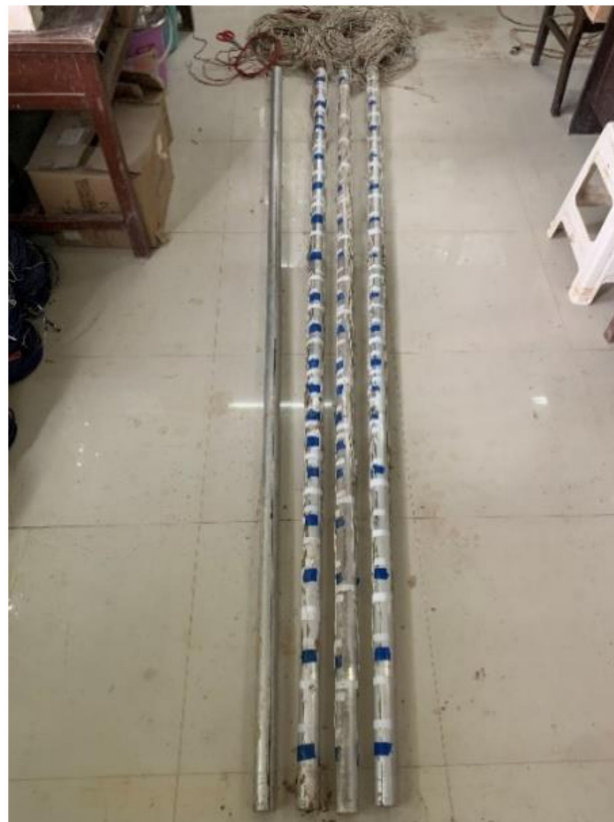
**Figure 4.** Micro steel piles used for the test.

In order to facilitate the burial of test instruments, the model piles used in this test were aluminum tube gypsum precast piles. A 3 m-long aluminum tube (diameter 5 cm, wall thickness 2 mm) was selected, and the tube was filled with gypsum, as shown in Figure 4. It should be mentioned that the filling material was chosen as gypsum in order to increase the bending resistance in the model test and to simulate the role of concrete in the real project.
