Article

Analysis of Fault Conditions in the Production of Prestressed Concrete Sleepers

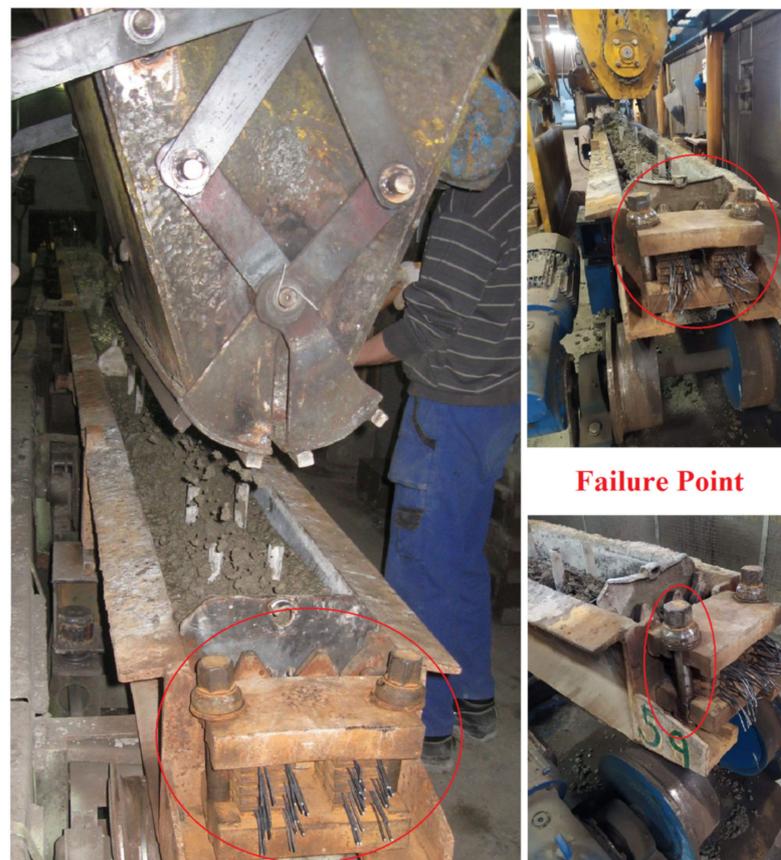
At the cutting and stacking workstation, the molds are overturned and the sleepers are pushed onto a conveyor, where they are separated. Subsequently, the surface and appearance of the product will be inspected. The surface of the sleeper must be well filled out. Isolated cavities with a closed surface up to 100 mm² and a depth up to 5 mm are permitted. Fragments on edges and surfaces are not permitted in places where they could interfere with the fastening function. The load-bearing surface of the sleeper (the surface that is in contact with the fastening) must be undamaged. The reinforcement must not protrude more than 8 mm from the sleeper front. The absence of longitudinal wire from the reinforcement or twisting of the wires is not allowed. The sleeper mold and failure point are shown in the Figure 1.

Figure 1. The sleeper mold and the failure point.

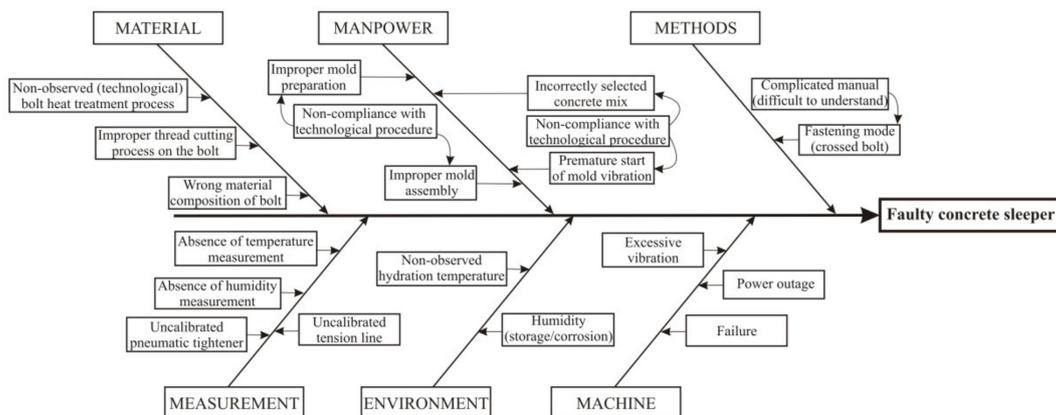
As can be seen in Figure 2, the ribs have been modified according to actual problems of the process of sleeper production (Measurement, Materials, Methods, Environment, Manpower, Machine). The whole diagram was not used to construct the Pareto diagram; rather, only the most numerous, and especially measurable, causes were taken into account.

Figure 2. Ishikawa diagram.

Regarding the “Measurement” rib, three possible causes of non-conformity in the final product were identified, namely the absence of temperature and humidity gauges, an uncalibrated pneumatic bolt tightener and an uncalibrated steel reinforcement tension line. Inaccurate torque settings of the tightening bolts can reduce their service life or cause

them to crack. The same applies to the tension line, where the prescribed arrangement of the steel wires may not be ensured at a low tension, while the wires may crack at high tension. The root cause for this rib is the absence of a measurement management system in the organization.

Three possible causes have been identified in the “Materials” rib: incorrect bolt material composition, non-compliant bolt heat treatment process or improper bolt cutting process. These causes are virtually unaffected by the organization. They concern only the supplier. The organization does not carry out an entry checks of bolts, rather it has been relying on the supplier’s certificate.

One possible cause was identified in the “Methods” rib: the method of fixing the steel reinforcement (improperly fitted wires, flanges, jaws, cross bolt). The manual is confusing, voluminous, and difficult to understand.

The “Manpower” rib is extremely important because the factors involved influence other ribs as well. The operator that forms its core is involved in what is happening in the other ribs and thus in the causes they contain. Three causes were identified in this rib: non-compliance with technological process (incorrect mold preparation, imperfect mold cleaning, imperfectly applied separation emulsion), incorrect mold furnishing (incorrect steel reinforcement preparation, improperly selected steel reinforcement preload, non-observed prescribed moment in bolt tightening process), the premature start of mold vibration could be a problem due to the segregation of concrete mix components and loosening or snapping of wires, improperly selected concrete mixture. Cracking and subsequent ejection of parts of bolts causes security threats where the operator may be injured or disturbed. An anxious operator is more prone to making a mistake.

Two causes have been identified in the “Machine” rib, namely excessive vibration and power outage or failure.

The “Environment” rib has two possible causes: non-compliance with the hydration temperature, non-compliance with the humidity in the warehouse (bolts, fronts, reinforcement elements) are exposed to corrosion.

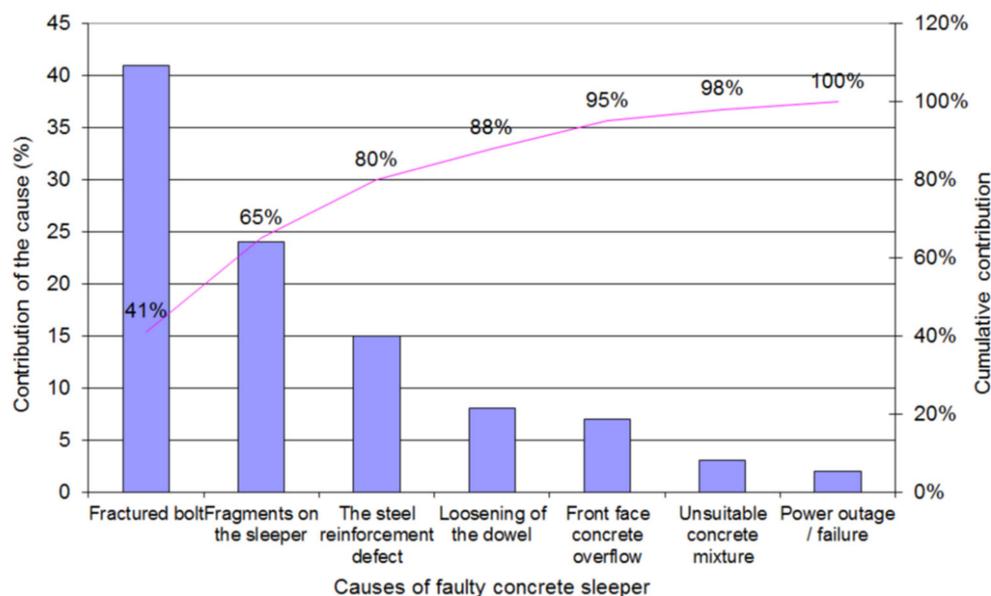
Figure 3. Pareto diagram—contribution of causes of faulty concrete sleepers.

It is clear from the diagram that the most significant source of the cause of the faulty concrete sleeper is the breakage (cracking) of the bolts that hold the prestressed steel reinforcement. As the visual inspection of the construction parameters (dimensions, surface, thread geometry. . .) of the bolt corresponds to the requirement, the research was further focused on material analysis, i.e., whether the material, mechanical properties and structure meet the customer’s requirements and the relevant technical standard.

Based on the Ishikawa diagram and statistical analysis of nonconforming products listed in Table 1, a Pareto diagram, Figure 3, was constructed.

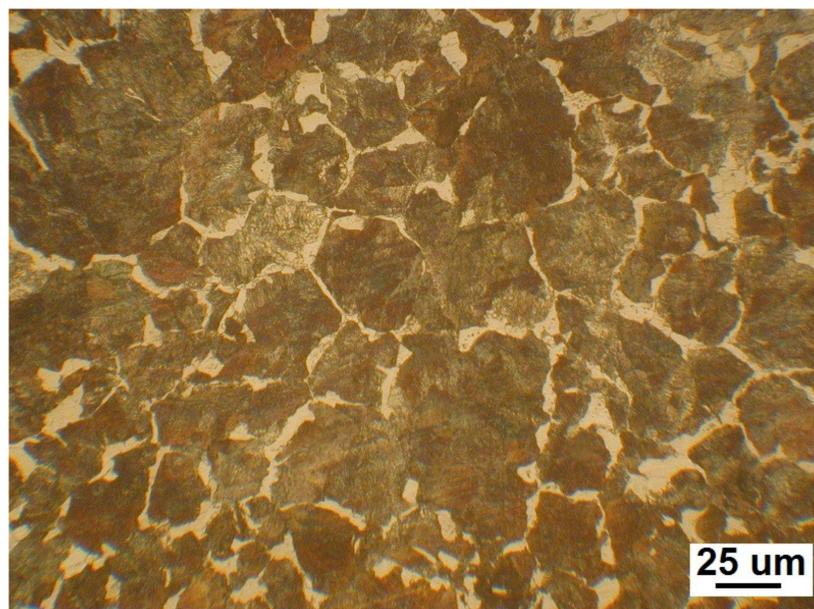
Structural analysis showed that sample no. 1 is formed by lamellar perlite grains with a diameter of 50 to 130 μm , lined with ferrite, Figure 4 (nital, 250 \times). The proportion of ferrite is 13.7%, the thickness of ferritic envelopes is 2–26 μm . Sample No. 2 has a similar microstructure, but with a lower proportion of ferrite (7.15%), Figure 5 (nital, 250 \times). The differences in microhardness are due to the different density of pearlitic lamellae. The microstructure of both samples indicated that they were not heat treated, and if so, then the heat treatment was only “formal”—the austenitization annealing temperature was low or the annealing time was too short, in both cases insufficient for visible changes in the microstructure. The third option would be sufficient austenitization, after which there was no hardening, but only slow cooling. The result is the presence of ferrite and low hardness, which is the cause of insufficient strength properties of bolts and their premature fracture.

Figure 4. Sample No. 1, microstructure (nital).

After considering the administrative and financial issues, the customer decided to continue to use heat-treated steel bolts STN 12 061 (corresponds to EN ISO C60E). The supplier carried out an audit to ensure compliance with the parameters of bolts production according to regulations with emphasis on the heat treatment process. As a corrective measure, the measurement of the hardness of the supplied bolts was introduced. This is a simple operation that allows the operative elimination of bolts with hardness lower than declared, the hardness of each supplied bolt is measured.

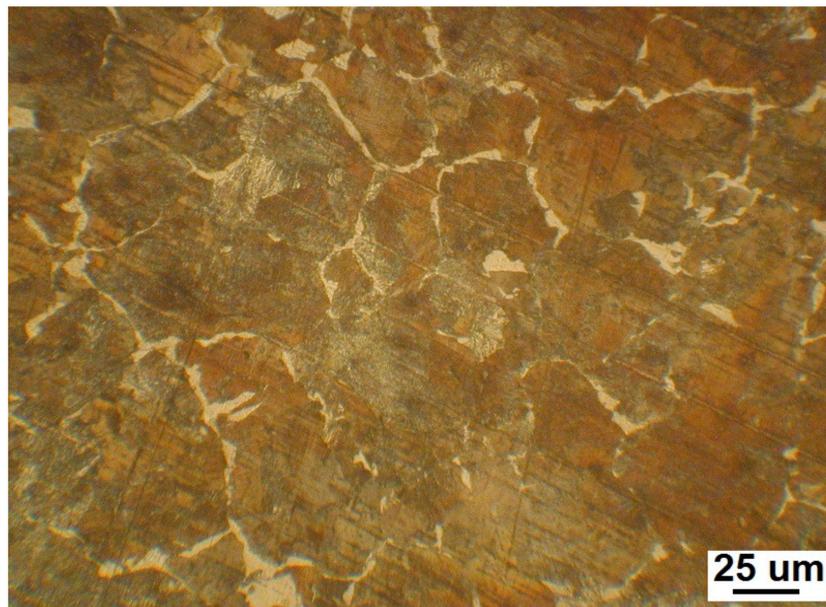
Figure 5. Sample No. 2, microstructure (nital).

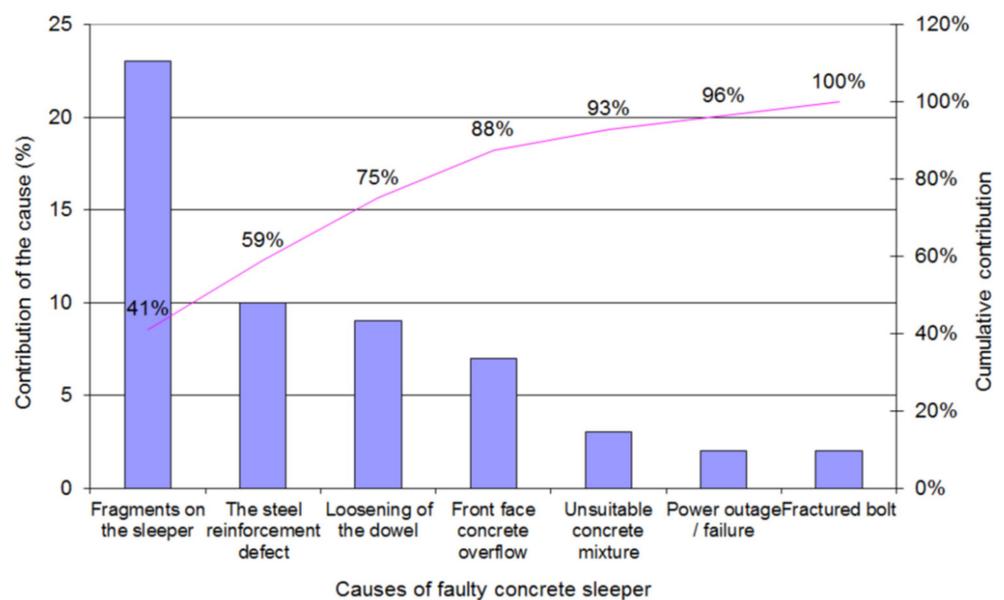
Figure 6. Pareto diagram after corrective action.

It is clear from the diagram that the corrective action practically eliminated the most frequent cause of the nonconforming sleeper and reduced the frequency of occurrence of the related cause of reinforcement error by 5%.

In the month of June 2021, after the adoption of corrective measures, 13,899 sleepers were produced, of which 139 pieces were defective or an error occurred in the production process, which prevented its finalization. The results were used to construct the Pareto diagram, Figure 6.
