Article

Monitoring Geologic Hazards and Vegetation Recovery in the Wenchuan Earthquake Region Using Aerial Photography

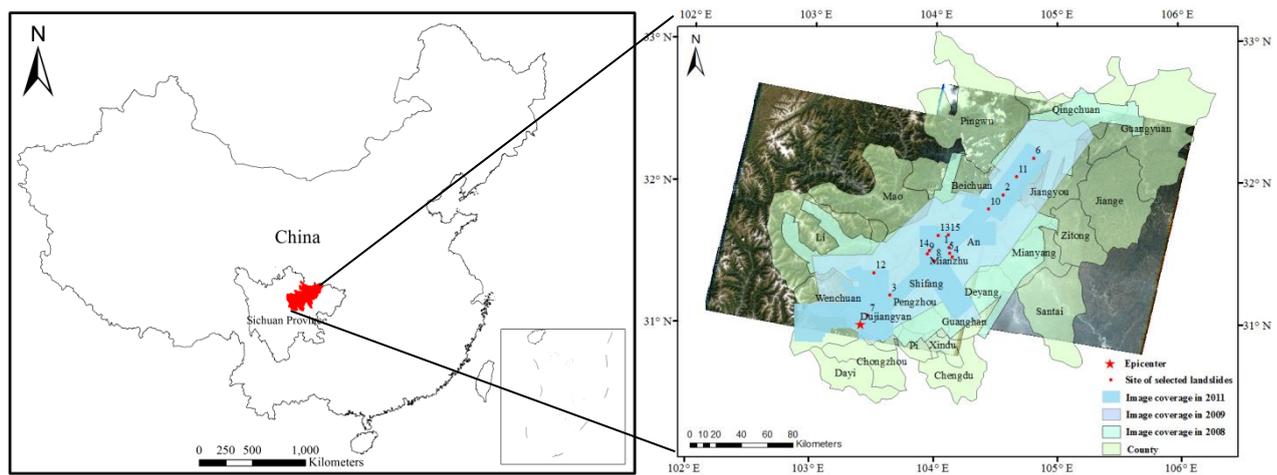
Figure 1. Airborne imagery across the earthquake region (background: Landsat TM image in 2007).

Sciences (CAS). A large number of remote sensing images of various types were acquired between 15 and 28 May 2008, for disaster assessment and rapid monitoring and evaluation of the severely damaged areas. The spatial resolution of these images ranged from 0.5 to 0.8 m depending on the flight altitude. During the subsequent years, airborne optical remote sensing images covering most of the heavily affected areas were again acquired in 2009, 2010, and 2011 to monitor the process of environmental restoration and reconstruction [38]. In our study, we used airborne optical images from 2008 to 2011 acquired from the Center for Earth Observation and Digital Earth (CEODE), CAS, to analyze the hazards development and ecological recovery in the earthquake-affected areas. Table 1 shows the flight task details.

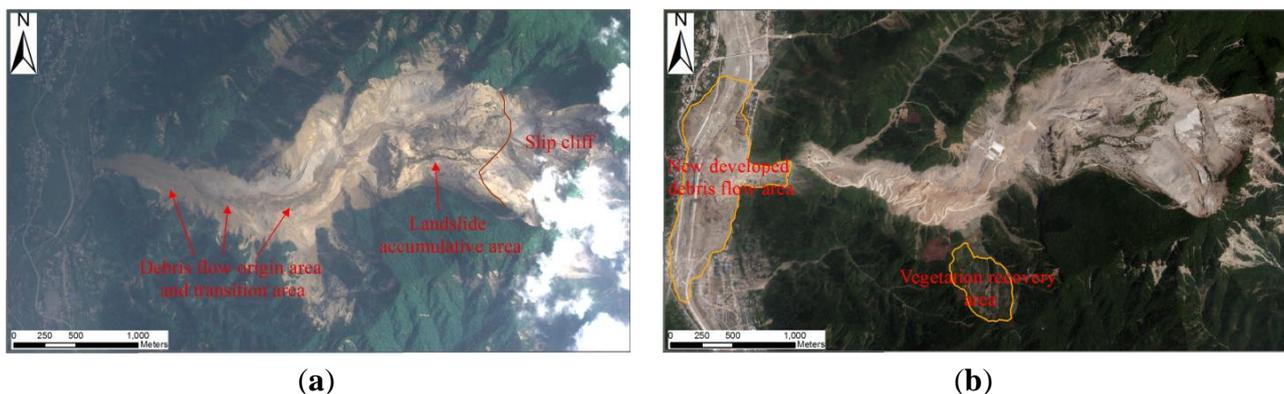
Figure 2. Airborne remote sensing images of Wenjiagou, Qingping Town, Mianzhu City (site No. 1) taken on 23 May 2008 (a) and 7 July 2011 (b).

A landslide is a downslope movement of rock or soil occurring on the surface of a rupture in which much of the material often moves as a coherent or semi-coherent mass with little internal deformation [39,40]. Landslides triggered by the earthquake often showed the following characteristics on remote sensing images: vegetation was disturbed, the deposits could be clearly identified at the foot of the slope along roads or rivers, and the interrupted region showed a bright white or dark brown contrast compared with the surrounding slopes. Debris flow is a common type of fast-moving mass movement in which loose soil, rock, and sometimes organic matter combine with water to form a slurry that flows downslope [41]. Debris flows usually start on steep hillsides as liquefied shallow landslides, and continue flowing down and through channels, accumulating water, sand, mud, trees, and other material. When the flows reach canyon mouths or flatter ground, the debris spreads over a broad area [42]. On remote sensing images, debris flows are usually characterized as an obvious flow channel and forms a large alluvial fan at the foot of the slope (Figure 2b).

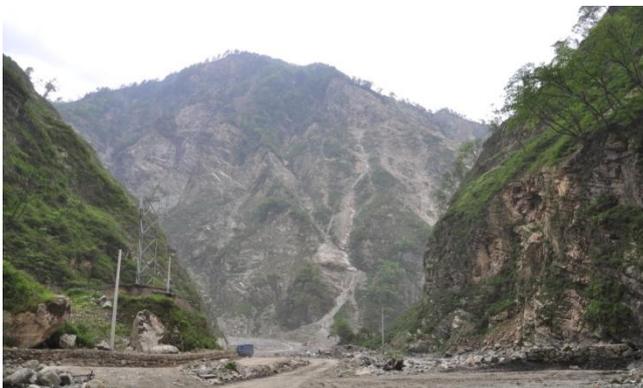
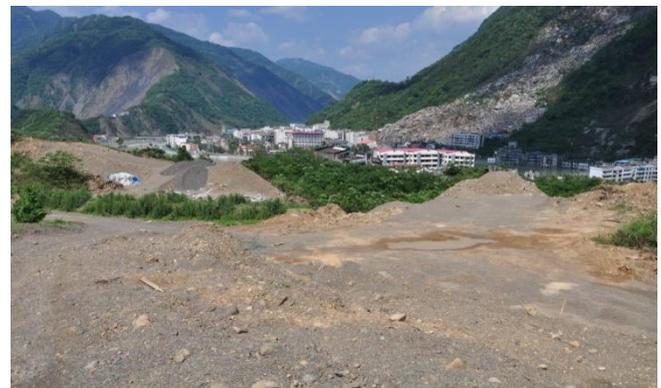
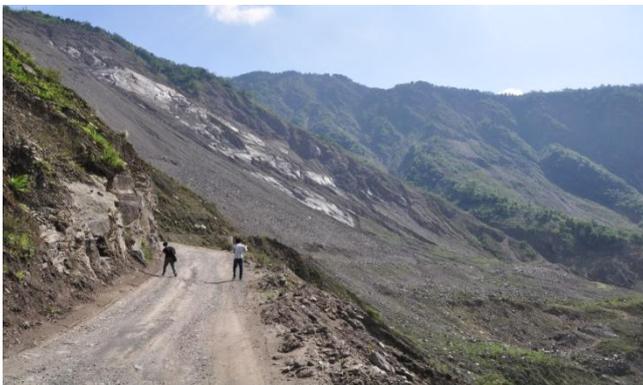
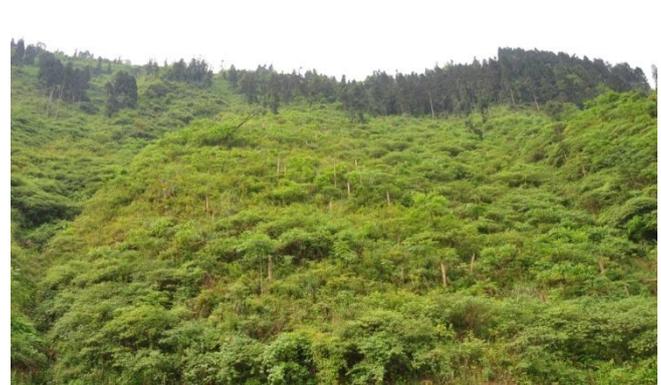
Figure 3. Photos taken at geologic hazard sites during the field investigation in May 2012. (a) Vegetation recovery in Yingxiu Town, Wenchuan County (site No. 7); (b) Old Beichuan Town, Beichuan County (site No. 10); (c) The huge failure in Tangjiashan, Beichuan County (site No. 10); (d) Vegetation recovery on the failure slope in Qingping Town, Mianzhu City (site No. 1).

To verify the interpretation results and identify the reason for various hazard developments, *in-situ* surveys were conducted from 6 to 13 May 2012 in several large slope movements. The field investigation covered most of the selected hazard sites (except for No. 8, No. 9 and No. 14) that were relatively easy to access, no equipment was used during the survey, and basic conditions in each site were recorded manually. The elements recorded included the soil structure (mainly particle composition), human activity (whether good for hazard prevention and recovery), and vegetation recovery conditions (yes or no) and patterns (naturally or artificially). Because of the complex conditions in each site for the large area and combined hazard group, the survey results were not listed here and were used in the following section to explain the remote sensing based results. Several example *in-situ* photos are shown in Figure 3.

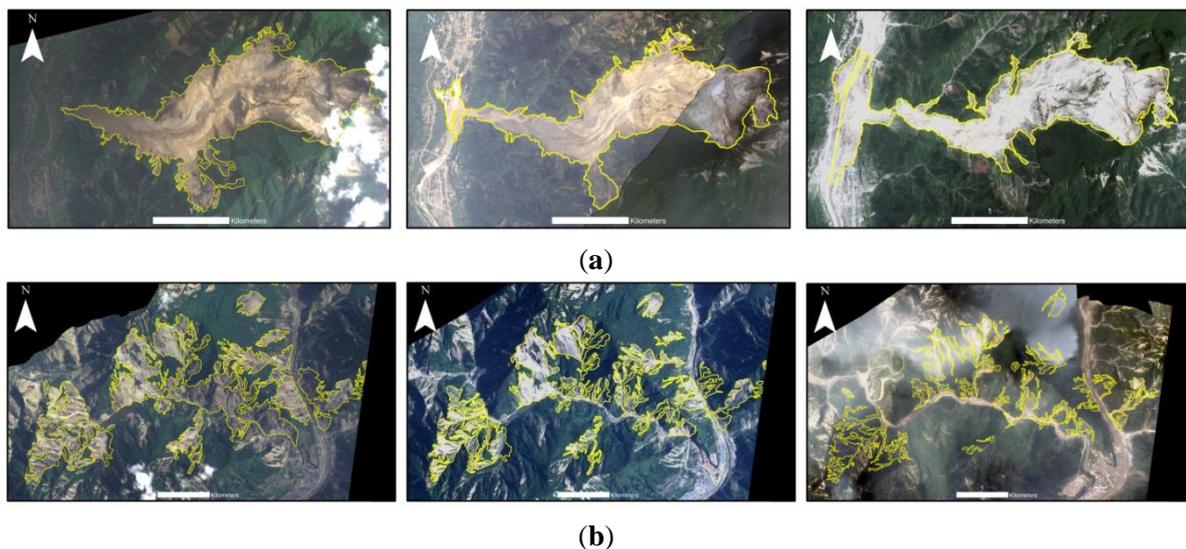
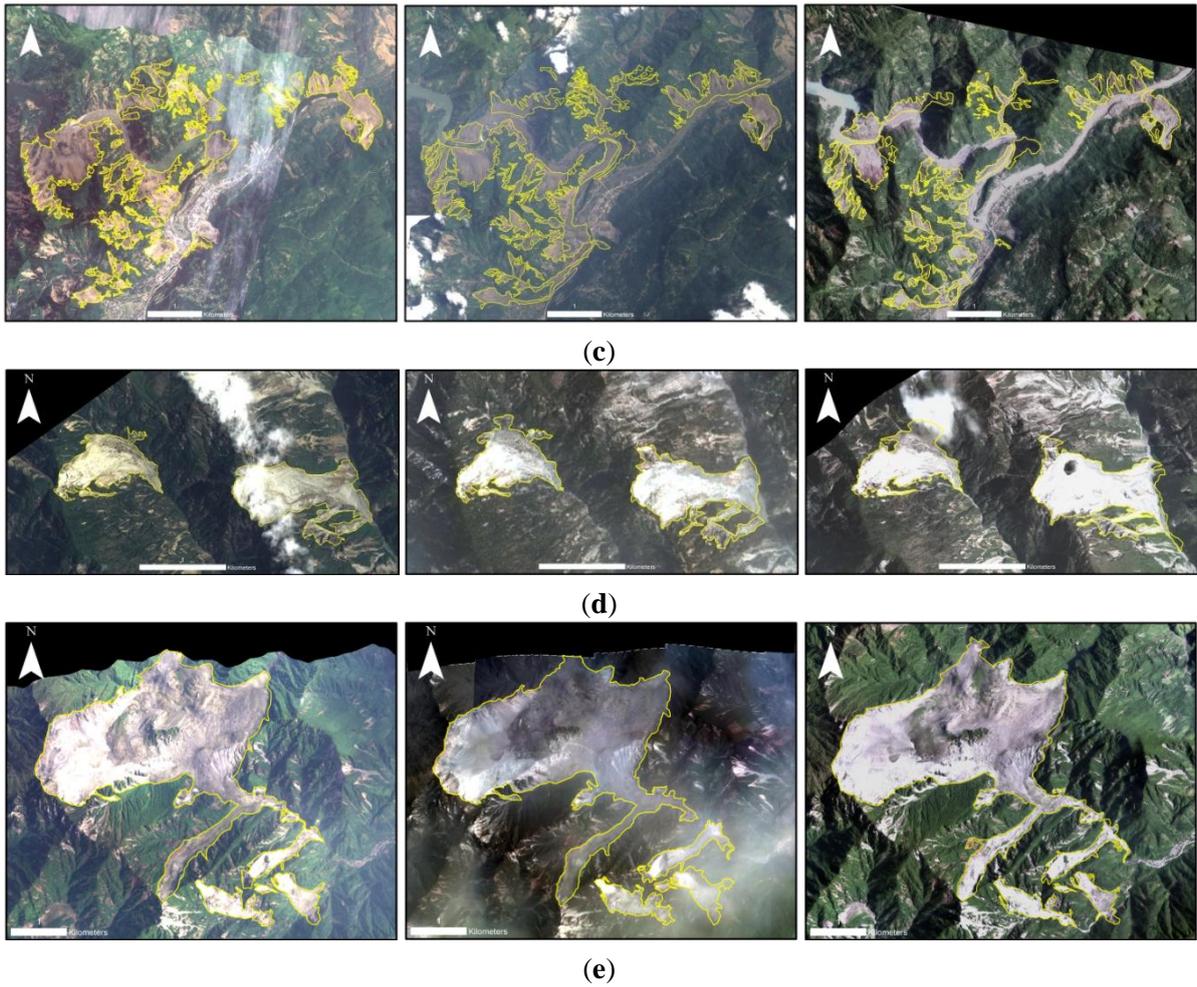
Figure 4. Airborne remote sensing images of several hazards in 2008, 2009, and 2011, respectively (from left to right). **(a)** The big landslide and debris flow of Wenjiagou, Qingping Town, Mianzhu City (site No. 1); **(b)** The big landslide group happened at Yingxiu Town, Wenchuan County (site No. 7); **(c)** The change of hazard happened at Tangjiashan, Beichuan County (site No. 10); **(d)** The change of hazard happened at Changheba, Mianzhu City (site No. 14); **(e)** The change of Daguangbao hazard group, An County (site No. 15).

geological hazards between 2008 and 2011 of several hazards are shown in Figure 4. From the monitoring results, the variations of geological hazards could be classified into four cases. The first case was for a continuous decrease in hazard area from 2008 to 2011 that included No. 2, No. 4, No. 5, No. 6, No. 7, No. 8, No. 12 and No. 13, accounting for 53.3% of all sites. The second case was for an increase in hazard area from 2008 to 2009, and a decreased hazard area in the next two years, such as the No. 3, No. 10, No. 11 and No. 15 sites. The third case was for a decreased area from 2008 to 2009 and an increase in hazard area in the next two years, such as the No. 1 and No. 9 sites. The last case was for a continuous increase in hazard area from 2008 to 2011, which pertained only to site No. 14. Nonetheless, from 2008 to 2011, the overall geologic hazard area decreased as vegetation growth rate exceed that of debris flow development, and the geologic hazards variation rate between 2008 and 2011 was approximately 12%, which was higher than the rate of the first year after the earthquake.

In this study, vegetation recovery refers to the vegetation growth based on the previous year's hazard region. Figure 4 in Section 4.1 also illustrates the vegetation recovery in the 15 selected sites (the decreasing area from 2008 to 2011). For most sites, the recovery conditions were very positive, and vegetation began to grow on the previously bare landslide mass. Utilizing Equation (1), the vegetation recovery areas were calculated. The results are shown in Table 5. In addition, the vegetation recovery region of several sites was illustrated in Figure 6 using overlay analysis in ArcGIS platform. The fastest vegetation recovery period occurred in the first year after the earthquake, which is in line

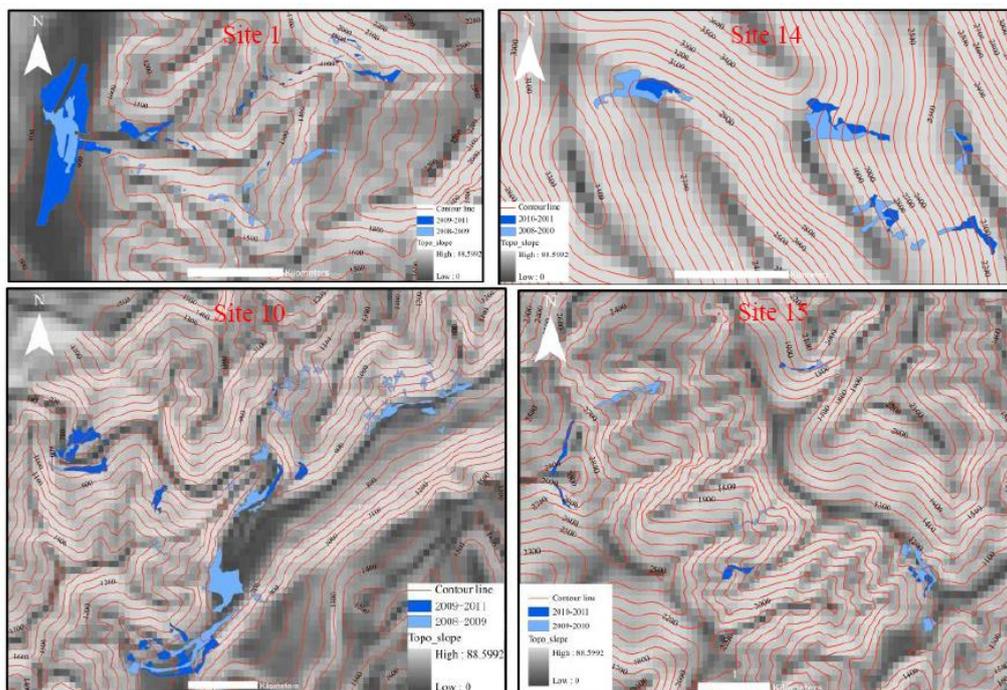
Figure 5. Changes in the debris flow regions of site 1, 10, 14, 15 from 2008 to 2009 and from 2009 to 2011.

After acquiring the geologic hazard areas from 2008, 2009, and 2011, the newly developed debris flow regions were obtained utilizing an overlay analysis between successive years. Table 4 presents the development of debris flows from 2008 to 2009 and from 2009 to 2011, and debris flow variation region of several typical sites were illustrated in Figure 5. During the first year after the earthquake, the activity of debris flows was particularly severe, causing the development of many new hazards areas. After two years, the activity gradually decreased but was still occurring. The developed areas and rates are shown in Table 4. From 2008 to 2009, the newly developed debris flow areas reached 402.05 ha, which was far larger than the average area that developed in the next two years, and the development rate was almost triple that between 2009 and 2011. In general, the average development rate in these three years for the entire region was 3%, which is in accordance with Chen's study [44].

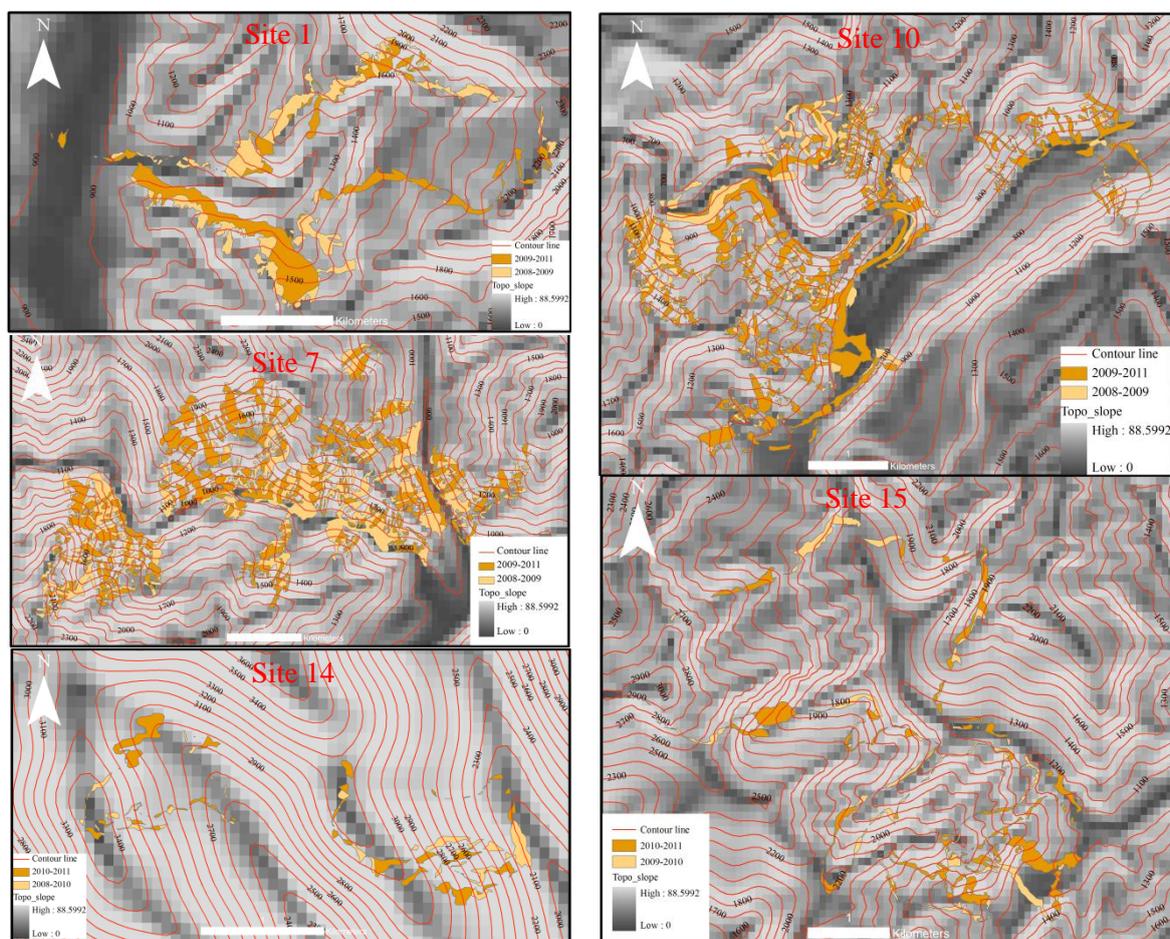
Figure 6. Vegetation recovery of site 1, 7, 10, 14, 15 from 2008 to 2009 and from 2009 to 2011.

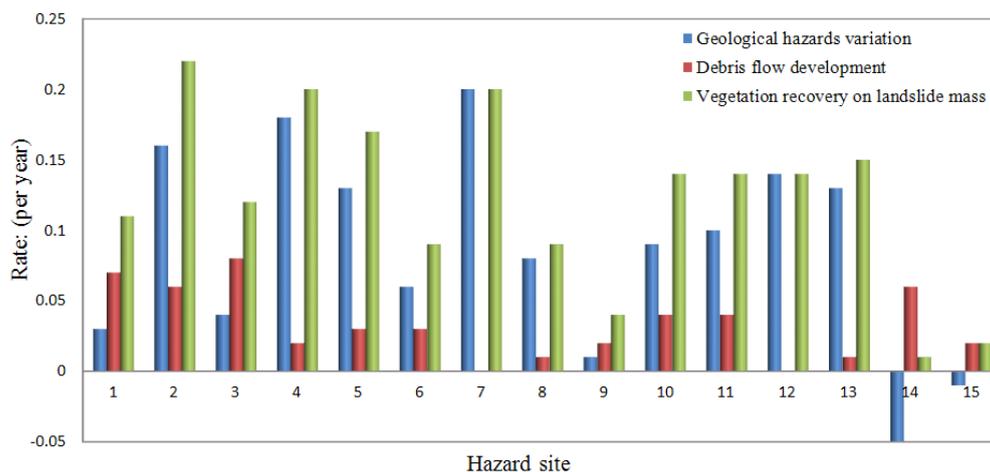
Figure 7. Comparison of hazard development rates from 2008 to 2011.

The vegetation recovery rate, the debris flow development rate and the geologic hazard variation rate are shown in Figure 7. The variations of the three rates from 2008 to 2011 were in close agreement, and the vegetation recovery rate was higher than that of each site’s geologic hazards variation rate. In geologic hazard areas, debris flow activity interrupts vegetation regrowth, so the faster debris flows develop, the slower the vegetation recovers, and the slower the geologic hazard varies. Figure 6 shows that, in most hazard sites, the vegetation recovery rate was higher than the debris flow development rate from 2008 to 2011, and the geologic hazard area values of the sites (except for No. 14 and 15) decreased.

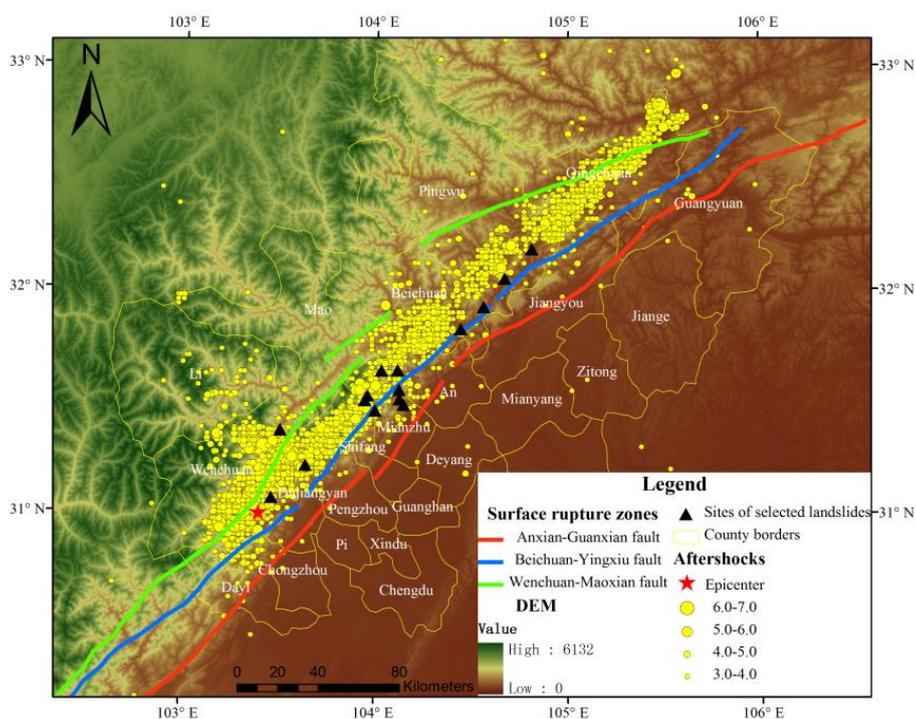
Figure 8. Map of aftershocks (up until 31 December 2008) and surface rupture zones of the Wenchuan earthquake region.

4.0 magnitude [46], and the occurrence of aftershocks was especially intense in the northeastern segment of the fault, which had some connection with the increased stress in this region [47]. Meanwhile, heavy rainfall occurred on 23 and 24 September 2008, reaching 250–350 mm and triggering new landslides and active old landslides, causing debris flow hazards to occur in groups [45]. Considering the four geologic hazard cases examined in Section 4.1 of this paper, the first case is relatively stable-aftershocks and heavy rainfall had little influence on the landslide mass, so the vegetation growth rate was faster than the hazard increase rate. For the second case, the geologic hazard variation is in accordance with the distribution of aftershocks and heavy rainfall. A study from Hua *et al.* [48] also showed that the aftershocks along the Longmenshan fault happened mainly within one year after the earthquake (Figure 8), and geodynamics and spatial pattern of vegetation damage was affected by rupture zones [49]. For the third and fourth cases, the geologic hazards are unstable, and the debris flow development of these two cases is consistent with human activity. For example, the anomalous variation of No. 9 and No. 14 sites was related to the Changheba Dam construction.

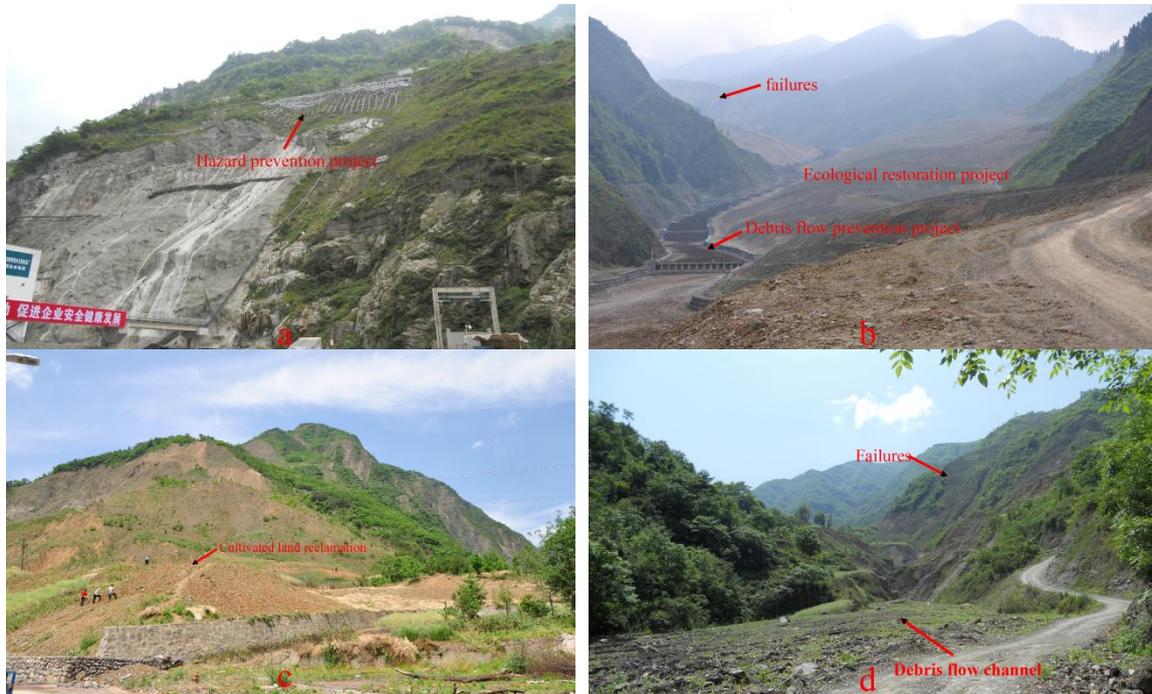
Figure 9. (a) Hazard prevention project in Yingxiu Town, Wenchuan County (site No. 7); (b) Human activity in Wenjiagou, Qingping Town (site No. 1); (c) Reclamation on the landslide mass in Chenjiaba, Mianzhu City (site No. 4); (d) Natural vegetation recovery in Chenjiaba, Mianzhu City (site No. 4).

Considering the whole hazard area, the recovery of hazards was comparatively slow in the first year after the earthquake, when the area suffered the most intense aftershocks and heavy rainfalls. The rate was 11.6%, less than the average speed of recovery. After 2009, slopes became more stable and the vegetation on the landslides recovered rapidly, with an annual recovery rate of 12%. Through field investigation, we found that some artificial measures and natural vegetation recovery (Figure 9d) were important for the development of debris flows, such as the hazard prevention projects, ecological restoration projects (Figure 9a,b) and cultivated land reclamation (Figure 9c) in the earthquake affected areas slowed down the progress of debris flow in some extend.

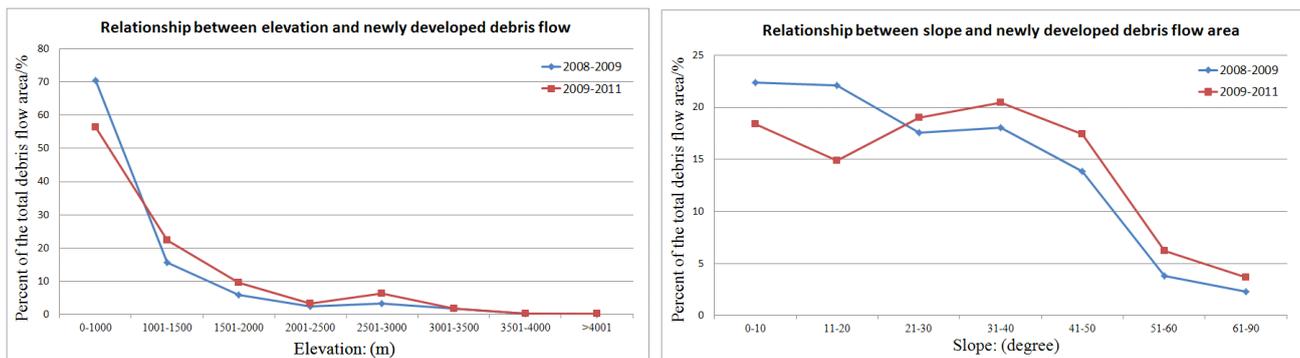
Figure 10. Relationship between newly developed debris flow area and topographic factors.

The debris flow development was also analyzed according to elevation and slope data (Figure 10). The newly developed debris flows mainly occurred in elevations below 2,000 m, accounting for 92.02% and 88.23% of the total debris flow area in 2008 to 2009 and 2009 to 2011, respectively. The debris flows also occurred on slopes of 0 to 50°, which account for 93.86% and 90.12% of the total debris flow area in 2008 to 2009 and 2009 to 2011, respectively. Large-scale landslides produced relatively large debris flows, such as the large-scale landslides in Wenjiagou, Qingping Town (site No. 1) and Yingxiu Town, Wenchuan County (site No. 7).

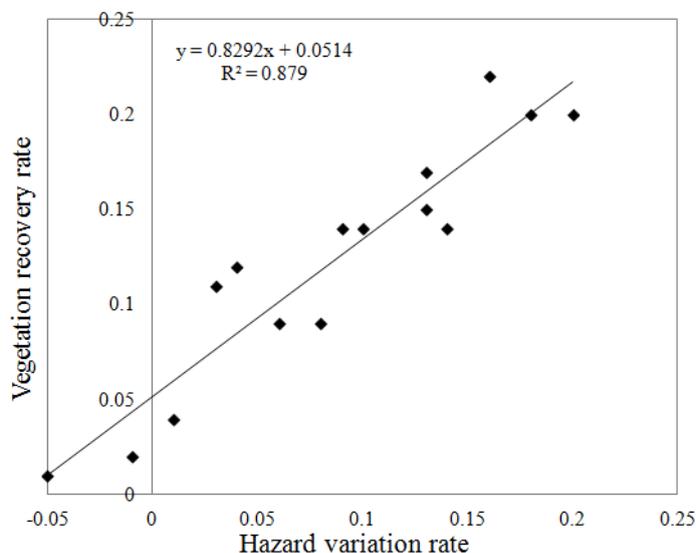
Figure 11. Relationship between vegetation recovery and geological hazards development from 2008 to 2011.

Our results demonstrate the possibility of vegetation recovery in earthquake-affected areas even under harsh conditions in some areas, and a positive correlation was found with geological hazard variation (Figure 11). In the one to two years after the earthquake, the loose soil produced by the earthquake combined with the sliding of the entire landslide mass in some hazard regions made it easier for the vegetation to recover. Community types of shrub and grass grew quickly in this period, resulting in the fastest vegetation recovery period. Subsequently, the vegetation recovery slowed due to woody plant re-establishment. The recovery patterns in the hazard areas were complex, with factors such as the terrain and soil also affecting the recovery's progress [3] and making vegetation recovery difficult (as with the No. 14 and No. 15 sites in Table 5).

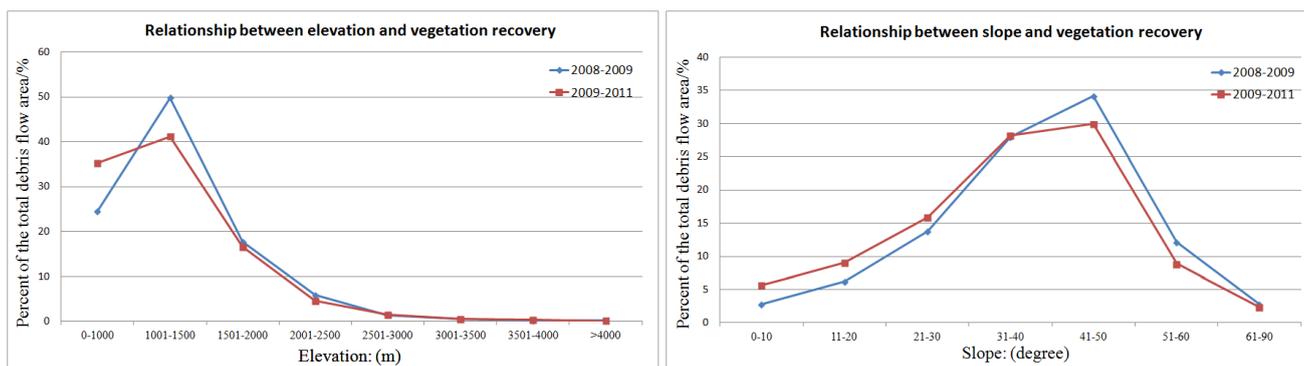
Figure 12. Relationship between vegetation recovery and topographic factors.

between the slope of 41–50°, Lin *et al.* [55] and Lu *et al.* [3] also observed similar results, they suggested that grass species that survived during this slope range facilitated the vegetation growth when adequate rainfall was supplied to the area. In addition, the good soil holding and storing water condition for the plants in the hazard sites is also critical to the vegetation recovery.
