Article

Evaluation of the Bond-to-Concrete Properties of GFRP Rebars in Marine Environments

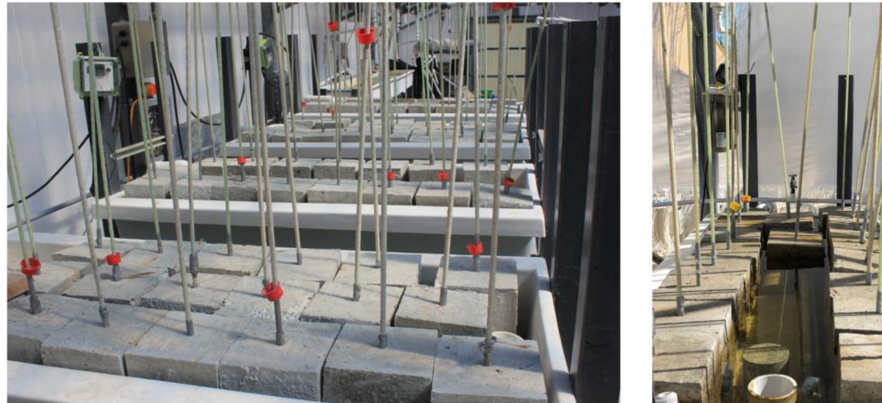
To accelerate the deterioration of the bond between the GFRP rebars and the concrete, the specimens were exposed to seawater at different temperatures. Of the 63 specimens, 54 were submerged in seawater tanks (see Figure 2), while the remaining nine were tested in their virgin state without conditioning, to obtain control values for the analysis of the potential deterioration (see Table 2).

Figure 2. Conditioning exposure of the specimens.

The specimens were exposed to three different environments: of the 54 specimens that were submerged in seawater, 18 were exposed to 23 °C, 18 to 40 °C and the last 18 to 60 °C. Each group of 18 rebars was formed by six rebars of each type (A, B and C). The reasons these temperatures were chosen included: (i) 23C for laboratory conditions; (ii) 60C because it is most commonly used in

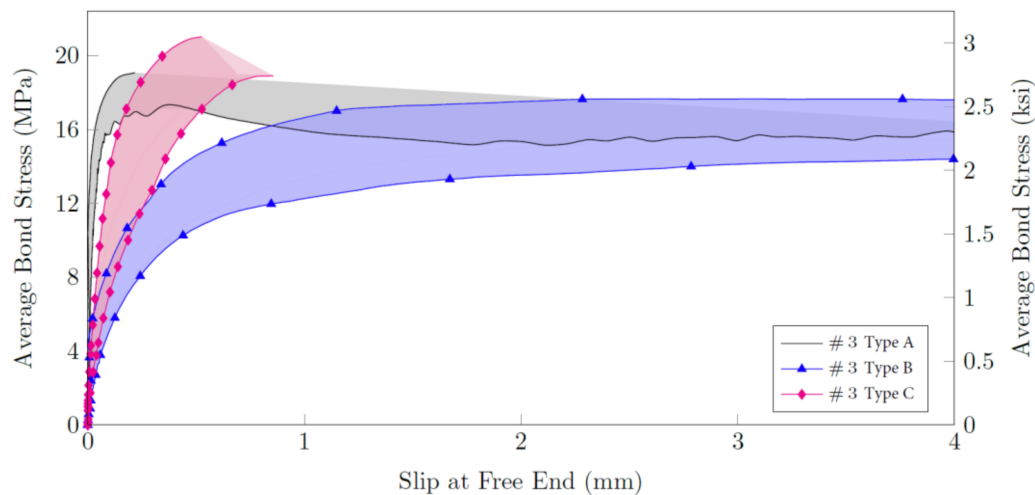
Prior to the analysis of the aged bond properties of the GFRP rebars, the bond behavior of unaged bond specimens was evaluated. Figure 4 shows the bond strength vs. free-end slippage of each of the tested unaged composite rebars. For each rebar type, the envelope including the bond-slip behavior of the three tested specimens is shown.

Figure 4. Bond-slip (free-end) behavior of unaged specimens.

It can be inferred that the bond-to-concrete behavior varied from rebar type to rebar type, as seen from the bond-slip graph in Figure 4; the initial slope, peak stress, slippage values and ‘post-failure’ behavior characteristics for each bar type. The ribbed rebars (type C) developed the highest maximum bond strength with a value of approximately 22.5 MPa; these were followed by the sand coated bars (type A) with about 18 MPa, while rebars with external cross fibers (type B) measured values ranging around 12.5 MPa. The peak bond strength for type A rebars was reached at a free-end slippage of about 0.25 mm, and after the peak, the bond strength decreased almost linearly. For rebars type B, the free-end slippage corresponding to the maximum bond strength, was about 20 times higher than the one for type A rebars (reaching approximately 5 mm). In this case, after the peak bond was reached, the bond strength decreased gradually. The ‘post failure’ behavior of type C rebars, however, was dissimilar to that of rebars type A and B: as soon as the maximum bond strength for the ribbed and sand coated rebars was attained (at about 0.7 mm), a sudden failure of the bond surface occurred.

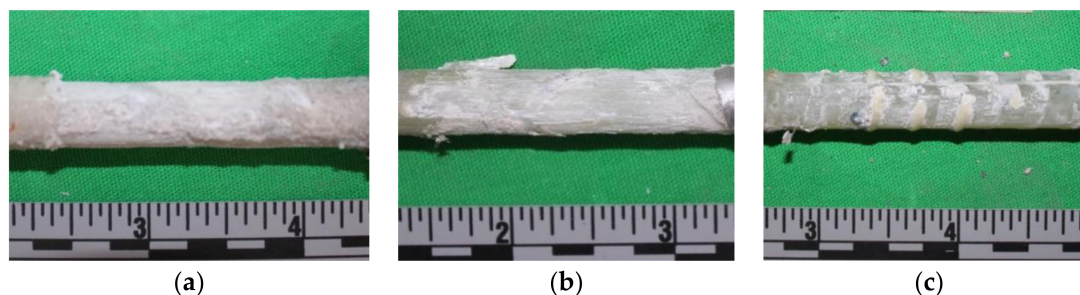
Every specimen tested showed a very similar failure mechanism: in all specimens (both control and conditioned), the failure occurred at the bond interface between the GFRP rebar and the concrete. No GFRP rebar failed in tension, nor was concrete splitting observed for any of the tested specimens, which differs from the observations made by others [11,20,21]. After the specimens were tested, the concrete blocks were split in half to evaluate the interface surface of the rebar (Figure 7).

Figure 7. Bond surface of the GFRP rebar after completion of the bond test: type A (a), type B (b) and type (c).

It can be seen that the damage to the rebars varied with the type of surface enhancement: for type A rebars, the sand coat was removed due to the friction between the rebar and the concrete. The type B rebars, however, showed damage in the most superficial fibers, though the helical grooves were not completely lost. Finally, the lugs in the type C rebars were partially or completely cut off during the pullout test, but the internal glass fibers of the rebar were not exposed to the surface.

The bond failure mode of GFRP specimens in concrete depended on the surface enhancement and was independent of the exposure temperature or duration. All specimens failed at the interface between the surface enhancement and the concrete, but each bar type was damaged differently: type A rebars lost the sand coat and then slipped, type B rebars suffered partial damage of the longitudinal external fibers before slip-out, and finally, the lugs of the type C rebars were cut off but the glass fibers remained intact.
