Article

Experimental Study on Cast-In-Situ Masonry Cavity Walls Subjected to In-Plane Cyclic Loading

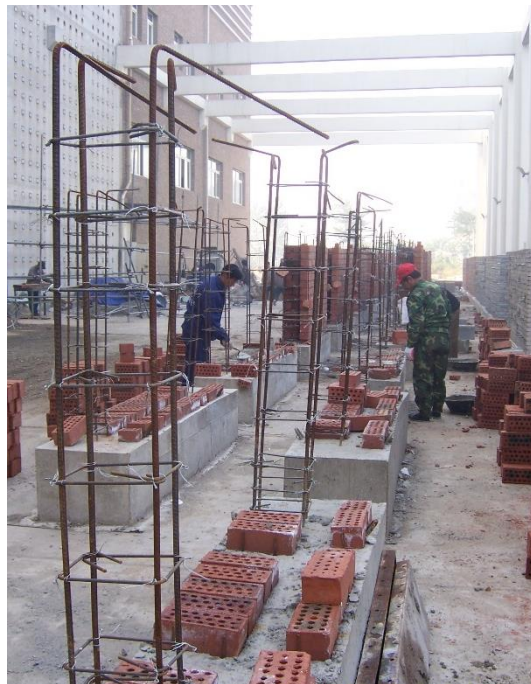
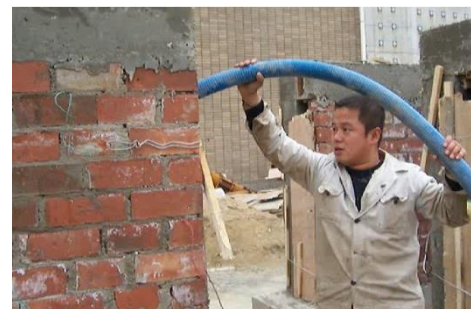
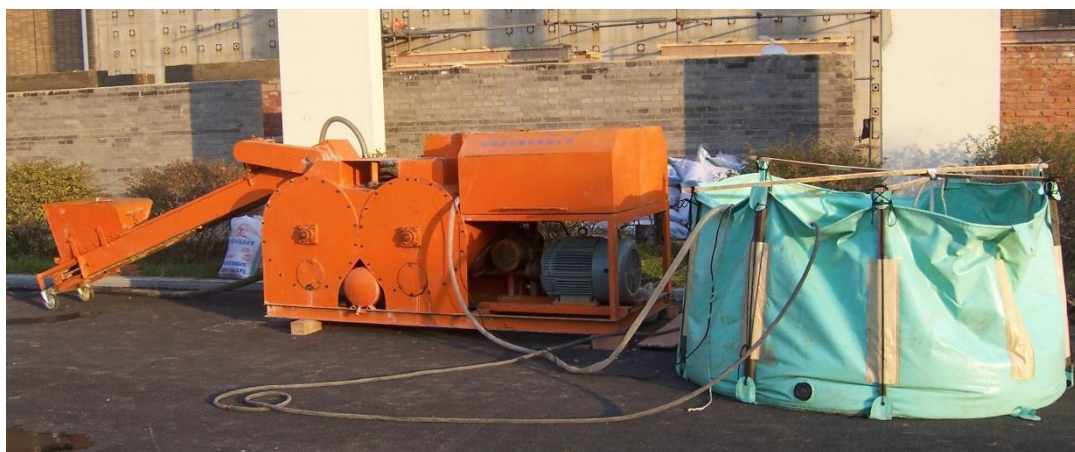
Figure 1. Illustration of masonry cavity wall construction process.

(a) construction

(b) Z-shape tie

(c) Rectangular tie

(d) casting

(e) cast-in-situ equipment

A total of thirteen cast-in-situ masonry cavity walls and one solid wall were tested. The wall construction process is illustrated in Figure 1 and a description of the test specimens is outlined in Table 1. The specimens are denoted $WDS_{h(or z)}S_v-T-P$, where D indicates the tie shape, H and Z stand for rectangular and Z-shaped ties, respectively [15]; S_h is the horizontal spacing of ties which was 600 or 800 mm; S_v is the vertical spacing of ties which was 300 or 400 mm; T is the thickness of insulating

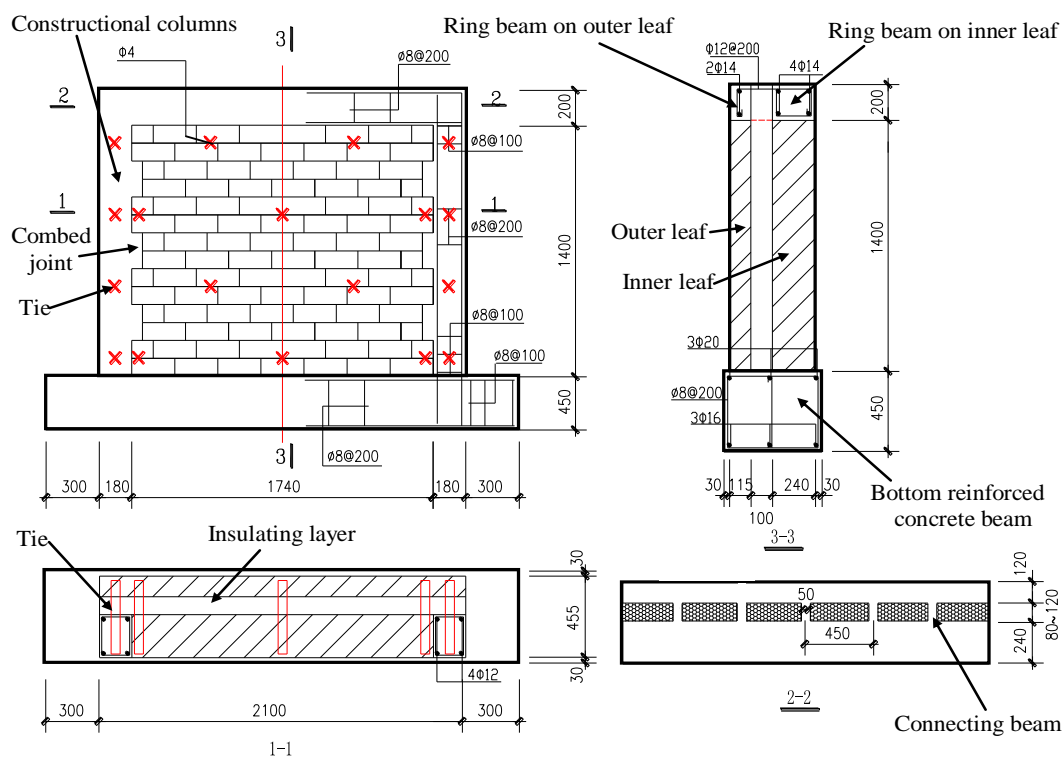
Figure 2. Construction drawing of cast-in-situ masonry cavity wall (WH84-100-1) (1. Test specimen; 2. Load sensor; 3. Vertical actuator; 4. Fixing beam; 5. Steel roller; 6. Reaction frame for vertical loading; 7. Ground anchor; 8. Load-distributing beam; 9. Reaction wall; 10. Horizontal actuator; 11. Displacement sensor; 12. Bottom RC beam).

layer; and P is the applied axial stress. Four levels of axial compression, expressed as σ_0 were used, as shown in Figure 2. All walls were 1400 mm high and 1740 mm wide, corresponding to a height to length ratio of 0.8. The thickness of the inner leaf was 240 mm, whereas the thickness of the outer leaf was 120 mm. The thickness of the insulating layer was varied from 80 to 120 mm with 20 mm intervals. The solid wall was 370 mm thick, having the same dimension as the cast-in-situ masonry cavity walls, but without a cavity.

The reinforced concrete-constructional columns were 240 and 180 mm in cross-section, while the beams were 240 by 200 mm in the inner leaves and 120 by 200 mm in the outer leaves, respectively. The coupling beams between the inner and outer leaves were at intervals of 450 mm and with dimensions

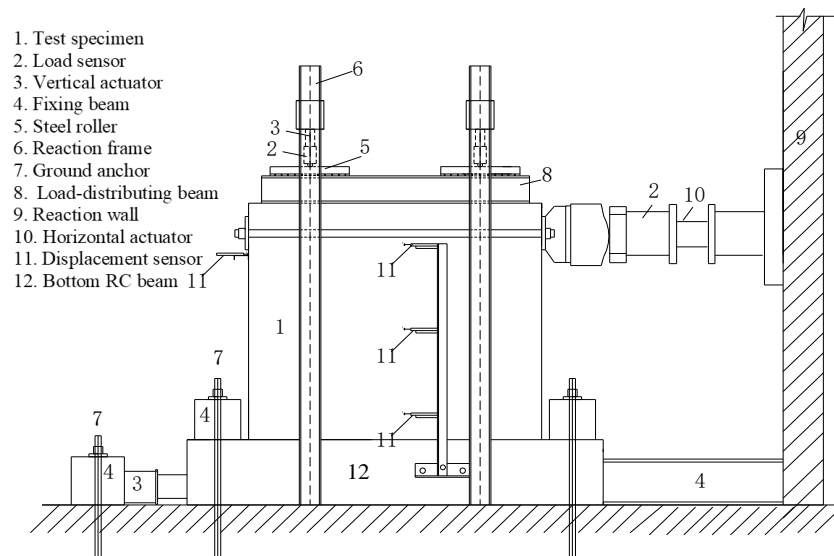
Figure 3. Test setup for in-plane cyclic horizontal load.

The wall specimens were tested under combined in-plane horizontal and vertical loading. The vertical loading simulates the weight of the story levels. During a seismic event, the wall experiences large displacements, and the axial compressive load may change due to the deformation of the bounding frame of the wall. However, since it is very difficult to simulate the actual boundary conditions, the walls were tested under constant vertical load. The test setup, shown in Figures 3 and 4, consists of the test unit, including a foundation beam, load-distributing beam, horizontal actuator, two vertical actuators, and a reaction wall. The bottom reinforced concrete (RC) beam of the wall was clamped to the floor with four fixing beams through six steel rods to avoid uplift and slippage of the base (Figure 3). The axial load was applied using two vertical actuators through a stiff steel beam to achieve uniform distribution of the vertical load. A set of steel rollers were used in-between the actuators and the steel beam to accommodate the potential lateral movement of the wall. A rubber layer was placed between the steel beam and the top of the concrete beam to provide a smooth surface for a better distribution of stress. The horizontal load was applied to the wall using an actuator acting against the reaction wall. Displacements of the wall were measured using LVDTs, as shown in Figure 5. LVDT 1-1 measures horizontal deformation, whereas instrument 1-2 records deformation of the inner leaf. LVDTs 2-1–2-3 capture the horizontal deformation at the center of the inner leaf at a different height. The LVDTs were fixed on the bottom beam to ensure stable reference of measurements while eliminating the influence of any potential movement of the bottom beam. Displacement sensors 2-4–2-6 measure the horizontal relative displacement between the inner and outer leaf at different heights. Strain gauges 3-1–3-8 monitor strains in the ties at various locations shown in Figure 5. The walls were subjected to in-plane cyclic loading, which was applied at the top ring beam on the inner leaves. The cyclic loading sequence consisted of two loading regimes and was adopted for all tests, as shown in Figure 6. Two test regimes were used. The first regime consisted of load-controlled cycles with load magnitudes limited by the wall cracking strength. These force cycles involved two cycles with stresses at 20% of the predicted cracking strength and one cycle at the predicted cracking strength. The predicted cracking strength was 400 kN, which was approximately equal to the sum of the cracking strength of the inner and outer leaf. The second regime was a displacement-controlled cyclic loading, where walls were cycled three times to the displacement of $1\Delta_c$ (Δ_c was the displacements at the first wall crack), $2\Delta_c$, and $3\Delta_c$, respectively. This was done to study the degradation of the stiffness and strength. This was followed by one cycle after the displacement of $3\Delta_c$ to the prescribed drift target, which was intended to investigate the restoring force model of the walls. Failure was defined as the point on the loading curve where the strength of the wall specimen decreased to 85% of the previously recorded maximum strength.

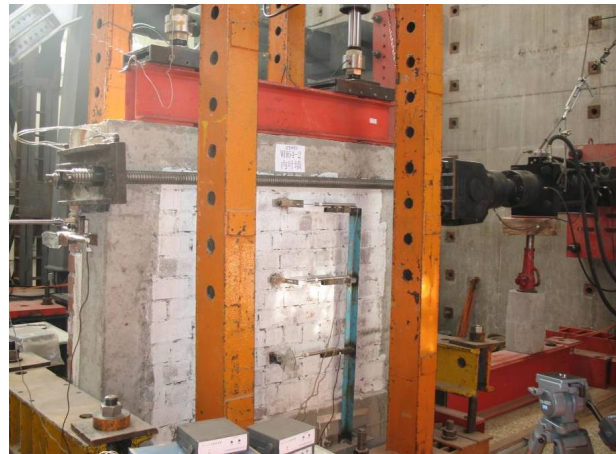
Figure 4. Photograph of testing setup.

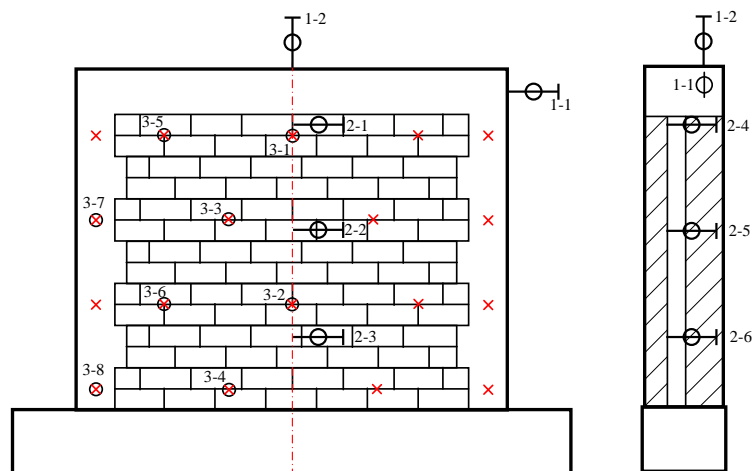
Figure 5. Load and displacement sensor arrangement (1-1,1-2. Load and displacement sensor; 2-1–2-6. Displacement sensor; 3-1–3-8. Strain gauge).

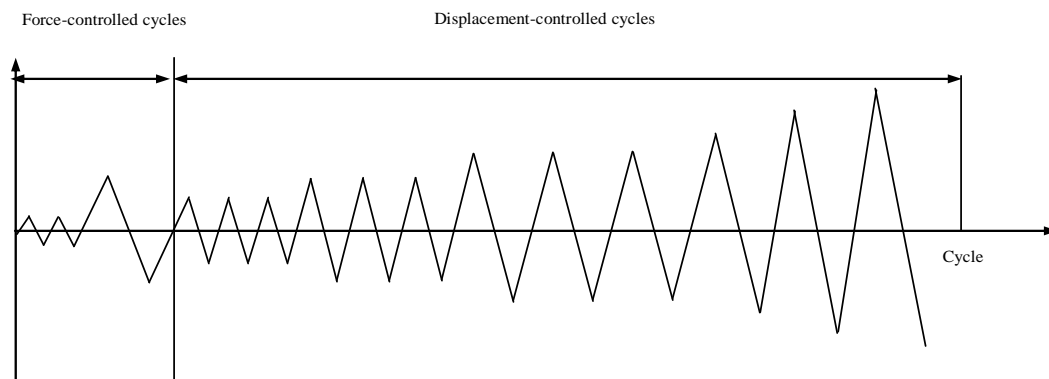
Figure 6. Loading history.

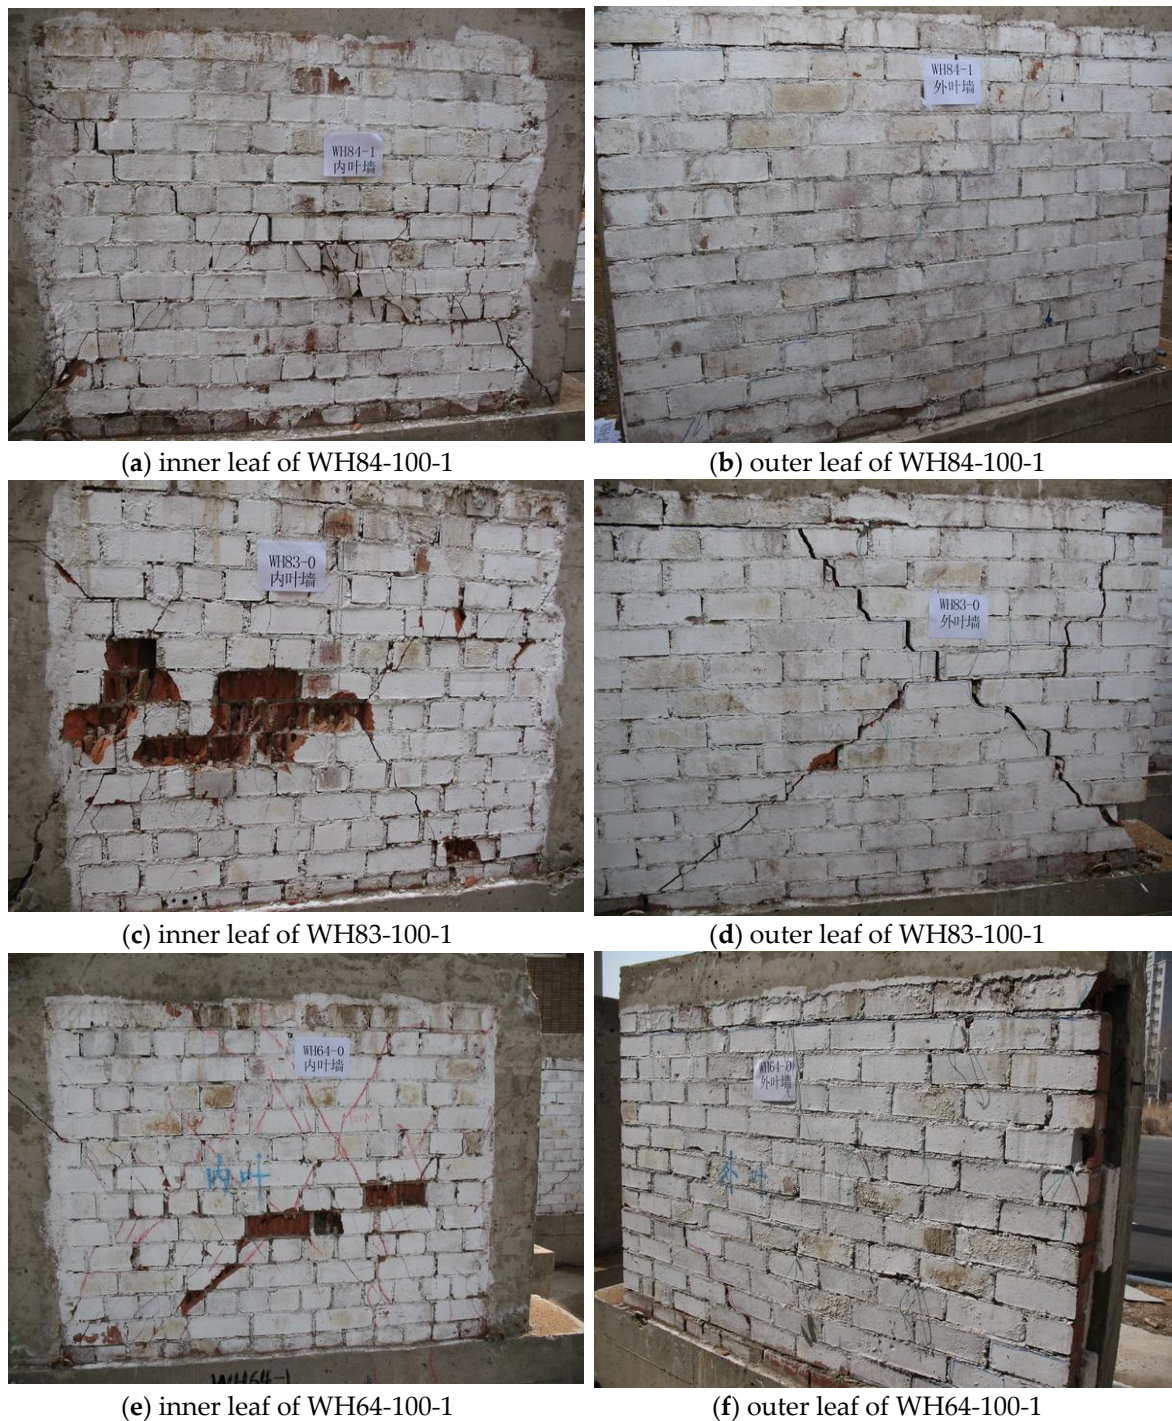
Figure 7. Damage state of the walls upon loading.

For all tested masonry wall specimens, failure was initiated by horizontal flexural cracks followed by the development of wide, diagonal cracks extending throughout the inner leaves. The behavior of the walls can be characterized by three critical points: formation of flexural crack, the opening of diagonal cracks, and crushing of the bottom corners. Figure 7 illustrates typical wall cracking patterns at the end of testing for three specimens. The walls exhibited shear failure as first fine diagonal cracks appeared in the inner leaves. As lateral displacement increased, the length of the diagonal cracks increased. At this stage, strains of the vertical reinforcement increased significantly, demonstrating its effective role in bearing tensile flexural stresses, avoiding the uplift of the base of the wall. With increasing lateral displacements, easily detectable diagonal cracks developed in mortar joints.

During the displacement-controlled cyclic regime, after three cycles at the displacement of $1\Delta_c$ (about 1.6 mm), first fine diagonal cracks in the inner leaf could be observed, while the width of diagonal cracks reached about 0.4 mm. During the three subsequent cycles at a displacement of $2\Delta_c$, the width of the diagonal crack increased to about 1.3 mm. During the three cycles at a displacement of $3\Delta_c$, the diagonal crack widened to about 3 mm, and their length also increased. New irregular cracks were observed as the crack opening increased and extended to the diagonal crack. At this stage, the loading had reached a maximum of about 1.5 times the cracking load. During the cycle at a displacement of $4\Delta_c$, the diagonal crack continued to widen to about 5 mm, and diagonal cracks in the inner and outer leaf emerged. After the cycle at a displacement of $5\Delta_c$, the load began to decline.

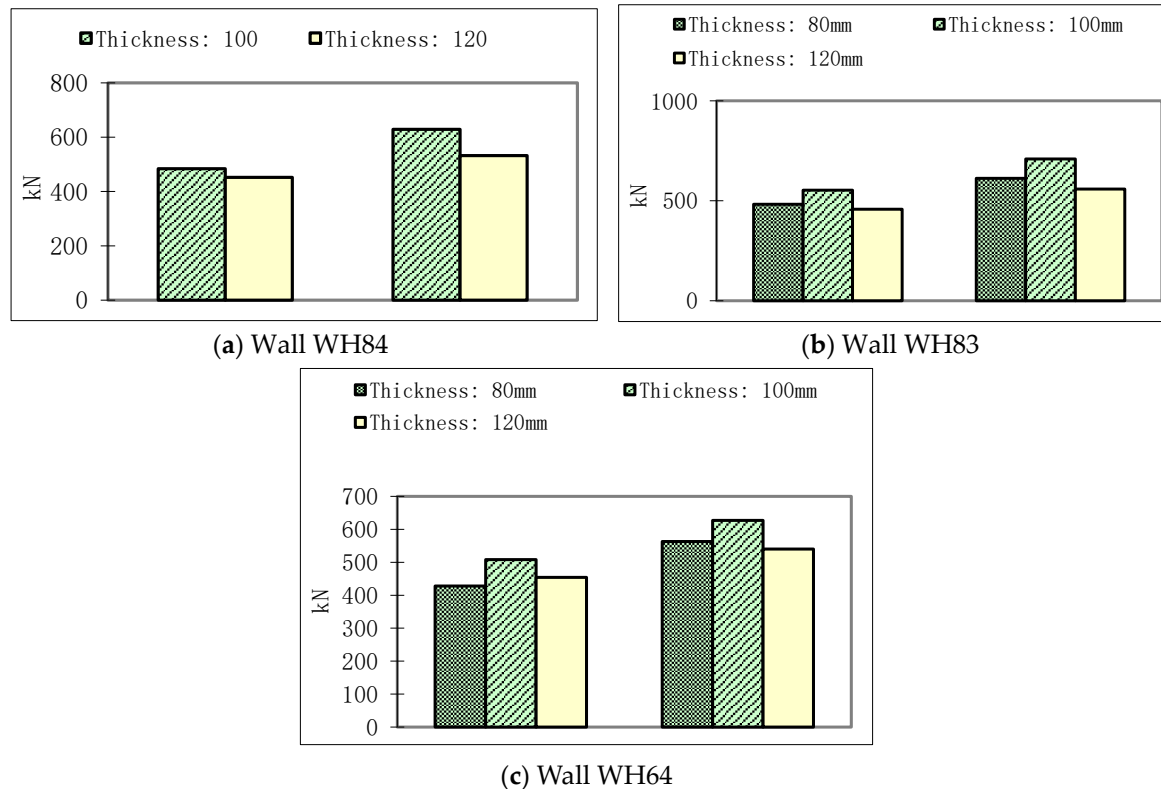
Figure 8. Comparison of the cracking load and ultimate load of walls with different thicknesses of insulating layers.

The cracking and ultimate loads of wall WH84-100-1 were 484 and 629 kN, respectively (Figure 8a). The walls had similar dimensions and reinforcement details, but the thickness of the insulating layer was varied. When this thickness increased from 100 mm to 120 mm, the cracking and ultimate loads declined by about 32 and 96 kN, respectively. As shown in Figure 8b, the cracking and ultimate loads of wall WH83-80-1 were 483 and 612 kN, respectively. The cracking and ultimate loads of wall WH83-100-1 increased by 70 and 93 kN, respectively, while that of wall WH83-120-1 decreased by 25 and 53 kN, respectively. The corresponding cracking and ultimate loads of wall WH64-80-1 were 428 and 563 kN, respectively (Figure 8c), while that of wall WH64-100-1 increased by 80 and 64 kN, respectively. The cracking load of wall WH64-120-1 increased by 26 kN, and the ultimate load of wall

WH64-120-1 decreased by 23 kN. The thickness of the insulating layer generally had a slightly negative influence on the wall shear strength. This is likely because the linear stiffness of the RC coupling beams connecting the inner and outer leaf decreased, and the coordination performance of inner and outer leaf degraded, imposing a negative effect on shear strength.

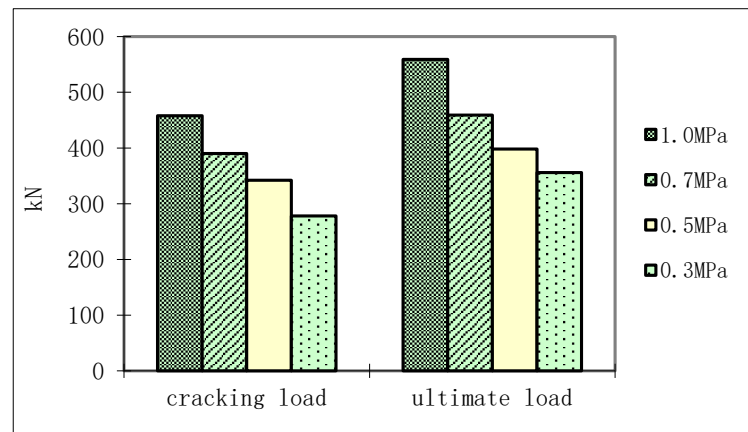
Figure 9. Comparison of the cracking load and ultimate load of walls with different axial compressive stresses.

As shown in Figure 9, the axial compression stress had a positive influence on the shear strength. The performance of wall specimens having similar dimensions and reinforcement details under varying levels of axial compression stress was compared. The cracking and ultimate loads of wall WH83-120-0.3 were 278 and 356 kN, respectively. When the axial compression stress was increased from 0.3 MPa to 0.5 MPa, 0.7 MPa, and 1.0 MPa, the cracking load increased by about 23.0%, 40.3%, and 64.7%, respectively, while the ultimate load increased by 11.8%, 28.9%, and 57.0%, respectively. An increase in axial compression stress delayed the initiation of cracks until larger lateral force was applied. A larger lateral force was required to exceed the compressive field resulting from the larger axial load, and the compressive field must first be overcome before cracking can initiate, as explained by principal stresses. However, ductility indicators declined with increased axial compression stress, and the failure mode became more brittle. Therefore, it is recommended that the axial compression stress should not exceed 1.0 MPa.

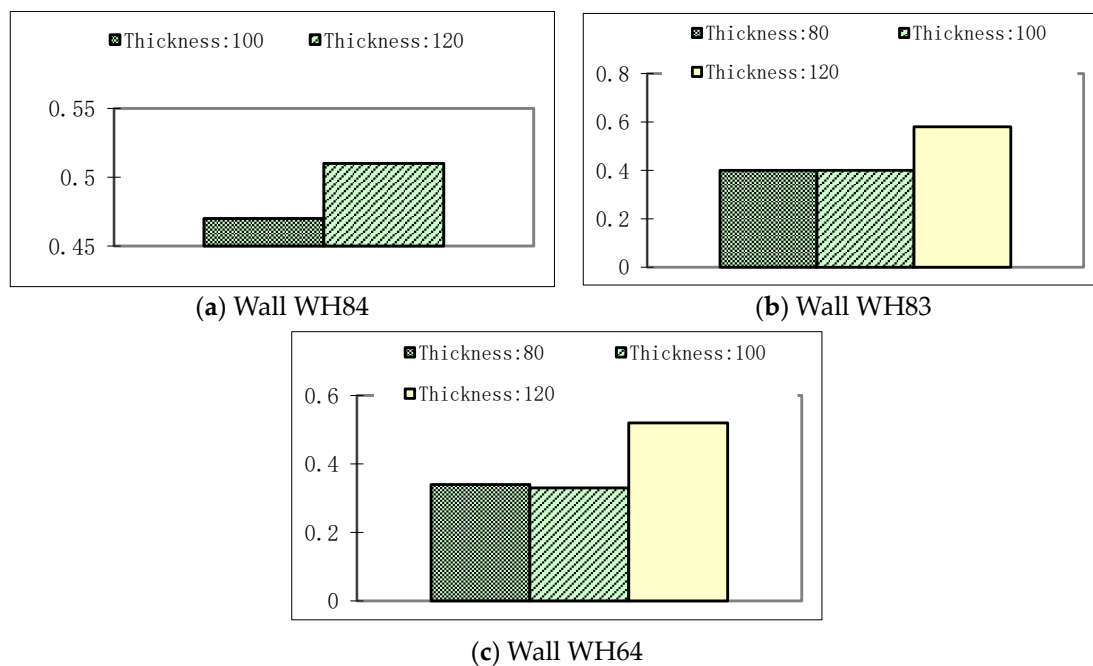
Figure 11. Comparison of δ/Δ of walls with different thickness of insulating layers.

As shown in Figure 11a, the ratio of maximum displacement of the inner to that of the outer leaves over the maximum displacement for the cast-in-situ masonry cavity wall WH84-100-1 was 0.47. The wall specimens had similar dimensions and reinforcement details, but the thickness of insulating layer was increased from 100 mm to 120 mm, making the δ/Δ value increase by 8.5%.

Figure 11b shows that the δ/Δ of wall WH83-80-1 was 0.40. When the thickness of the insulating layer was increased from 80 to 100 and 120 mm, the δ/Δ value increased by 0% and 45%, respectively. Likewise, δ/Δ of wall WH64-80-1 was 0.34 (Figure 11c). When the thickness of the insulating layer was increased from 80 to 100 and 120 mm, δ/Δ increased by 3% and 53%, respectively. It was concluded that δ/Δ increased with increasing thickness of the insulating layer, while coordination work performance of the walls declined.

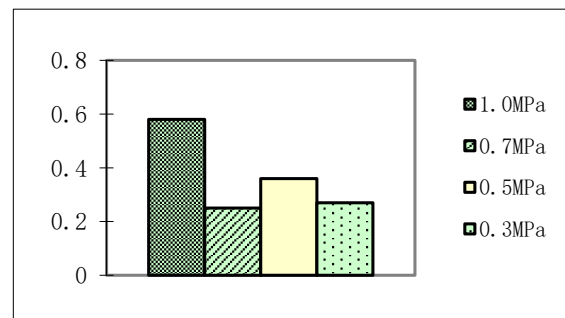
Figure 12. Comparison of δ/Δ of walls with different axial compressive stresses.

Figure 12 shows that δ/Δ of wall WH83-120-0.3 was 0.27. The performance of the wall specimens having similar dimensions and reinforcement details subjected to varying levels of axial compression stress were compared. When the axial compression stress was increased from 0.3 MPa to 0.5 MPa, 0.7 MPa, and 1.0 MPa, δ/Δ was 0.36, 0.25, and 0.58, respectively. The δ/Δ decreased as the axial compression stresses decreased, and the coordination work performance of the walls increased. The axial compression stress generally had a negative influence on the cooperation work performance of inner and outer leaves.

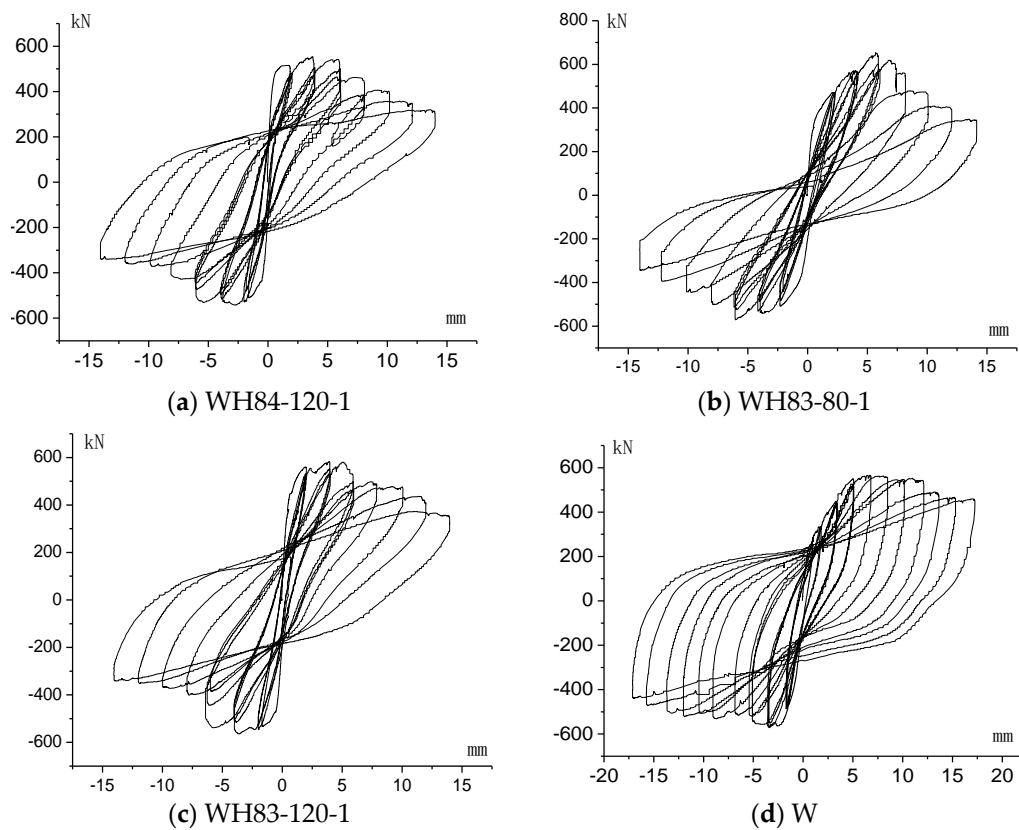
Figure 13. Hysteretic curves of walls.

The hysteretic loops under quasi-static loading were spindle-like. Good aseismic behavior is demonstrated in Figure 13. The difference of hysteretic loops of the cast-in-situ masonry cavity walls and that of a solid wall was not significant. The hysteretic loops of all walls, which were shuttle shapes, were full. This indicates that the cast-in-situ insulating layer can improve the collaborative performance of the inner and outer leaves. The cast-in-situ masonry cavity walls have desirable ductility and energy dissipative capacity. The envelope curves of the wall specimens can be divided into three stages: elastic stage, elastic-plastic stage, and failure stage, as displayed in Figure 14. For the convenience of comparative analysis, the envelope curves are simplified as a tri-linear substitute model, as shown in Figure 15. The slope of the line connecting the cracking point to the origin point was K_c , where $K_c = b/a$; the slope of the line connecting the cracking point to the ultimate load point is K_1 , where $K_1 = (1 - b)/(1 - a)$; the slope of the line connecting the ultimate load point to the failure point is K_2 , where $K_2 = (1 - 0.85)/(c - 1)$. K_c , K_1 , and K_2 of the walls are summarized in Table 5. K_c of the cast-in-situ masonry cavity walls was about 2.03–3.75, and the ratio of K_c of the cast-in-situ masonry cavity walls to that of the solid wall was in the range of 0.86 to 1.8. Compared with the solid wall, the initial stiffness of cast-in-situ masonry cavity walls did not decrease significantly, and the degenerative process of the stiffness of the cast-in-situ masonry cavity walls was delayed to some degree. This indicates that the cast-in-situ insulating layers contributed to resisting stiffness degradation.

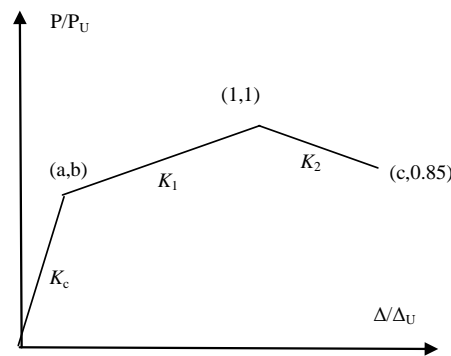
Figure 15. Trilinear substitute model of envelope curves.

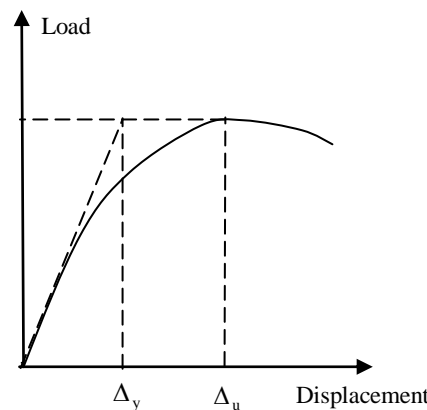
Figure 16. Method of determining ductility factor.

Figure 16 outlines the method of determining the ductility factor, μ_y , which is the ratio of the displacement corresponding to the ultimate load (Δ_u) and the equivalent yield displacement (Δ_y).
