Integrating Non-Destructive Testing, Laser Scanning, and Numerical Modeling for Damage Assessment: The Room of the Elements

study of a wall in the Room of the Elements in Palazzo Vecchio in Florence, Italy. A qualitative crack map of the existing damages was made using a combination of documentation methods. Subsequently, a three-dimensional model was generated for numerical simulation. Additionally, whereas Carpinteri et al. (2005) uses a single, known input load [15], this work, given the existing crack pattern, evaluates several load combinations and yields the most probable loading scenario which caused the existing damage. Using finite-distinct element modeling, the wall was simulated under a variety of loading conditions including dead load and settlement. The results of the simulations were directly compared to the existing crack patterns to understand how they could have originated. By understanding the extent and origins of the damage, a more comprehensive assessment of a structure's health can be made. Additionally, a second study was carried out examining the impacts of different materials used as infill. This investigation into how different initial assumptions can alt

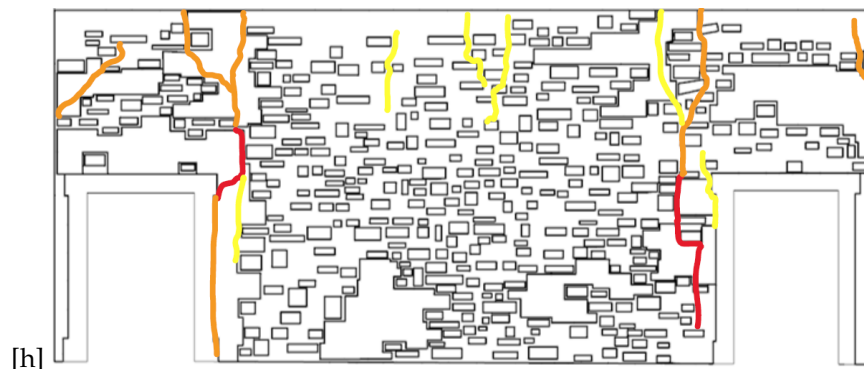
Figure 5. Map of existing cracks on the foundation wall. Red indicates cracking over 1 cm; yellow indicates cracking on the order of 1 mm; orange indicates cracking in between these two limits.

Using a combination of information from laser scanning, photogrammetry, thermography, as well as previous crack maps, a new map of the existing cracks and their relative sizes can be found in Figure 5. Since the cracks are not all visible with line-of-sight methods, the magnitudes of the cracks are approximate. In this plot, red lines denote cracks with the width on the order of 1 cm or larger, yellow denotes those on the scale of 1 mm, and orange denotes those between these limits. As can be seen in Figure 5, the widest cracks on the wall occur in the vicinity of the door jams. The widest cracks originate there and then reduce in magnitude as they continue to propagate through the wall's height. Smaller cracks can be seen at the corners of the room as well as some in the top-middle section of the wall.
