Article

Salt Weathering of 7th Century CE Granite Monument of Shore Temple, Mahabalipuram—Scientific Investigation and Conservation Strategy

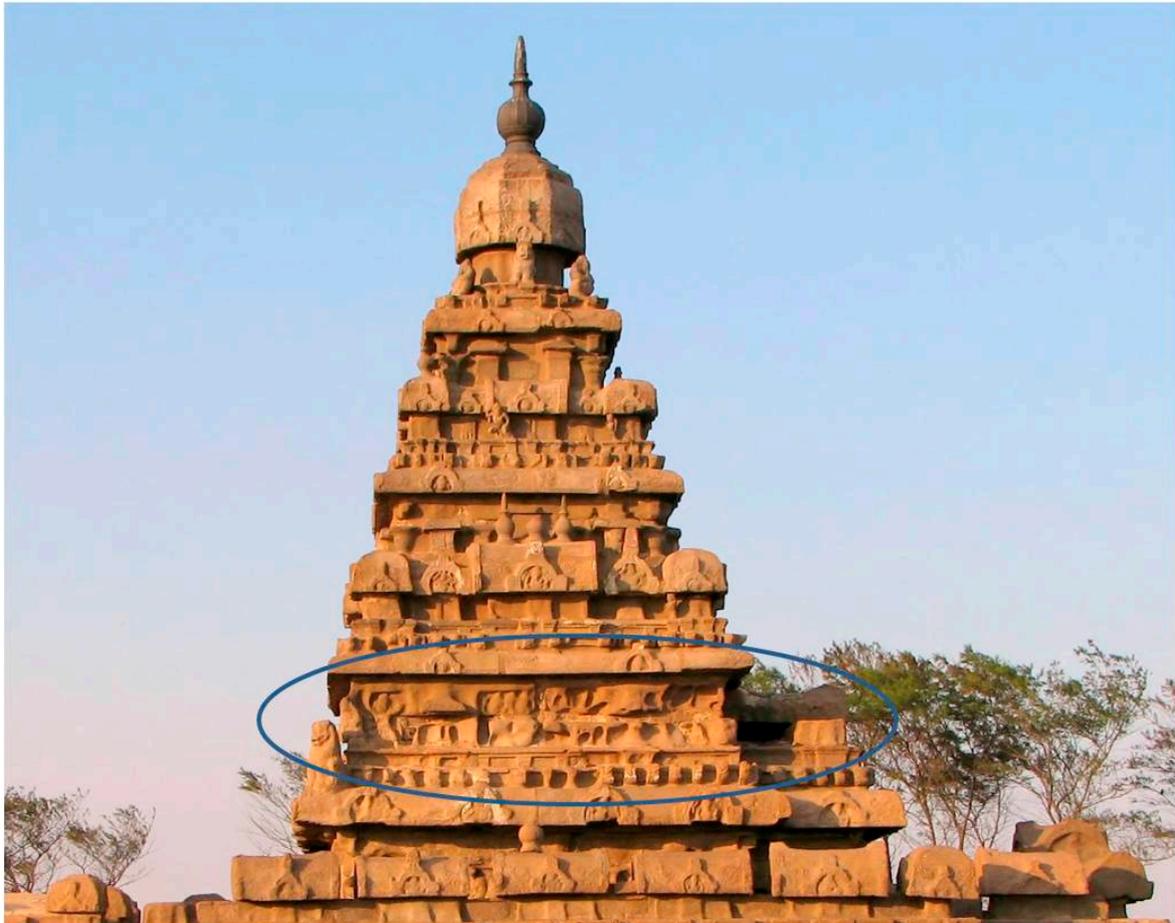
Figure 1. Photograph showing the “alveolarization” in the south side main vimana of the Shore Temple.

Alveolarization (honeycomb weathering) is a type of weathering of rocks and stones that is also known as stone lattice, stone lace, and fretting or alveolar weathering [21,22]. It is a common phenomenon among many rock surfaces with important implications in geomorphology, environmental geology, and stone conservation [23]. The alveolarization is mainly formed in coastal areas [24], in hot and cold deserts [25], and in some continental areas. This type of weathering is also found in many historical buildings constructed with various stone materials [26]. A previous study also reported the evidence of alveolarization on Mars [27]. The alveolarization is formed on stone surfaces that undergo periodic heavy spray and splash during stormy weather and are therefore regularly exposed to both wind and salt deposition. The loss of stone on historic buildings affected by alveolarization has been the concern of both conservators and researchers for a long time, who must understand its origins in order to develop mitigation methods. Alveolarization was noticed on three sides of the walls of the main Gopura of the Shore Temple (Figure 1).

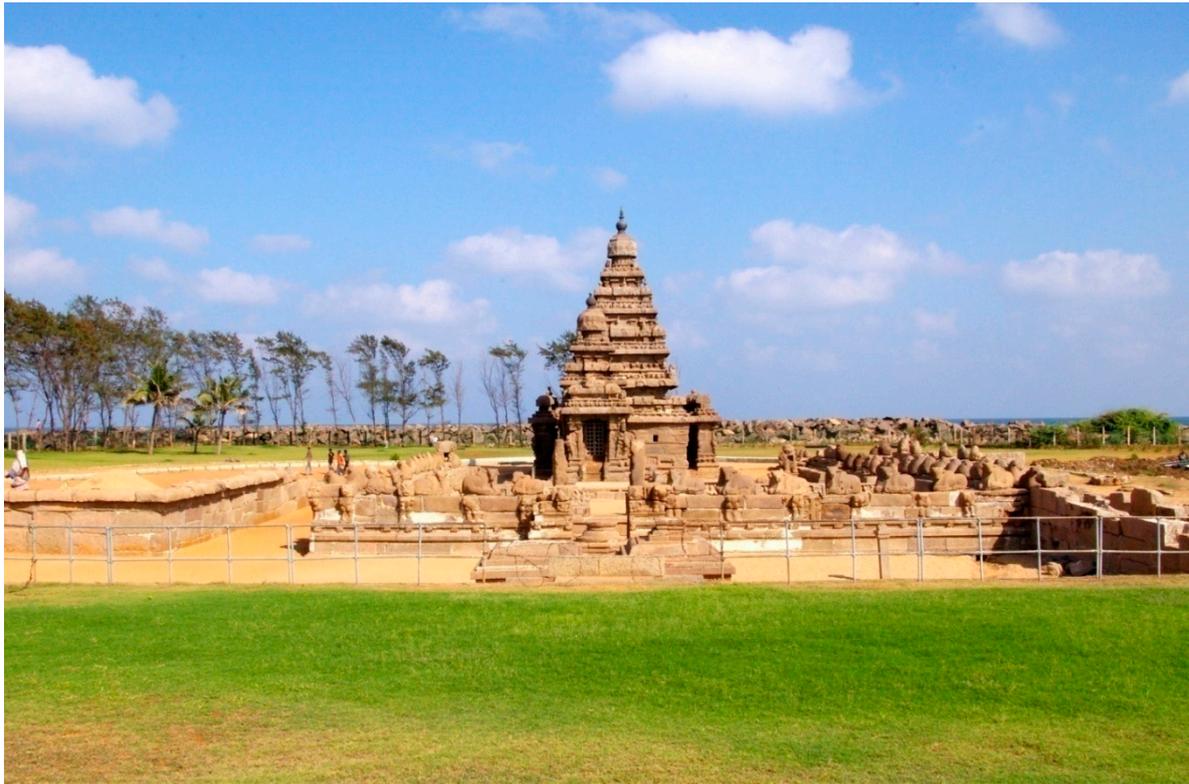
Figure 3. Location and plan map of Shore Temple, Mahabalipuram.

The Shore Temple, located in Mahabalipuram ($12^{\circ}36'59''$ N $80^{\circ}11'55''$ E) and attributed to the famous Pallava, who was the ruler of Narasimhavarman-II (722 CE), is one of the first stone temples in the South Indian Dravidian style. It was built with half of it in the sea and a half of it on land in the 7th–8th century CE [28]. The general view of the Shore Temple is shown in Figure 2. The paramount problem of this temple is its location. The location and plan map of the Shore Temple in Mahabalipuram is shown in Figure 3.

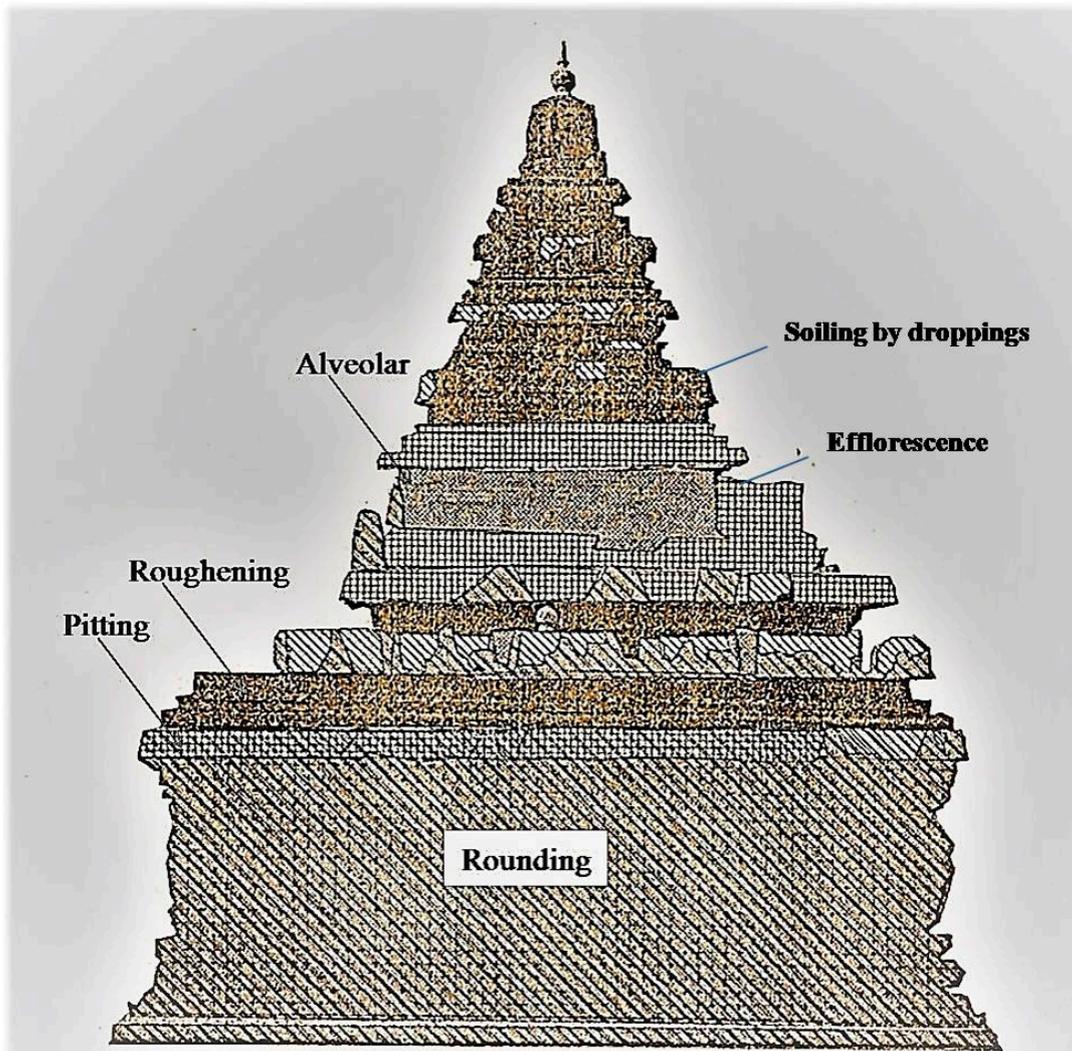
Figure 4. Conservation mapping of Shore Temple (southern side) showing the different types of deterioration and discoloration/deposits observed.

At Shore Temple, the side exposed directly to the sea was damaged to such an extent that sculptures were obliterated beyond recognition. The sculptures of the northern and the western sides were also damaged, but the profile remained. The extensive erosion observed on the upper part of the temple—about two meters from ground level—was probably due to the striking high-velocity winds. The loss of stone materials occurred in two ways. Firstly, morphological changes of the stone types due to partial/selective weathering, called relief, were noticed. This consisted of severe pitting on the stone surface due to the action of wind. In some places, alteration of gloss due to corrosion or loss of small stone particles from the stone surface was also observed. Secondly, soiling due to efflorescence (the formation of salty accretions due to efflorescence) was also observed on the stone monument. As the temple was constructed in granitic stone of different compositions and textures, the rate of deterioration was not the same in different stone blocks. The main weathering patterns observed were the color alteration, loss of cohesion, disaggregation, and detachment of the surface layer. The combined impact of high temperature and high precipitation also caused bio-colonization, which enhanced bio-deterioration. The deposition of bat excreta was observed, and a few bats were found roosting inside the ceiling of the interior portion of the temple. Due to high humidity, the guano has spread and contaminated the original stone surface. On the upper part of the temple, bird droppings were observed. The weathering by bird droppings seems to be an active factor of the structural and textural changes, as well as the deterioration in some of the stones, as evidenced by various researchers [29–32]. A conservation mapping of Shore Temple that shows different types of deterioration and discoloration/deposits is shown in Figure 4.

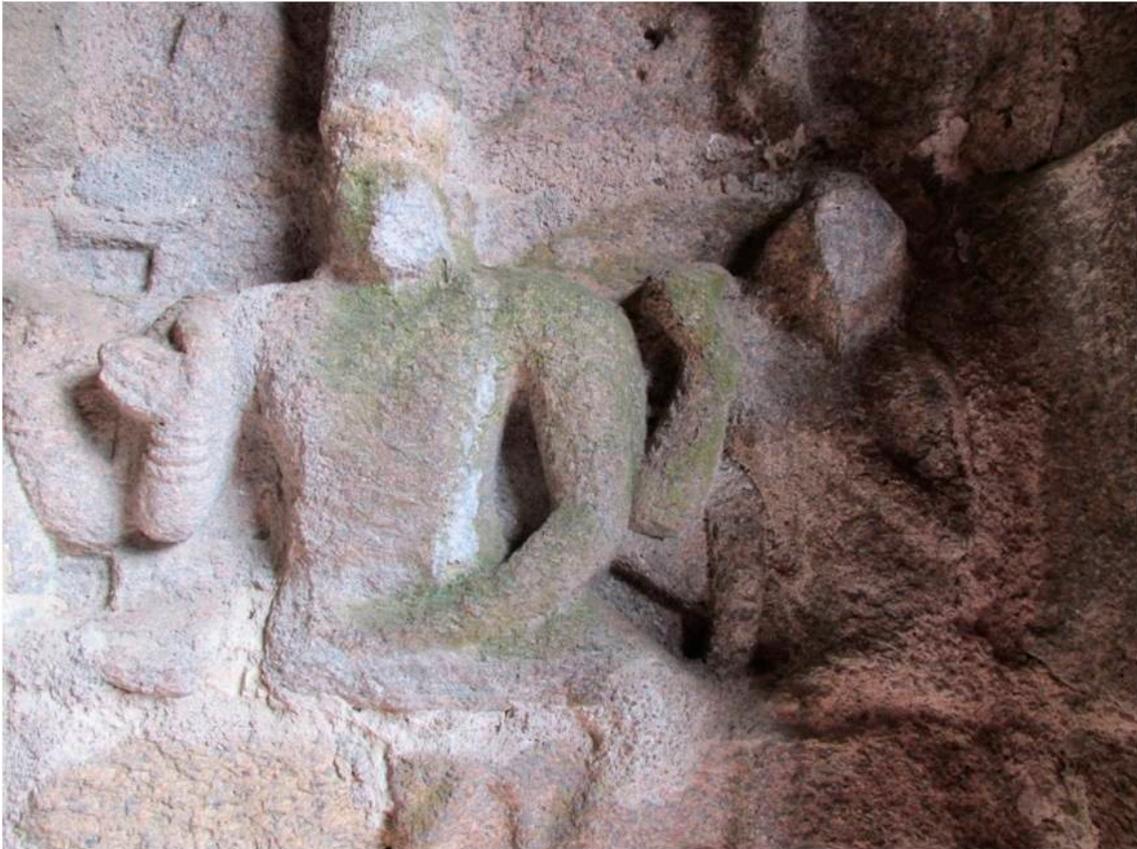
Figure 5. The photograph shows the various types of deterioration noticed in Shore Temple.

The deterioration of building materials induced by environmental factors is a complex interplay of the climatic effect and local meteorological parameters, biological processes, and complicated chemical processes resulting from the impact of pollutants and natural constituents from the surrounding environment. Climatic conditions and meteorological parameters can affect damaging processes in the form of mechanical stress, desiccation, surface scaling, attrition, and cracking, and may also accelerate certain forms of chemical attacks on the materials. The climate factors like air temperature, sunlight radiation, air humidity, different forms of precipitation (rain, snow, etc.), wind velocity, and direction are undoubtedly significant. The impact of these environmental parameters varies and depends on the sunshine, temperature fluctuations (rapid and large diurnal temperature changes), air movement/pressure, rain intensity, and frequency of local soil hydrology. The photograph shows the various types of deterioration noticed in Shore Temple (Figure 5).

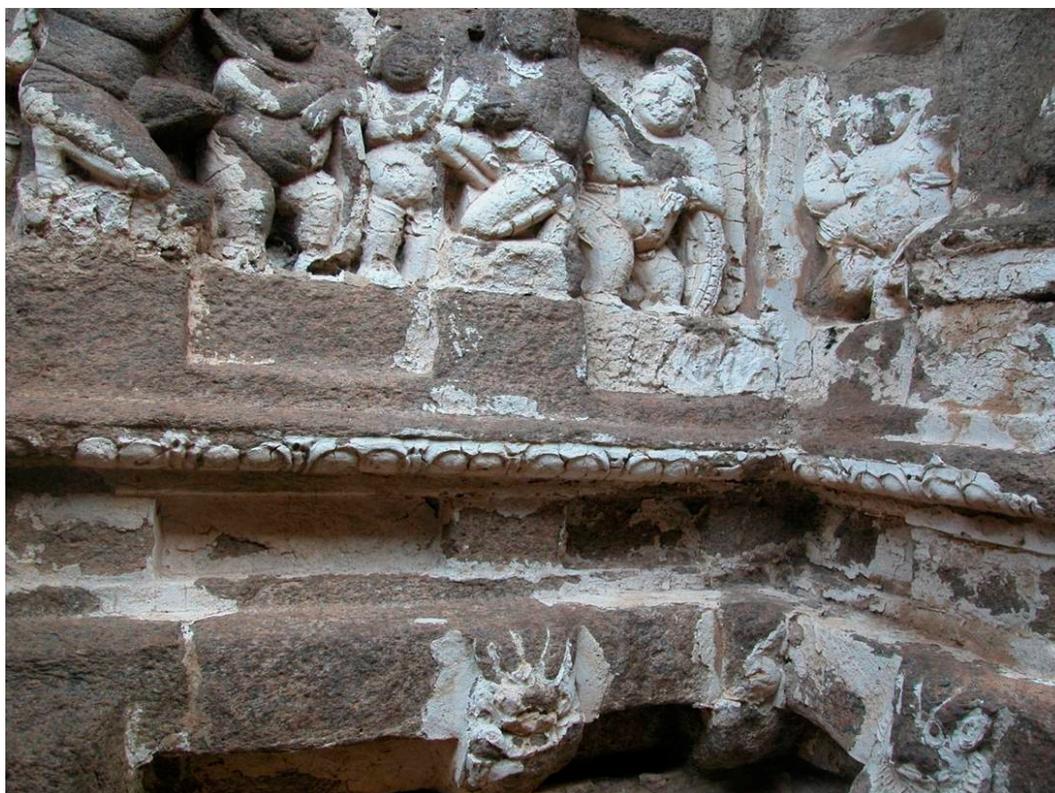
Figure 6. Photograph showing the remnants of old lime plasters at Shore Temple, Mahabalipuram.

From close inspection of the exterior and interior parts of the stone surface of the monument, it appeared that the monument was lime plastered in the past as a protective layer. All of the lime plaster layers were lost during the course of time, and traces remain on the inner sculpture and the shelter area (Figure 6). The lime plaster sample of the temple was subjected to particle size analysis with the help of an electronic particle size analyzer (Eye Tech particle size and shape analyzer, Ambivalu, Netherlands) to understand the distribution of grain size. The plaster sample was also analyzed with differential thermal analysis (DTA) and thermo gravimetric analysis (TGA), which was performed with the Mettler Toledo star thermal analyzer to study the purity of the plaster.

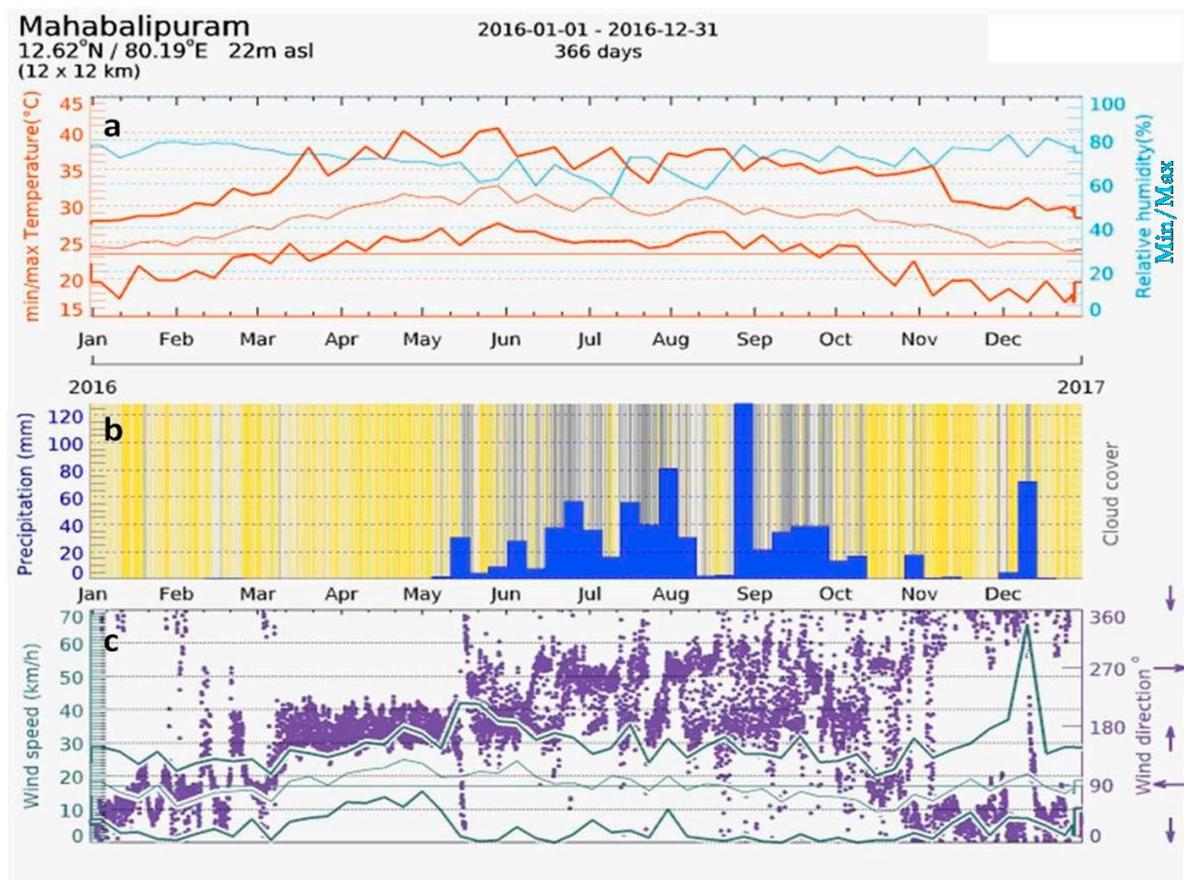
Figure 7. (a) Temperature and relative humidity versus time graph of Mahabalipuram; (b) precipitation diagram of Mahabalipuram; (c) graph showing the wind direction and wind speed at Mahabalipuram (derived from www.meteoblue.com).

Mahabalipuram has a tropical climate. In the winter, there is much less rainfall than in the summer. The Koppen–Geiger climate classified the site as Aw (tropical wet-dry climate) [38,39]. The climate is either classified as tropical wet-dry or tropical savanna climate. The drier months see precipitation totals less than 60 mm (2.4 in) and less than 4% of the total arrival precipitation. The average annual temperature in Mahabalipuram is 28.4 °C. In one year, the average rainfall is 1219 mm. The maximum temperature (upper brown line) for a year at Mahabalipuram is in the range of 28 °C to 41 °C (Figure 7a). Likewise, the average minimum temperature (lower brown line) for a year varies between 19 °C to 27 °C. The annual relative humidity (RH) at Mahabalipuram is in the range of 50% to 80% (shown in blue). However, the relative humidity recorded by the AWS installed in the temple complex varied between 31% to 98.97% in various seasons (Table 1). The precipitation diagram of Mahabalipuram (Figure 7b) shows the precipitation level during the months of January 2016 to December 2016. In Figure 7b, the cloudy days are shown in the grey background, and clear skies are shown with a yellow background. The darker the grey background, the denser the cloud cover. In tropical and monsoon climates, these amounts may be underestimated. The least amount of rainfall occurred in the period from January 2016 to April 2016. The most precipitation occurred during the months of June 2016 to December 2016, and the most remarkable changes were in the months of September 2016 to December 2016.

Figure 7c shows the wind speed and wind direction at Mahabalipuram for a period from January 2016 to December 2016. The wind speed and direction was, in degrees, 0° = north, 90° = east, 180° = south, and 270° = west. In the meteogram (Figure 7c), the purple points represent the wind direction, as indicated on the right axis. From the meteogram, it can be seen that the maximum wind flowing directions were in the order of south, west, and north, respectively. The three lines represent the maximum, minimum, and average wind speeds. As the temple is located on the seashore, the salt-laden wind from the sea—especially from the south, east, and north directions—strike the walls of Shore Temple, causing a major conservation threat to the temple. The direction of the wind is mainly south to west during rainy seasons, while in dry times with lower humidity, the winds flow from the north. This has implications in the material decay processes. The high relative humidity (more than 50%) also forms aerosols with the salt particles and deteriorates the stone surfaces of the Shore Temple [14,16]. The hot, humid, and salty environmental conditions are conservation perils to the Shore Temple.

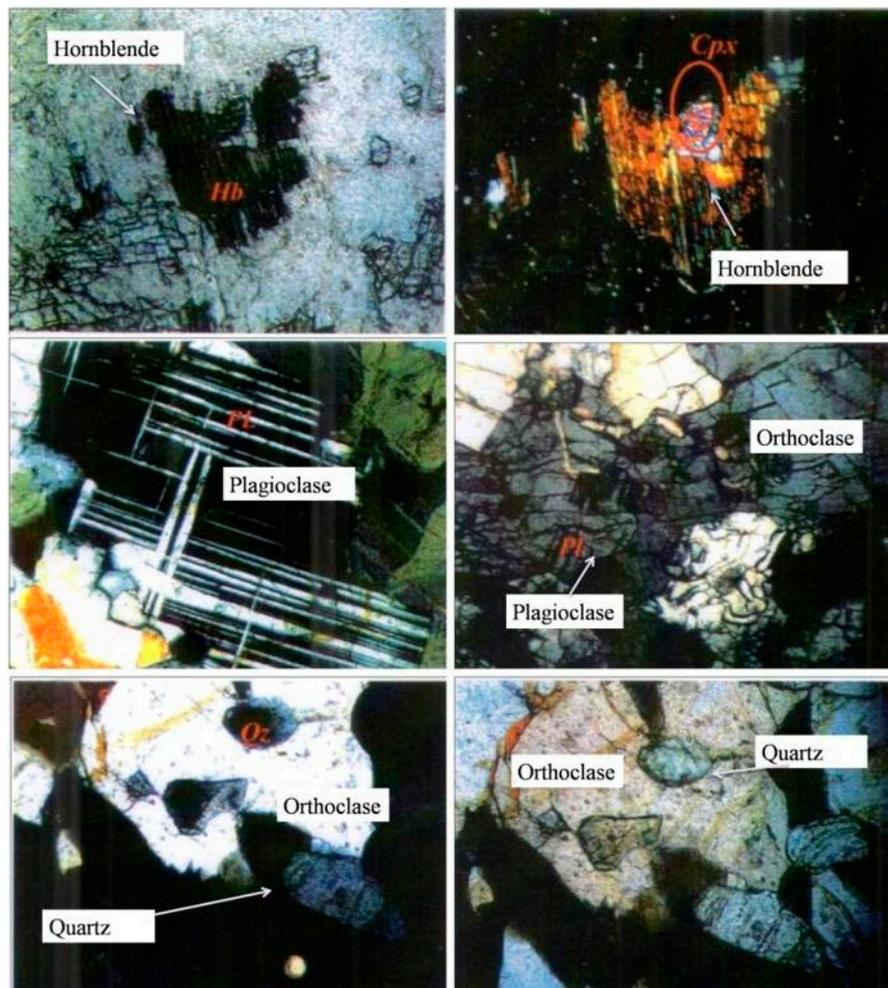
Figure 8. Thin section images of stone samples of Shore Temple, Mahabalipuram (Qz = Quartz, Pl = Plagioclase, Cpx = Clinopyroxene, Hb = Hornblende).

The granite rock of Shore Temple, Mahabalipuram is dark grey and medium grain. It exhibits a hypidiomorphic granular texture with indistinct to well-developed foliation, which indicates metamorphic rocks. The minerals noticed under the petrographic microscope from the thin section image of the granite stone are shown in Figure 8 under various magnifications. The presence of major minerals like quartz, microcline, orthoclase, plagioclase, and brown biotite in minor quantity is observed from the petrographic images. Zircon and apatite are also seen in trace quantities in the

thin section. The hornblende observed in the thin section is a complex inosilicates series of mineral that easily alters to chlorite and epidote. Based on our results of the thin section images of the stone samples, the rock was identified as “garnetiferous hornblende biotite granite”. All of the minerals are seen approximately in the composition, as shown in Table 2.

All of the felsic minerals—namely quartz, microcline, and plagioclase—broadly showed two size ranges, ranging from 0.05 mm to 0.07 mm and 0.02 mm to 0.25 mm. Slightly larger grains were seen in some samples, in which the grain size ranged from 0.05 mm to 0.15 mm.

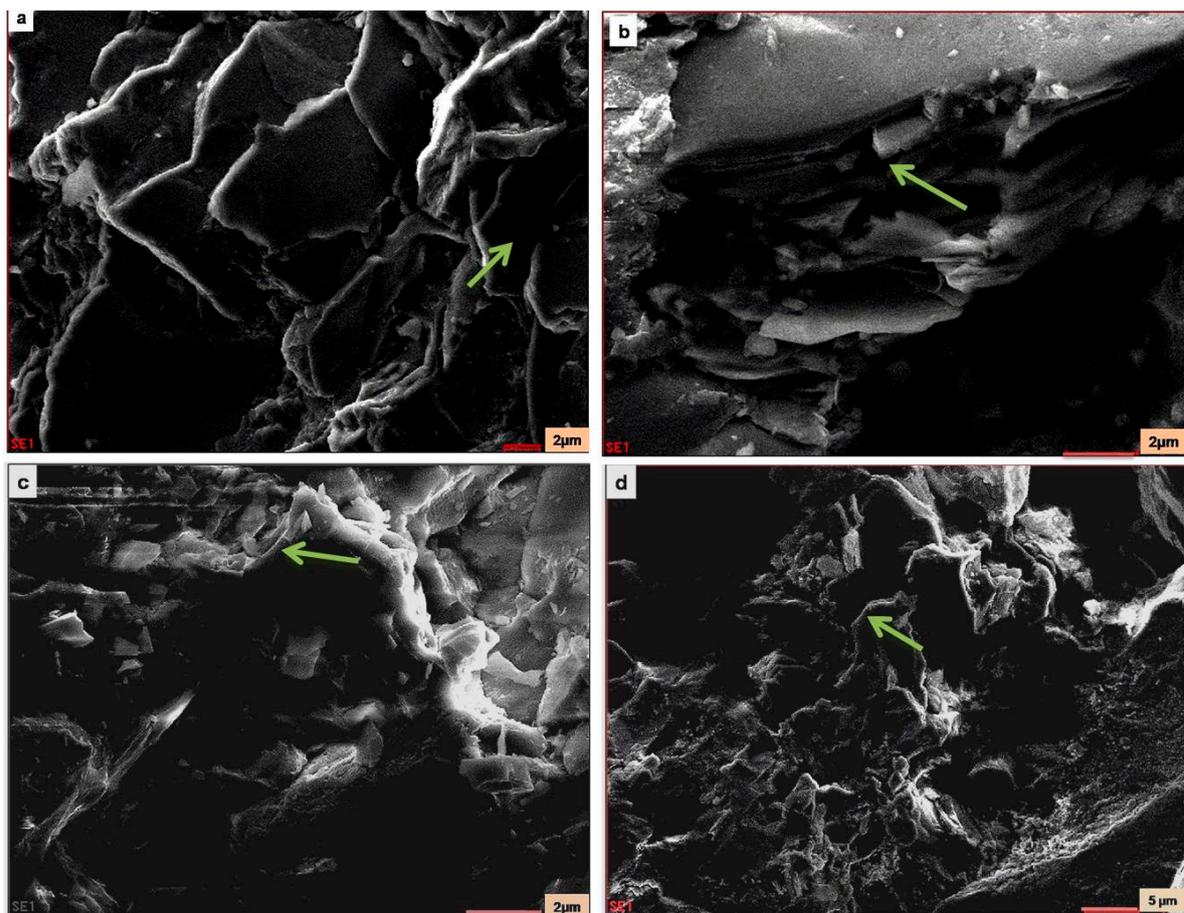
Figure 9. SEM images of the pristine stone sample: (a) arrow shows Mica–Biotite; (b) arrow shows K-feldspar and Mica; (c) arrow shows quartz; (d) arrow shows quartz.

SEM-EDX of pristine samples (samples collected from the Vimana of the temple) and weathered granite stone are shown in Figures 9 and 10, respectively. From the SEM photomicrograph and EDX, the presence of authigenic K-feldspar overgrowths was observed. In SEM, these overgrowths appeared as small (2–10 μm) rhombic crystals (arrow). Identification of the authigenic mineral was based on EDX analysis and yielded the major elements Si, Al, and K. This was a typical EDX spectrum for K-feldspar. The presence of plagioclase feldspar with K-feldspar overgrowths was also seen as plagioclase feldspar grain partly covered with authigenic K-feldspar overgrowths. In Figure 9b, the isolated rhombic crystal was observed. The morphology of this grain was not distinctive in SEM. Thus, identification was based on the analysis of the major elements, as determined in the EDX analysis. The EDX spectrum indicated the presence of Si, Al, Ca, and Na, and their relative peak heights were consistent with the formula for plagioclase feldspar. The EDX spectrum (Figure 11) is shown as representative (not all the EDX spectra are shown). The overgrowths consisted of S, Al, and K, and the relative peak heights indicated K-feldspar. Elongated detrital (sand-size framework component together with any interstitial primary) biotite grain compacted between detrital quartz grains were also seen in the SEM photomicrograph. Individual cleavage planes of biotite appeared as flakes. Identification of mica as biotite was based on EDX analysis showing the major elements of biotite (Si, Al, Mg, K, Fe, and Ti).

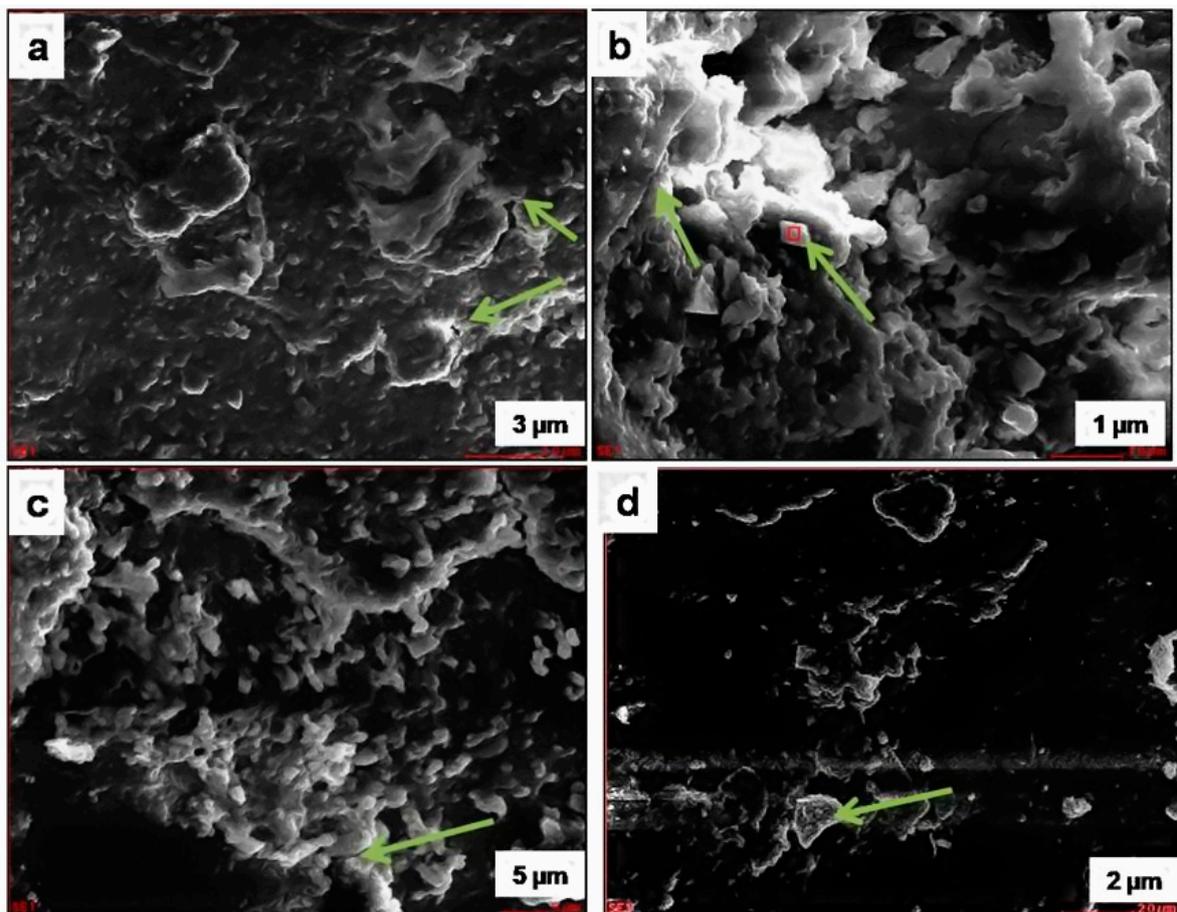
Figure 10. SEM image of the deteriorated stone sample: (a) arrow shows quartz; (b) arrow shows plagioclase feldspar with K-feldspar overgrowths; (c) arrow shows Mica-Biotite; (d) arrow shows Mica-Biotite.

Authigenic quartz overgrowths partly filling pores between detrital quartz grains were also observed from the SEM images. The overgrowth grew against a pore wall, and the authigenic quartz molded itself around the druse-lined detrital grain (arrow; Figure 10a), forming the texture seen in the SEM image. From the SEM photomicrographs of the deteriorated sample, it was clear that the presence of crystallization of the minerals and salt efflorescence (Figure 10b) was evidenced. The quartz may be attributed to the resultant products of the deterioration of the stone samples due to weathering caused by the salt-laden winds from the sea. The results correlated with the chemical composition of the samples.

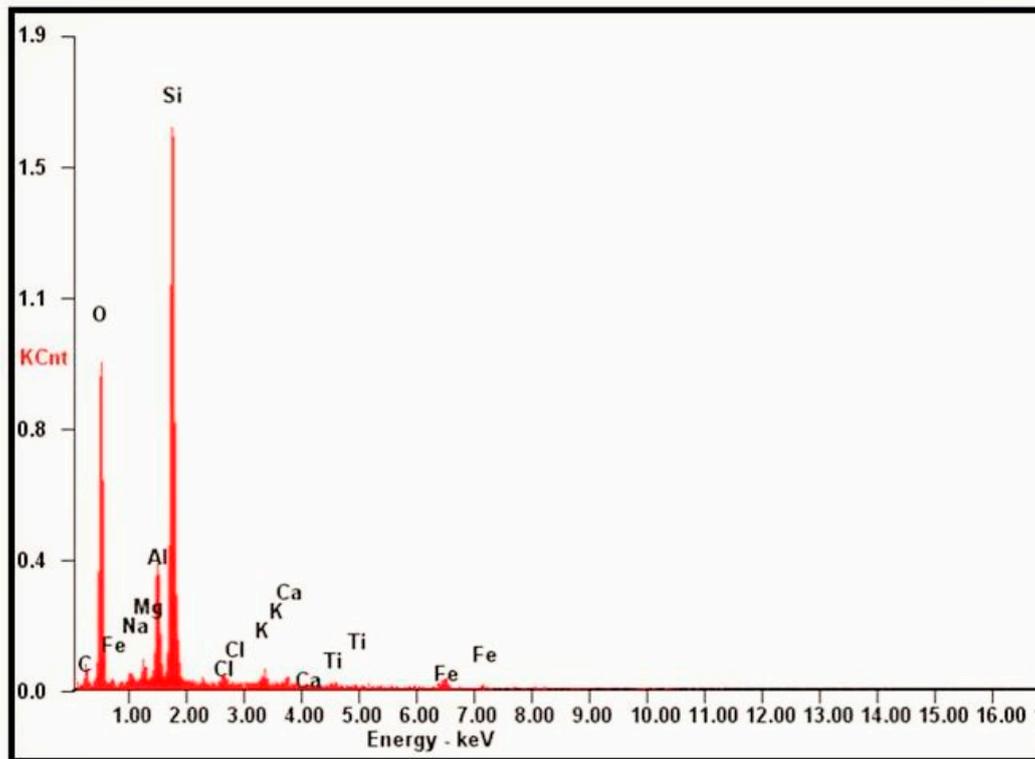
Figure 11. The representative SEM-EDX spectrum.

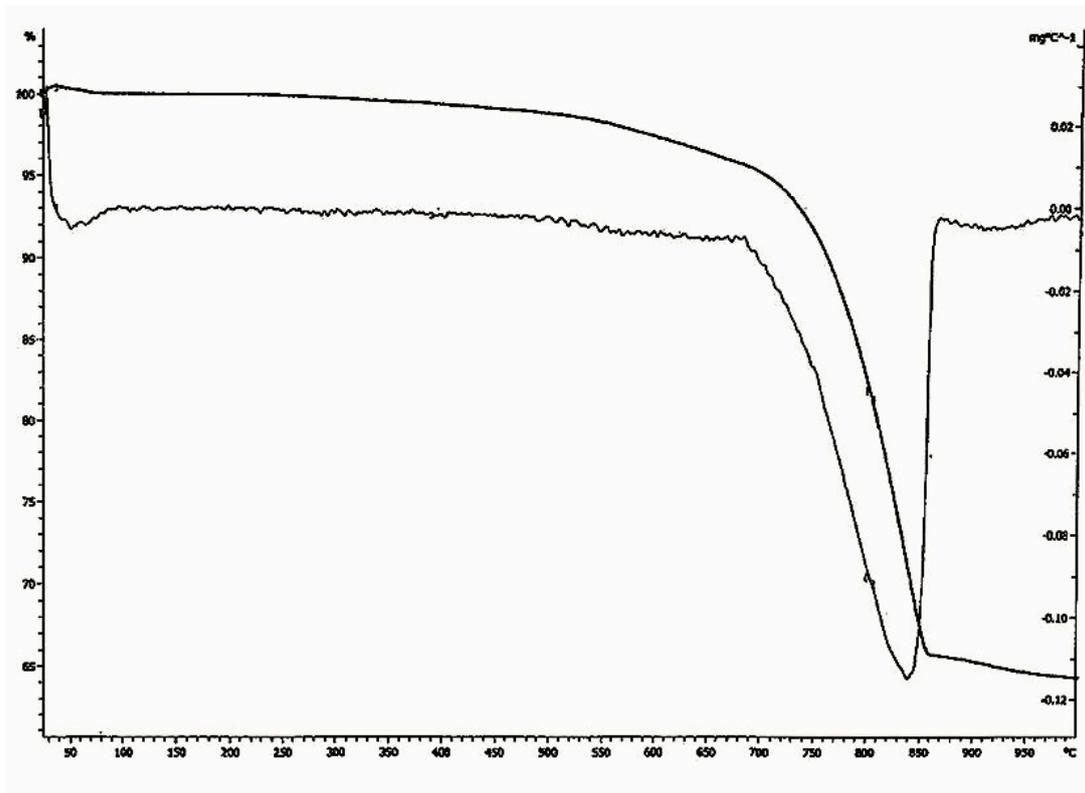
Figure 12. Thermo gravimetric analysis (TGA)—differential thermal analysis (DTA) diagram of lime plaster of Shore Temple, Mahabalipuram.

As already stated, the monument may have been lime plastered in the past as a protective layer that has now diminished. Only the profile remains in the shelter area, as well as a few sculptures. The sculpture with remnants of historical plasters is still in a good state of conservation despite the adverse climatic condition. Thermal analysis graph DTA/TGA is shown in Figure 12.

In the thermo gravimetric (TG) curve, the continuous weight loss was observed between the temperature range of 700 °C to 840 °C for the sample. Since the temperature of decomposition of calcium carbonate depends on its crystallinity, this suggests that part of the binder was perfectly crystalline. As pure calcium carbonate decomposes at 840 °C, the lime used for the plaster preparation of Shore Temple might have been an aerial lime of high purity. From the particle size analysis of the lime plaster (Figure 13), it was observed that the size of the aggregates used for the plaster was in the range of 1 μm to 700 μm . The majority of the aggregates were in the size range of 100 μm to 500 μm , which denotes that the aggregates used in the preparation of the plaster were mostly uniform in size. From the thermal analysis data, it was observed that the plaster of the temple was a non-hydraulic lime of high purity.

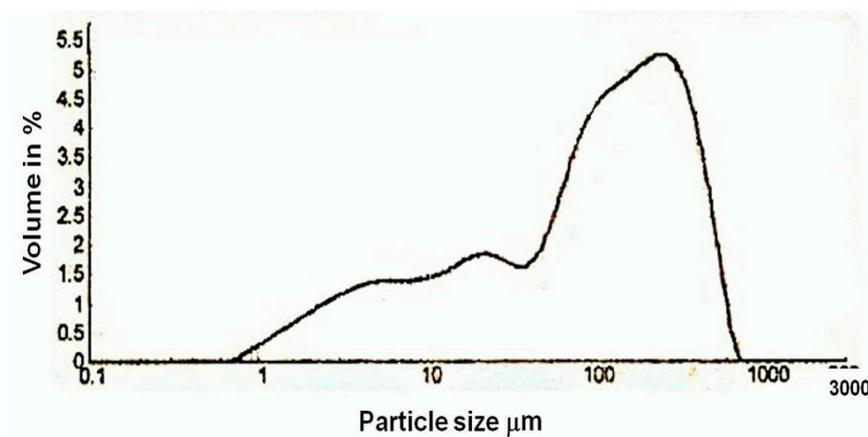
Figure 13. Particle size analysis diagram of lime plaster of Shore Temple, Mahabalipuram.

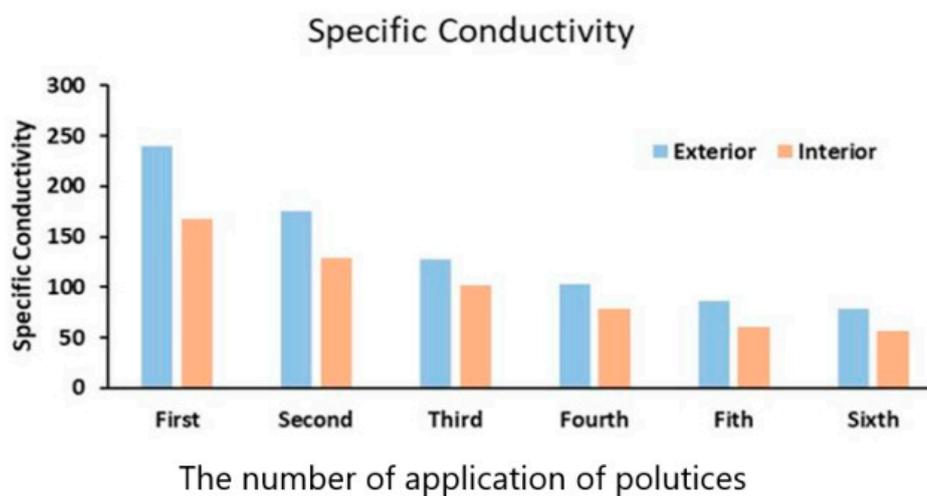
Figure 14. Specific conductivity ($\mu\Omega \text{ cm}^{-1}$) of the aqueous extract extracted from the Shore Temple by several applications of paper pulp.

The results on conductivity data of the paper pulp applied to both the exterior and the interior areas of the southern prakara wall of the temple versus the number of applications of poultices is shown in Figure 14. The specific conductivity decreased with an increase in the application of paper pulp (Table 5). From Figure 14, it was observed that the decrease in the chloride content was quite considerable to the fifth application of paper pulp, and thereafter it was not. From Figure 14, it was also observed that cellulose-based poultices were able to remove about 70% of salts in the humid environment of Mahabalipuram. Complete removal is rather difficult. Moreover, replenishment of the salts on the stone surface occurred due to sea sprays. Figure 15 shows a view of the temple during paper pulp treatment. Six to eight applications of paper pulp were carried out to achieve the desired results. The effectiveness of this treatment was also tested by carrying out conductivity measurements of the aqueous extract of the paper pulp.

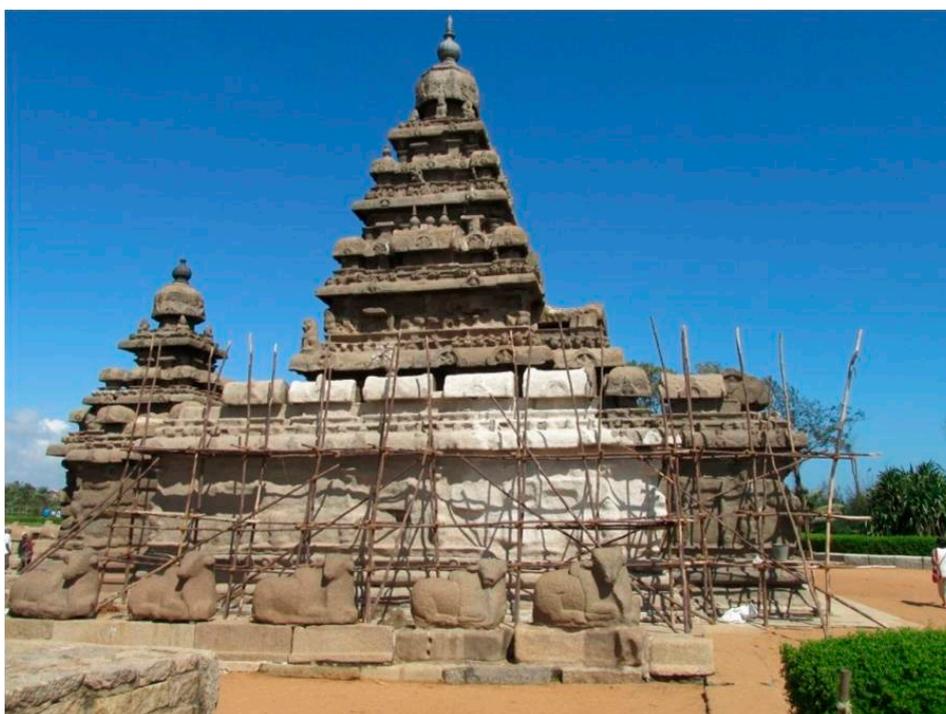
Figure 15. The photograph showing the paper pulp poultice application at the Shore Temple, Mahabalipuram.

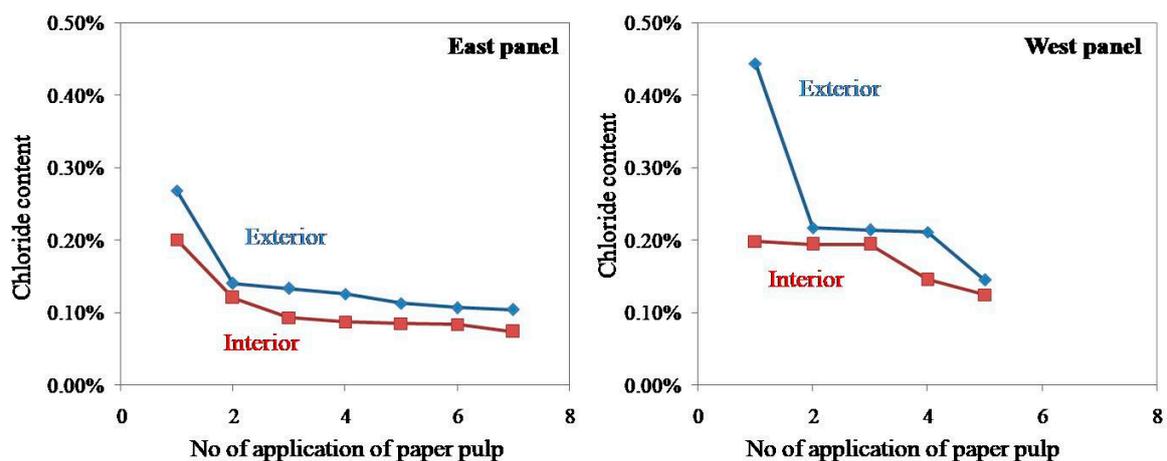
Figure 16. The graph of chloride percentage against a number of applications of paper pulp.

In the present study, the chloride content of paper pulp applied on both exterior and interior surfaces of a western panel of the monument was estimated, and the results are shown in Figure 16. The graph of chloride percentage versus a number of applications of paper pulp shows that the repeated application of paper pulp considerably reduced the concentration of salts, but the salt content could not be reduced beyond a certain point despite repeated applications. A nearly straight line in Figure 14 suggests that the cost of application of paper pulp would be very high if it continued beyond the fifth time. After the application of poultices treatment, the granitic stone turned to its original texture and color—on a limited scale. However, a constant spray of salts from the sea again replenished the salts, and the stone returned to its original condition.
