Article

Understanding Deterioration due to Salt and Ice Crystallization in Scandinavian Massive Brick Masonry

Citation: Balksten, K.; Strandberg-de Bruijn, P. Understanding Deterioration due to Salt and Ice Crystallization in Scandinavian Massive Brick Masonry. *Heritage* **2021**, *4*, 349–370. <https://doi.org/10.3390/heritage4010022>

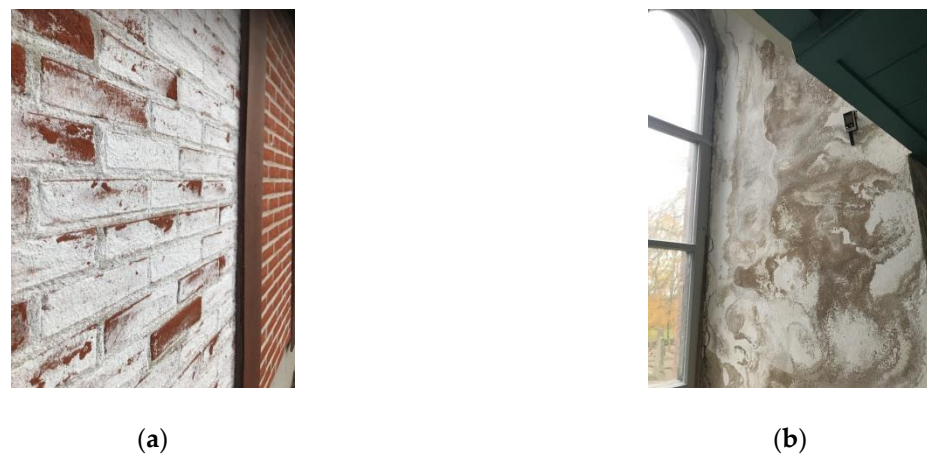
Figure 4. Sulphate damage to brick and cement surfaces: (a) Test wall built with bricks that were saturated with sodium sulphate. The surface of the bricks has been gradually degraded due to the explosive effect of the salts; (b) on a strong and dense cement plaster, sulphates are visible as dark salt roses where the paint layer has come off and the plaster has darkened as if it were constantly wet.

The most harmful salts for a plaster or a painted wall appear to be the sulphates [15,66], see Figures 1–4. These can be based on sodium Na_2SO_4 (forming salt crystals called thenardite or mirabilite) but also potassium K_2SO_4 , magnesium MgSO_4 and calcium CaSO_4 [67]. These are particularly harmful because sulphates crystallise in places where they cause great damage. They can cause disintegration due to crystallization in a porous material and they can also affect the dissolution of lime due to acid-base reactions. Sodium sulphate can crystallise inside the surface and switch between two phases (Na_2SO_4 and $\text{Na}_2\text{SO}_4 \cdot 10\text{H}_2\text{O}$) with an explosive effect due to hydration pressure and crystallization pressure [15,66].

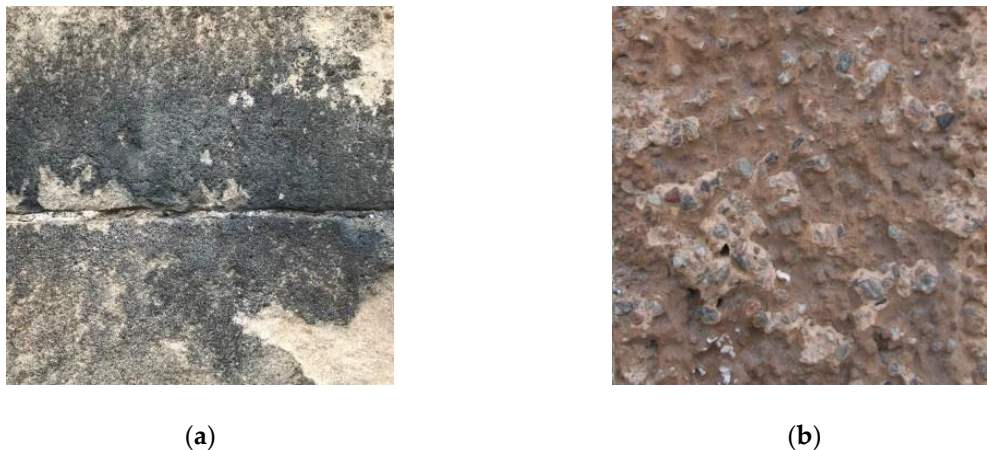
Figure 6. (a) Black crust is usually seen when sulphur has reacted with lime on the surface of calcareous rock or lime render and lime wash; (b) a close-up of a coloured lime cement mortar where the surface has transformed into gypsum. This causes the surface to appear to be very dirty. The original colour of the lime cement mortar can still be observed.

Calcium sulphate (gypsum) $\text{CaSO}_3 \cdot 2\text{H}_2\text{O}$ is usually formed on the surface of limestone or lime mortar as sulphur in the air reacts with lime to form gypsum [64,65]. Its salt crystals are called ettringite; see Figure 5. Where parts of the surface layer dissolve, it grows to form an often dirty or black crust on the outside; see Figure 6.

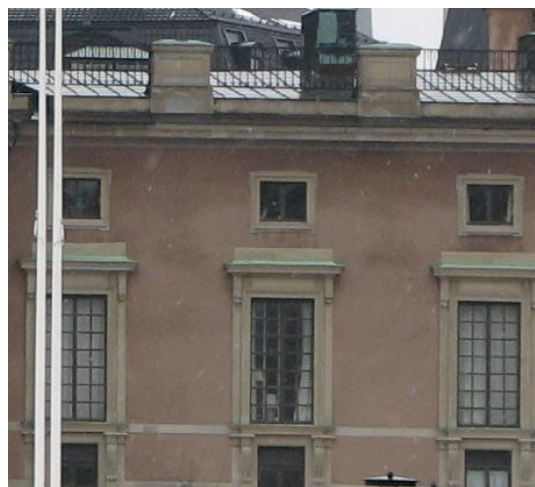
Figure 7. Stockholm Castle showing a coloured lime cement render. As sulphur-containing air causes the formation of gypsum, this usually shows clearly where the rain impinges on a façade. As gypsum is highly soluble in water, the damage is greatest on surfaces sheltered from rain.

Calcium sulphate forms on a rain-protected surface or crystallises inside a lime mortar by the sulphating of calcium carbonate, forming needles in the voids. Calcium sulphate is often formed when air pollution containing sulphur is involved in the process and is most intensely visible on the surfaces that rain does not reach [64,65]; see Figure 7.

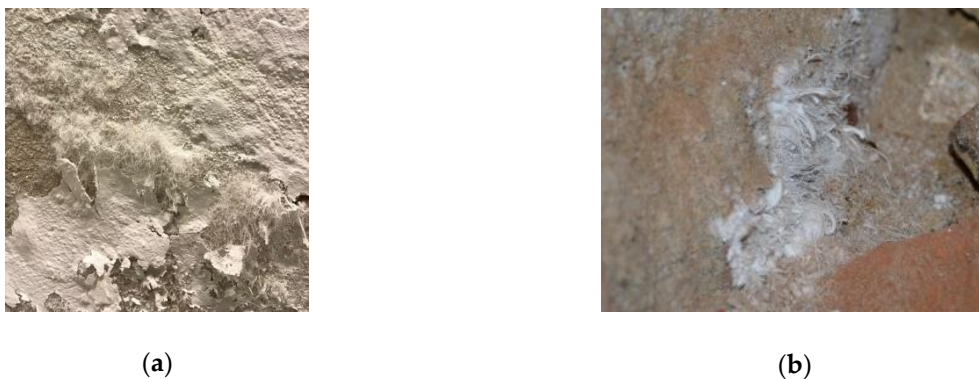
Figure 9. Examples of halite crystals that formed in basements where food had been stored: (a) Halite crystals on a brick wall; (b) halite crystals grow from a surface, forming both compact crystals and long strands.

Sodium chloride NaCl usually deposits on the surface, forming salt crystals called halite; see Figure 8. It grows like a beard, with salt crystals and long strands [26]. If there are tight/impermeable paint layers, it is deposited under the surface and lifts the paint off, but if there is a homogeneous porous material, it is deposited on the surface [10]. If the sodium chloride comes from sea winds, it does not usually cause great damage. In a hydration or dehydration process, it may, however, generate dissolution of the surface, since at different temperatures it can also affect other salts that may be present [62,67]. Sodium chlorides are often found in cellars used for food storage; see examples in Figure 9.

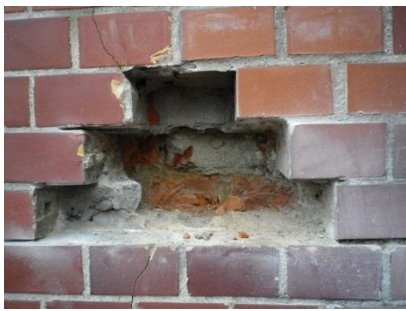
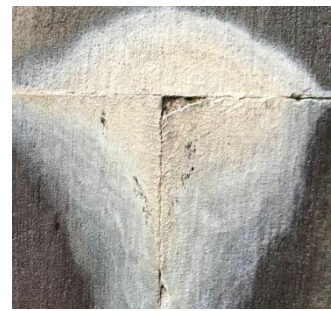
Figure 11. When lime mortar is trapped in a damp wall that is exposed to water for a long time, the lime dissolves: (a) The mortar in the brick wall is dissolved behind the dense surface of façade brick and cement mortar; (b) lime mortar from the inside of the wall is deposited as floatstone on the surface.

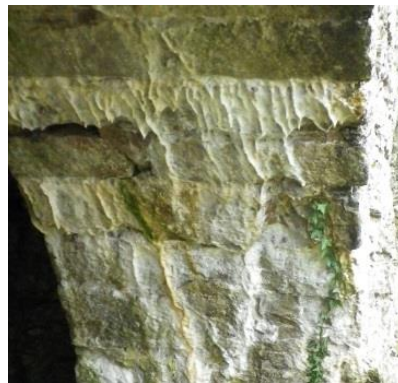
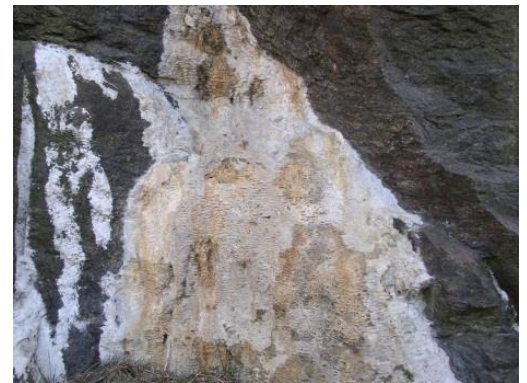
Figure 12. Lime dissolved inside masonry repointed with cement is deposited as stalactites on the surface: (a) Stalactites from dissolved lime mortar on Visby city wall; (b) floatstone on a granite wall.

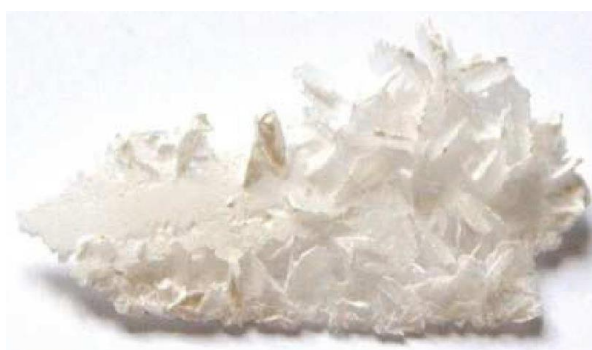
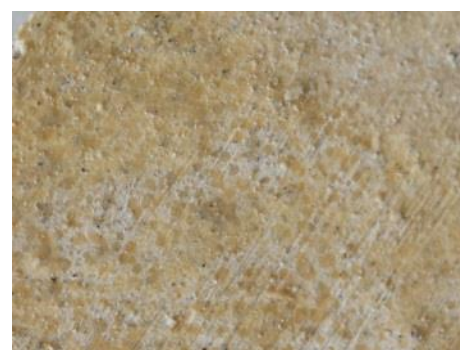
Figure 13. Calcite crystals: (a) Calcite crystals have grown slowly over time on a surface with free access to calcium hydroxide and water. The large trigonal crystals are approx. 5 mm; (b) a surface where calcite crystals were formed on the external surface of a matt lime paint. This gives an apparently oily film with a glassy character. The hexagonal shapes of the crystals are discernible.

Calcium carbonate CaCO_3 is the binder in lime mortar and limestone. Calcium carbonate itself has no disintegrating effect when crystallised [67,68], forming salt crystals called calcite; see Figure 10. It can, however, dissolve and recrystallise under prolonged humid conditions and with the presence of acidic salts. Upon recrystallization, it forms crusts that are very hard and difficult to dissolve. These can sometimes be seen on the outside of masonry repointed with cement, in the form of floatstones and stalactites; see Figures 11 and 12. It can also sometimes be seen as a thick, colour- intensive layer on lime render that has a dense film of binder at the surface, where the lime from inside the render has been deposited on the surface in a glassy calcite layer on the external surface of the lime wash; see Figures 13 and 14.

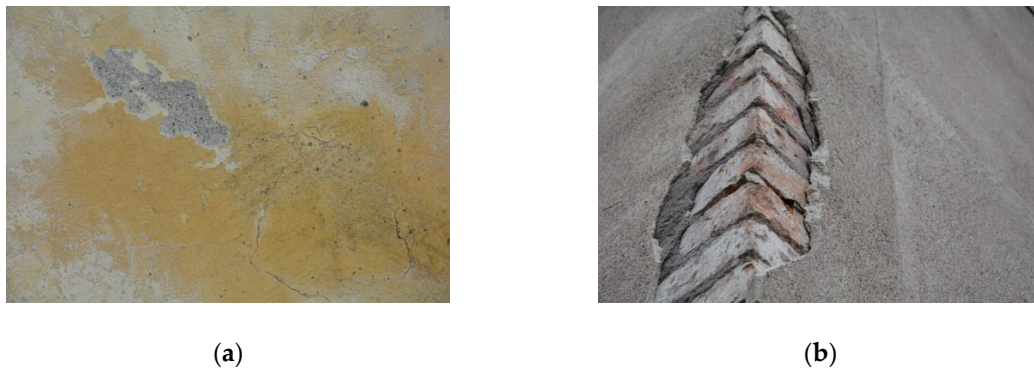
Figure 14. Calcite crystallization and recrystallization: (a) A thick, glassy film of calcite on the external surface of a lime wash. The calcite film prevents new lime wash from attaching, causing the lime wash to spall off when freezing; (b) the surface of a porous lime render restored in the 1970s has changed colour due to some recrystallization.

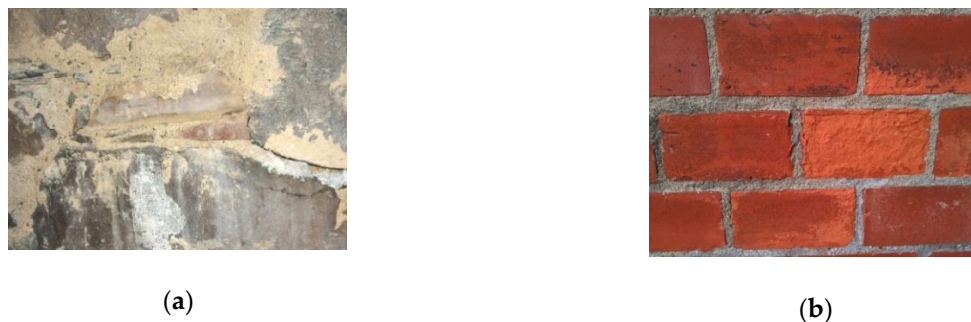
Figure 15. Frost damage on masonry: (a) A layer of ice covering brick inside a church tower. The ice is formed from water-saturated brick and so this effect is not found on the adjacent granite; (b) frost-damaged brick. On some bricks, only the compact surface layer has frozen off, and on others deeper frost damage has resulted in more extensive material loss.

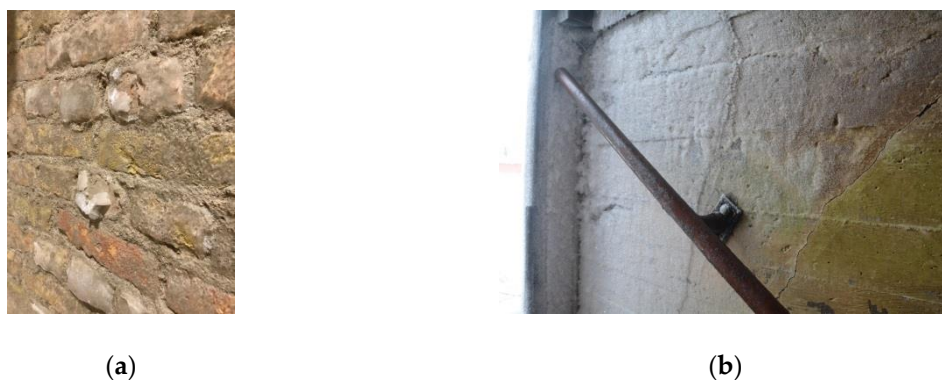
Figure 16. Ice crystal formation on masonry: (a) Ice crystals cover the entire inside of a brick tower on a cold winter's day. Here, the ice crystals have formed an armour-like layer of ice as well as some filiform crystals of approx. 2 cm; (b) an example from a basement where a thick layer of porous ice crystals covers the internal concrete surface. This phenomenon can be observed when porous materials saturated with water are exposed to frost.

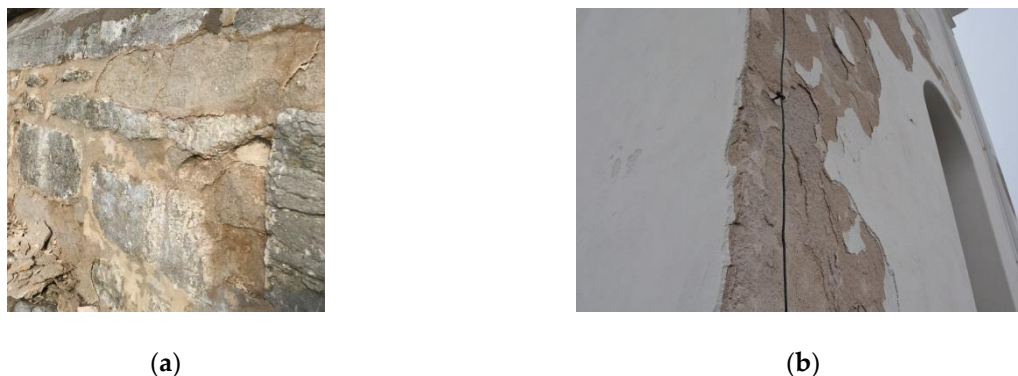
Figure 17. Spalling of lime mortar due to ice formation: (a) When lime mortar freezes and spalls off it leaves a characteristic flake-shaped pattern; (b) each separate render layer spalled off is caused by freezing temperatures in a lean lime render saturated with water.

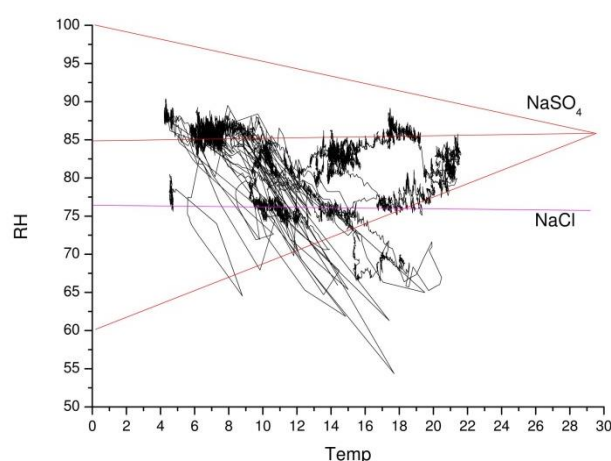
Figure 19. A diagram of climate measurement—indoor temperature [°C] and relative humidity [%]—in a salt-damaged church on the island of Gotland, Sweden. The indoor climate often exceeds the critical RH of sodium chloride (NaCl) or is between the two crystal phases of sodium sulphate (NaSO₄). Illustration by Magnus Wessberg, Uppsala University, and reproduced with his kind permission.

A phase diagram for sodium sulphate [19] shows how the salt moves between its different phases depending on relative humidity and temperature changes. Every time the climate in the material passes a phase a change occurs, causing what is known as a crystallization cycle, and the salt changes its crystal phase. As a result, the crystals degrade the material with every crystallization cycle. An illustrative phase diagram can be found in the references [19,71]. It is here exemplified in Figure 19, where temperature and RH were measured on an interior surface of a church with salt crystallization problems.

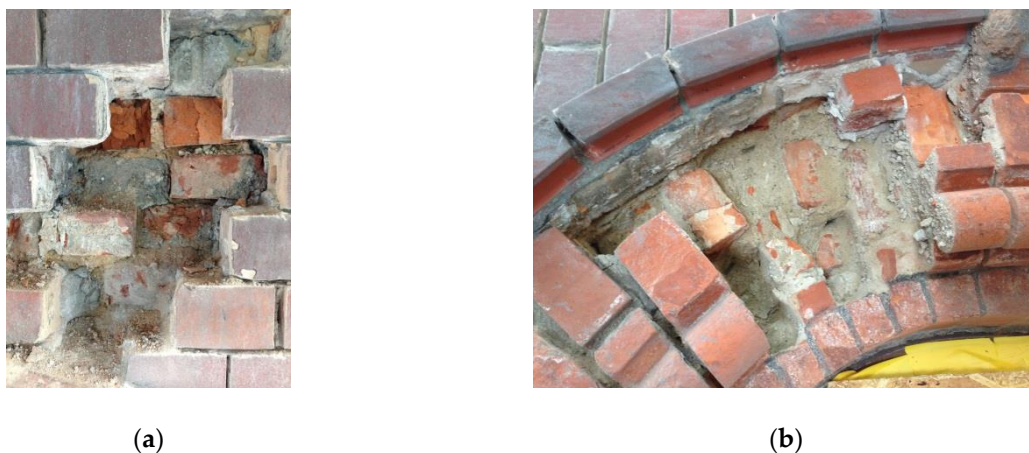
Figure 21. (a) Neo-Gothic masonry where accumulated moisture inside the masonry has caused “masonry rot”; (b) the bricks have frozen and split, while the lime mortar has assumed the character and characteristics of wet sand.

When degradation has been ongoing over several decades, which is currently the case with most large historic masonry constructions in Scandinavia, it has often caused the lime binder, initially present as binder in joints and bedding mortars, to leach out [4,56]. The high content of moisture inside the masonry has likewise led to frost damage inside the wall. What remains inside the masonry is not a bedding mortar with bonding ability but mainly moist, lime-containing sand. This phenomenon is described in archive material [5] where it was observed that both the mortar and the bricks had been completely pulverised and had a high moisture content—in older Swedish literature this is sometimes described as “masonry rot” [73,74]; see Figure 21.
