# Conservation of Earthen Bricks in Architecture: An Experimental Campaign to Test Different Treatments on Vernacular Built Heritage

**Keywords:** earthen architecture; earthen bricks; conservation issues; protective products; test methods

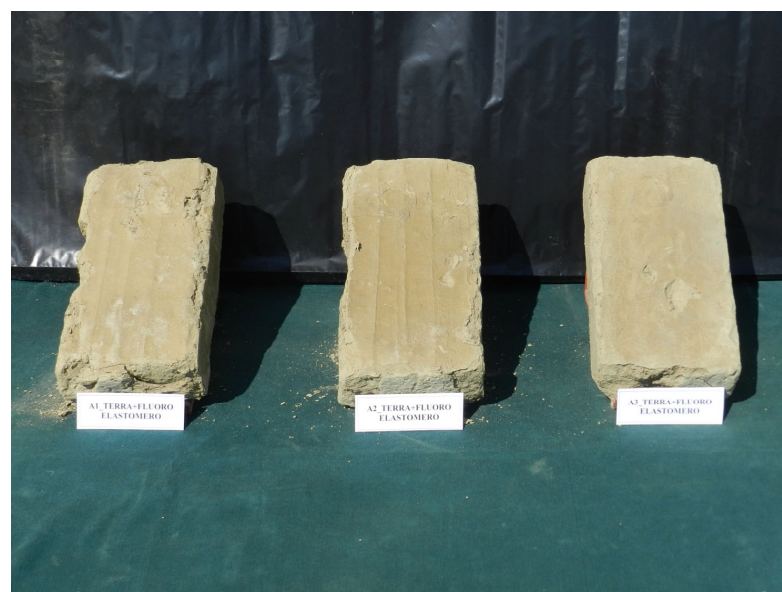
**Figure 5.** Earthen bricks: Specimens made with local earth (from Alessandria, Italy) and treated with a fluoroelastomer (Tecnoflon N215).

The dimensions of the earthen bricks used for the experimentation were  $26 \times 13 \times 6$  cm. Not fissured bricks with relatively regular surfaces were chosen. They were previously cleaned with a chisel stonemason and a brush, removing all traces of plaster, mortar, and any vegetal residues (Figures 5 and 6).

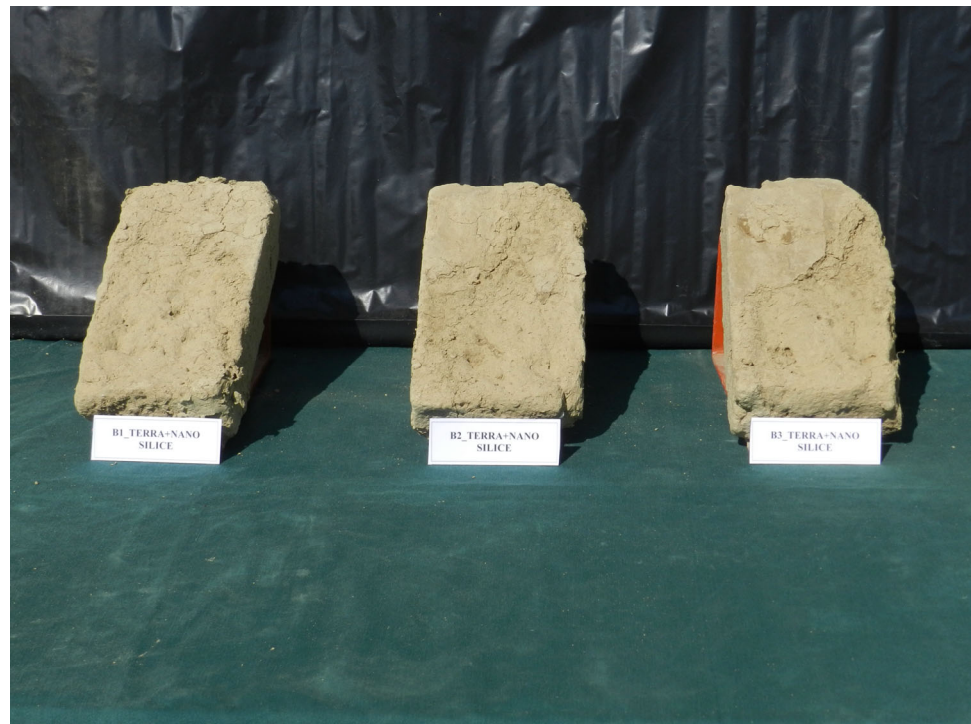
**Figure 6.** Earthen bricks: Specimens made with local earth (from Alessandria, Italy) and treated with nano-silica (Nano Estel).

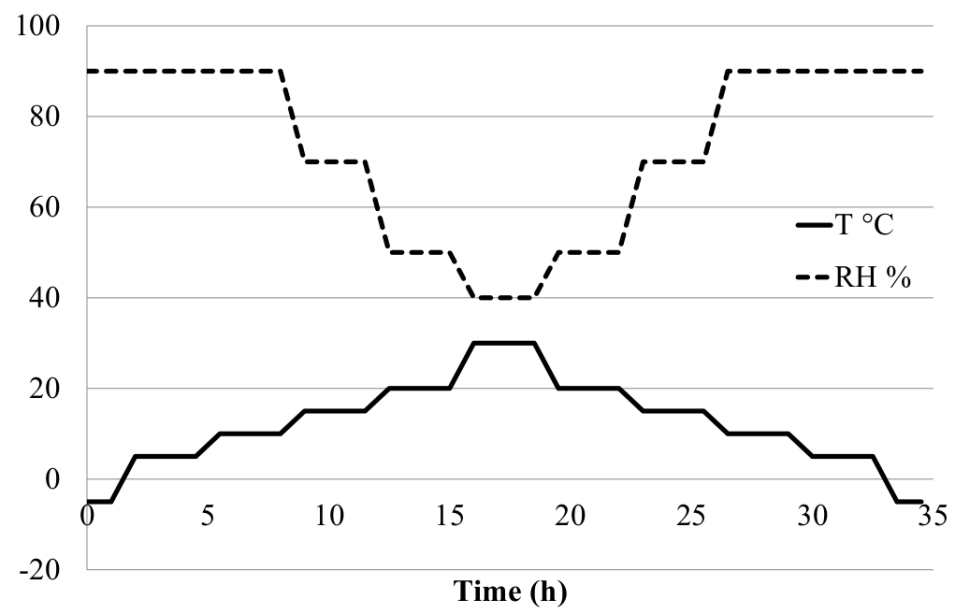
**Figure 7.** Diagram representative of the TH cycle (credit: Rescic).

The not treated and treated earthen bricks were exposed to artificial ageing in an Angelantoni Challenge 500 Climatic Chamber. The thermo-hygrometric conditions were simulated experimentally based on the cycle represented in Figure 7. This cycle was carried out by reprocessing original data recorded by “Rete di Monitoraggio Meteoidrografica” of ARPA Piedmont in the Alessandria Lobbi weather station over ten years. The data were averaged, and one-year behaviour was converted to an RH cycle of 35 h ranging from  $-5^\circ\text{C}$  to  $30^\circ\text{C}$  and from 40 to 90% RH. The cycle was repeated 50 times. Colorimetric change, weight, and contact angle measurements were performed before and after accelerated ageing.

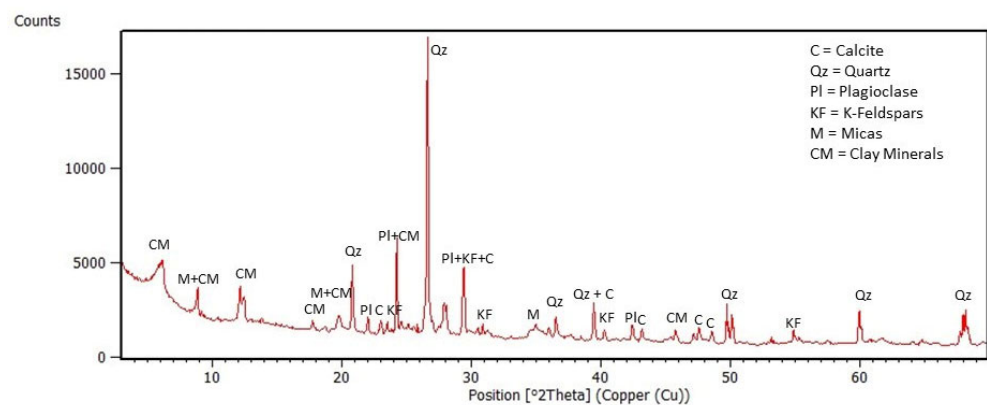
**Figure 8.** XRD diagram of the main mineralogical composition of the earthen not treated brick (credit: Rescic).

The grain size distribution of the earthen material (sand 24%, silt 45%, clay 31%) taken from the farmhouse under demolition was obtained through sieving. The main mineralogical composition of the earthen bricks, performed by X-ray diffraction, is as follows: quartz, feldspars, calcite, micas, and clay minerals (Figure 8).

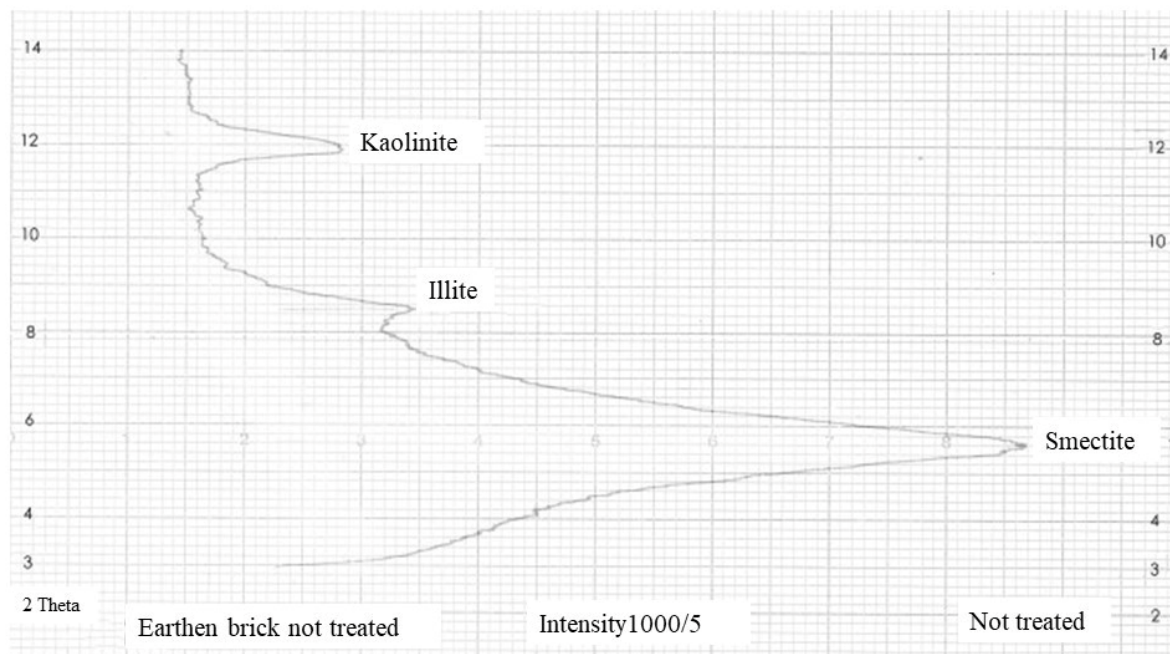
**Figure 9.** XRD diagram of the clay mineral fraction: Not treated sample.

The semi-quantitative composition of the clay fraction was as follows: kaolinite 35%, illite 20%, and smectite 45% (Figures 9–11).

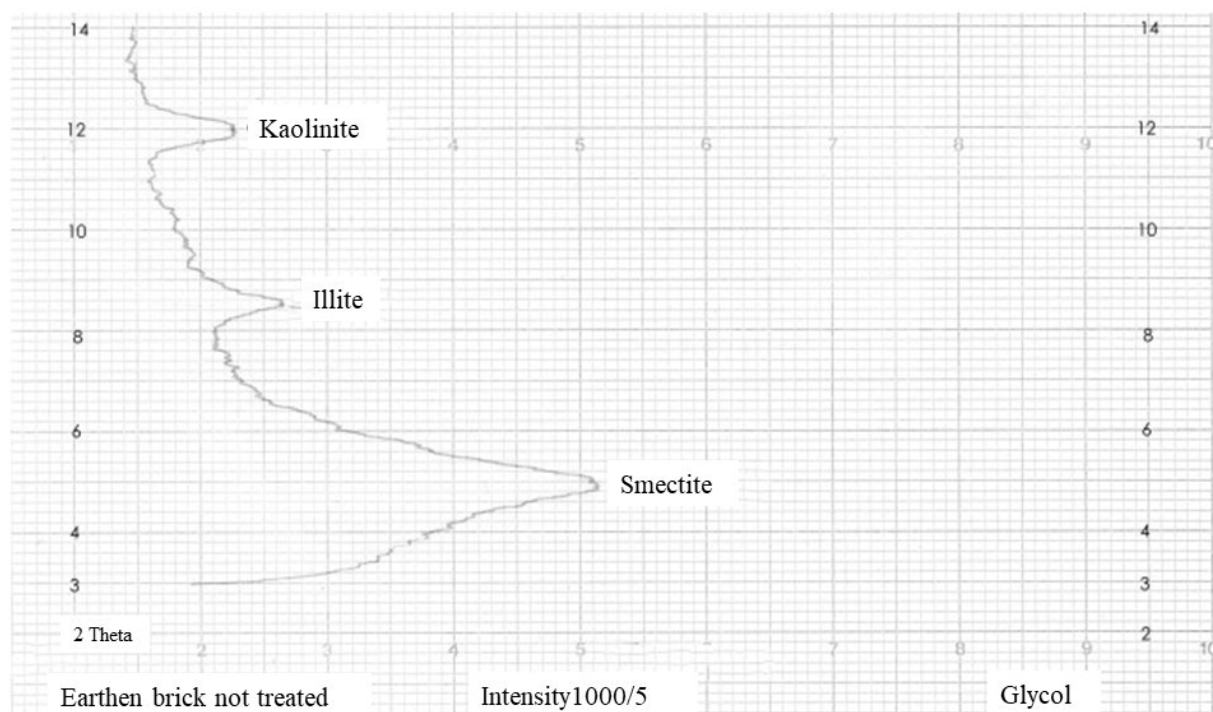
**Figure 10.** XRD diagram of the clay mineral fraction: glycol sample.

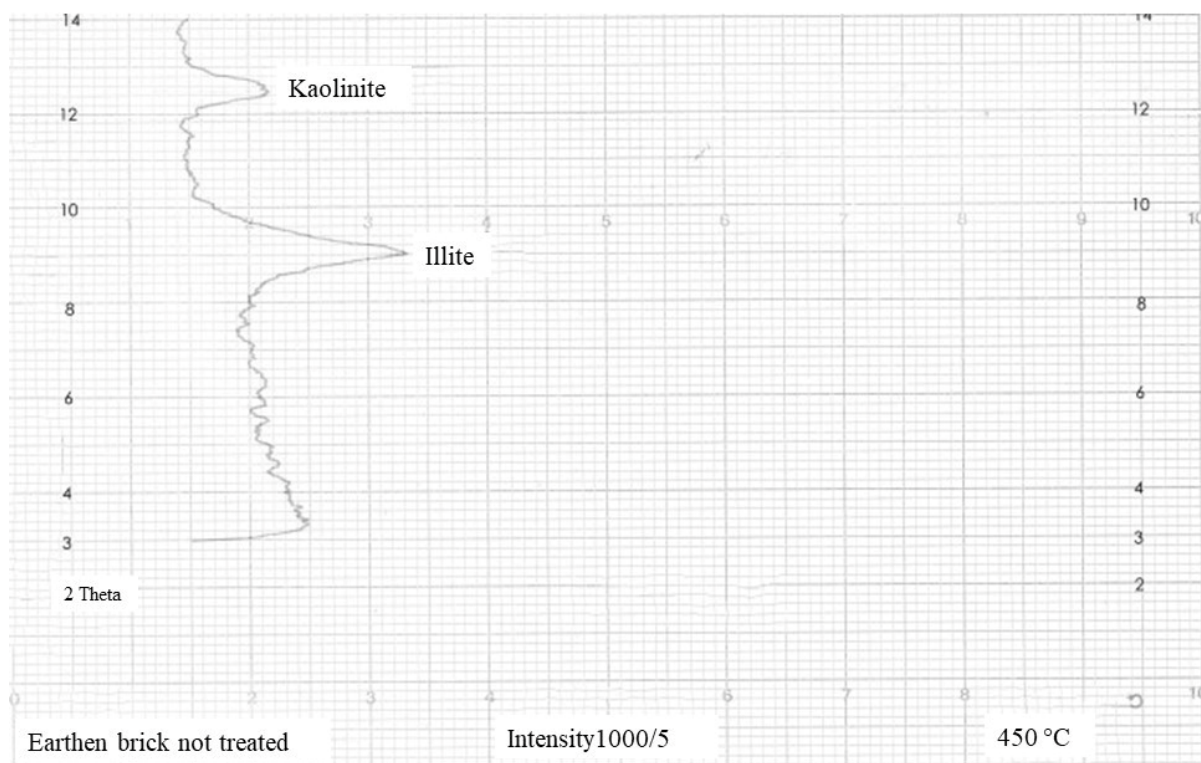
**Figure 11.** XRD diagram of the clay mineral fraction: sample at 450 °C.

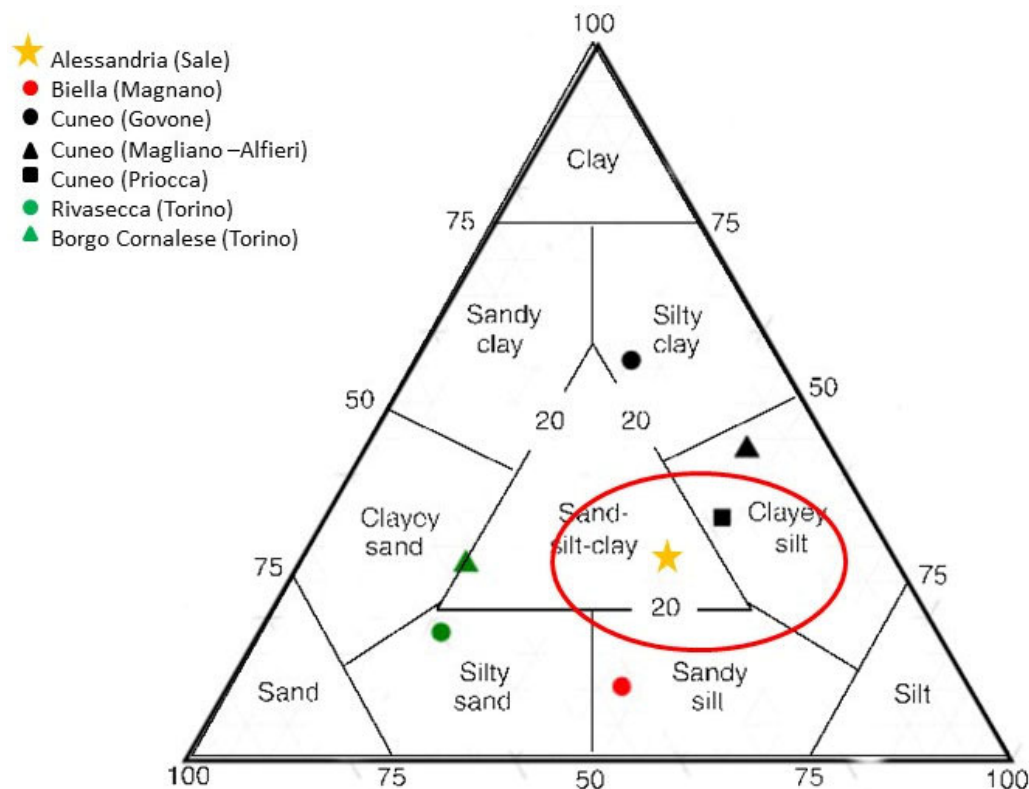
**Figure 13.** Diagram of the grain size composition of the earthen brick from Sale (Alessandria) compared with others from the Cuneo, Biella, and Turin provinces; within the red circle is the area of acceptability for adobe reported by CRAterre.

The bricks from Sale and Priocca (Figures 12 and 13) lie in this area, while those of Govone and Magliano-Alfieri are more clayey. Another similarity with the bricks from the Cuneo area concerns the mineralogical composition of the clay fraction with the presence

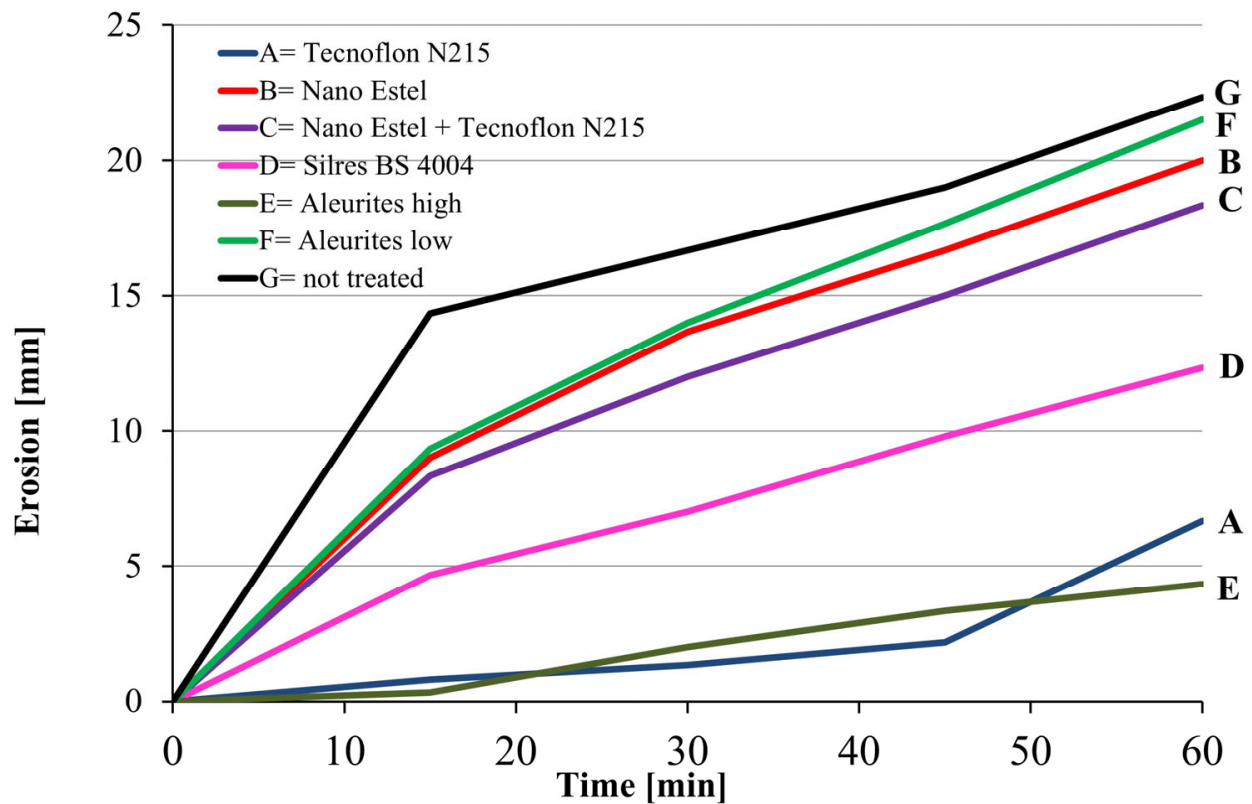
**Figure 14.** Spray erosion test diagram (credit: Mattone).

The results of the spray erosion tests are shown in Figure 14.

The results of the spray erosion test allow for the following considerations:

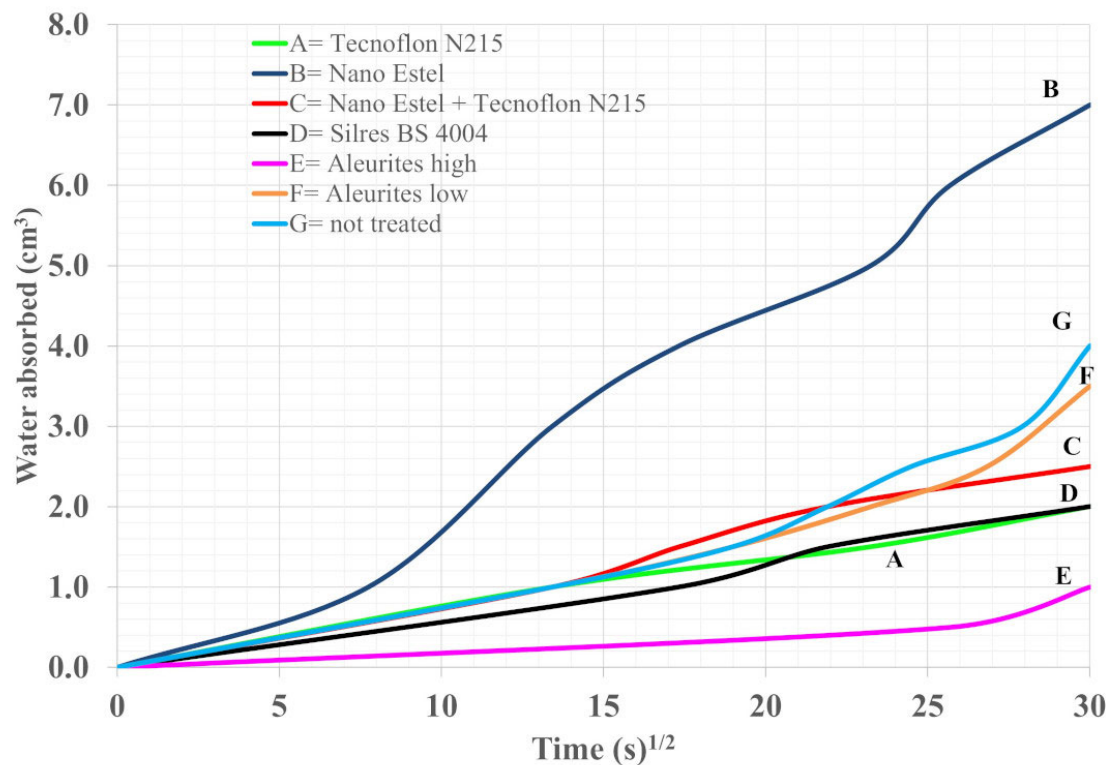
Figure 15. Water absorption diagram.

The results of the water absorption test with the Karsten method are shown in Figure 15.

The results of the water absorption test allow for the following considerations:

- Earthen brick B (Nano Estel) showed the worst results compared to the not treated brick (G). It absorbed the maximum amount of water (i.e., 7 cm<sup>3</sup>) and began to absorb from the first minute. This result is not unexpected for two reasons: nano silica is a consolidating but not a protective product, and second, it is applied in an aqueous solvent. The aqueous solvent could have caused partial melting of the earth with a reorganization of the matter that favoured the creation of a porous network more accessible to liquid water [47];

- Earthen brick D began to absorb water after 6 min, showing that the treatment decreased water absorption. Nevertheless, at the end of the test, the amount of absorbed water was similar to that of A and C, even if lower than the untreated brick.

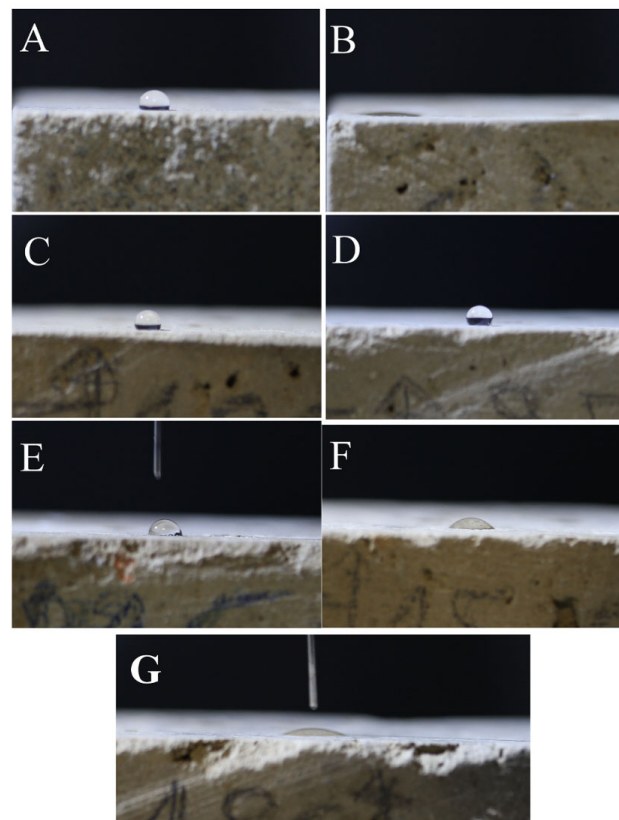
**Figure 16.** Contact angle of the earthen brick samples treated (A–F) and not treated (G). (A = Tecnoflon N215; B = Nano Estel; C = Nano Estel + Tecnoflon N215; D = Silres BS 4004; E = Aleurites high; F = Aleurites low; G = not treated) (credit: Rescic).

The hydrophobic action of the treatments was also performed through an evaluation of the contact angle change. The results are shown in Figure 16 and Table 6.

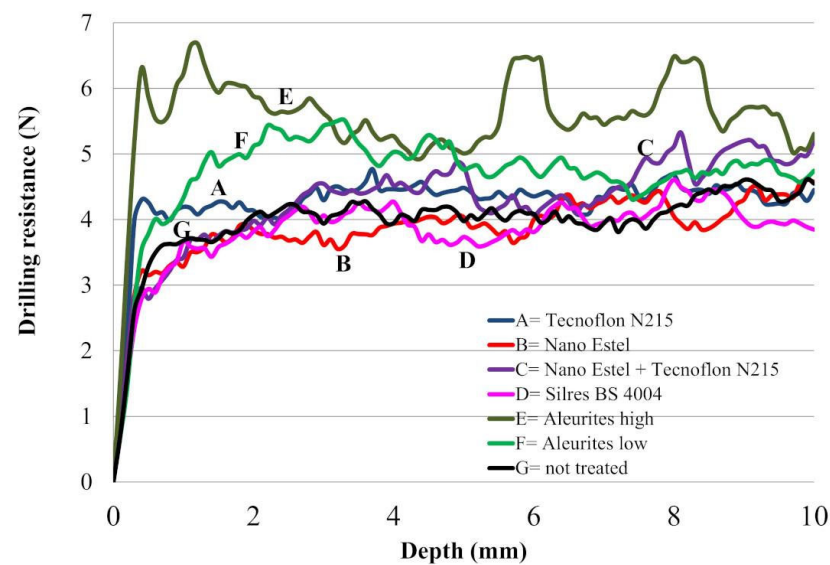
**Figure 17.** Drilling resistance profiles (A = Tecnoflon N215; B = Nano Estel; C = Nano Estel + Tecnoflon N215; D = Silres BS 4004; E = Aleurites high; F = Aleurites low; G = not treated) (credit: Rescic).

The results reported in Table 9 and Figure 17 show that:

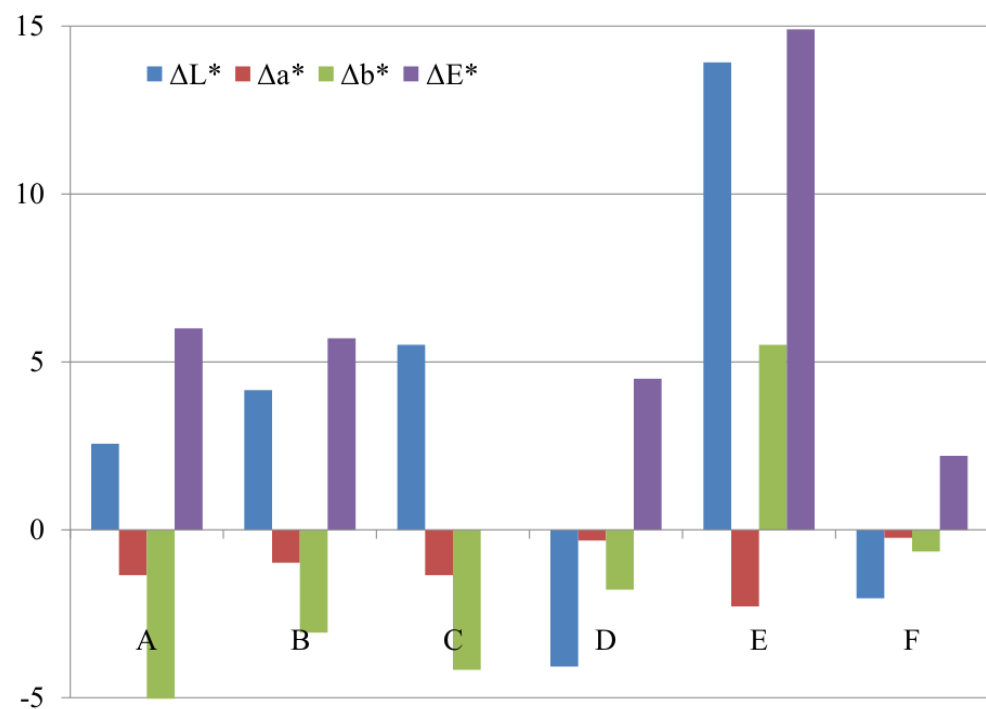
**Figure 18.** Average values of the variations in the chromatic parameters of the different treatments (A = Tecnoflon N215; B = Nano Estel; C = Nano Estel + Tecnoflon N215; D = Silres BS 4004; E = Aleurites high; F = Aleurites low; G = not treated) (credit: Luvidi).

All treatments, except for D and F, showed a total variation in colour perception ( $\Delta E$ ) appreciable with the naked eye ( $\Delta E > 5$ ). In particular:

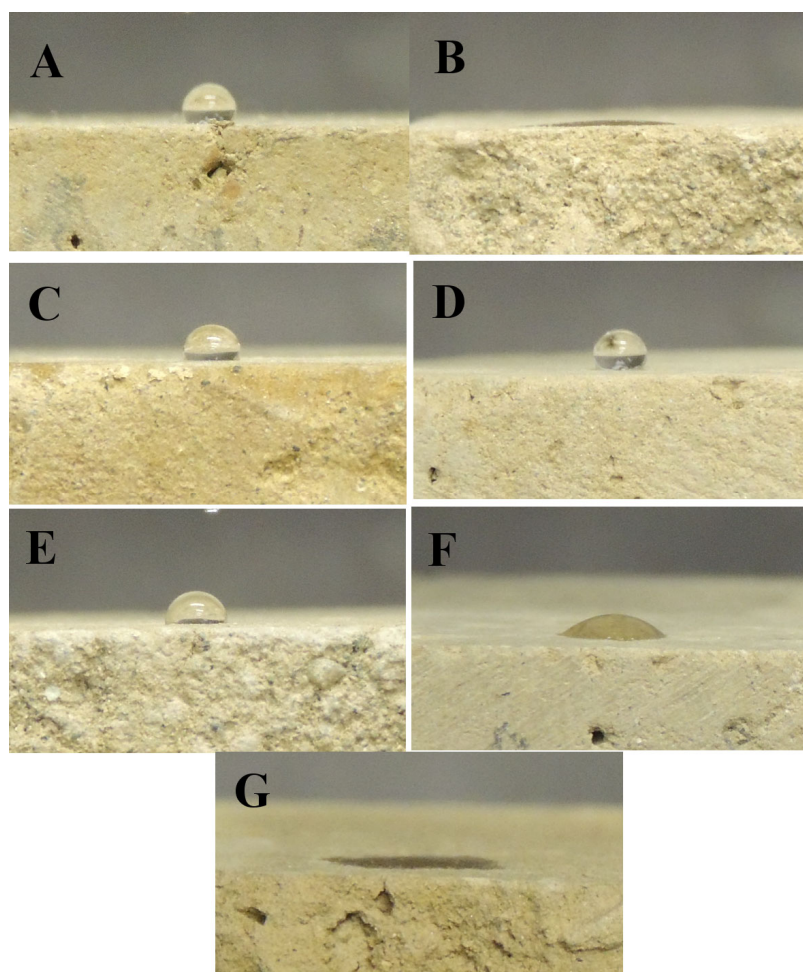
**Figure 19.** After ageing, contact angle of the earthen brick samples treated (A–F) and not treated (G). (A = Tecnoflon N215; B = Nano Estel; C = Nano Estel + Tecnoflon N215; D = Silres BS 4004; E = Aleurites high; F = Aleurites low; G = not treated) (credit: Rescic).

The untreated earthen brick appeared to be the only one with a slight worsening in its natural capacity of hydrophobicity, with a contact angle reduction and an increased absorption rate. The contact angle and the corresponding water absorption rate for all other treatments remained practically unchanged.
