# Conservation and In Situ Enhancement of Earthen Architecture in Archaeological Sites: Social and Anthropic Risks in the Case Studies of the Iberian Peninsula

**Abstract:** Archaeological sites constitute one of the main tourist attractions in the heritage offerings of most populations. Their ability to convey the ways of life and construction techniques of past societies through physical remains positions them as a culturally significant alternative for visitors. However, their physical conservation, essential for efficiently ensuring information with precision, poses a serious challenge for the various professionals involved, as numerous social and anthropic risks threaten long-term preservation for the enjoyment of future generations. Of all traditional building materials, earth is undoubtedly one of the most fragile and sensitive to loss in the absence of the original protection systems, so that a precise assessment of its threats is essential to minimizing the destruction of these non-renewable assets. The objective of this study is to evaluate the most determining human risk factors within the territorial scope of the Iberian Peninsula, including aspects such as its museali

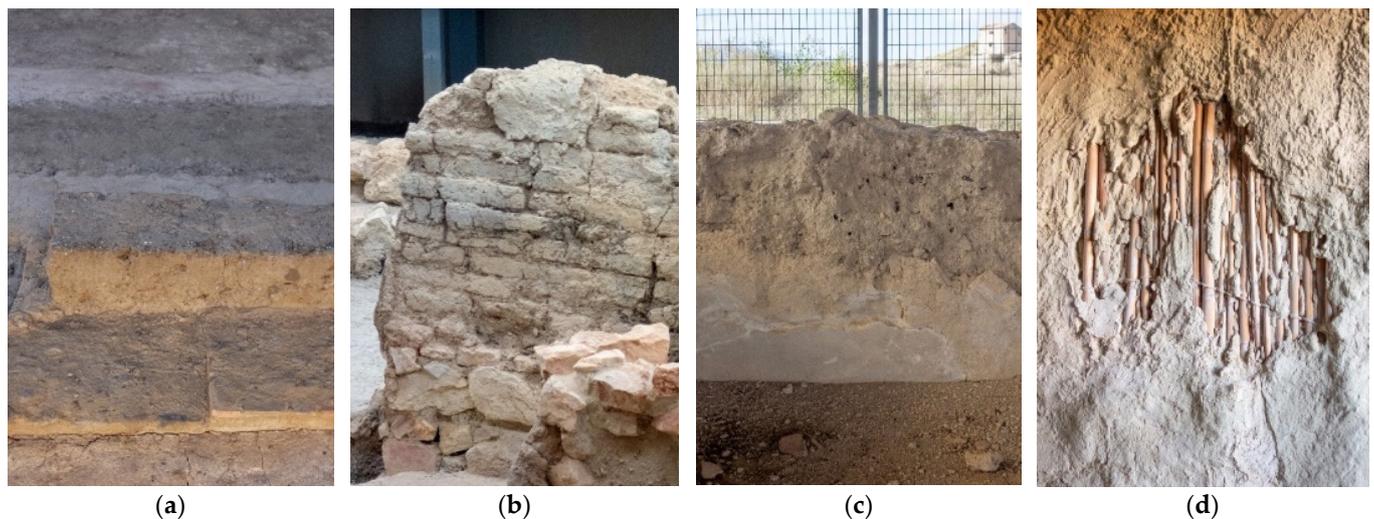
**Figure 1.** Earthen architecture families identified in the study area: (a) Cob wall at the archaeological site of the Roman villa La Olmeda (Pedrosa de la Vega, Palencia); (b) Adobe wall with alternating courses at the Roman domus in sector 18 of Libisosa (Lezuza, Albacete); (c) Rammed earth and plaster wall in the Mezquita del Cortijo del Centeno (Lorca, Murcia); (d) Modern reconstruction of a mixed wall with woven reeds at Castellón Alto (Galera, Granada).

The different studies carried out in Spain have revealed a rich representation of all sorts of construction techniques, although these are far more limited among the more vulnerable typologies, such as domestic, productive and funerary constructions, given their characteristics and size. These vulnerable groups are of greater interest as case studies, as they feature different remains in cob (Figure 1a), adobe (Figure 1b), and rammed earth (Figure 1c), as well as mixed structures in conjunction with wood. However, that combination cannot be directly observed in their original execution on site due to the biological nature of wood, which facilitates its decomposition over time, and requires interpretative reconstructions for the purposes of education (Figure 1d). The most commonly preserved cases until the Roman period are stabilized adobe structures with vegetation, complemented with stone masonry at the base [13]. In contrast, rammed earth appears to have been standardized at a later stage [14], while preserved examples of cob are identified less consistently.

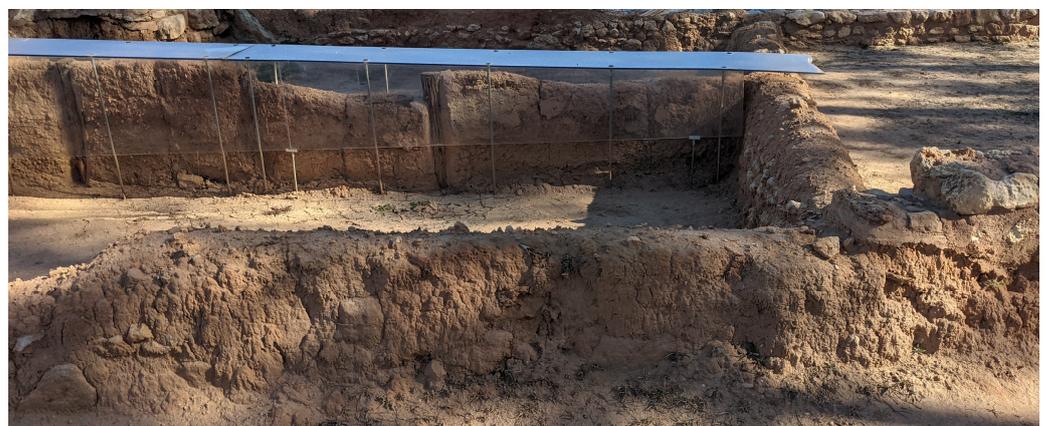
**Figure 2.** Earthen structures preserved and protected in the archaeological site of La Celadilla (Ademuz, Valencia).

While in recent times the preservation of these remains was predominantly addressed in response to natural threats, including quantitative assessments of cultural heritage in specific relation to those associated with climate change [19–22], the demand for new awareness of human actions in this field began to emerge at the end of the last century [23]. This aimed to encompass the entire process, from the survival of remains in the natural substrate despite agriculture or soil material extraction; uncovering and rescue measures; management, physical protection, and legal safeguards. Evaluating associated human factors can serve as a starting point for proposing guidelines and strategies in the adaptation of earthen archaeological sites to minimize effects, to contribute to the preservation of remains for future generations, as well as to promote the proper transmission of non-renewable historical, construction, and ethnological knowledge they hold (Figure 2).

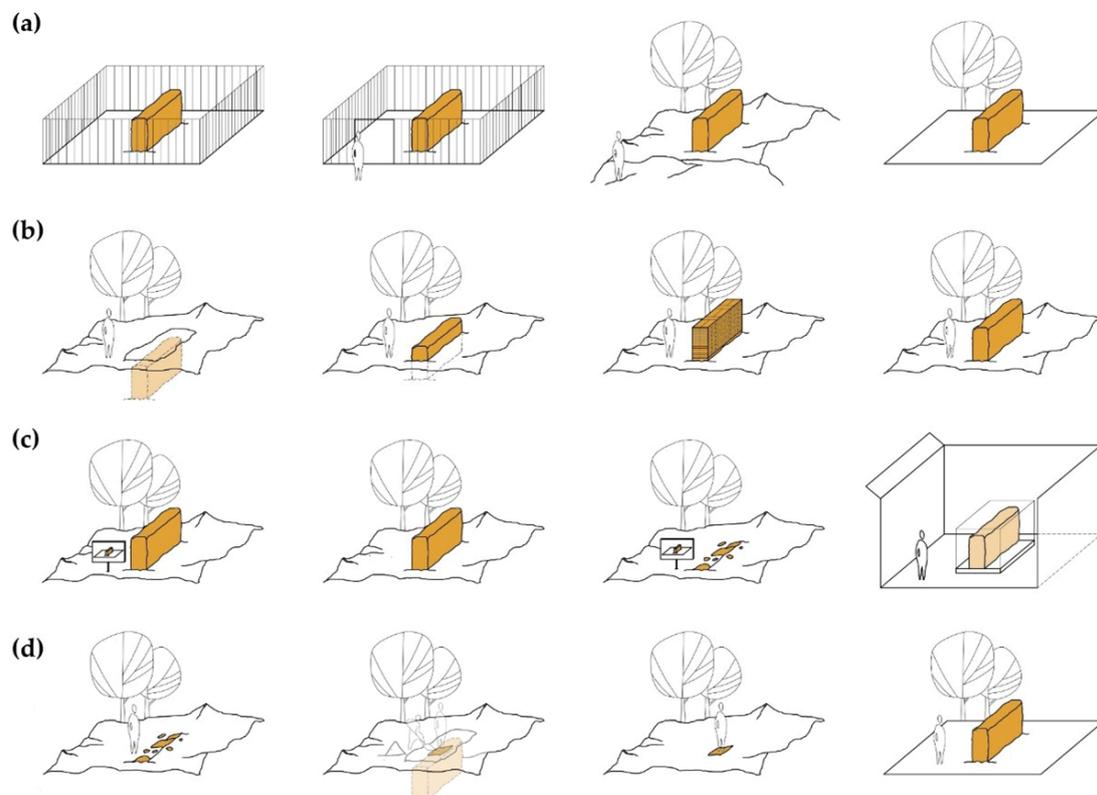
**Figure 4.** Schematic examples of analysed features: (a) Restricted access, limited, obstructed, or completely free; (b) Limited exposure due to burial, partially visible, visible with modern materials or original materials; (c) Visible with information, visible without information, through signage, or showcased in a museum; (d) Destruction, looting, walking over or without vandalism.

its decontextualization, as modern intervention increases its invasiveness into structures, potentially causing issues for the interpretation of original materials and techniques, as well as undesired homogenizations [5] (Figure 4b); or musealization efforts (in situ or ex situ), where the selection of signage content linked to these tasks has been under discussion [31], limiting the visitor's experience of this type of architecture, as the signage of conservation of original materials is considered optimum, with the capacity of transmission decreasing depending on which of these is lacking [23], until its decontextualization due to transfer to a museum (Figure 4c) or the destruction and rendering hidden of remains.

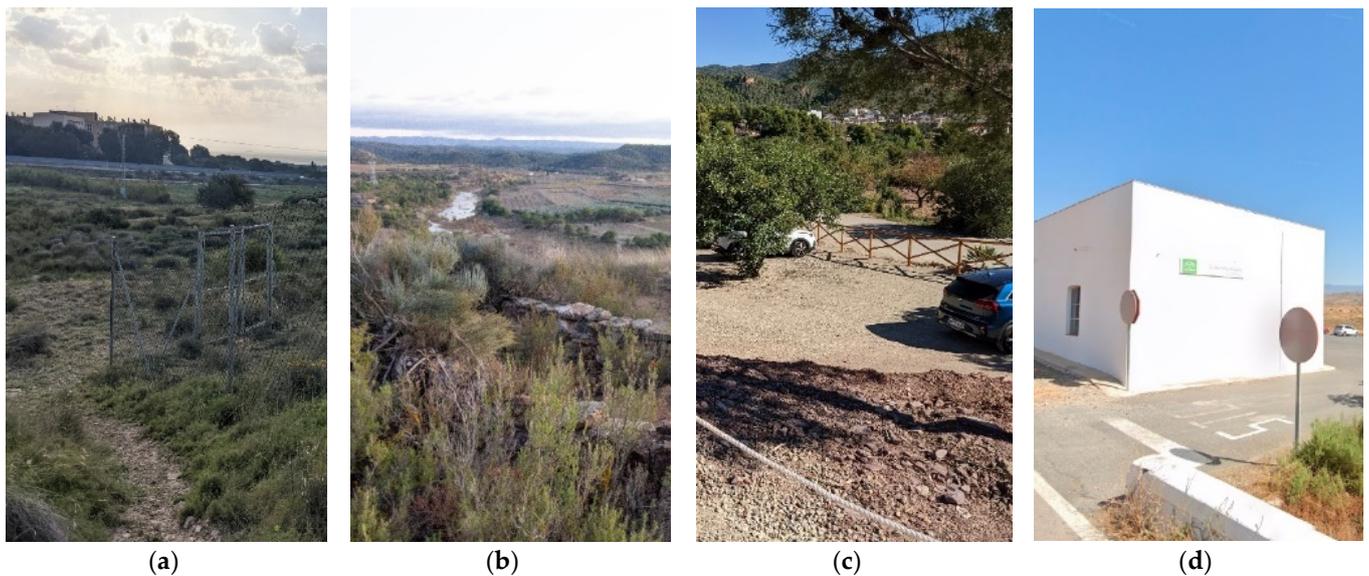
**Figure 5.** Examples of access and visits in different archaeological sites: (a) Restricted access, lack of a road and musealization efforts at El Oral (San Fulgencio, Alicante); (b) Full-time open access through rural roads in Tossal del Moro (Pinyeres, Tarragona); (c) Roadside parking with a pedestrian path to Puntal dels Llops (Olocau, Valencia); (d) Vehicle parking adjacent to the site in Los Millares (Santa Fe de Mondújar, Almería).

In this regard, the records from Spain present a high number of sites accessible via paved roads with varying degrees of suitability, making up 82% of the sample. However, there are different situations, such as the lack of paved accessibility, as in the case of El Oral (San Fulgencio, Alicante) (Figure 5a), complicating future valorisation efforts. Other examples include the absence of arrival signage and the use of agricultural roads, as seen in Tossal del Moro (Pinyeres, Tarragona) (Figure 5b); the construction of parking lots connected by pedestrian pathways to the archaeological site in Puntal dels Llops (Olocau, Valencia) (Figure 5c) or adjacent to the archaeological site itself, as in the cases of Vilars d'Arbeca (Arbeca, Lleida) and Los Millares (Santa Fe de Mondújar, Almería) (Figure 5d). This implies that one fifth of the sample would clearly be difficult for the general public to access, although it could also potentially have a positive effect by hindering illegal prospecting for looting or vandalism.

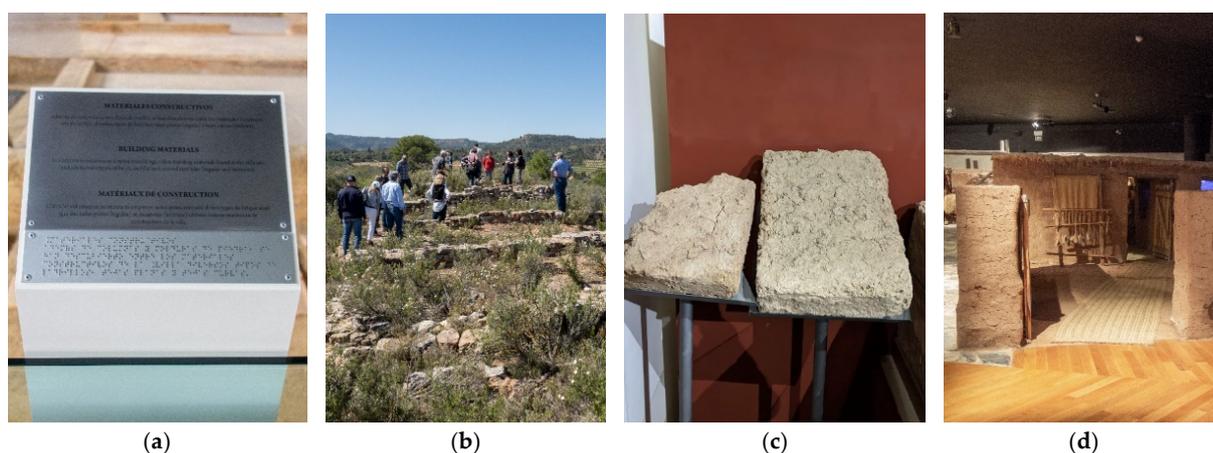
**Figure 10.** Examples of musealization and dissemination in different archaeological sites: (a) Selection of construction content excluding earthen techniques at the Roman villa of La Olmeda (Pedrosa de la Vega, Palencia); (b) Guided tours with a focus on adobe construction at Tossal del Moro (Pinyeres, Tarragona); (c) Exhibition of movable assets (adobes) extracted from the excavation at the museum of Cerro de la Cruz (Almedinilla, Córdoba); (d) Ex situ reconstruction of an earthen dwelling at the interpretation centre of the Cerro de las Cabezas (Valdepeñas, Ciudad Real).

selection, potentially prioritizing other areas (historical, anthropological, etc.) over earthen construction (Figure 10a), without making up for the omitted information through QR codes or websites. This can result in information silence, further exacerbating the already diminished social recognition of earthen architecture by the general public, as seen in La Olmeda (Pedrosa de la Vega, Palencia), where reconstruction videos do not explore the material architectural characterization.

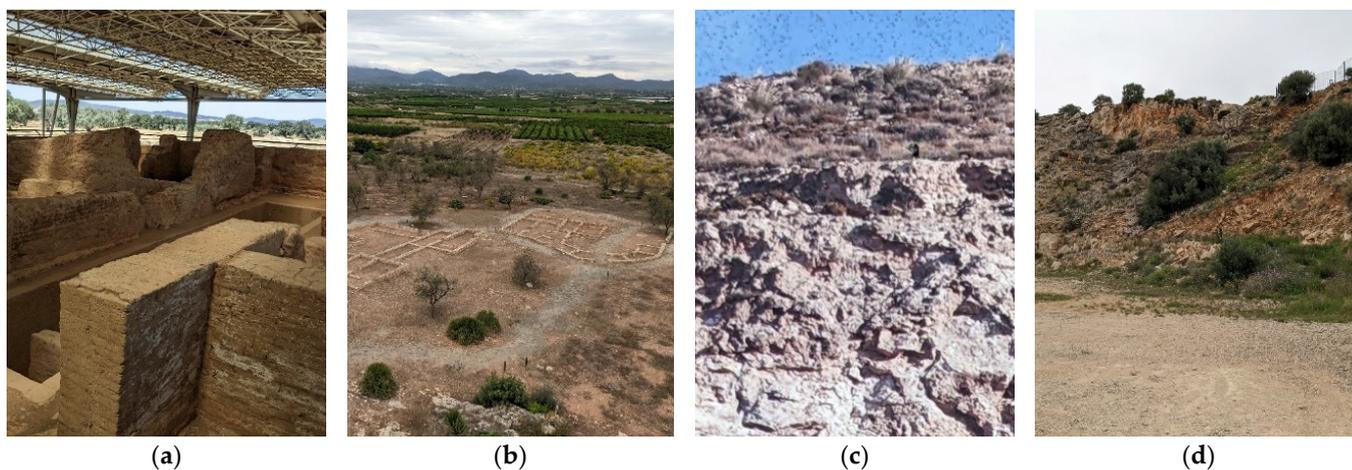
**Figure 15.** Examples of events and threats regarding land use: (a) In the foreground, reconstructed adobes after loss caused by agricultural activities. In the background, original structures unaffected by these, at Cancho Roano (Zalamea de la Serena, Badajoz); (b) Agricultural use near the archaeological site of Alquería de Bofilla (Bétera, Valencia); (c) Loss of structures due to gypsum quarrying at Cabezo Redondo (Villena, Alicante); (d) Loss of structures due to stone quarrying at Puig de la Nau (Benicarló, Castellón).

These scenarios have been observed in various archaeological sites under study, such as Cancho Roano (Zalamea de la Serena, Badajoz), where the impact of agriculture has led to the destruction of half of the adobe walls [44] (Figure 15a), which are currently reinterpreted through reconstructions. Another example is the Castellet de Banyoles (Tivissa, Tarragona), where the walls were reduced to a mere 30 cm in height [45] and have now been entirely lost. Other examples of reported intense agricultural activity could include the Castanheiro do Vento complex (Vila Nova de Foz Côa, Guarda), affecting the south, east, and west [46]; Casa del Mitreo (Mérida), in agricultural operation until the 20th century; or the Roman villa Piecordero I (Cascaete, Navarra), with potential damage [47]. However, while the relationship between archaeological discoveries and farming activities is common, quantifying the actual extent of loss of structures is challenging once the remains are found. In general terms, up to 61% of the sample does not present a notable current risk due to factors derived from this issue, while 31% of structures are located in neighbouring or adjacent plots, and 9% show explicit agricultural use either before or after excavation (Figure 13).

The destruction caused by material extraction, now inactive, has potentially contributed to the widespread disappearance of structures, as observed in Puig de la Nau (Benicarló, Castellón) [33] (Figure 15d), El Oral (San Fulgencio, Alicante), and Cabezo Redondo (Villena, Alicante) [49] (Figure 15c), making 7% of total case studies; 93% of the samples did not experience these threats (Figure 14). It should also be noted how these earth-moving activities can introduce changes in topography that alter water runoff, disruptions in soil stratigraphy, or complications for tourist or scientific visits.

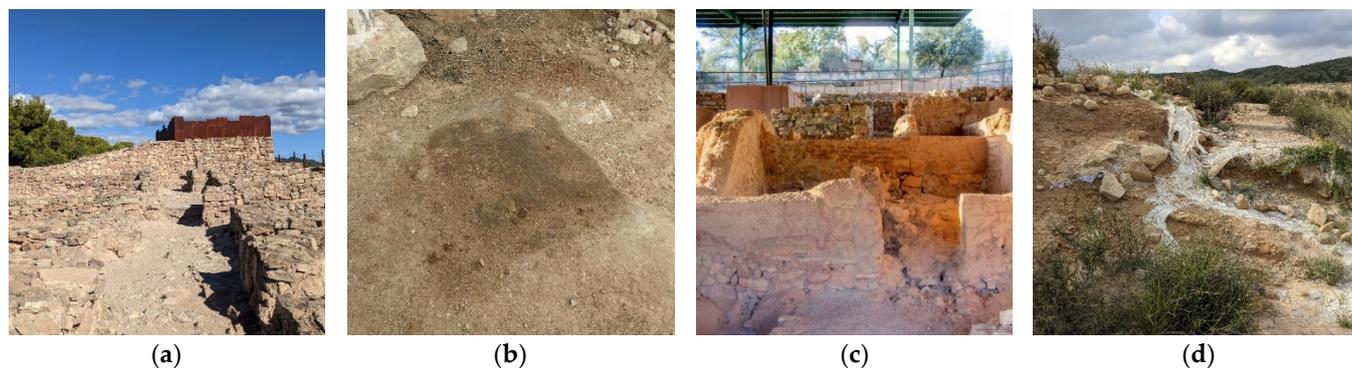
**Figure 17.** Examples of events and effects related to anthropic damage: (a) Anthropogenic integral destruction of adobe structures at Puntal dels Llops (Olocau, Valencia); (b) Volume loss due to trampling in the hearth at Puig de la Nau (Benicarló, Castellón); (c) Reduction in height and thickness in adobe structures at Cerro de la Cruz (Almedinilla, Córdoba), currently restored; (d) Potential walking over due to elevation changes at Caramoro I (Elche, Alicante).

However, these degradation effects can also indirectly be caused by the visiting public, either due to poorly planned circulations and routes, an excess of visitors, or other damage derived from poor awareness of value and preservation. This can take the form of walking over or carving on the structures. This damage can range from the complete destruction of earthen structures, as seen in Puntal dels Llops (Olocau, Valencia) [34] (Figure 17a) and La Casa Grande (Alcalá del Júcar, Albacete) [51], the loss of volume, as in the hearths of Puig de la Nau (Benicarló, Castellón) (Figure 17b), or the gradual reduction in thickness, as gradually experienced in the adobe structures of Cerro de la Cruz (Almedinilla, Córdoba) until their definitive enhancement (Figure 17c). Occasionally, the placement of structures in spaces with changes in elevation, such as the cob wall of Caramoro I (Elche, Alicante) [52], could cause future problems due to the lack of signage (Figure 17d). Visitor carving, on the

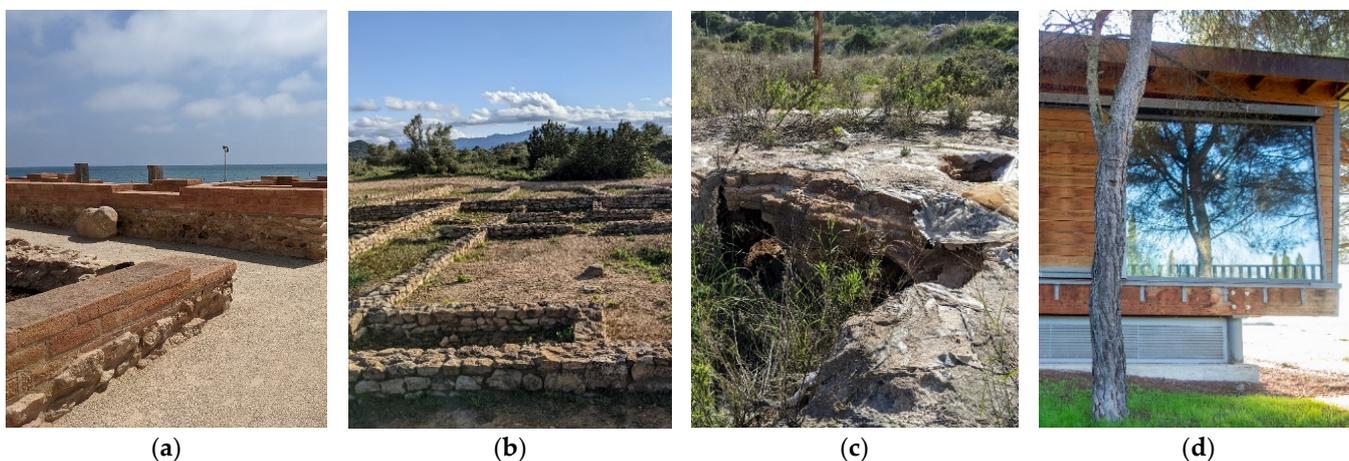
**Figure 20.** Examples of the impact of other anthropogenic factors: (a) Loss of structures due to the absence of relief measures, due to the delayed acquisition of remains at Illeta dels Banyets (El Campello, Alicante); (b) Dismantling of pavement and adobe benches for documentary reasons to complete the archaeological sequence at Castellet de Banyoles (Tivissa, Tarragona); (c) Abandonment and risk of urbanization over kilns at Tossal de les Basses (Alicante); (d) Ventilation of structures in the semi-basement of the container building of Cerro de la Mota (Medina del Campo, Valladolid).

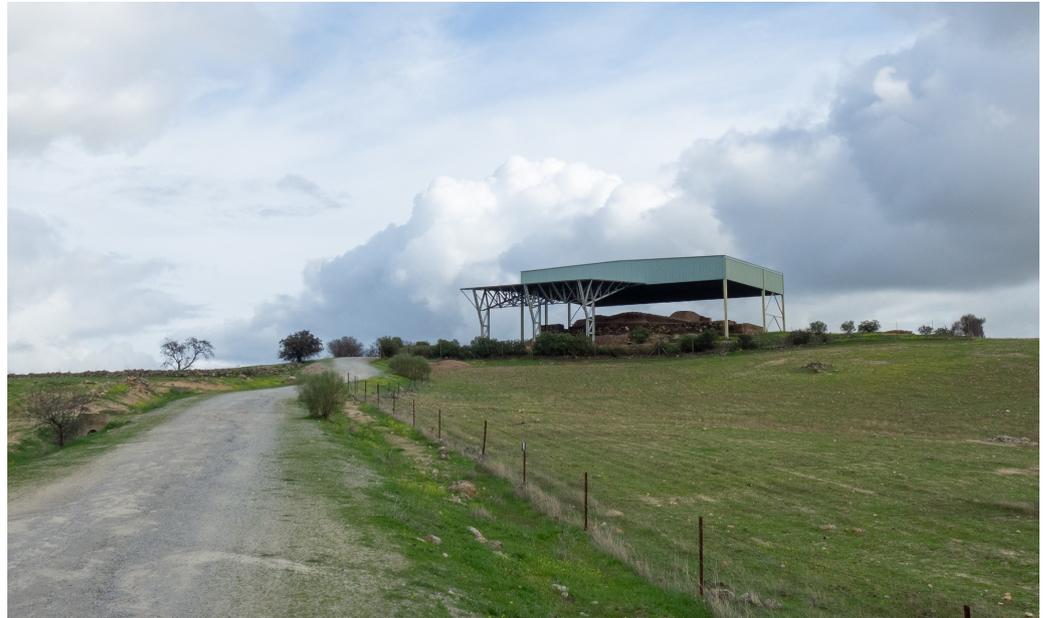
**Figure 26.** Enhancement and protection through permanent covers in La Mata (Campanario, Badajoz), as a focal point in municipal tourism promotion.
