An Integrated Plastic Contamination Monitoring System for Cotton Module Feeders

Citation: Wanjura, J.D.; Pelletier, M.G.; Holt, G.A.; Barnes, E.M.; Wigdahl, J.; Doron, N. An Integrated Plastic Contamination Monitoring System for Cotton Module Feeders. *AgriEngineering* **2021**, *3*, 907–923. <https://doi.org/10.3390/agriengineering3040057>

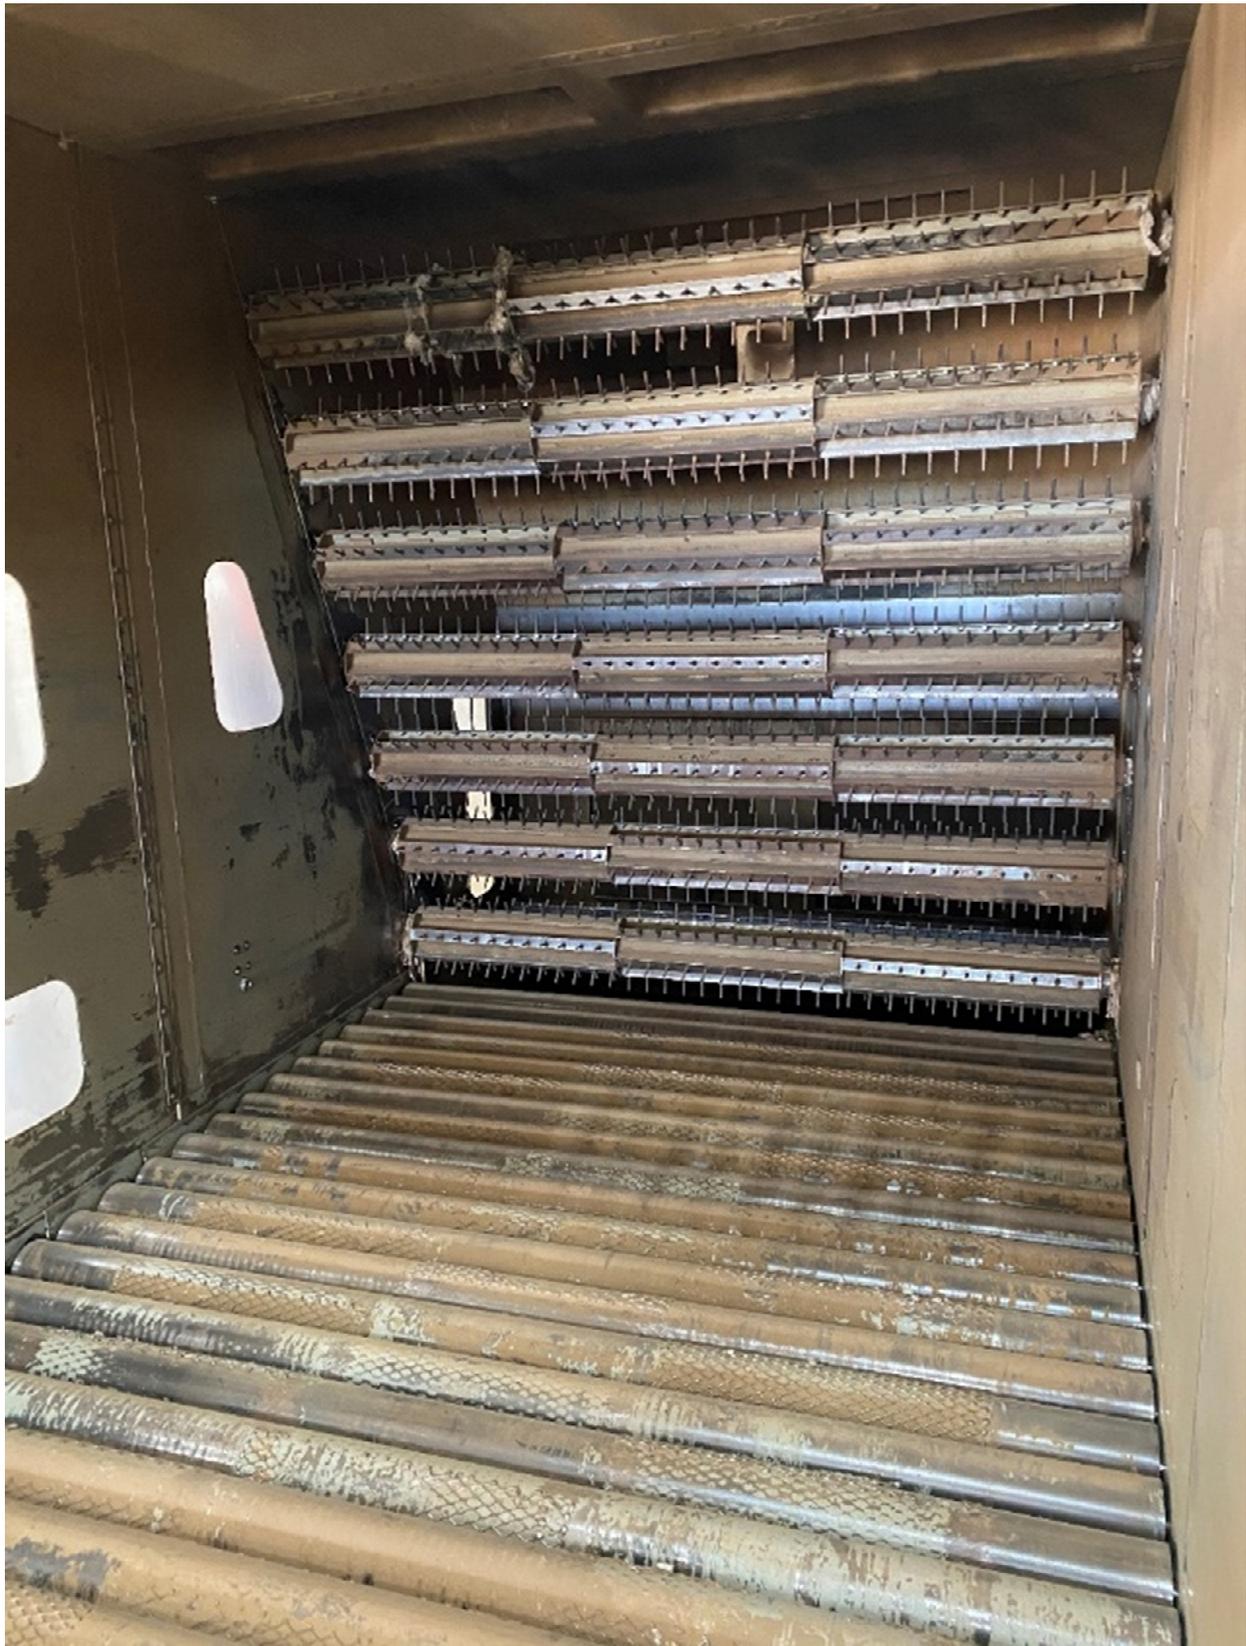
Figure 1. Module feeder dispersing cylinders used to break apart cotton modules and feed the material into the ginning process. Dispersing cylinders are approximately 2.75 m long and 46 cm tip to tip diameter covering a total vertical height above the bed rollers of about 3.25 m.

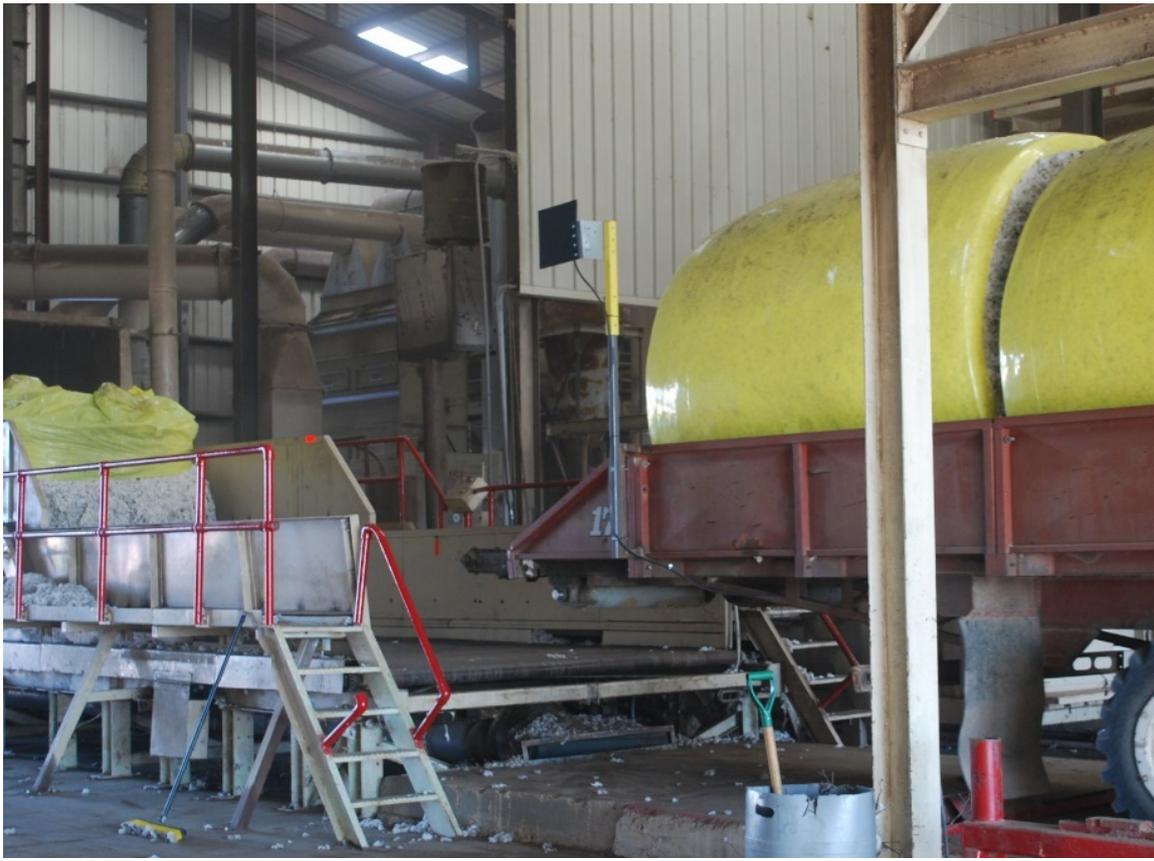
Figure 2. Photo of the intake end of a cotton module feeder showing round cotton modules being unloaded from a transport vehicle onto the feeder bed.

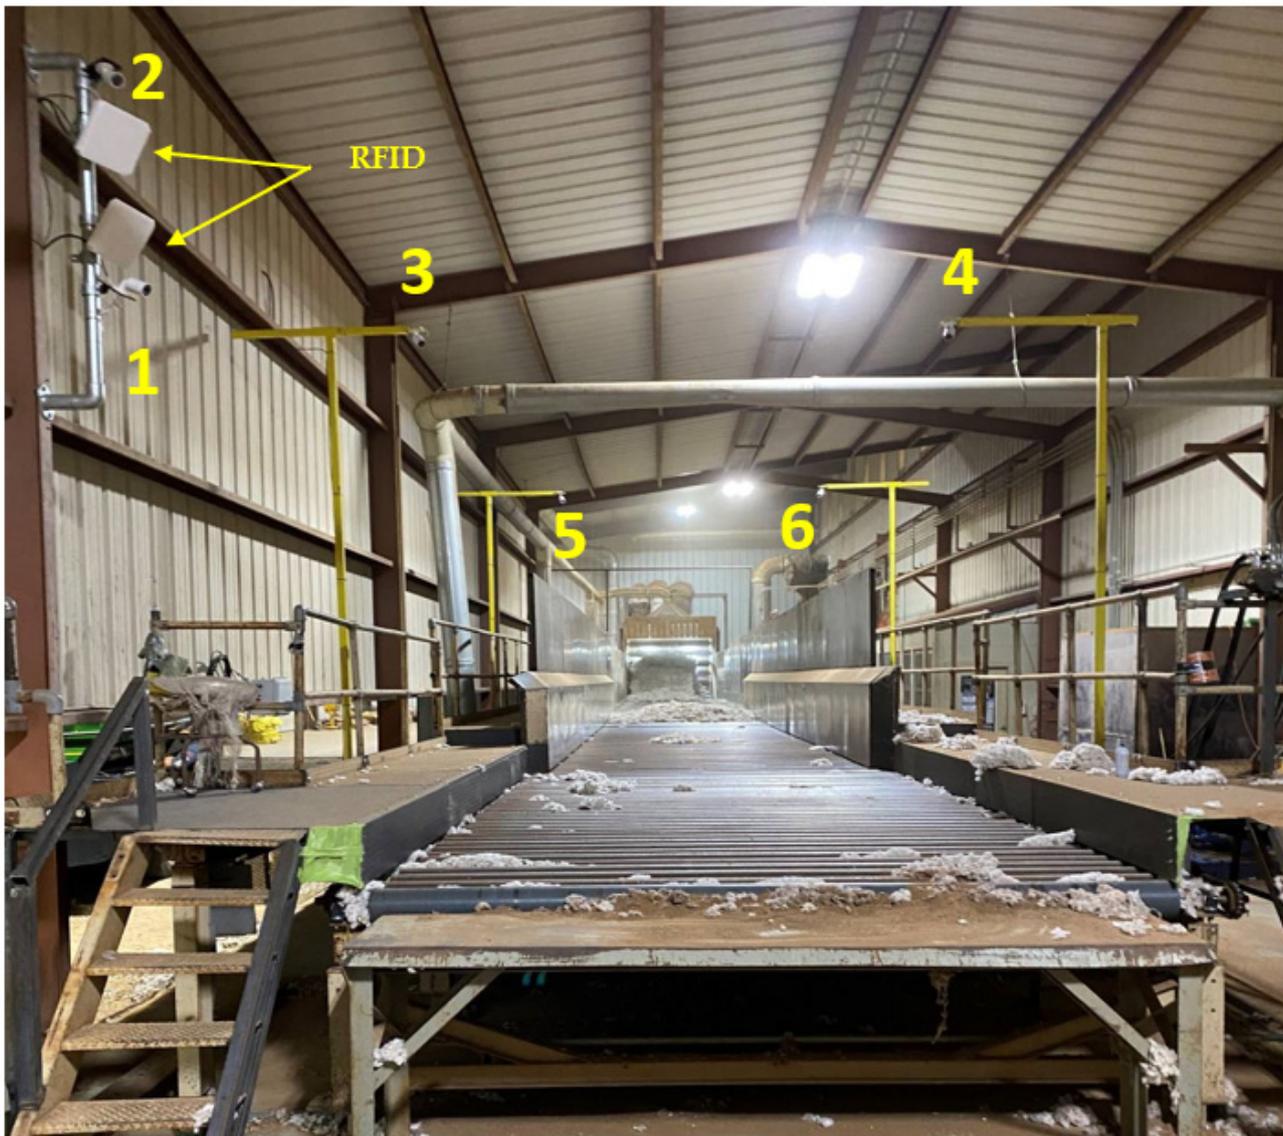
Figure 3. Photo showing camera position numbers 1–6 used on the module feeder at one commercial gin installation in 2020. RFID antennae located between camera positions 1 and 2 were focused on a region located about 2.5 m above the midpoint of the first roller on the module feeder bed. Camera positions 1 and 2 were configured to record the condition of the module covers before the modules were placed on the feeder by the transport vehicle. Camera positions 3 and 4 were configured to record the cover removal process as each module was placed on the module feeder bed. Camera positions 5 and 6 were configured to provide a more general view of the entire process of cover removal and placement of modules on the feeder bed and provide a final view of the cotton in each module before passing to the dispersing cylinder end of the feeder.

The RFID Feeder Bridge system [10,11] was deployed at the intake end of the module feeders to scan the RFID tags contained in the plastic wrap on each round module and create a timestamped processing log for all modules placed onto the module feeder (Figure 3). The plastic material covering each round module contained four passive ultra-high frequency RFID tags that were affixed to the plastic film by the manufacturer during production. The RFID tags in each individual module cover portion were preprogrammed by the manufacturer with a hexadecimal module identifier string that contained a serial number unique to each module. Two left-hand circular polarized antennas (PAL90209H, Laird Connectivity, Akron, OH, USA) were mounted approximately 4 m above the location where modules were placed onto the feeder bed to interrogate the RFID tags in each module. Radio frequency energy from the antennae was focused on a circular region (approximately 3–4 m diameter) centered about 2.5 m above the first roller on the module feeder bed. The antennas were controlled by an RFID reader (Speedway R420, Impinj, Seattle, WA, USA) that transferred RFID scan data (module identifier and scan timestamp) to custom written software running on a Windows 10 (Microsoft, Redmond, WA, USA) ruggedized computer (K300, OnLogic, South Burlington, VT, USA) through a power over ethernet (PoE) connection. The RFID Feeder Bridge software generated a datafile containing a time-ordered list of the following data for each module scanned: date and time of scan event, module serial number, cotton ownership data (client/farm/field), cotton cultivar, wrap color, and gin load number.

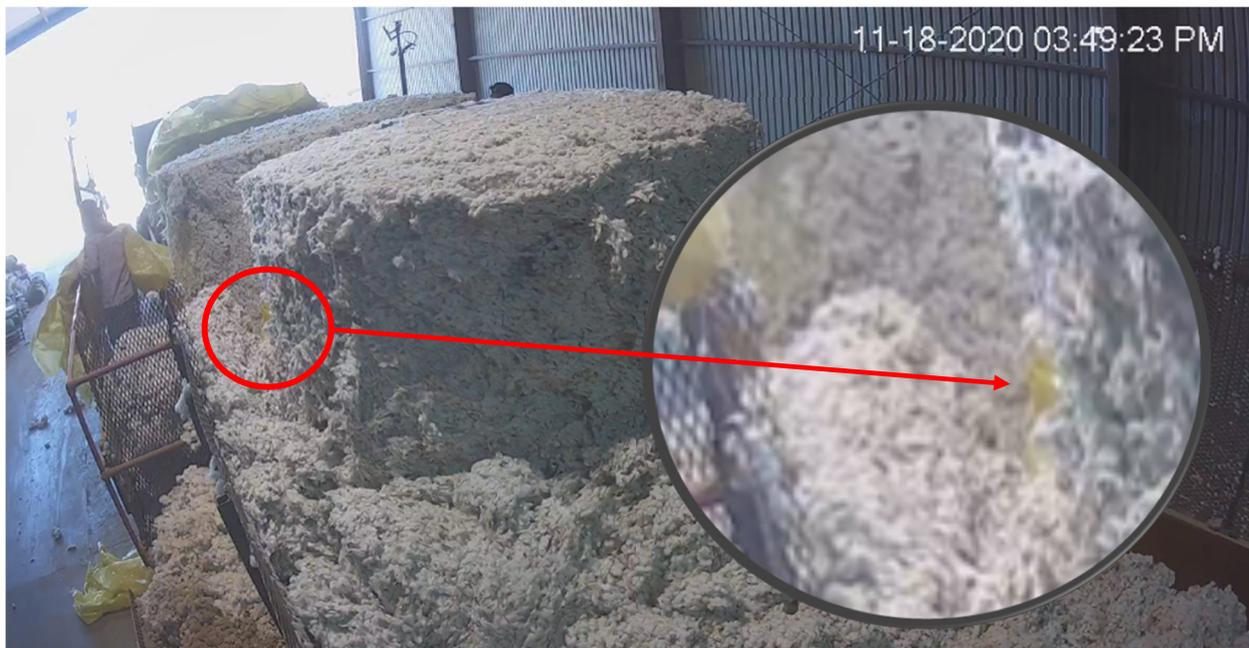
Figure 14. Still image from the unloading video captured for module SN 19410229688 showing a piece of yellow plastic remaining in cotton between modules (inside red circle) after the wrap was removed from the top of the module.

An example of one potential contamination event captured by the integrated module feeder monitoring system at a commercial gin in 2020 is shown in Figures 12–14. In this event, yellow module wrap plastic was caught by the lowest dispersing cylinder as seen in the image from the bottom module feeder camera image (Figure 12). Upon removal of the plastic from the dispersing cylinder, the module was identified by serial number 19410229688 from the RFID tag found on the plastic (Figure 13). Using the module serial number, the unloading/unwrapping video for the module was directly extracted and viewed from the report file generated by the IRB software. The video showed that the module was unloaded properly with no issues and the plastic was cut and pulled to the top of the module as is standard practice at the gin. However, when the wrap was finally cut and removed from the module as it reached the midpoint of the module feeder, a piece of the yellow plastic material fell between module 19410229688 and the previously unloaded module (Figure 14). The workers were unable to see the plastic in the cotton between the modules as a portion of the cotton from 19410229688 fell burying the plastic.

An additional challenge to be addressed in future developments of this system is to provide gin workers an indication of when plastic has been detected on the module feeder bed. As shown in Figure 14, the system was able to document the event where plastic was inadvertently allowed to remain in the cotton. Had the gin worker been alerted to the condition by the integrated plastic contamination monitoring system, they could have taken action to remove the plastic before it was caught by the dispersing cylinders (Figure 12).
